**ATLANTIC INTRACOASTAL
WATERWAY
MAINTENANCE DREDGING
NASSAU COUNTY REACH I, FLORIDA**

DMMA NA-1 Site Reconnaissance Report
DMMA DU-2 Site Reconnaissance Report

Re: Professional Engineering Services, Task 1.2 DMMA Reconnaissance (NA-1)
Maintenance Dredging of Nassau Reach I and Applicable Portions of Fernandina Harbor Project,
Nassau County, FL
FIND Work Order 15-08; TE Contract C2015-048

Re: Professional Engineering Services, Task 1.2 DMMA Reconnaissance (DU-2)
Maintenance Dredging of Nassau Reach I and Applicable Portions of Fernandina Harbor Project,
Nassau County, FL
FIND Work Order 15-08; TE Contract C2015-048

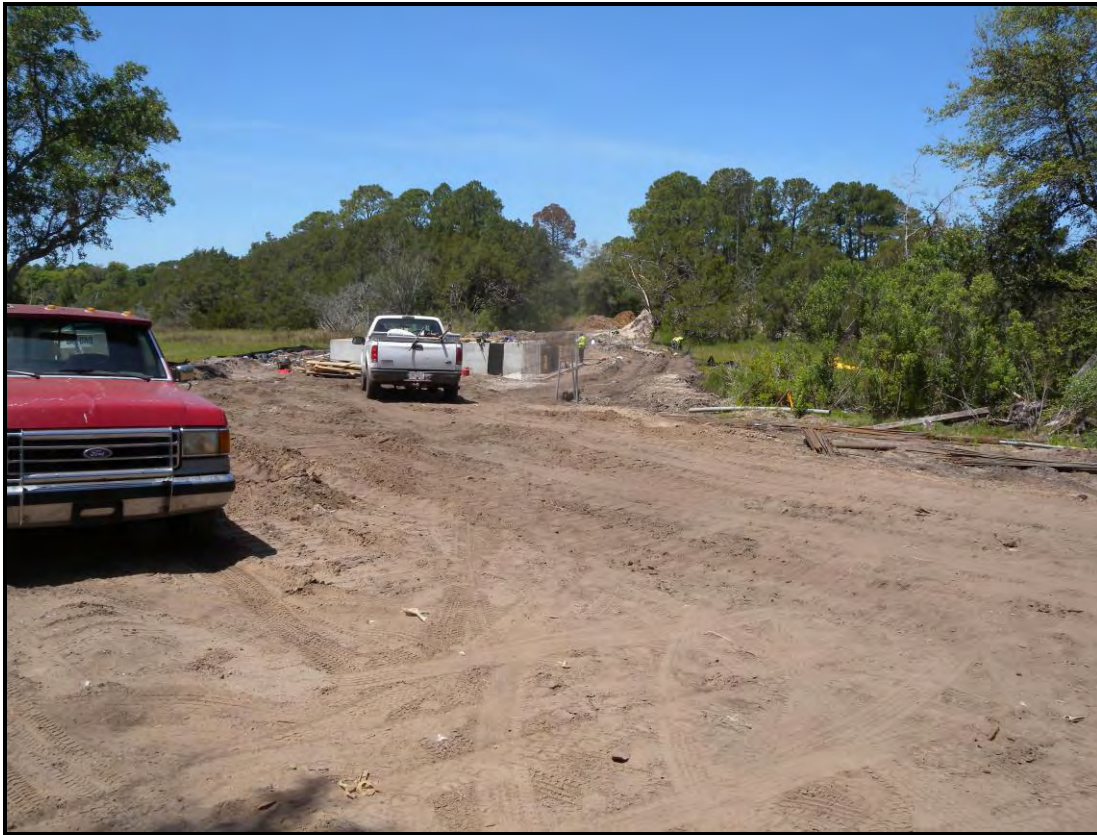
- (1) The primary access road to the site was blocked by ongoing culvert construction (Attachment B, Image 1). At the time of our visit the construction crew, employed by the Crane Island land developer, indicated that culvert construction would be complete within two weeks. Access to the site is critical to completion of geotechnical and maintenance tasks required prior to use of the site.
- (2) In general, the containment basin and dikes are well vegetated; however, portions of the site are becoming overgrown with vegetation due to lack of access to the site (Attachment B, Images 2, 3, and 6-8).
- (3) The dike exterior contains a large number (15+) of armadillo (*Dasypus novemcinctus*) burrows (Attachment A, Images 19 and 20) that will require repair prior to dredging commencement.

Image 1. View towards west northwest of access road box culvert installation in progress

- (1) Coordinate with the Crane Island land developer to ensure permanent access will be available for the upcoming dredging project and future DMMA operation and maintenance. This is critical path for the upcoming maintenance dredging job.
- (2) Prior to use of the site:

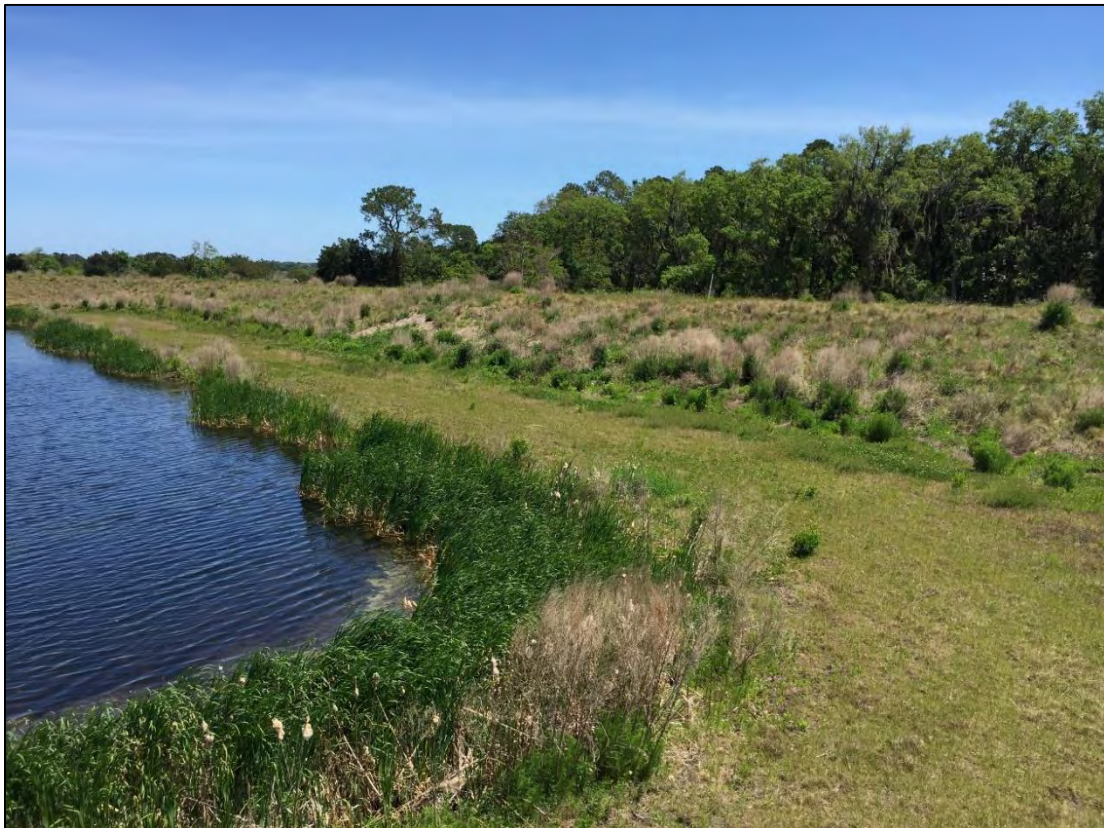
Image 14. Looking southeast from weir deck at southern dike

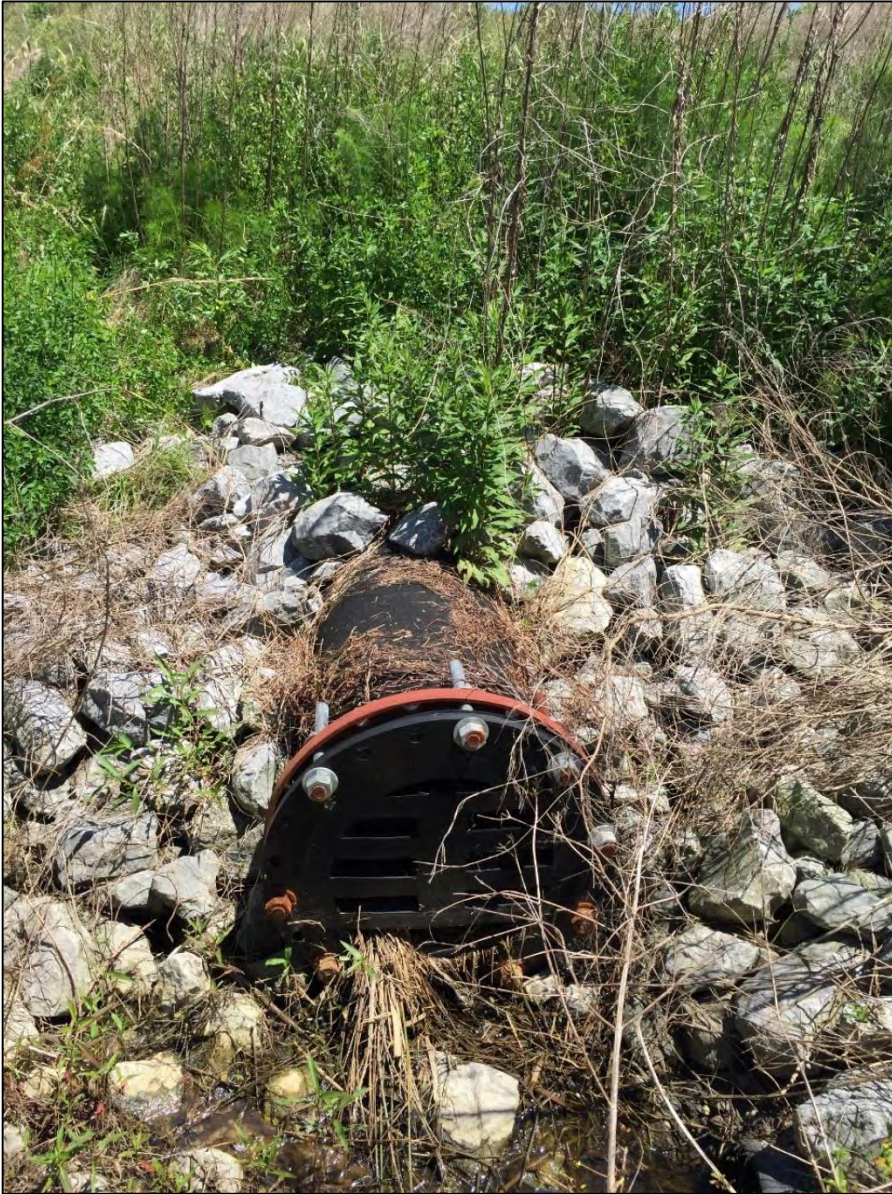
The overall weir condition appeared excellent. The timber decking and weir structure showed no readily visible evidence of settling, cracking, or warping. In addition, the HDPE weir outfall pipes showed no signs of decay and the flanged outfall end is readily accessible with stainless hardware in good condition (Attachment B, Image 15).

Image 15. Looking east at flanged end of weir outlet pipe

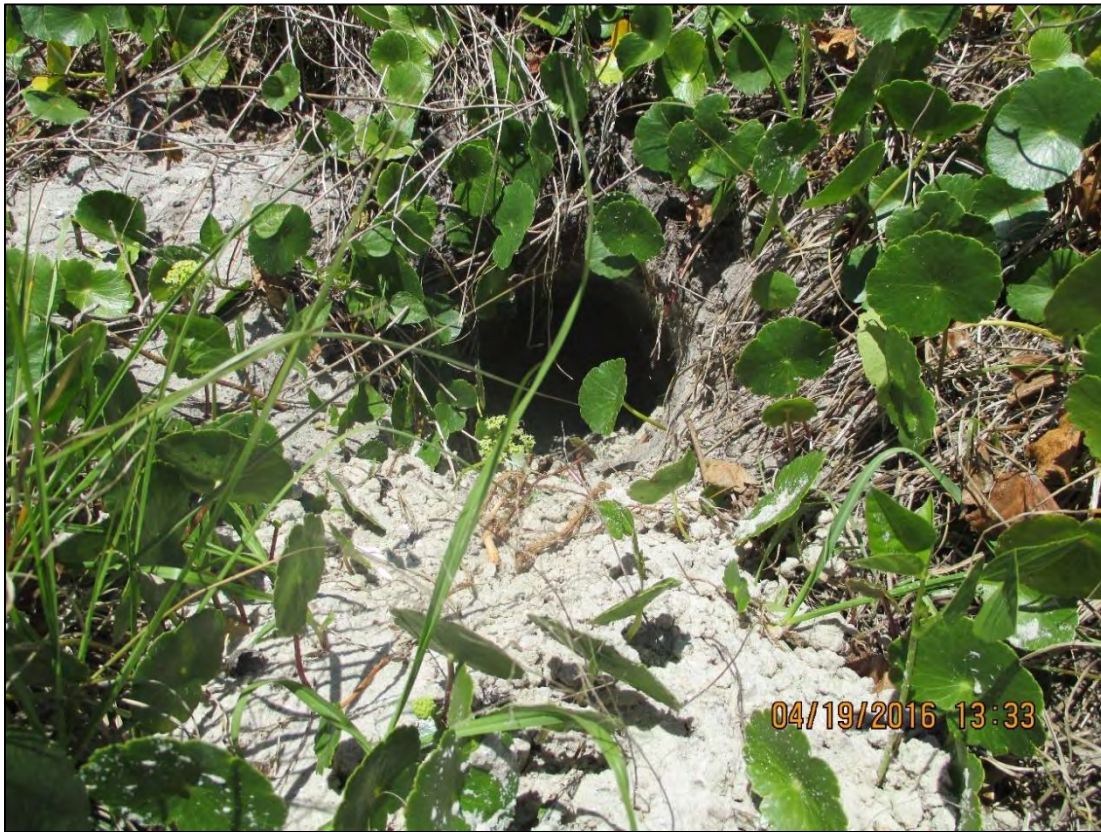
Image 19. Animal burrow into southern stability berm

- a. Mow all dikes, roads, and exterior areas, including areas leading to the two western pipeline access gates.
- b. Within 90 days of construction commencement, complete a biological survey to identify all animal burrows within site embankments. Backfill all burrows prior to use of the site. Restoration measures for the burrows can be found in "Technical Manual for Dam Owners, Impacts of Animals on Earthen Dams", FEMA 473; page 58 Section 5.3.1 Restoration Measures.

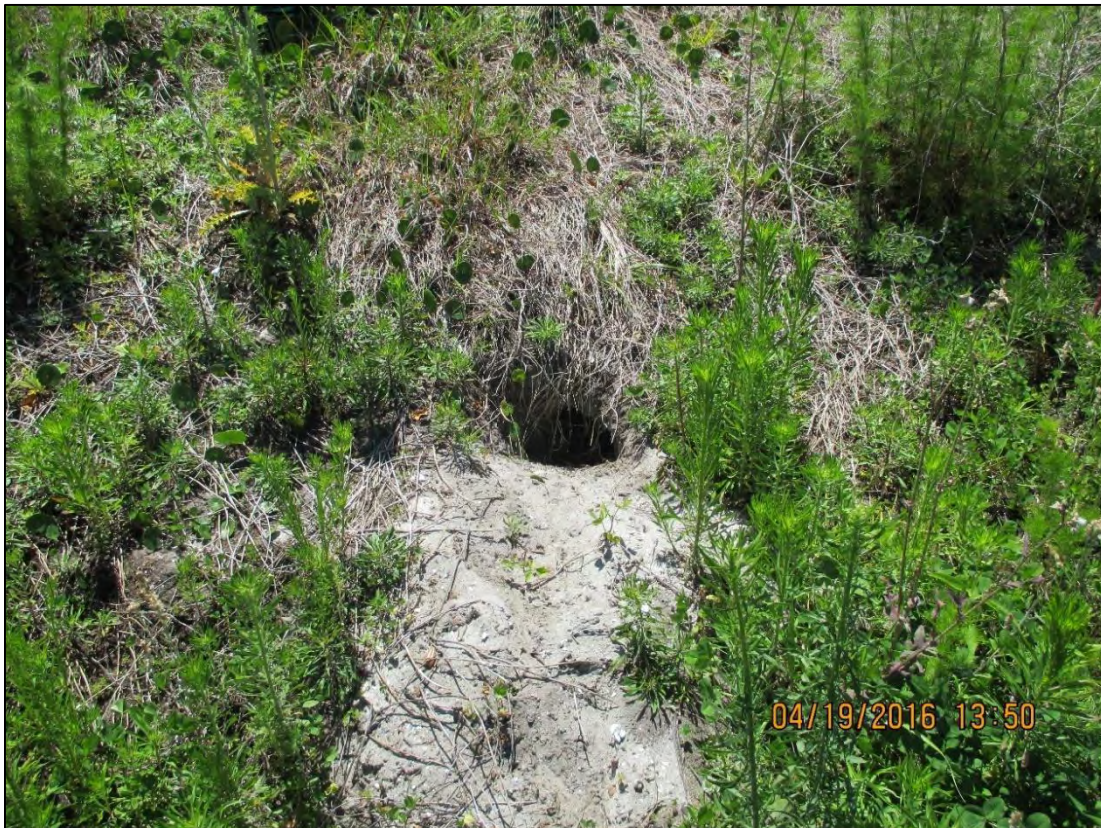
Image 20. Animal burrow into eastern stability berm

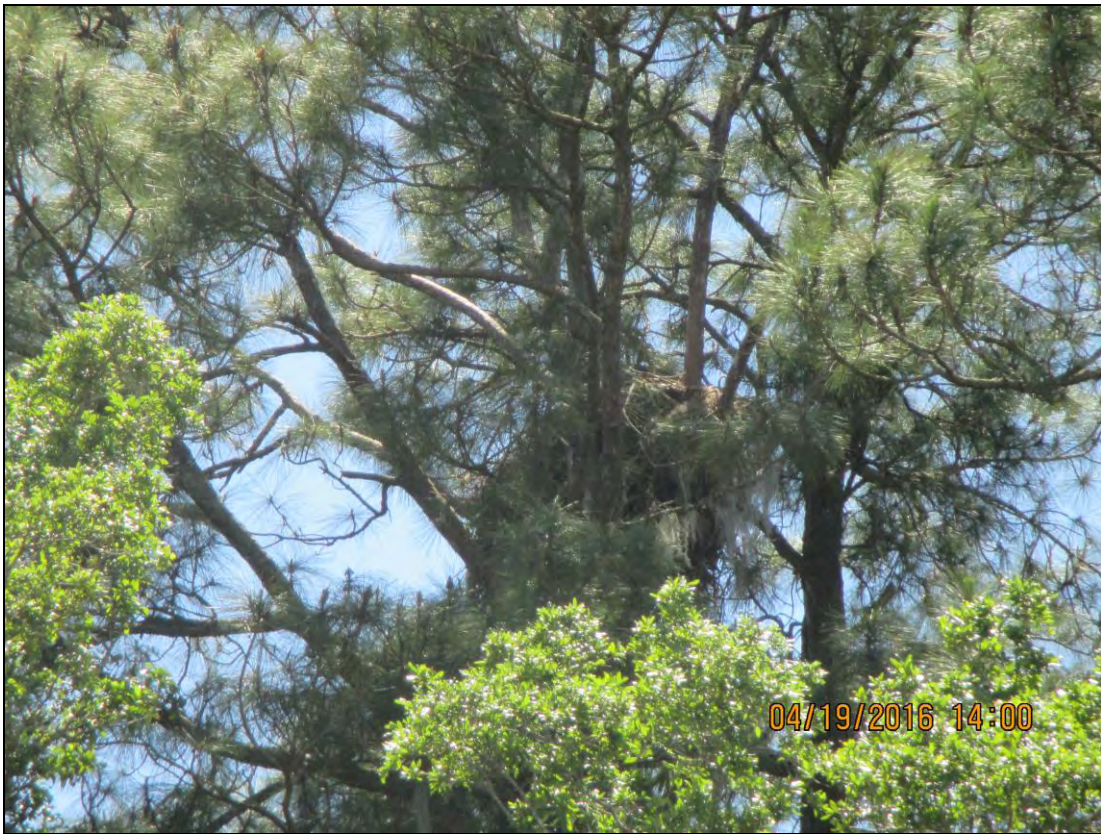
During the site visit Taylor Engineering staff identified eagle nest NA911 in its described location (Appendix B, Image 31). Staff members also observed the presence of one juvenile and one adult bald eagle in close proximity to the nest (Appendix B, Image 32). No nesting activities were observed during the site visit. Through ongoing permitting activities for the upcoming construction project, Taylor Engineering is coordinating with USFWS and Environmental Services, Inc., FIND's environmental consultant for the eagle nest, to ensure that proper measures are taken to limit disturbance to the eagles.

Image 31. Looking south toward active eagle nest at southwestern corner of DMMA site

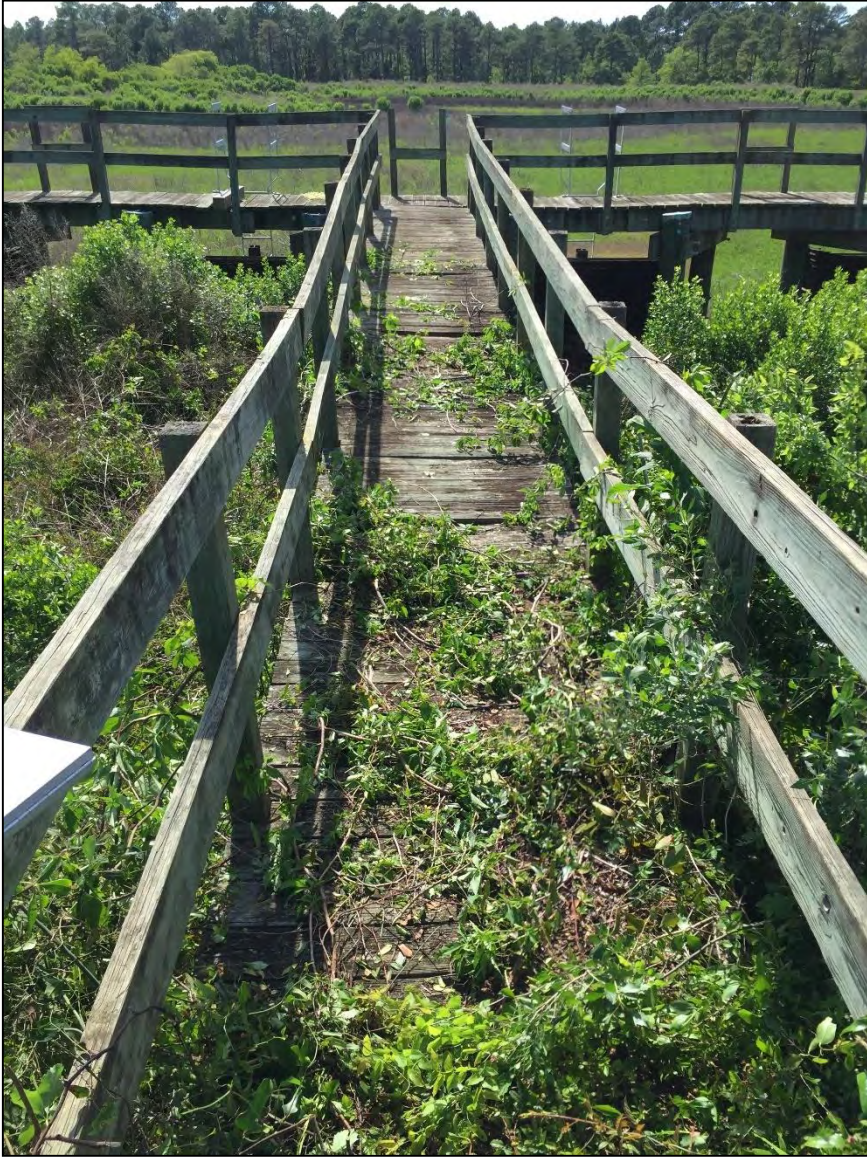
- (2) The timber decking of the weir walkway is rotted, with broken or missing boards in many places (Attachment B, Images 13-16).
- (3) There is no guard rail or chain along the western timber deck platform (Attachment B, Image 14).

Image 13. Looking west along weir timber deck walkway

- (1) Prior to the next use of DU-2, replace the weir system.
 - When weirs are replaced, the upgrades should consider steel frame boxes, composite weir boards, and HDPE discharge pipes
- (2) During future uses, require the dredging contractor to extend the existing corrugated metal outfall pipe such that discharge occurs in the ICWW channel, in compliance with the DU-2 management plan, to prevent further shoreline erosion.
- (3) Consider shoreline restoration for the eroded shoreline that has resulted from the discharge.
- (4) Within 90 days of construction commencement, complete a gopher tortoise survey. Either trap and relocate tortoises or mark and fence off a 25-foot radius around any tortoise burrows.
- (5) Backfill all mammal burrows in the embankments.

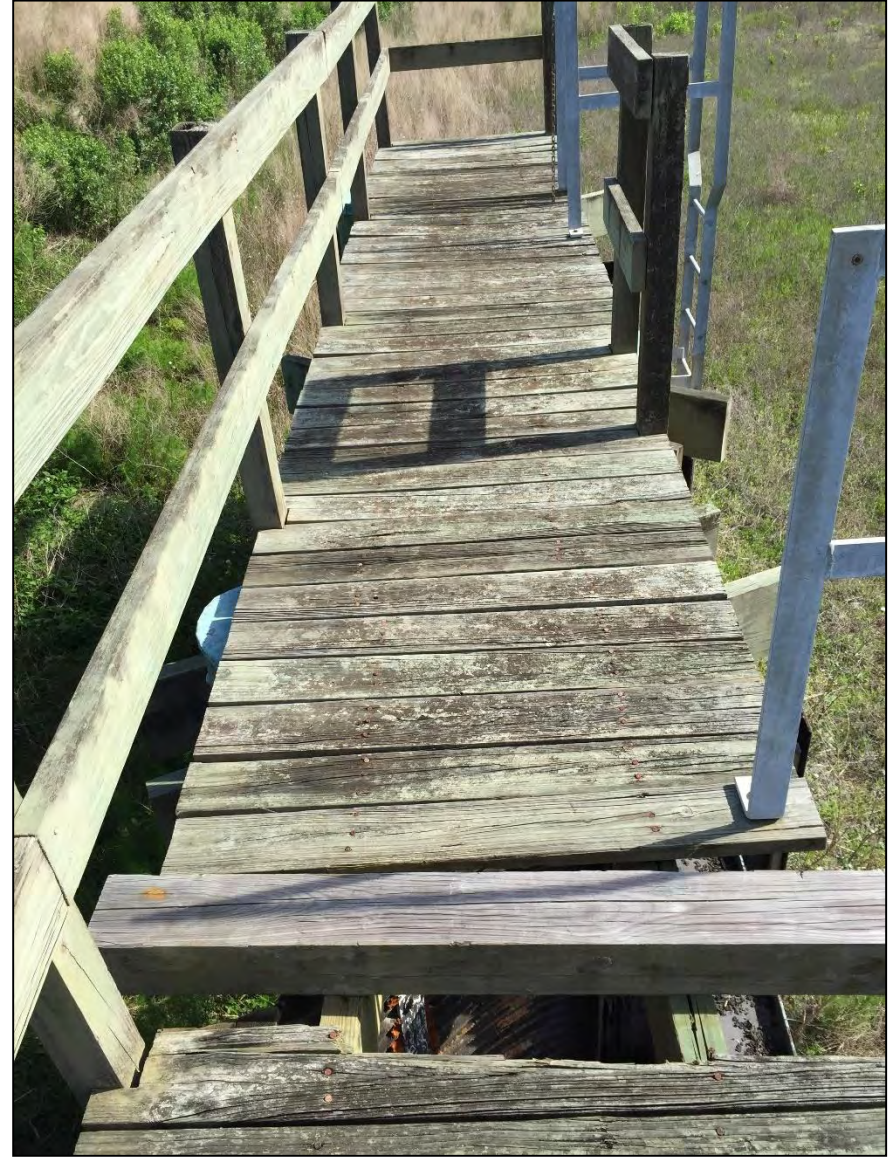
Image 14. Looking south along weir walkway timber deck

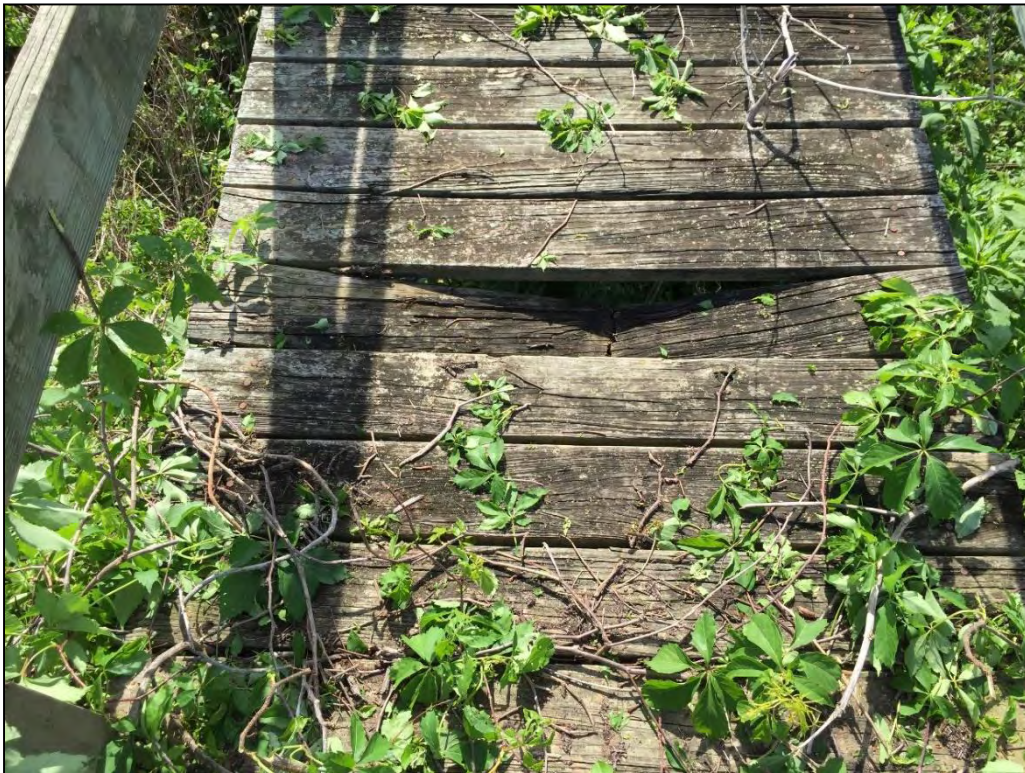
Image 15. Broken board on weir walkway timber deck

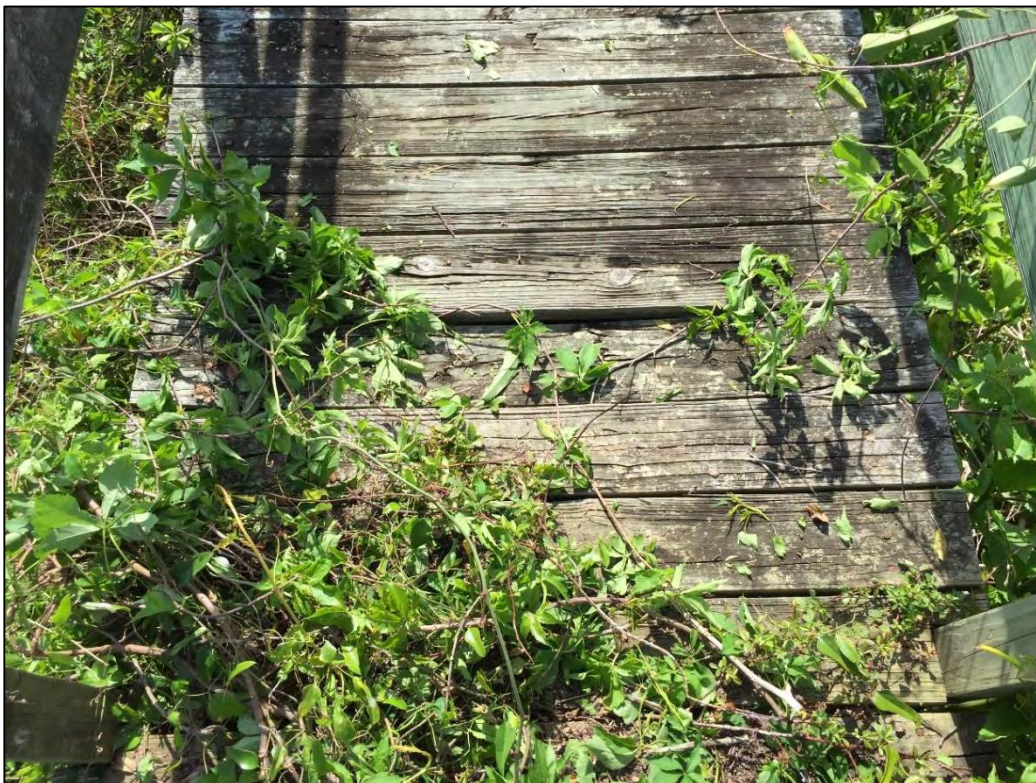
Image 16. Broken, decaying, board on weir walkway timber deck

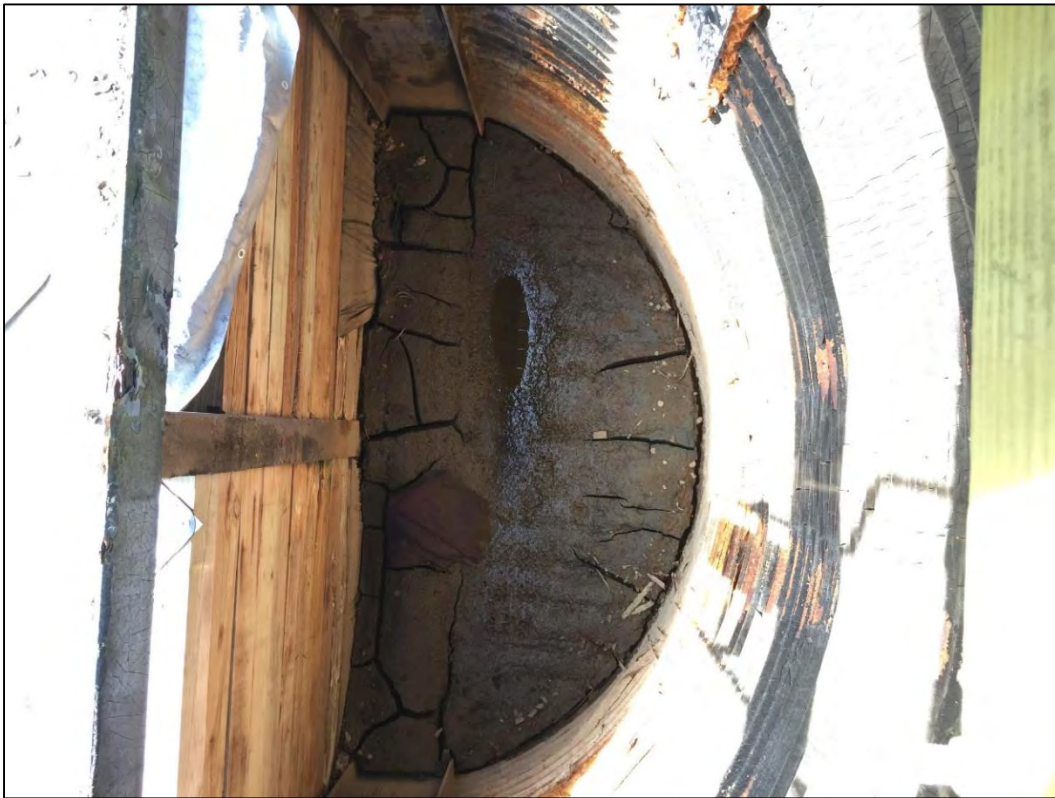
- (4) 3 out of 4 of the weir inlets are blocked with sandbags. One weir inlet is blocked with sediment (Attachment B, Images 17 and 18).
- (5) There are no individual weir boards (removable flashboards). It appears that the last user controlled the weirs using plywood sheets backed by vinyl tarps (Attachment B, Image 20).

Image 17. Looking into weir #3 at sediment blocking inlet

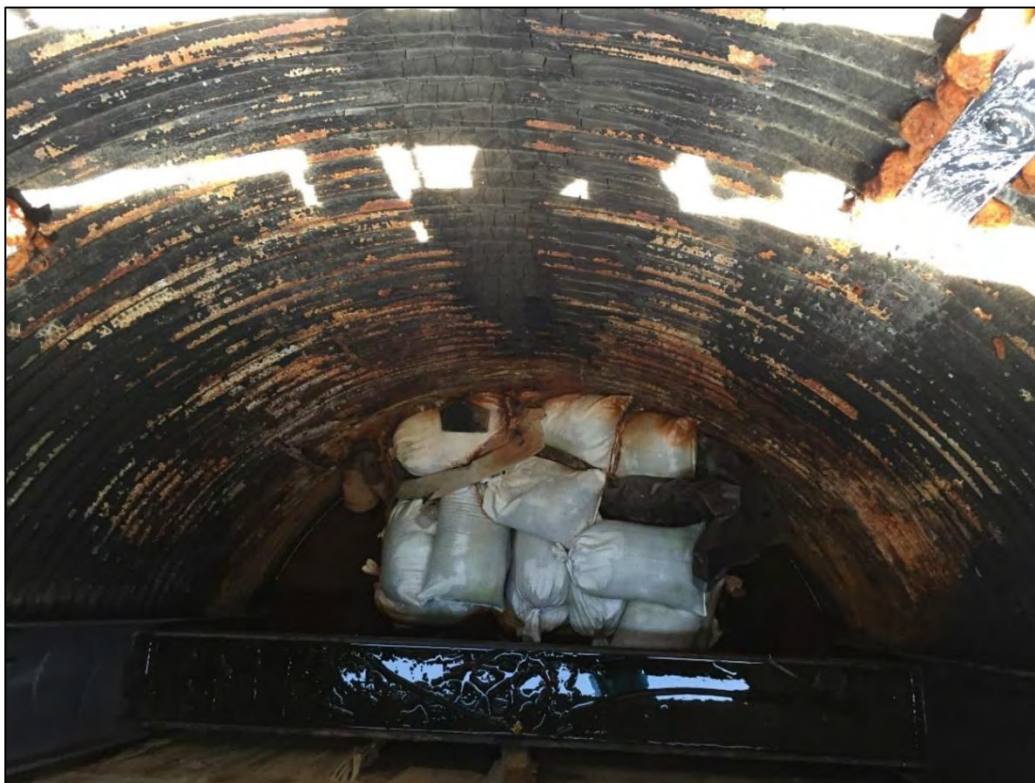
Image 18. Looking down into sandbag blocked weir #1 inlet. Weirs 2, and 4 are in the same condition

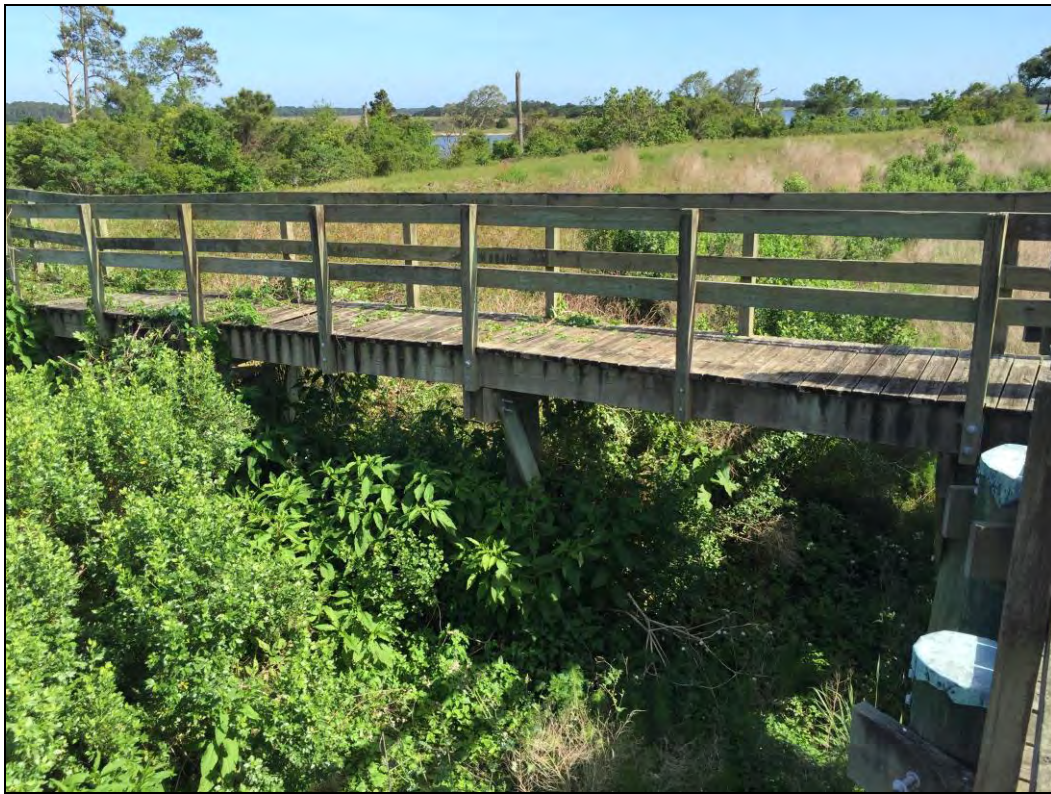
From the above observations, the overall weir condition appeared poor and in need of significant repair or replacement prior to the next use. The main structure of the weir showed no readily visible evidence of settling, cracking, or warping; however, it was relatively overgrown with vegetation (Attachment B, Images 19-21) and the exterior of the standpipes appeared in poor condition.

Image 19. Looking southeast at timber deck walkway and eastern dike

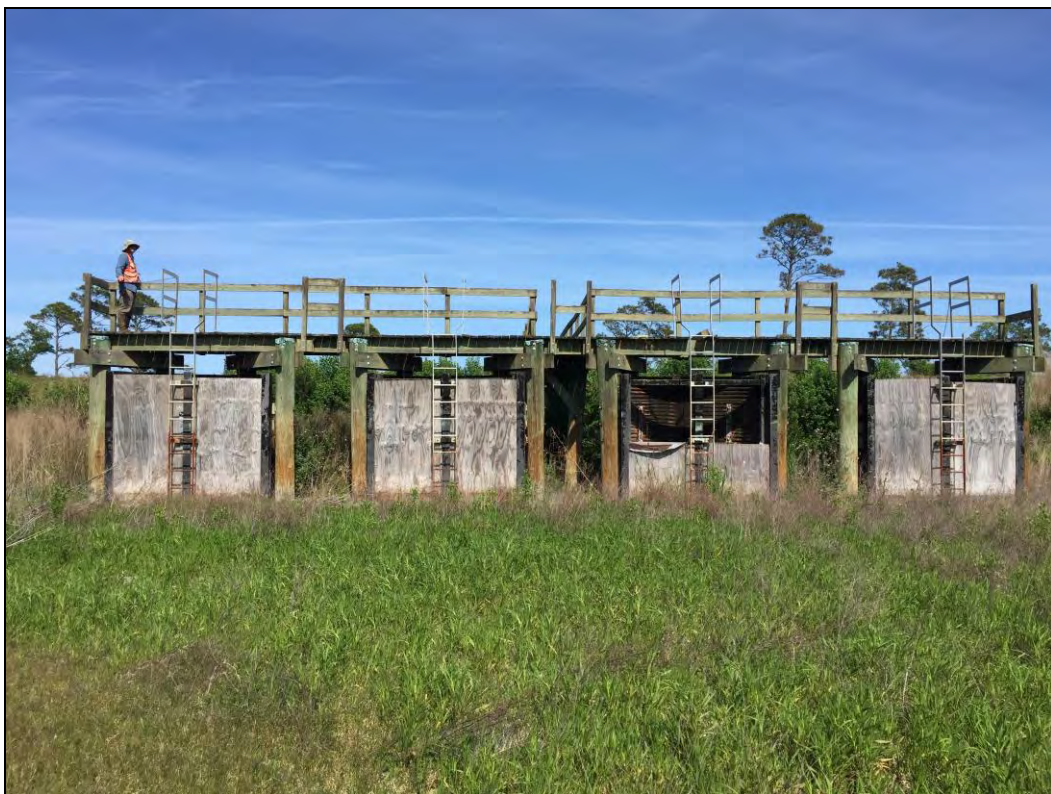
Image 20. Looking east from DMMA interior at weirs

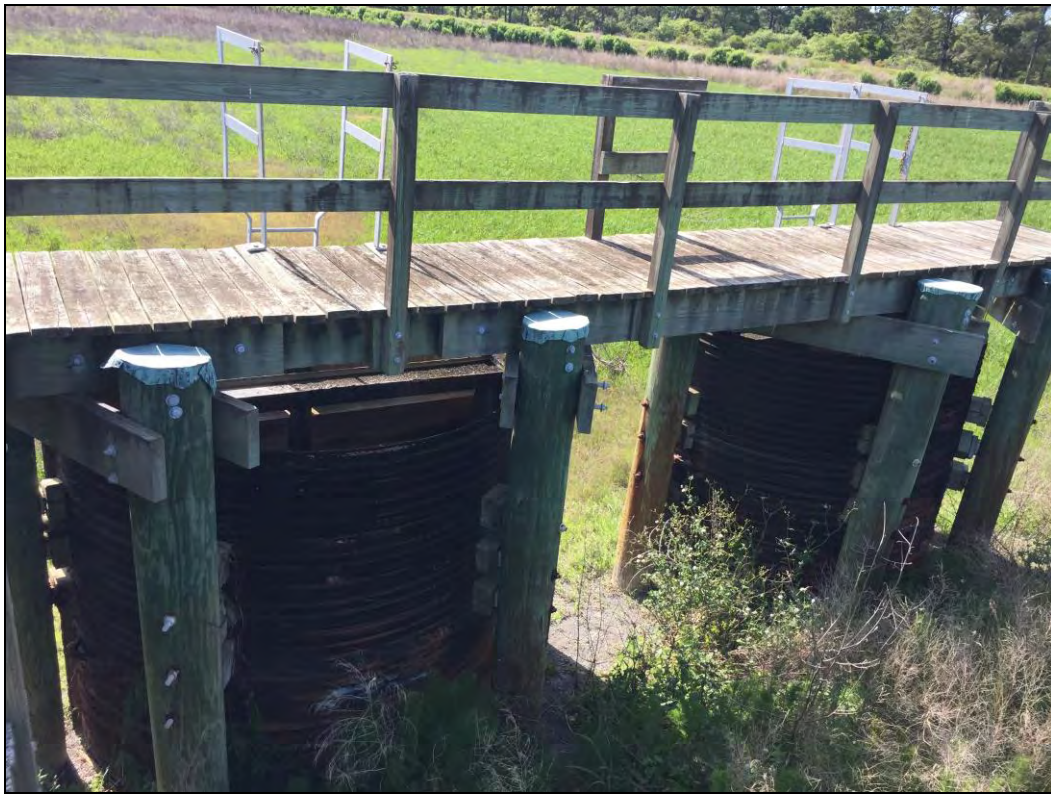
Image 21. Looking northeast at backside of weirs 1 and 2 and timber deck walkway

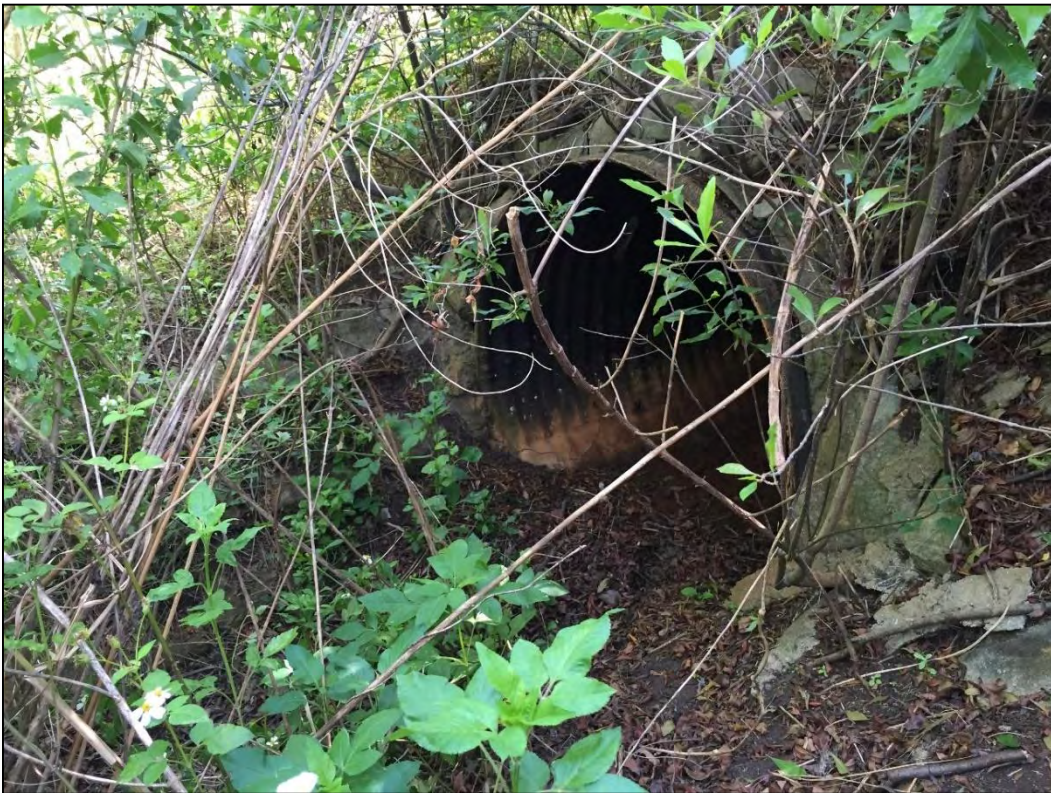
It appears that previous users of the site have allowed discharge water to flow out of the main outfall pipe (Attachment B, Image 22) and into an outfall ditch back toward the Intracoastal Waterway (ICWW). This has caused significant shoreline erosion at the northern pipeline access point. There is evidence of a previous use of temporary gabions as a shore protection measure, however these gabions have failed and are no longer effective. The shoreline at the northeastern corner of the site is eroded under the fence and access gate (Attachment B, Image 27).

Image 22. Looking west at weir outfall pipe

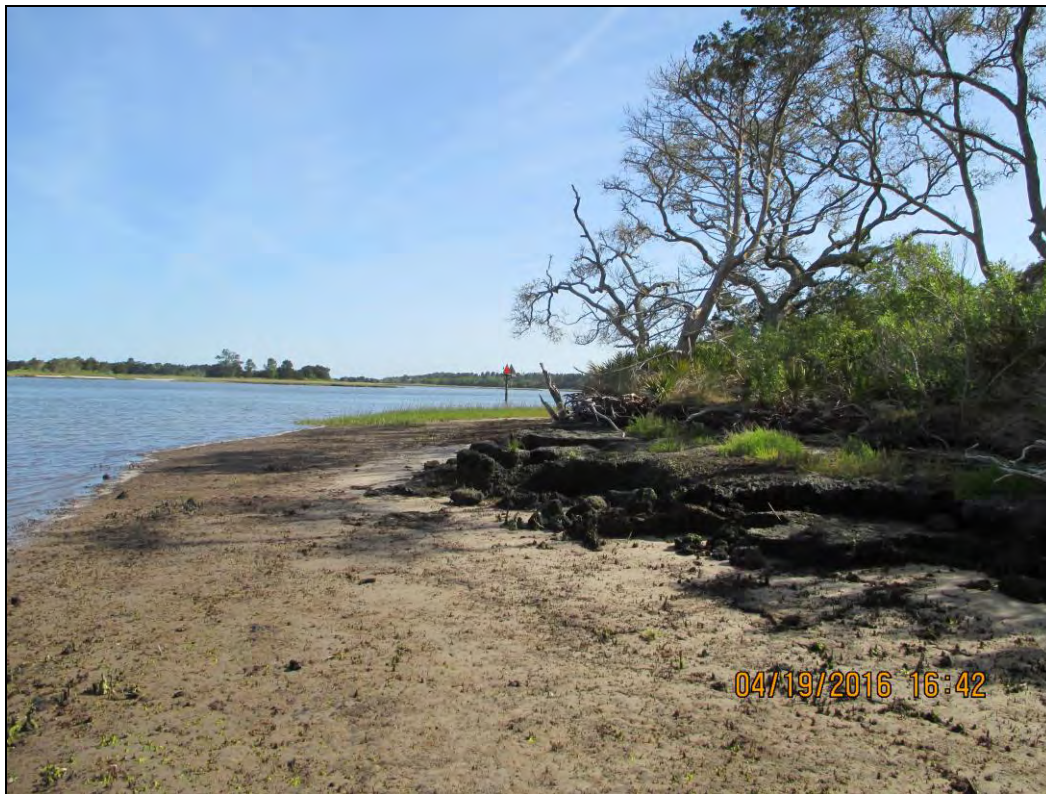
- (6) The exterior of the existing half-pipe weirs appear in poor condition and highly corroded.
- (7) The shoreline at the northern pipeline access area (outfall) is severely eroded (Attachment B, Images 25-27).

Image 25. Looking south from northern pipeline access point

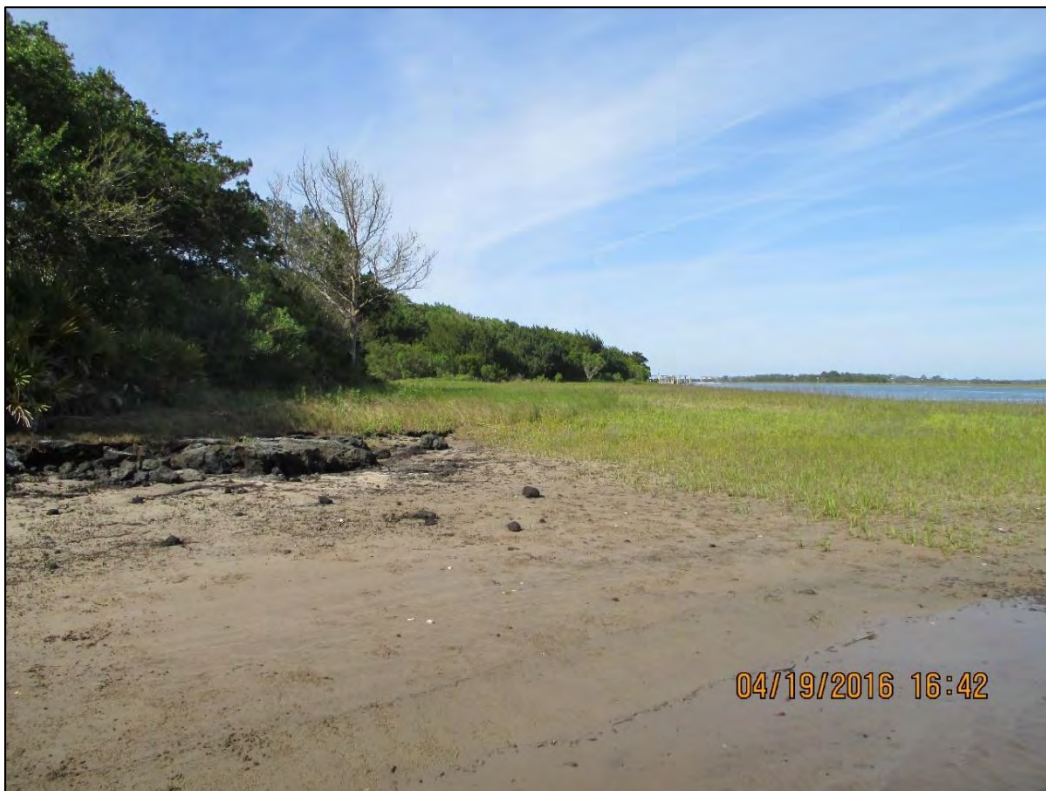
Image 26. Looking north from northern pipeline access point

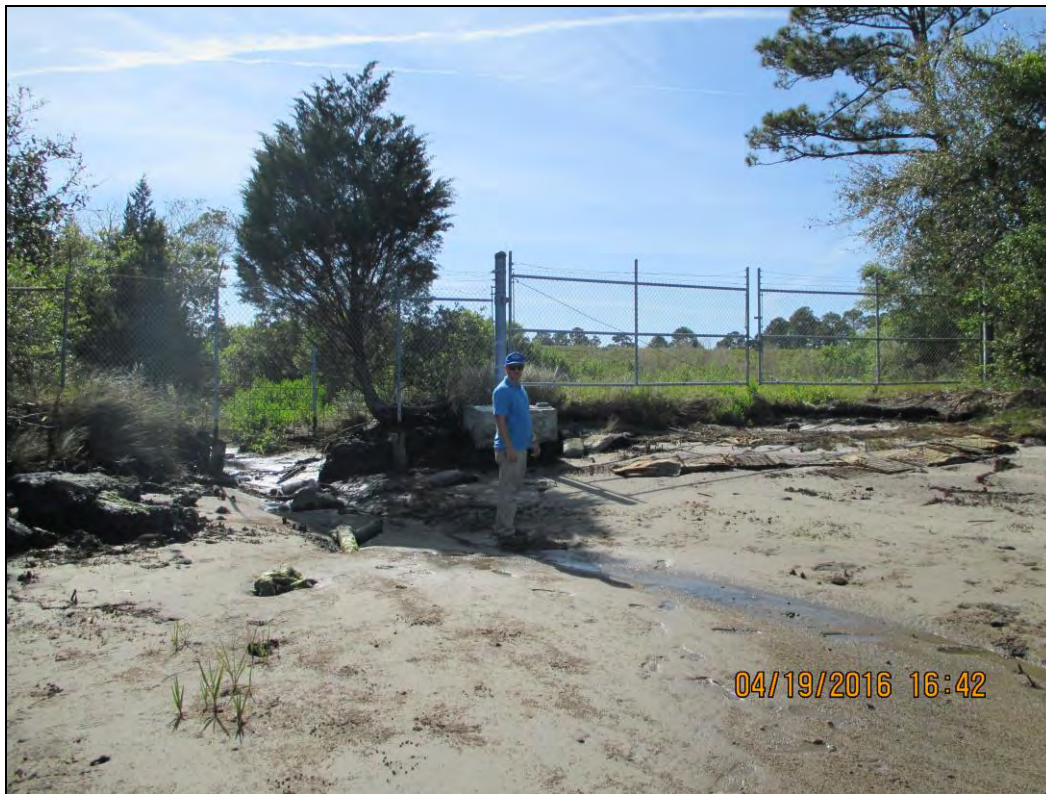
Image 27. Looking west at eroded shoreline of northern pipeline access point and weir outfall ditch

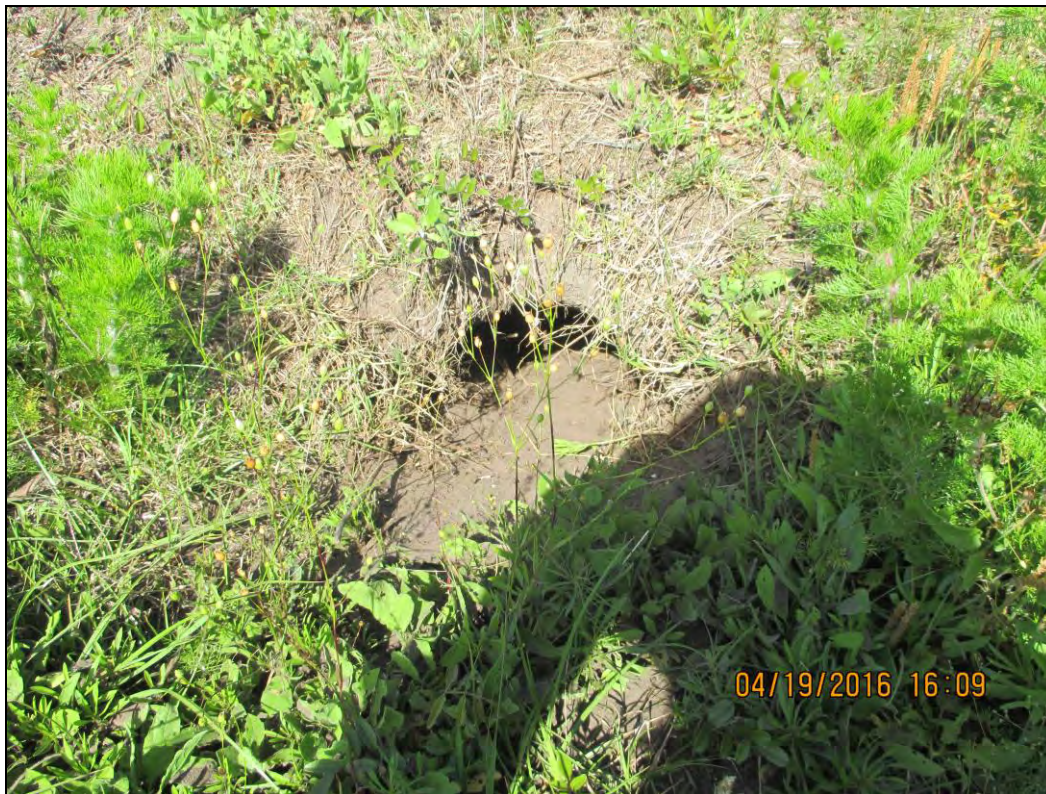
- (8) A gopher tortoise burrow and several mammal burrows occurred in the exterior slopes of the western embankments (Attachment B, Images 31 and 32).

Image 31. Looking east at a gopher tortoise burrow into the exterior of the southwestern embankment

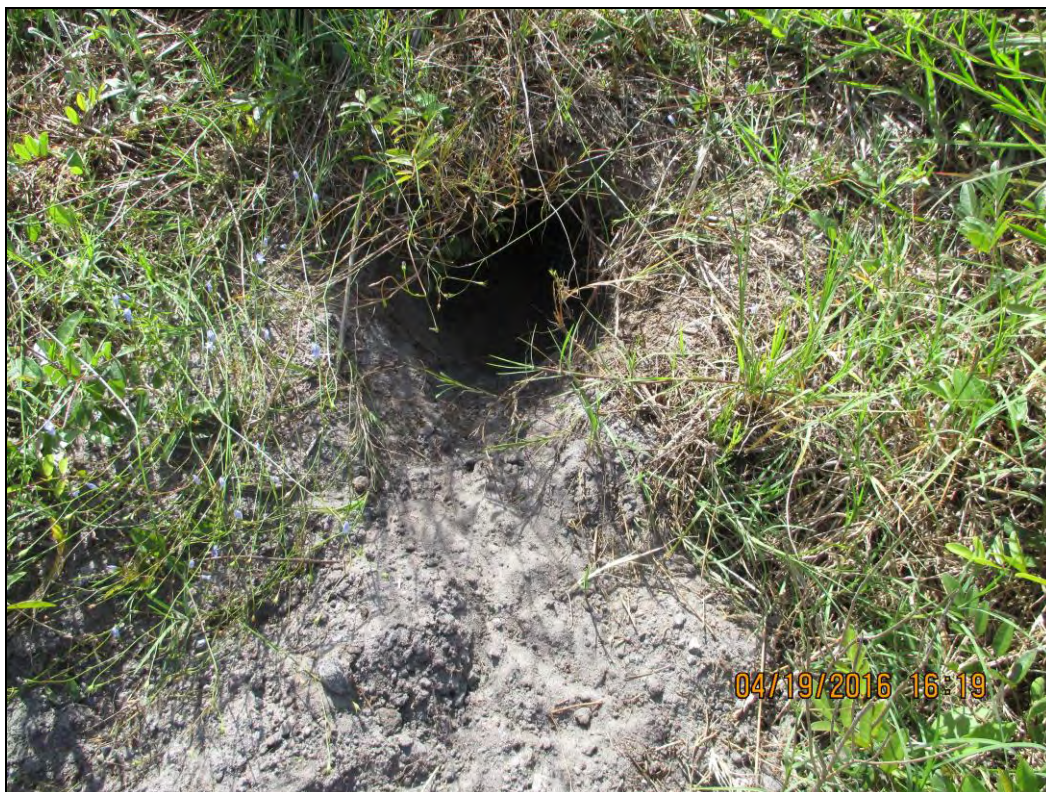
Image 32. Mammal burrow in exterior embankment
