Re: Lake Okeechobee Route 1 Cross Lake Channel Aids to Navigation Coordination  
(Work Order Number 20-11)

FLORIDA INLAND  
NAVIGATION DISTRICT  
LAKE OKEECHOBEE  
ROUTE 1 CHANNEL  
AIDS TO NAVIGATION  
LOCATIONS

Lake Okeechobee Route 1 Cross Lake Channel Existing Aids to Navigation Summary

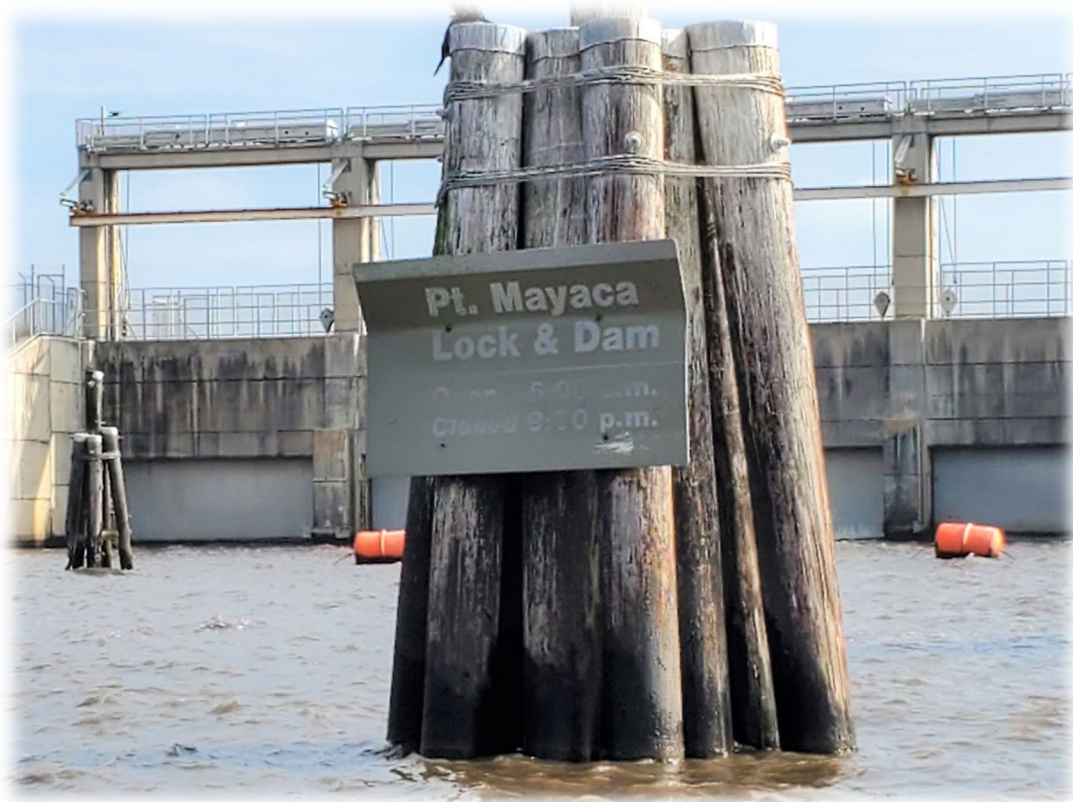
| Photograph<br>(Attachment B) | Aid to Navigation | Type | Material | Observation | Recommendation |
|---|--|---|---|--|--|
| Page 1 | Port Mayaca Lock Entrance South Side; Pt. Mayaca Lock & Dam<br>Open 6:00 AM<br>Closed 9:00 PM | Daybeacon | Timber Dolphin Pile | Daymark damaged and faded | Replace Daymark |

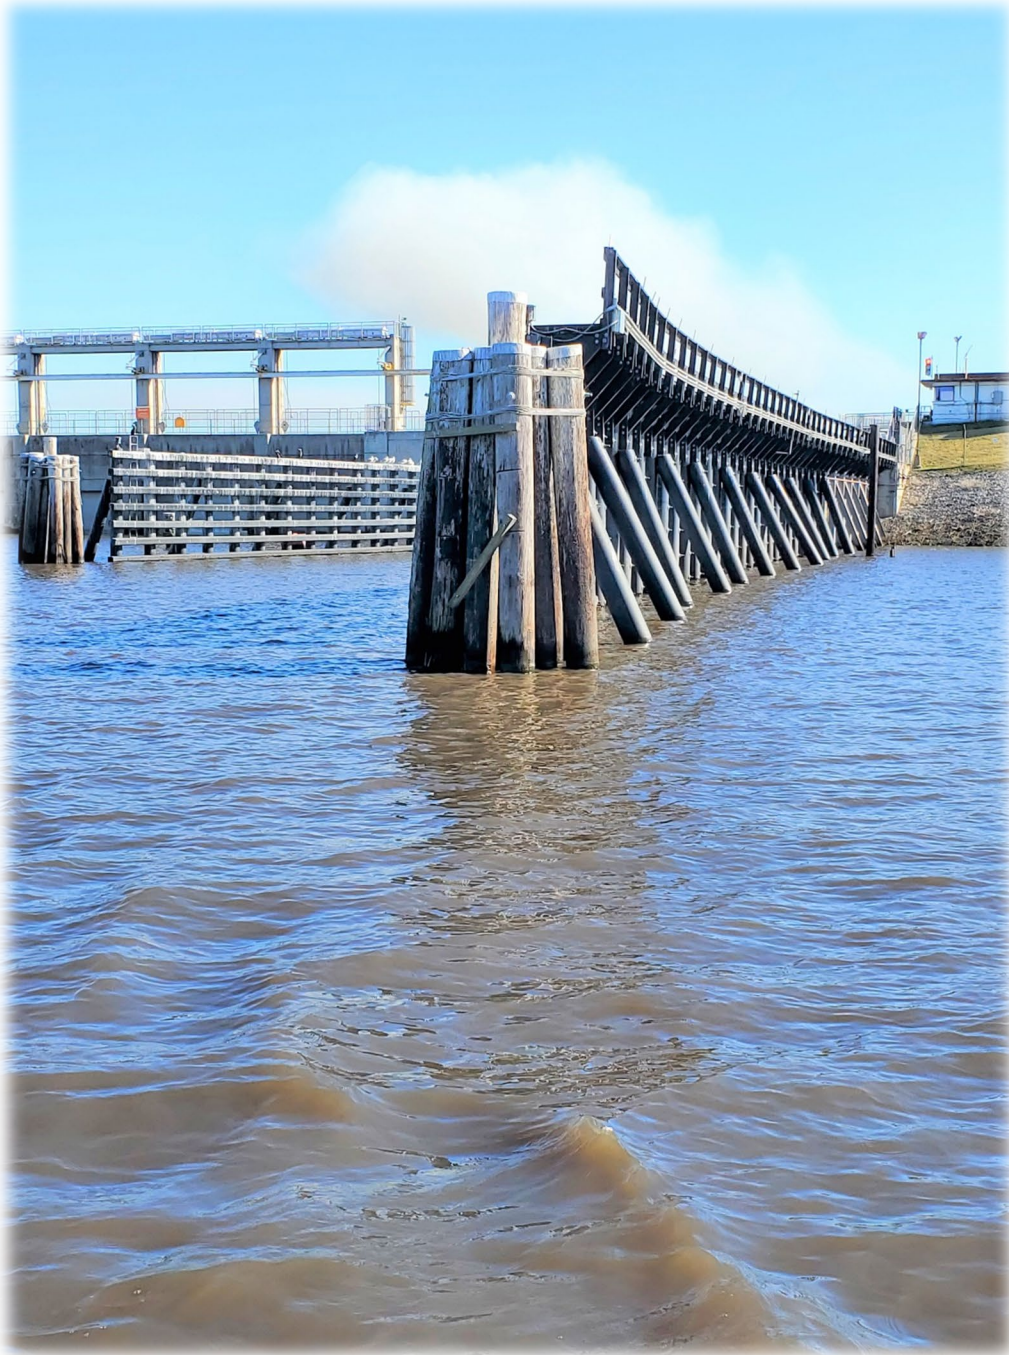
| Photograph<br>(Attachment B) | Aid to Navigation | Type | Material | Observation | Recommendation |
|---|--|---|---|--|--|
| Page 2 | Port Mayaca Lock Entrance North Side Sign; Pt. Mayaca Lock & Dam<br>Open 6:00 AM<br>Closed 9:00 PM | Daybeacon | Timber Dolphin Pile | Daymark missing / Destroyed | Replace Daymark |

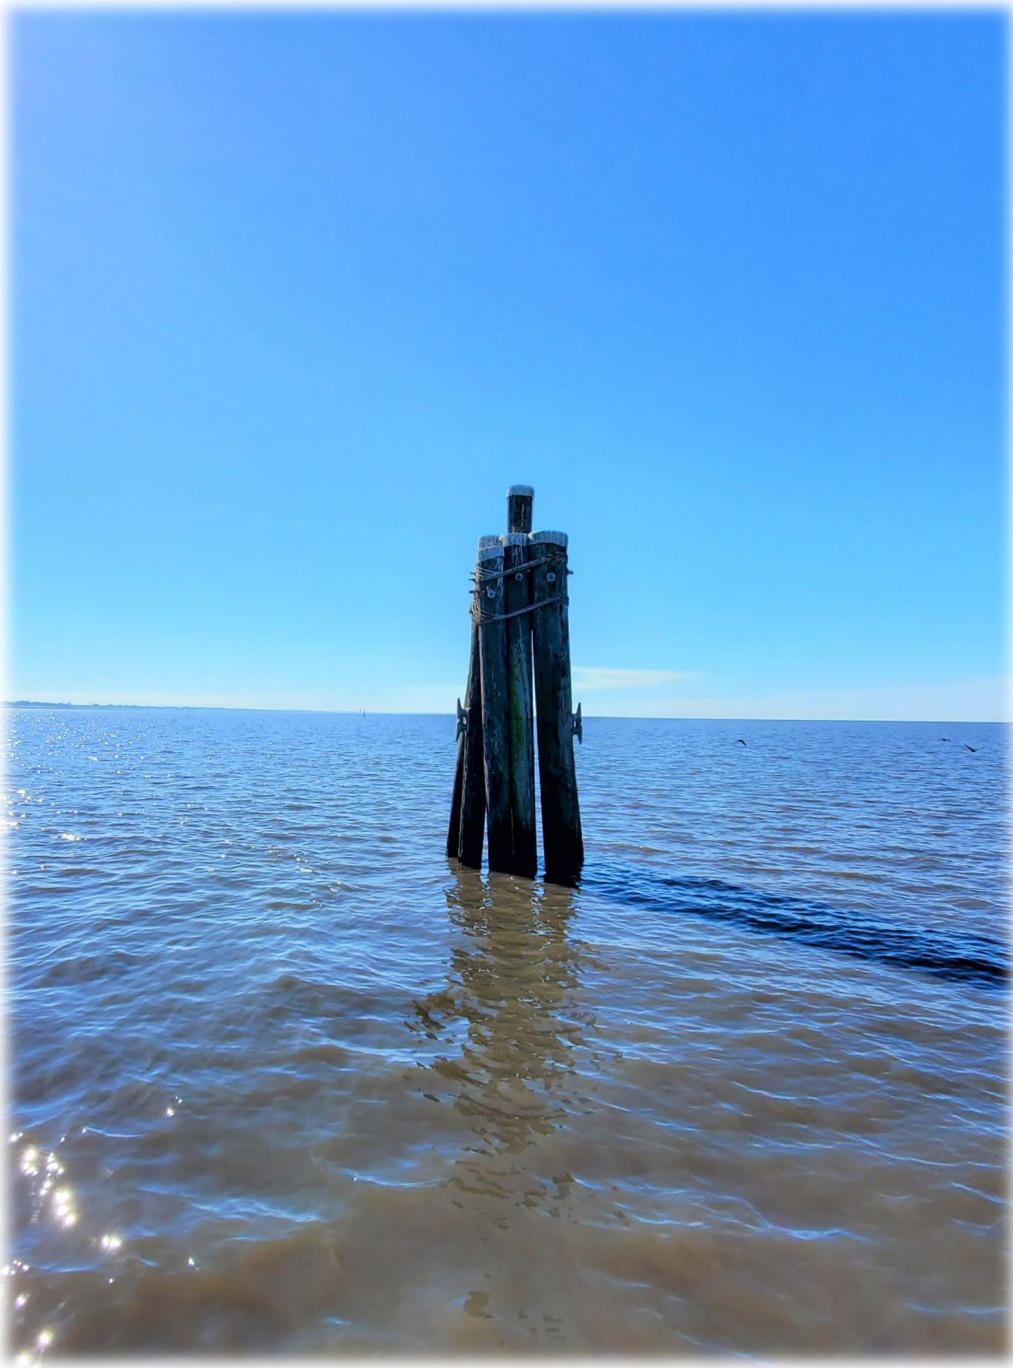
| Photograph<br>(Attachment B) | Aid to Navigation | Type | Material | Observation | Recommendation |
|---|--|---|---|--|--|
| Page 3 | Dolphin pile (non-ATON) | Dolphin | Timber Dolphin Pile | Loose cable wrap, pile deterioration, pile configuration atypical | Structural inspection |

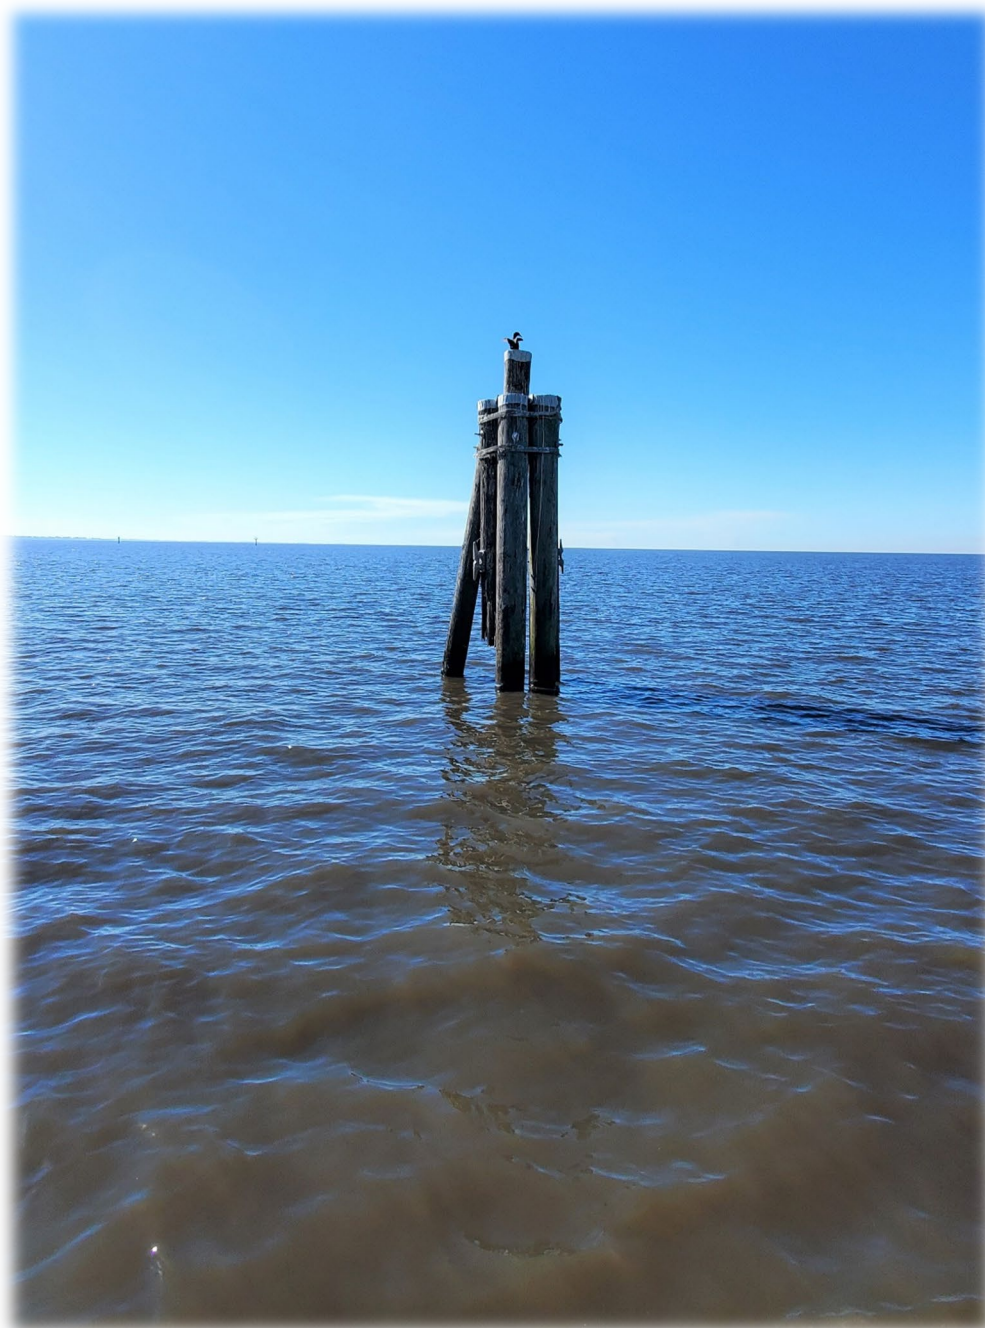
| Photograph<br>(Attachment B) | Aid to Navigation | Type | Material | Observation | Recommendation |
|---|--|---|---|--|--|
| Page 4 | Dolphin pile (non-ATON) | Dolphin | Timber Dolphin Pile | Broken pile, pile deterioration | Structural inspection |

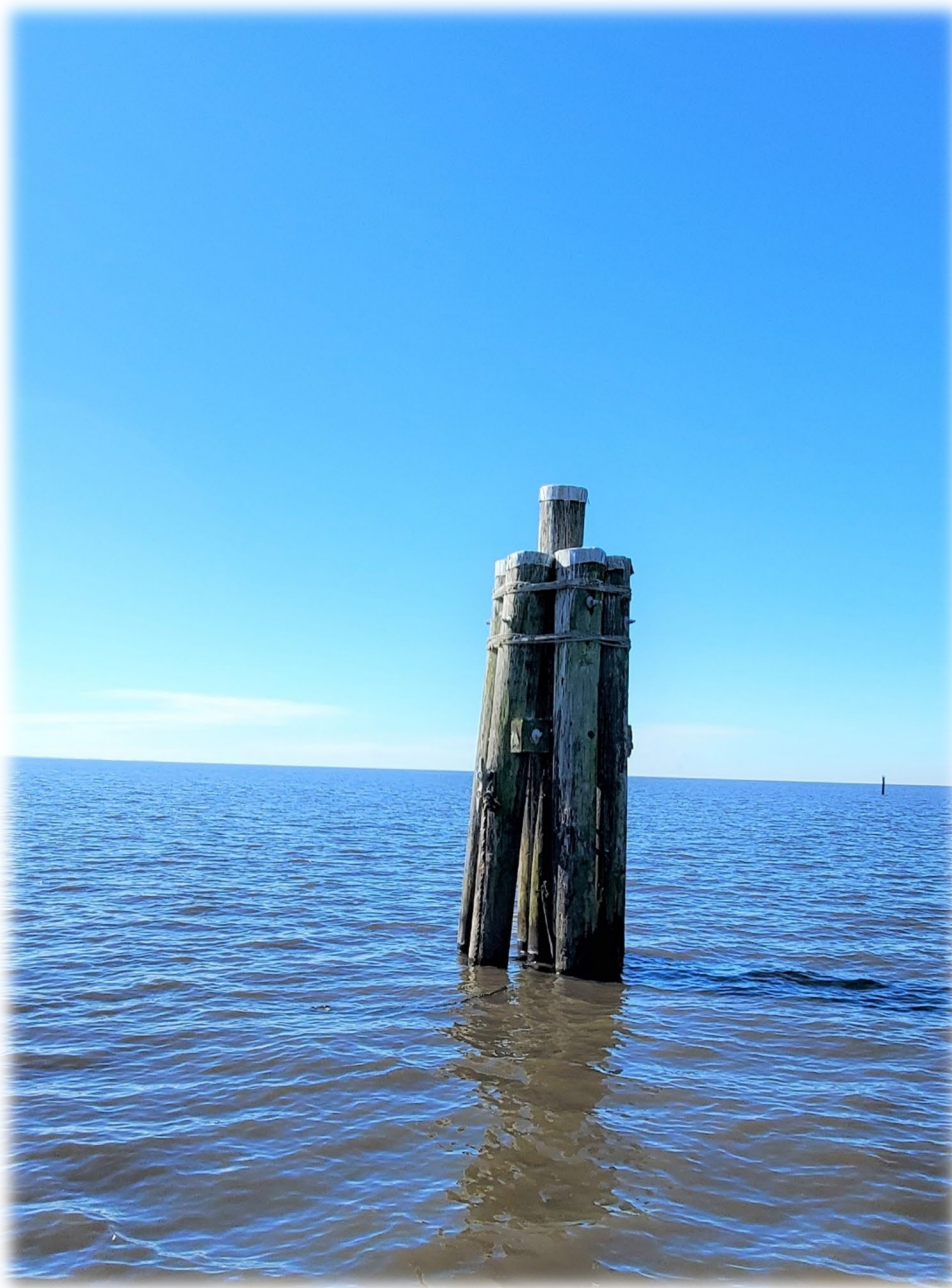
| Photograph<br>(Attachment B) | Aid to Navigation | Type | Material | Observation | Recommendation |
|---|--|---|---|--|--|
| Page 6 | Dolphin pile (non-ATON) | Dolphin | Timber Dolphin Pile | Pile deterioration | Structural inspection |

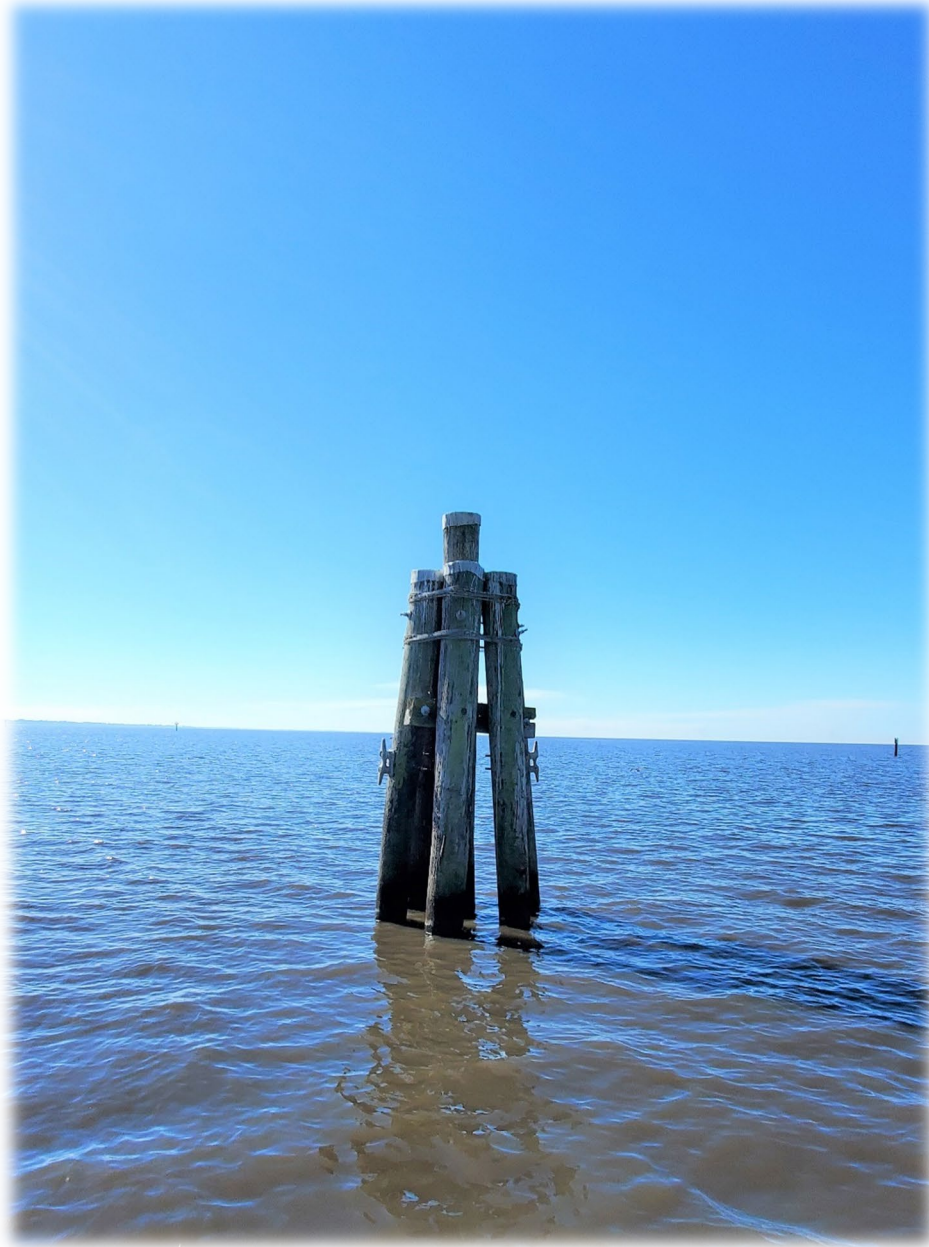
| Photograph<br>(Attachment B) | Aid to Navigation | Type | Material | Observation | Recommendation |
|---|--|---|---|--|--|
| Page 7 | Dolphin pile (non-ATON) | Dolphin | Timber Dolphin Pile | Pile deterioration | Structural inspection |

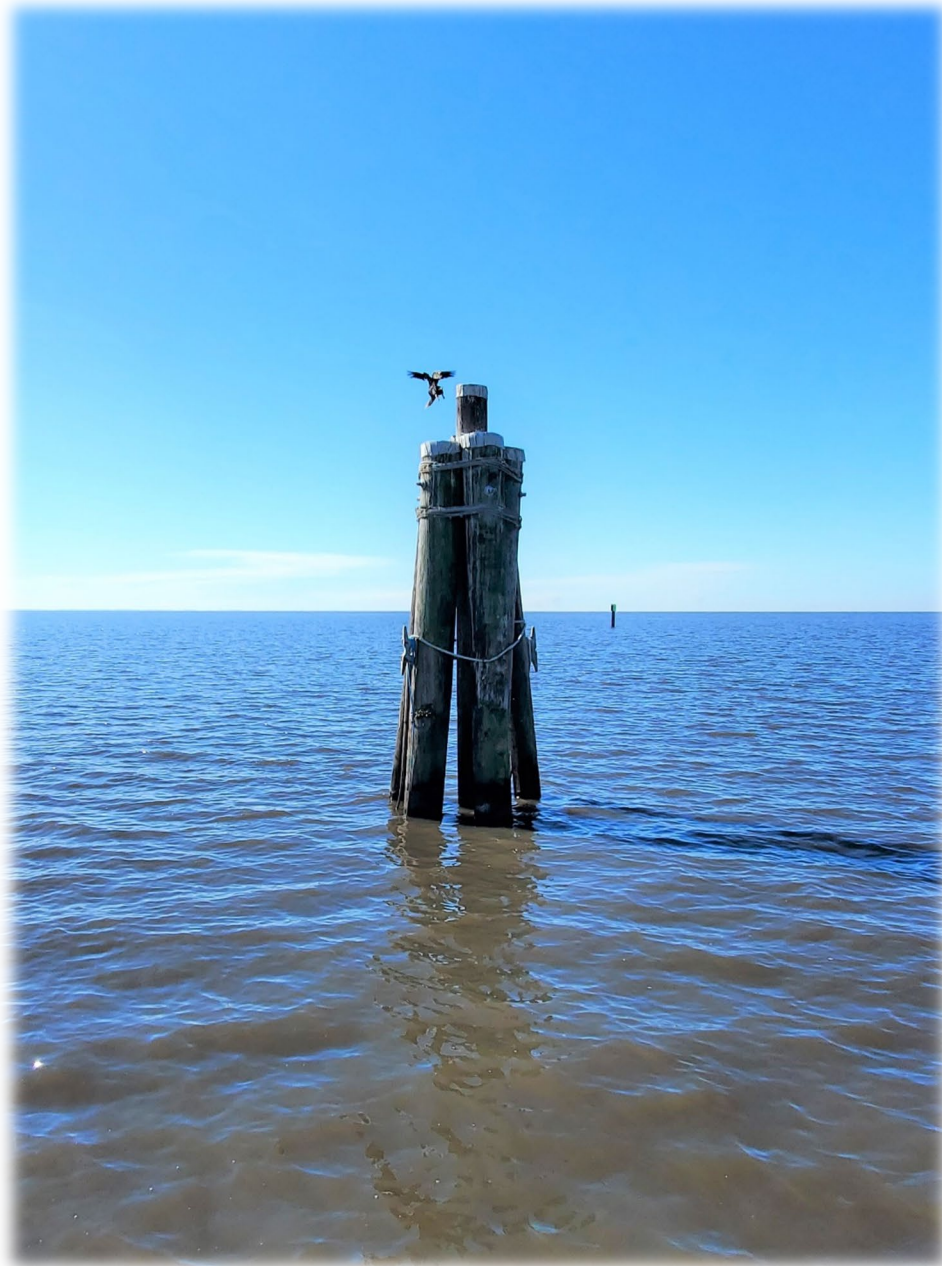
| Photograph<br>(Attachment B) | Aid to Navigation | Type | Material | Observation | Recommendation |
|---|--|---|---|--|--|
| Page 8 | Dolphin pile (non-ATON) | Dolphin | Timber Dolphin Pile | Pile deterioration | Structural inspection |

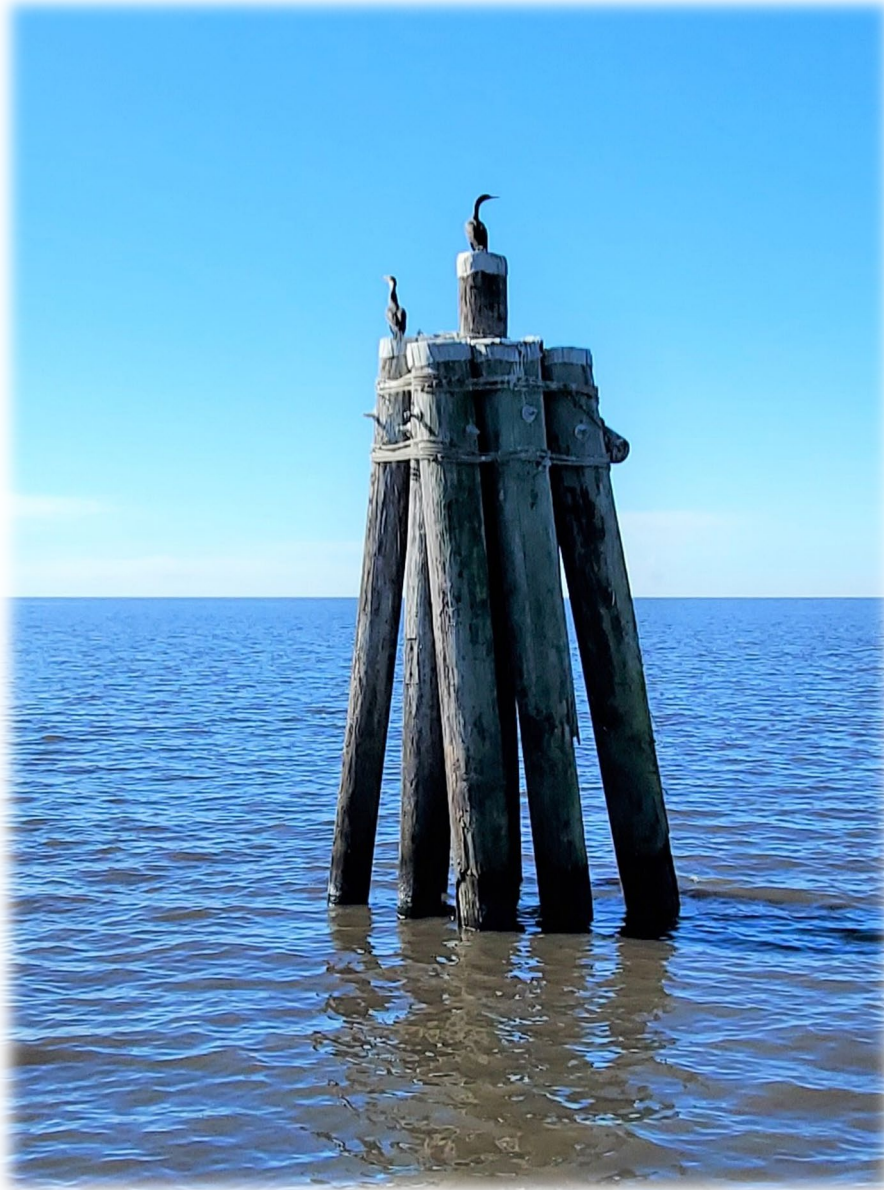
| Photograph<br>(Attachment B) | Aid to Navigation | Type | Material | Observation | Recommendation |
|---|--|---|---|--|--|
| Page 9 | Dolphin pile (non-ATON) | Dolphin | Timber Dolphin Pile | Pile deterioration | Structural inspection |

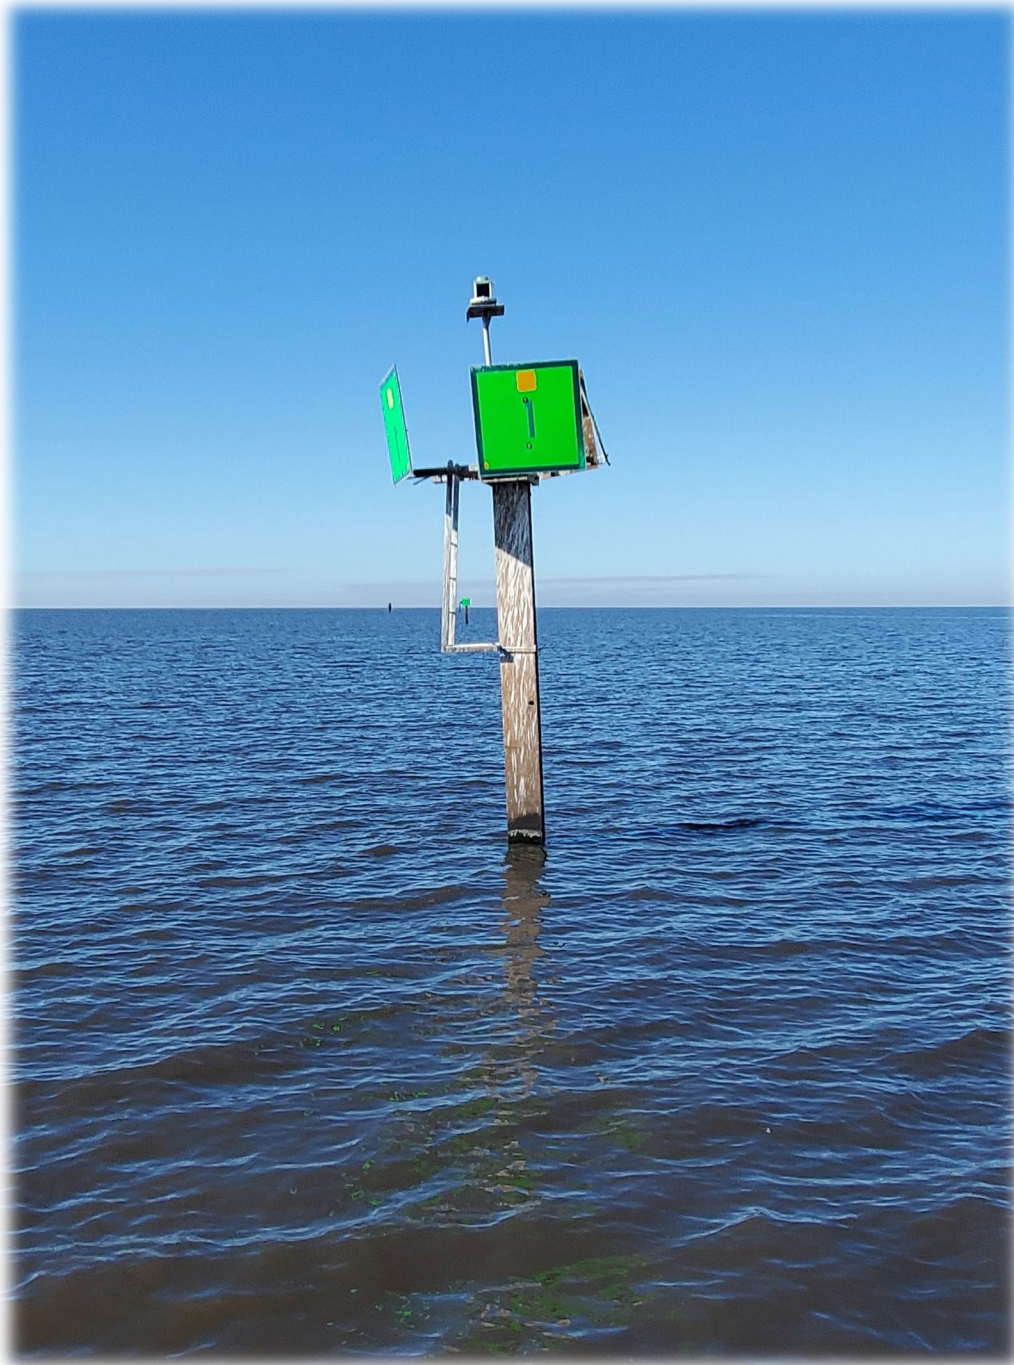
| Photograph<br>(Attachment B) | Aid to Navigation | Type | Material | Observation | Recommendation |
|---|--|---|---|--|--|
| Page 10 | G 1 LIGHT (Route 1 & Route 2) | Daybeacon with Light; 3 Daymarks | Steel H-Pile | Out of plumb, faded daymark, light function unknown | Structural inspection |

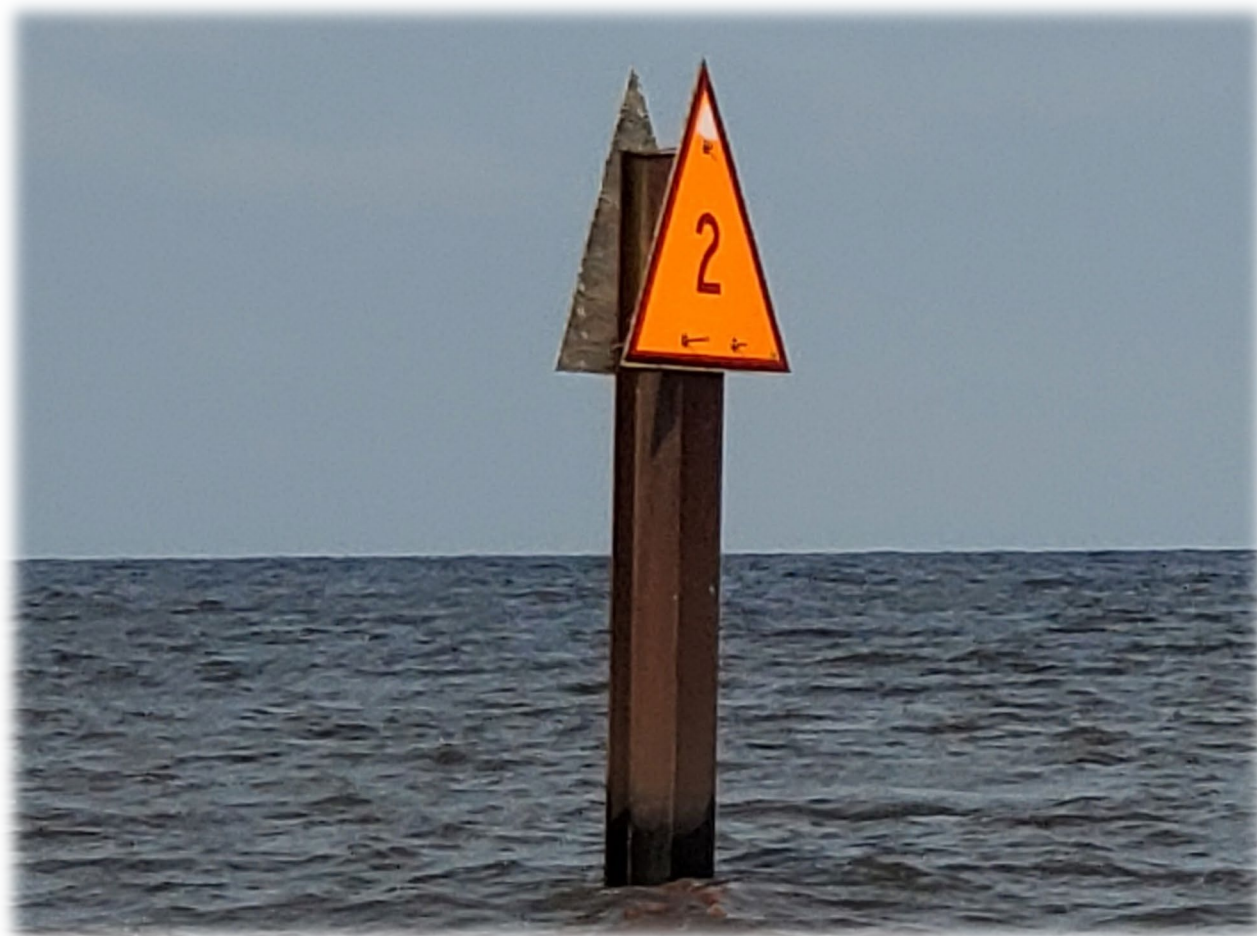
| Photograph<br>(Attachment B) | Aid to Navigation | Type | Material | Observation | Recommendation |
|---|--|---|---|--|--|
| Page 11 | R 2 | Daybeacon; 2 Daymarks | Steel H-Pile | Out of plumb | Structural inspection |

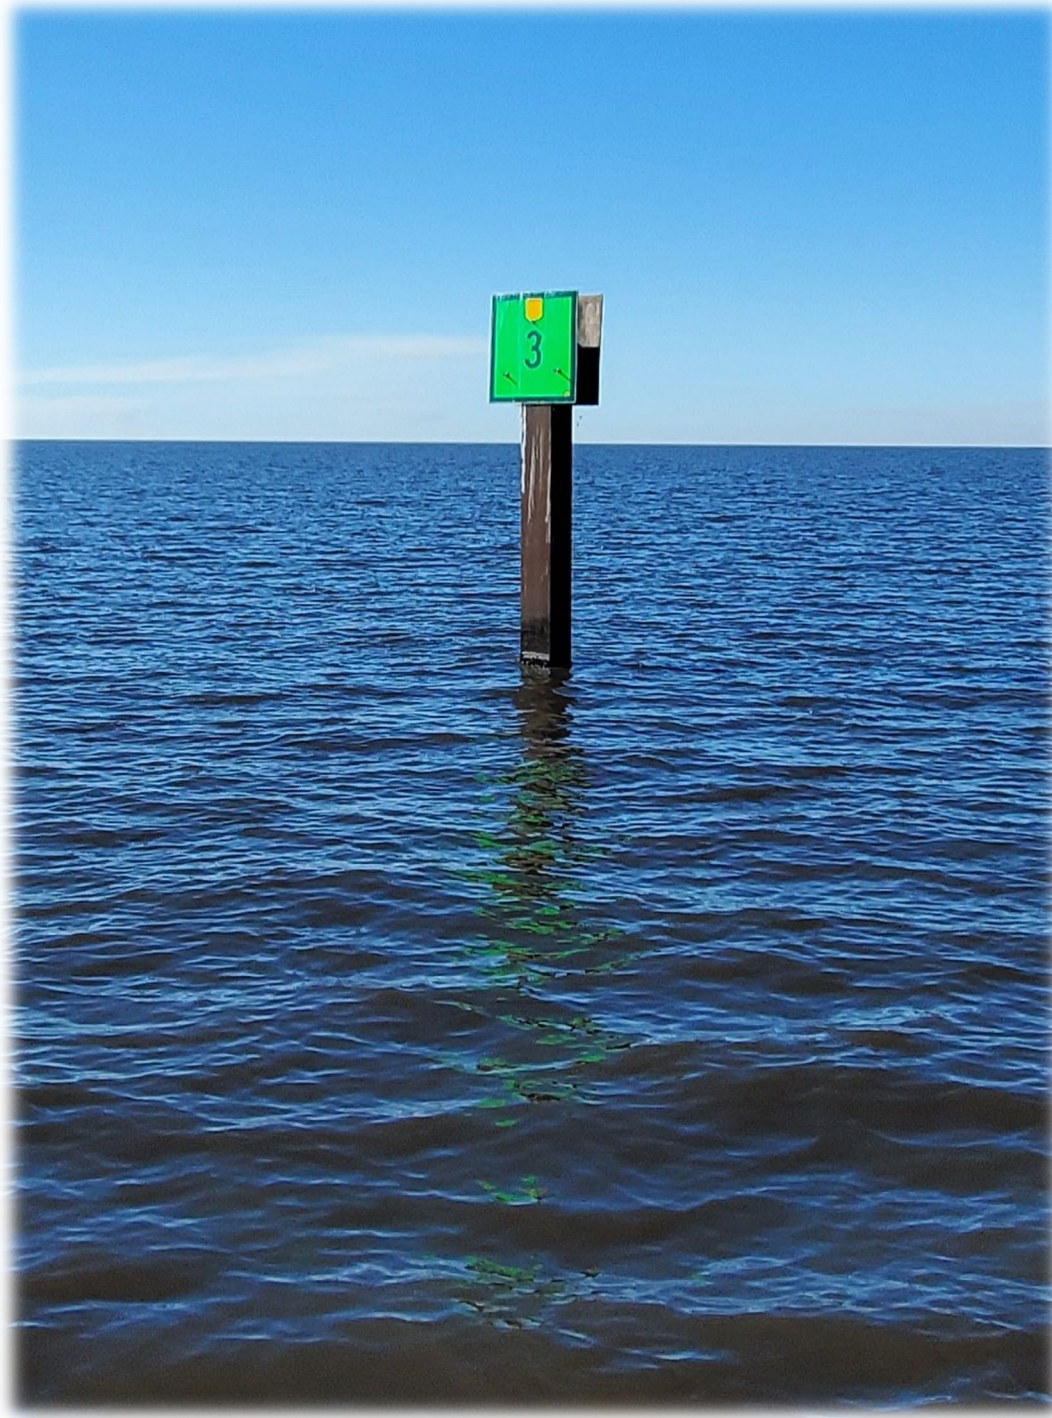
| Photograph<br>(Attachment B) | Aid to Navigation | Type | Material | Observation | Recommendation |
|---|--|---|---|--|--|
| Page 12 | G 3 | Daybeacon; 2 Daymarks | Steel H-Pile | Out of plumb | Structural inspection |

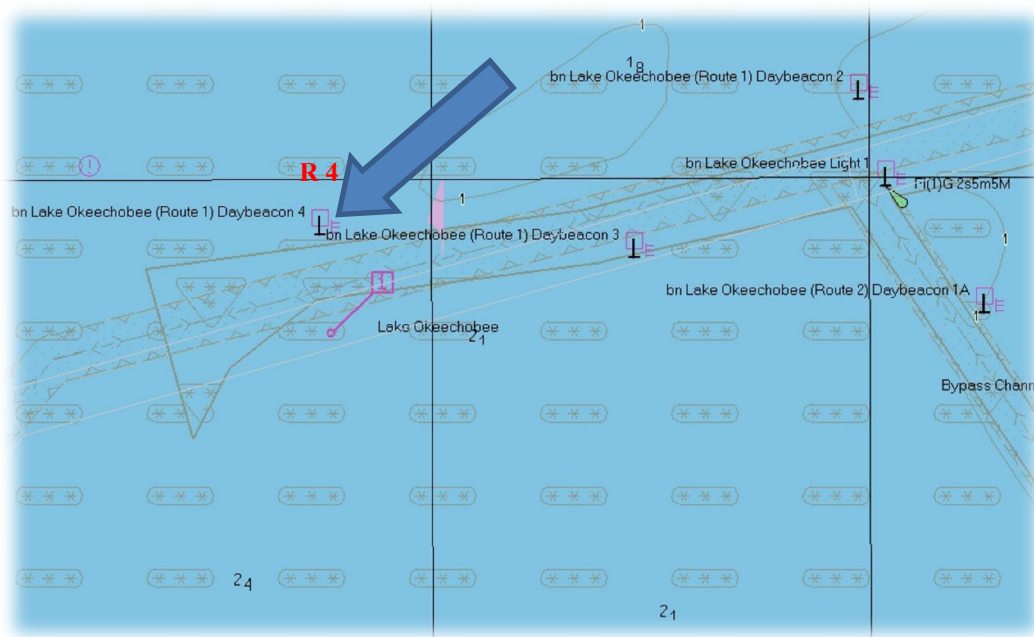
**4**

**Not Found  
Missing / Destroyed**

| Photograph<br>(Attachment B) | Aid to Navigation | Type | Material | Observation | Recommendation |
|---|--|---|---|--|--|
| Page 13 | R 4 | N/A; 2 Daymarks | N/A | Missing / Destroyed | Replace ATON |
