DIVER INVESTIGATION SURVEY OF POTENTIAL BURIED UTILITIES INTRACOASTAL WATERWAY, CUT PB-36 THROUGH CUT PB-41 PALM BEACH COUNTY, FLORIDA

TAYLOR ENGINEERING, INC.

DATE: FEBRUARY 15, 2018 COMMISSION NUMBER: 5303.16

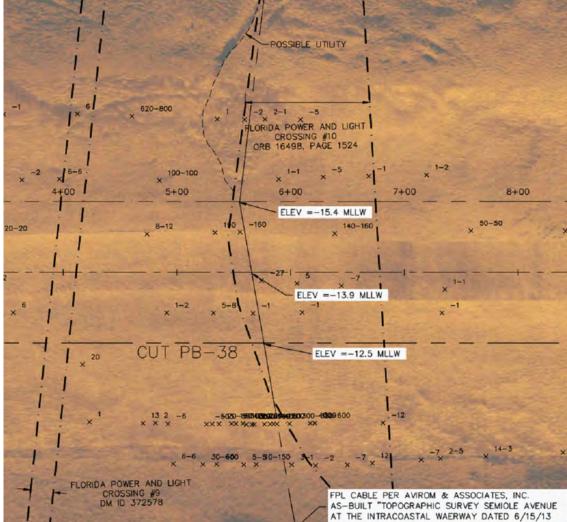
Possible Utility 00 is a possible cable or pipeline meandering from the as-built plot of an FPL cable at the north edge of FPL Crossing #10 easement. The contact image starts at the northern easement boundary and moves north 30 feet from the

Figure 1. Short dashed black line at top of image is Possible Utility 00

boundary then bends back and meets the plotted cable just inside the boundary on the east end for a total length of about 120 feet (See Figure 1).

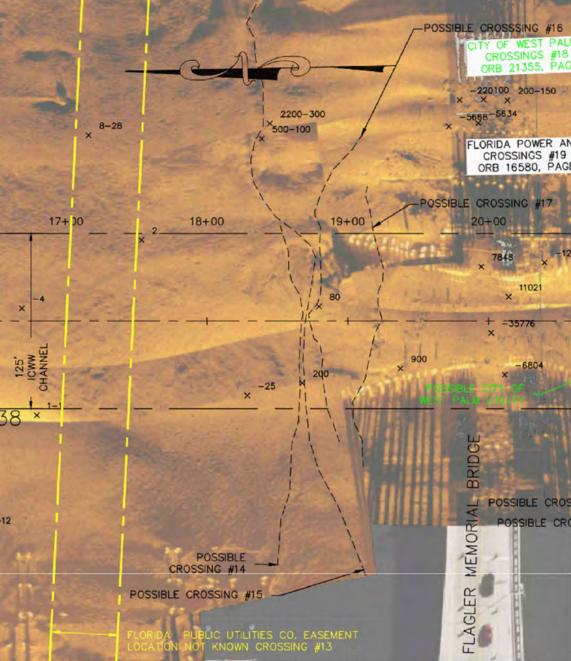
Possible Utility 01 crosses the waterway about 20 – 30 feet north of the north fender piles of the Flagler Memorial Bridge. It is adjacent to Possible Utilities 02 and 03. It is not within or close to any utility easements known to us at this time (See Figure 2). We are designating it as Crossing #14.

Possible Utility 02 is adjacent and south of Possible Utility 01 and runs across the entire waterway survey area (See Figure 2). We are designating it as Crossing #15.

Possible Utility_03 is adjacent and south of Possible Utility_02 (See Figure 2). We are designating it as Crossing #16.

Figure 2. Short dashed black lines are Possible Crossings #14, #15, #16 and #17.

Possible Utility_04 runs through the north fender piles of the Flagler Memorial Bridge (See Figure 2). We are designating it as Crossing #17.

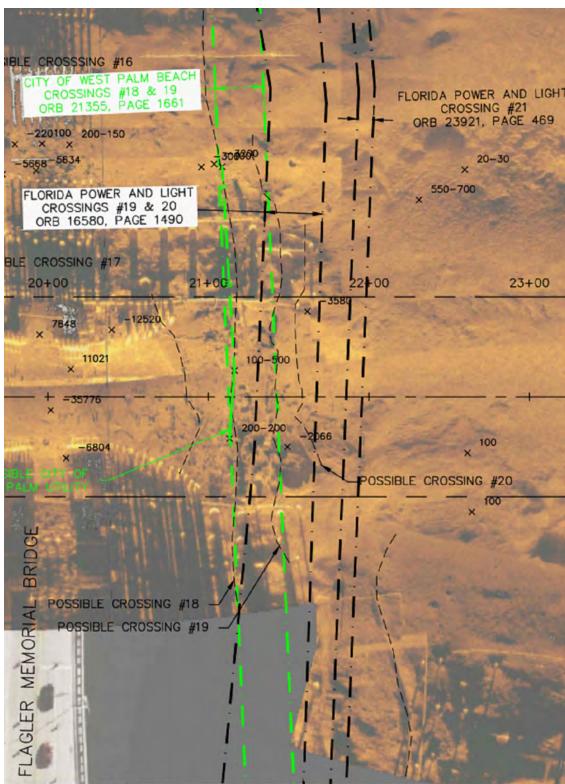
Possible Utility_05 runs between the south fender piles of the Flagler Memorial Bridge about 15 to 30 feet north of the City of West Palm Beach Crossing #18 easement boundary (See Figure 3).

Figure 3. Short dashed black lines are Possible Crossings #18, #19 and #20. Possible Crossing 18A (leftmost) and 20A (rightmost) are unlabeled.

runs across the entire waterway survey area, through the south fender piles and along the northern boundary of the City of West Palm Beach easement (See Figure 3). We are designating it as Crossing #18.

Possible Utility 07 runs across the entire waterway survey area, through the south fender piles and along the southern boundary of the City of West Palm Beach easement (See Figure 3). We are designating it as Crossing #19.

Possible Utility 08 runs from just inside the east fender piles on the south side of the bridge within the FPL easement to the west side of the channel (See Figure 3). We are designating it as Crossing #20.

Possible Utility 09 runs from the west extent of the sonar coverage to the west edge of the channel (See Figure 3). It varies from 13 to 37 feet south of the Florida Power & Light Crossing #21 easement.

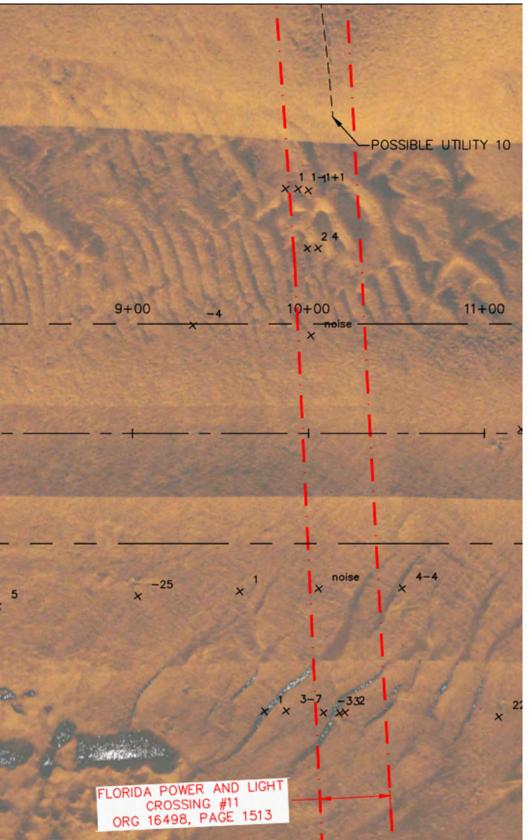
Possible Utility 10 runs for less than 100 feet on the eastern edge of the sonar coverage within the FP&L Crossing #22 easement (See Figure 4). Magnetometer string 8 was detected west of this feature and within the northern half of the easement. These two features were joined to form "Possible FPL Cable" in Figure

Figure 4. Short dashed black line is Possible Utility 10.

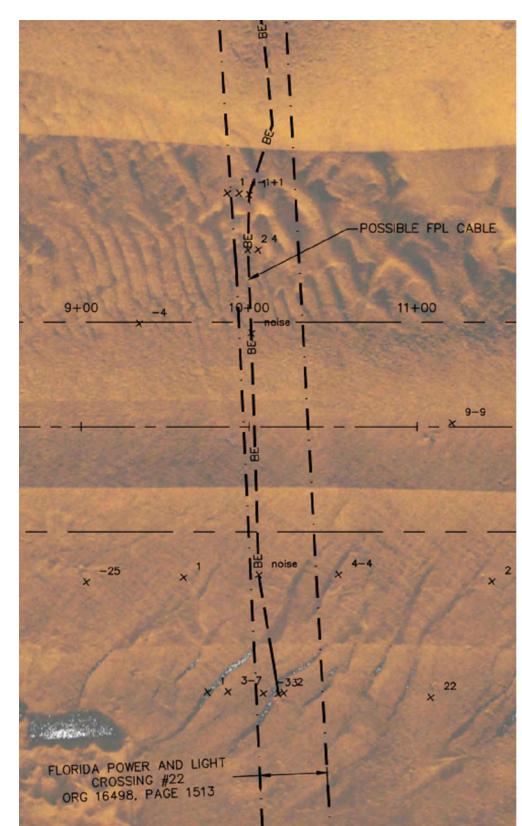
Figure 4a. "Possible FPL Cable" is combined mag string 8 and sonar feature

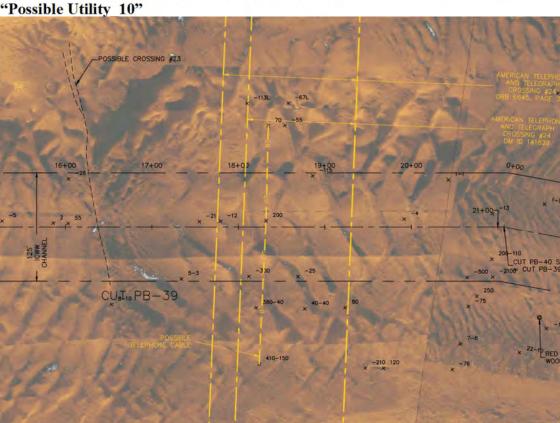
Possible Utility_11 merges with Possible Utility_12 east of the channel after a run of less than 100 feet and is not near a known easement (See Figure 5).

Possible Utility 12 runs from the west edge of the channel to approximately 150 feet west of the channel and is not near a known easement (See Figure 5). We have designated Possible Utility 12 as crossing #23.

Figure 5. Short dashed black lines at left are Possible Crossing 23. Yellow dashed line is mag string 9 labeled as Possible Telephone Cable.

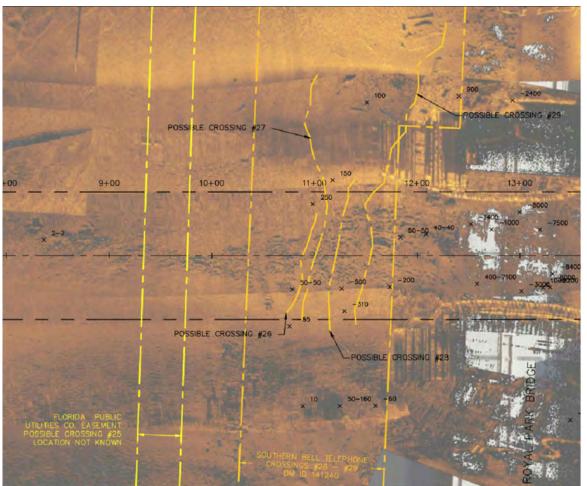
Possible Utility 13 runs from the west edge of the channel and most of the way across toward the east edge (See Figure 6). Possible Utility 13 has been designated as Crossing #26.

Possible Utility_14 runs from the west edge of the channel to 125 feet beyond the east edge (see Figure 6). Possible Utility 14 has been designated as Crossing #27.

Possible Utility_15 runs from just outside the west edge of the channel to just outside the east edge (See Figure 6). Possible Utility 15 has been designated as Crossing #28.

Possible Utilty_16 runs from the west edge of the channel to just inside the last fender pile on the northeast side of the Royal Park Bridge and continues almost to the extent of the sonar coverage to the east (See Figure 6). Possible Utility 16 has been designated as Crossing #29. Possible Utilities 13, 14, 15 and 16 are all within the Southern Bell Telephone easement (See Figure 6).

Figure 6. Short dashed yellow lines are Possible Crossings #26, #27, #28, and #29.

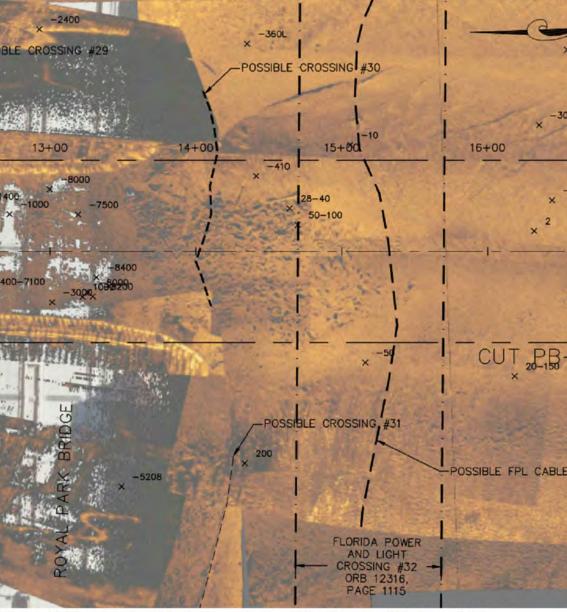
Possible Utility 17 starts within the channel on the west side and runs about 70 feet past the east edge of the channel south of the fender pilings on the south side of the Royal Park Bridge (See Figure 7). Possible Utility_17 has been designated as Crossing #30.

Possible Utility 18 starts about 75 feet west of the west channel edge and runs west to the extent of the sonar coverage. It may be another segment of Possible Utility_17 and both are outside of any known easements (See Figure 7). Possible Utility 18 has been designated as Crossing #31.

Possible Utility 19 runs most of the way across the waterway for 400 feet and is within the Florida Power & Light easement (Crossing #32) just south of the Royal Park Bridge (See Figure 7).

Figure 7. Short dashed black lines are Possible Crossing #30, 31 and 32.

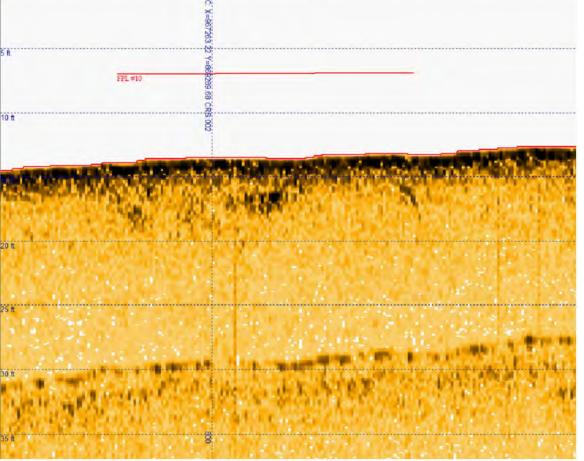
Figure 8. Partial profile of line 7N.001 showing a possible ½ hyperbolic target at right. Top of target is approximately 2.4' below surrounding bottom. The red line above marks the width of the FP&L easement from south (left) to north (right).

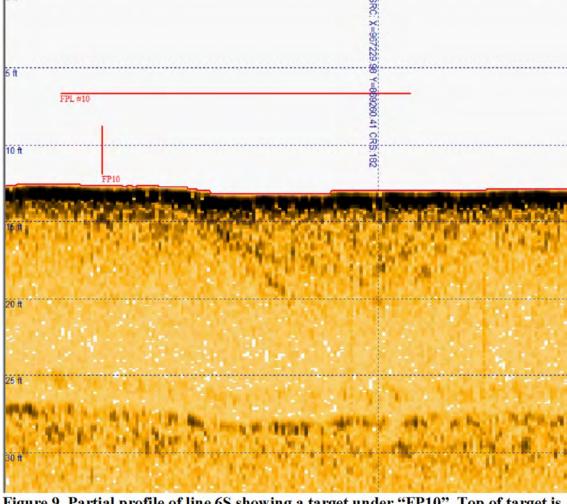
Figure 9. Partial profile of line 6S showing a target under "FP10". Top of target is approximately 1.8' below surrounding bottom. The red line above marks the width of the FP&L easement from north (left) to south (right).

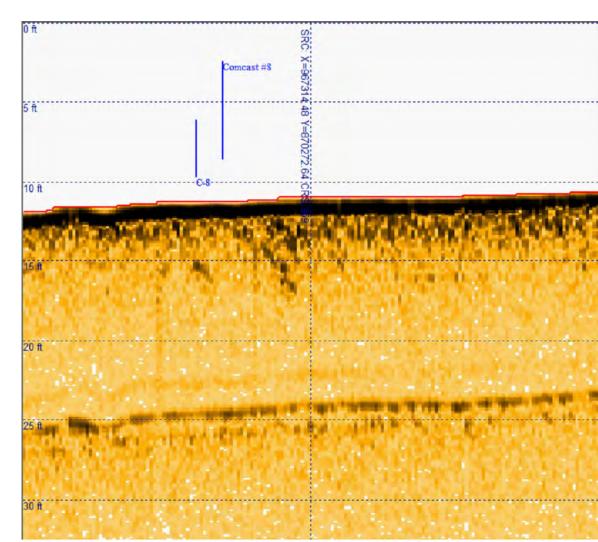
Figure 10. Partial profile of line 3N showing a target under "C8". Top of target is approximately 2.5' below surrounding bottom.

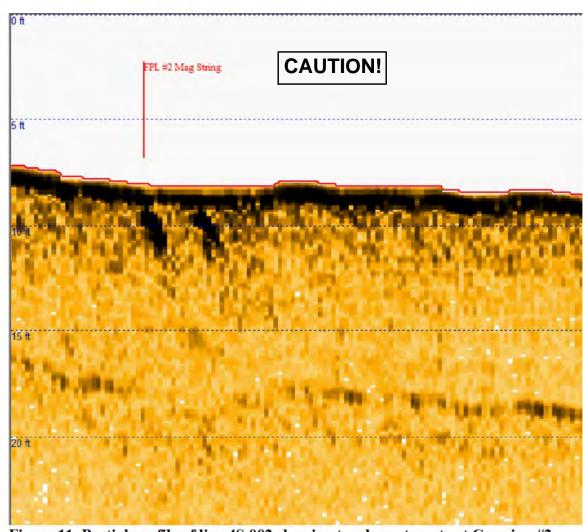
Figure 11. Partial profile of line 4S.002 showing two large targets at Crossing #2. Top of targets are approximately 1.3' below surrounding bottom.
