Levee Inspection Report

Name of System: Bennington Flood Control Project

Name of Segment: Bennington, Roaring Branch Left Bank

Date(s) of Inspection: 06/06/2022 - 06/07/2022

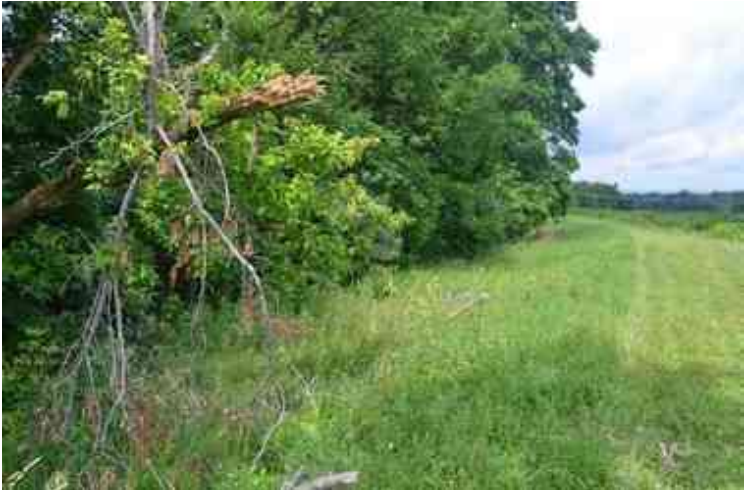
| | <p>Inspect ID: 2016-0095 Title: 4504000006_CENAN_2022_B_0095_2_20220615T192448.jpg Rated Item: 1. Unwanted Vegetation Growth Caption: Rating: Minimally Acceptable; Remarks: Trees encroached on the toe of protected side of levee slope.; Action: Maintain vegetation free zone in accordance with USACE guidelines.</p> |

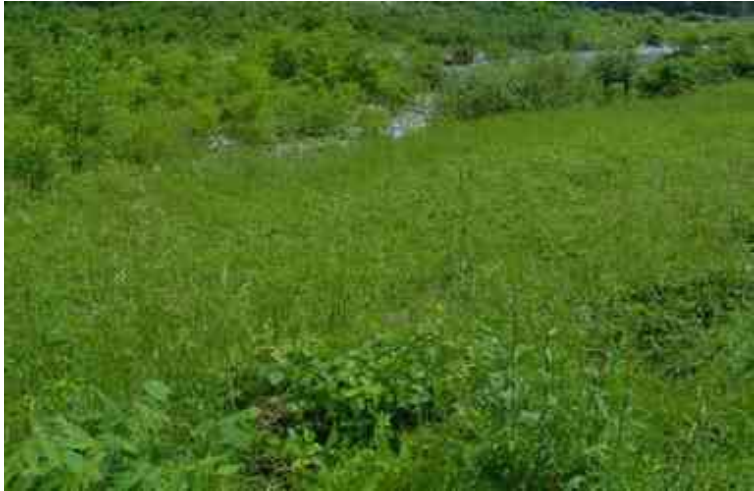
| | <p>Inspect ID: 2016-0097 Title: 4504000006_CENAN_2022_B_0097_2_20220615T193042.jpg Rated Item: 1. Unwanted Vegetation Growth Caption: Rating: Minimally Acceptable; Remarks: 8-inch diam. tree stump located on unprotected side of levee near levee crown. This section was widened. Cannot confirm in 2022 inspection due to vegetation; Action: Maintain vegetation free zone in accordance with USACE guidelines.</p> |

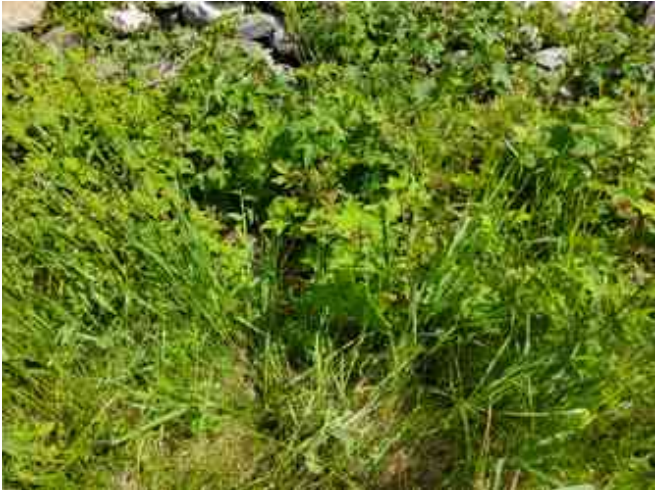
| | <p>Inspect ID: 2016-0062 Title: _2_20220607T135509.jpg Rated Item: 8. Depressions/ Rutting Caption: Rating: Minimally Acceptable; Remarks: Large hole in unprotected side filled with rocks. Cannot confirm in 2022 inspection due to vegetation.; Action: Re-establish line and grade of the embankment, and provide erosion protection in accordance with USACE guidelines.</p> |

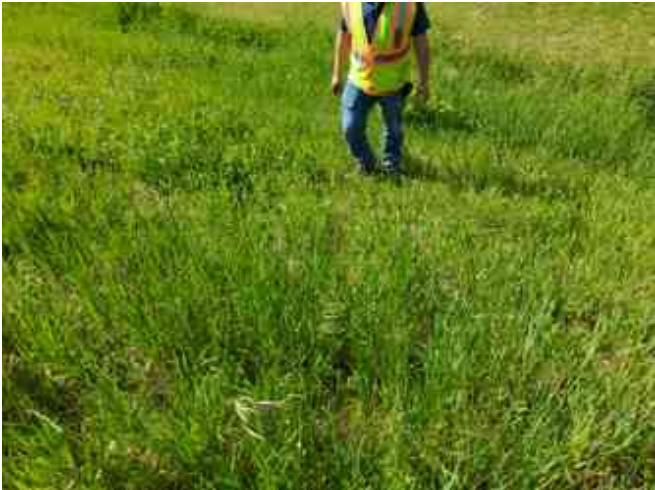
| | <p>Inspect ID: 2016-0065 Title: _2_20220607T135948.jpg Rated Item: 8. Depressions/ Rutting Caption: Rating: Minimally Acceptable; Remarks: Depression in levee slope on protected side. Levee slope is irregular and is typical conditions.; Action: Provide topsoil, seed and mulch in accordance with USACE guidelines.</p> |

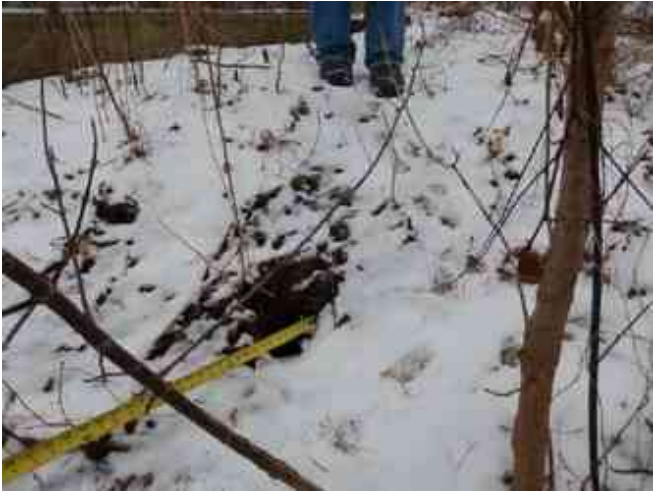
| | <p>Inspect ID: 2016-0152 Title: 4504000006_CENAN_2022_B_0152_1_20220616T122613.jpg Rated Item: 10. Animal Control Caption: Rating: Minimally Acceptable; Remarks: Noted previously a deep borrow hole located on top of DS #4. Cannot confirm in 2022 inspection due to vegetation.; Action: Fill burrow in accordance with USACE guidelines.</p> |

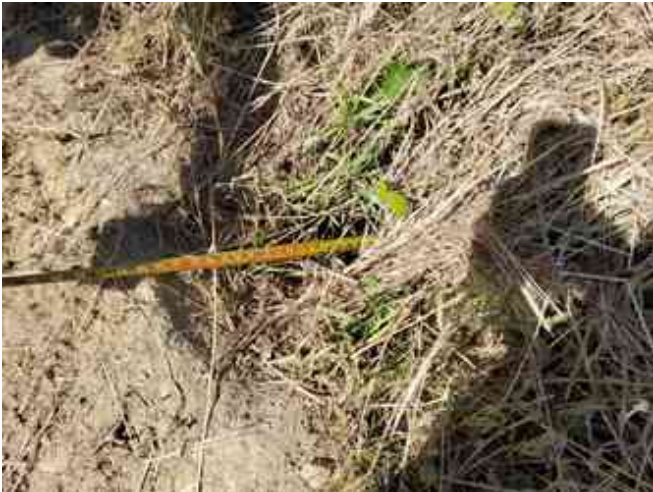
| | <p>Inspect ID: 2022-0002 Title: _1_20220607T130527.jpg Rated Item: 10. Animal Control Caption: Rating: Minimally Acceptable; Remarks: Multiple animal burrows on protected side slope.; Action: Fill in burrows in accordance with USACE guidelines.</p> |

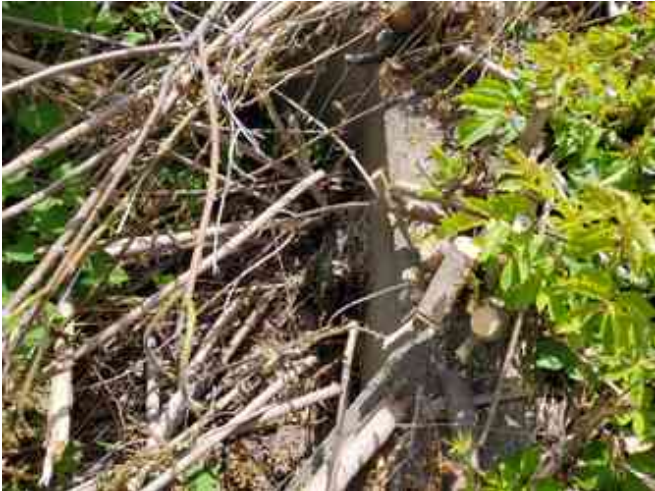
| | <p>Inspect ID: 2016-0104 Title: _1_20220607T150416.jpg Rated Item: 11. Culverts/ Discharge Pipes (This item includes both concrete and corrugated metal pipes.) Caption: Rating: Unacceptable; Remarks: The culvert to D.S. # 3 contains small cobbles, pipe sections seem to be offset, and there appears to be a belly in the pipe. The 11 Nov 2014 video inspection report notes a circumferential fracture at 13.1 ft, however the video shows more damage. Vegetation surrounding structure in 2022 inspection.</p> |

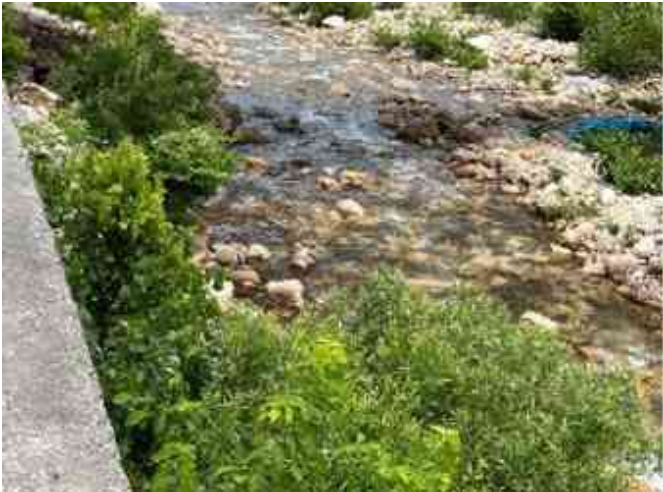
| | <p>Inspect ID: 2022-0163 Title: 4504000006_CENAN_2022_B_0163_1_20220630T164953.jpg Rated Item: 12. Riprap Revetments & Bank Protection Caption: Rating: Minimally Acceptable; Remarks: There was significant vines and start of small trees on riprap. Highly recommend that the city begin a vegetation spray control plan to keep this under control. Once this becomes established it is significantly more costly to get back under control.; Action: Maintain vegetation free zone in accordance with USACE guidelines.</p> |

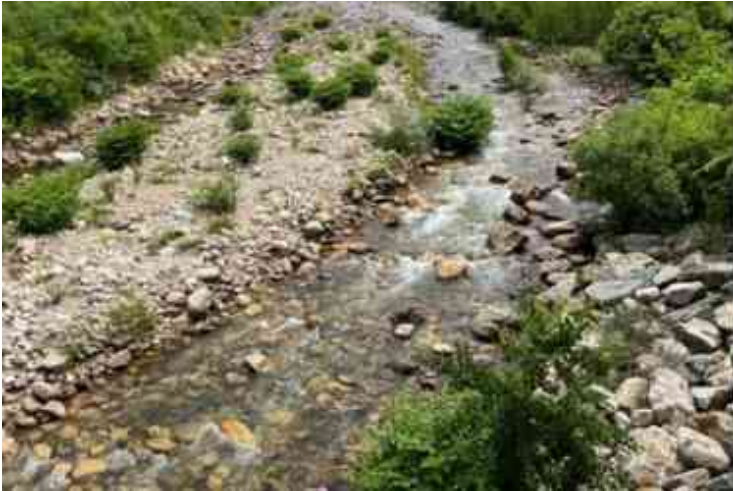
| | <p>Inspect ID: 2022-0163 Title: 4504000006_CENAN_2022_B_0163_2_20220630T165005.jpg</p> <p>Rated Item: 12. Riprap Revetments & Bank Protection</p> <p>Caption: Rating: Minimally Acceptable; Remarks: There was significant vines and start of small trees on riprap. Highly recommend that the city begin a vegetation spray control plan to keep this under control. Once this becomes established it is significantly more costly to get back under control.; Action: Maintain vegetation free zone in accordance with USACE guidelines.</p> |

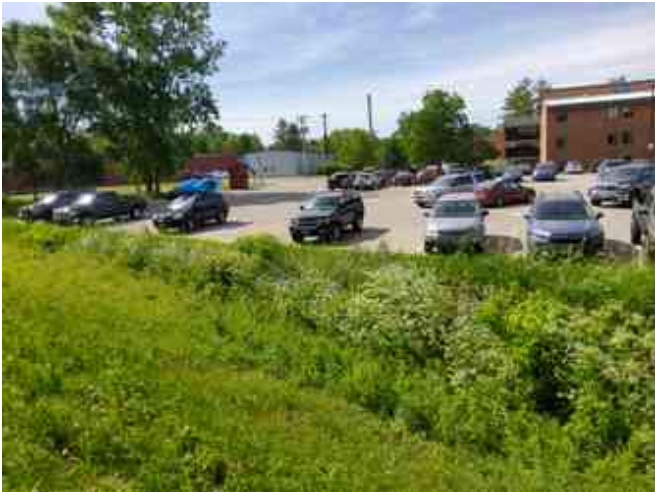
| | <p>Inspect ID: 2016-0059 Title: _2_20220607T135032.jpg</p> <p>Rated Item: 14. Underseepage Relief Wells/ Toe Drainage Systems</p> <p>Caption: Rating: Unacceptable; Remarks: New school parking lot runs up against the levee toe drain, and interior drainage ditch. Drainage ditch is constructed from pervious material and is now sod covered - determine if this is an appropriate cover.; Action: The toe drain system should be inspected with a video camera to determine if construction of the school parking caused any damage to the 18-in porous pipe of the system. The local sponsor should inform the school of the project boundary and protect it.</p> |

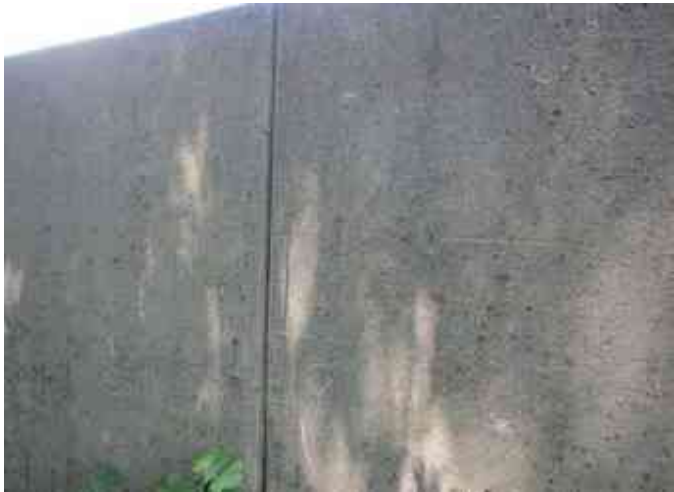
| | <p>Inspect ID: 2016-0112 Title: 4504000006_CENAN_2022_B_0112_2_20220616T125753.jpg Rated Item: 4. Concrete Surfaces Caption: Rating: Minimally Acceptable; Remarks: Vertical crack in local floodwall on protected side. Cannot confirm in 2022 inspection due to vegetation.; Action: Repair concrete surfaces in accordance with USACE guidelines.</p> |

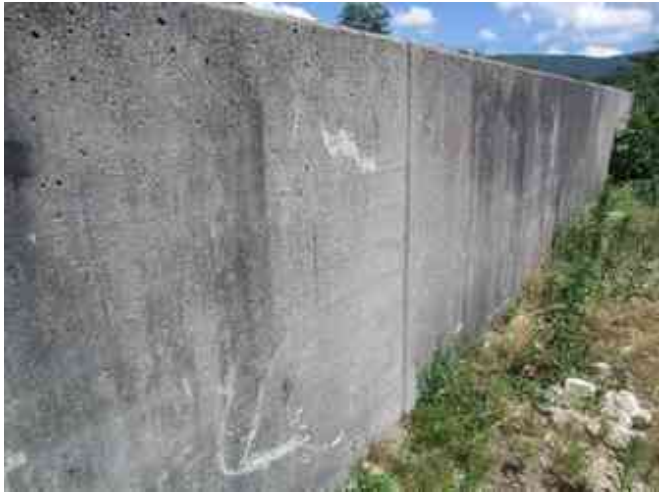
| | <p>Inspect ID: 2016-0114 Title: 4504000006_CENAN_2022_B_0114_2_20220616T125901.jpg Rated Item: 4. Concrete Surfaces Caption: Rating: Minimally Acceptable; Remarks: Surface defects on the protected face of the local floodwall.; Action: The local sponsor should make provisions to protect the project features.</p> |

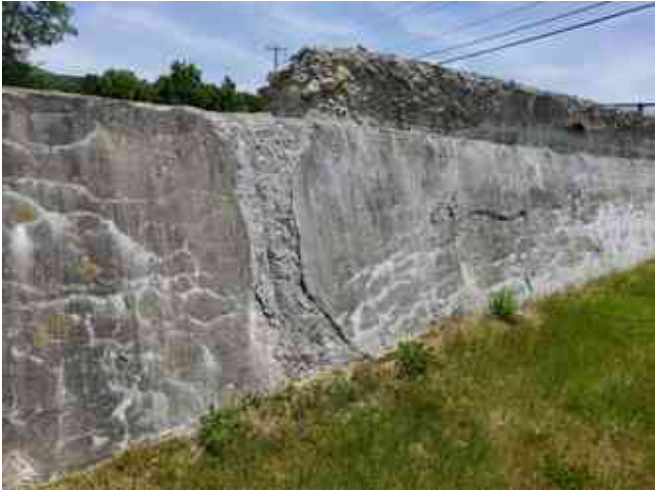
| | <p>Inspect ID: 2016-0120 Title: _1_20220607T154410.jpg Rated Item: 4. Concrete Surfaces Caption: Rating: Minimally Acceptable; Remarks: Spalling of local floodwall at monolith joint on unprotected side.; Action: Repair concrete surfaces in accordance with USACE guidelines.</p> |

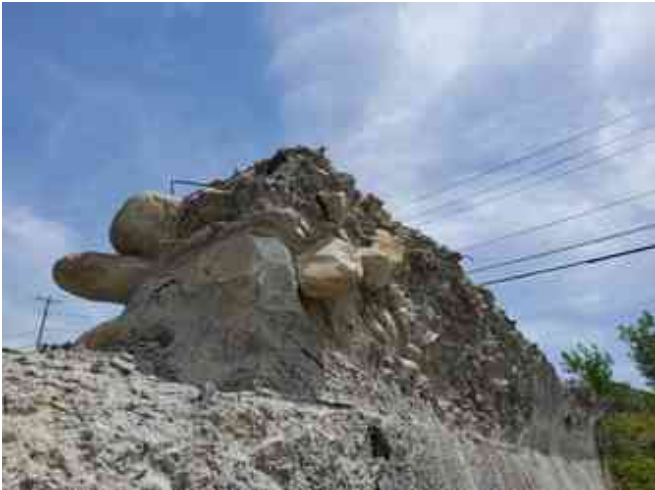
| | <p>Inspect ID: 2016-0121 Title: _5_20220607T154455.jpg Rated Item: 4. Concrete Surfaces Caption: Rating: Minimally Acceptable; Remarks: Concrete spalling along top of local floodwall, exposed reinforcement.; Action: Repair concrete surfaces in accordance with USACE guidelines.</p> |

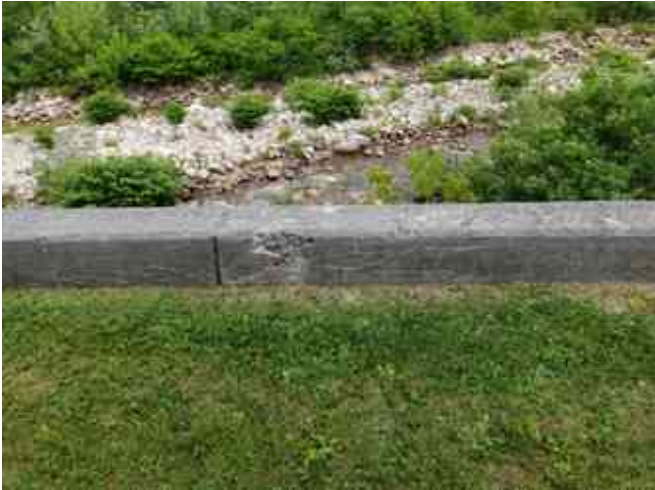
| | <p>Inspect ID: 2016-0137 Title: _2_20220607T162139.jpg Rated Item: 4. Concrete Surfaces Caption: Rating: Minimally Acceptable; Remarks: Cracking and spalling of retaining wall on protected side.; Action: Repair concrete surfaces in accordance with USACE guidelines.</p> |

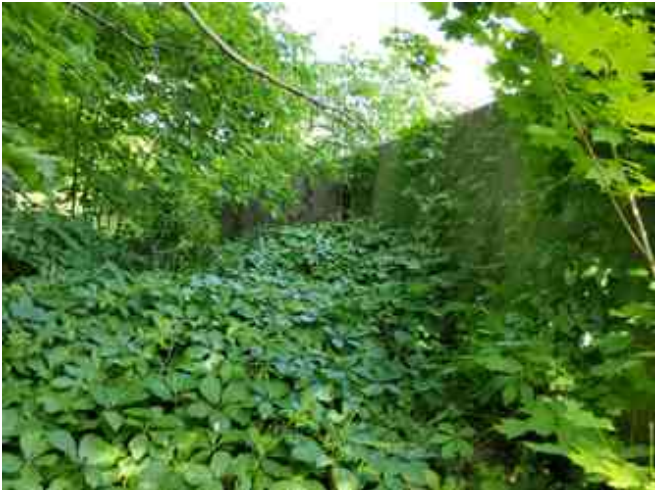
| | <p>Inspect ID: 2016-0108 Title: _7_20220607T152557.jpg Rated Item: 5. Tilting, Sliding or Settlement of Concrete Structures Caption: Rating: Minimally Acceptable; Remarks: Noted in the previous inspection, 2-inch joint separation between floodwall and abutment. The joint between monolith #6 and the local floodwall has displacement 1-5/8-in. The monolith also tips slightly to the unprotected side. Cannot confirm in 2022 inspection due to vegetation.; Action: The O&M manual should be revised to include the monitoring of the displacements of the floodwall concrete monoliths during normal and flood conditions.</p> |

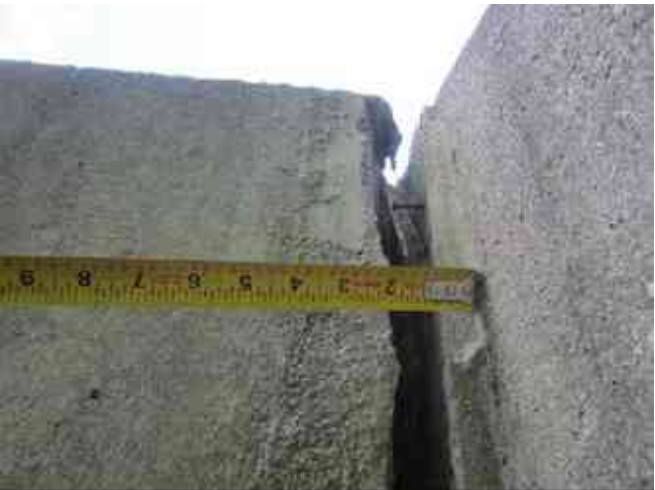
| | <p>Inspect ID: 2016-0108 Title: 4504000006_CENAN_2022_B_0108_2_20220616T133322.jpg</p> <p>Rated Item: 5. Tilting, Sliding or Settlement of Concrete Structures Caption: Rating: Minimally Acceptable; Remarks: Noted in the previous inspection, 2-inch joint separation between floodwall and abutment. The joint between monolith #6 and the local floodwall has displacement 1-5/8-in. The monolith also tips slightly to the unprotected side. Cannot confirm in 2022 inspection due to vegetation.; Action: The O&M manual should be revised to include the monitoring of the displacements of the floodwall concrete monoliths during normal and flood conditions.</p> |

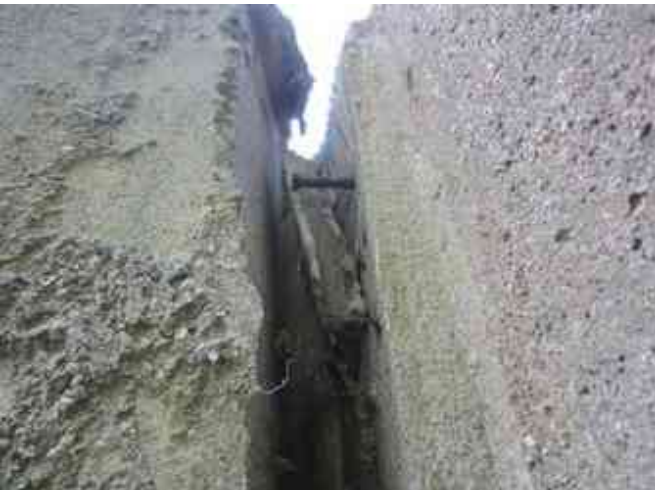
| | <p>Inspect ID: 2016-0108 Title: 4504000006_CENAN_2022_B_0108_3_20220616T133332.jpg</p> <p>Rated Item: 5. Tilting, Sliding or Settlement of Concrete Structures Caption: Rating: Minimally Acceptable; Remarks: Noted in the previous inspection, 2-inch joint separation between floodwall and abutment. The joint between monolith #6 and the local floodwall has displacement 1-5/8-in. The monolith also tips slightly to the unprotected side. Cannot confirm in 2022 inspection due to vegetation.; Action: The O&M manual should be revised to include the monitoring of the displacements of the floodwall concrete monoliths during normal and flood conditions.</p> |

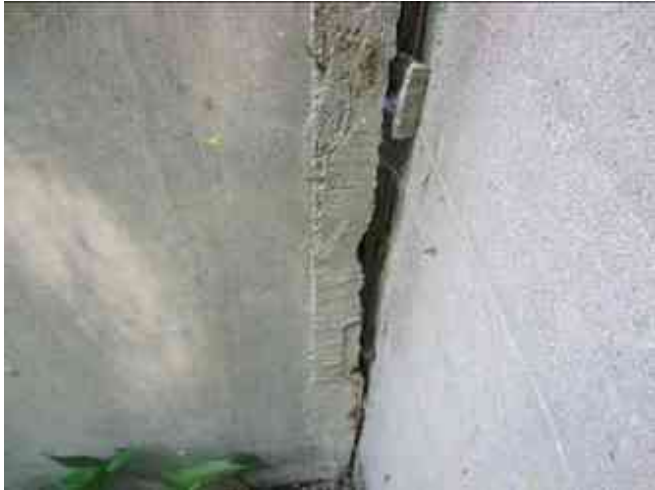
| | <p>Inspect ID: 2016-0108 Title: 4504000006_CENAN_2022_B_0108_4_20220616T133341.jpg</p> <p>Rated Item: 5. Tilting, Sliding or Settlement of Concrete Structures Caption: Rating: Minimally Acceptable; Remarks: Noted in the previous inspection, 2-inch joint separation between floodwall and abutment. The joint between monolith #6 and the local floodwall has displacement 1-5/8-in. The monolith also tips slightly to the unprotected side. Cannot confirm in 2022 inspection due to vegetation.; Action: The O&M manual should be revised to include the monitoring of the displacements of the floodwall concrete monoliths during normal and flood conditions.</p> |

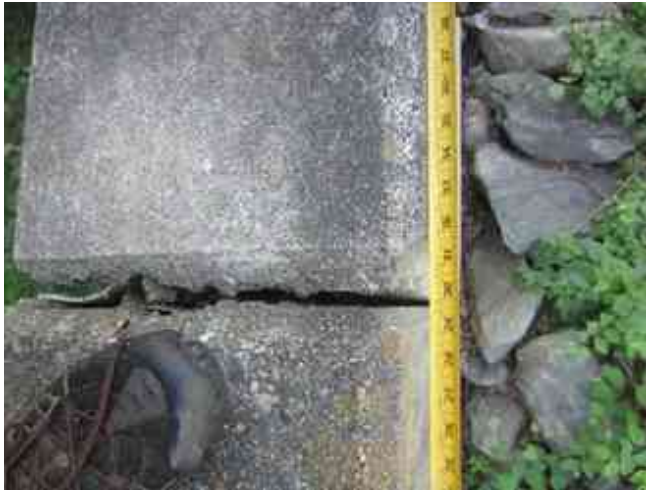
| | <p>Inspect ID: 2016-0108 Title: 4504000006_CENAN_2022_B_0108_5_20220616T133348.jpg</p> <p>Rated Item: 5. Tilting, Sliding or Settlement of Concrete Structures Caption: Rating: Minimally Acceptable; Remarks: Noted in the previous inspection, 2-inch joint separation between floodwall and abutment. The joint between monolith #6 and the local floodwall has displacement 1-5/8-in. The monolith also tips slightly to the unprotected side. Cannot confirm in 2022 inspection due to vegetation.; Action: The O&M manual should be revised to include the monitoring of the displacements of the floodwall concrete monoliths during normal and flood conditions.</p> |

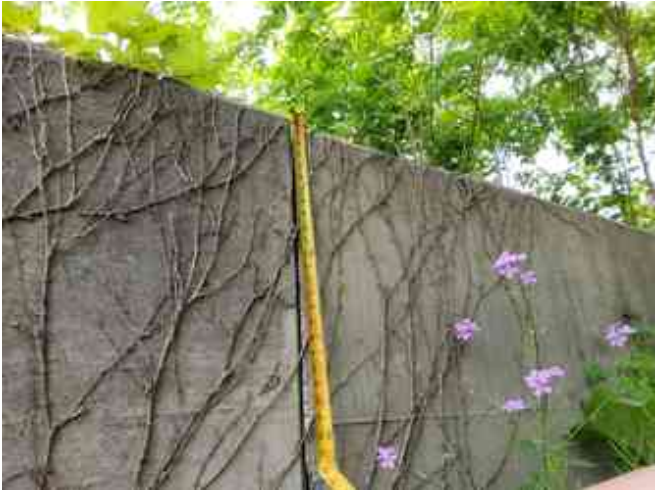
| | <p>Inspect ID: 2016-0149 Title: _2_20220607T163824.jpg Rated Item: 5. Tilting, Sliding or Settlement of Concrete Structures Caption: Rating: Minimally Acceptable; Remarks: 1/2-inch vertical displacement at monolith joint between monoliths 7 & 8.; Action: The O&M manual should be revised to include the monitoring of the displacements of the floodwall concrete monoliths during normal and flood conditions.</p> |

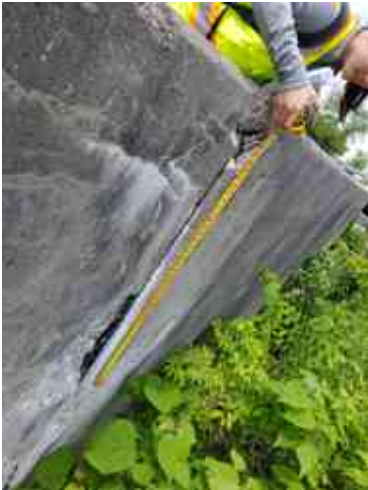
| | <p>Inspect ID: 2022-0005 Title: _1_20220607T160444.jpg Rated Item: 5. Tilting, Sliding or Settlement of Concrete Structures Caption: Rating: Minimally Acceptable; Remarks: Concrete at joint between monoliths severely degraded. Large (18") piece of concrete loosely hanging off water side of floodwall. Severe cracking on top of the floodwall at the joint.; Action: The O&M manual should be revised to include the monitoring of the displacements of the floodwall concrete monoliths during normal and flood conditions.</p> |

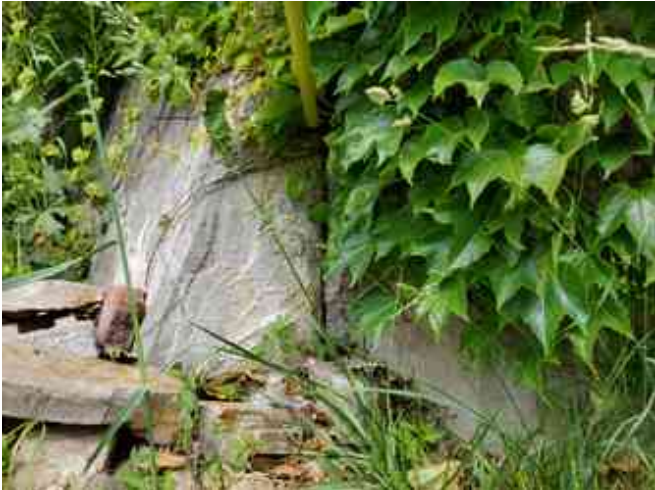
| | <p>Inspect ID: 2016-0148 Title: _4_20220607T163725.jpg Rated Item: 7. Monolith Joints Caption: Rating: Minimally Acceptable; Remarks: Separation at monolith joint where local retaining wall meets floodwall monolith #7.; Action: The O&M manual should be revised to include the monitoring of the displacements of the floodwall concrete monoliths during normal and flood conditions.</p> |

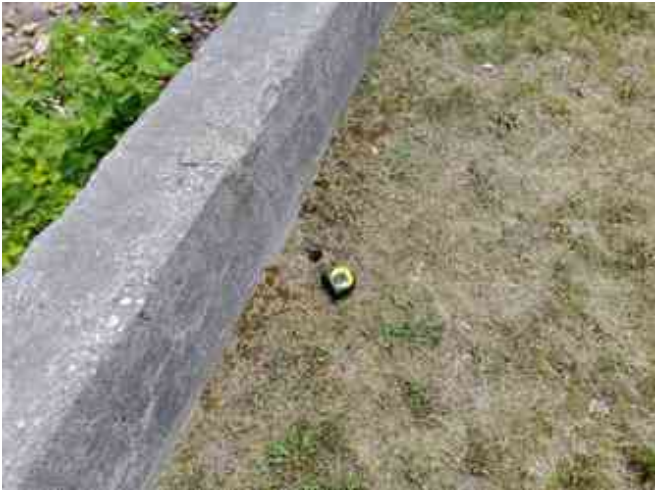
| | <p>Inspect ID: 2022-0006 Title: _1_20220607T161448.jpg Rated Item: 9. Seepage Caption: Rating: Minimally Acceptable; Remarks: Small rodent hole about one foot deep and 3 inches in diameter behind floodwall.; Action: Fill burrow in accordance with USACE guidelines and monitor area for seepage.</p> |

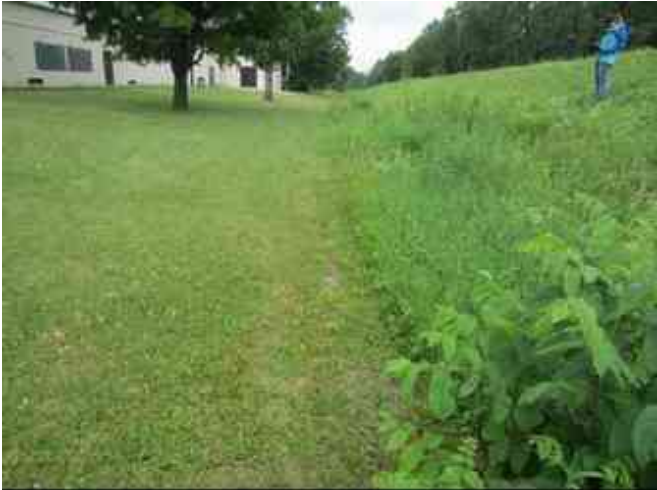
| | <p>Inspect ID: 2016-0070 Title: 4504000006_CENAN_2022_B_0070_2_20220622T142530.jpg Rated Item: 1. Vegetation and Obstructions Caption: Rating: Minimally Acceptable; Remarks: Drainage ditch is partially filled.; Action: Restore the interior drainage swale in accordance with USACE guidelines.</p> |

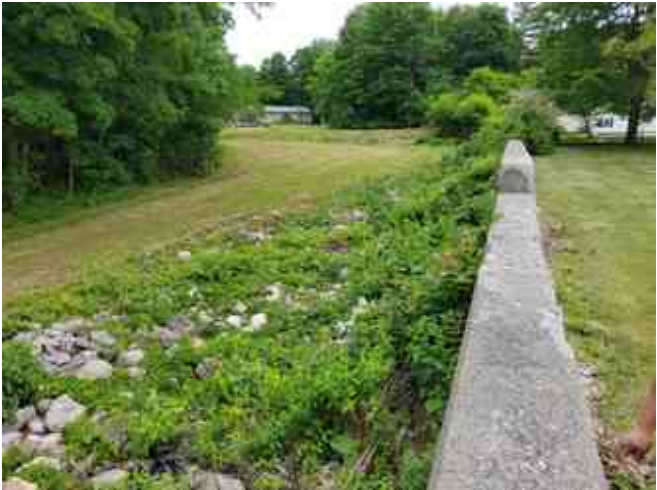
| | <p>Inspect ID: 2016-0145 Title: _3_20220607T163022.jpg Rated Item: 1. Vegetation and Obstructions Caption: Rating: Minimally Acceptable; Remarks: It was noted previously that the drainage ditch leading from DS #4 was filled in by riprap. The path for the discharge from DS #4 appears to slope upward for some distance.; Action: Re-establish line and grade of the drainage ditch, and provide erosion protection in accordance with USACE guidelines.</p> |

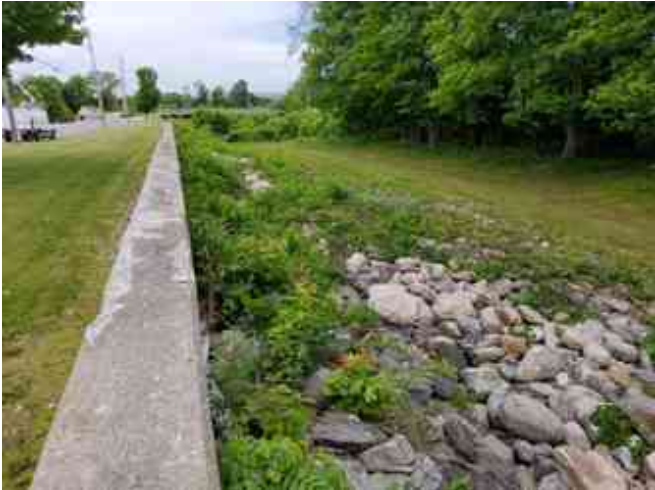
| | <p>Inspect ID: 2016-0145 Title: _4_20220607T163035.jpg Rated Item: 1. Vegetation and Obstructions Caption: Rating: Minimally Acceptable; Remarks: It was noted previously that the drainage ditch leading from DS #4 was filled in by riprap. The path for the discharge from DS #4 appears to slope upward for some distance.; Action: Re-establish line and grade of the drainage ditch, and provide erosion protection in accordance with USACE guidelines.</p> |

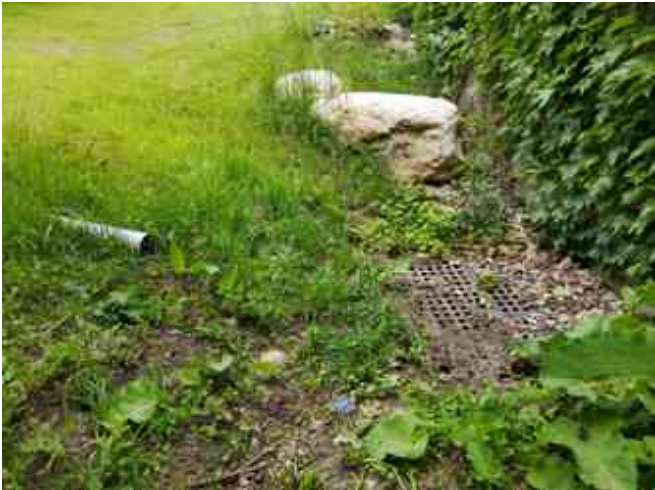
| | <p>Inspect ID: 2016-0150 Title: _5_20220607T163930.jpg Rated Item: 1. Vegetation and Obstructions Caption: Rating: Unacceptable; Remarks: DS #4 debris and vegetation in front of structure. Most of the vegetation has been cut, but some remains. Outfall looks clear and flapgate closes. Intake is covered with leaves and debris. Inlet could not be found.; Action: Maintain vegetation free zone in accordance with USACE guidelines.</p> |

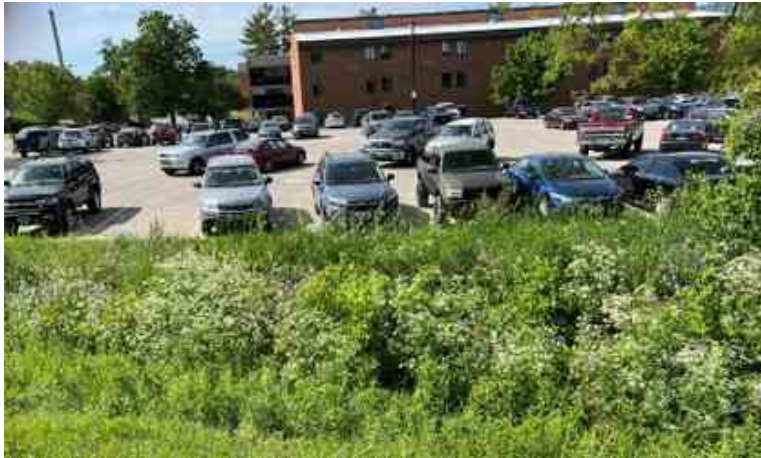
| | <p>Inspect ID: 2016-0009 Title: 4504000006_CENAN_2022_B_0009_4_20220622T143103.jpg</p> <p>Rated Item: 2. Encroachments Caption: Rating: Minimally Acceptable; Remarks: Changes at the school includes a parking lot adjacent to the ponding area and removal of the perimeter fence. There is dirt access, construction equipment, and debris in the ponding area.; Action: Documentation of the review/approval of the Mt. Anthony Union High School Site Plan needs to be added to the project archives. The local sponsor should remove non-project items from the ponding area.</p> |

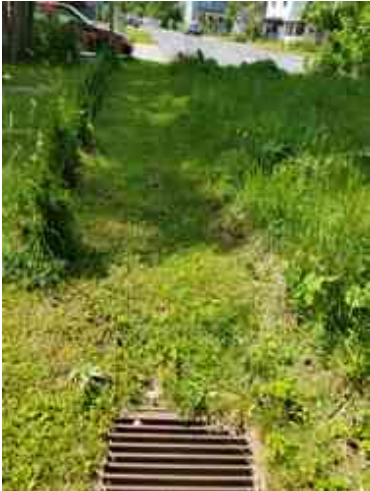
| | <p>Inspect ID: 2016-0106 Title: _3_20220607T145957.jpg Rated Item: 9. Culverts/ Discharge Pipes Caption: Rating: Acceptable; Remarks: DS #3 drop inlet appears clean and functional.</p> |

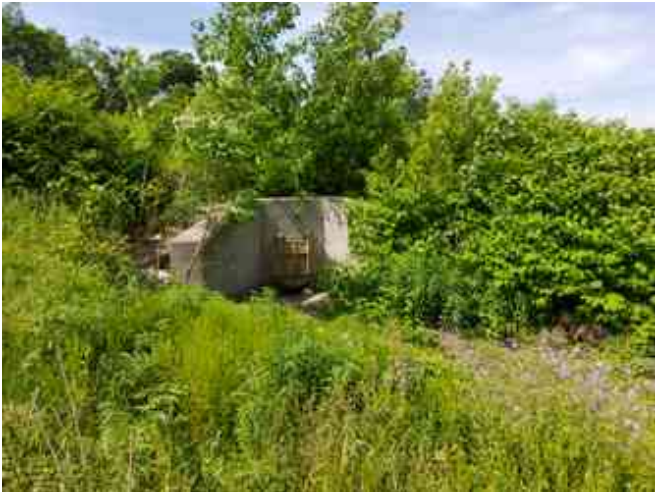
| | <p>Inspect ID: 2016-0081 Title: _6_20220607T142517.jpg Rated Item: 11. Flap Gates/ Flap Valves/ Pinch Valves Caption: Rating: Acceptable; Remarks: DS#2 outfall was reconstructed in 2012. concrete is in good condition except for 12" spall on top of floodwall. Flap gate operational and pipe is clear. Some sediment buildup and vegetation in drainage channel outlet of DS #2.; Action: Maintain vegetation in accordance with USACE guidelines.</p> |

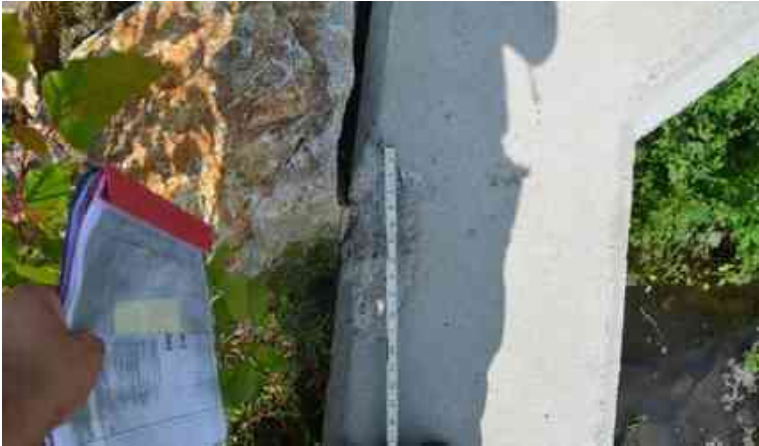
| | <p>Inspect ID: 2016-0081 Title: 4504000006_CENAN_2022_B_0081_3_20220622T150226.jpg Rated Item: 11. Flap Gates/ Flap Valves/ Pinch Valves Caption: Rating: Acceptable; Remarks: DS#2 outfall was reconstructed in 2012. concrete is in good condition except for 12" spall on top of floodwall. Flap gate operational and pipe is clear. Vegetation surrounding DS #2 and in drainage channel outlet.; Action: Maintain vegetation in accordance with USACE guidelines.</p> |

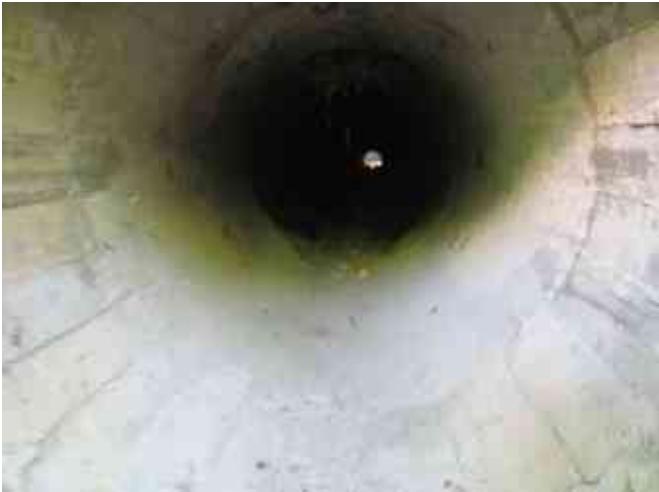
| | <p>Inspect ID: 2016-0102 Title: 4504000006_CENAN_2022_B_0102_2_20220616T184107.jpg Rated Item: 11. Flap Gates/ Flap Valves/ Pinch Valves Caption: Rating: Minimally Acceptable; Remarks: Noted previously vegetation covering flap gate for D.S. #3. Structure is obscured greatly by vegetation and is becoming very overgrown. Flap gate still operates. Cannot confirm in 2022 inspection due to vegetation.; Action: Maintain vegetation free zone in accordance with USACE guidelines.</p> |

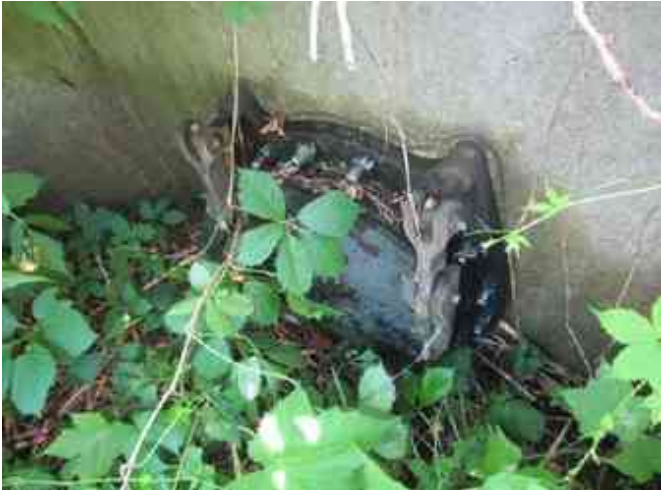
| | <p>Inspect ID: 2016-0102 Title: 4504000006_CENAN_2022_B_0102_2_20220622T150922.jpg Rated Item: 11. Flap Gates/ Flap Valves/ Pinch Valves Caption: Rating: Minimally Acceptable; Remarks: Noted previously vegetation covering flap gate for D.S. #3. Structure is obscured greatly by vegetation and is becoming very overgrown. Flap gate still operates. Cannot confirm in 2022 inspection due to vegetation.; Action: Maintain vegetation free zone in accordance with USACE guidelines.</p> |

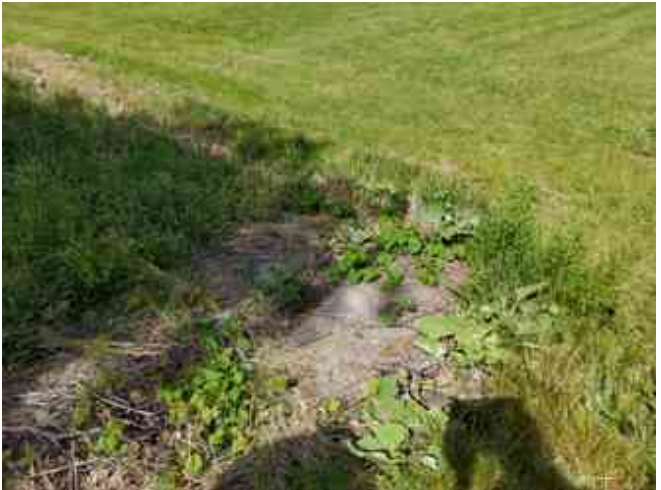
| | <p>Inspect ID: 2016-0055 Title: _5_20220607T134623.jpg Rated Item: 14. Riprap Revetments of Inlet/ Discharge Areas Caption: Rating: Minimally Acceptable; Remarks: Erosion, scouring and undermining next to concrete toe drain outlet channel. The channel itself is spalling. The headwall also has spalling. Pipe was recently video inspected and cleaned. Minor vegetation in toe drain.; Action: Restore the scour in the area around the toe drain outlet, and repair concrete surfaces in accordance with USACE guidelines.</p> |

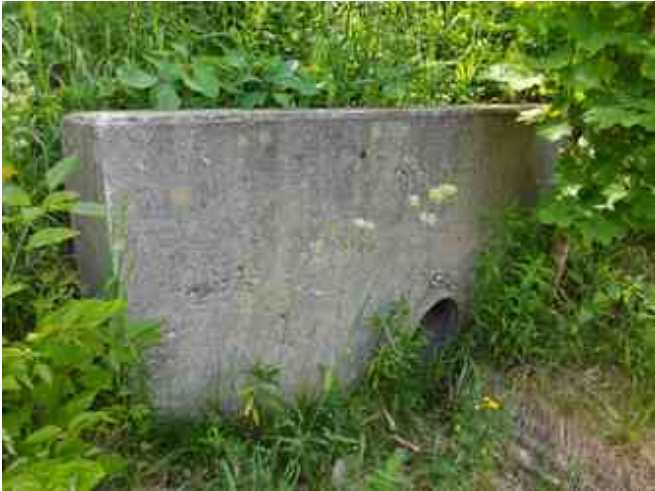
| | <p>Inspect ID: 2016-0055 Title: _6_20220607T134634.jpg Rated Item: 14. Riprap Revetments of Inlet/ Discharge Areas Caption: Rating: Minimally Acceptable; Remarks: Erosion, scouring and undermining next to concrete toe drain outlet channel. The channel itself is spalling. The headwall also has spalling. Pipe was recently video inspected and cleaned. Minor vegetation in toe drain.; Action: Restore the scour in the area around the toe drain outlet, and repair concrete surfaces in accordance with USACE guidelines.</p> |

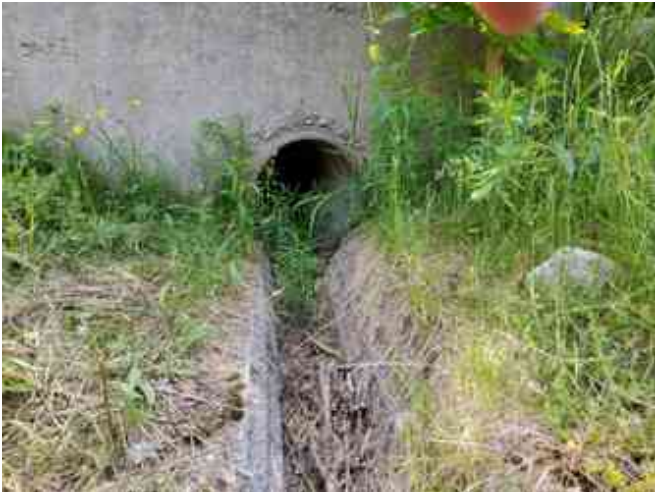
| | <p>Inspect ID: 2016-0055 Title: _7_20220607T134643.jpg Rated Item: 14. Riprap Revetments of Inlet/ Discharge Areas Caption: Rating: Minimally Acceptable; Remarks: Erosion, scouring and undermining next to concrete toe drain outlet channel. The channel itself is spalling. The headwall also has spalling. Pipe was recently video inspected and cleaned. Minor vegetation in toe drain.; Action: Restore the scour in the area around the toe drain outlet, and repair concrete surfaces in accordance with USACE guidelines.</p> |

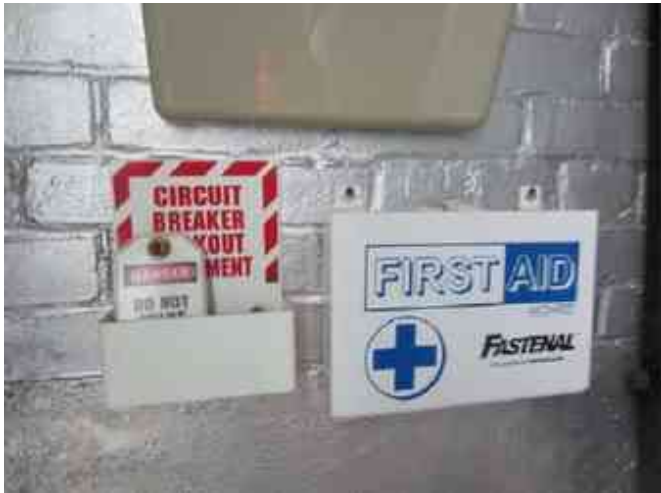
| | <p>Inspect ID: 2016-0015 Title: 4504000006_CENAN_2022_B_0015_2_20220622T151546.jpg</p> <p>Rated Item: 3. Safety Compliance Caption: Rating: Acceptable; Remarks: All the staff responsible for the station are certified treatment plant operators. Town safety team does inspections and the results are recorded. There have been no significant findings.</p> |

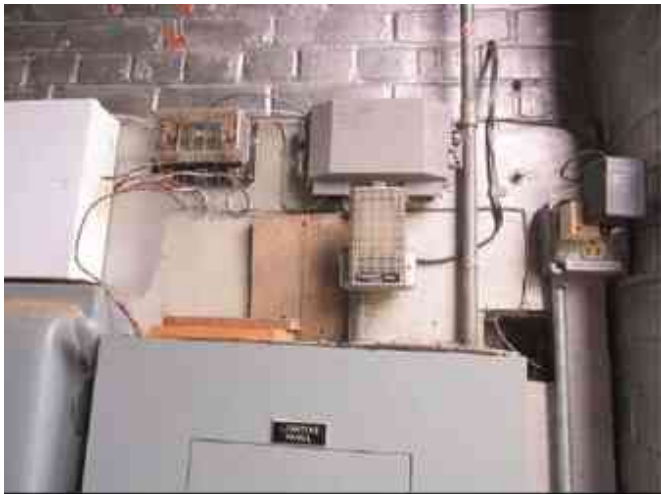
| | <p>Inspect ID: 2016-0016 Title: 4504000006_CENAN_2022_B_0016_2_20220621T203029.jpg</p> <p>Rated Item: 4. Communications (A or M only) Caption: Rating: Minimally Acceptable; Remarks: Cellular phone and two-way radios are used. There is also an auto dialer that notifies the town on pump failure. 2022: Auto dialer has been disconnected. Action: Restore auto dialer to previous working condition</p> |

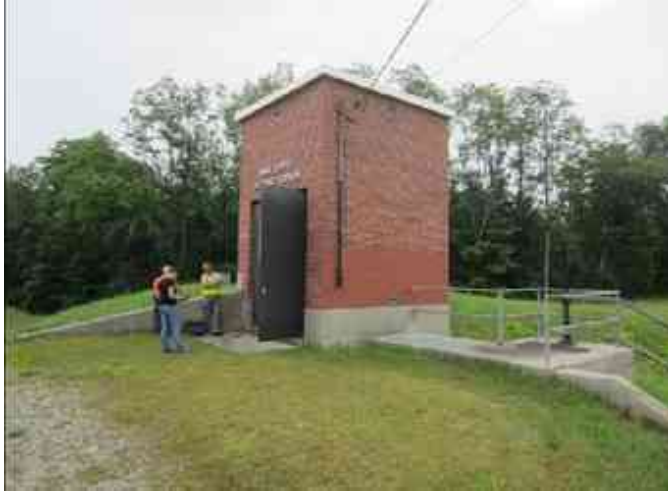
Inspect ID: 2016-0019 **Title:** 4504000006_CENAN_2022_B_0019_2_20220622T152031.jpg
Rated Item: 6. Fencing and Gates **Caption:** Rating: Acceptable; Remarks: The pump station is not fenced or otherwise protected from intrusion. Staff noted that there had been incidents of vandalism in the past. There is no fence on the As-Built drawings.; Action: Consider improving the security of the pumping station.

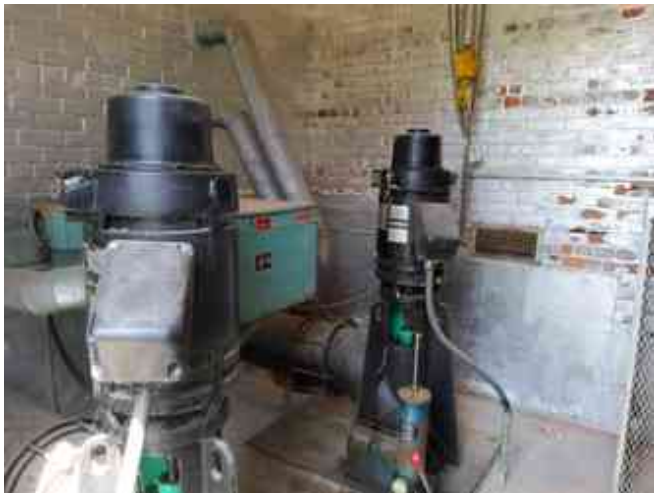
Inspect ID: 2016-0020 **Title:** _2_20220606T184444.jpg
Rated Item: 7. Pumps **Caption:** Rating: Minimally Acceptable; Remarks: The pump station includes two(2) 30Hp vertical turbine pumps (5000 gpm at 13.5'TDH) and a 50 gpm sump pump for draining the wet well. All three were run briefly (no water in wet well) and ran without excessive noise and vibration. ; Action: Maintain pumps in accordance with USACE guidelines.

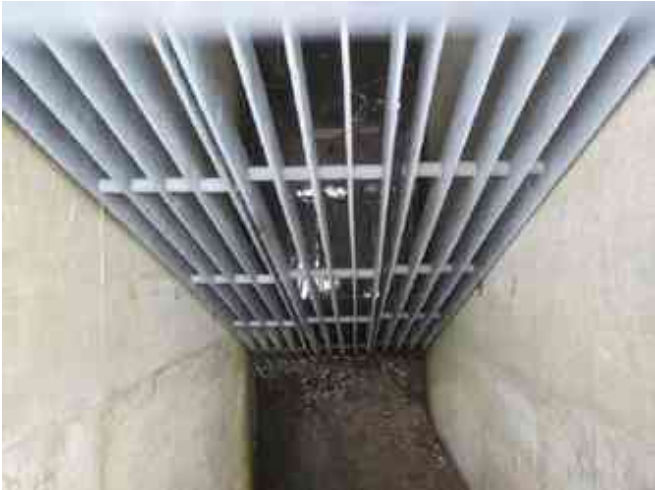
| | <p>Inspect ID: 2016-0022 Title: 4504000006_CENAN_2022_B_0022_2_20220622T152608.jpg Rated Item: 11. Non-Mechanical Trash Racks Caption: Rating: Acceptable; Remarks: There are only manual trash racks which appear to be in good condition with one or two of the bars slightly bent.</p> |

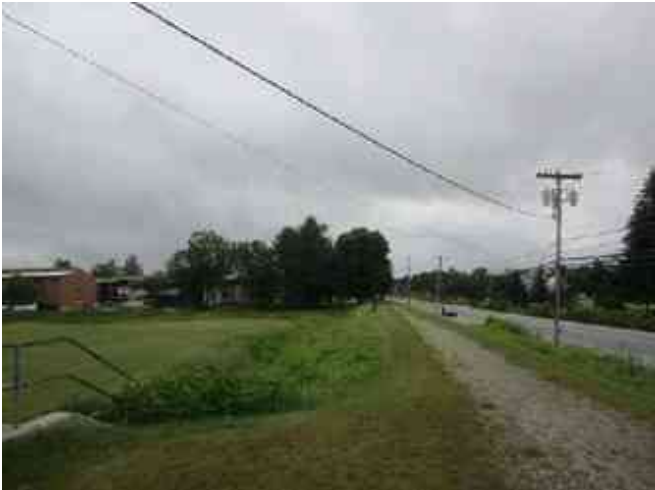
| | <p>Inspect ID: 2016-0026 Title: 4504000006_CENAN_2022_B_0026_2_20220622T153341.jpg Rated Item: 13. Power Source Caption: Rating: Minimally Acceptable; Remarks: There is no backup power (i.e., generator) at the pumping station; nor are there provisions for connecting a mobile generator. The pumping station does not presently have a main service disconnect (main circuit breaker or main fused disconnect switch).; Action: To increase reliability of the pumping station, a generator should be added, or provisions for connecting a mobile generator should be provided. It is recommended that a main service disconnect be provided. Photo taken from 2016.</p> |

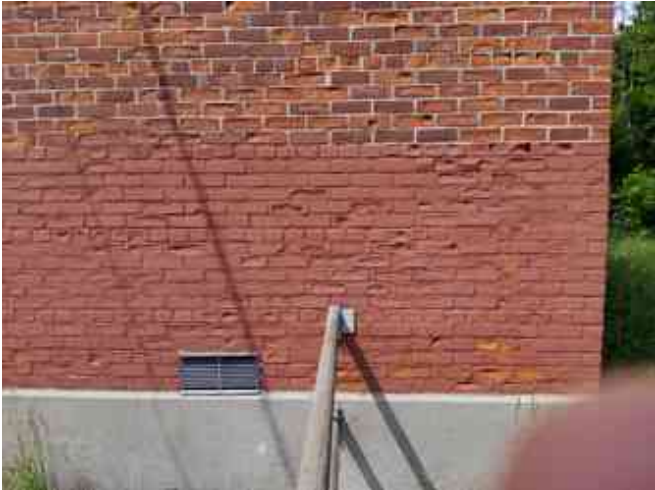
| | <p>Inspect ID: 2016-0027 Title: _4_20220606T185313.jpg Rated Item: 14. Electrical Systems Caption: Rating: Minimally Acceptable; Remarks: There are no lights in the wetwell or on the building exterior. The receptacles are not GFI protected.; Action: Replace the wetwell and exterior building lighting. Replace the interior receptacles with GFI protected outlets.</p> |

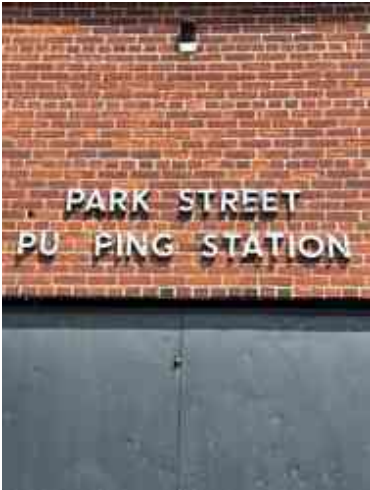
| | <p>Inspect ID: 2016-0027 Title: 4504000006_CENAN_2022_B_0027_5_20220622T153828.jpg Rated Item: 14. Electrical Systems Caption: Rating: Minimally Acceptable; Remarks: There are no lights in the wetwell or on the building exterior. The receptacles are not GFI protected.; Action: Replace the wetwell and exterior building lighting. Replace the interior receptacles with GFI protected outlets.</p> |

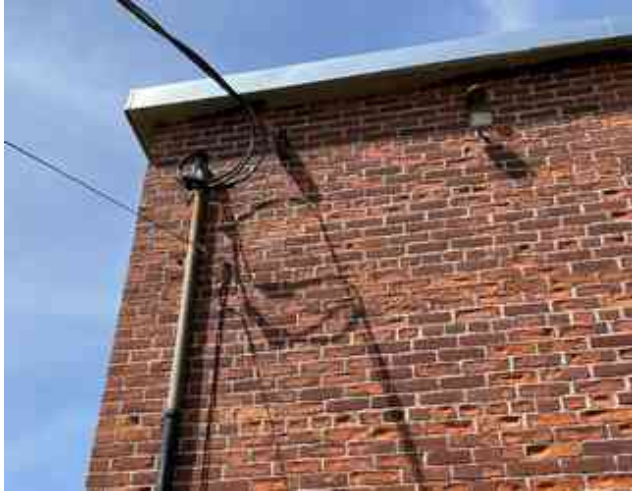
Inspect ID: 2016-0027 **Title:** 4504000006_CENAN_2022_B_0027_6_20220622T153834.jpg
Rated Item: 14. Electrical Systems **Caption:** Rating: Minimally Acceptable; Remarks: There are no lights in the wetwell or on the building exterior. The receptacles are not GFI protected.; Action: Replace the wetwell and exterior building lighting. Replace the interior receptacles with GFI protected outlets.

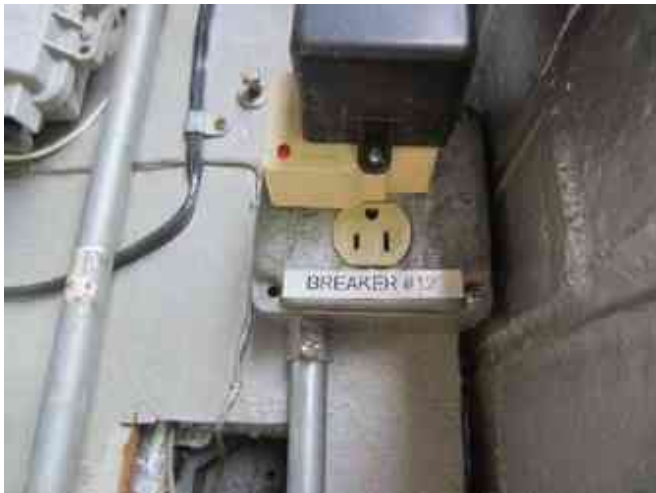
Inspect ID: 2016-0027 **Title:** 4504000006_CENAN_2022_B_0027_7_20220622T153908.jpg
Rated Item: 14. Electrical Systems **Caption:** Rating: Minimally Acceptable; Remarks: There are no lights in the wetwell or on the building exterior. The receptacles are not GFI protected.; Action: Replace the wetwell and exterior building lighting. Replace the interior receptacles with GFI protected outlets.

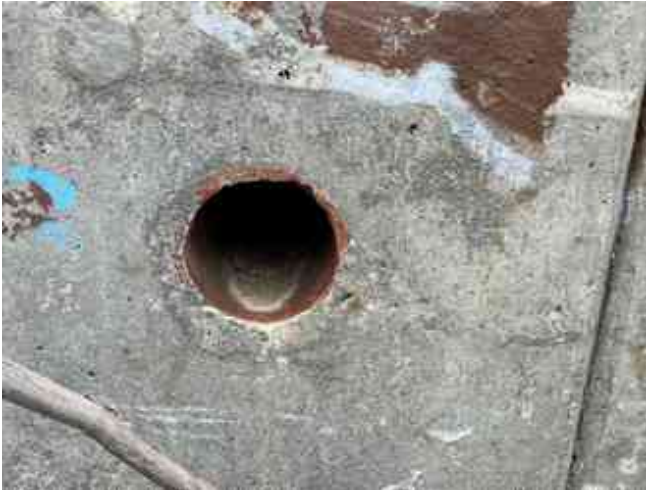
| | <p>Inspect ID: 2016-0132 Title: 4504000006_CENAN_2022_B_0132_1_20220622T160419.jpg Rated Item: 1. Vegetation and Obstructions Caption: Rating: Minimally Acceptable; Remarks: Debris in retaining wall weephole.; Action: The Bennington FRMP is predicated on the continued maintenance by the local sponsor of the locally constructed floodwall, retaining wall, and other revetments. Failure of these improvements could cause a cascading failure of the entire project.</p> |

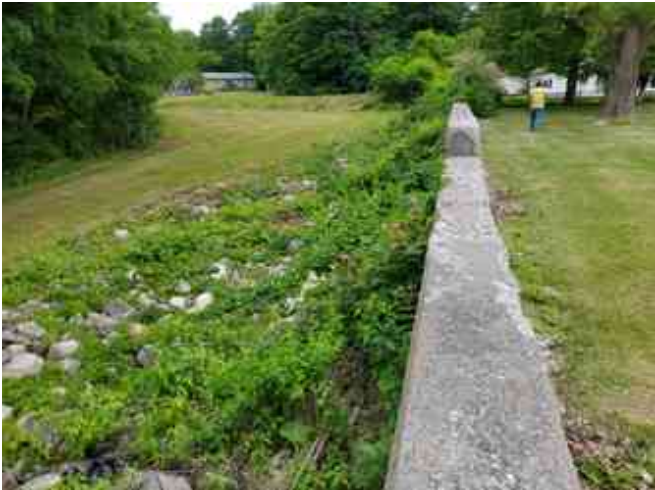
| | <p>Inspect ID: 2016-0144 Title: _3_20220607T163114.jpg Rated Item: 1. Vegetation and Obstructions Caption: Rating: Minimally Acceptable; Vegetation located along the retaining wall on unprotected side of levee.; Action: Maintain vegetation free zone in accordance with USACE guidelines.</p> |

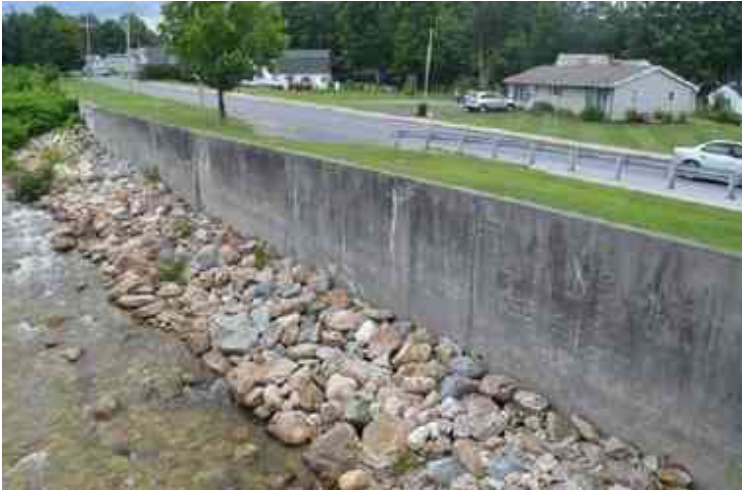
| | <p>Inspect ID: 2016-0122 Title: 4504000006_CENAN_2022_B_0122_3_20220622T174429.jpg Rated Item: 5. Concrete Surfaces Caption: Rating: Unacceptable; Remarks: Horizontal cracking on the unprotected face of the local sponsor constructed retaining wall with efflorescence running entire length of retaining wall.; Action: The Bennington FRMP is predicated on the continued maintenance by the local sponsor of the locally constructed floodwall, retaining wall, and other revetments. Failure of these improvements could cause a cascading failure of the entire project.</p> |

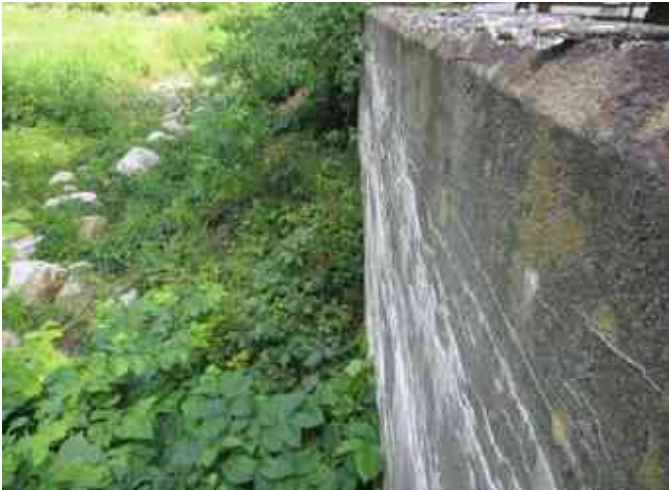
| | <p>Inspect ID: 2016-0122 Title: 4504000006_CENAN_2022_B_0122_4_20220622T174439.jpg Rated Item: 5. Concrete Surfaces Caption: Rating: Unacceptable; Remarks: Horizontal cracking on the unprotected face of the local sponsor constructed retaining wall with efflorescence running entire length of retaining wall.; Action: The Bennington FRMP is predicated on the continued maintenance by the local sponsor of the locally constructed floodwall, retaining wall, and other revetments. Failure of these improvements could cause a cascading failure of the entire project.</p> |
