Levee Inspection Report

Name of System: Bennington Flood Control Project

Name of Segment: Bennington, Roaring Branch Left Bank

Date(s) of Inspection: 06/06/2022 - 06/07/2022

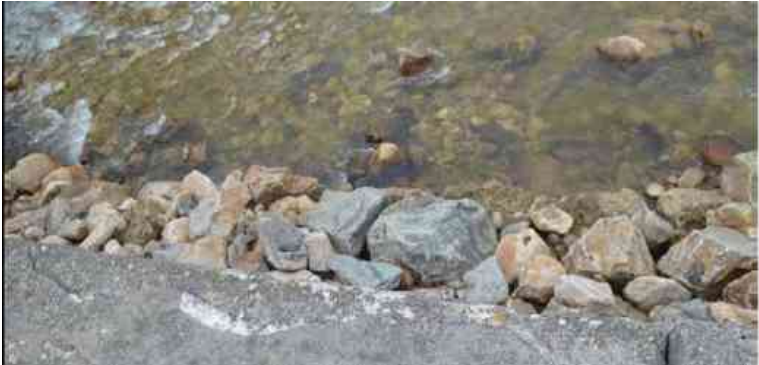
| | <p>Inspect ID: 2016-0127 Title: 4504000006_CENAN_2022_B_0127_1_20220622T182512.jpg Rated Item: 5. Concrete Surfaces Caption: Rating: Minimally Acceptable; Remarks: Spalling of unprotected face of retaining wall at monolith joint.; Action: The Bennington FRMP is predicated on the continued maintenance by the local sponsor of the locally constructed floodwall, retaining wall, and other revetments. Repair concrete.</p> |

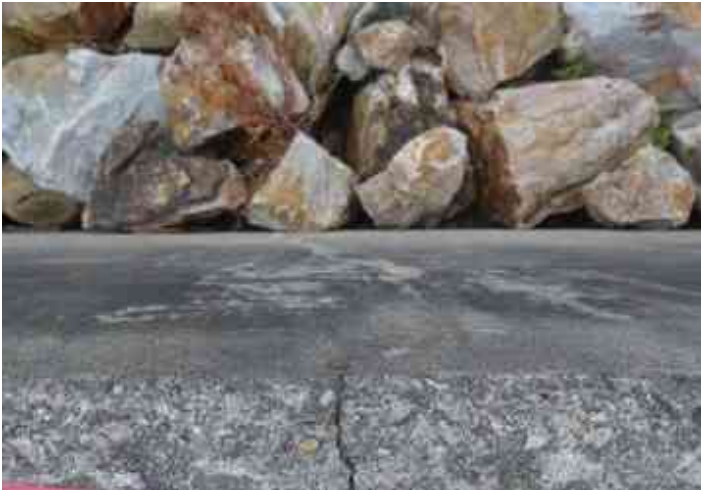
| | <p>Inspect ID: 2016-0128 Title: 4504000006_CENAN_2022_B_0128_2_20220622T182703.jpg Rated Item: 5. Concrete Surfaces Caption: Rating: Minimally Acceptable; Remarks: Large vertical crack in retaining wall on the unprotected side.; The Bennington FRMP is predicated on the continued maintenance by the local sponsor of the locally constructed floodwall, retaining wall, and other revetments. Repair concrete.</p> |

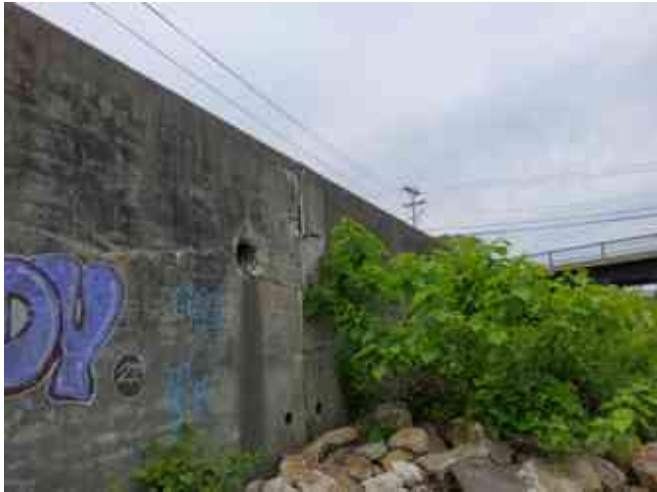
| | <p>Inspect ID: 2016-0130 Title: _2_20220607T170614.jpg Rated Item: 5. Concrete Surfaces Caption: Rating: Minimally Acceptable; Remarks: Spalling and cracking of unprotected face of retaining wall near culvert and monolith joint.; Action: The Bennington FRMP is predicated on the continued maintenance by the local sponsor of the locally constructed floodwall, retaining wall, and other revetments. Failure of these improvements could cause a cascading failure of the entire project.</p> |

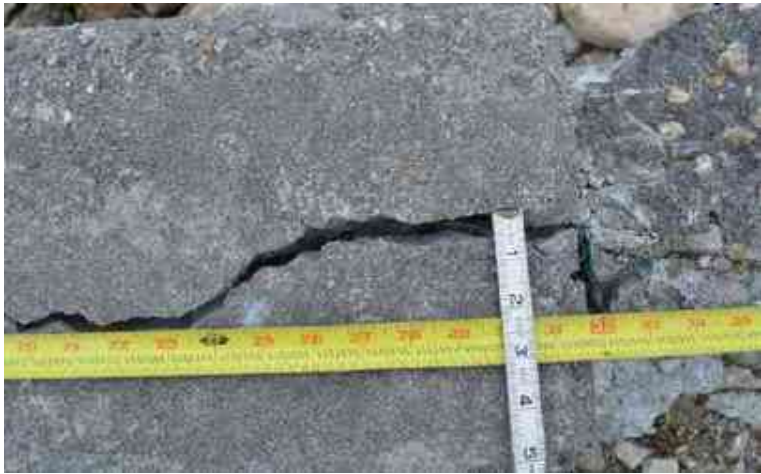
| | <p>Inspect ID: 2016-0133 Title: 4504000006_CENAN_2022_B_0133_2_20220622T182955.jpg Rated Item: 5. Concrete Surfaces Caption: Rating: Unacceptable; Remarks: Large horizontal crack leading to vertical crack on unprotected side.; Action: The Bennington FRMP is predicated on the continued maintenance by the local sponsor of the locally constructed floodwall, retaining wall, and other revetments. Failure of these improvements could cause a cascading failure of the entire project. Repair concrete.</p> |

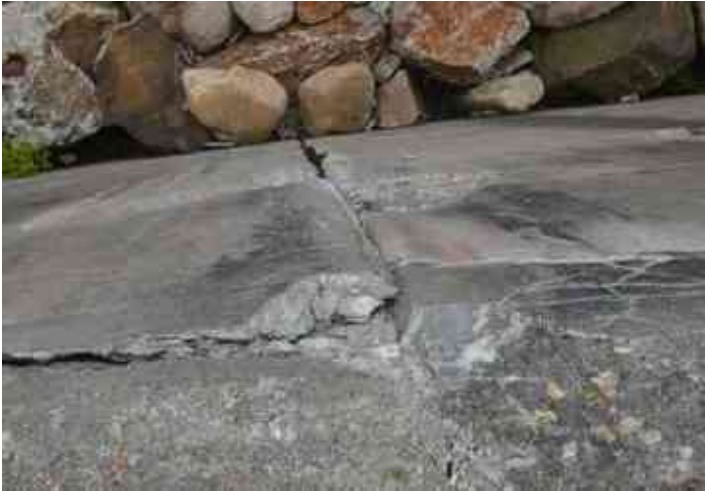
| | <p>Inspect ID: 2016-0133 Title: 4504000006_CENAN_2022_B_0133_3_20220622T183014.jpg Rated Item: 5. Concrete Surfaces Caption: Rating: Unacceptable; Remarks: Large horizontal crack leading to vertical crack on unprotected side.; Action: The Bennington FRMP is predicated on the continued maintenance by the local sponsor of the locally constructed floodwall, retaining wall, and other revetments. Failure of these improvements could cause a cascading failure of the entire project. Repair concrete.</p> |

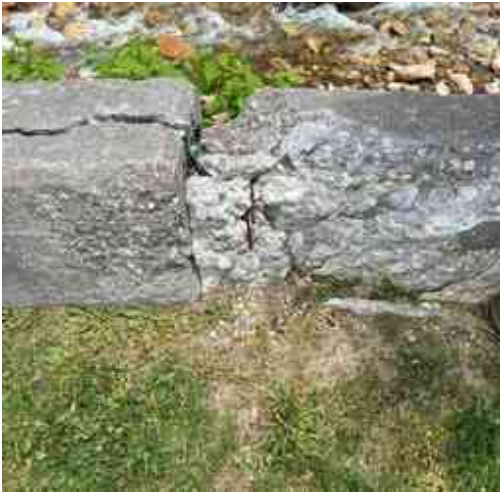
| | <p>Inspect ID: 2016-0134 Title: 4504000006_CENAN_2022_B_0134_2_20220622T183750.jpg Rated Item: 5. Concrete Surfaces Caption: Rating: Unacceptable; Remarks: Spalling of retaining wall on protected side.; Action: Repair concrete surfaces in accordance with USACE guidelines.</p> |

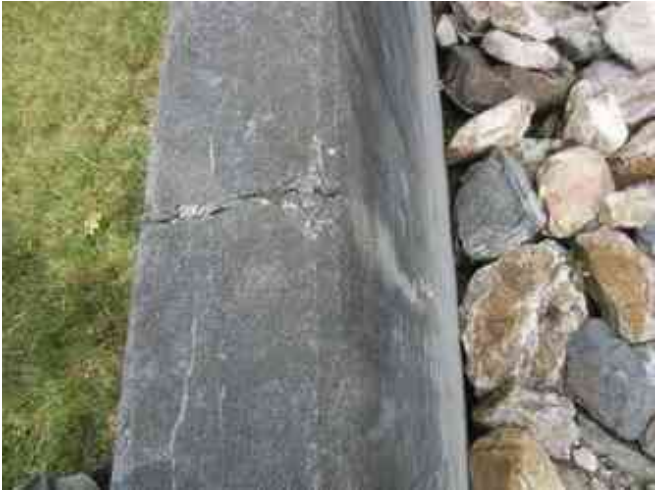
| | <p>Inspect ID: 2016-0135 Title: 4504000006_CENAN_2022_B_0135_2_20220622T180106.jpg Rated Item: 5. Concrete Surfaces Caption: Rating: Minimally Acceptable; Remarks: Large vertical crack in retaining wall on the unprotected side.; Action: The Bennington FRMP is predicated on the continued maintenance by the local sponsor of the locally constructed floodwall, retaining wall, and other revetments. Failure of these improvements could cause a cascading failure of the entire project. Repair concrete.</p> |

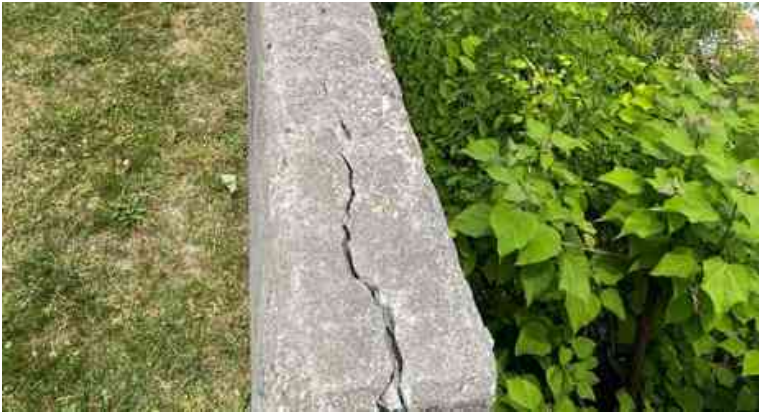
| | <p>Inspect ID: 2016-0136 Title: 4504000006_CENAN_2022_B_0136_2_20220622T181935.jpg Rated Item: 5. Concrete Surfaces Caption: Rating: Minimally Acceptable; Remarks: Cracking on top of retaining wall.; Action: Repair concrete surfaces in accordance with USACE guidelines.</p> |

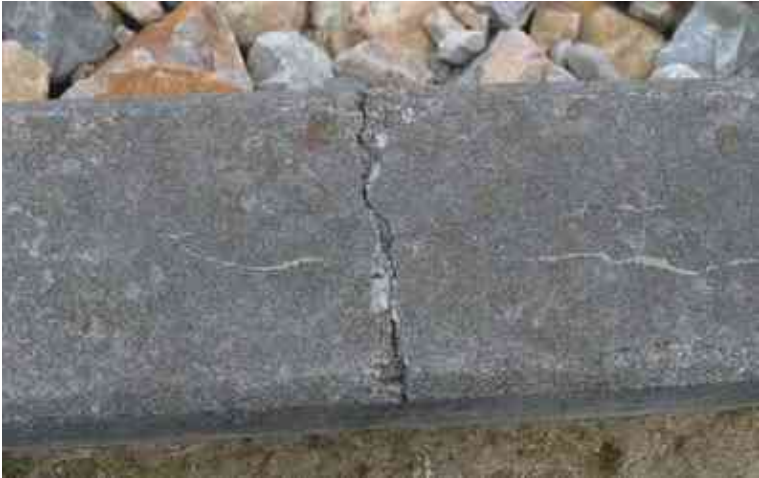
| | <p>Inspect ID: 2016-0139 Title: 4504000006_CENAN_2022_B_0139_2_20220622T183541.jpg</p> <p>Rated Item: 5. Concrete Surfaces Caption: Rating: Unacceptable; Remarks: Large vertical crack in retaining wall on the unprotected side.; Action: The Bennington FRMP is predicated on the continued maintenance by the local sponsor of the locally constructed floodwall, retaining wall, and other revetments. Failure of these improvements could cause a cascading failure of the entire project. Repair concrete.</p> |

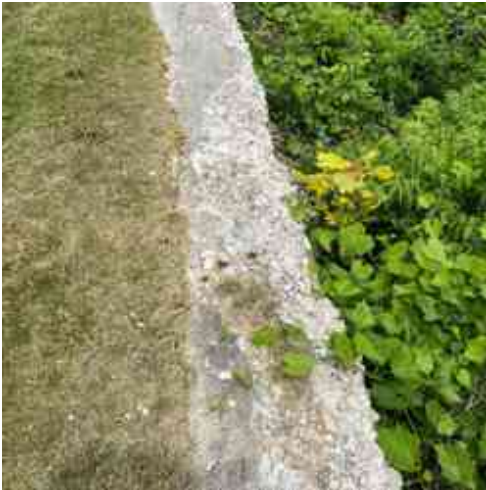
| | <p>Inspect ID: 2016-0140 Title: 4504000006_CENAN_2022_B_0140_4_20220622T180957.jpg</p> <p>Rated Item: 5. Concrete Surfaces Caption: Rating: Unacceptable; Remarks: Noted previously, older retaining wall with significant cracking and spalling.; Action: The Bennington FRMP is predicated on the continued maintenance by the local sponsor of the locally constructed floodwall, retaining wall, and other revetments. Repair concrete.</p> |

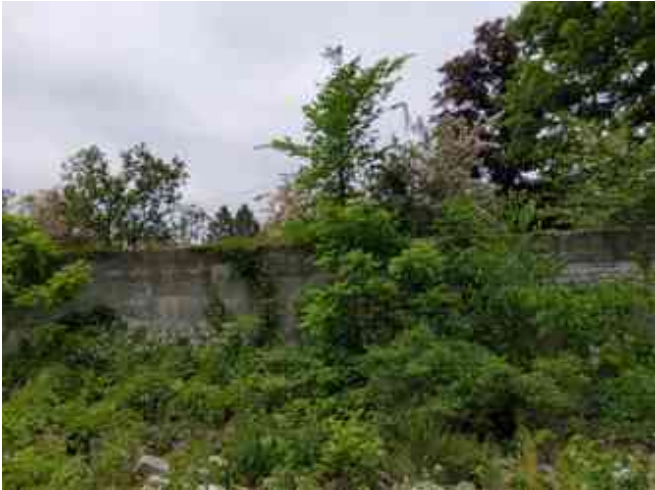
| | <p>Inspect ID: 2016-0142 Title: _2_20220607T165235.jpg Rated Item: 5. Concrete Surfaces Caption: Rating: Unacceptable; Remarks: Spalling of unprotected face of retaining wall at the monolith joint causing holes.; Action: The Bennington FRMP is predicated on the continued maintenance by the local sponsor of the locally constructed floodwall, retaining wall, and other revetments. Failure of these improvements could cause a cascading failure of the entire project. Repair concrete.</p> |

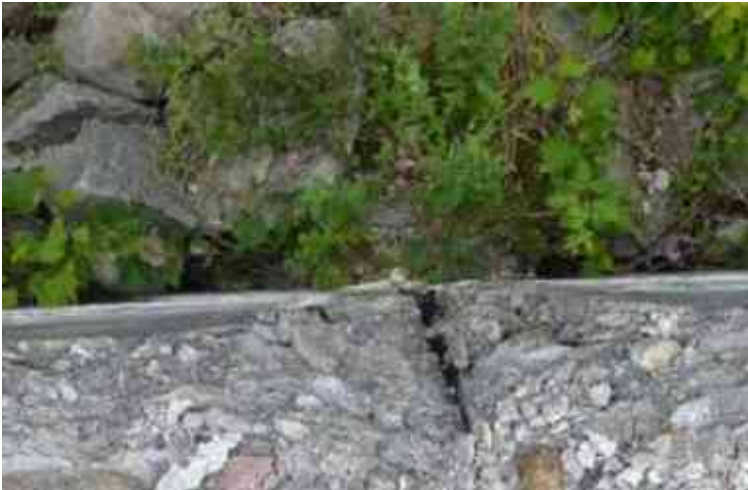
| | <p>Inspect ID: 2016-0142 Title: 4504000006_CENAN_2022_B_0142_3_20220622T180443.jpg Rated Item: 5. Concrete Surfaces Caption: Rating: Unacceptable; Remarks: Spalling of unprotected face of retaining wall at the monolith joint causing holes.; Action: The Bennington FRMP is predicated on the continued maintenance by the local sponsor of the locally constructed floodwall, retaining wall, and other revetments. Failure of these improvements could cause a cascading failure of the entire project. Repair concrete.</p> |

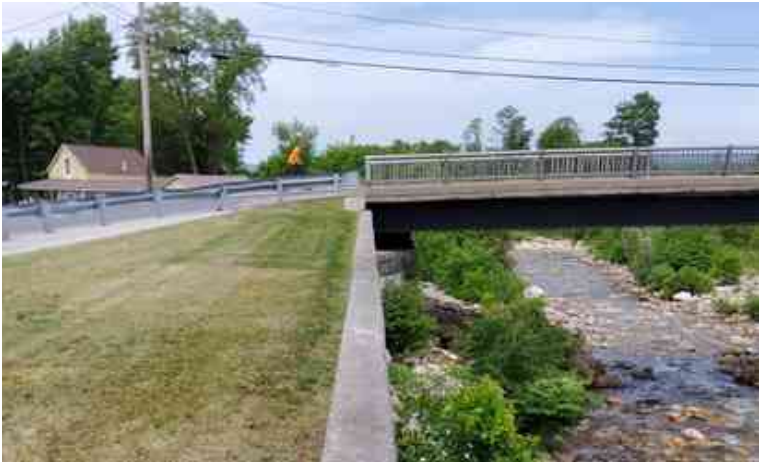
| | <p>Inspect ID: 2016-0126 Title: _3_20220607T161020.jpg Rated Item: 6. Tilting, Sliding or Settlement of Concrete Structures Caption: Rating: Minimally Acceptable; Remarks: Monolith of local retaining wall is tilting toward the unprotected side by 3 inches, but less than 2" from adjoining monolith.; Action: The Bennington FRMP is predicated on the continued maintenance by the local sponsor of the locally constructed floodwall, retaining wall, and other revetments. Failure of these improvements could cause a cascading failure of the entire project.</p> |

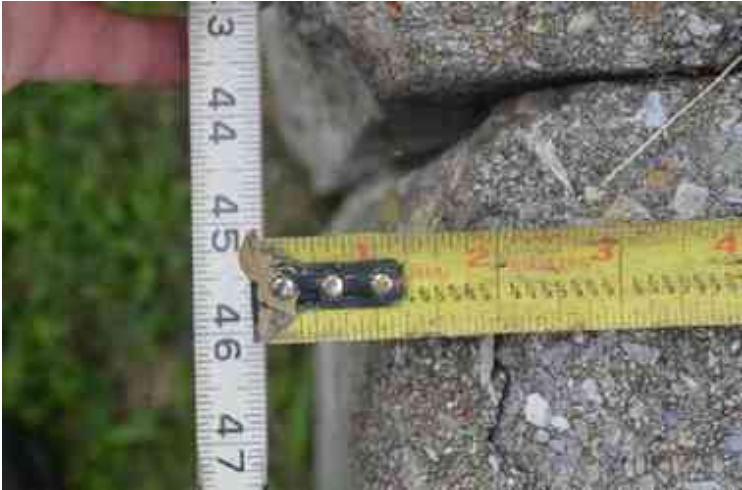
| | <p>Inspect ID: 2016-0126 Title: 4504000006_CENAN_2022_B_0126_2_20220622T172825.jpg Rated Item: 6. Tilting, Sliding or Settlement of Concrete Structures Caption: Rating: Minimally Acceptable; Remarks: Monolith of local retaining wall is tilting toward the unprotected side by 3 inches, but less than 2" from adjoining monolith.; Action: The Bennington FRMP is predicated on the continued maintenance by the local sponsor of the locally constructed floodwall, retaining wall, and other revetments. Failure of these improvements could cause a cascading failure of the entire project.</p> |

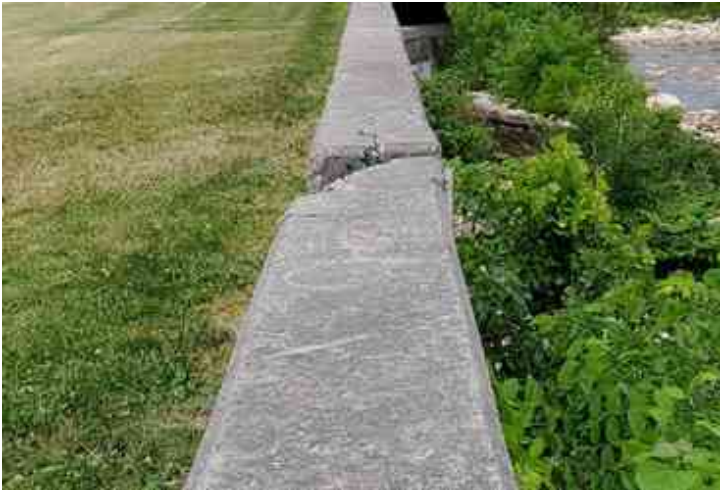
| | <p>Inspect ID: 2016-0131 Title: _2_20220607T161740.jpg Rated Item: 6. Tilting, Sliding or Settlement of Concrete Structures Caption: Rating: Minimally Acceptable; Remarks: A pair of retaining wall monoliths are tilting approximately 4 inches toward unprotected side, but less than 2" from adjoining monolith.; Action: The Bennington FRMP is predicated on the continued maintenance by the local sponsor of the locally constructed floodwall, retaining wall, and other revetments. Monitor displacements for further movement.</p> |

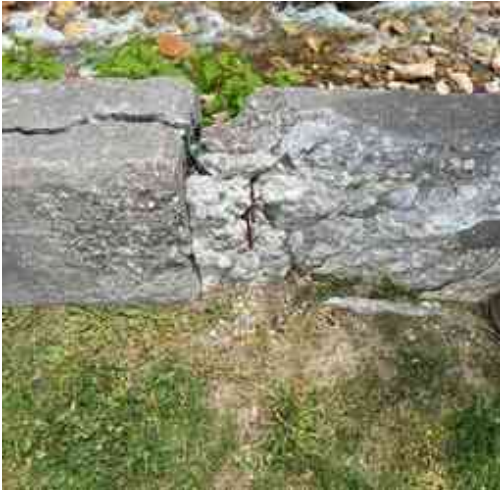
| | <p>Inspect ID: 2016-0131 Title: 4504000006_CENAN_2022_B_0131_2_20220622T173214.jpg Rated Item: 6. Tilting, Sliding or Settlement of Concrete Structures Caption: Rating: Minimally Acceptable; Remarks: A pair of retaining wall monoliths are tilting approximately 4 inches toward unprotected side, but less than 2" from adjoining monolith.; Action: The Bennington FRMP is predicated on the continued maintenance by the local sponsor of the locally constructed floodwall, retaining wall, and other revetments. Monitor displacements for further movement.</p> |

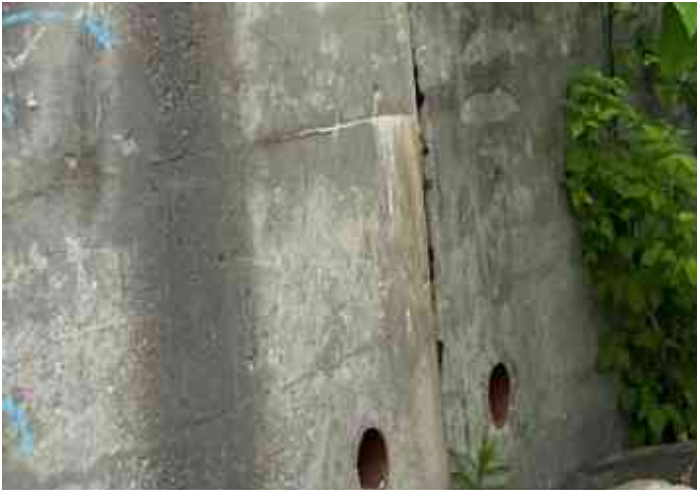
| | <p>Inspect ID: 2016-0125 Title: 4504000006_CENAN_2022_B_0125_1_20220622T173632.jpg Rated Item: 7. Foundation of Concrete Structures Caption: Rating: Minimally Acceptable; Remarks: Several newly drilled weepholes at base of retaining wall.; Action: Verify authority for drilled weepholes.</p> |
