650 MAIN ST., BENNINGTON, VT- ROOF REPORT

August 12, 2022

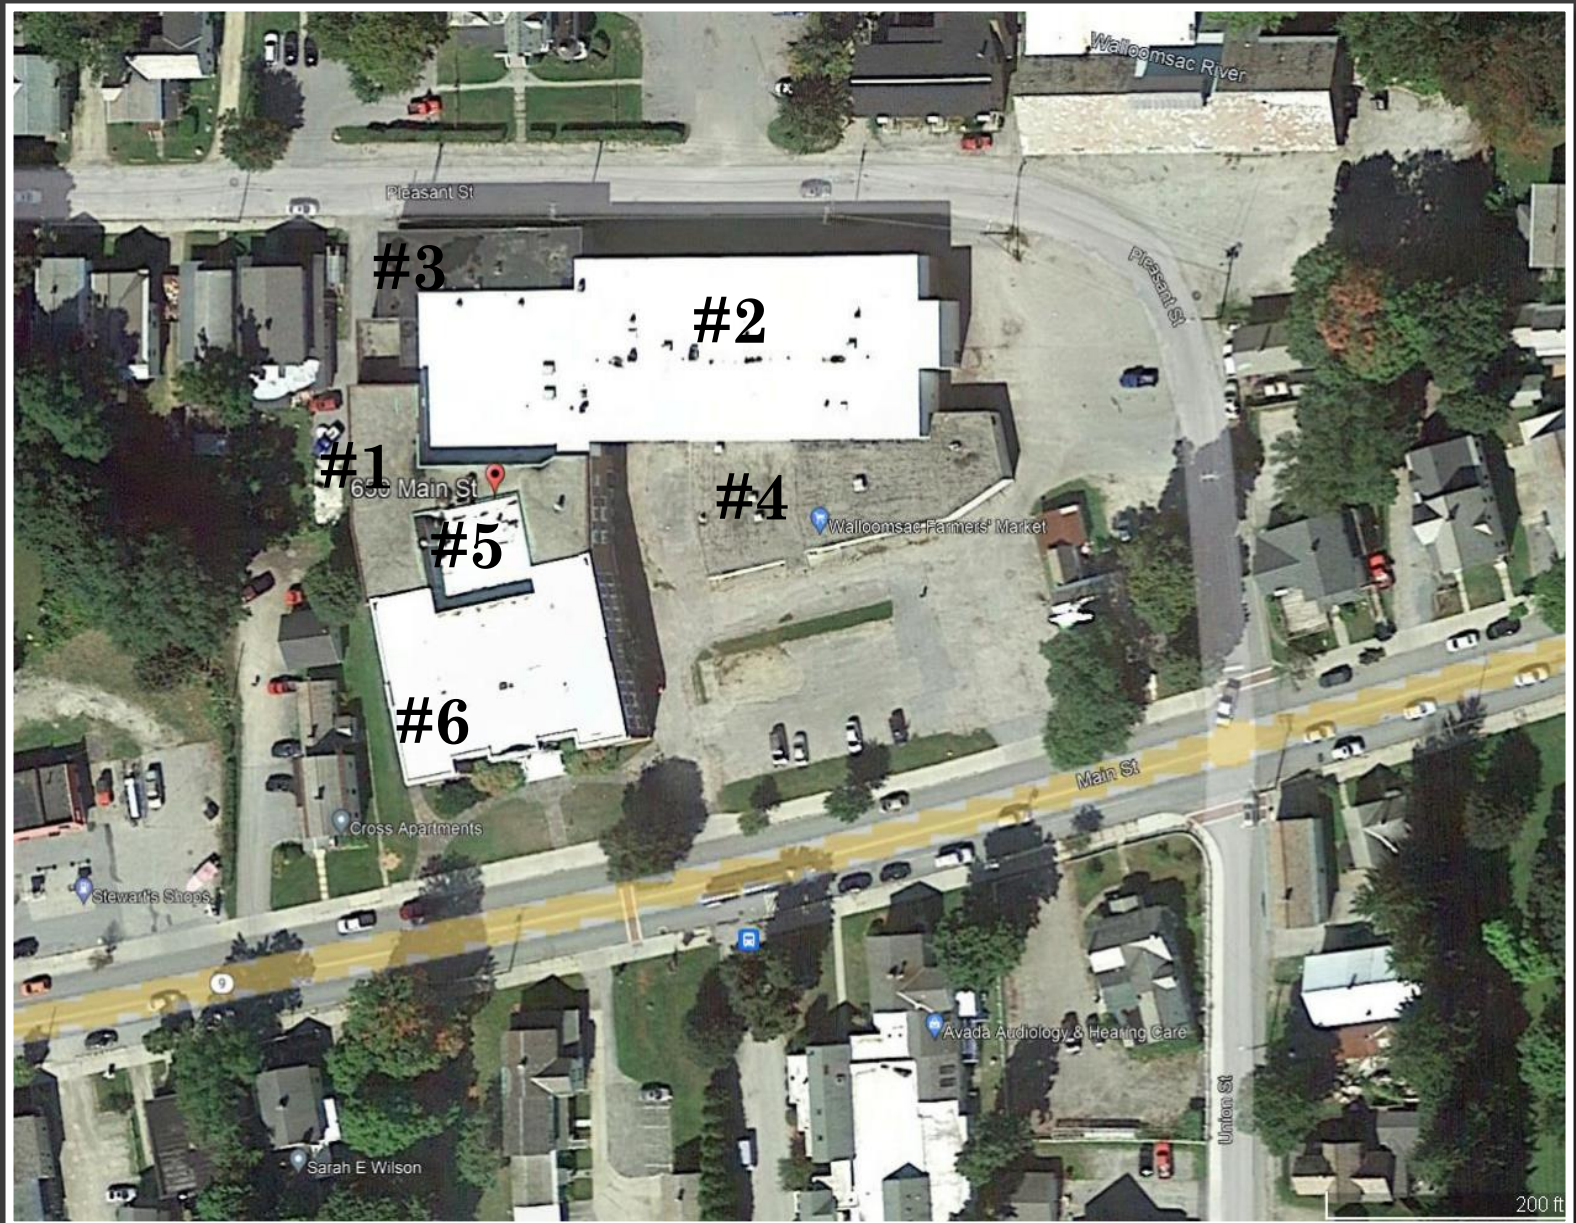
ROOF LAYOUT

Types 1-6

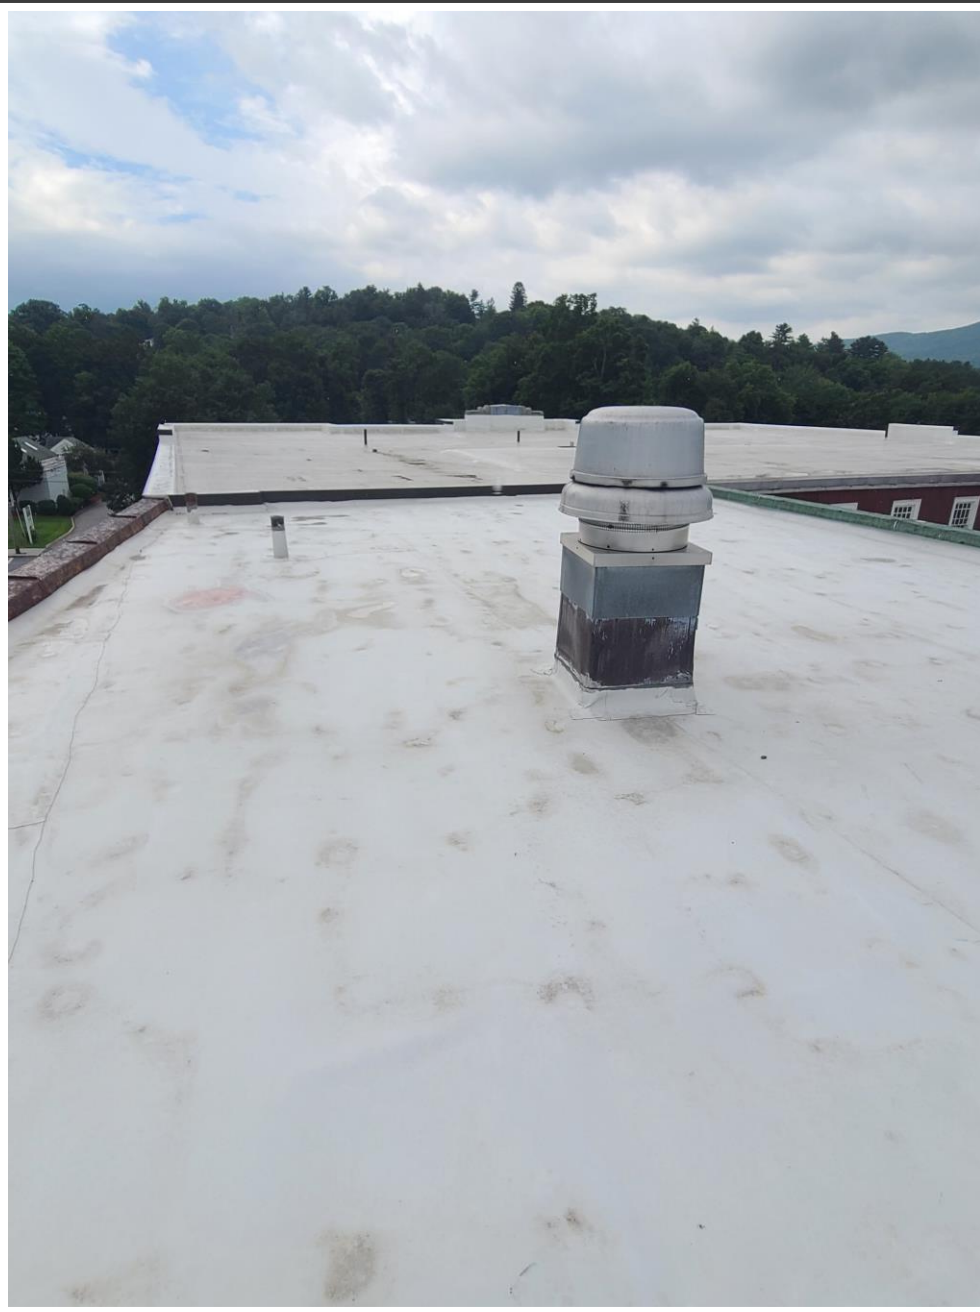
ROOF TYPE #1

TPO 060 Membrane
1" poly-ISO
1" Built-up
 $\frac{1}{2}$ " Fiberboard
Tectum Deck

Roof failing in multiple areas.
Improper install.
Wet insulation.

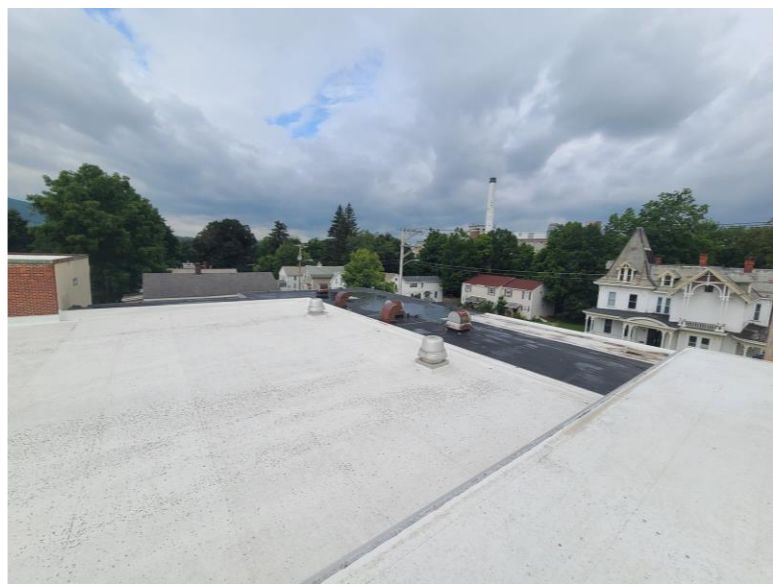
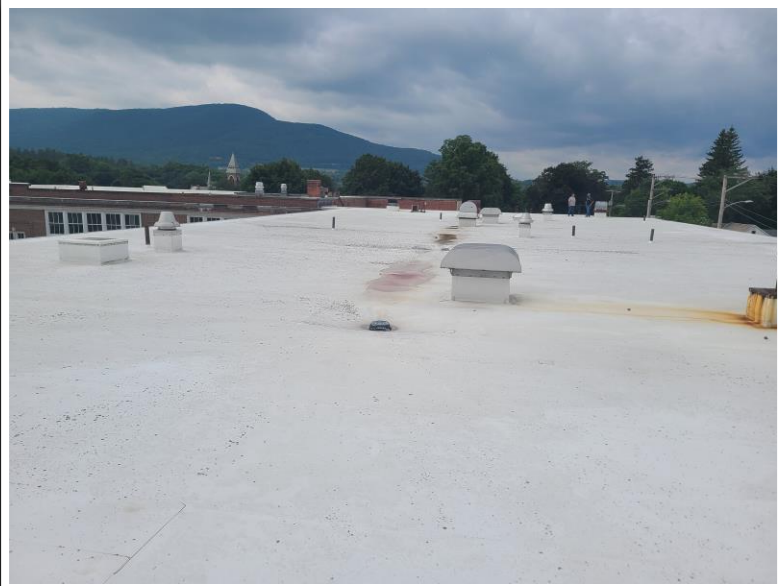
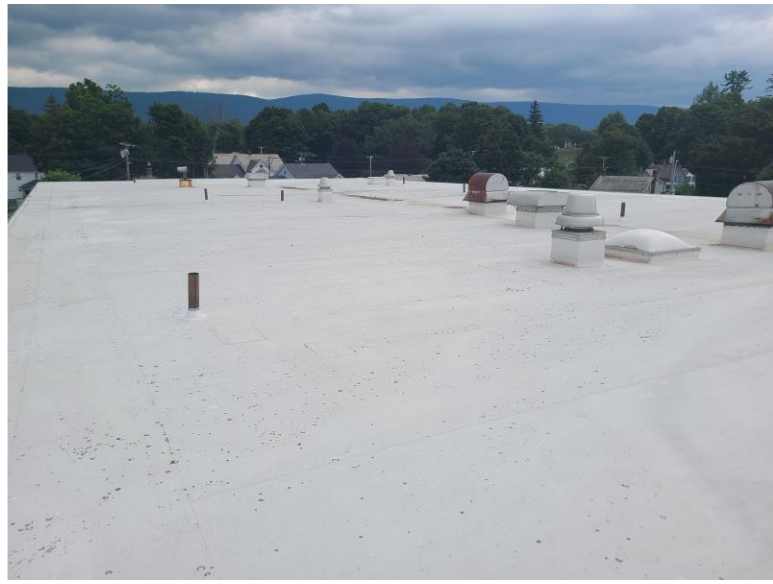
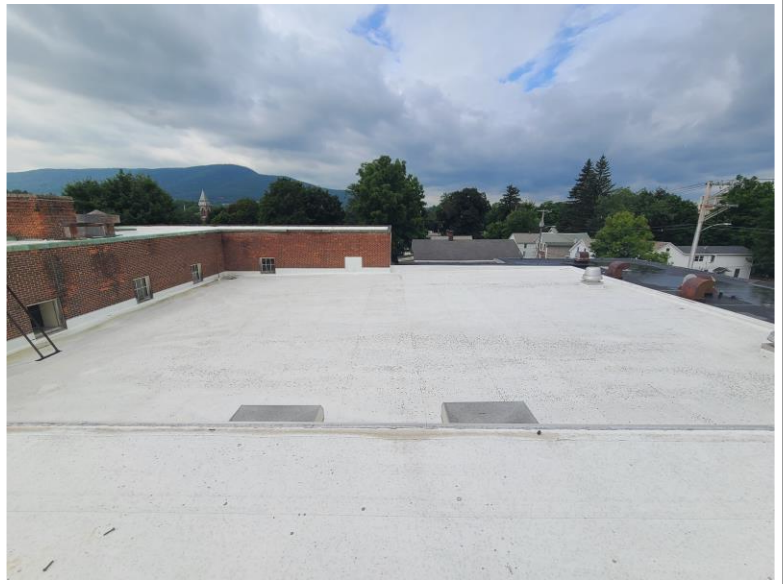
Roof Type #2

TPO 060 Membrane, 2 Layers of 3" poly-Iso, Wood/Steel Deck

Notes: Improper install. Seams failing.
No RPF strip at walls

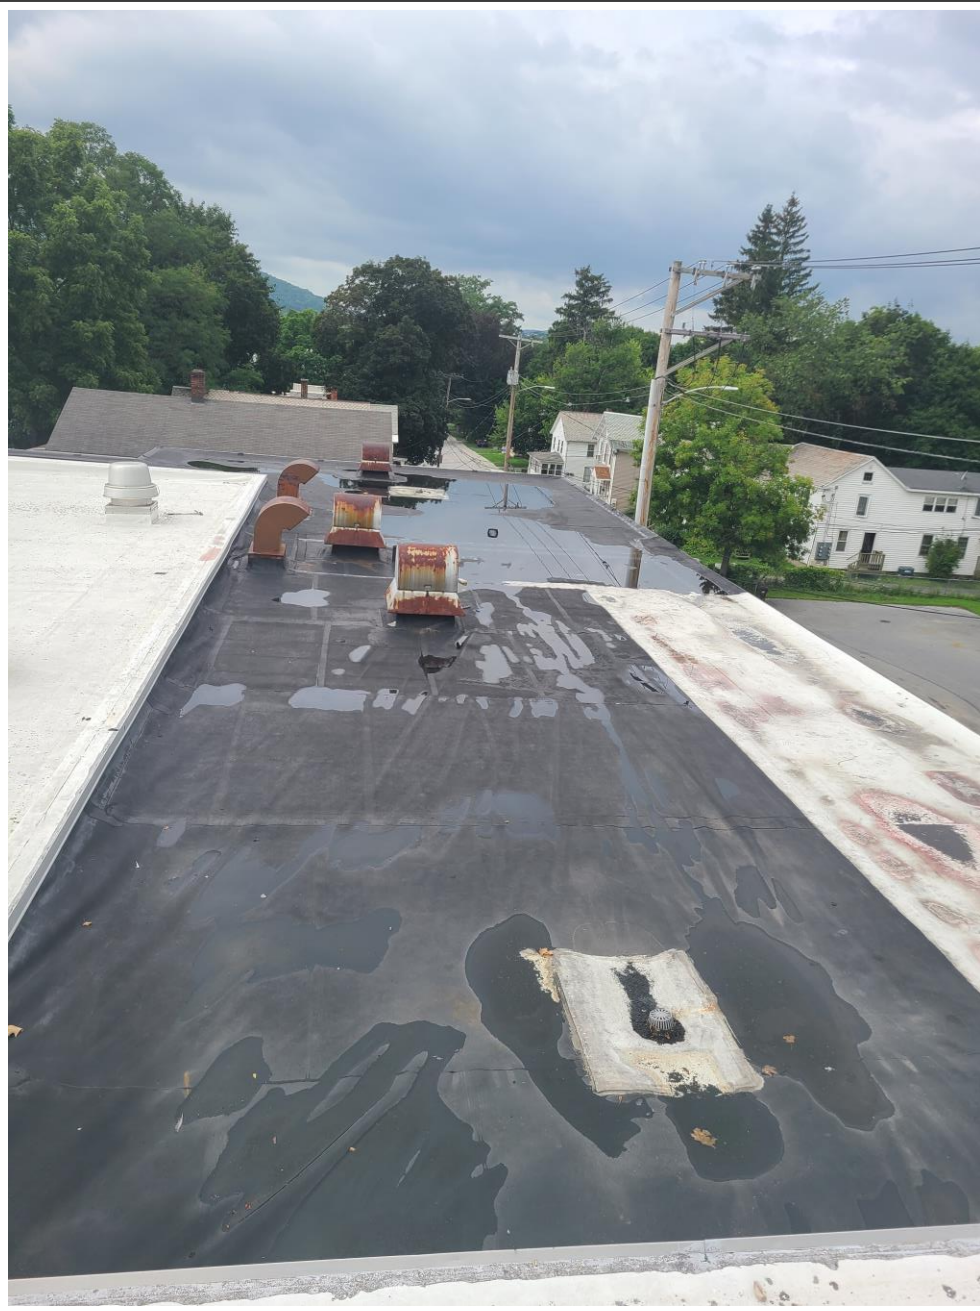
ROOF TYPE #3

060 EPDM & TPO

Roof failing in multiple areas.
Improper install.

Wet insulation.

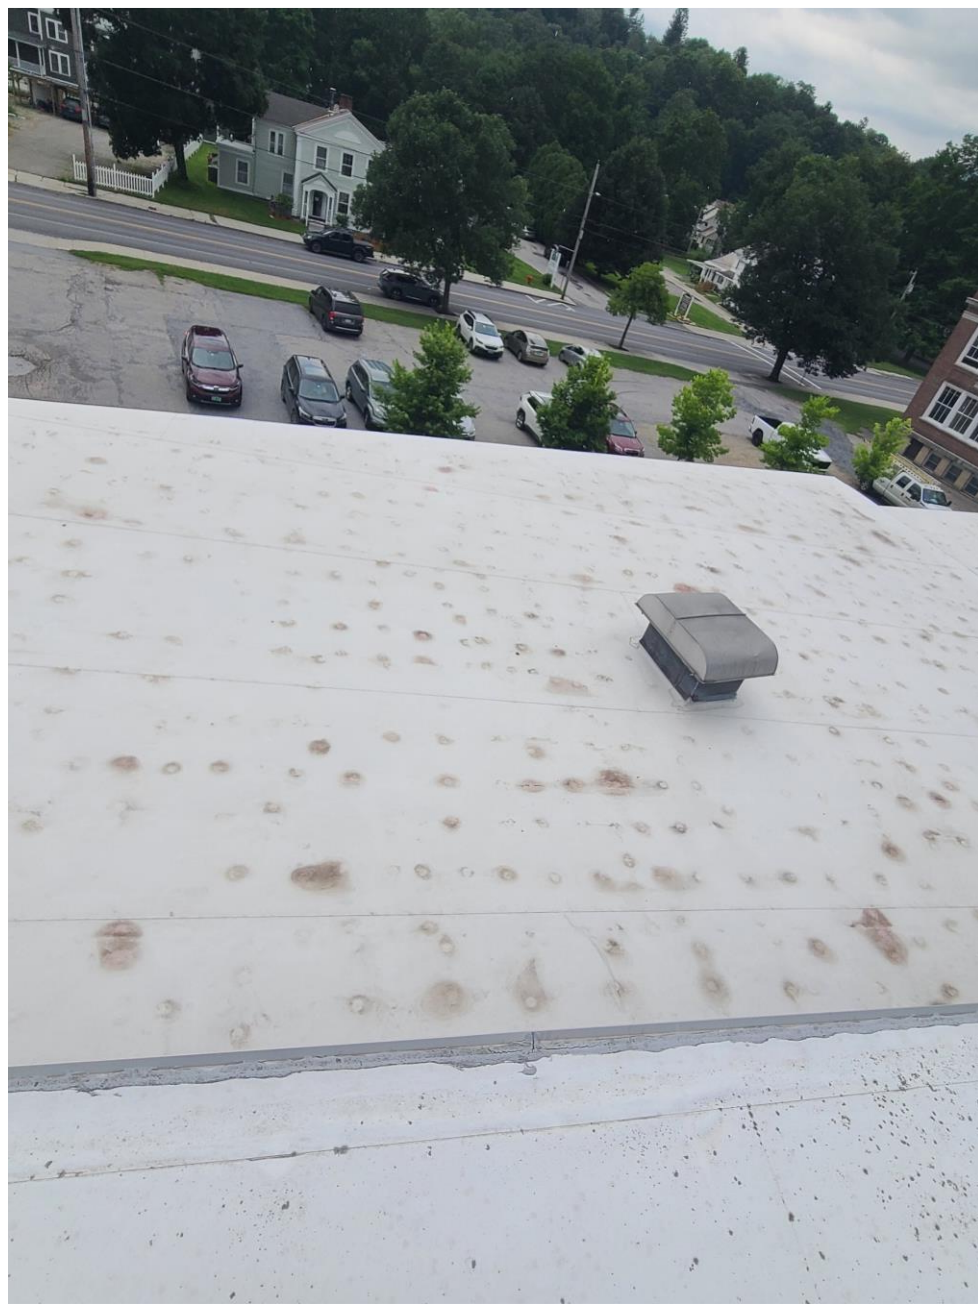
ROOF TYPE #4

TPO 060 Membrane

Roof in good condition.

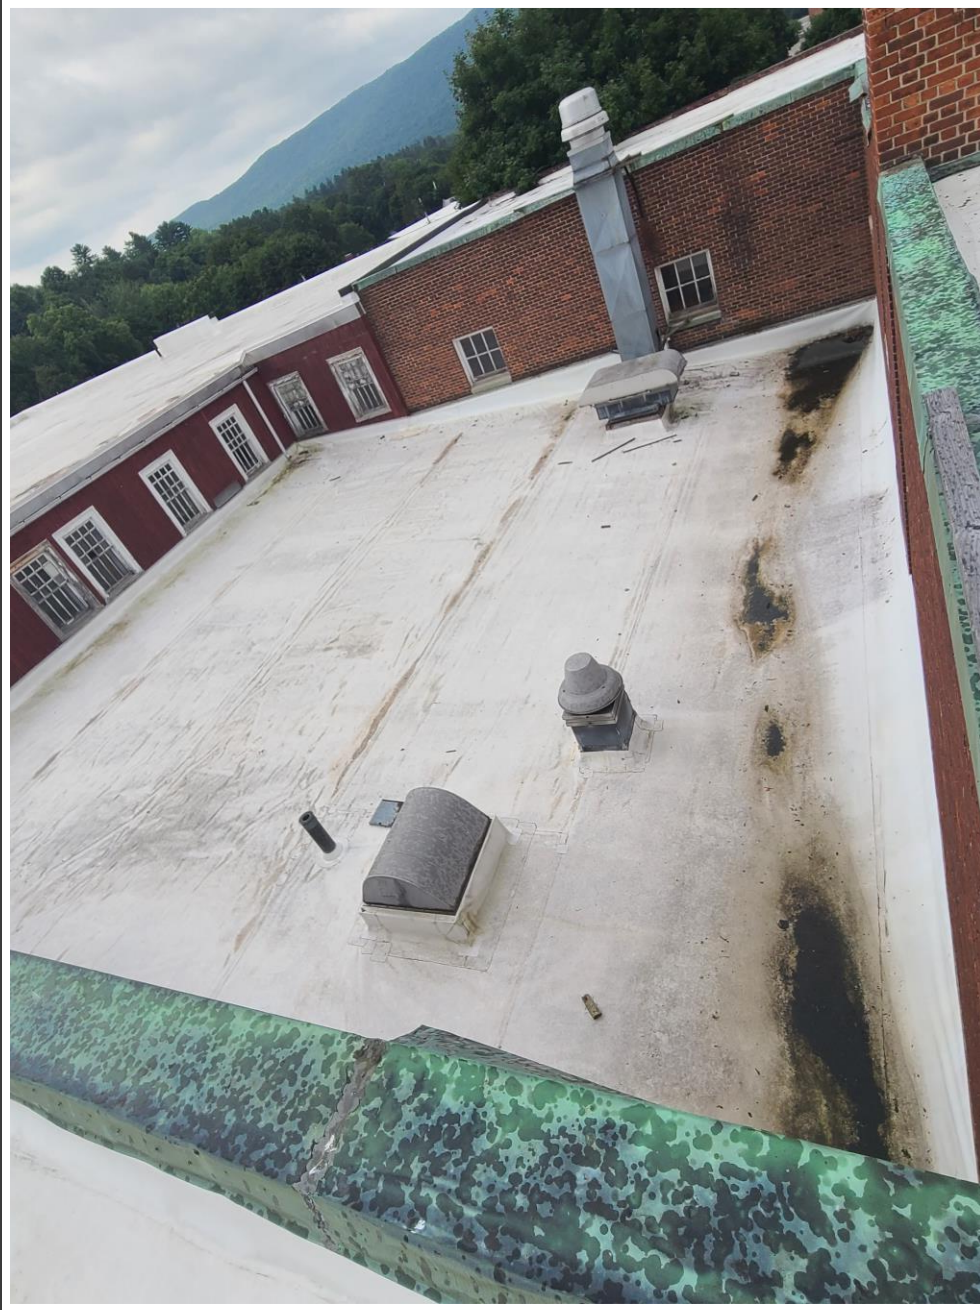
ROOF TYPE #5

TPO 060 Membrane
½" Fiberboard
1-1/2" Built-up
Wood Deck

Improper install- No RPF at walls & curbs not flashed properly. Seams OK.

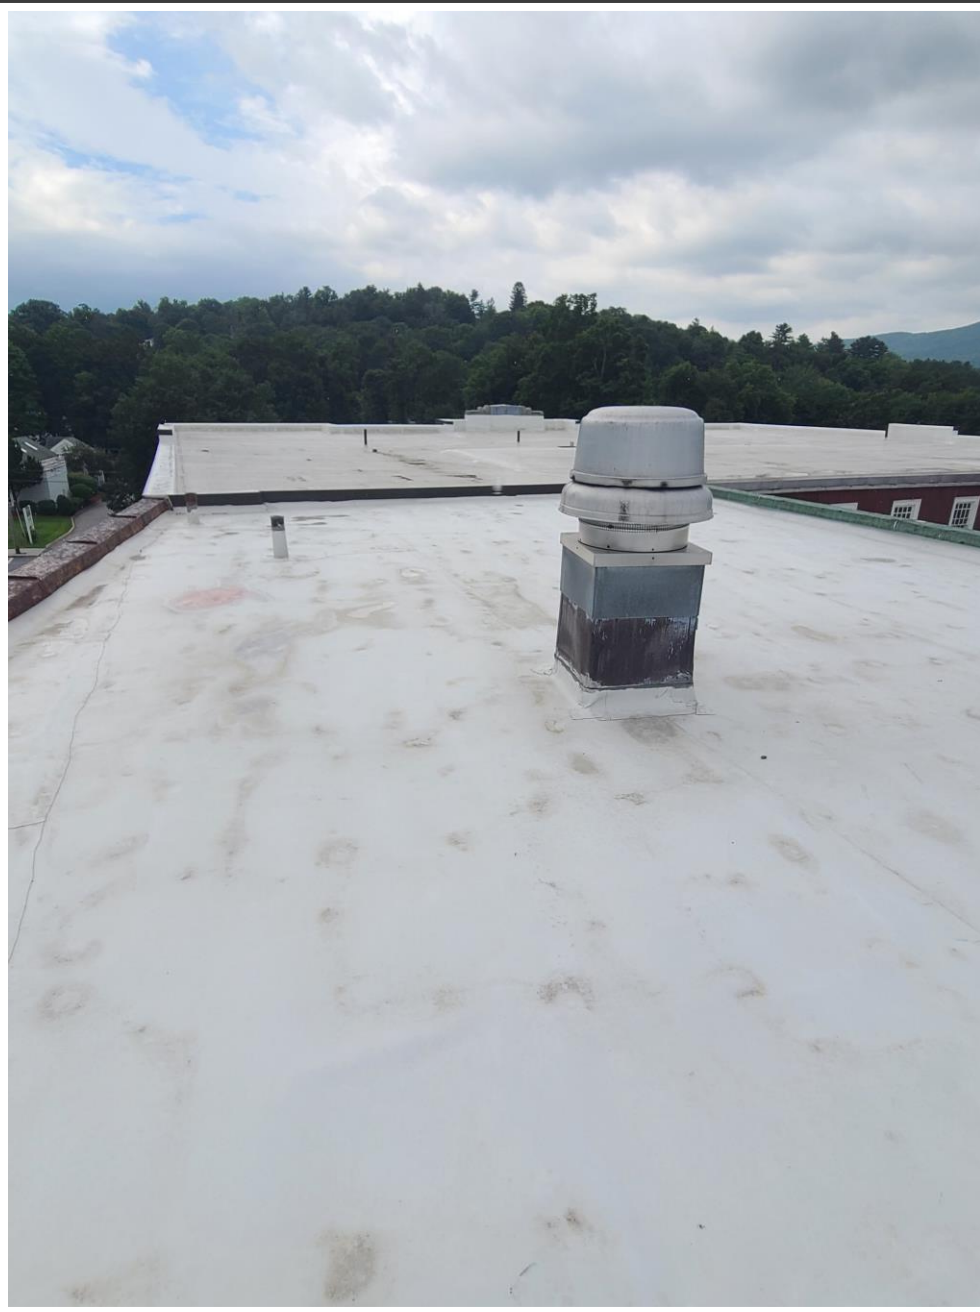
ROOF TYPE #6- ROOF AT TOP OF PICTURE (MAIN ENTRANCE)

Firestone 090 TPO Membrane
2 Layers of 3" poly-ISO
Wood Deck

Roof in good condition.

Field membrane & seams OK.

Insulation dry.

30 Yr. Warranty in place.
