MEMORANDUM

TO: Sharon McCullough
DATE: January 27, 2023
FROM: Douglas Johnson, RVE
CC: Joshua Pratt, RVE
SUBJECT: 2023 Road Program Tree Evaluation

2023 ROAD IMPROVEMENT PROGRAM

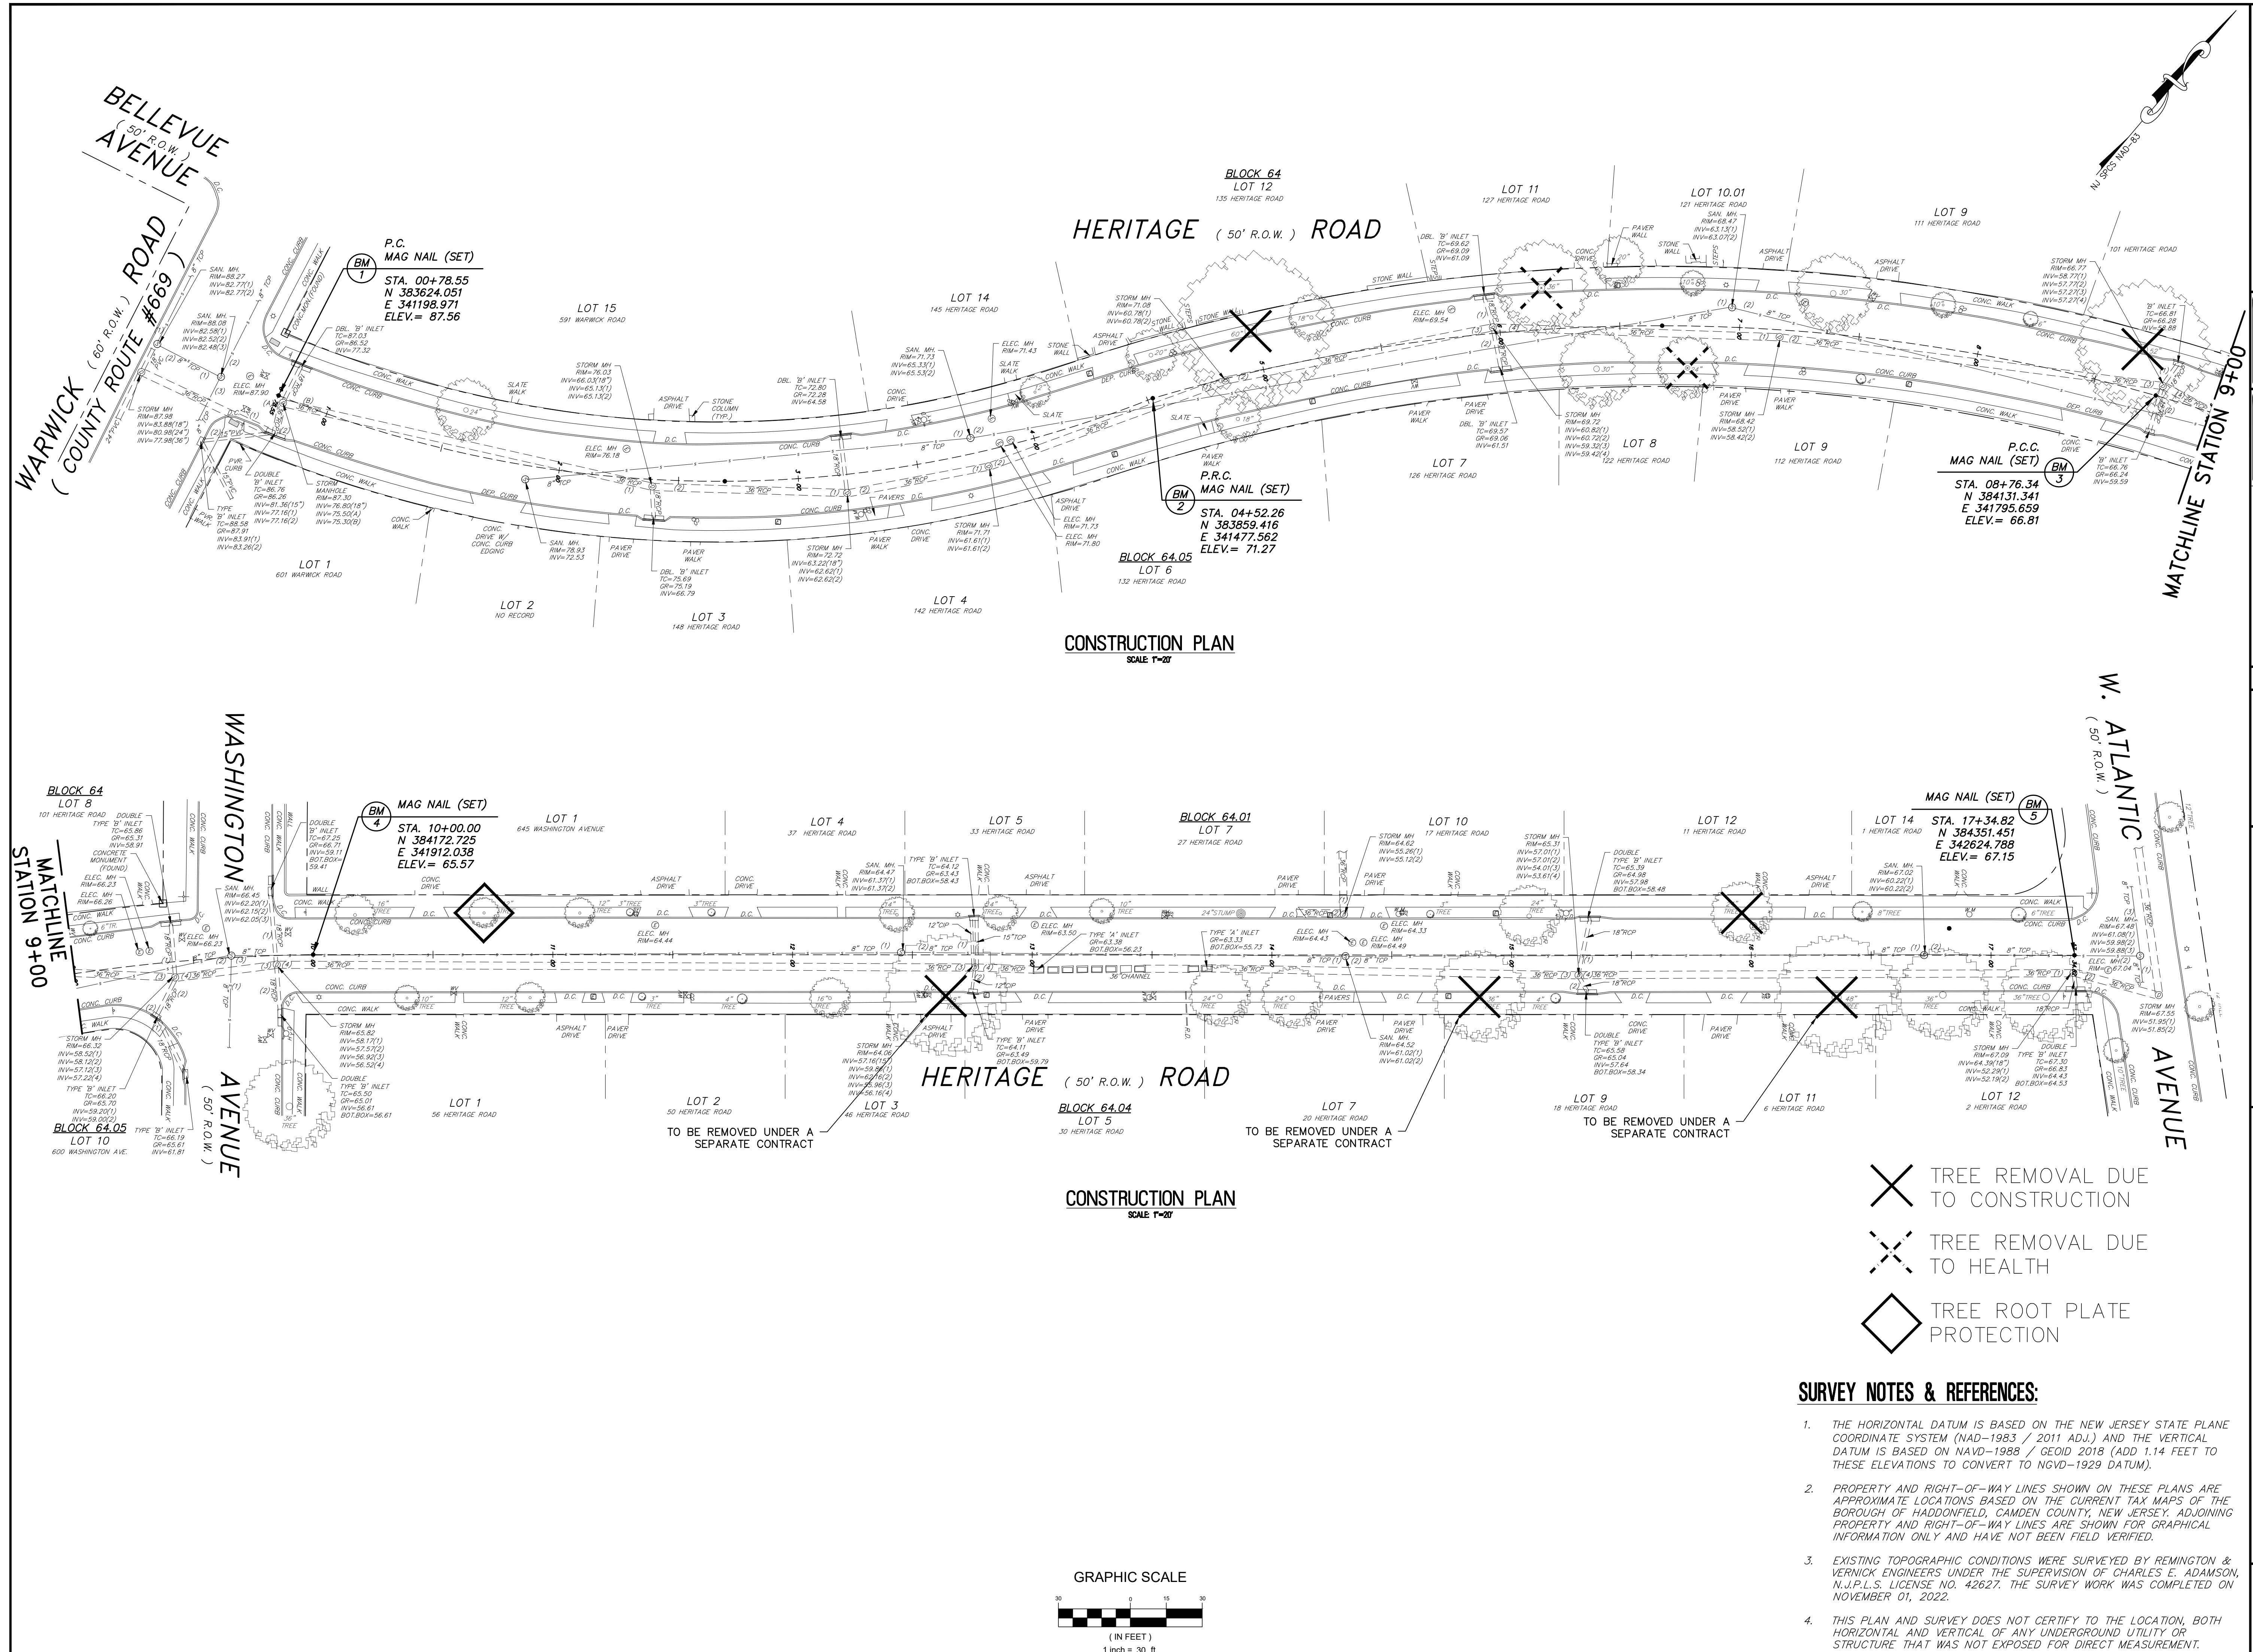
HERITAGE ROAD
CONSTRUCTION PLAN

112 Heritage Road	16" Crab Apple (F2) is in poor condition	Tree to be removed due to poor condition
46 Heritage Road	48" tree with roots overhanging the curb and pushing the curb out	Tree to be removed under separate contract
18 Heritage Road	36" tree with roots overhanging the curb and pushing the curb out	Tree to be removed under separate contract
6 Heritage Road	48" tree with roots overhanging the curb and pushing the curb out	Tree to be removed under separate contract
9 Lafayette Avenue	24" tree with roots against curb	Tree root protection plate to be installed
11 Lafayette Avenue	28" Sweetgum (F1) is in good condition and overhangs part of the curb and road	Tree to be removed due to construction
15 Lafayette Avenue	36" Sweetgum (F1) is in good condition and overhangs part of the curb and road	Tree to be removed due to construction
17 Lafayette Avenue	40" London Plane tree (F1) is in good condition but slightly pushes the curb out	Tree to be removed due to construction
