Mystic River Restoration Project - Mill Creek Restoration Assessments

FY18 MassBays Healthy Estuaries Grant Program

Chelsea and Revere, Massachusetts

July 15, 2019

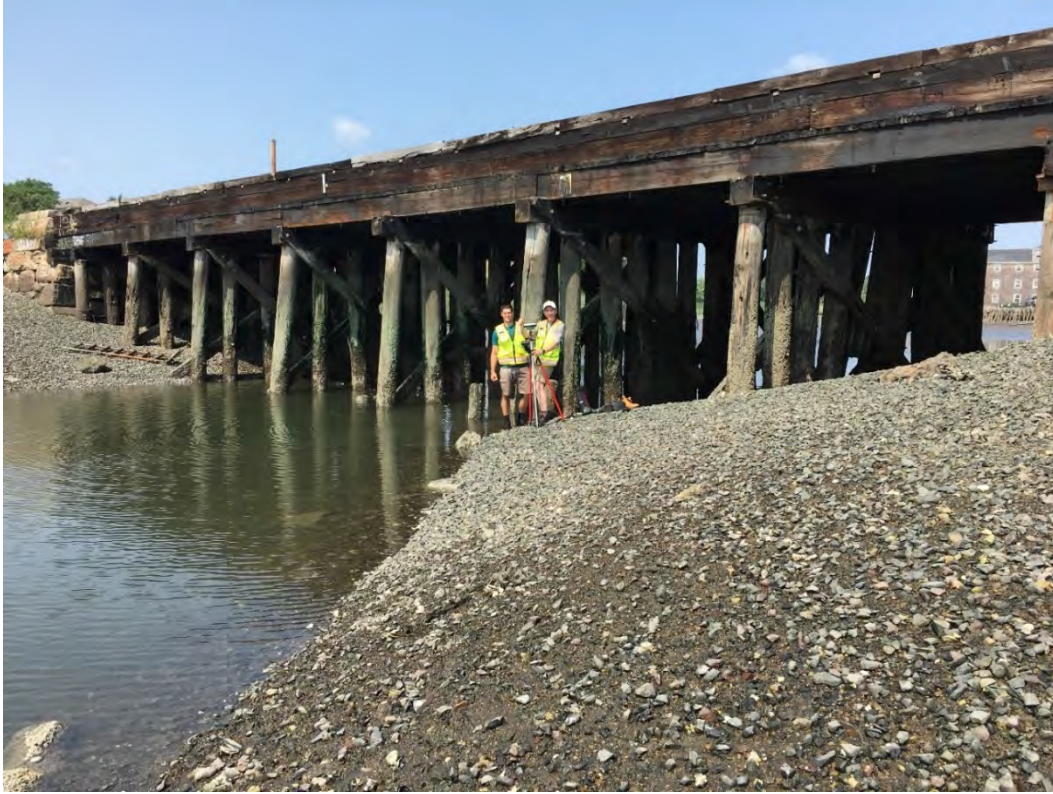
Photo 1. MBTA Railroad Crossing (looking upstream)

The most downstream of the potential tidal restrictions within the project area, the MBTA railroad bridge is a viaduct servicing two travel directions of the Newburyport/Rockport MBTA Commuter Rail line. The viaduct is a timber structure resting on cut granite block abutments and supported by a creosote-treated timber pile causeway (Photo 1).

Crushed stone and rip rap are present below and surrounding the bridge to armor a roughly trapezoidal channel. The bottom of the lowest supporting beam (low chord) is a maximum of 14 feet above the thalweg bottom at the deepest point in the channel, 6.8 feet above the channel bottom near the north end of the bridge (to the right in Photo 1), and 4.1 feet above at the south end (to the left in Photo 1). A closer view of the north end of the bridge is shown in Photo 2.

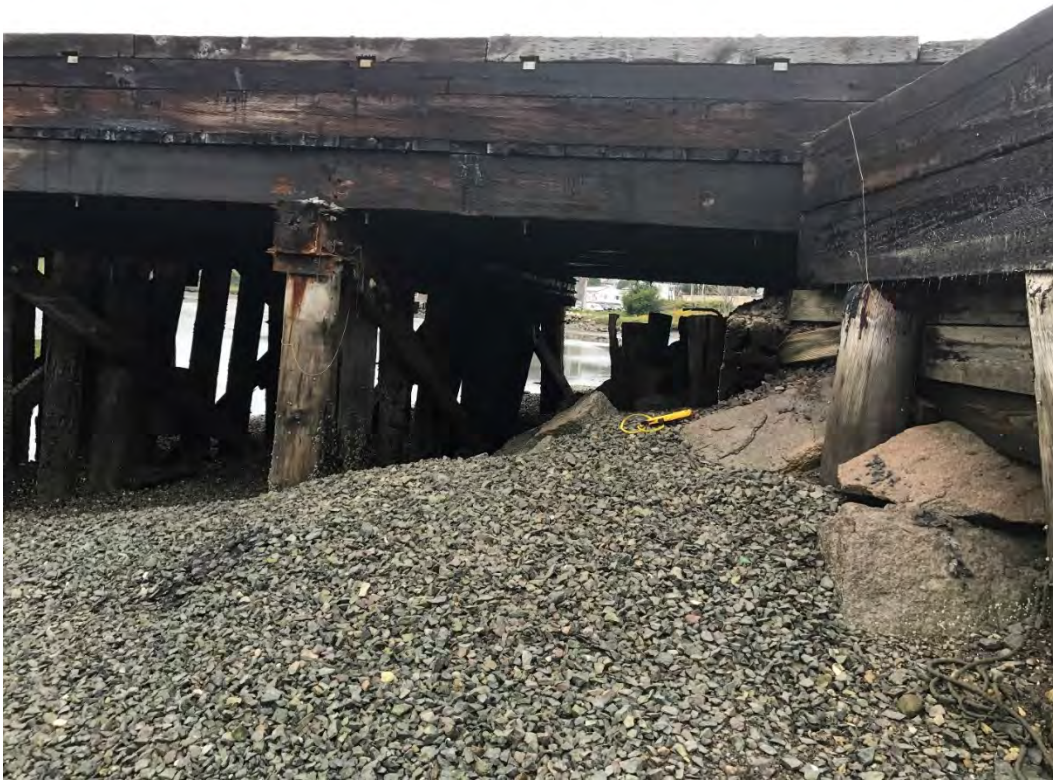
Photo 2. North End of MBTA Bridge

The width between the abutments is 94 feet and there are seven rows of 15-inch-diameter timber piles supporting that span. The open, cross-sectional area between piles and abutments below the low chord of the bridge deck is approximately 945 square feet.

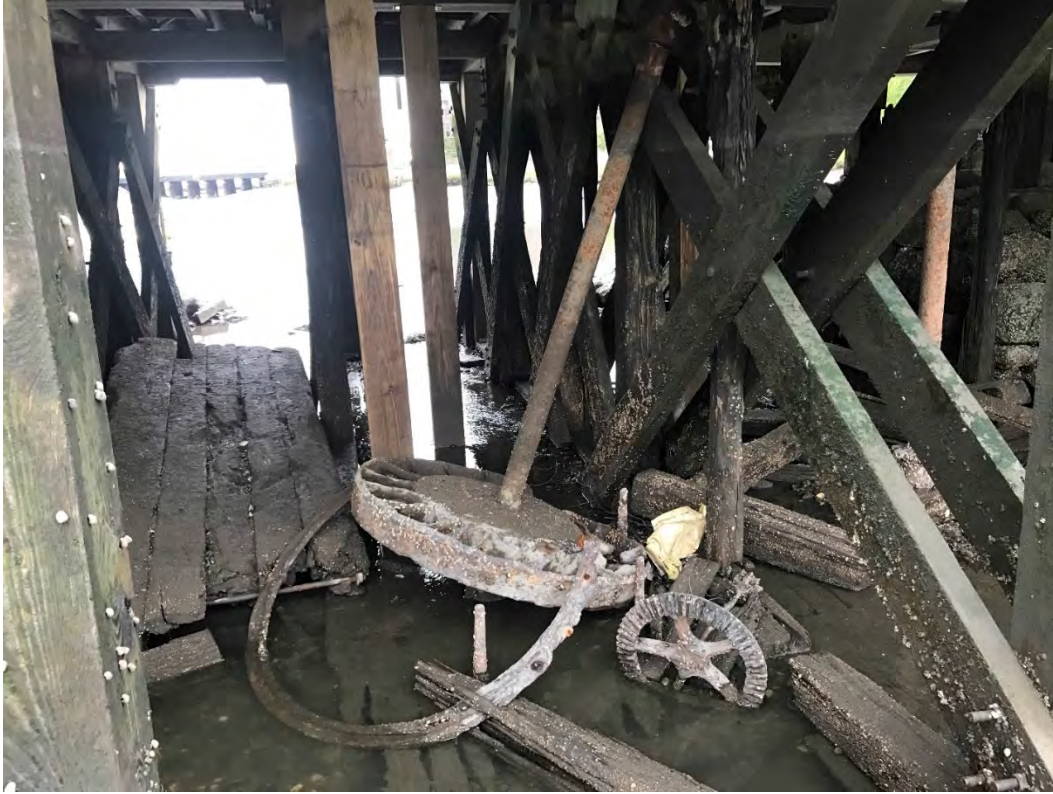
Photo 3. Foundation of Spice Mill

The historic Slade Spice Mill building, originally built in 1721, was a tidal-powered grist mill with an attached 30-foot-thick earthen dam to impound high tide for water power purposes. The mill building sits atop a foundation consisting of a combination of cut granite blocks, stone and masonry rubble, and old and new timber columns of various sizes (Photo 3).

There are many impediments to flow that can be found on the ground amongst the timber piles (e.g. boulders, large metal objects, piles of rubble, and rigid boards affixed to the channel bottom) (Photos 3 and 4). At its greatest height, near the center of the downstream building face, the bottom of the lowest supporting beam is 11 feet above the thalweg bottom (Photo 5). The opening beneath the mill building is 46 feet wide and has an open cross-sectional area of about 350 square feet.

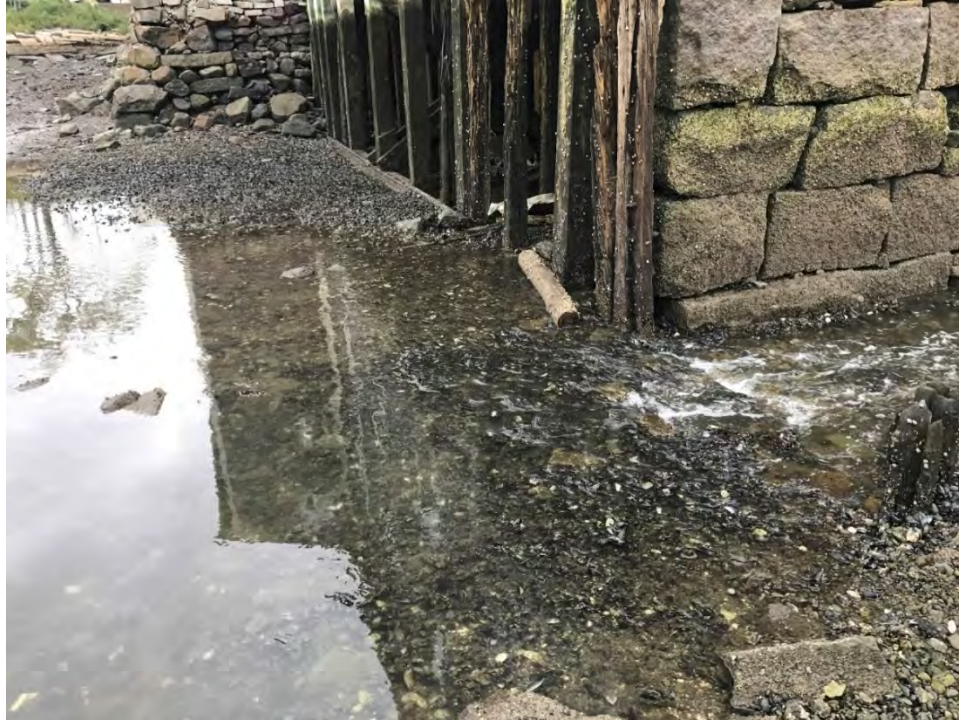
Photo 4. Low Level Flow Obstructions Beneath Mill Building

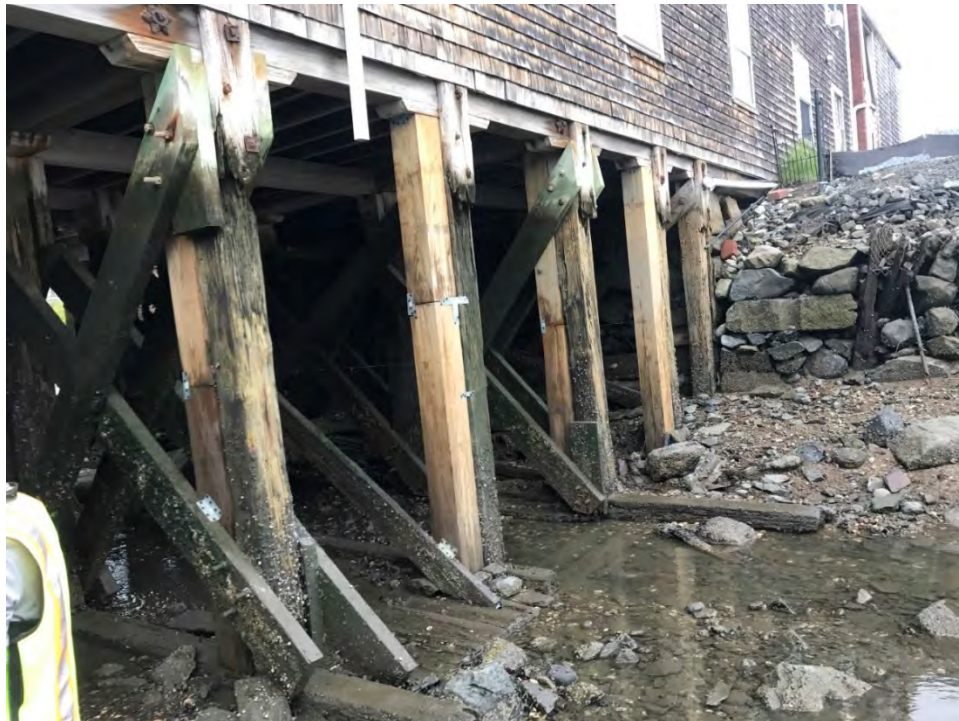
Photo 5. Maximum Channel Clearance Beneath Mill

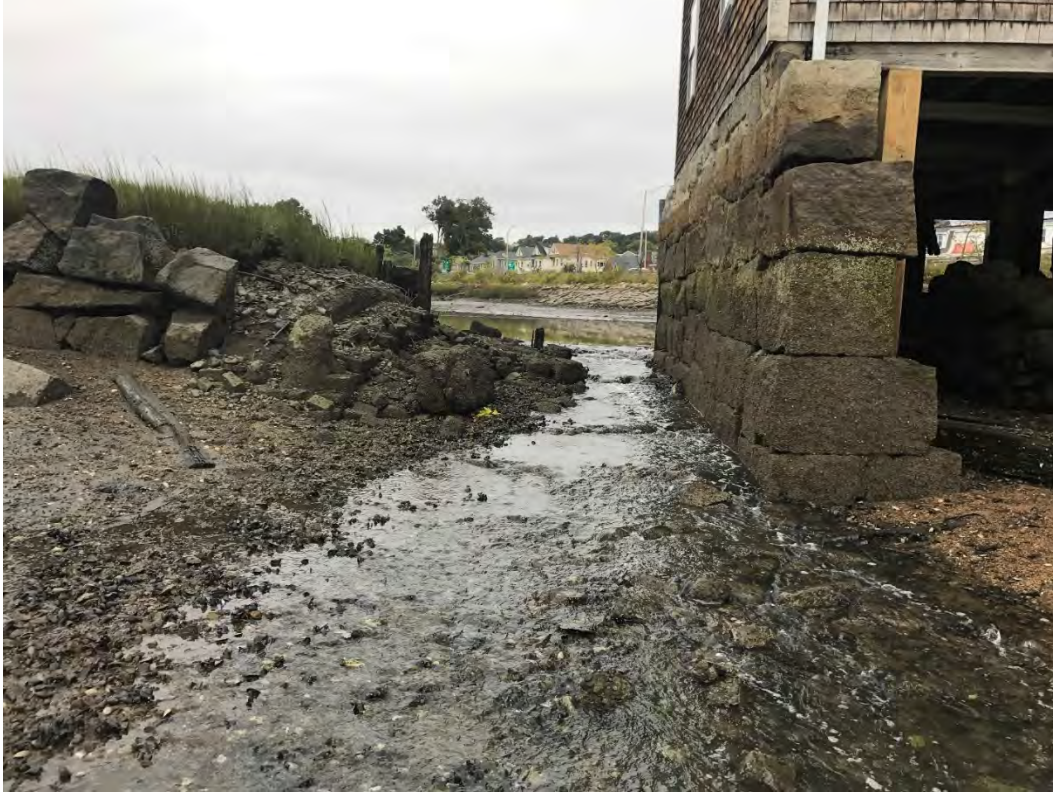
At some point in the past a cut was made to the earthen dam to provide a route for flow through the creek in addition to the open area beneath the building. The cut is about 17 feet wide on the downstream side and about four feet wide on the upstream side (Photo 6). There is also a second, smaller cut in the earthen dam on its north end near where it meets the shoreline opposite the mill building (Photo 7). The invert elevation of this secondary cut is higher than the primary cut beside the mill building, and therefore only conveys flow at higher water levels.

Photo 6. Primary Cut in Spice Mill Earthen Dam

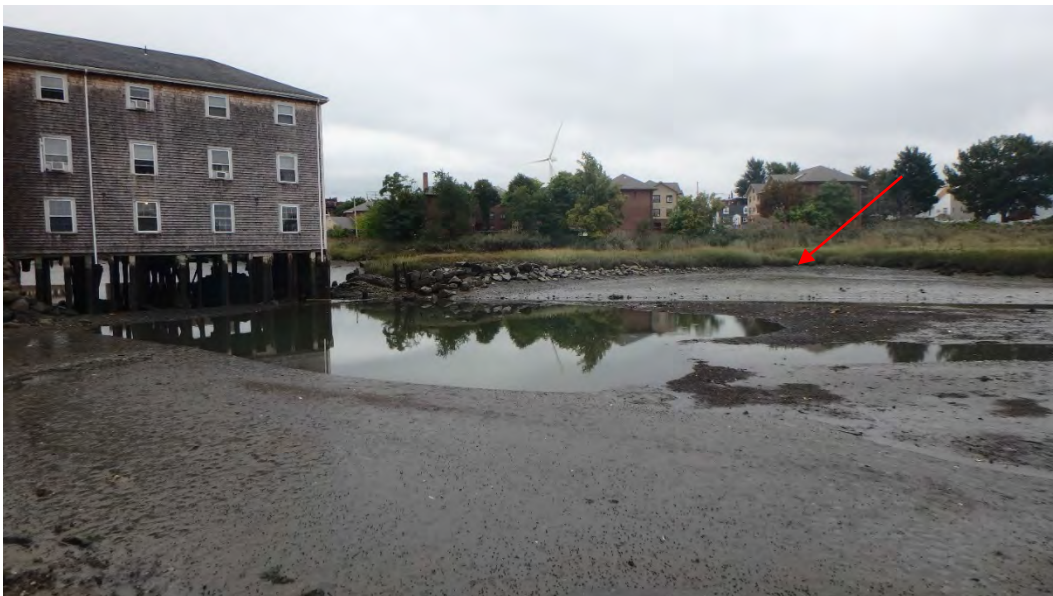
Photo 7. Secondary Cut in Earthen Dam (red arrow)

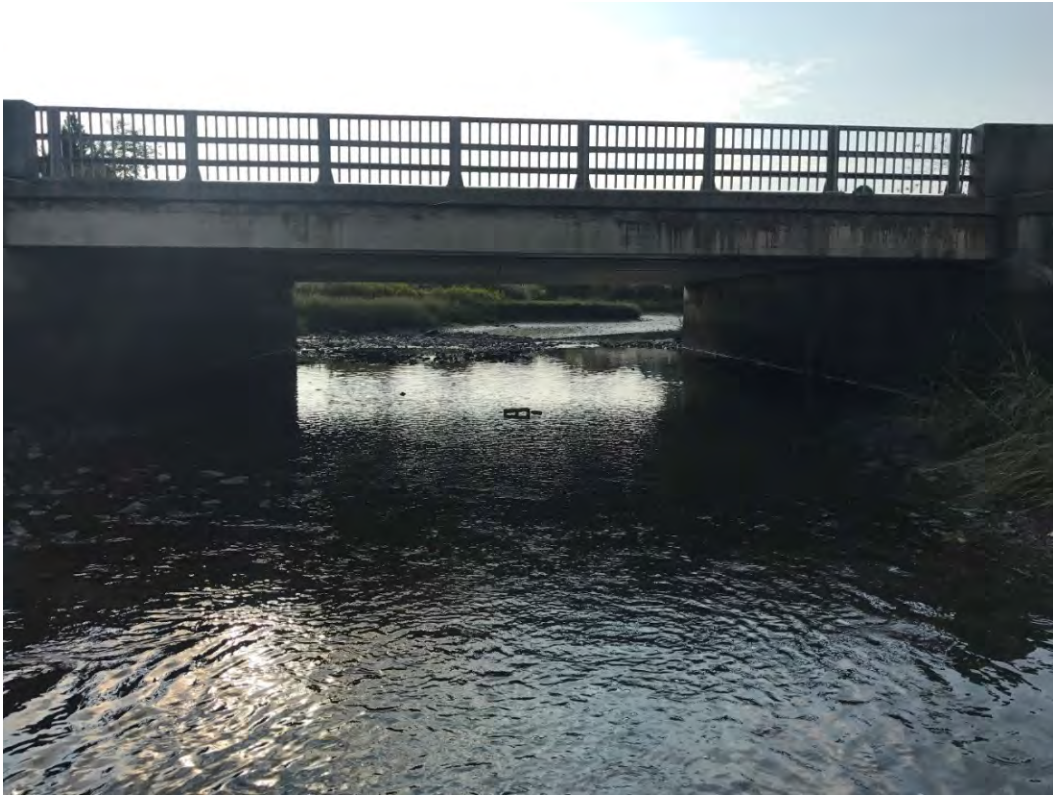
Photo 8. Broadway Bridge Looking Upstream

The Broadway Bridge is an approximately 48-foot wide open span bridge that carries two lanes of Broadway and its sidewalks across Mill Creek (Photo 8). The low chord bottom of the bridge deck is approximately eight feet above the thalweg bottom and the open area is approximately 385 square feet. The bottom of the channel and side slopes around the bridge abutments are armored with crushed stone and riprap with an average diameter of about nine inches. The stone material and fine sediments that have accumulated downstream of the bridge appear to create a flow restriction under low tide (Photo 9).

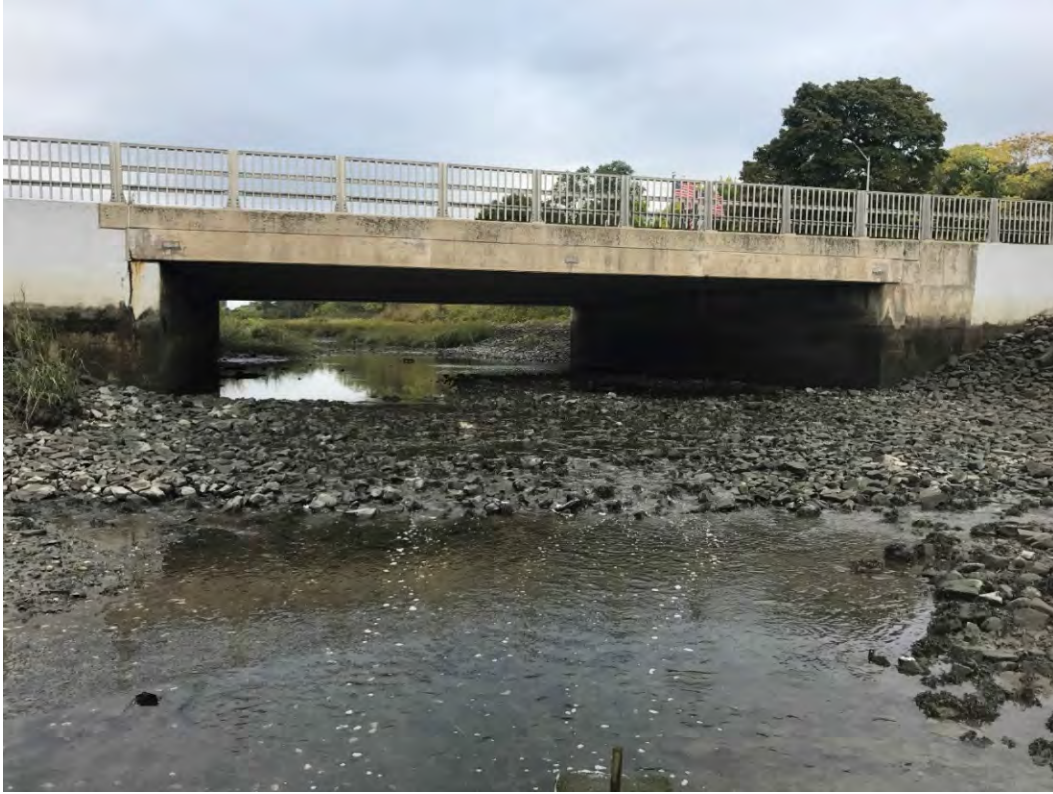
Photo 9. Accumulated Material Downstream of Broadway Bridge

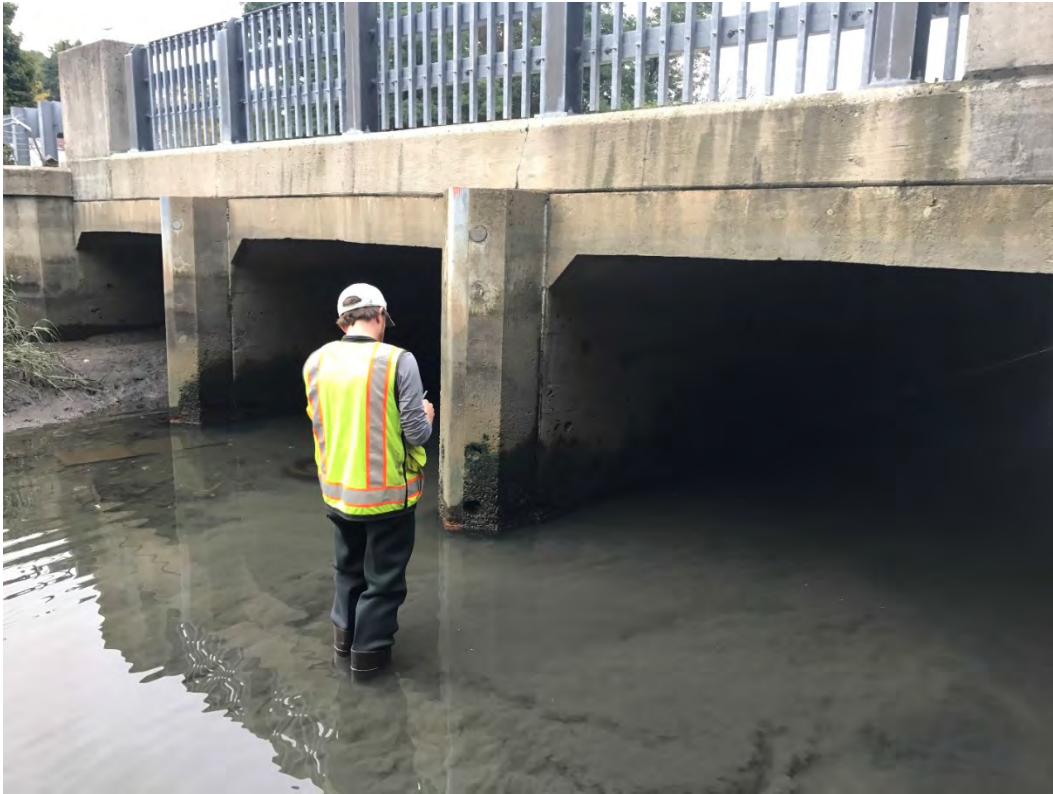
Photo 10. Parkway Plaza Bridge and Culvert

The Parkway Plaza bridge carries two lanes of automobile traffic atop a triple-barrel precast concrete box culvert system (Photo 10). The culverts roof height is a maximum of about seven feet above the channel thalweg (culverts are eight feet high with variable sediment depth in the bottoms) and each opening is ten feet across. The concrete walls between the culverts are approximately 1.9 feet wide and divide the creek into three channels with a combined open cross-sectional area of about 213 square feet. Flow through the northernmost culvert is heavily impeded by built-up fine sediment and muck to the point that it is completely blocked at lower water levels (left side of Photo 10 and Photo 11). The middle and southern channels are also filled with sediment, though to a lesser degree. A shopping cart and automobile tire were observed in the center channel (Photo 12).

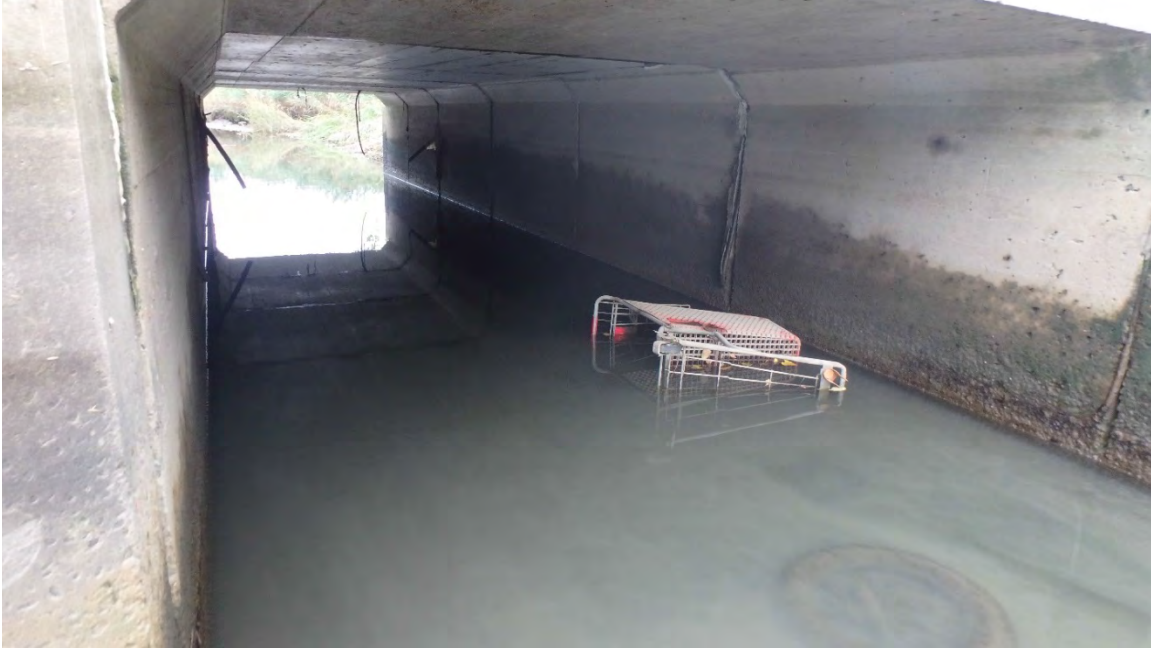
Photo 12. Center Culvert of Parkway Plaza Bridge

A temporary improvement in flow conditions may be achieved by dredging one or more channels through the Parkway Plaza culvert and the Route 1 off/on-ramp culverts, removing some of the several feet of fine sediments that have accumulated in those narrow portions of the system (see Photos 11 and 24). However, hydraulic and/or sediment transport assessment and modeling would be necessary to determine what the sources and amounts of the current sediment deposits are to determine the overall impact of the removal and cost effectiveness. Further, modeling will help to determine whether there would be an increased flooding risk if those sediments were temporarily removed. Unless sediment sources from the subwatershed and in-stream erosion are addressed beforehand, sediment removal would offer only temporary improvement.

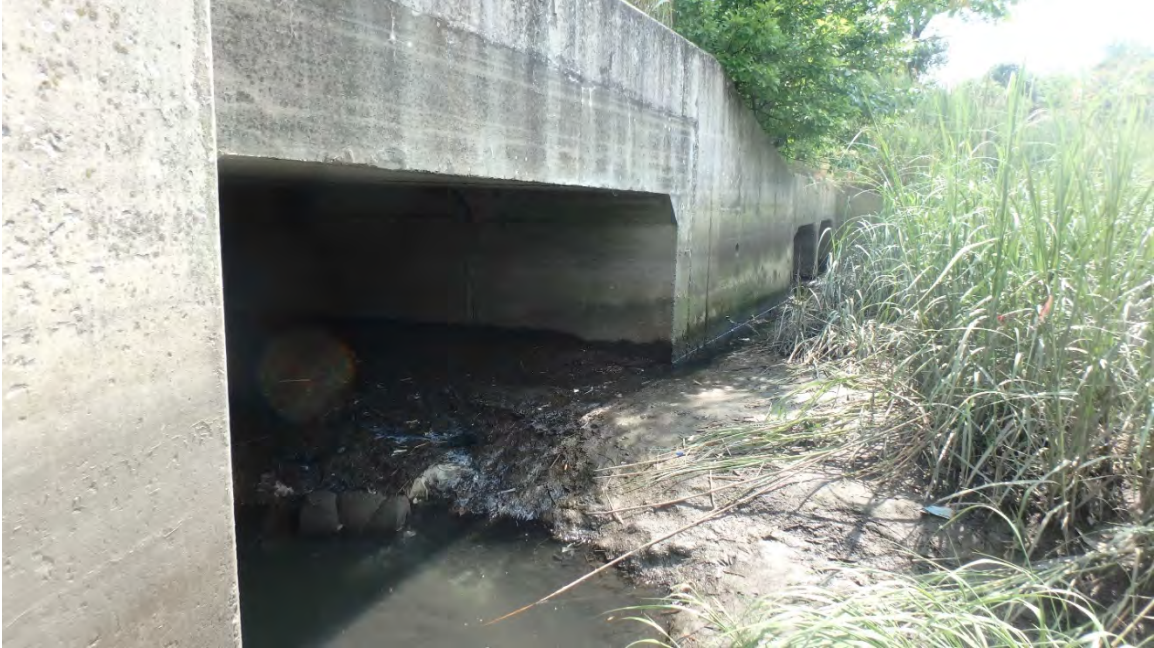
The smaller pair of culverts were observed to be filled with sediment and no water was observed flowing through them at either of the two site visits. For the larger (northern) culvert pair, the northernmost barrel was observed conveying only limited flow (Photo 14). The bottom of the channel everywhere in this vicinity is covered with at least two feet of fine, mucky sediment.

Photo 13. Route 1 Off/On-Ramp Culverts Looking South

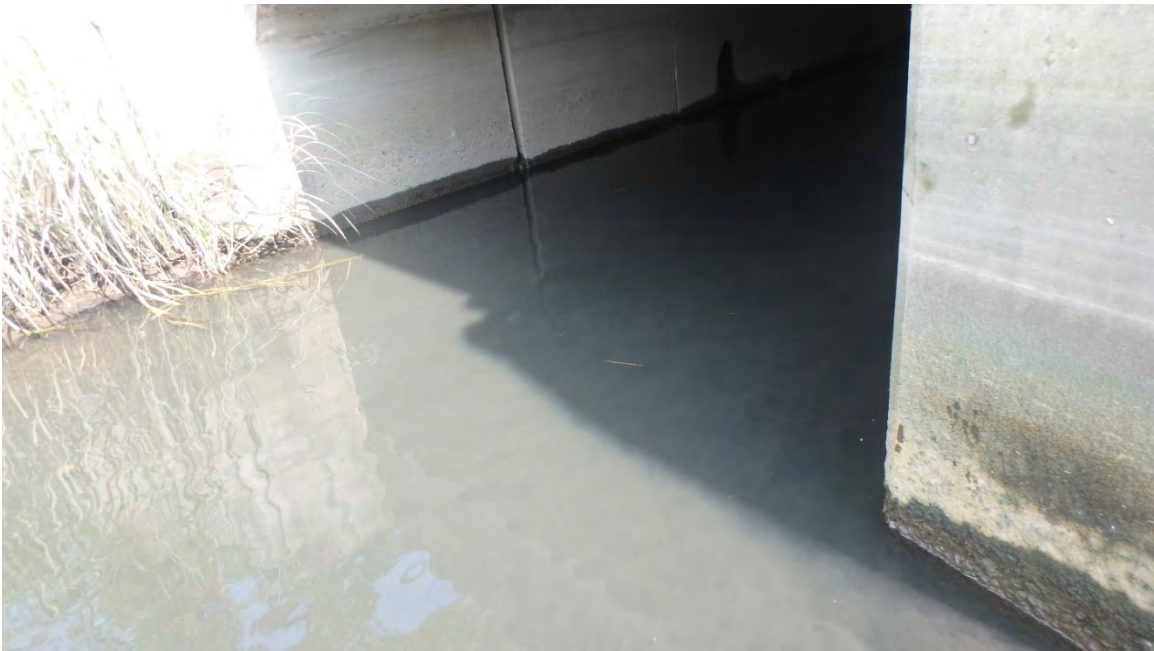
Photo 14. Northernmost Route 1 Off/On-Ramp Culvert

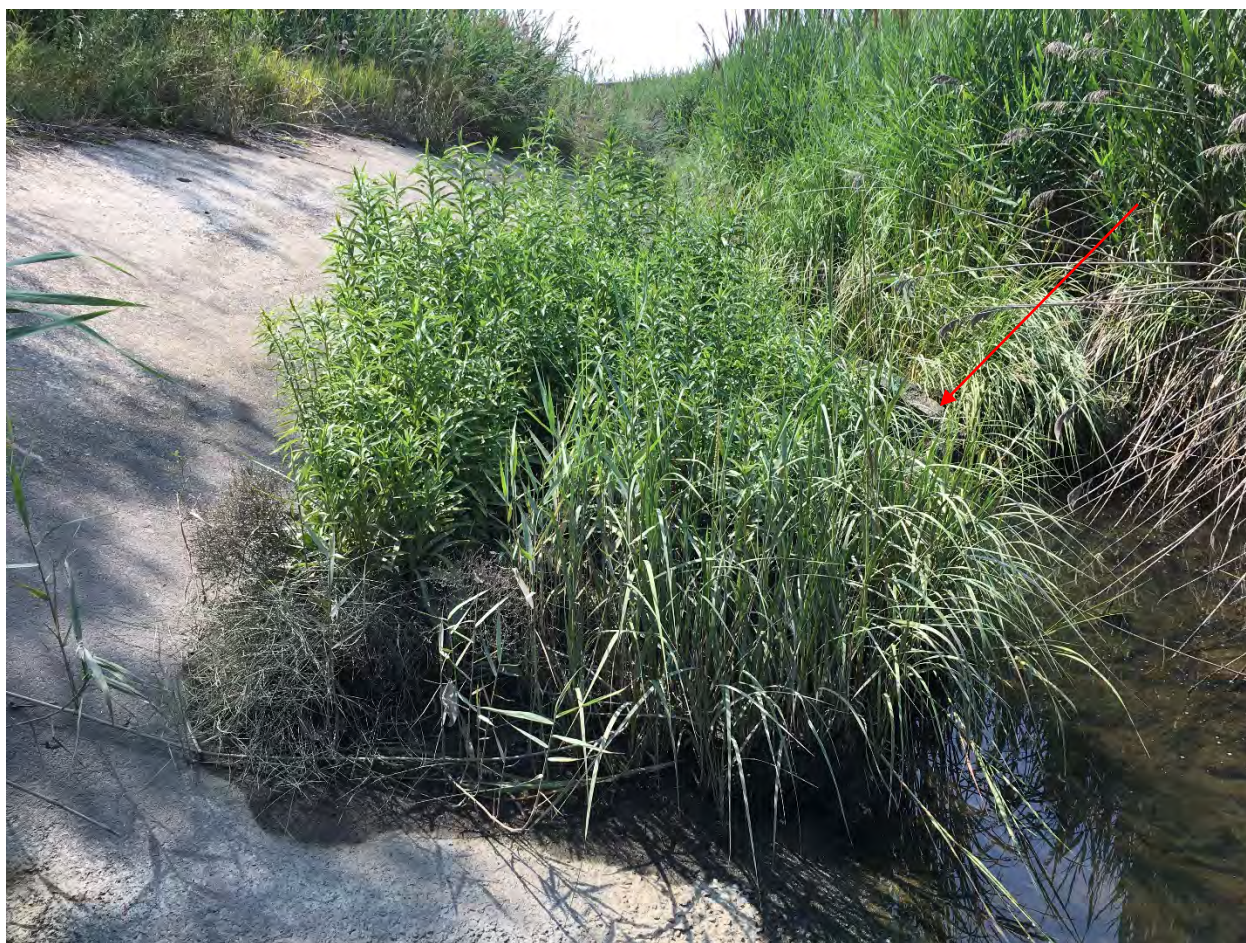
This restriction is located on an unnamed tributary to Mill Creek where the channel narrows between areas of fill that support the U.S. Route 1 off-ramp and the Home Depot shopping plaza. On the U.S. Route 1 off-ramp side the channel slope consists of a vegetated hillside on the north bank of the creek with an approximate slope of 2.75 to 1. On the Home Depot side, the channel slope has been covered with concrete at an approximate slope of 4.5 to 1. The intersection of these two slopes creates a narrow creek channel with a bottom width of approximately two feet (Photo 15). A reinforced concrete pipe outfall with a flared end is at this location protruding into the channel from beneath the slab on the south bank (red arrow in Photo 15). The purpose of this outfall is unknown. We were not able to attain record plans depicting this outfall or additional information from the City of Chelsea indicating its purpose. The combination of the narrow channel profile and the outfall pipe appear to create a significant restriction to flow. Due to the relatively low invert elevation and trapezoidal shape of the channel, the flow restriction is likely more significant at lower water levels than at higher ones.

Photo 15. Narrow Tributary Channel with Concrete Slope

The tributary channel to Mill Creek encounters a bottleneck restriction between filled lands used to create the U.S. Route 1 off/on ramp and the Home Depot plaza. The steep slope on the Home Depot side of the channel is covered with concrete. The origin of the concrete is uncertain. It could potentially have been installed during the construction of the Home Depot plaza to prevent scour, erosion, slumping, and slope failure. It could also be potentially capping hazardous fill material underneath. The narrow nature of the bottleneck the concrete revetment, and the outfall pipe are all serving to restrict tidal flow to and from an upstream marsh area significantly impacted by invasive common reed growth. An alternative slope stabilization approach (potentially including retaining walls or living walls) could be designed at this location to lower the invert elevation of the channel and widen its cross-sectional area to allow improved tidal flow in and out the upstream salt marsh.

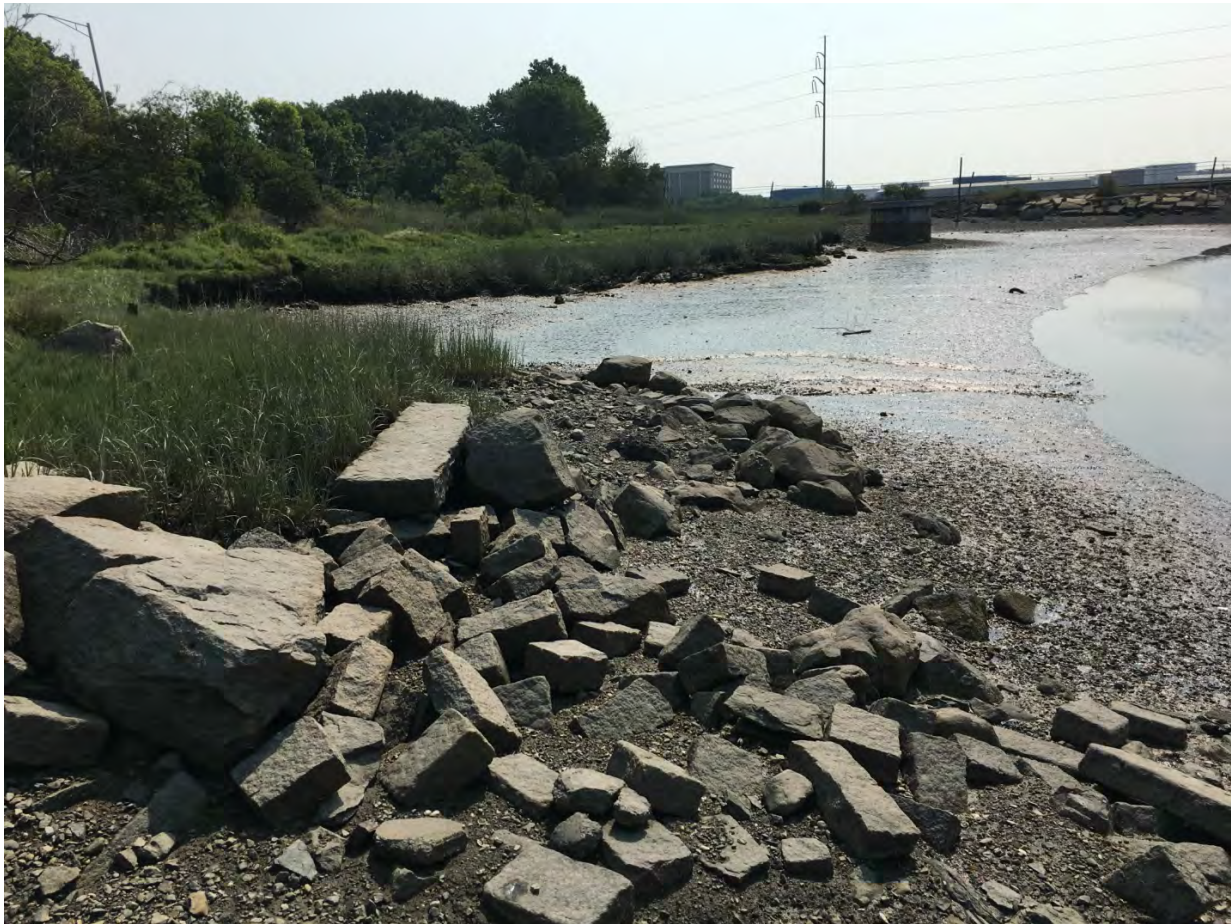
Photo 16. Granite blocks downstream of the Spice Mill

A similar approach could be taken at places where large granite blocks line the channel, most notably observed in the vicinity of the Spice Mill dam which could be replaced with vegetated shoreline stabilization methods.

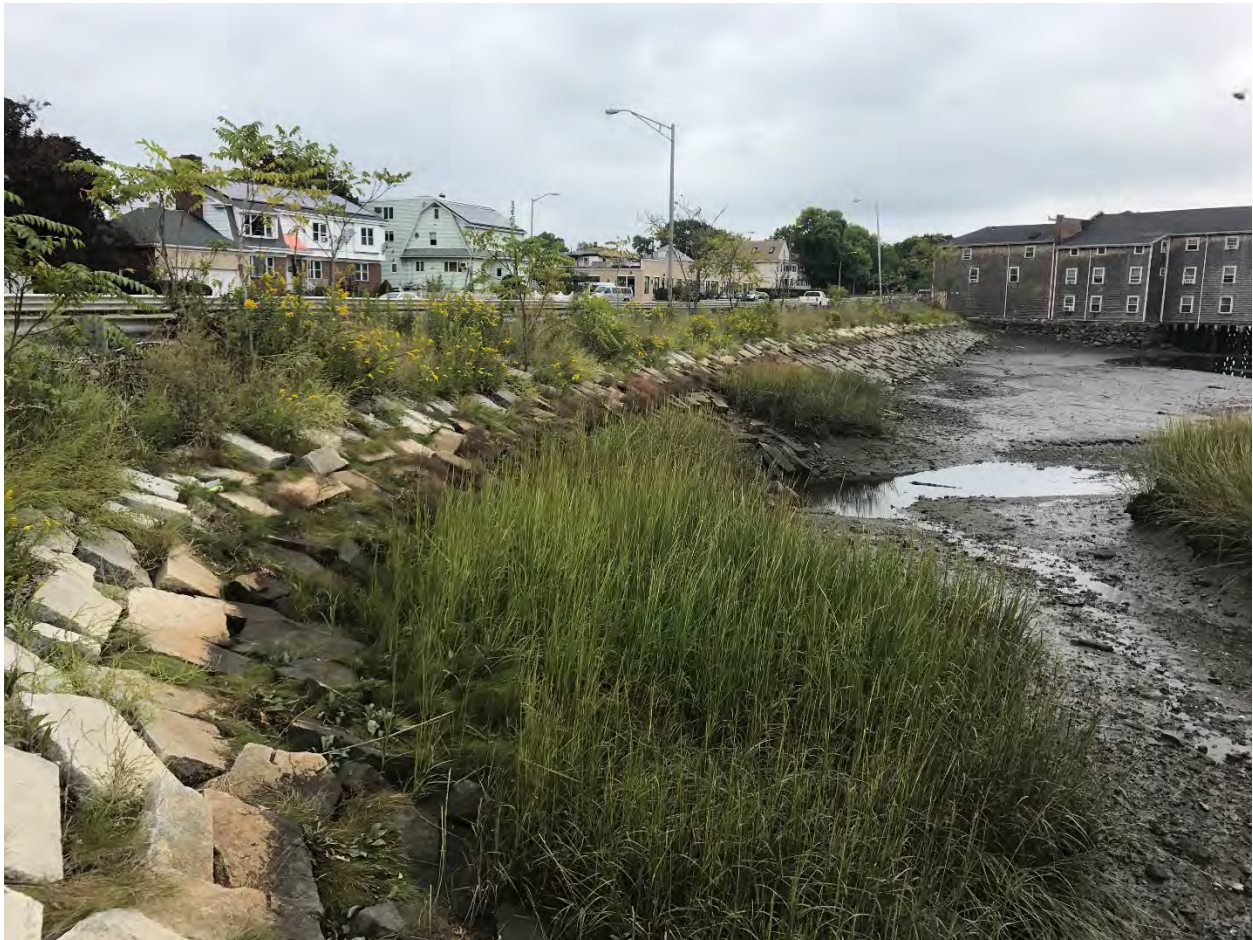
Marsh C is located upstream of the Slade Spice Mill building and earthen dam and downstream of the Broadway Bridge. The creek along this stretch is approximately 120 feet wide. Large granite slabs line the northern bank of the stream (Photo 17). An occasional salt marsh plant grows through the cracks between the slabs including saltmarsh hay, sea lavender, and seaside goldenrod, but otherwise there is no room for significant vegetative growth. There are tree-of-heaven trees along the upland slope. The salt marsh on the south bank is more expansive because it has more room to grow.

Photo 17. Large Granite Slabs on the North Bank

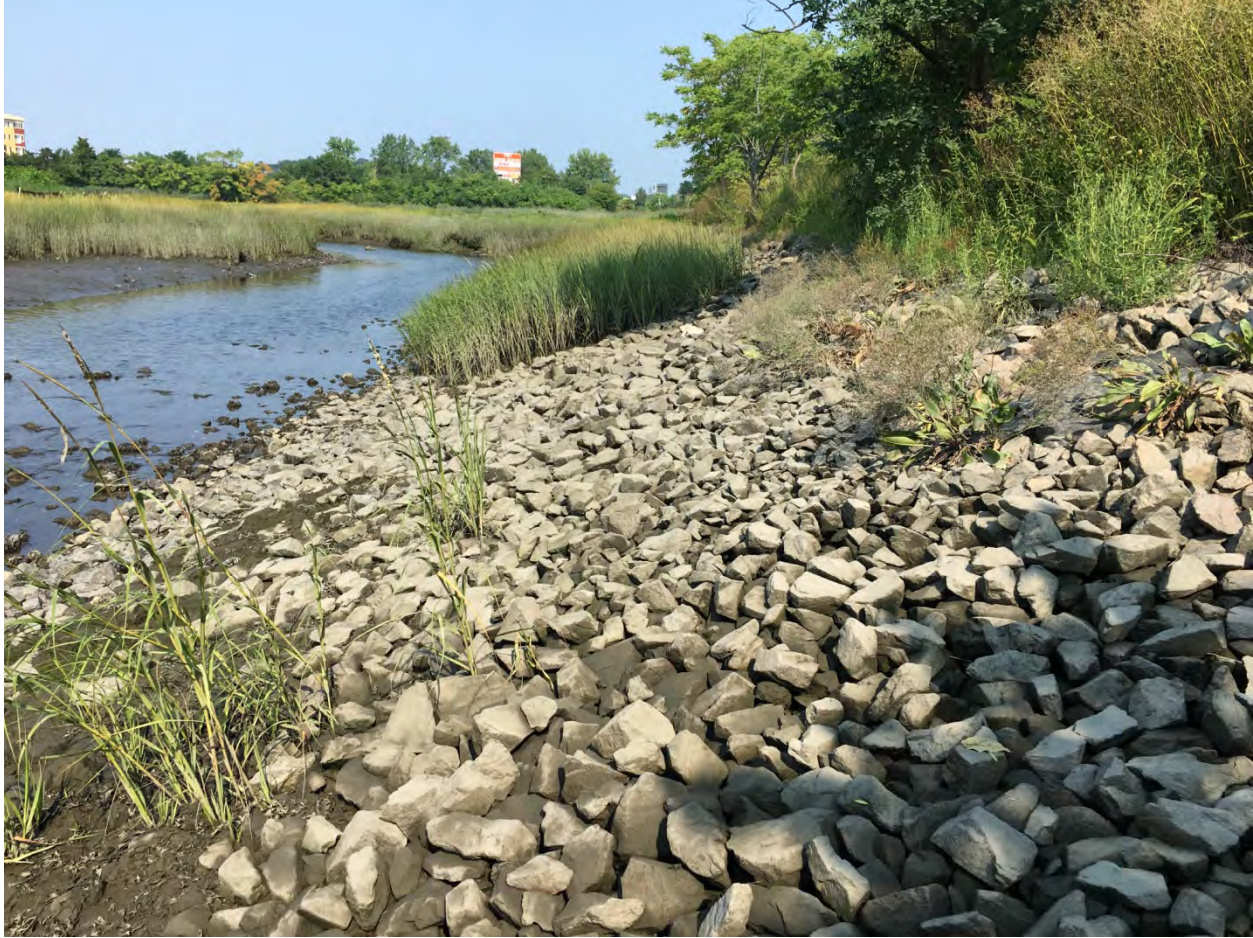
Marsh D is located between the Broadway bridge and the Parkway Plaza bridge. The creek bottom has riprap of various sizes covering sediment. Along both sides of the bank slope there is extensive riprap with occasional salt marsh plant species (*S. alterniflora*, *L. carolinianum*) growing between the rocks (Photo 19).

Photo 19. Riprap Upstream of Broadway Bridge on Northeast Bank

Excessive or unnecessary riprap, most notably observed in the vicinity of the Broadway bridge, could be removed to increase available habitat space for native salt marsh plants. Softer shoreline stabilization methods (for example using coir logs and vegetated slopes) could be used instead of hard armoring for seemingly low-velocity environments.

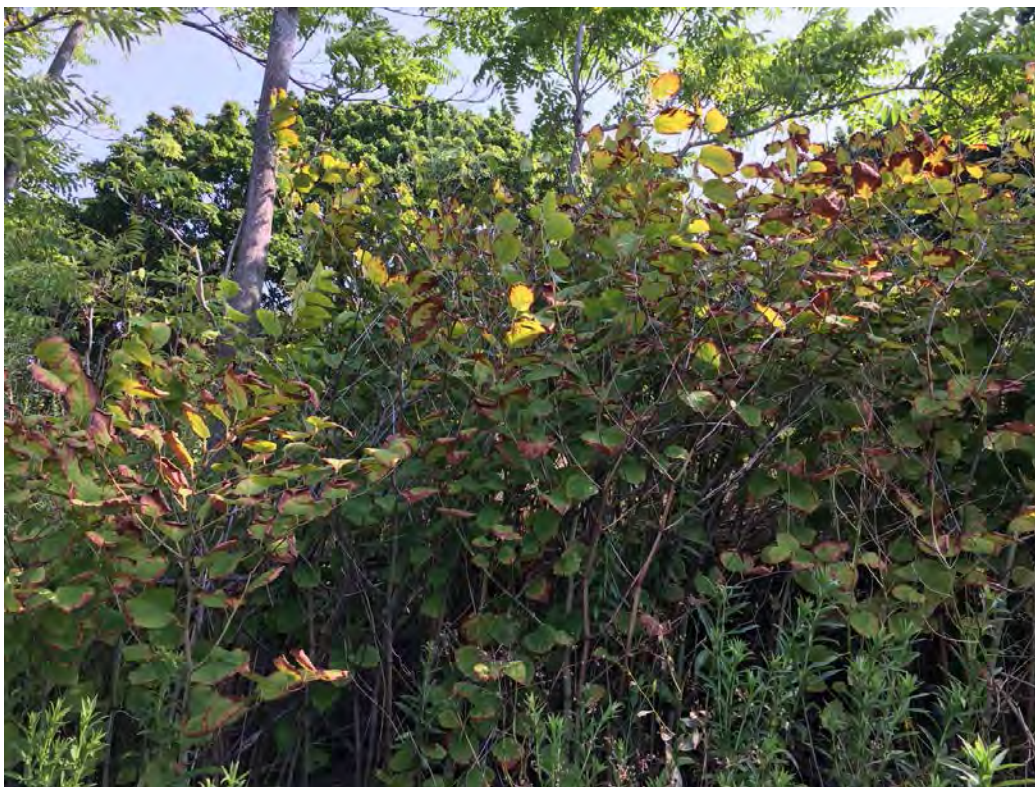
Photo 21. Japanese Knotweed in the Creek

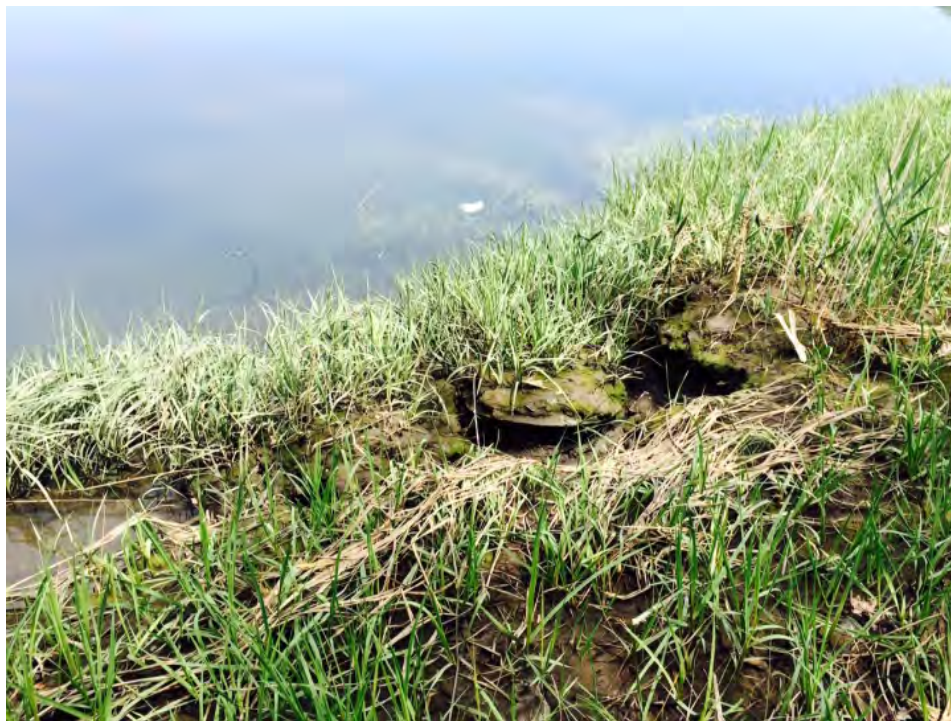
Photo 22. Low Marsh Slumping

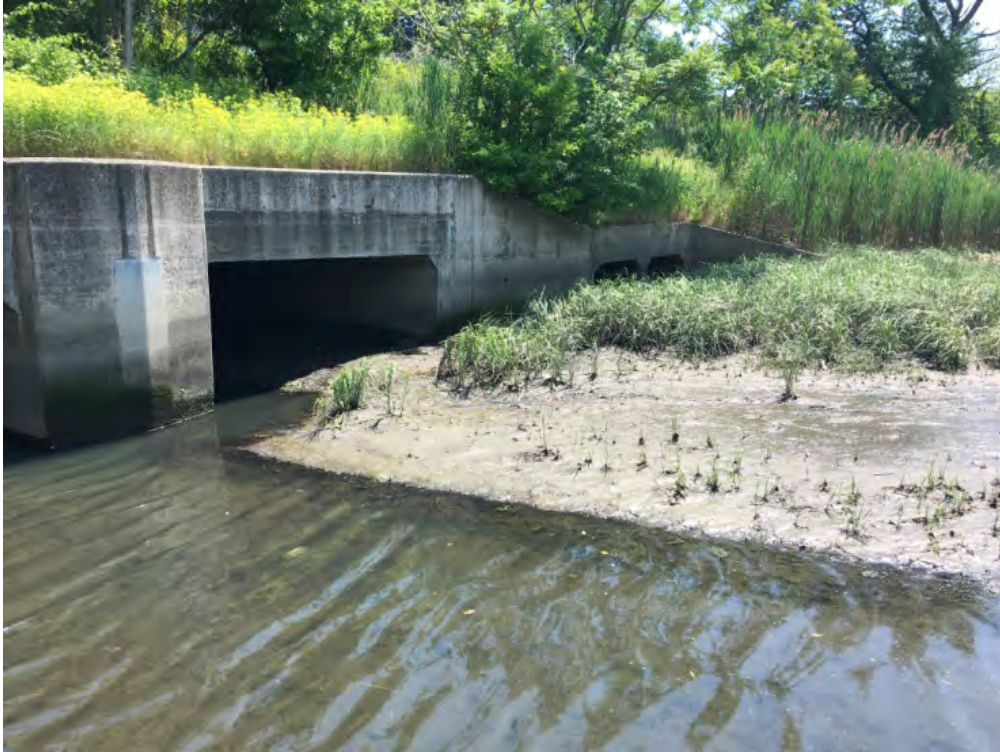
Marsh F is located between the U.S. Route 1 off/on-ramp and U.S. Route 1. The water at this stretch of the stream was observed to be stagnant and murky. Along the banks of the creek there is accumulation of muck which is unvegetated. The lower sections of the low marsh are tidal flats with no vegetation (Photo 24). At the higher elevations of low marsh robust smooth cordgrass is growing amid patches of muddy unvegetated areas. The vegetation in the high marsh is dominated by common reed with some spike grass, seaside goldenrod, sea lavender, saltmarsh hay, black grass present. Upslope of the marsh the invasive tree-of-heaven was observed. This stretch of salt marsh is degraded with some salt marsh vegetation surrounded by unvegetated muddy expanses and Phragmites.

Photo 24. Marsh F Upstream of U.S. Route 1 Off/On-Ramp

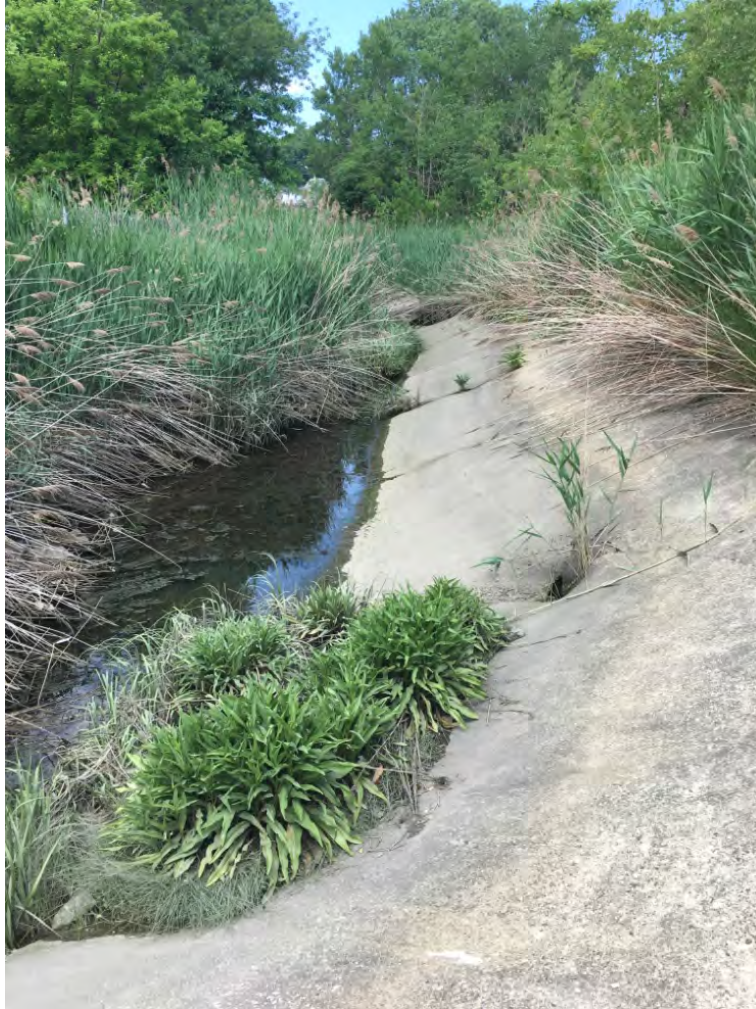
Marsh G is located at the end of the Mill Creek tributary channel between the Chelsea Housing Authority (Scrivano Apartments), Home Depot and the U.S. Route 1 off/on-ramp. The tributary is bottle-necked by steep slopes on both sides, one of which (on the Home Depot side) is lined with concrete (Photo 25). The creek along this stretch was observed to be stagnant with a mucky bottom. At the time of the site visit the creek was still flowing out, four hours after predicted low tide. The vegetation along this narrow portion of the creek is dominated by common reed with a thin strip of smooth cordgrass mostly only present on the north side of the creek.

Photo 25. Concrete Revetment on South Bank of Tributary Channel

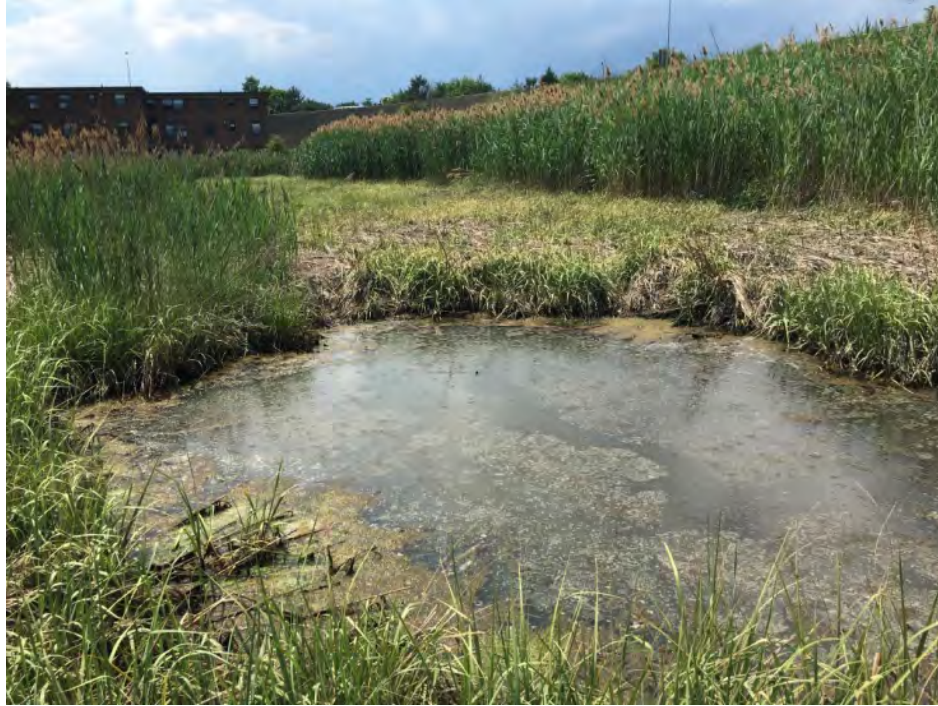
In the middle of this section of salt marsh there is a pool with deep water and no visible vegetation (Photo 26). The salt marsh in this location does not appear to be healthy with large areas that have no vegetation or are dominated by *Phragmites*.

Photo 26. Open Water Pool in Marsh G

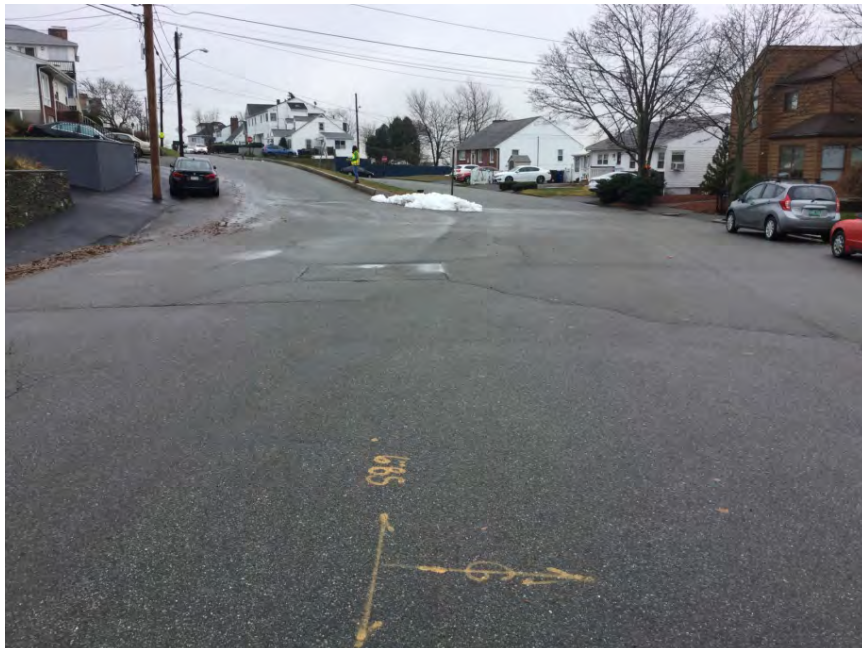
configurations contributed to excess pavement as well; Suffolk Avenue in Revere (Photo 28) has a road width of 50 feet where the street splits into two one-way roads before joining at Tudor Street. Sidewalks, typically 5 to 7 feet in width, were present on both sides of the street in most areas.

Photo 28: Suffolk Avenue in Revere, MA

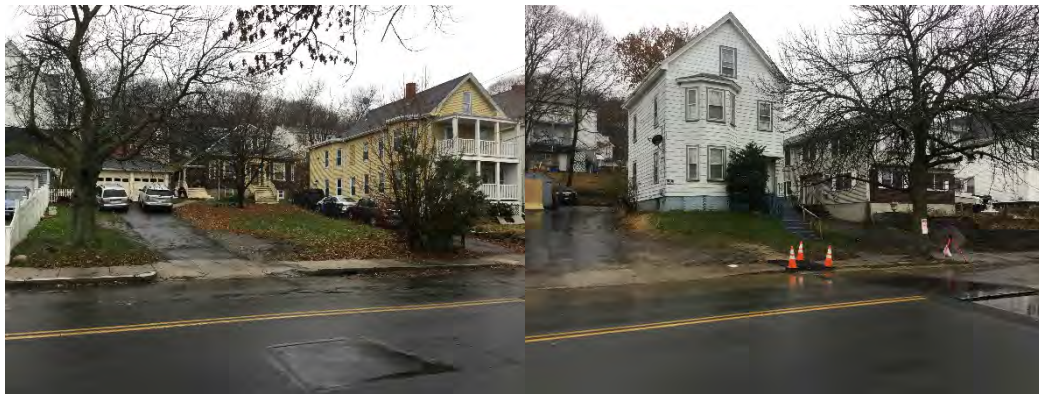
- 3) Sediment and pollutants: Acknowledging that sediment is a large contributor to the impacts within Mill Creek, HW staff looked throughout the priority subcatchments for potential sediment sources. One of the potential sources is construction sites. HW noticed one site in the ROW on Webster Avenue in Chelsea that appeared to have no sediment or erosion control. HW also observed exposed soil at several residential properties where residents appeared to be parking their vehicles (Photo 29). Another likely upland source, though not observed at the time of the site visit, is the use of sand during winter seasons. Other pollutants observed included leaves, debris, trash and oil/grease which were present throughout the subcatchments.

Photo 29: Photos of exposed soil at residential sites
