Mystic River Restoration Project - Mill Creek Restoration Assessments

FY18 MassBays Healthy Estuaries Grant Program

Chelsea and Revere, Massachusetts

July 15, 2019

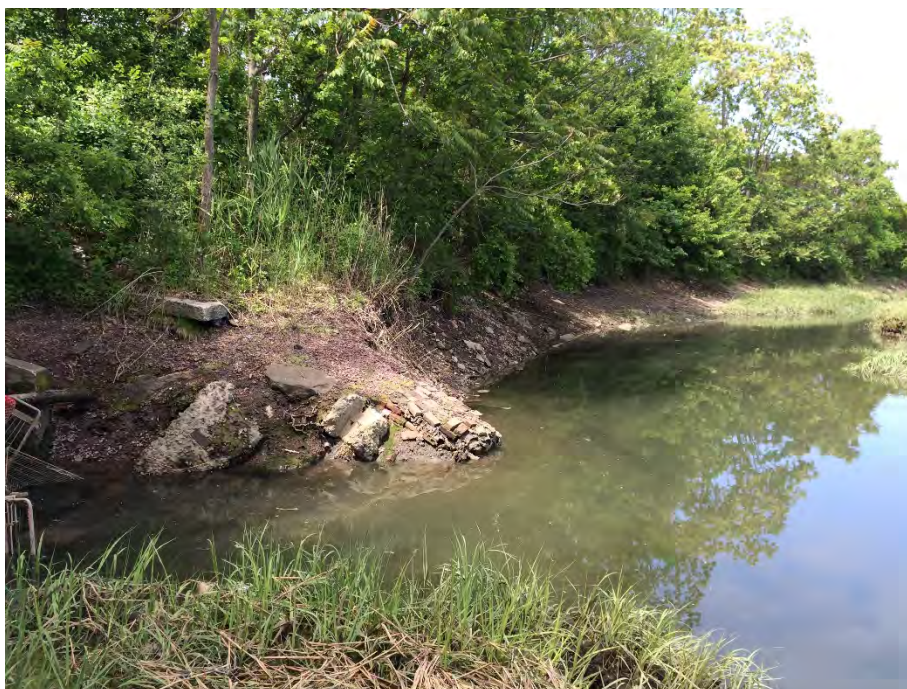
Photo 30. Exposed Bank Near Beth Israel Deaconess HealthCare

The bank and buffer of a section of 500 linear bank starting at the Beth Israel Deaconess and Walgreens Parking lot extending north could be restored and stabilized. This project could include the regrading of the shoreline to restore floodplain connection, soft shoreline stabilization methods, removal of approximately an acre of existing invasive species and revegetation of native buffer species. Pilot-scale salt marsh replenishment could also be considered as part of this project. In discussions with local community members and groups, including GreenRoots, this site also has a potential to become an active and/or passive recreation space due to the proximity of the existing Creekside Commons Park, the Mill Creek Riverwalk and the available water access. A photo of the existing site is shown in Photo 30.
