# VILLAGE OF DECATUR

BUILDING ASSESSMENTS OF VILLAGE HALL & POLICE DEPARTMENT

DATE: April 15th, 2022

## BUILDING ASSESSMENTS OF PUBLIC WORKS DEPARTMENT

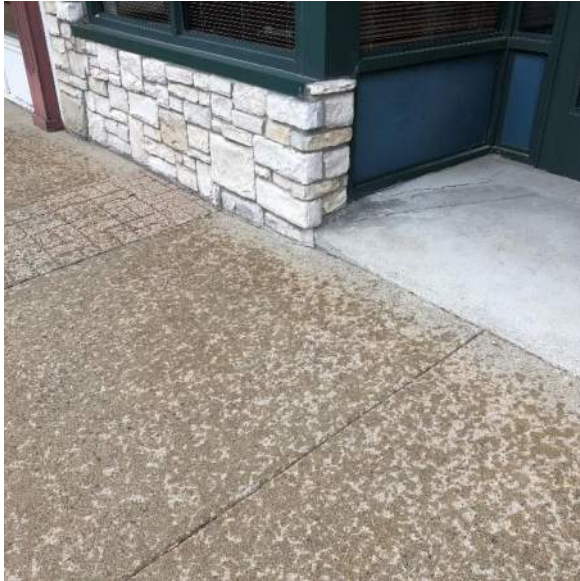
A-i: Concrete Pad

- i. Concrete Pad at entry door is showing signs of cracking & has a 1"-2" lip on the east & west side of pad at sidewalk, presents trip hazard. (Photo A-i)  
**Recommendation:** Remove & Replace new.  
**Cost Parameters:** \$500-\$1,500
- ii. Concrete Pad at entry door is not ADA compliant. (Photo A-ii)  
**Recommendation:** Redesign sidewalk in front of entrance (Design required).  
**Cost Parameters:** \$3,500-\$5,000

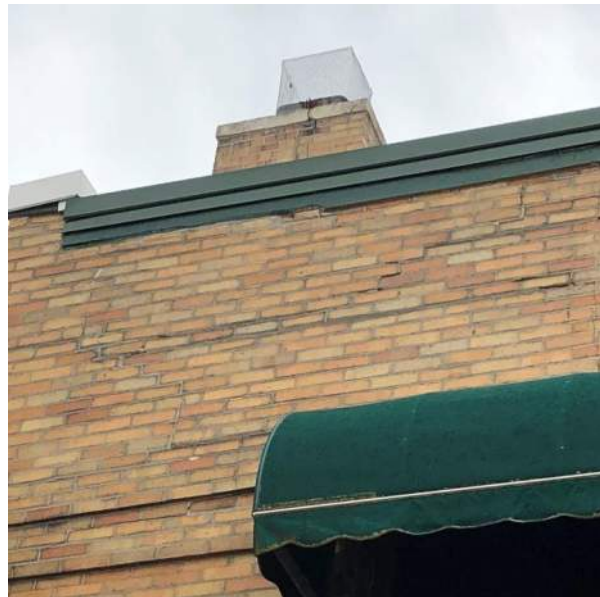
B-v: Failing Brick

- v. Failing Brick at multiple locations. (Photo B-iv)  
**Recommendation:** Replace damaged brick and tuck-pointing.  
**Cost Parameters:** \$40,000-\$50,000

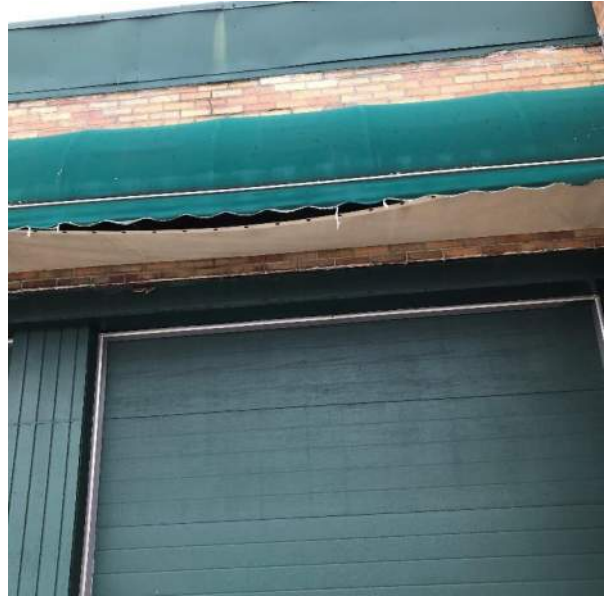
B-vi: Metal at Top of Wall

- vi. Replace sheet metal at top of wall above overhead doors. (Photo B-iv)  
**Recommendation:** Replace sheet metal at top of wall.  
**Cost Parameters:** \$3,000-\$5,000

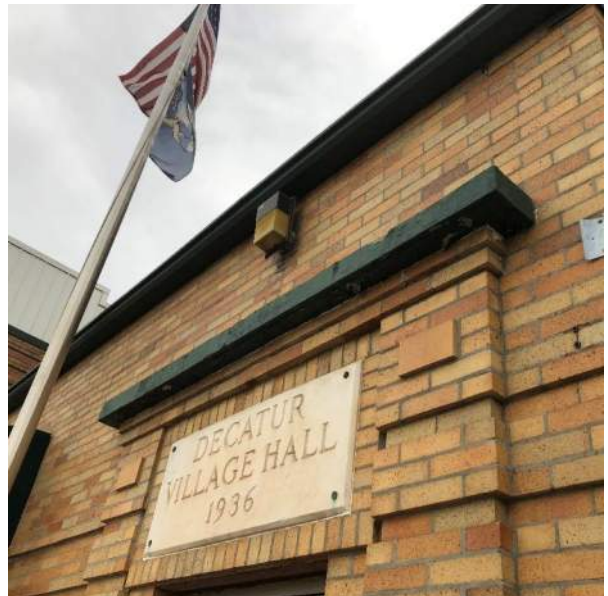
B-viii: Window Sill/Door Cap

- vii. Damaged awning cover and soffit material. (Photo B-v)  
**Recommendation:** Replace awning cover  
**Cost Parameters:** \$10,000-\$15,000
- viii. Concrete Window Sill (Sealed) & Entry Cap. (Photo B-vi)

**Recommendation:** Prep & Paint.  
**Cost Parameters:** \$2,000-\$3,000
- ix. Brick & Steel Lintel above stair door. (Photo B-vii)  
**Recommendation:** Replace lintel above door and brick.

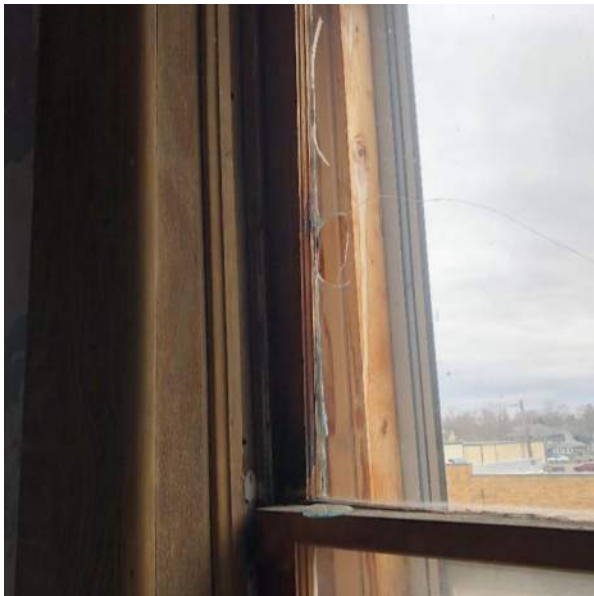
C-i: Broken Window

- i. Broken glazing 2<sup>nd</sup> floor wood window 3'x5'. (Photo C-i)  
**Recommendation:** Replace Window  
**Cost Parameters:** \$5,000-\$7,000

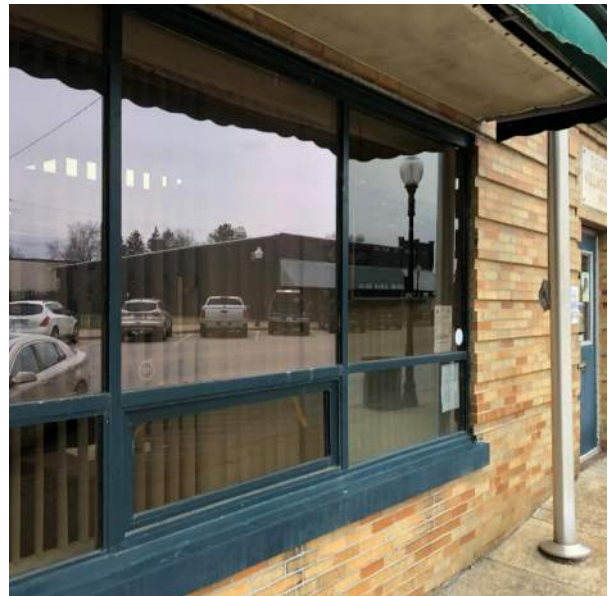
C-ii: Steel Window

- ii. Outdated steel window 5'x12'. (Photo C-ii)  
**Recommendation:** Replace Window  
**Cost Parameters:** \$7,000-\$10,000
- iii. Outdated steel window lower level 5'x8'. (Photo C-iii)  
**Recommendation:** Remove windows and Fill-In with brick  
**Cost Parameters:** \$2,000-\$3,000
- iv. Outdated stairwell #2 wood window 2'x3'. (Photo C-i)  
**Recommendation:** Replace Window  
**Cost Parameters:** \$1,000-\$2,000

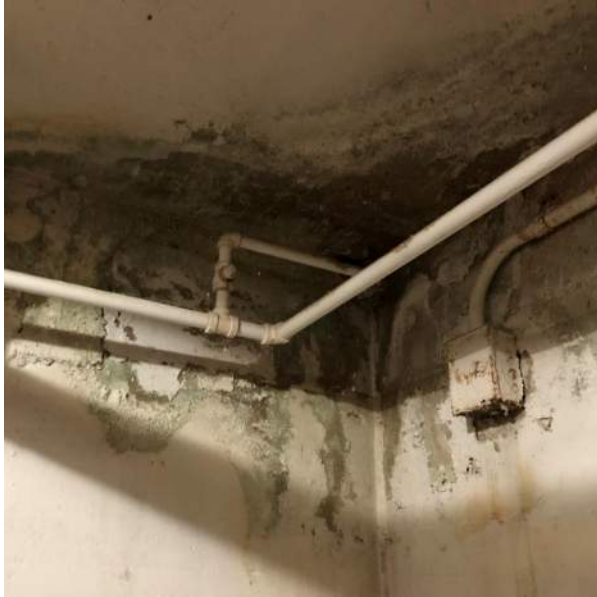
F-i: Moisture Damage

- i. Evidence of water damage in southeast corner (Photo F-i)  
**Recommendation:** Waterproof coating  
**Cost Parameters:** \$2,000-\$4,000
- ii. Dirty and worn slab (Photo F-ii)  
**Recommendation:** Clean & paint finish  
**Cost Parameters:** \$3,000-\$5,000
- iii. Paint plaster at wall and ceiling (Photo F-iii)  
**Recommendation:** Repair & Paint  
**Cost Parameters:** \$7,000-\$10,000

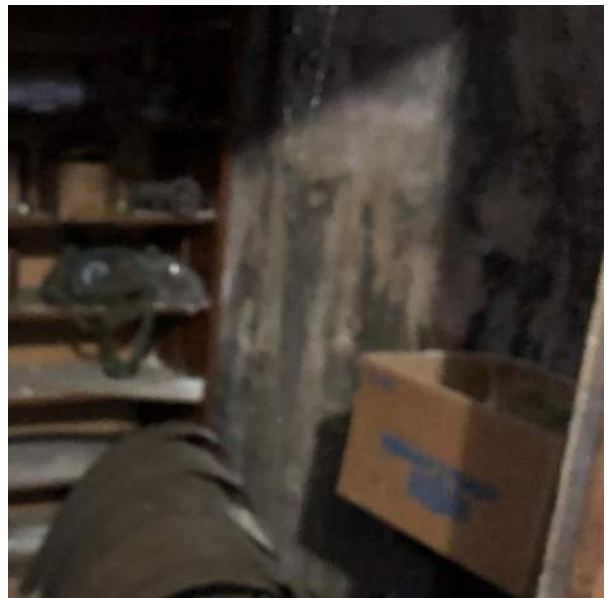
F-iv: Moisture Damage

- iv. Evidence of water damage on south wall (Photo F-iv)  
**Recommendation:** Waterproof coating  
**Cost Parameters:** \$3,000-\$5,000
- v. Dirty and worn slab (Photo F-v)  
**Recommendation:** Clean & paint finish  
**Cost Parameters:** \$1,000-\$3,000
- vi. Concrete Stair, rail & headroom does not meet code (Photo F-vi)  
**Recommendation:** No feasible solution  
**Cost Parameters:** N/A
- vii. Concrete Ceiling (exposed rebar) (Photo F-vii)  
**Recommendation:** Reinforced & pour concrete (review by structural engineer)  
**Cost Parameters:** N/A

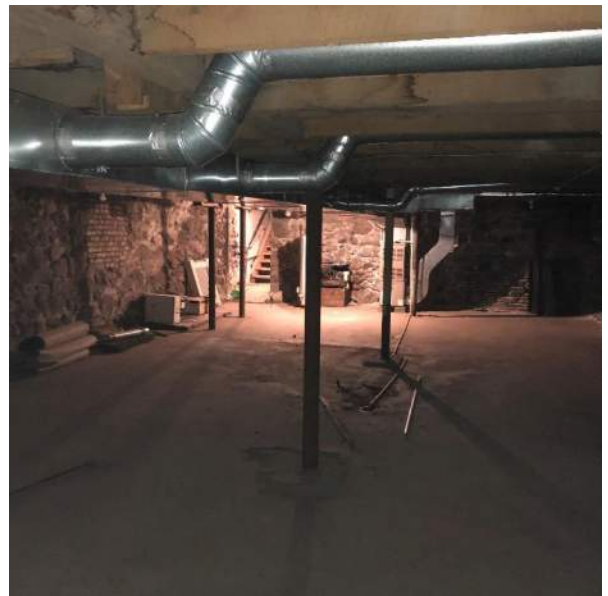
F-viii: Dirty Concrete

- viii. Dirty and worn slab (Photo F-viii)  
**Recommendation:** Clean & paint finish  
**Cost Parameters:** \$3,000-\$5,000
- ix. Multiple Jack Post below Bath & main entry door (Photo F-ix)  
**Recommendation:** Investigate  
**Cost Parameters:** \$2,000-\$5,000
- x. Wood Stair, rail & headroom does not meet code (Photo F-x)  
**Recommendation:** No feasible solution  
**Cost Parameters:** N/A

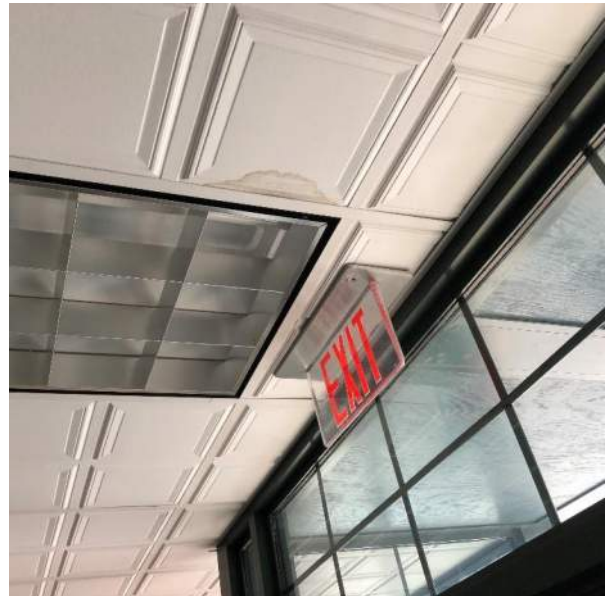
F-xii: Water Damage

- xi. Outdated carpet is in fair condition (Photo F-xi)  
**Recommendation:** Remove & Replace  
**Cost Parameters:** \$5,000-\$8,000
- xii. Water damaged ceiling tile (Photo F-xii)  
**Recommendation:** Investigate, Remove & Replace  
**Cost Parameters:** \$500-\$1,000

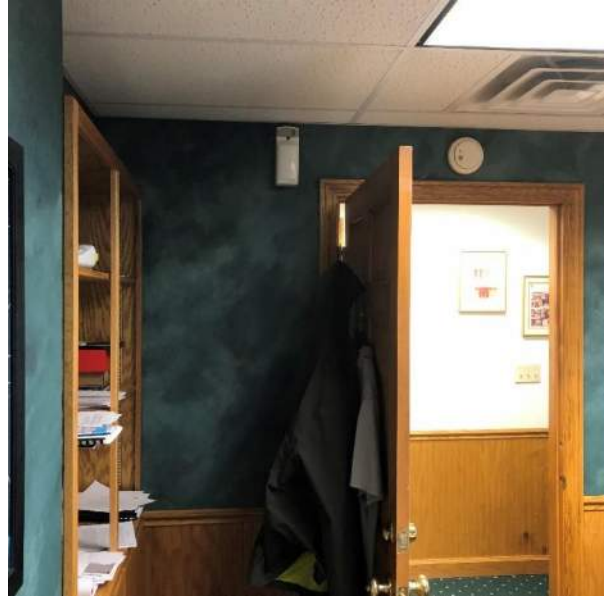
F-xiv: Wallpaper

- xiii. Outdate carpet is in fair condition (Photo F-xiii)  
**Recommendation:** Remove & Replace  
**Cost Parameters:** \$1,500-\$3,000
- xiv. Wallpaper is in fair condition (Photo F-xiv)  
**Recommendation:** Remove & Replace  
**Cost Parameters:** \$1,500-\$2,500

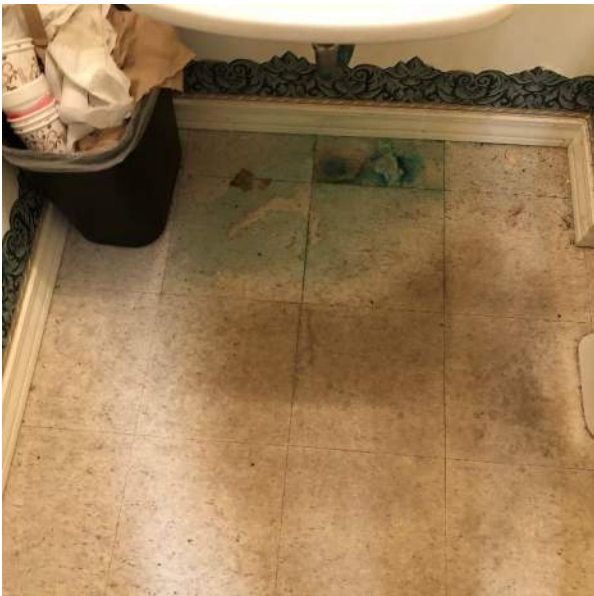
F-xv: Worn Vinyl Tile

- xv. Worn vinyl tile flooring is in poor condition (Photo F-xv)  
**Recommendation:** Remove & Replace  
**Cost Parameters:** \$1,000-\$2,000
- xvi. Paint is in poor condition (Photo F-xvi)  
**Recommendation:** Remove & Replace  
**Cost Parameters:** \$500-\$1,500

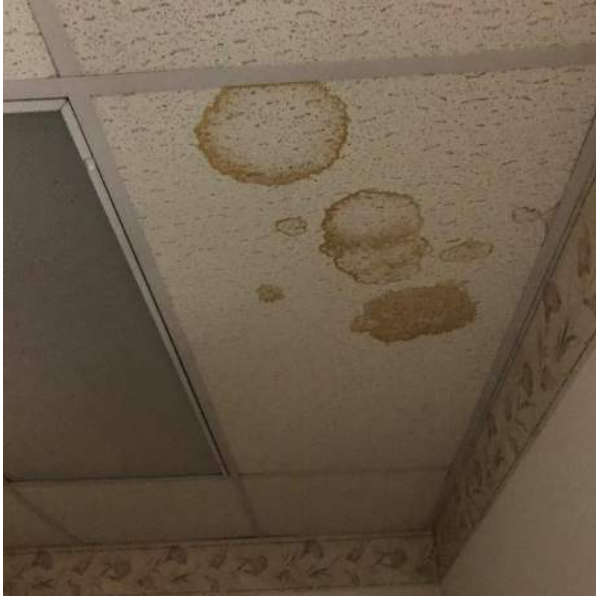
F-xxi: Water Damage

- xx. Wallpaper is in fair condition (Photo F-xx)  
**Recommendation:** Remove & Replace  
**Cost Parameters:** \$1,000-\$2,000
- xxi. Water damaged ceiling tile (Photo F-xxi)  
**Recommendation:** Investigate, Remove & Replace  
**Cost Parameters:** \$500-\$1,000

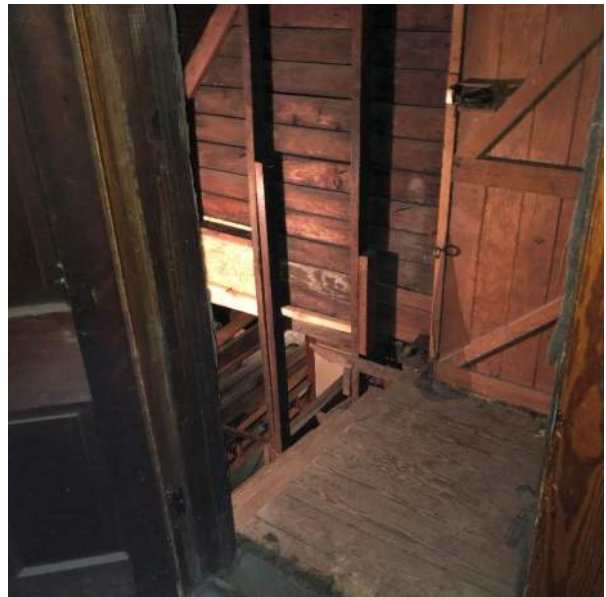
F-lxxxv: Wall & Ceiling

- lxxxiv. Wood Stair does not meet code (Photo F-lxxxiv)  
**Recommendation:** No feasible solution  
**Cost Parameters:** N/A
- lxxxv. Walls & ceiling is in poor condition (Photo F-lxxxv)  
**Recommendation:** Insulate wall & ceiling
