EVART DEPOT

EVART CITY HALL

MAINTENANCE ANALYSIS AND PLAN

April 2, 2019

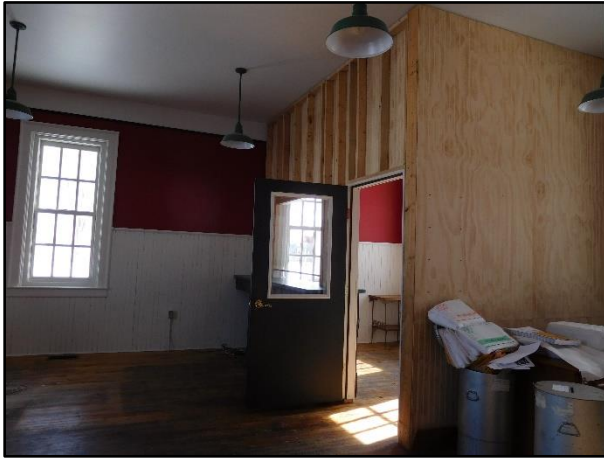
Temporary wall at front office

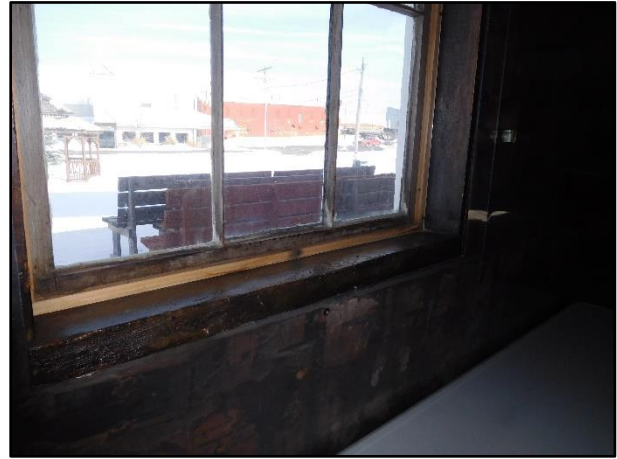
Wall preserved behind Plexiglas

More thought may need to be employed in the Community Room at the exposed wood walls. If insulation is added from the exterior, will it be visible from the interior? This wall wouldn’t be painted, so how would it achieve a vapor barrier? Would the Plexiglas that protects the wood finish act as a vapor barrier?

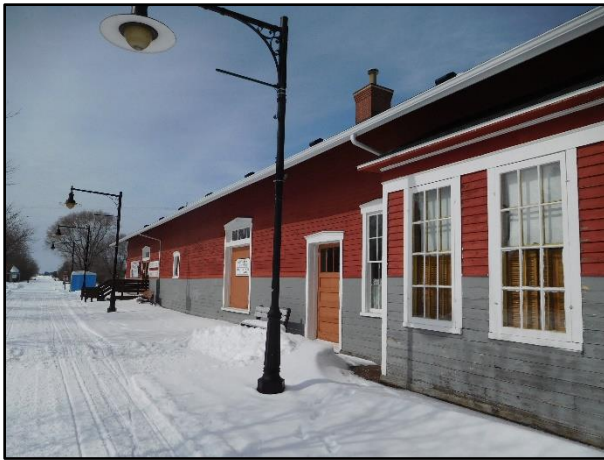
It is thought that some new wood windows were custom made at the time to match existing with mullions and muntins. The only windows with storm windows are at the bay of the former station master's office. Some of the original windows still exist at the back and have had Plexiglas installed over them on the interior to protect them from damage and to function as an interior storm window. They do not have exterior storm windows. The glass transoms at the west end of the building, at the railway room and restroom are original. Exterior doors are new wood doors, but original sliding track doors are still preserved in place on the interior. The basement window well has a single pane wood window with a metal grille installed on the interior for security. There was not a storm window in place.

Early storm windows at bay

An interior storm window should be added that is custom fit for the opening. This will help cut down on air infiltration, improving comfort and decreasing drafts. They need to be tight fitting with a sealing gasket around the glass. Preferably, they should not have meeting rails, but if they do, they shouldn't conflict with the meeting rails of the historic windows. They should align with those of the historic window. I suggest a standard interior storm window made by Indow Windows, (503) 673-6922, <https://indowwindows.com>. They are reasonably priced, lightweight acrylic, easily installed without any additional hardware, and custom sized. Existing storm windows at the former station master's office can be kept and reinstalled in the winter if they are in good shape. A storm window should be provided for the basement window as well. This could be an interior storm or an exterior storm, depending on if the metal grille will remain in place. If a glass storm window is preferred throughout, consider a clear, low-e glass.

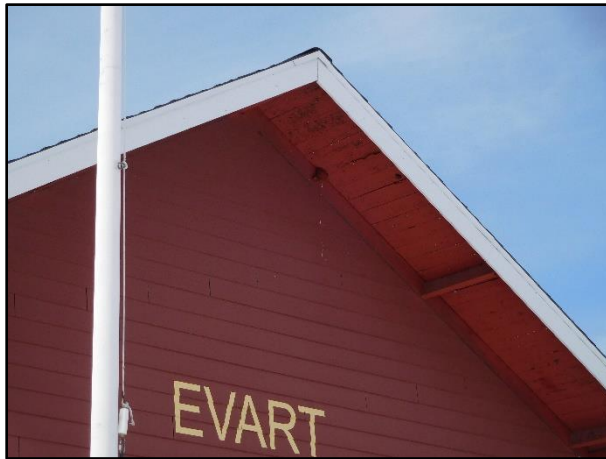
Fiber cement siding was installed on the east gable end of the building in the early 2000s. This is pulling apart at the vertical joints and causing gaps between clapboards at those locations. A steel replacement door has been added on the north façade at the east end. It sits behind a storm door with the traditional wood frame trim and hood to match the other windows and doors.

Siding and Paint – Some of the wood siding is in very poor condition and is breaking away or cracking. The vertical joints of the fiber cement board siding are opening up. Both of these situations will allow water behind the siding and will accelerate deterioration of the siding and the wall structure behind. The condition of the siding could be contributing to the energy inefficiency. Paint is peeling significantly on the exterior siding, particularly on the south façade. Some peeling is typical after 7-10 years, depending on the preparations made and paint used.

Fiber Cement siding

On the east wall where wood clapboards were replaced with fiber cement clapboard siding, the siding is pulling apart at the joints. It is quite brittle and over time does not hold up well in wet or freeze/thaw conditions. Replacement with wood clapboards should be considered.

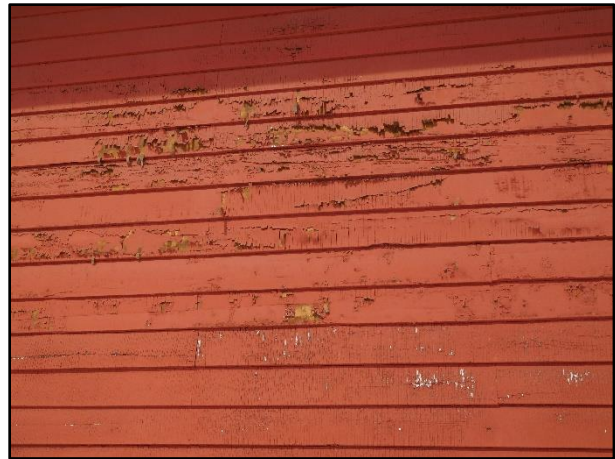
Peeling paint

The wood siding is cracking through and deteriorating. Preserving this siding will require a significant amount of physical labor. The paint is alligatored and peeling extensively showing bare wood in some locations. It's unknown whether a vapor barrier was used when some of these walls were insulated 25 years ago. If it wasn't, that could have accelerated the deterioration of the paint and siding. Before stripping begins, the wood should be inspected for rot and cracks. Mark sections for repair or replacement. Anything that needs to be replaced doesn't need to be stripped. The Michigan Historic Preservation Network Lead Guidelines should be followed.

For the best paint job, it is vital to have good surface preparation. Existing paint should be removed wherever there are signs of failure. Siding and trim should be scraped, sanded, re-primed, and painted. Stripping can be done with heat guns and scrapers if very tightly controlled for fire safety. Scrapers should have rounded edges rather than sharp edges so they don't damage the wood. Don't use heat guns near windows. Chemical strippers are often best in areas where it's difficult to use a heat gun and scraper. Wood should only be repainted after it's been given a chance to dry properly.

Deteriorated wood must be replaced with new, sound wood. Siding repairs should be made with primed redwood or cedar as both are more durable than pine. Any new siding or trim pieces should be back painted prior to installation. While working, protect the wooden surfaces while repairs are made. Finish with two prime coats and two top coats of paint, with sanding between prime coats. If the wood is excessively dry, consider priming with an oil alkyd primer cut by 20% with mineral spirits. Oil primer is used for its ability to bond to wood and the mineral spirits will increase the depth of paint penetration. This will rejuvenate the dried wood and give the subsequent coats a good surface for bonding. Two finish coats of acrylic latex paint provide excellent color stability, good durability and breathability. With a compatible oil alkyd primer, it also has good flexibility to handle expansion and contraction with Michigan's temperature extremes.

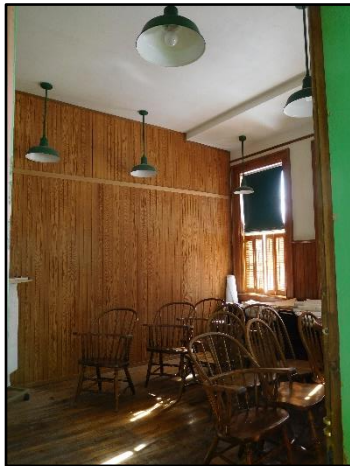
On the depot, there are two different roof conditions. One is a gabled attic above the ceiling in the front half, over the office area, and at the rear of the building, at the toilet rooms. There may be a layer of insulation on top of the ceiling joists. The other roof condition is the tall ceiling space in the Community Room with a finished wood ceiling attached directly to roof rafters. There may

Ceiling in office

In the attic space, it is recommended to add multiple layers of unfaced batt insulation. Each layer should run perpendicular to the prior layer. They should stack high enough to run above the ceiling joists, remembering to keep the vent areas clear and allowing for air circulation in the attic space. Insulated the upper side of the attic door. Achieving an R80 in this area of the building would be desirable.

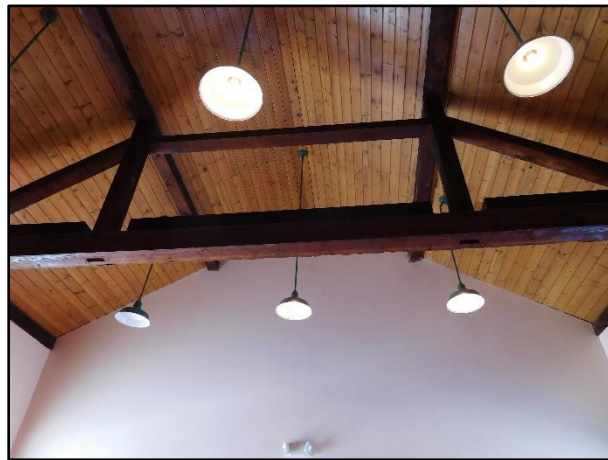
be a layer of insulation between the ceiling and the roof deck. In both cases, there are roof vents provided part way up the pitched sides of the roof. These vents need to be kept clear on the inside of the roof for good air circulation in both the attic and rafter locations.

Ceiling in Community Room

Blown-in cellulose insulation is recommended for use in rafter areas, but baffles must be used between the roof rafters where the ceiling joists meet the rafters if this area allows for venting or at the roof vents to allow for free air movement for ventilation of the enclosed rafter space. Batt or rigid foam panels could also be used in this area if the space between the rafters were accessible. Spray foam insulation is not recommended between rafters because it doesn't allow for air movement and may adhere permanently to the historic materials.
