Re: Greenfield Library Overview (Leavitt Hovey House)

Determination of Occupancy Load
And
Egress Requirements for Basement Meeting Rooms
Greenfield Public Library
420 Main Street
Greenfield, MA

**Greenfield Public Library
402 Main Street
Greenfield, Massachusetts**

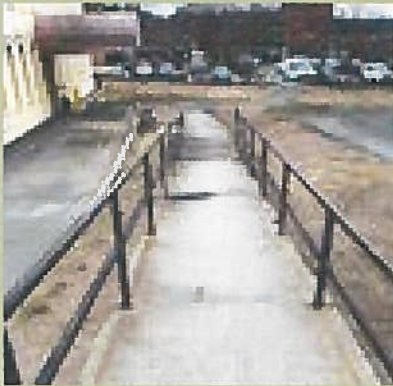
The library's accessible entrance ramp has cracks and crevices. Route from parking to entrance crosses an emergency vehicles lane.

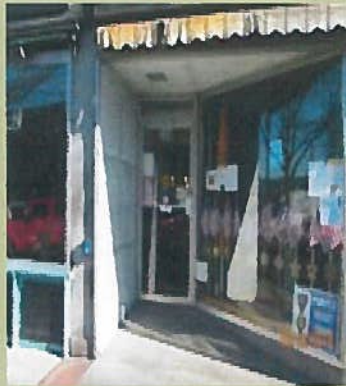
Accessible route from parking to entrance at the Veteran's Center has large crevices and is uneven.

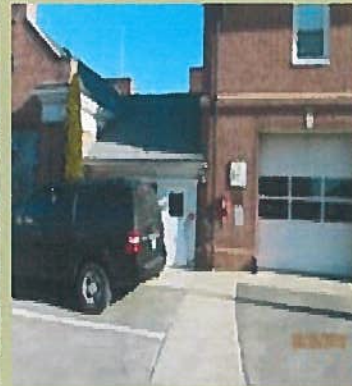
There is not an accessible route to the entrance of the fire station from accessible parking.

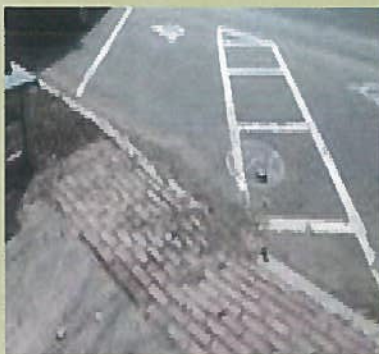
Accessible route from on-street parking location in front of 114 Main Street is uneven and not stable.

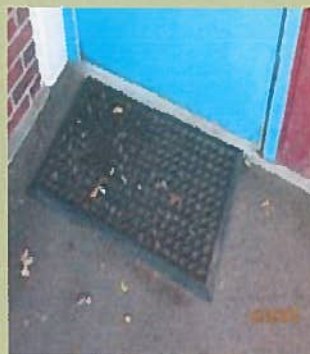
Route to City Offices entrance is uneven, damaged, and door is not ADA compliant.

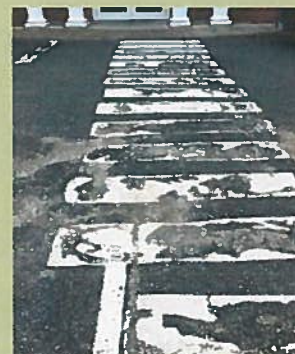
The surface of the route to Federal Street entrance is not stable or accessible.

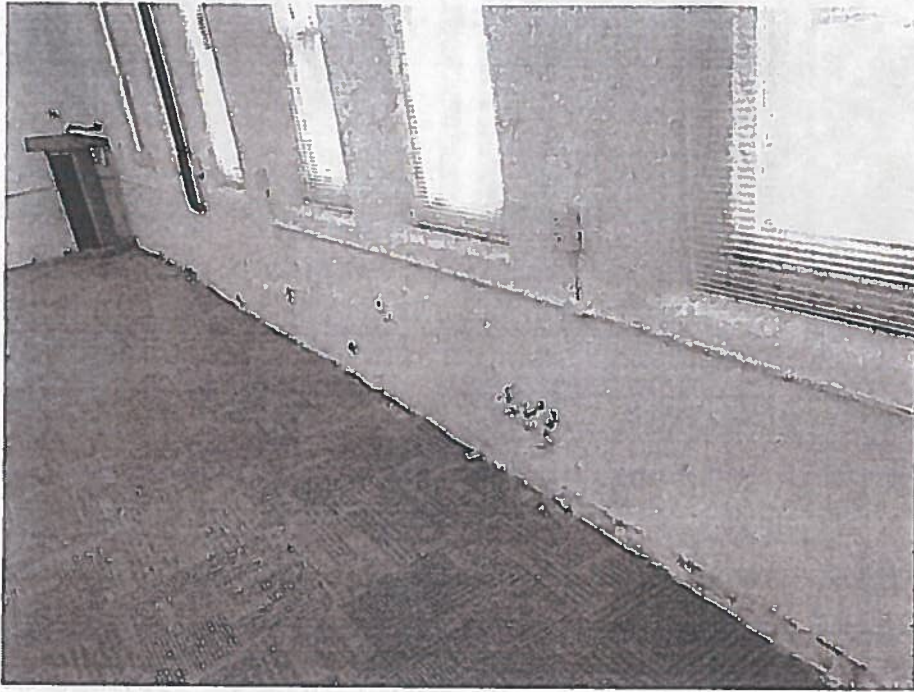
Picture 1

- Room B101 had extensive water damage along its western wall (Picture 1). Attempts were made to repair in the form of gypsum wallboard patches used to fill holes in the base of the plaster wall. The use of gypsum wallboard is inappropriate because the backing can mold-colonized if chronically wet. (Refer to P5)

Room B101 had extensive water damage along its western wall

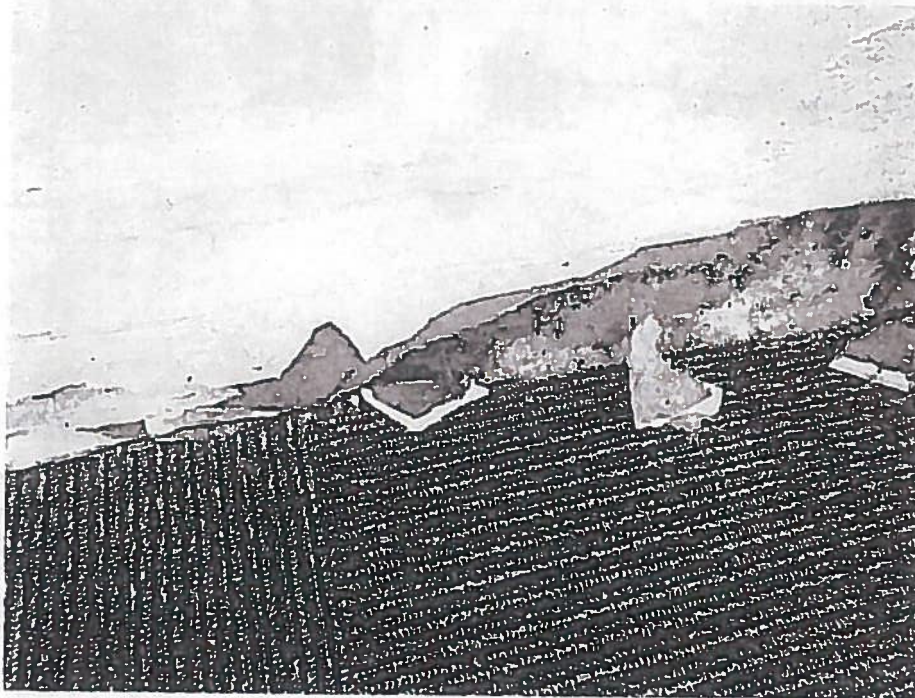
Picture 2

GW inside plaster wall

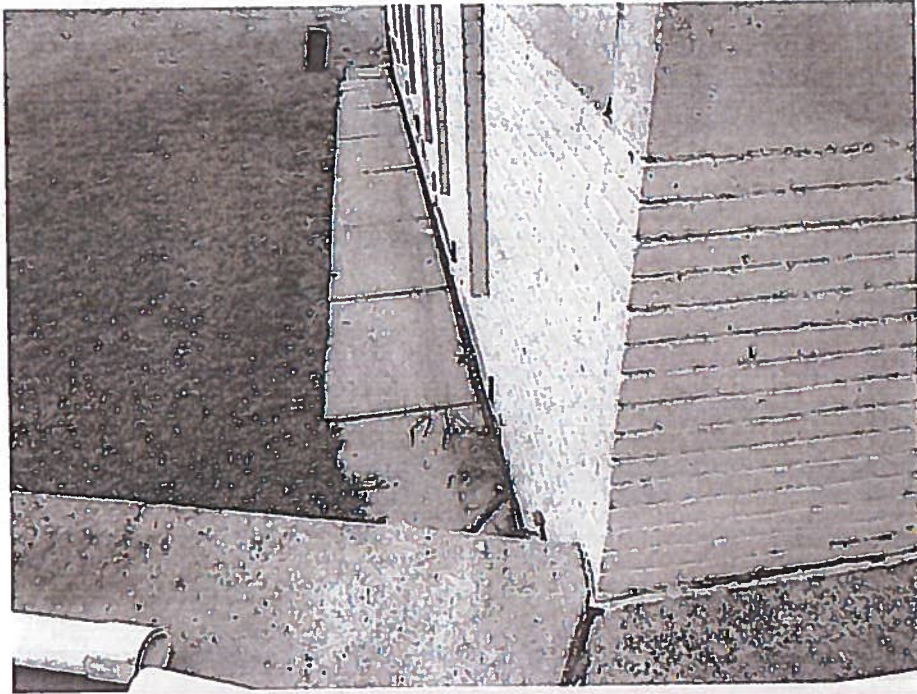
Picture 3

**Subsiding and ajar cement slabs at base of west wall
(Note missing sealant in slab/wall junction)**

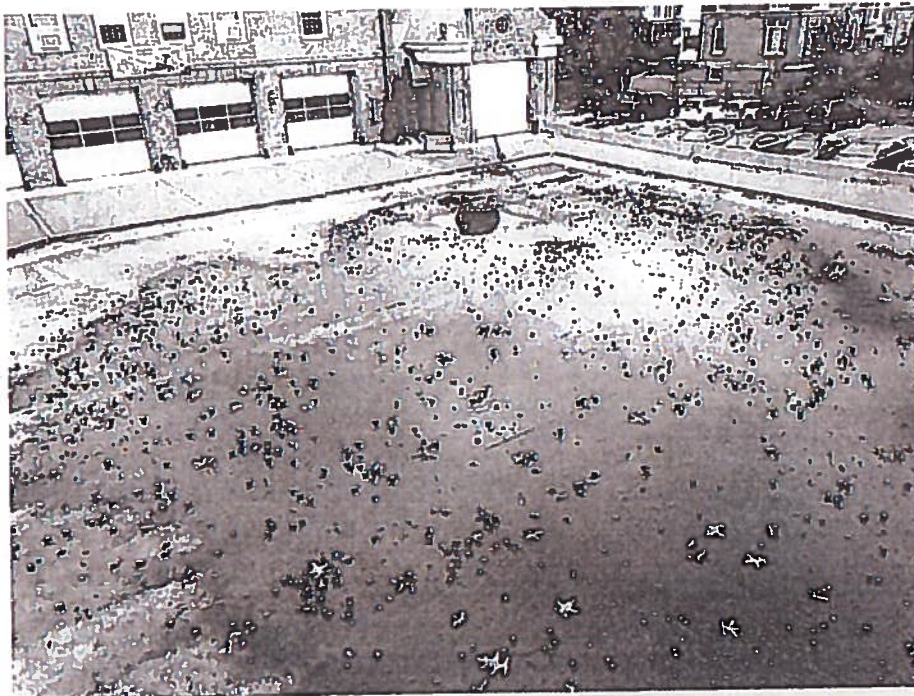
Picture 4

- Water damaged ceiling tiles; some of the stained tiles were from roof leaks that have reportedly been repaired. The roof of the building was also examined. The roof membrane has become loose, resulting in pooling water. (Refer to P6)

Pooling water on roof

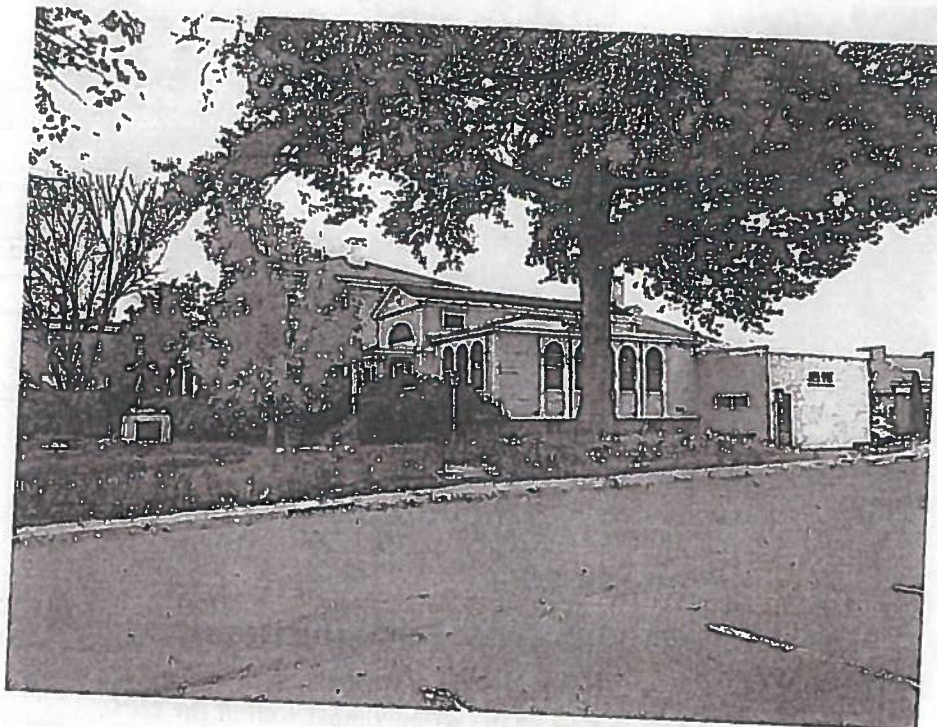
Picture 5

Oak tree overhanging building

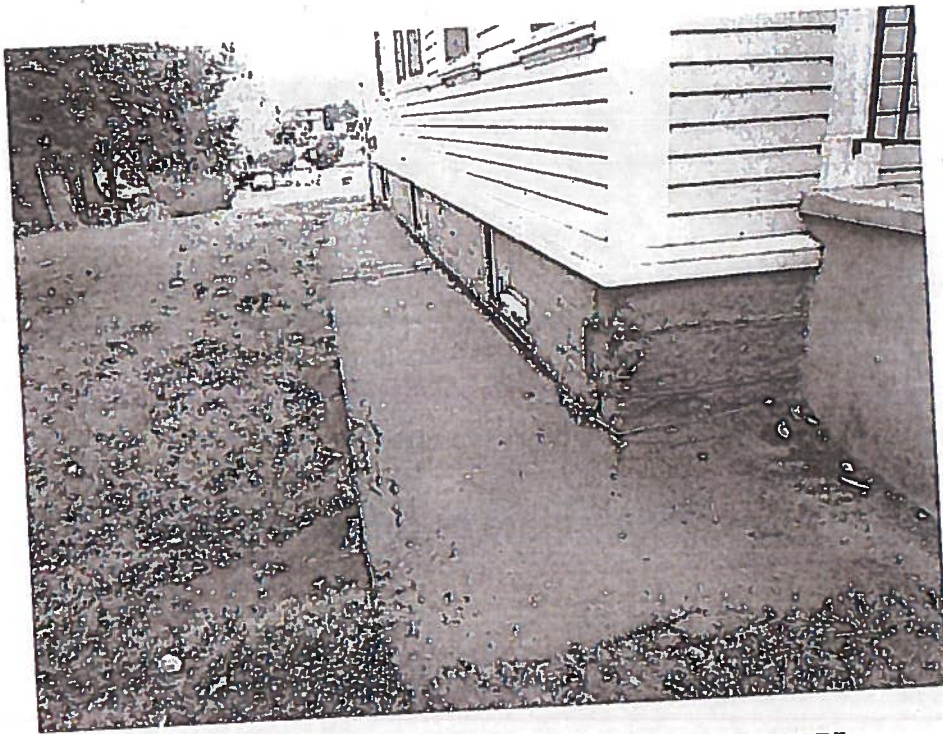
Picture 7

Tarmac apron at base of the westernmost wall of the GPL

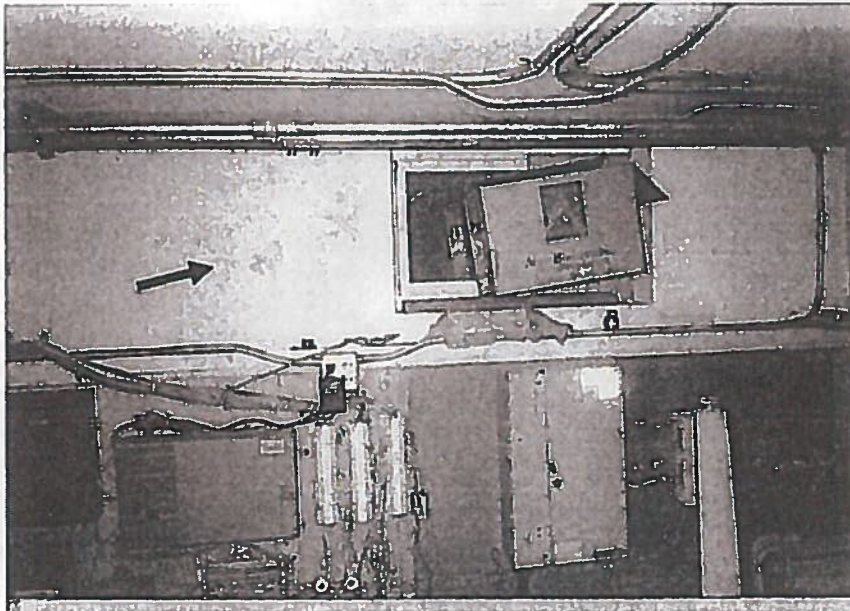
Picture 4

Water Damage to Foundation Wall

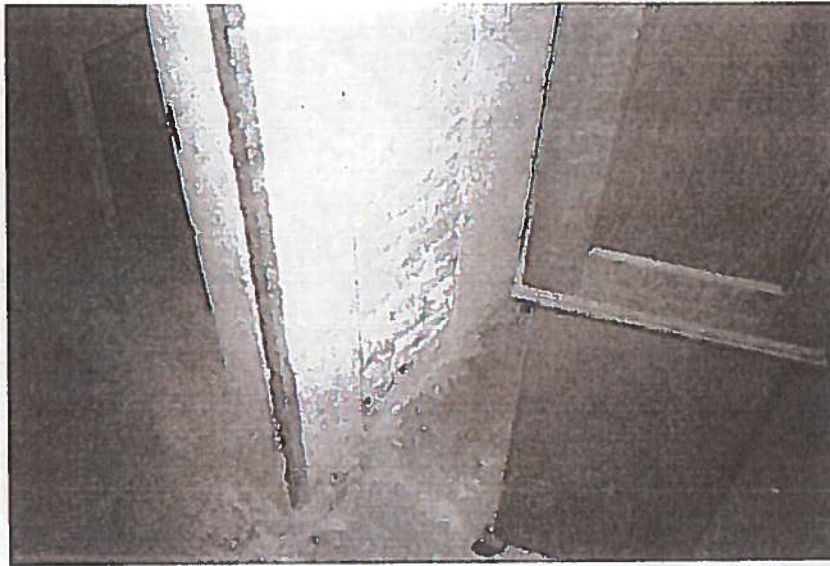
Picture 5

Water Damage to Brick Support Pillars

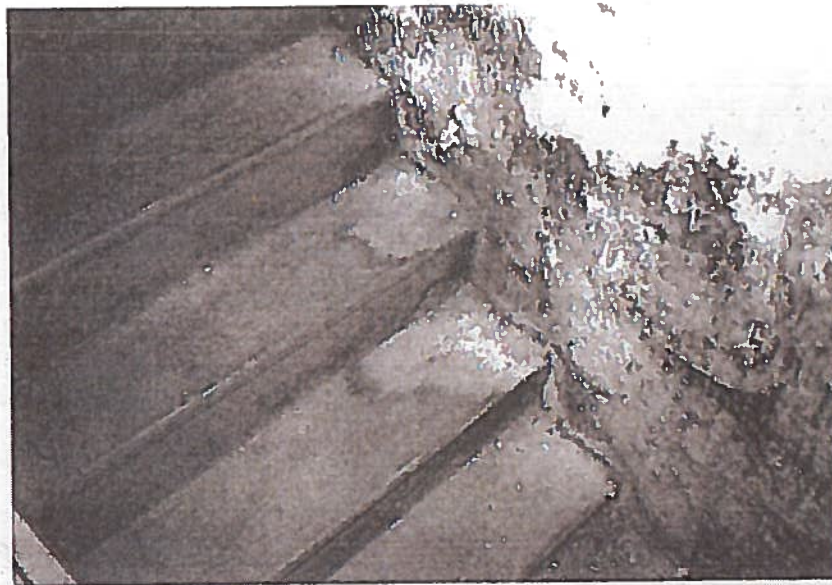
Picture 6

Water Damage to Basement Stairwell and Foundation Wall

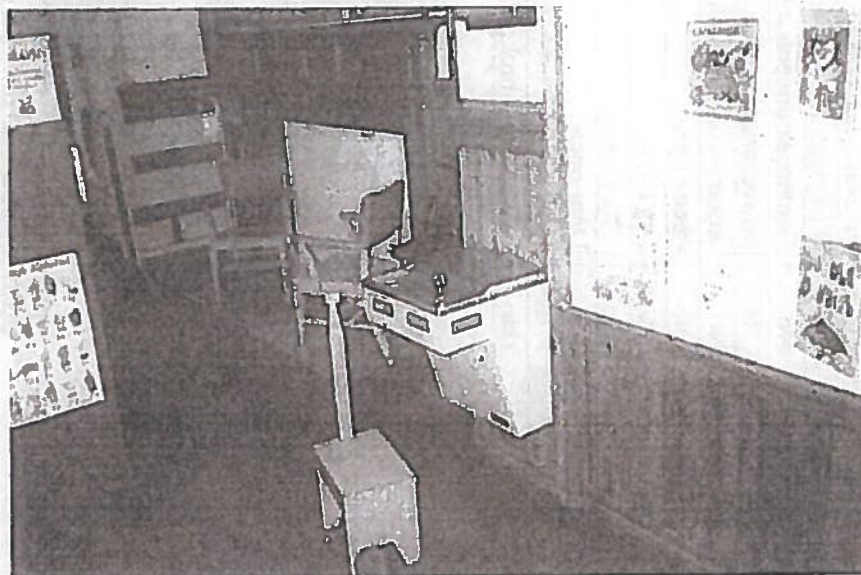
Picture 11

Water Fountain Observed Above Carpeting in the Children's Section

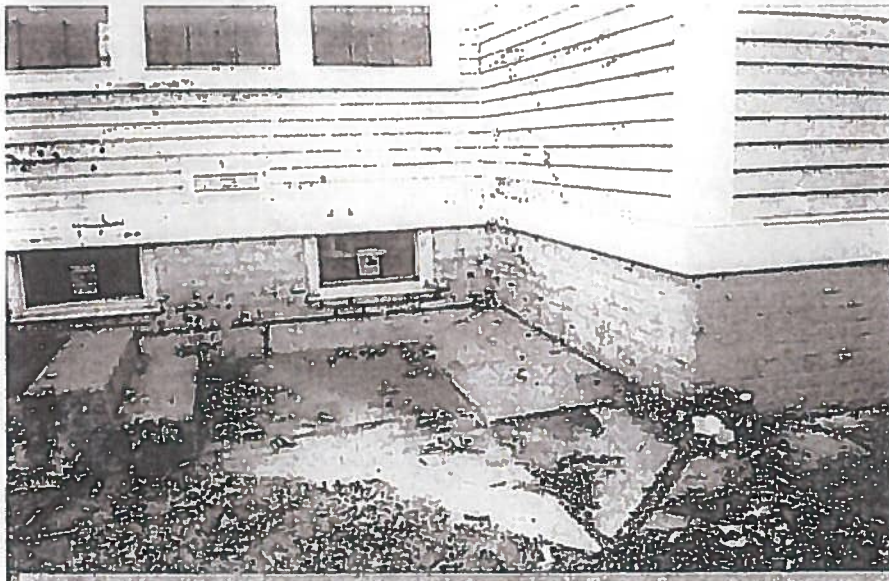
Picture 8

Exterior Wall at Rear of Building Formerly Covered With Substantial Ivy Growth

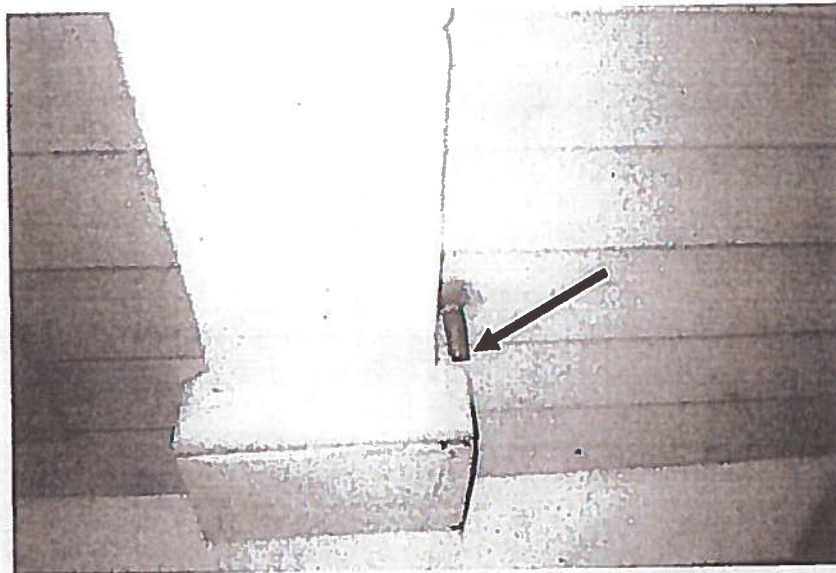
Picture 10

**Condensation Drain Emptying Onto Exterior Wall Clapboard,
Note Damage to Wood below Drain**
