# WENDELL A. BARWOOD ARENA

## Refrigerated Floor and Dasher Board Assessment

April 19, 2018

Re: **Wendell A Barwood Arena**  
**Refrigerated Floor Assessment**

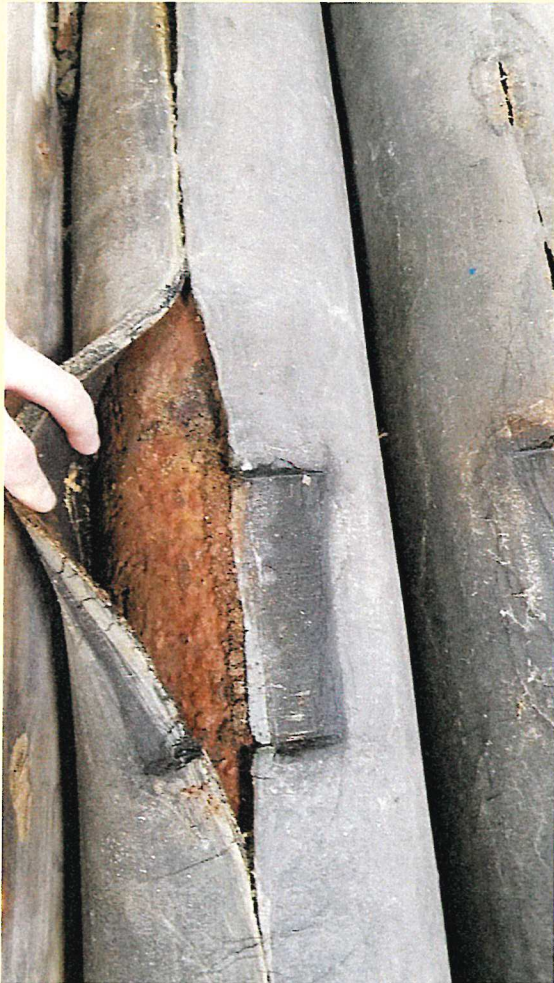
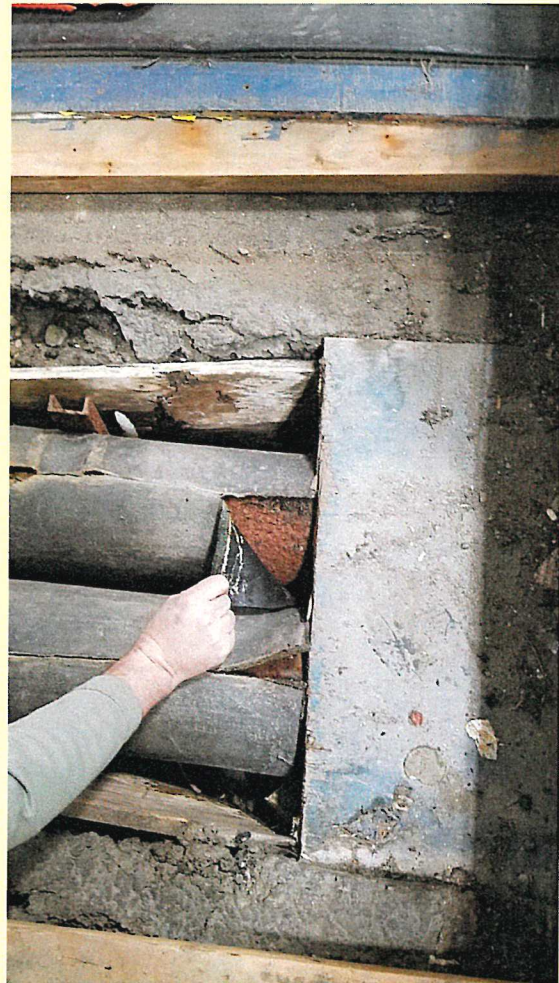
**Heavy External Corrosion**

We submitted a sample of your existing calcium chloride brine to an independent lab for testing. The results indicate that it is very high in suspended iron and has an acidic PH level. This is evidence of substantial degradation of steel piping internals. Inspection of the piping at the exposed section under the players boxes also indicate heavy external corrosion on the piping with a reduction in external wall thickness at this area.

Corrosion on steel piping between refrigeration room and header trench.

It is our opinion that the cold floor steel header piping was not designed correctly. The immense amount of suspended iron in the exiting acidic brine coupled with demonstrated external corrosion will lead to a steel failure. We are uncertain when this will happen but suspect it to be short term and will more than likely present its ugly head during pressurized winter operation. This will create a potential for contamination of the subsoil and (at minimum) render the facility unsuitable for immediate repairs. Rotten steel pipe may thwart any welded repair placing the facility out of operation.

The replacement of the steel headers is in essence the need for a more efficient new floor. As part of this we would recommend increasing the insulation to 4" versus the 2" in place and minimizing energy loss into the subsoil. We would advise that the existing concrete berm be removed and a new haunch of proper dimension and radiuses be installed.

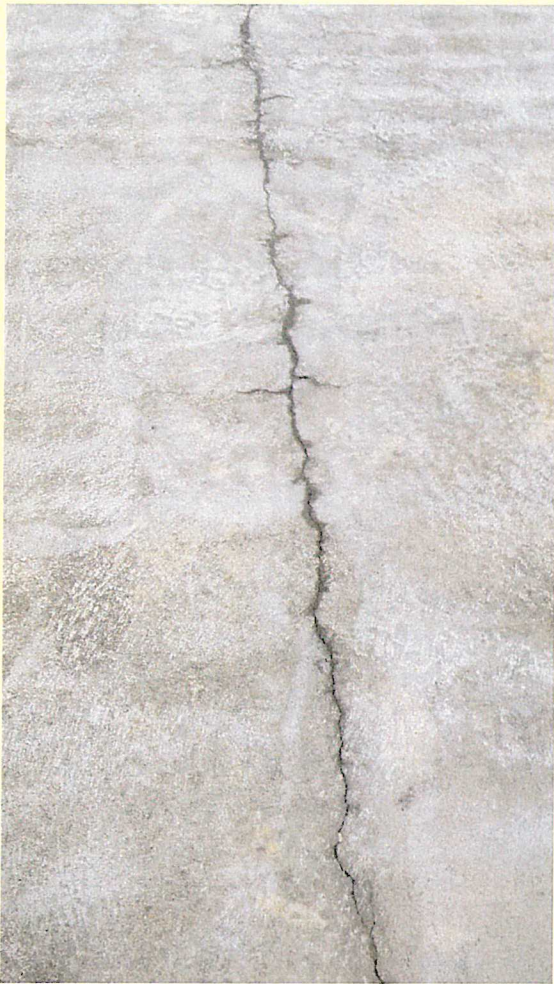
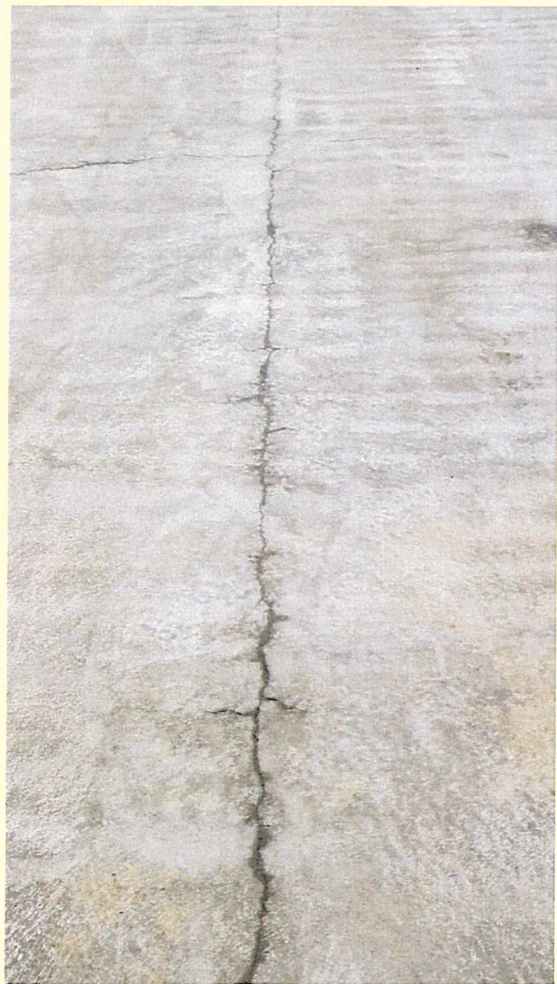
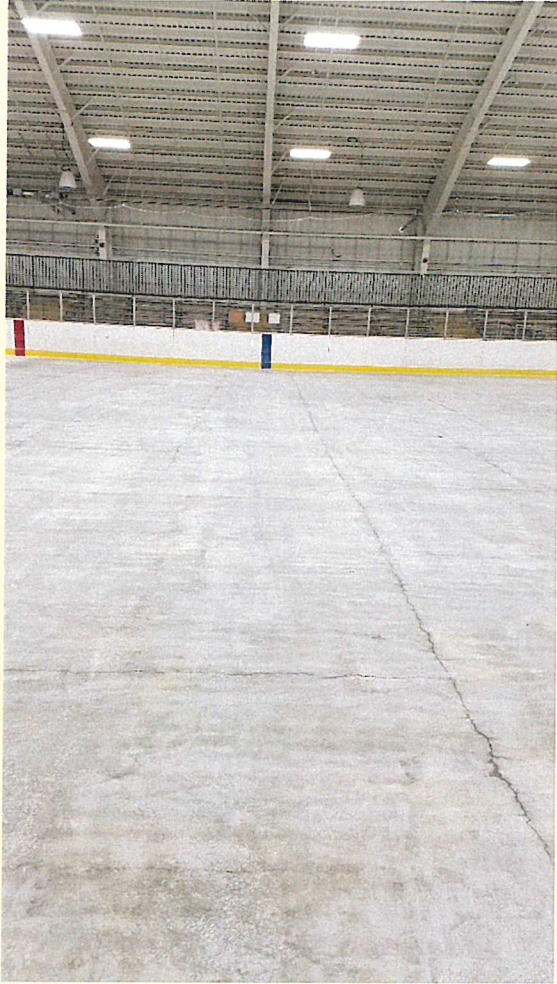
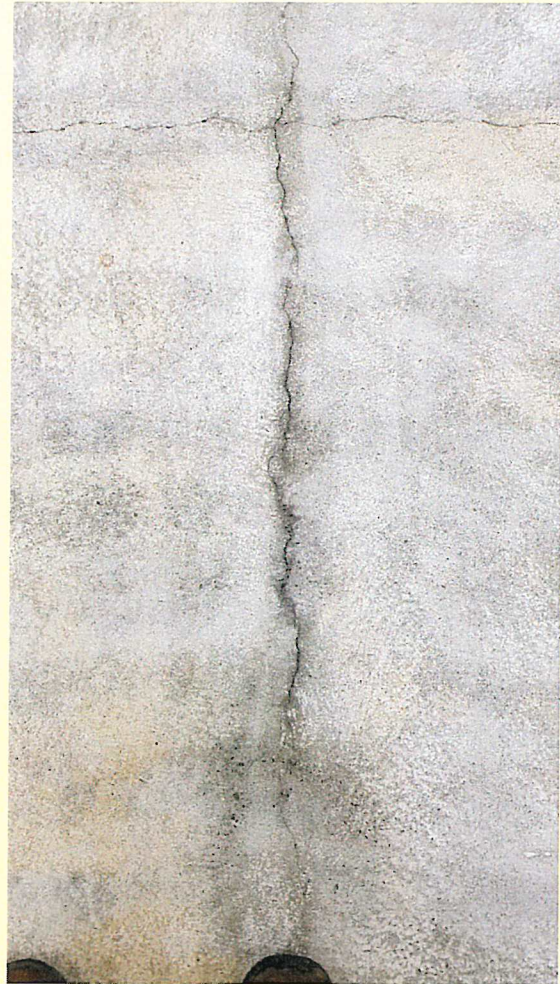
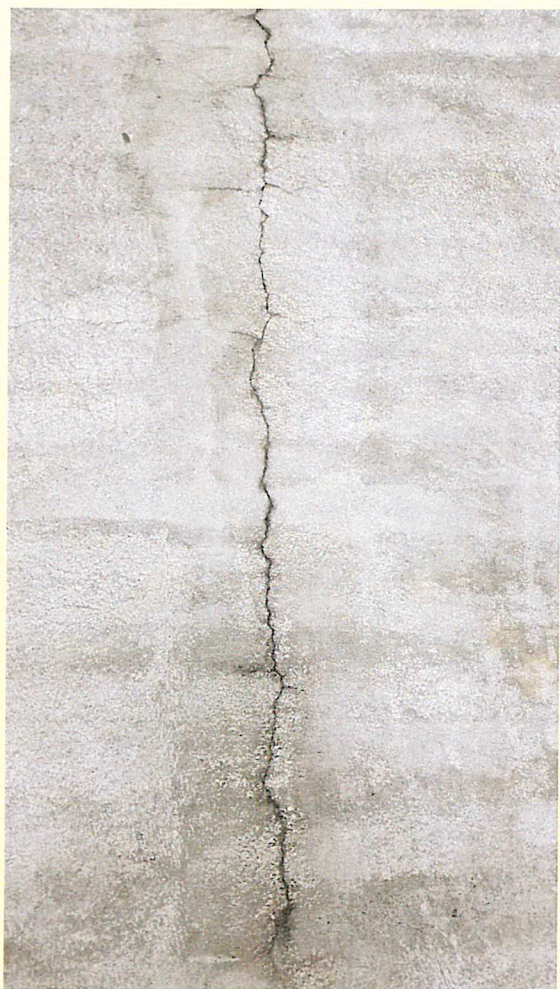
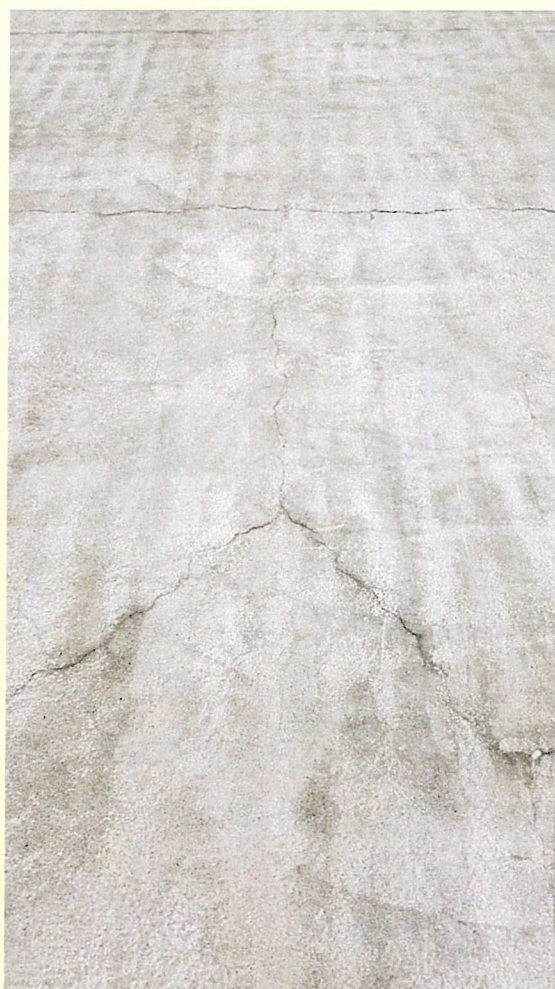
### **Floor Cracks**

Visual inspection of the concrete cold floor shows considerable cracking. The cracking is mostly laterally across the floor. The cracking is uniform in between the column lines but not on the column lines and in places has opened to exceed .25". There are several areas where the cracks have forked and traveled longitudinally across the floor. There are surface tension cracks at the edges of the floor that are thin and have more than likely been present since the initial pouring and contraction of the floor.

Floor cracks with up to ¼" openings.

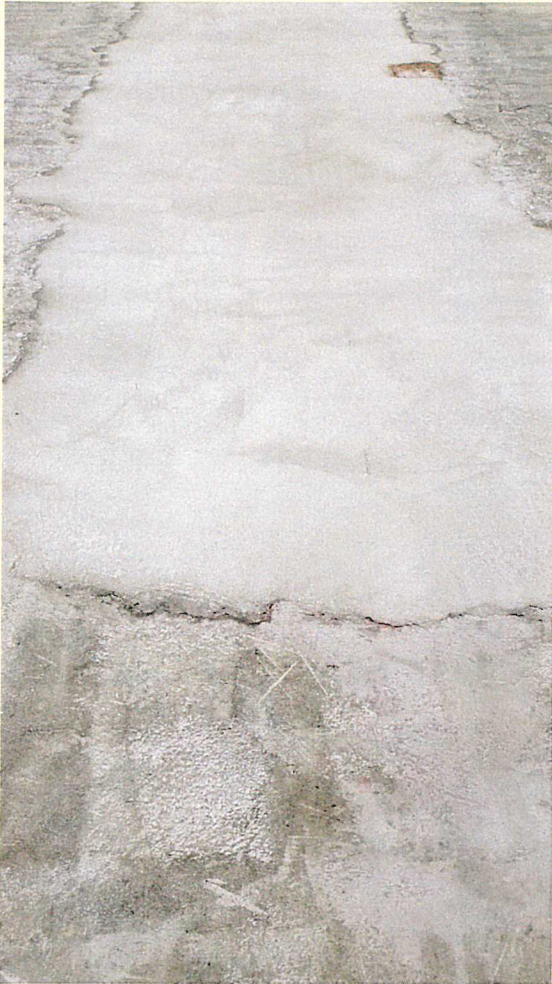
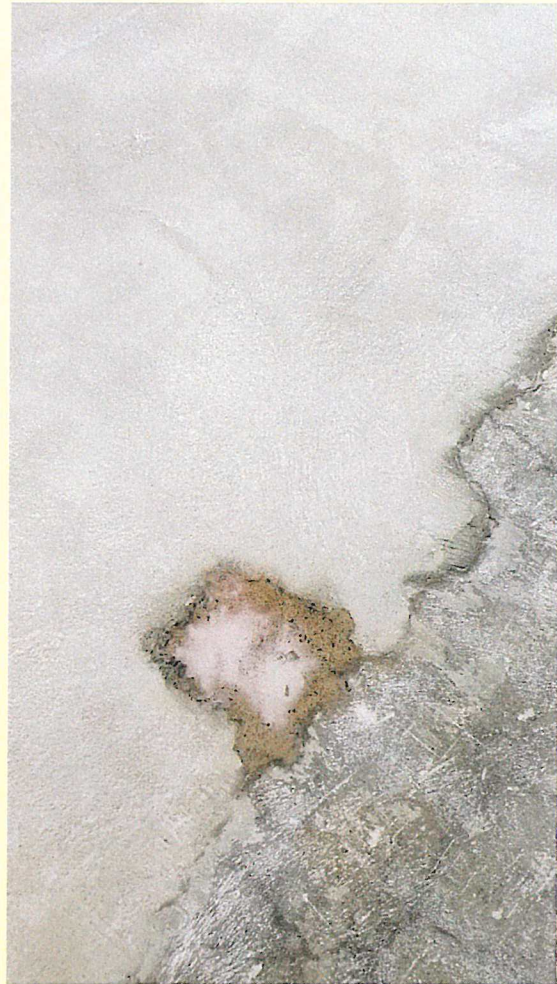
The most recent repairs to the blocked header were performed in house. There is a significant skim coat patch of concrete over this repair.

Concrete patch at header trench recently performed to repair blocked nozzles.

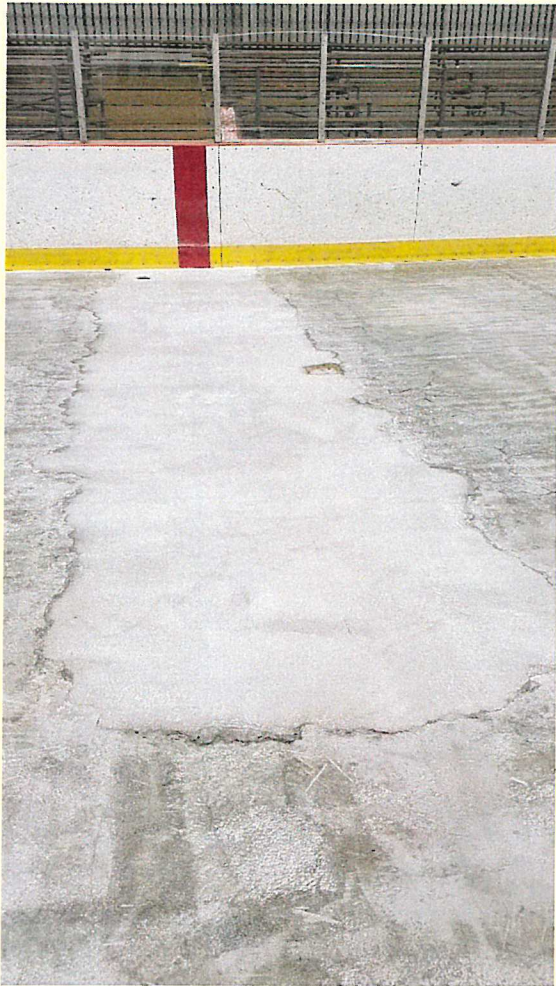
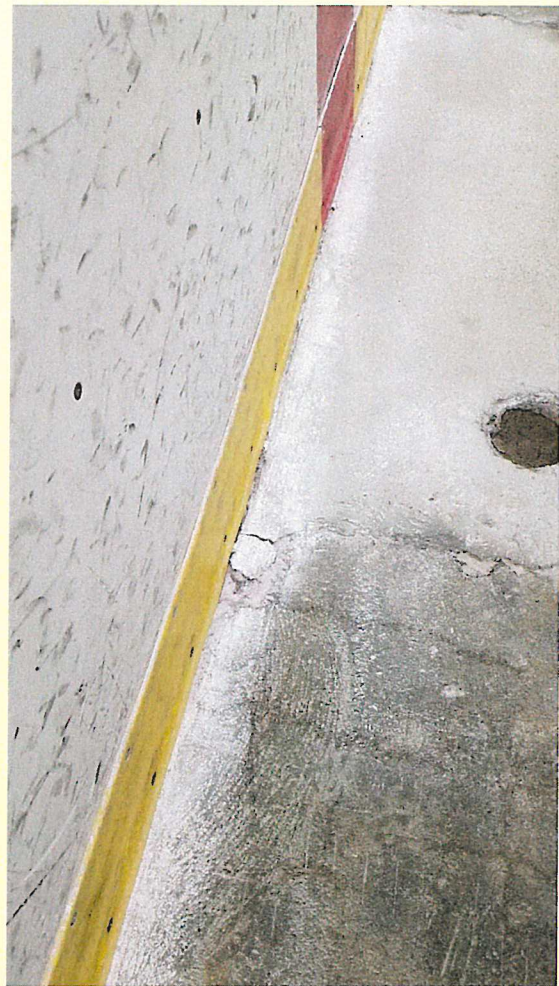
Open hole at concrete patch, shrinkage cracks at perimeter as well as tennis post holes.

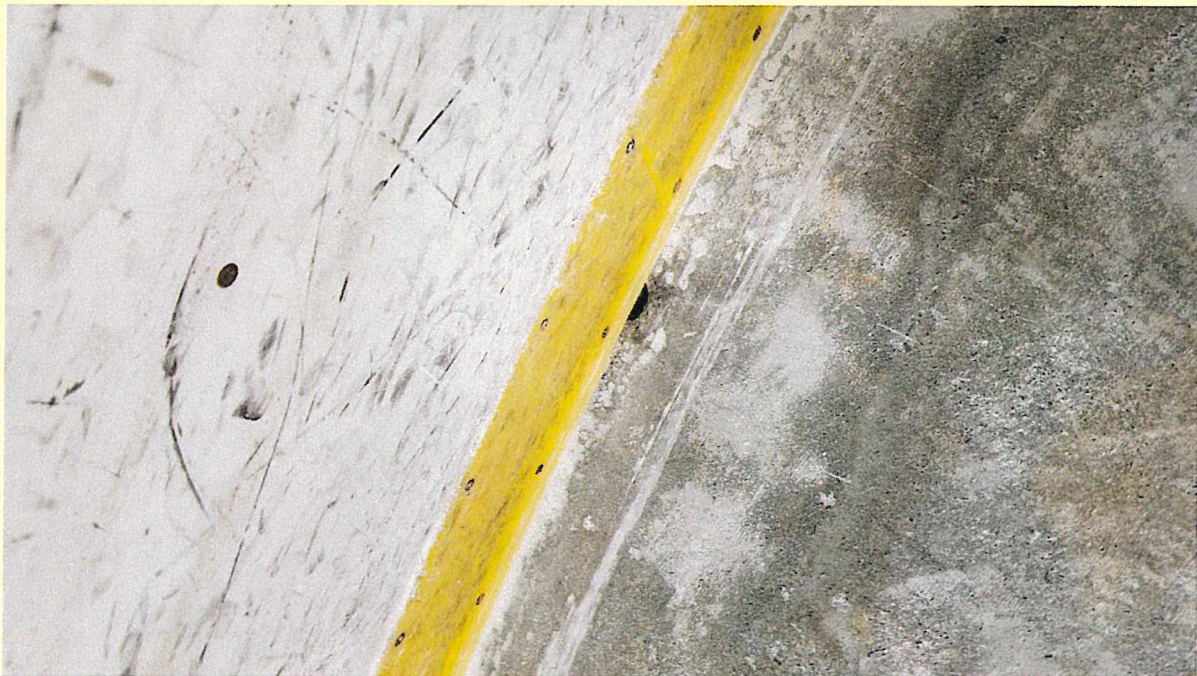
Old post hole at perimeter.

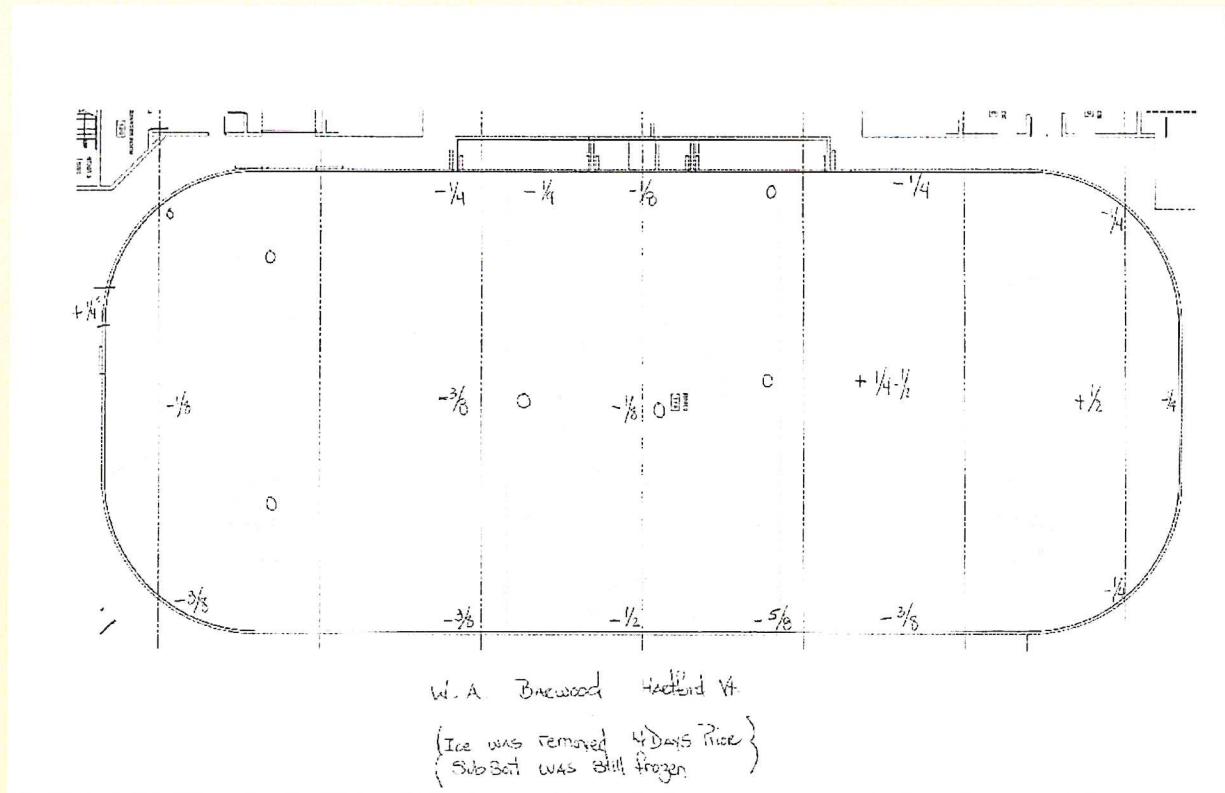
# EXHIBIT C: LASER TEST READINGS

Using a laser transit at center ice a grid of the floor was obtained. We initially used the entrance at the Zamboni door as our zero benchmark, travelling over the entire floor. However, post readings adjustment ¼" lower presented that most of the floor was within a ¼". We did find a low area by ½" in front of the home team players bench. In front of the seating area it was low from 3/8" through ½".

There is one high spot on the floor from the far goal travelling down the center of the floor stopping before the blue line. If we were to rate this floor based on flatness it would score an 8 out of 10. If we were to rate this floor based on cracking we would rate it a 2 out of 10.

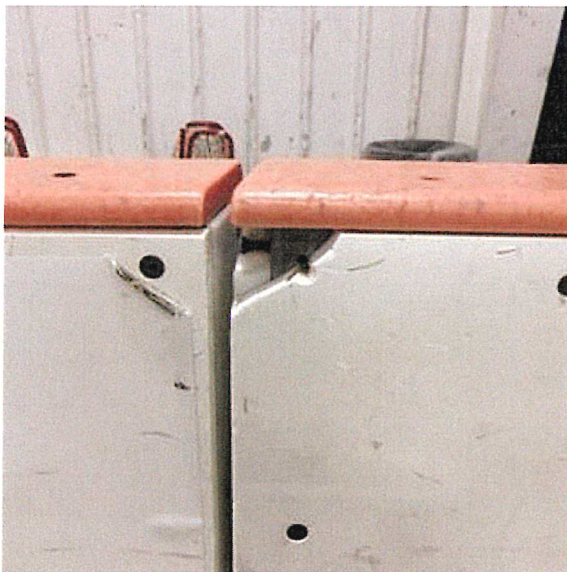
Typical condition. Broken HDPE facing and gaps in facing.

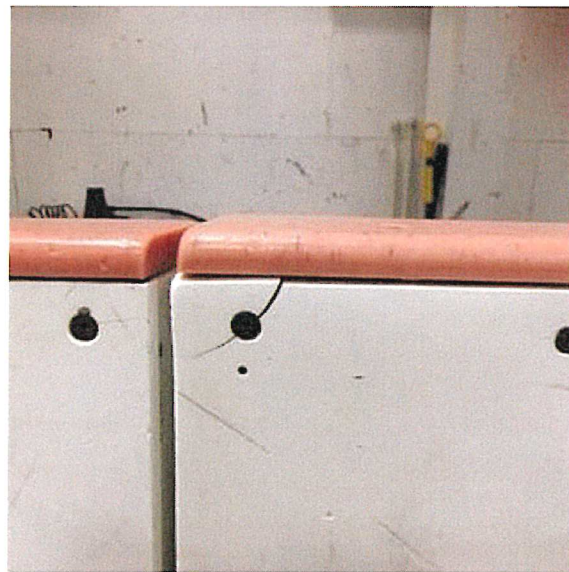
Another area quickly becoming a safety hazard.

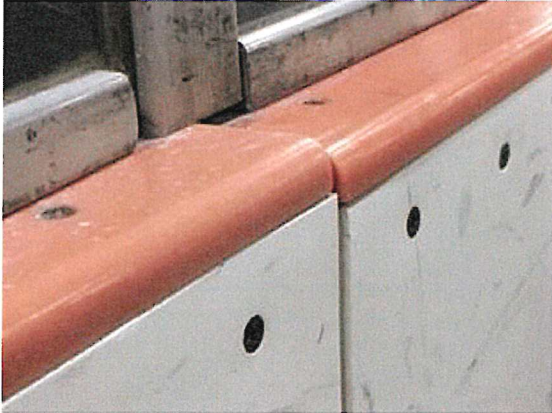
There are several areas throughout the arena where adjoining panels are not flush and even. This inconsistency is visible based upon the cap rail joints being uneven, up to a ½" off. For competitive hockey at any level, where there is constant, forceful, contact in these areas, this is a player safety hazard. The result appears to be caused by an uneven substrate below the dasher frames.

Uneven cap rail, resulting effect of an uneven substrate.

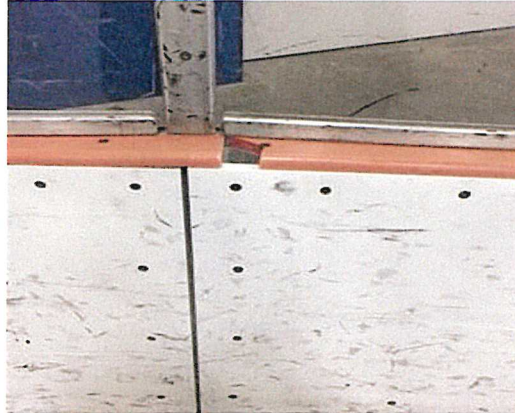
Another area with missing/broken HDPE creating a hazard.

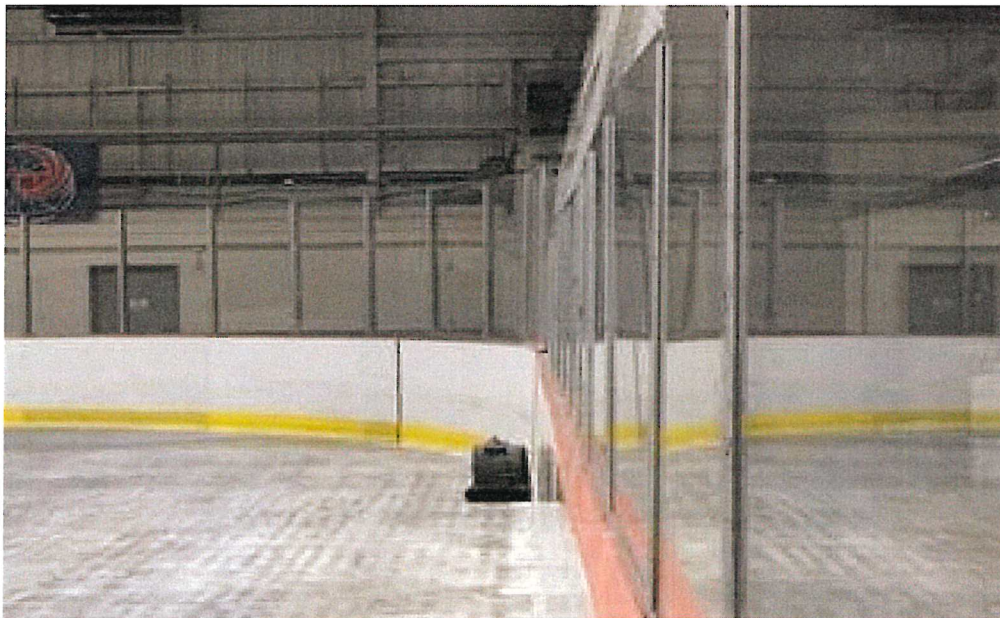
Another condition that is present is how the boards appear to be leaning away from the ice surface. Cross ice measurements taken at each goal line, blue line, and center ice line show the rink to be approximately 2" wider than originally constructed. This condition appears to be a result of years of the ice resurfer touching the boards while making a sheet of ice. Empty, most ice resurfer machines (Zamboni or Olympia) weigh approximately 9,000lbs. Filled with water, they can weigh over 10,000lbs. Given the narrow 3" frame, and lack of any external support posts, the frames over the years have been forced into this position.

Boards leaning back. Visible line on white facing from where the resurfer makes contact in the corner. This is a typical condition throughout the arena.

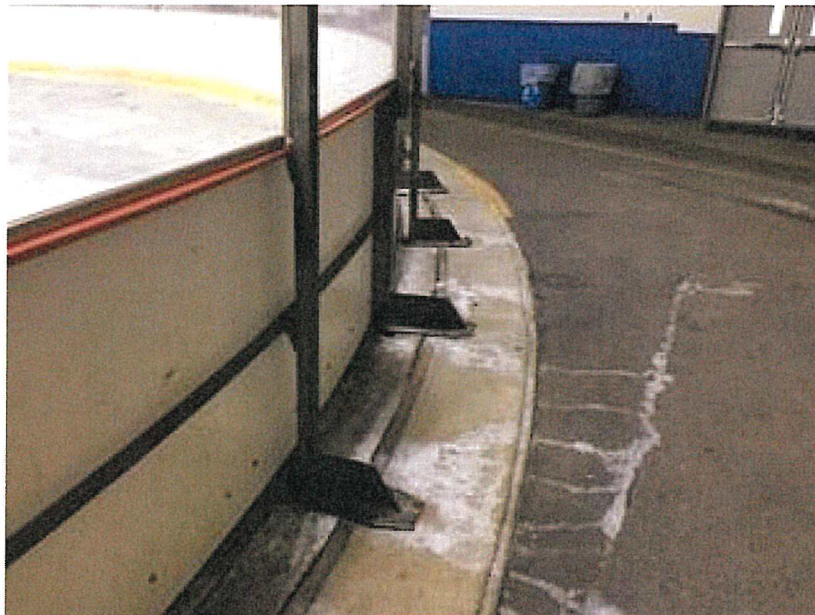
Because plastics expand and contract with temperature change, the 1/4" HDPE used as kickplate material is no longer flush against the facing material. Over time, this has begun to tear itself away from the facing. Typically, the kickplate material would be the same as the facing, 1/2" HDPE. There was no backer attached to these boards at the arena. Backer is typically 3/8", and covers the backside (outside) of the frames. Its purpose is to create a clean look. It's an area trash and dirt will collect.

Typical condition/No Backer.

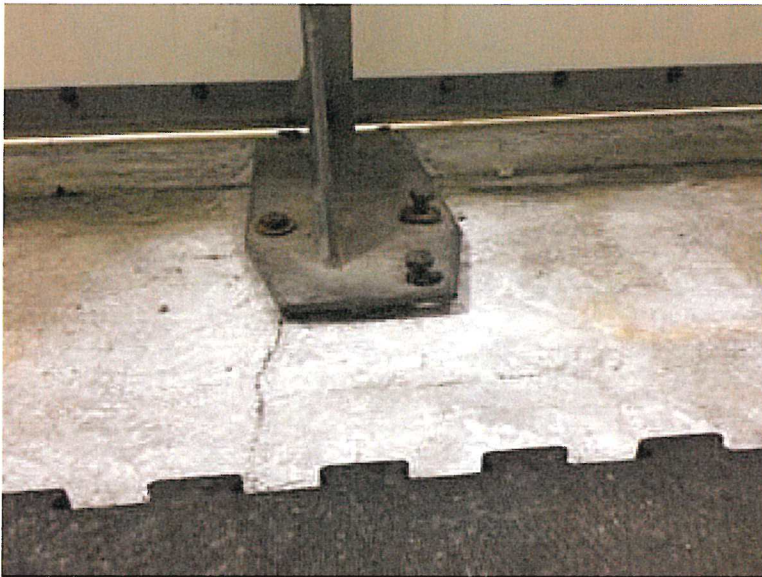
Over the years, based on the amount of play, resurfacing the ice, or possibly having the boards taken out and re-installed (unknown), there are several anchors missing, as well as several anchors that have backed out. This is a potential safety concern, as in several areas the boards are improperly anchored which allows for unnecessary movement.

Anchors backing out, and footplate bent. This condition is evident in several locations.

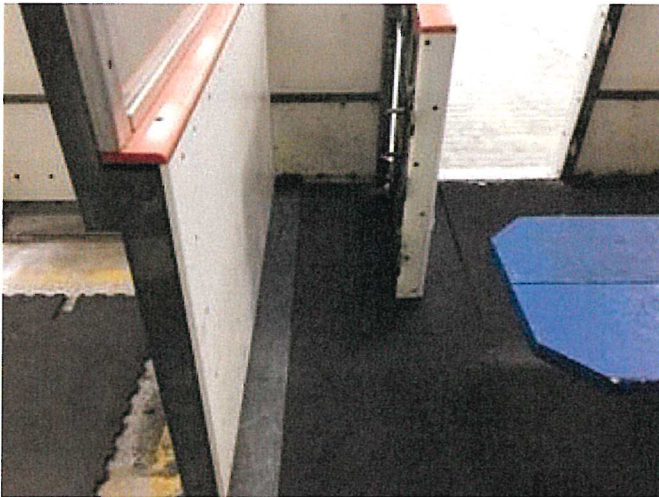
The player and penalty boxes have panels used as dividers. These boxes have elevated floors, typical in hockey rinks. The framing for the elevated boxes is made of wood. The divider panels were attached to the elevated wood floors, and each one of them was easily moved with little effort. This is a potential safety hazard. Typically, these dividers would be attached directly to the perimeter concrete. The manufacturing of these panels was designed to sit on the raised floor so the divider cap rail would be at the same elevation as the main rink cap rail.

Divider panels anchored to wood, creating a safety hazard to any user.

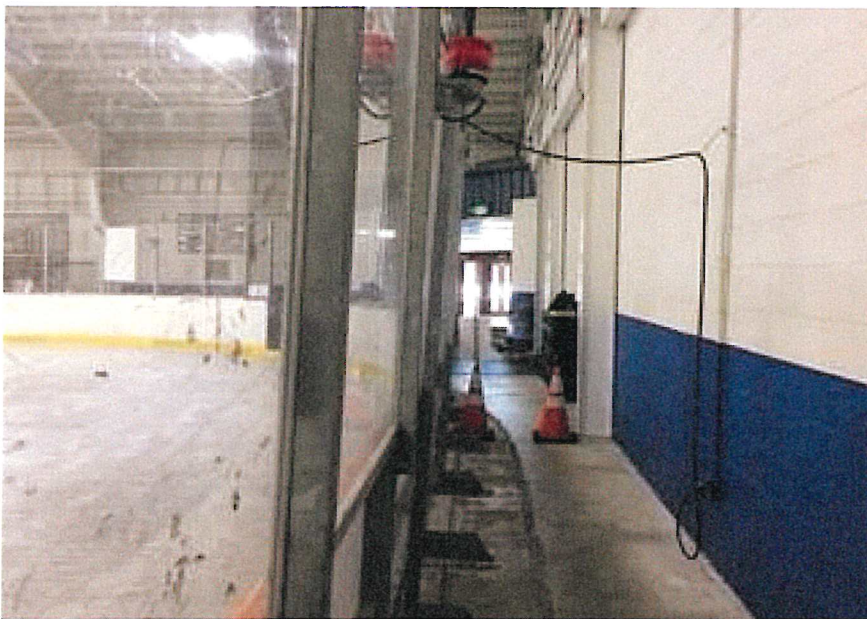
The shielding throughout the arena is acrylic. This material is a plastic, poly (methyl methacrylate), and often referred by the trade name Plexiglass. As a resin, this material is easily scratched. Currently, viewing at the arena is impaired as a result of this condition. The advantage to using this shielding material is it is lighter than tempered glass. It is not, however, stronger than tempered glass, and it is more expensive.

Acrylic shielding marked and scratched up. This cannot be corrected.
