ADDENDUM NO. 1

**MHA Central Office
Window, Lighting, and HVAC Renovation
Memphis, TN**

**RE: Hazardous Material Survey
Memphis Housing Authority
700 Adams Avenue
Memphis, Tennessee 38105**

Hazardous Materials Survey

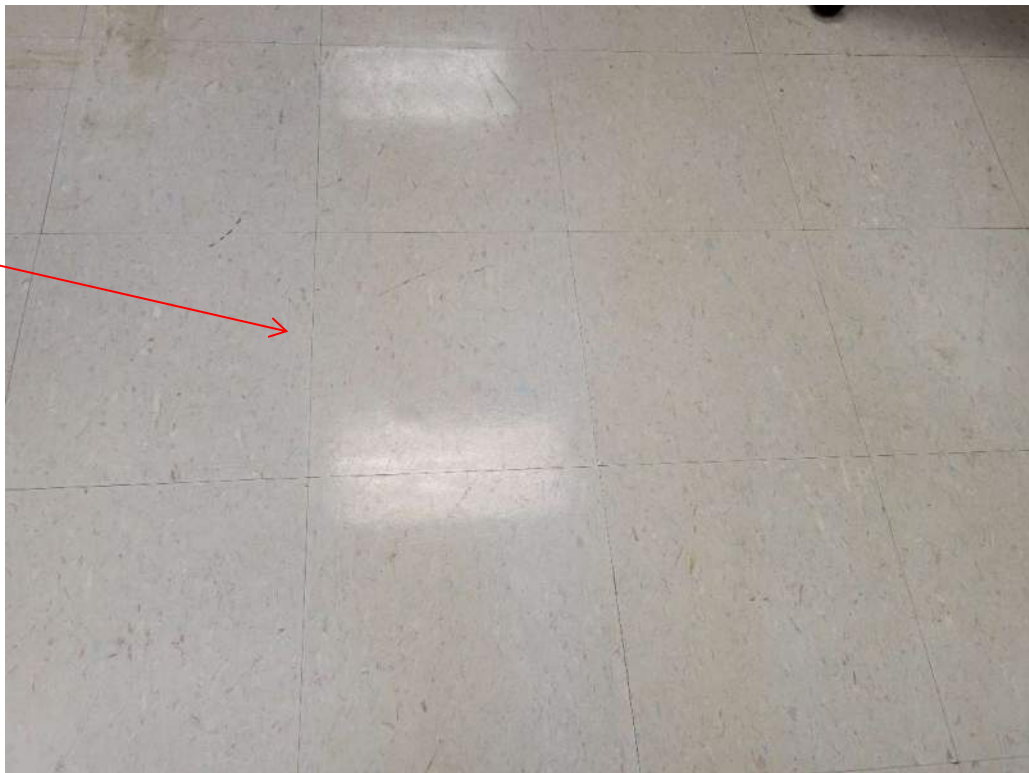
Client Name: Memphis Housing Authority		Site Location: MHA Main Offices 700 North Adams Avenue	Project No. 251214.00
Photo No. 13	Date: 12/1/2021

Description: Asbestos Sample MHA-05 12"x 12" White Floor Tile w/ Colored Specs with Black Mastic and Tan Mastic Tested Positive for Asbestos			
Photo No. 14	Date: 9/27/2021

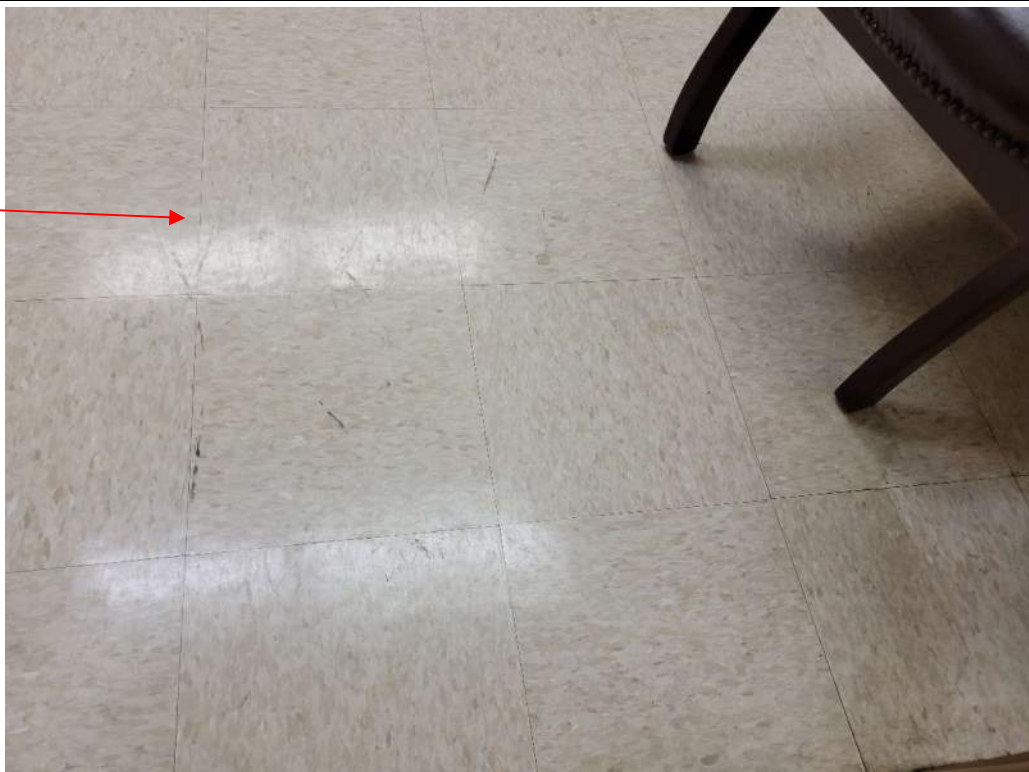
Description: Asbestos Sample MHA-06 12"x12" Beige Floor Tile w/ Streaks with Yellow Mastic and Black Mastic Tested Positive for Asbestos

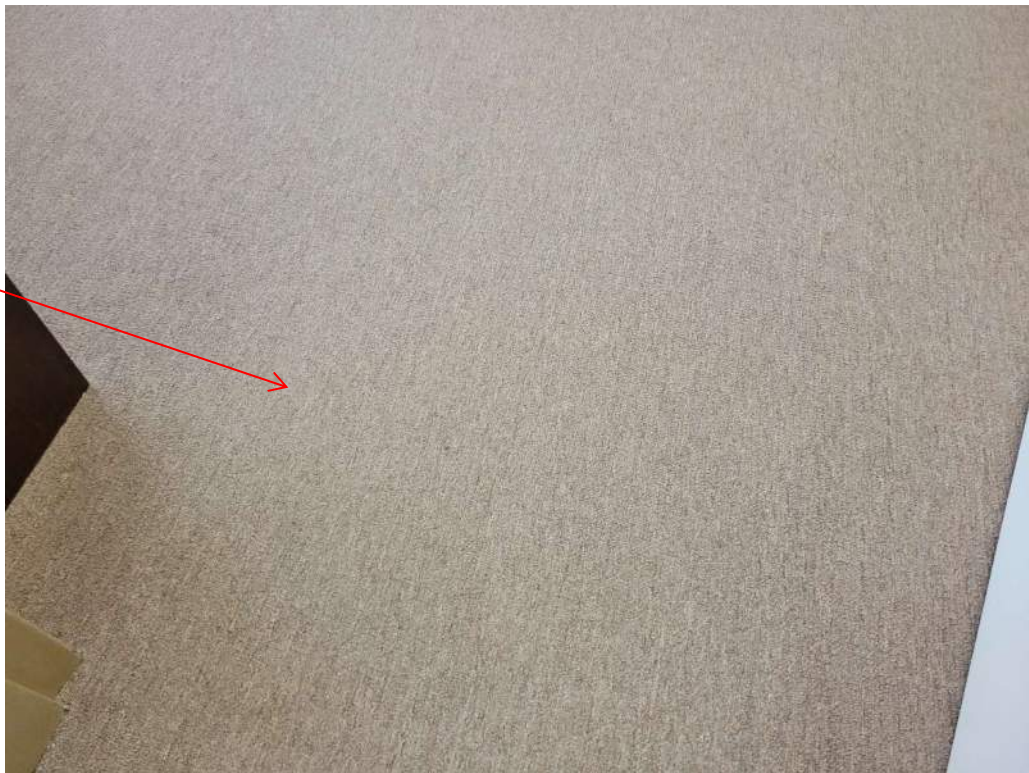
Client Name: Memphis Housing Authority		Site Location: MHA Main Offices 700 North Adams Avenue	Project No. 251214.00
Photo No. 17	Date: 12/1/2021

Description: Asbestos Sample MHA-09 Brown Carpet with Yellow Mastic and Black Mastic Tested Positive for Asbestos			
Photo No. 18	Date: 12/1/2021

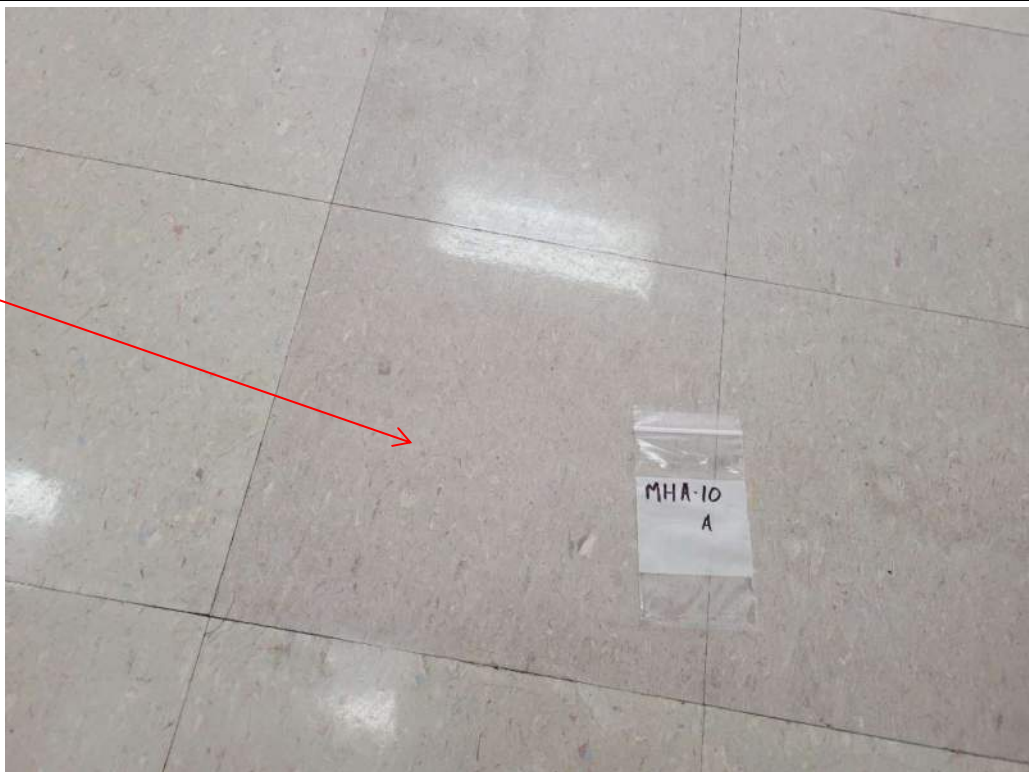
Description: Asbestos Sample MHA-10 12"x12" Gray Floor Tile with Tan Mastic and Black Mastic Tested Positive for Asbestos

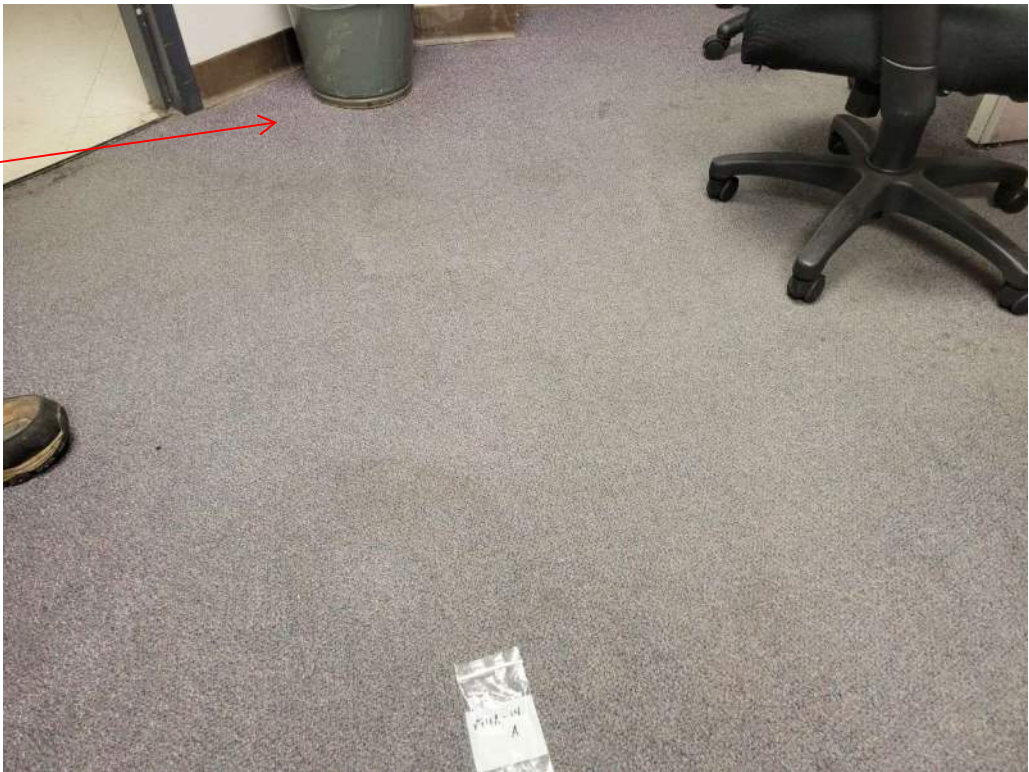
Description: Asbestos Sample MHA-14 Purple and Green Carpet with Tan Mastic and Black Mastic Tested Positive for Asbestos

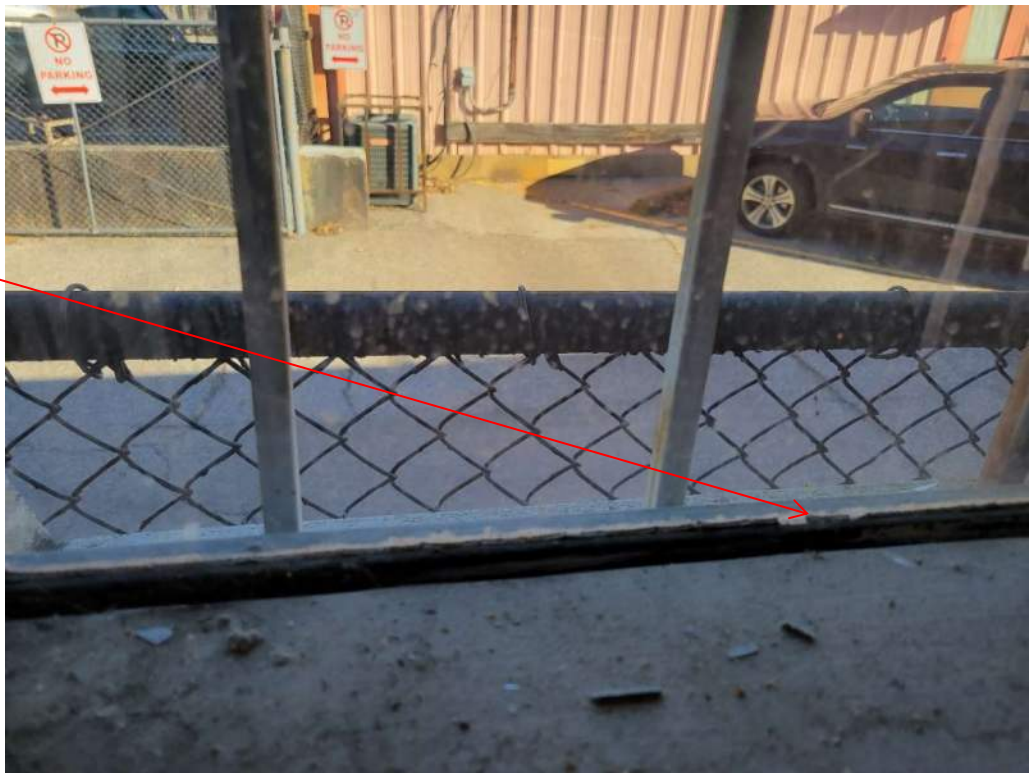
Client Name: Memphis Housing Authority		Site Location: MHA Main Offices 700 North Adams Avenue	Project No. 251214.00
Photo No. 53	Date: 12/1/2021

Description: Asbestos Sample MHA-45 Grey Interior Window Caulk Tested Positive for Asbestos			
Photo No. 54	Date: 12/1/2021

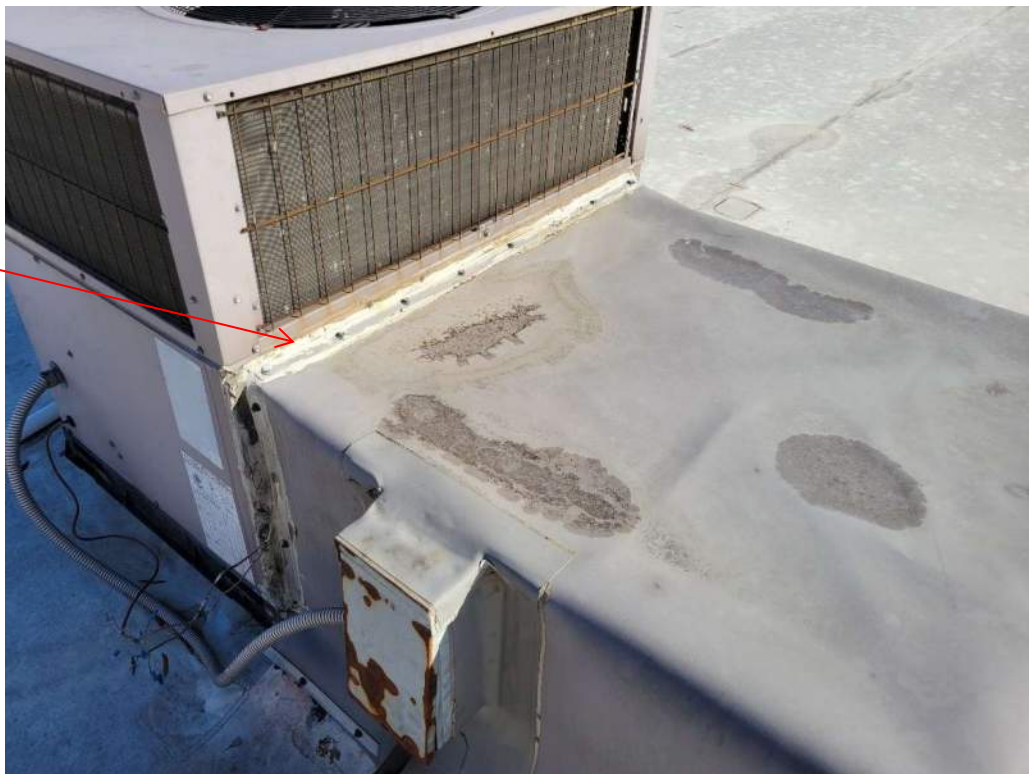
Description: Asbestos Sample MHA-88 White HVAC Caulk Tested Negative for Asbestos HVAC Unit with Possible Refrigerants to Be Recovered

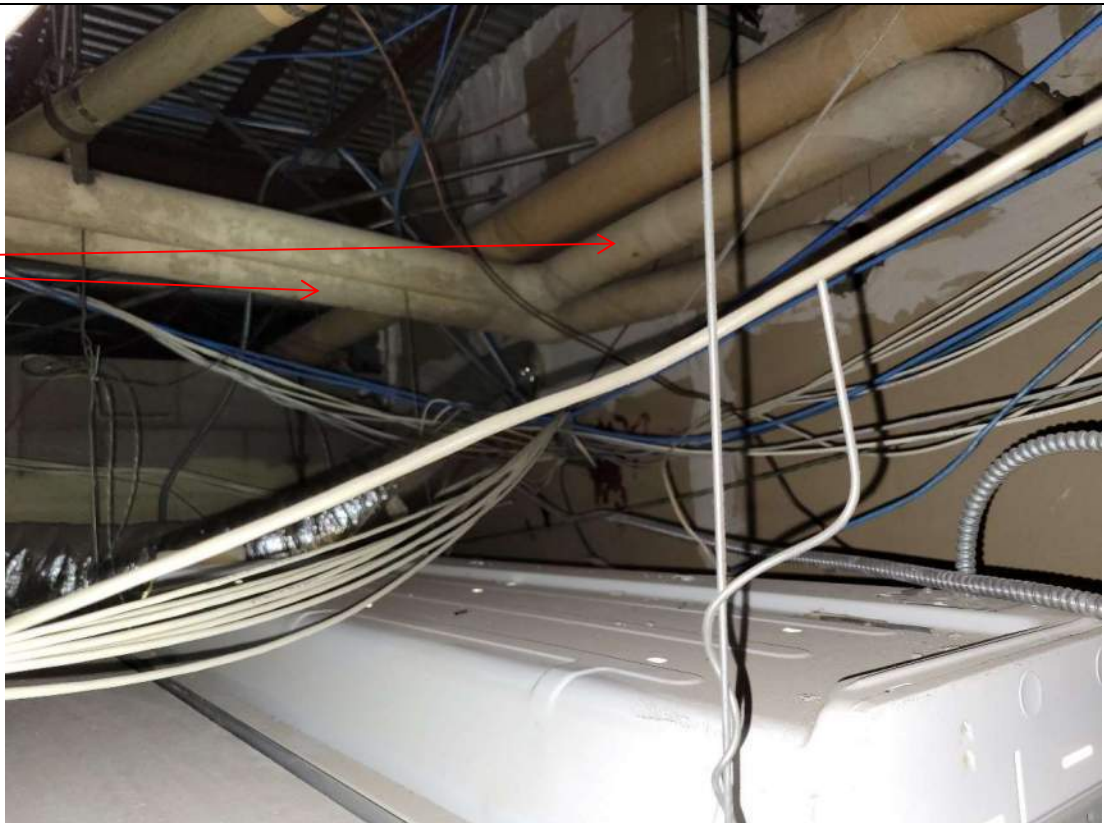
Description: 1 st Floor Pipe Wrap Insulation leading from elevator closet across hallway to Mechanical Room (picture taken above drop ceiling in main hallway) Identified as ACM during 2008 Survey

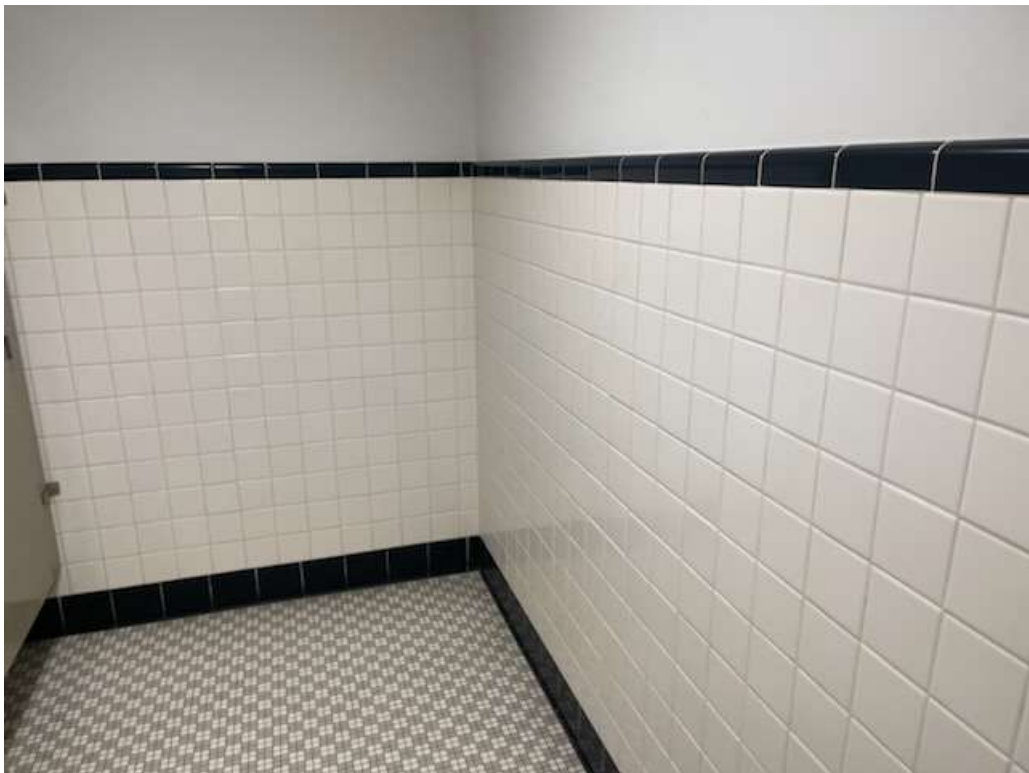
Description: Example Black and White Ceramic Bathroom Tile Found in Men's Restrooms 108, 119, & 204 and Women's Restrooms 109 & 120 Tested Positive for Lead Based Paint			
Photo No. 106	Date: 12/1/2021

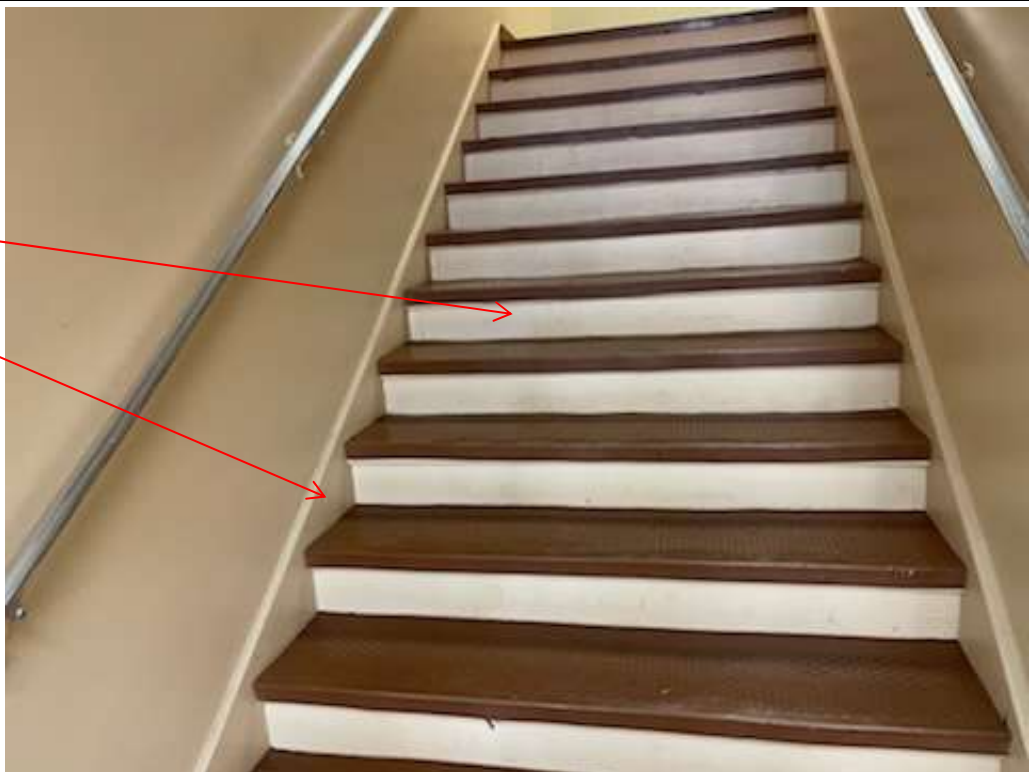
Description: Lobby 101 Stair Riser Stair Stringer Tested Positive for Lead Based Paint

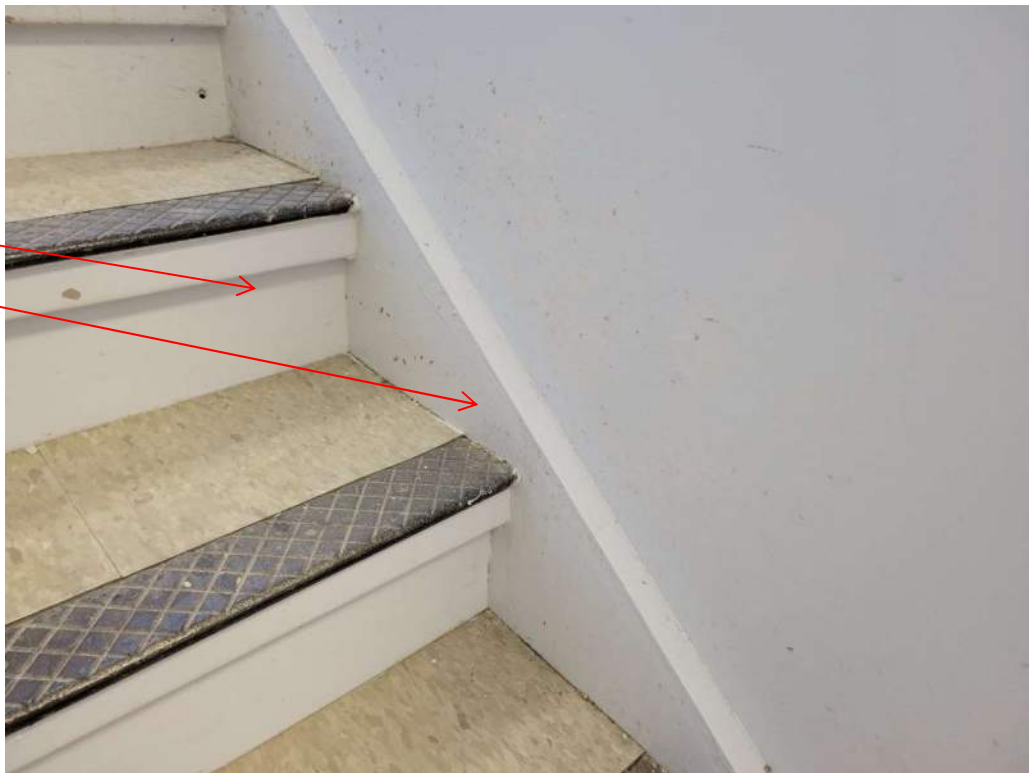
Description: Stairwell 159 Stair Riser Stair Stringer Tested Positive for Lead Based Paint			
Photo No. 108	Date: 12/1/2021
