# Zero by Degrees LLC

## Building Energy Plan

**RE: March 15<sup>th</sup> & 27<sup>th</sup>, 2018 Energy Audit at the Middlebury Police Department – Middlebury, VT**

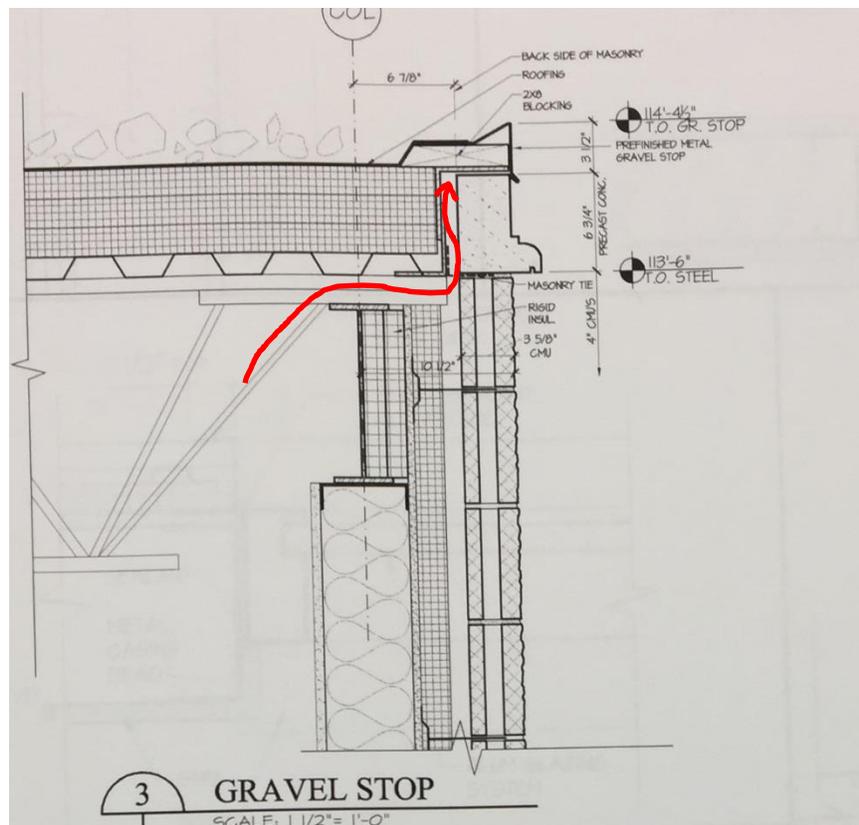
When investigating above the drop ceiling plane in the Multi-Use/Training Room 105 and Patrol 128, we noticed a significant temperature difference and could feel air movement in those spaces. What we found was cold, outdoor air infiltrating the conditioned space where the exterior walls meet the roof. This means that under normal conditions, warm air is able to escape the building at these locations, via the space between the metal deck and the steel I-beam which appears to be directly connected to the outdoor masonry air space or according to the drawings.

*Warm air is easily able to migrate between the metal roof deck and the top of the steel beam via the pathway show, beyond any air barrier materials. Depending on the wall configuration, interior drywall or interior CMU are typically the materials acting the most like an air barrier.*

The air leakage is occurring in both direction of the roof deck flutes where it meets the exterior walls, not only in these rooms, but around the entire perimeter of the building. We recommend air sealing the wall to roof connections from the inside to help eliminate the air leakage in these areas. The air seal should be made with closed cell spray foam between the metal roof deck and the steel I-beam the deck rests on. Where bar joists interrupt this detail intermittently, the foam will need to be sprayed continuously onto either side of the bar joist and foam should be introduced between the two pieces of angle iron at the center of the bar joists' terminal end over the I-beam. The foam will need to be covered with a 15-minute thermal barrier. See Appendix 'A' at the end of this report. This air seal detailing should be made around the entire perimeter of the building at the wall to roof connection.

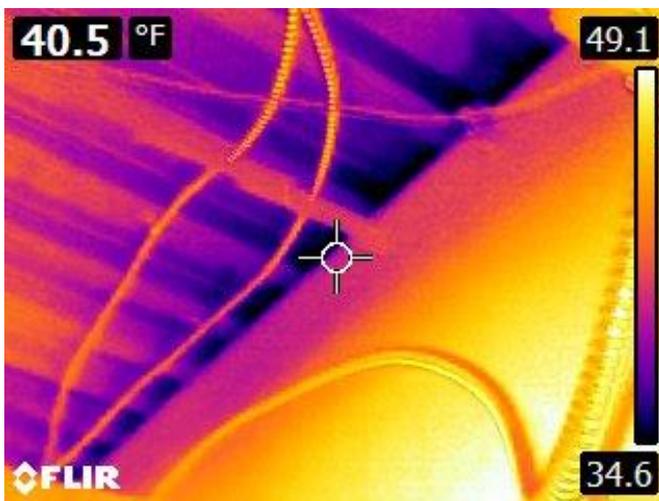
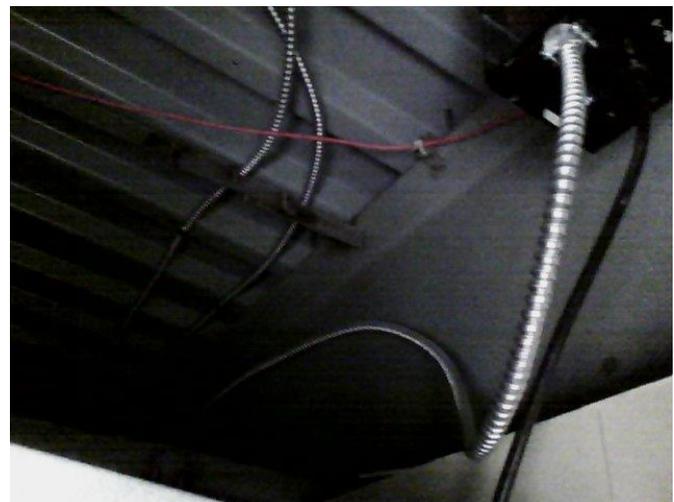
Air leakage at the wall to roof connection in the multi-use 105 room at the east exterior wall.

Measure	Propane Saved (Gal)	Propane Saved (\$)	Elec. Saved (kWh)	Elec. Saved (\$)	Total Savings (\$)	Approx. Cost of Measure	Lifecycle (Years)	Simple Payback (Years)	SIR
ECM #1 – Wall to Roof Air Sealing	227	\$415	234	\$31	\$446	\$6,000	25	13.5	1.85

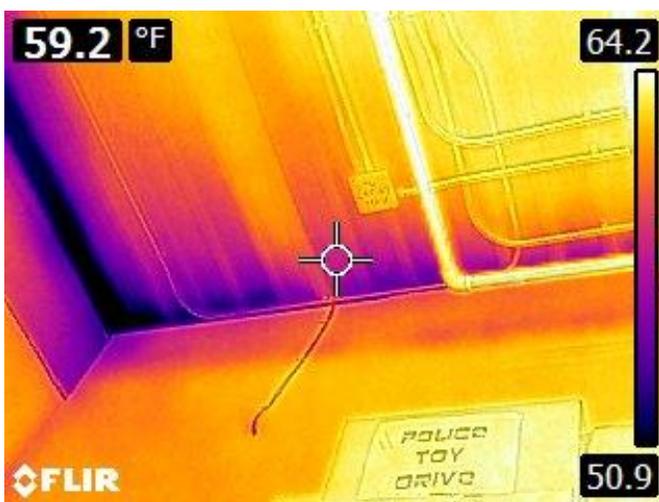
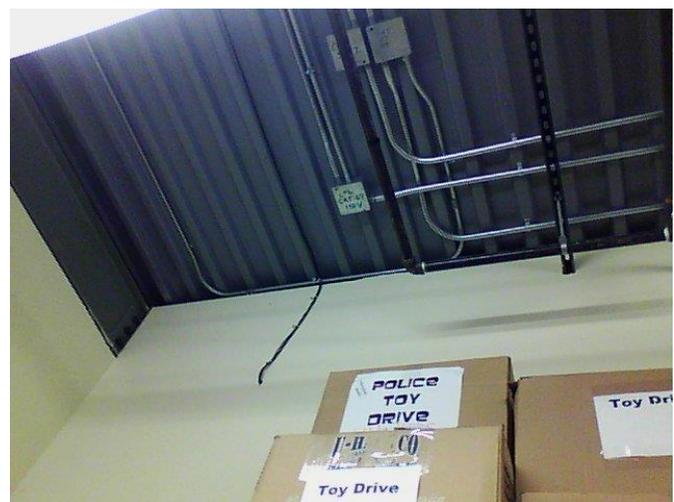
Air leakage at the wall to roof in the storage room Visible light image.  
116.

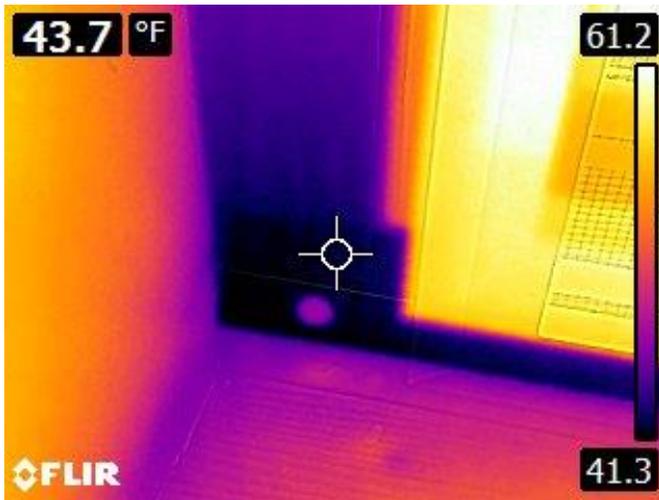
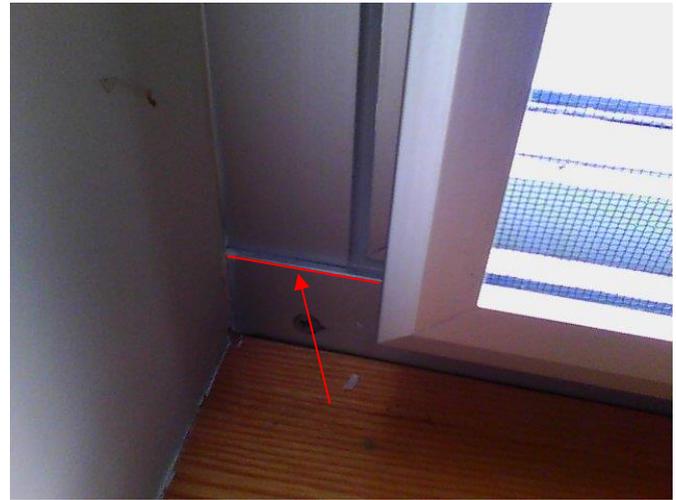
From an air leakage standpoint, both the operable sections and the rough openings of the units appeared to perform fine. Any air leakage seen/felt was where the window frame connects to the window sill receiver plate.

The air leakage between the window frame and sill receiver plate is not seen clearly, but these images are more intended to show the locations where the air leakage was found in most of the windows throughout the building.

Visible light image. The red arrow indicates the joint where air was felt coming in and where we recommend installing the bead of caulk.

To directly eliminate the air leakage between the frame and sill receiver plate we recommend installing a bead of caulk at the joints shown above at each window. Regarding general R-value and air leakage improvement, we also suggest adding compression fit interior storms to all window units. Compression fit storms are custom fit to each window and come with a perimeter gasket to install tightly so that air movement to the interior of the building through the window units is minimized. The additional pane also increases R-value. In rooms with many and/or large windows they do double duty to reduce energy costs. 1- In many cases they double the R-value of the window and, 2- they decrease radiant losses from the human body to the windows. People feel warmer when in the room so they leave the thermostat at a lower setting.

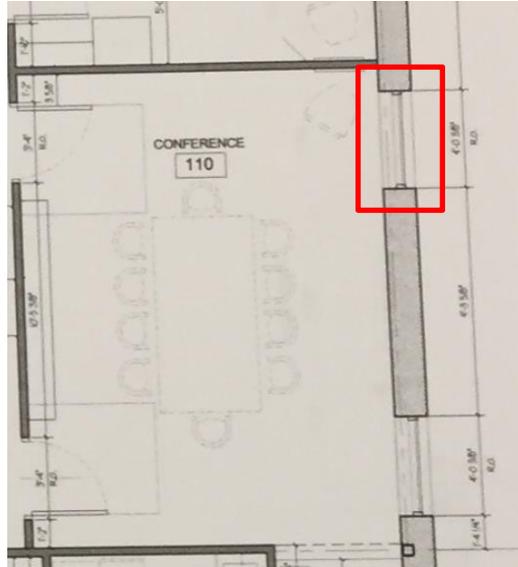
Location of the window described above.

At one window in the conference room (110), we found air leakage under the wood sill of the window return. There is a gap located where the drywall meets the wood sill where the air is

seen and felt coming in at. We recommend caulking this gap the entire length of the sill to eliminate the air leakage here. The window and leak location are indicated below.

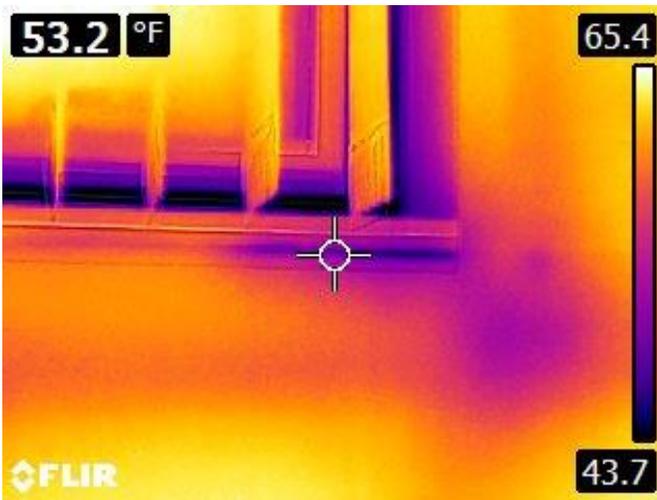
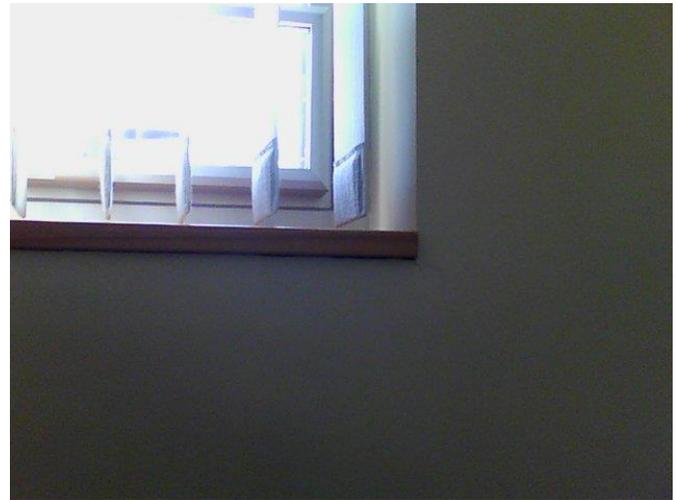
Air leakage through a gap between the drywall and wood sill on the window return.

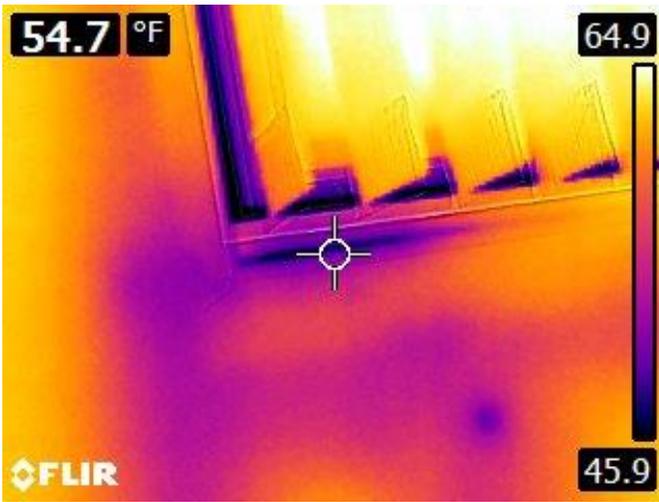
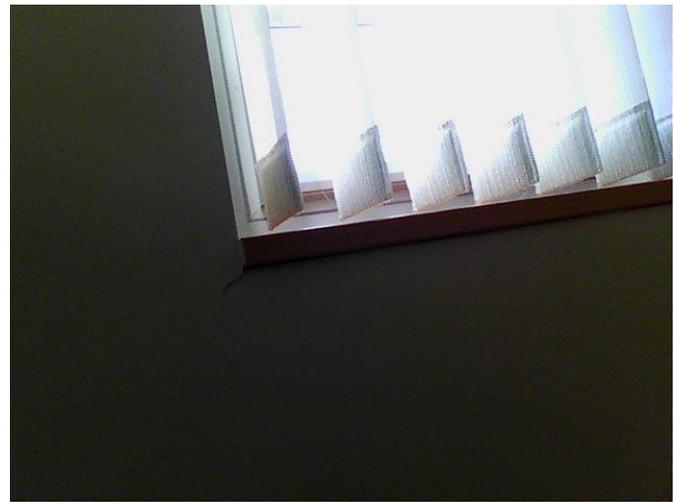
Air leakage through a gap between the drywall and wood sill on the window return. Same window as above but opposite corner.

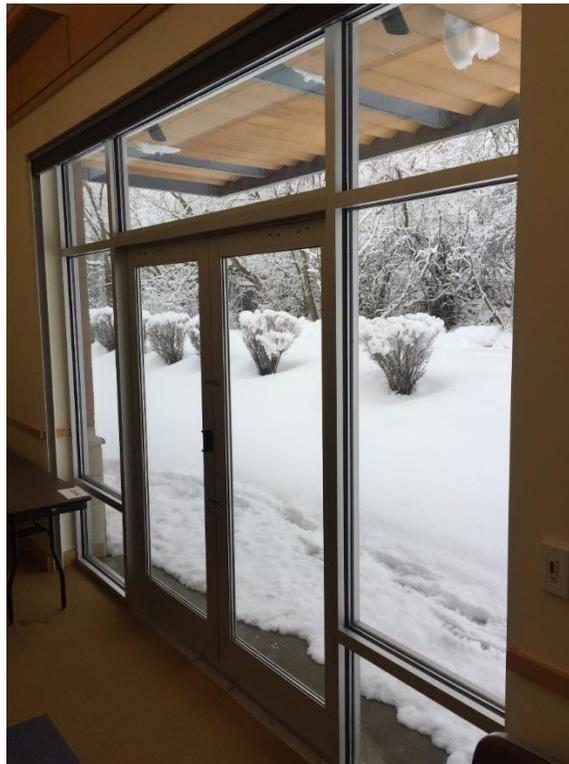
During our initial site visit, Chief Hanley expressed significant comfort concerns in the Multi-Use/Training 105 room which he suspected are attributed to the storefront units. For the reasons aforementioned about windows in the subsection above, as well as a high ratio of glass to insulated wall, we agree that the storefront systems in this room are a major factor of the building envelope playing into overall comfort of this space, especially since this space is a corner room with two exterior walls. The oversized nature of the HVAC systems in this space also appear to play a significant role as well. This is discussed in the “Mechanical Systems” portion of the report, provided by JFPCS. Some measures have been taken to reduce comfort/energy concerns in the form of air sealing the operable portions of the storefront entrance on the east elevation. The doors in this storefront system do not get utilized and have been caulk-sealed shut to reduce air leakage. During our second visit on 3/27/18, we noted that the insulated blinds installed over the storefronts in the room were not being utilized. Not only do we recommend they be utilized while the room is occupied, primarily for reasons of comfort, but also when the room is unoccupied as this will help maintain the room at a higher temperature around the clock and make it more comfortable to begin with when the room is ready to be used. Not to mention, reduced energy load. While this is a good short-term strategy, we think a more intensive long-term strategy for handling these comfort issues should be considered. Chief Hanley had mentioned some of his thoughts about replacing a portion of the storefront units with

infilled/insulated wall assembly, in the long-term. We agree completely with this line of thinking. We think that a small portion of the surface area that the storefronts occupy could be “saved” to allow for some natural day lighting, but that otherwise, the openings get replaced with an insulated wall system. First, remove the existing storefronts in room 105 in their entirety. Then, in the existing openings frame out 2x6 wall, 16” on center. with fiberglass mat-faced gypsum sheathing, a building wrap over the sheathing to act as a drainage plane, and 1x3 strapping to stand-off a cladding system. The estimated cost assumes fiber-cement clapboards, but finishes can be much more or less expensive. Before framing, note that a portion of the openings at the top should be framed out for new transom window units, to salvage some natural daylight. Then on the inside, insulated between the studs with 5.5” of closed cell spray foam, filling each bay. See appendix A at the end of the report regarding the application of spray foam. Then finish with 5/8” drywall, mudded and taped. This kind of long-term solution will significantly raise the average R-value of the exterior surface area in the room, reducing its overall heat load and increasing overall occupant comfort.

*We believe that the storefronts can be removed and infilled with a wall assembly similar to that of the existing insulated walls. A small portion of the opening may be salvaged for a natural daylighting, but the overall average R-value of the exterior surface area will be greatly improved.*

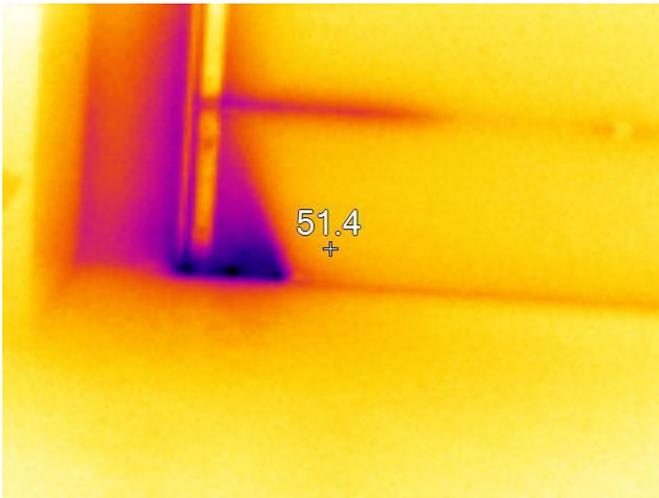
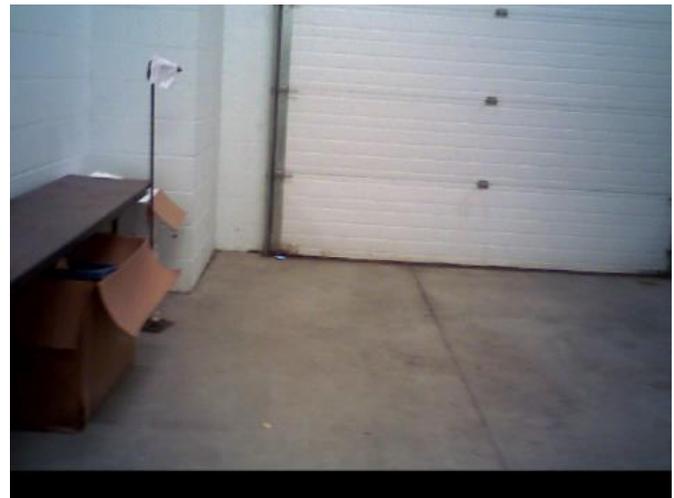
Air leakage was found at a few different locations of the sally port overhead door. Because the door was hit by a car, it is now slightly displaced. The bottom section of the door is caved in and bottom corners do not make contact with the ground when in the closed position. Because the corners of the door and the weather stripping don't make contact with the ground, air is able to slip under the door in and out of the conditioned space. Because this lower section is damaged, we recommend replacing just that lower damaged section so that it aligns evenly with the slab below and can create a tight seal when the door is in a closed position. Air leakage was also seen at the head of the overhead door. We recommend adding and adjusting weather stripping here so the door head fits tightly, so no air is able to move past it. When all improvements are made, verify that when the door is closed it closes to its full vertical position, and still makes continuous contact with the gasket at the head and jambs, and that the bottom gasket contacts the floor continuously.

Air leakage at the bottom left corner of the overhead door.

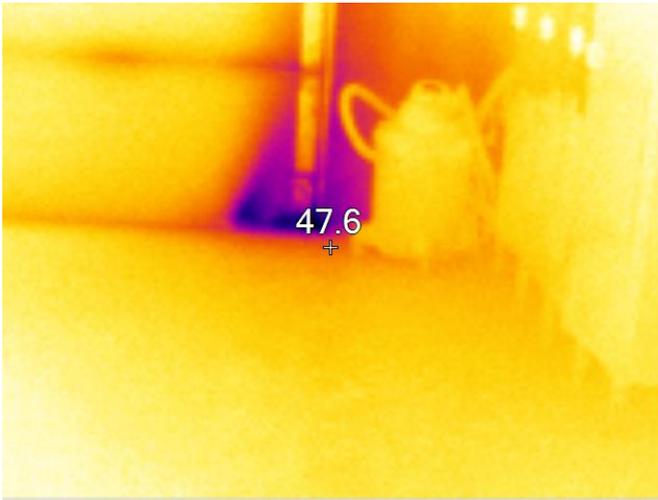
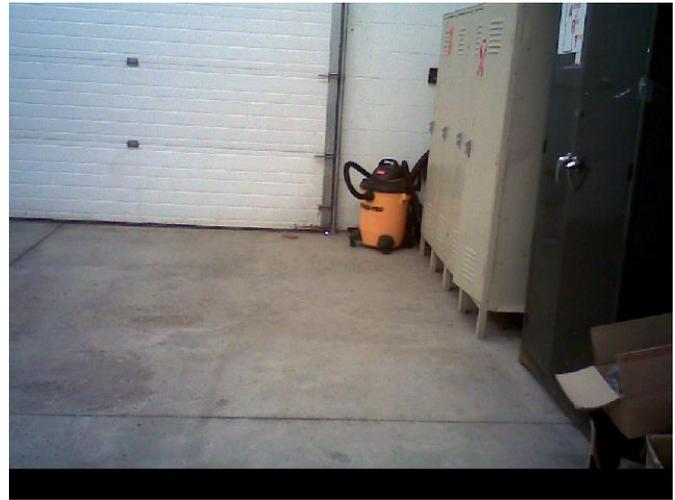
Air leakage at the bottom right corner of the overhead door.

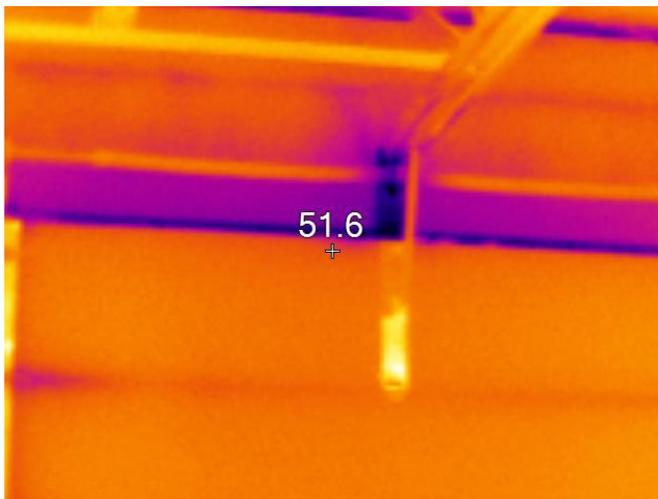
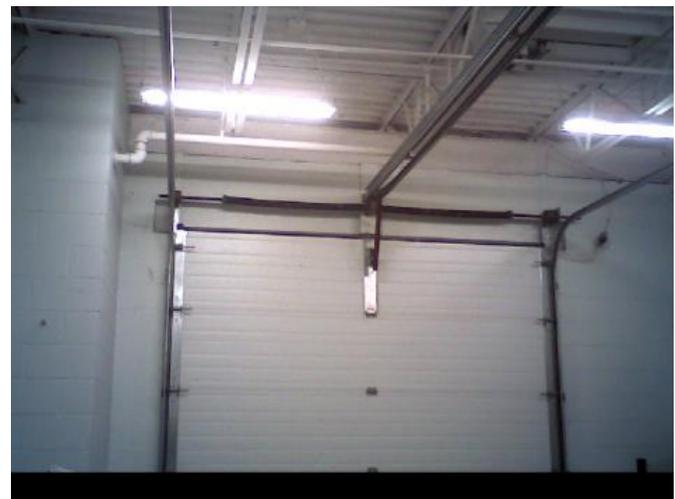
Air leakage at the overhead door head.

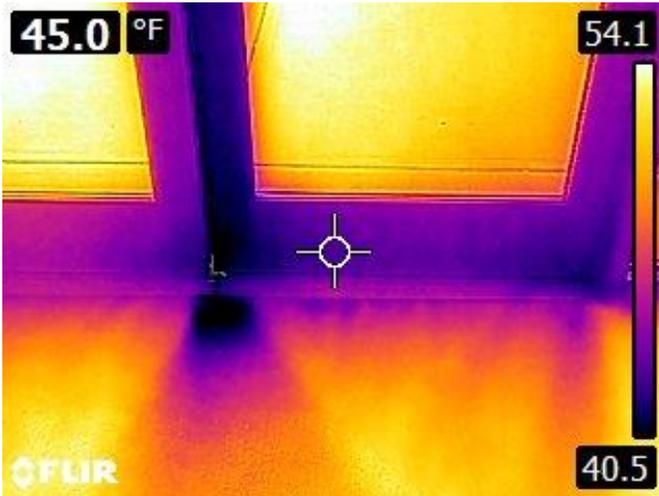
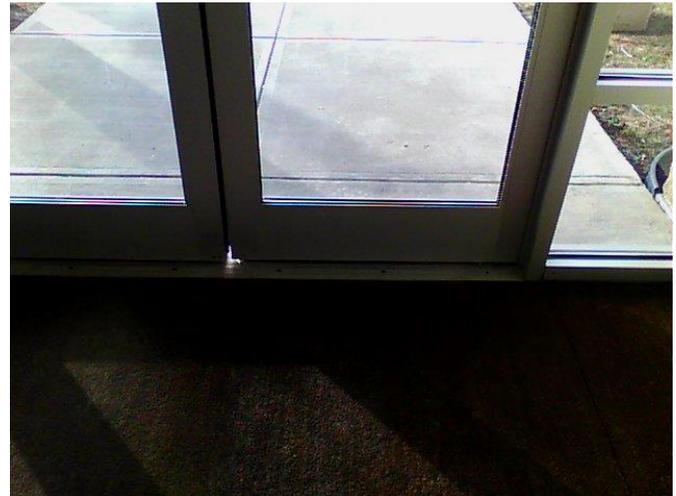
Air leakage was found through most doors due to insufficient weather stripping. Some doors are worse than others, but we recommend inspecting each exterior door and the roof access hatch and its weather stripping and adjust or replace as necessary. Weather-stripping should be on all of the exterior doors at the head, jambs, and especially at the threshold. When the door is closed the weather stripping should made continuous contact with the door and you should not be able to see daylight at the perimeter. Door thresholds also need to be added/replaced if they can be, if not, door sweeps should be added. Focus weather stripping efforts first on doors that are used rarely and emergency exits since they have to perform more like walls most of the time.

Air leakage at the astragal and threshold of the exterior double at the main entrance.

Commercial grade weather-stripping can be found at [www.draftseal.com](http://www.draftseal.com) or Q-lon available through The Energy Federation [www.efi.org](http://www.efi.org) or replacement parts from the original manufacturer if available. On doors that are still in good shape the most cost effective measure is to check the thresholds, sweeps, and weather-stripping of all the exterior doors and hatches once a year and replace as needed.

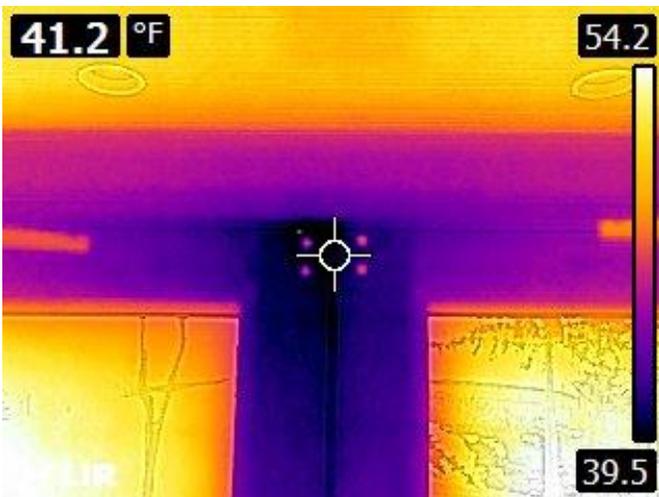
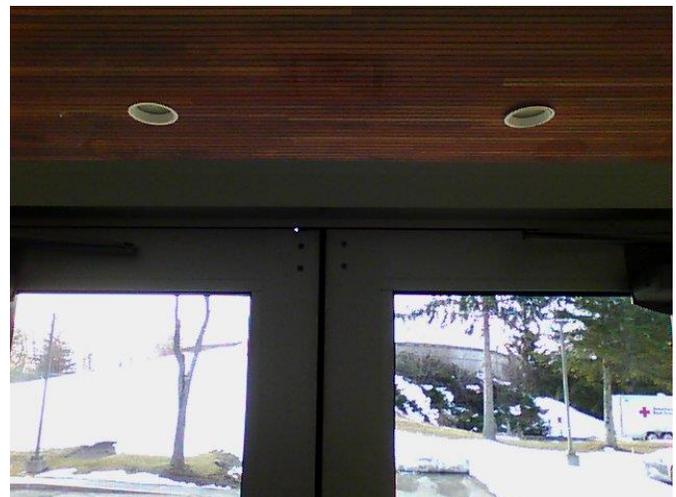
Air leakage at the astragal and head of the exterior double doors of the main entrance.

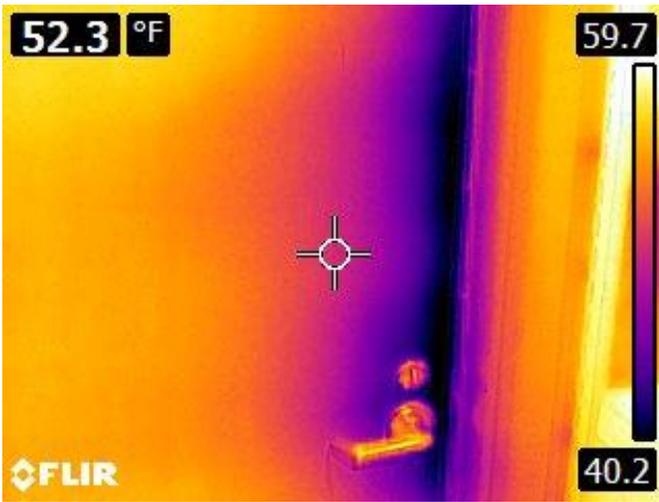
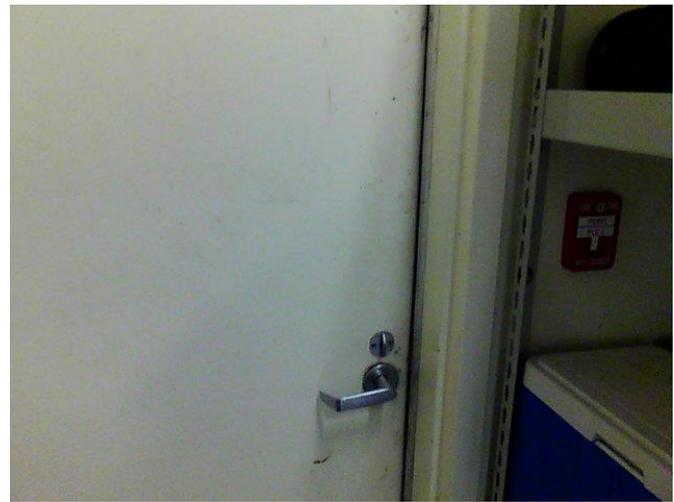
Air leakage through the jamb of the north exterior door located in the storage room 116.

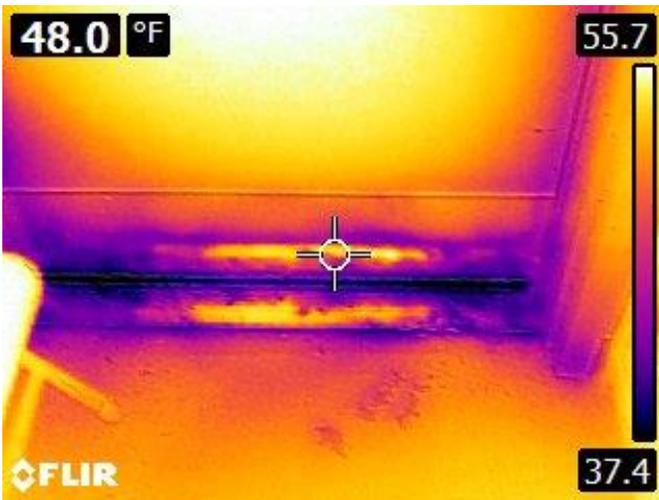
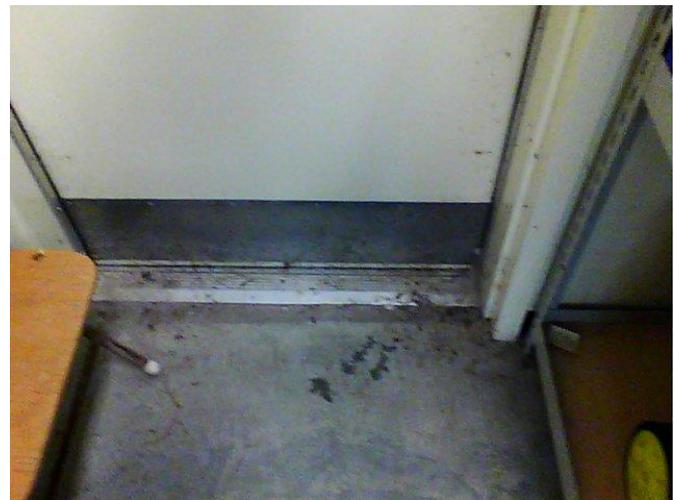
Air leakage at the threshold of the north exterior door in the storage room 116.

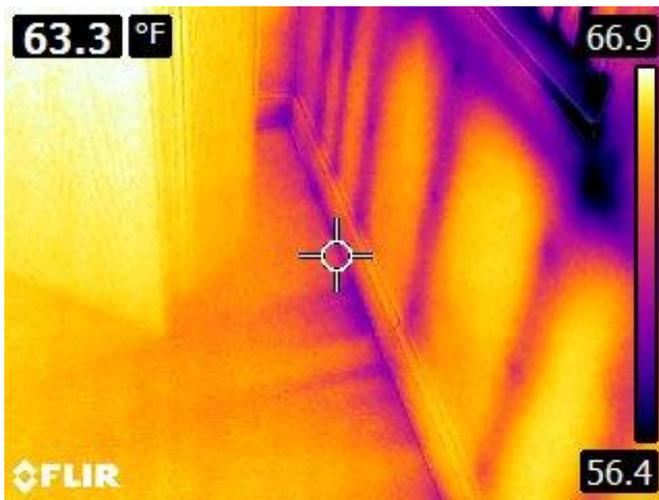
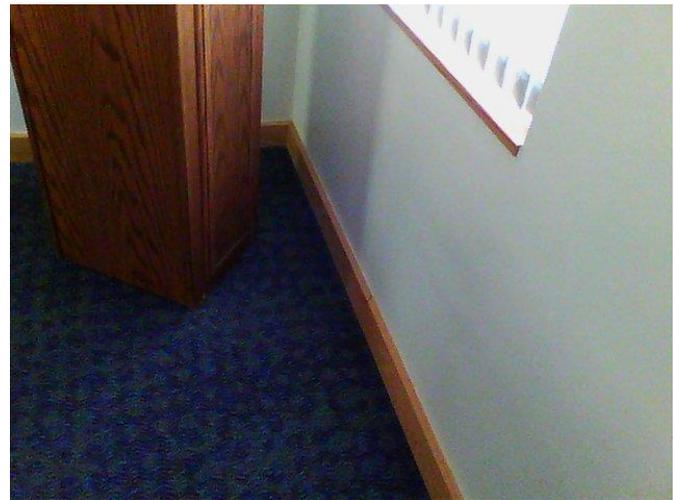
Though not a major source of air leakage, we did find evidence of air leakage at a few different sections of the wall to floor connection in the exercise room and conference room. Since this type of leak occurrence was only in a few locations, making repairs won't result in significant energy savings opportunities, but may improve comfort in the rooms. To repair these leakage areas, we recommend removing the baseboard trim to expose where the drywall meets the floor and caulking that joint.

Air leakage at the wall to floor connection in the conference room.

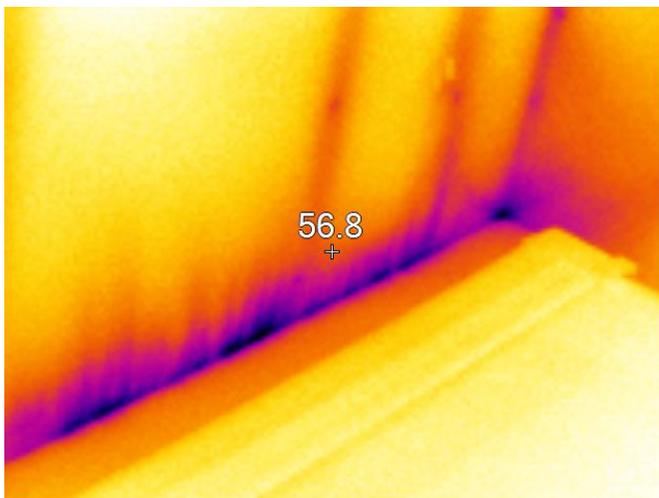
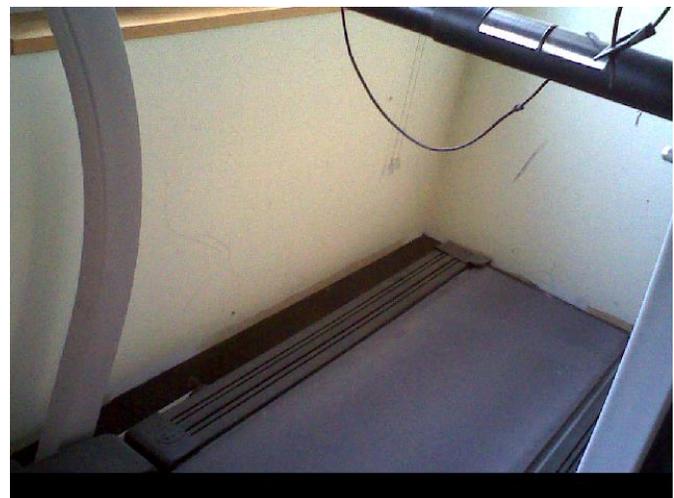
Air leakage at the wall to floor connection in the exercise room.

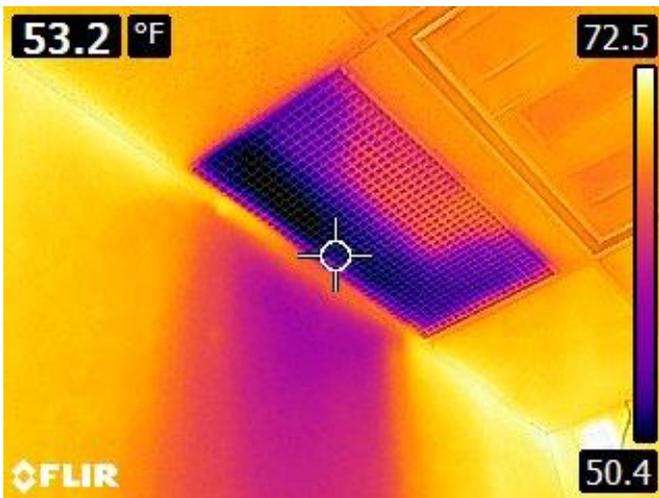
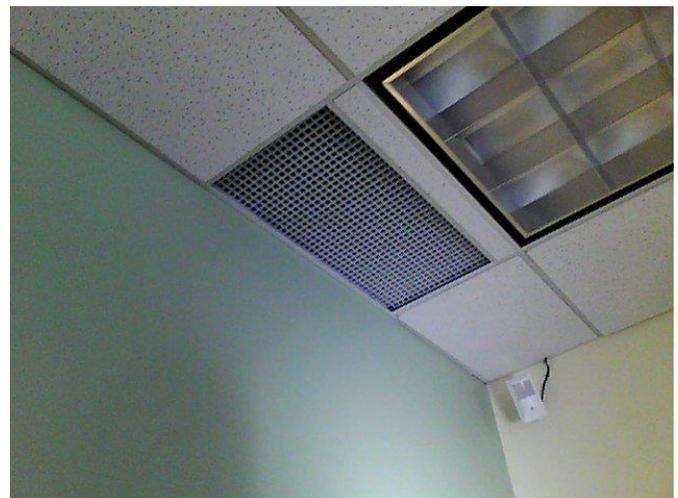
Seen consistently throughout the building was cold air being drawn in through all of the ventilation supply and return registers as well as the exhaust openings. The ventilation system should have mechanical dampers in them to significantly reduce the amount of uncontrolled air moving in or out of the building, but this evidence suggests the dampers may not be functioning properly. This may not be an issue if the ventilation system runs at all times, but if the system runs intermittently, then these dampers should be further inspected and tuned to open and close properly to prevent unwanted air leakage. Any improvements made regarding dampers should be considered carefully as it relates to other mechanical improvements suggested by JFPCS so as not to implement redundant or conflicting improvements.

Cool air being drawn in through the supply/return register into the conference room.

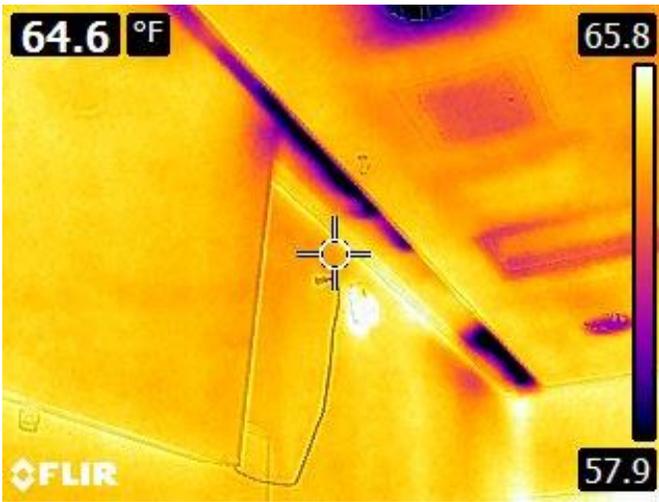
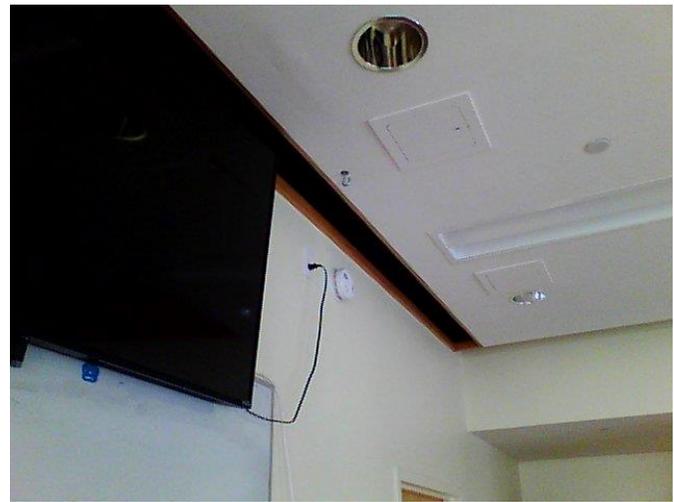
Air leakage through the ceiling registers in the multi-use/training room.
