Zero by Degrees LLC

Building Energy Plan

RE: March 15th & 27th, 2018 Energy Audit at the Middlebury Teen Center- Middlebury VT

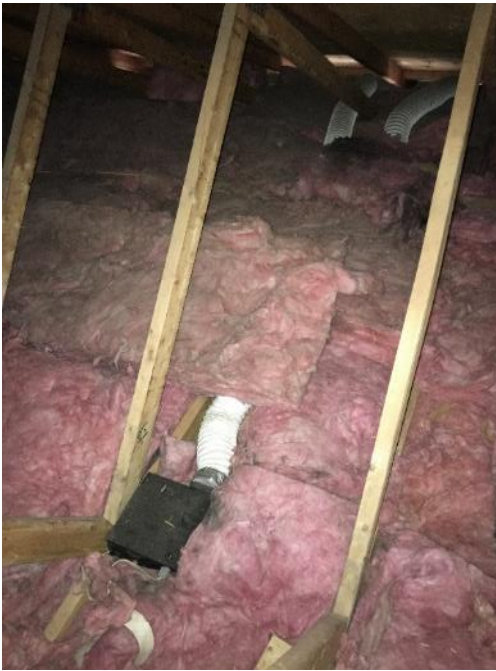
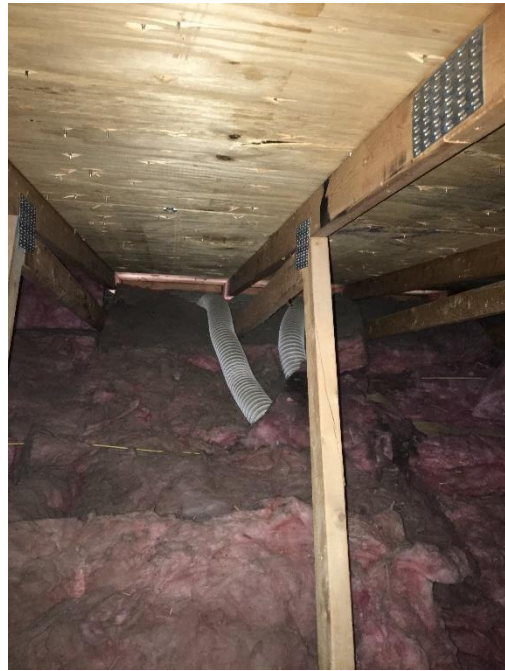
1. The exhaust fan of the bathroom contains flex ducting in the attic that exhausts to the outdoors via the soffit at the eave. Our first concern here is where the flex ducting is exhausting the air. The flex ducting leads to the soffit of the roof eave where it then forces the air straight down. The concern here is that the exhausted air is able to rise directly back up to the underside of the eave and even back into the attic, especially in the winter when the exhausted air is warmer than the outdoor air. If the warm, moist, exhausted air rises back up to the eave and back to the attic this leaves opportunity for moisture to condense on colder attic surfaces, particularly during the winter months, posing a risk for things such as mold, mildew, or wood rot. That being said, there doesn't appear to be any historical evidence of anything significant like this occurring, but it could still be contributing to any ice dam issues that may occur at this eave. The second concern with the flex duct is the irregular path it creates. Flex duct tends to dip and bend and can create low points, where moisture can condense and accumulate, especially if the duct is above the plane of the insulation, as it is in this case. We recommend that the flex ducting be replaced with a hard PVC pipe that runs straight up through the roof, rather than out through the soffit. The PVC is recommended for its durability and also for greater compatibility when air sealing as is described below. The PVC pipe should be fitted with an updraft cap so that warm air is not exhausted down onto the roof itself (to reduce snow melt and ice dam potential) and is also protected from rain entering the pipe.

The flex duct is routed both above and below the plane of the insulation out to the soffit. We're not sure why there are two ducts, perhaps there is a second exhaust fan below the insulation that we could not observe from the attic.

- b) Bathroom vent fan: replace any bathroom vent flexible ducts with hard PVC pipe that runs through the roof with updraft caps. Then install an insulated box over the bathroom fans similar to the boxes over the recessed lights, sealing in the PVC penetration as well.

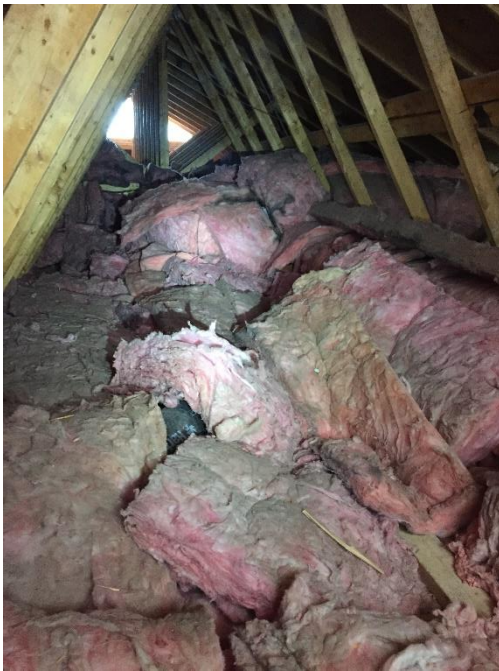
The current fiberglass batts insulating the attic are unevenly laid over top of joists and between the bays.

The best attic improvements can be made by first removing all of the current insulation from the attic flat, the cathedral slopes around the perimeter, out of the knee wall, and out from around the duct work. Once the attic insulation has been completely removed, air sealing measures can begin. The following details should be air sealed with spray foam.

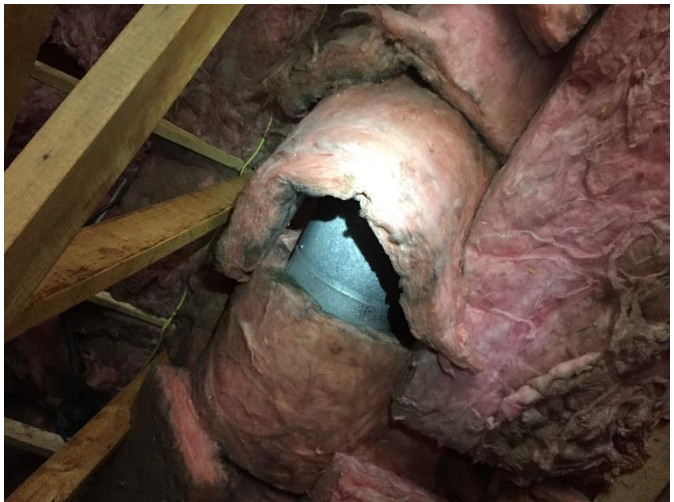
The ductwork is partly insulated with several gaps and voids.

Seal the ductwork that runs through the attic with duct mastic. Be generous on the mastic, we've tested it when applied in the typical amounts and the joints still leak. A common guideline is to make it "as thick as a nickel". After sealing the ducts they should be carefully wrapped in R11 insulation to form a continuous jacket around all the ducts. Alternatively the ductwork can be wrapped completely with 2 inches of closed cell spray foam which would address both air seal and insulate.

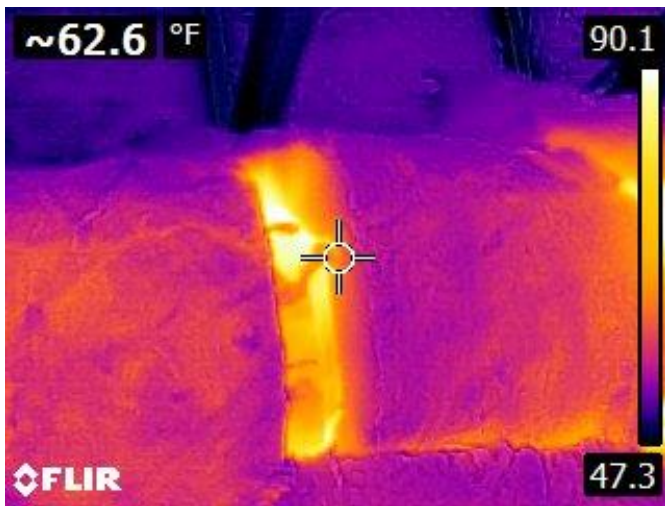
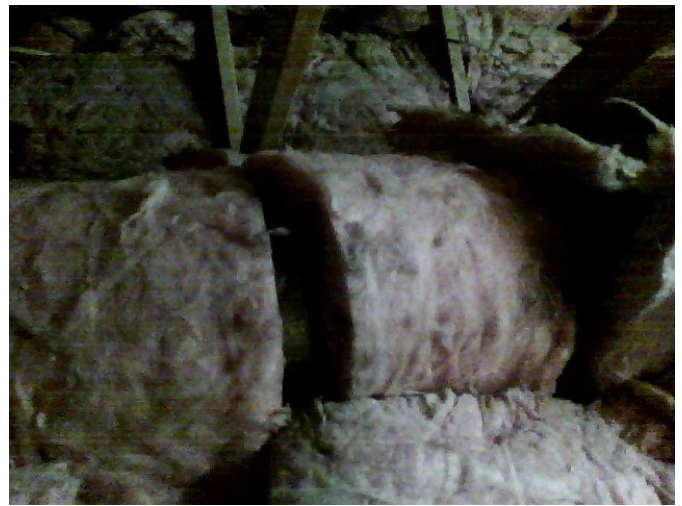
This image shows the heat loss from an uninsulated section of ductwork.

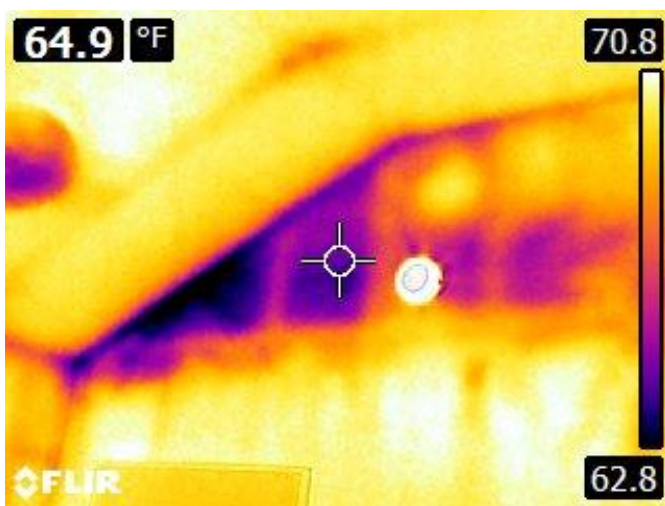
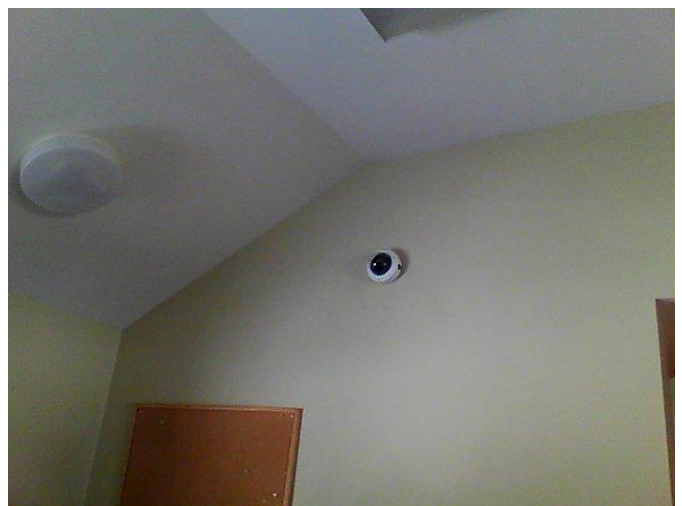
This image shows cold spots in the attic knee wall where it rises up to the cathedral ceiling. This indicates areas of missing insulation,

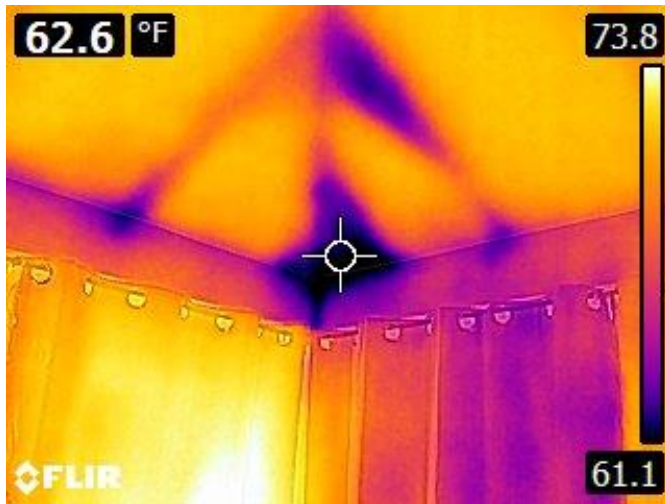
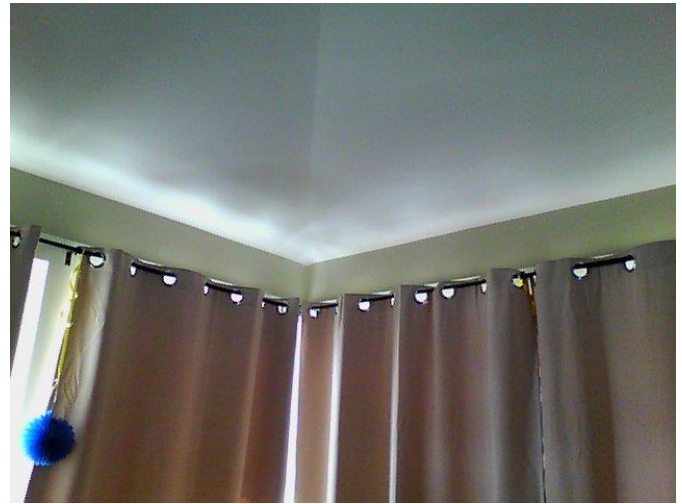
A cold spot indicating missing insulation in the south west corner of the cathedral ceiling.

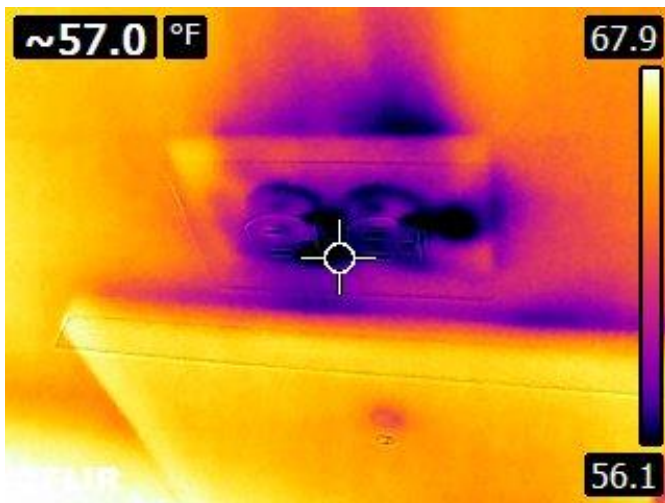
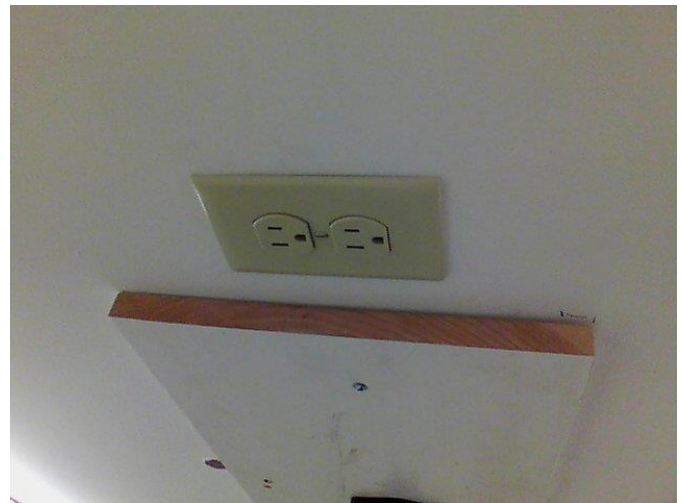
Air leakage around the ceiling outlet and wood board in the open space room.

- g) Outlets: kill power to the switch/outlet, remove the cover and pull the switch/outlet (leave wiring attached), caulk the box to the sheetrock, foam seal the location where the wiring enters the box, and then install a foam insert before you put the cover back on.

- i) Wood board: depending on the condition above, spray foaming where it connects through the drywall on the attic side or caulking around its perimeter from below will prevent air from being able to move around it.

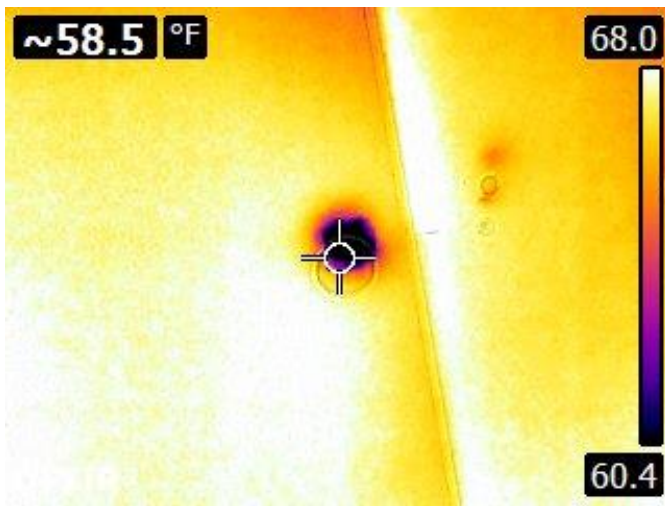
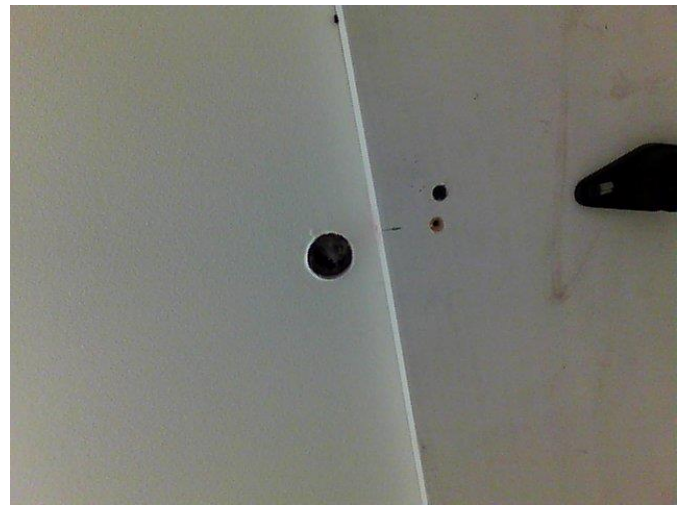
Air leakage through a hole in the ceiling drywall in the open space room.

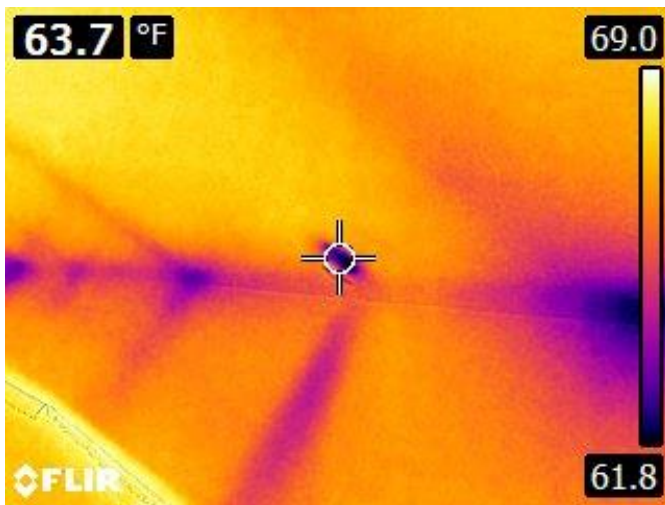
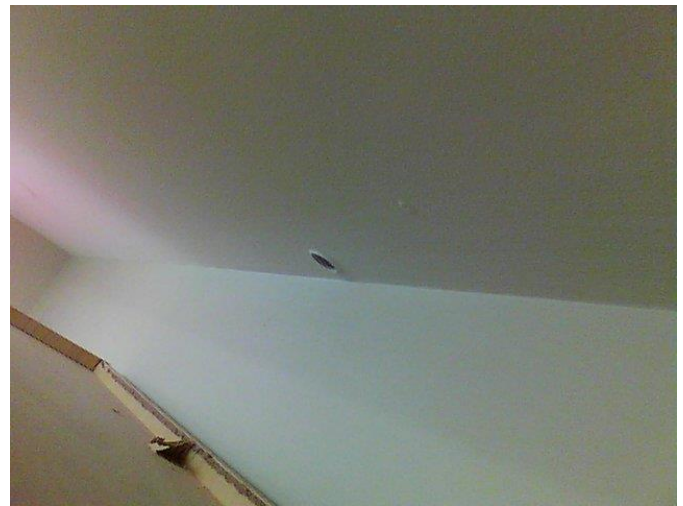
Air leakage through a hole in the drywall ceiling in the open space room near the east exterior door.

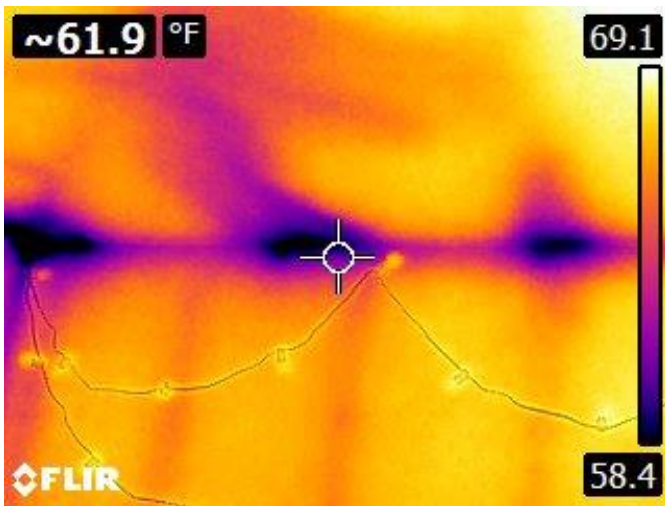
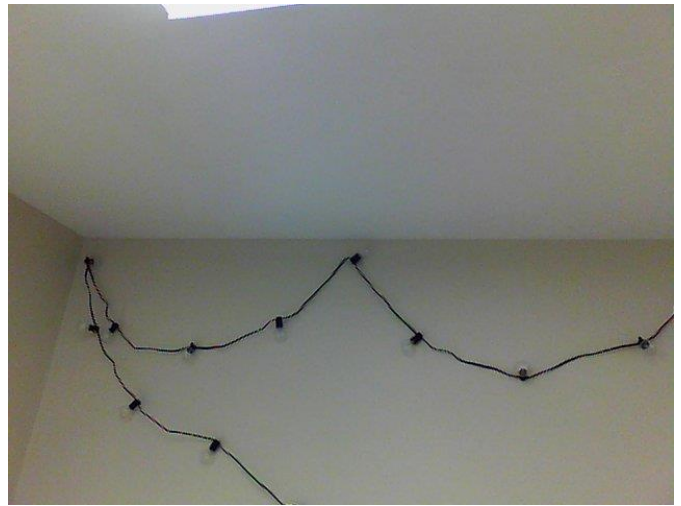
Air leakage at the wall to ceiling connection in the open space room.

- c) Perimeter wall top plates: cover top plates completely with spray foam. Note, that not all perimeter wall top plates will be accessible due to the cathedral slopes which limit access

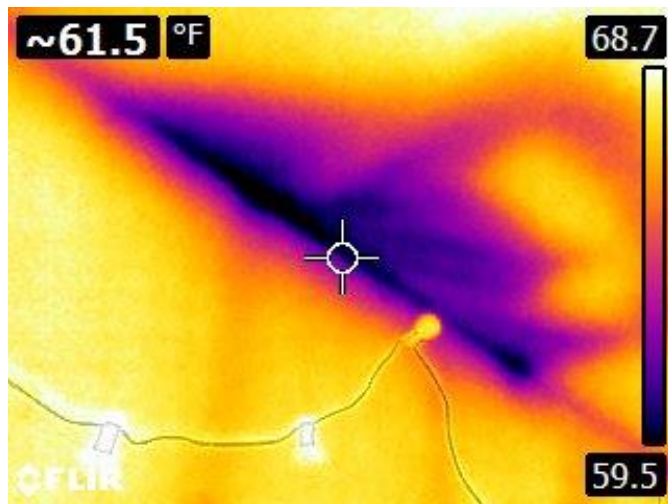
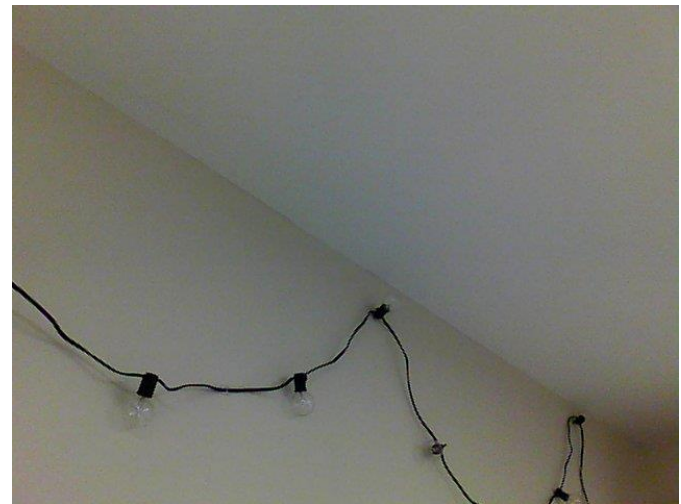
Air leakage at the wall to ceiling connection in the open space room.

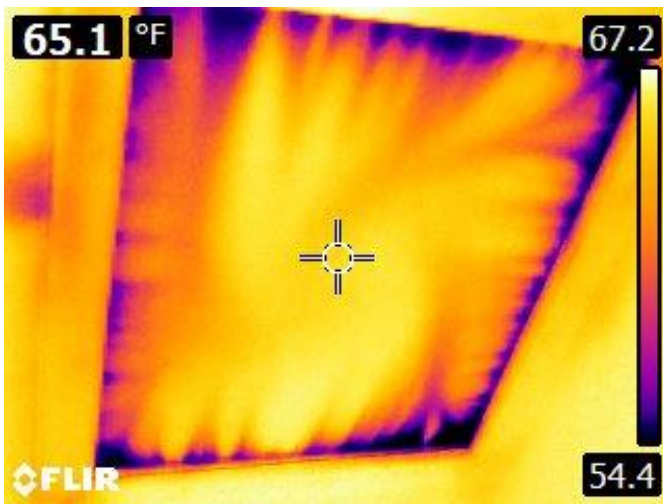
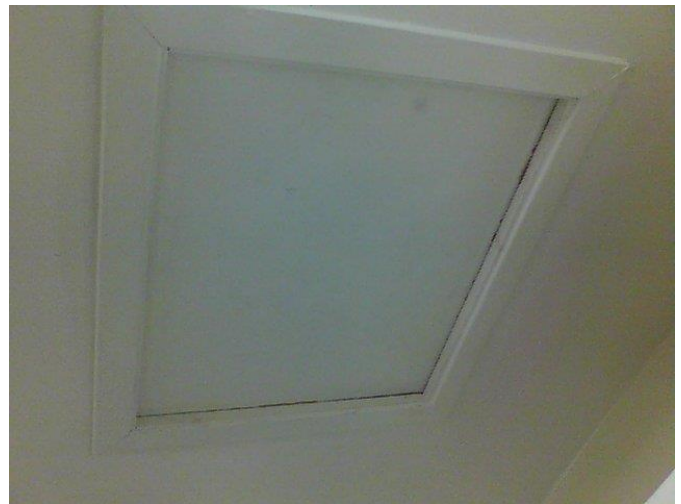
Air leakage around the attic hatch door.

- f) The attic hatch: The current hatch is insulated well but should be weather-stripped around the down facing perimeter. 2 layers of $\frac{3}{4}$ " plywood should be added to the hatch to add weight to create a tighter seal.

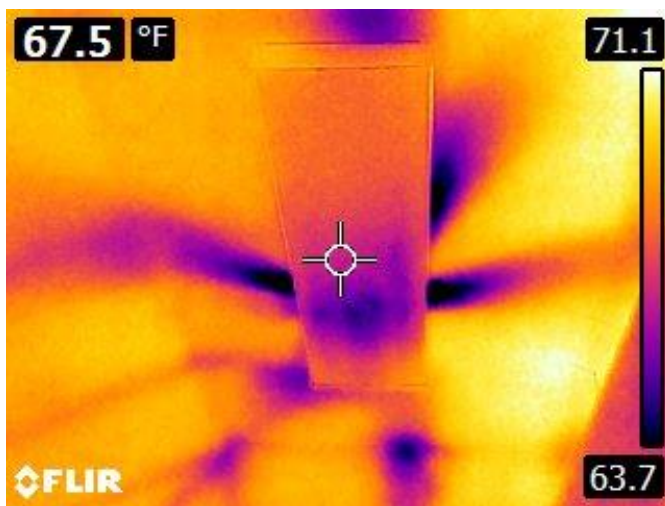
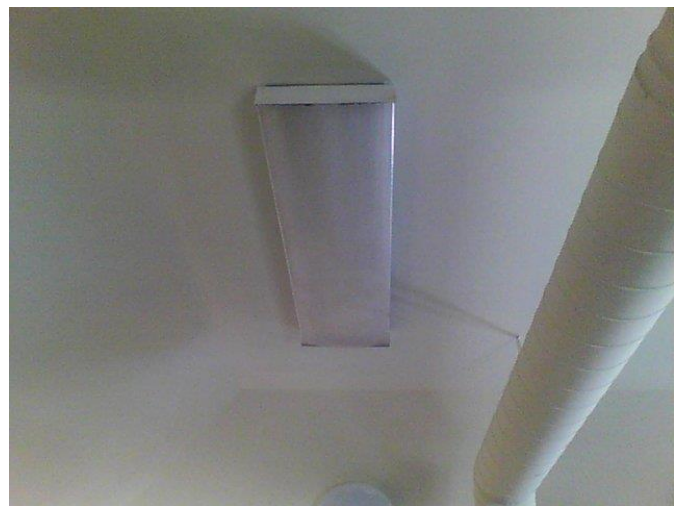
This image shows the air leakage around a typical ceiling light fixture in the lounge area.

- a) Recessed lights: Cover the lights with boxes made out of foil faced polyisocyanurate board (Dow Tuff R) that maintain at least a 3" air space on all sides of the light (including above). The boxes should be taped together with aluminum tape and foamed to the back of the sheetrock from inside the attic. CFL or LED bulbs should be used in these lights from then on to prevent the light from overheating which at best would cause the light to shut off at random times and at worst cause a fire .

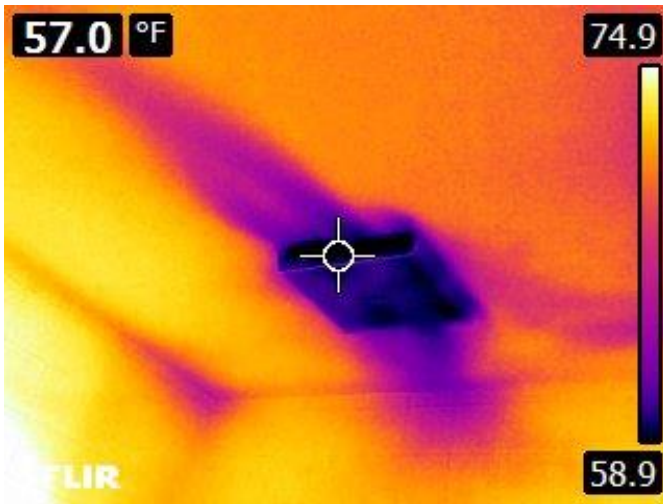
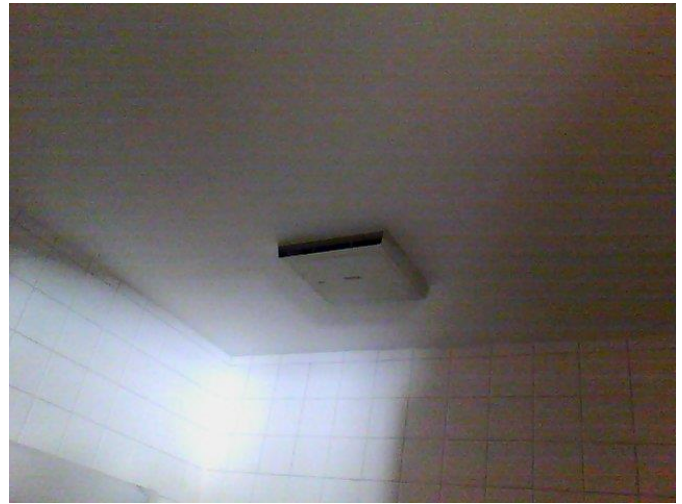
Air leakage through the bathroom exhaust fan.

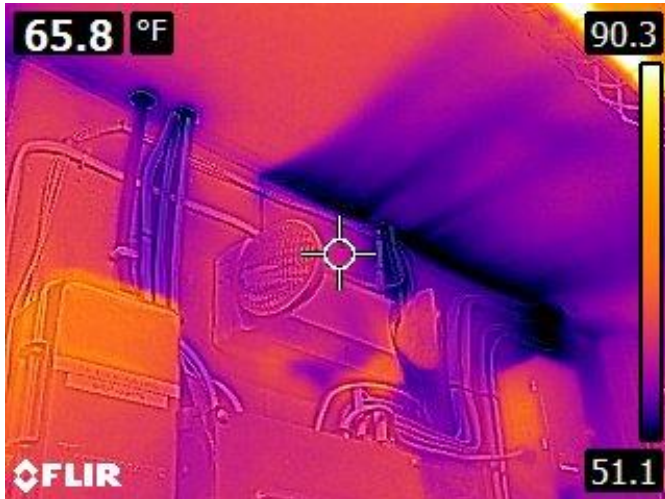
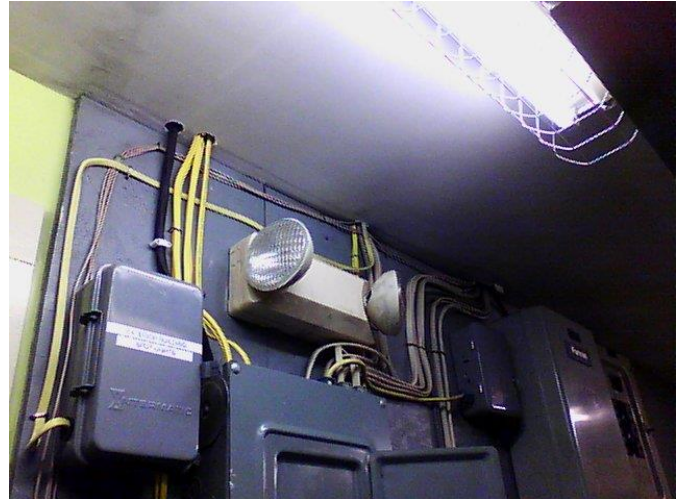
Air leakage through the wall to ceiling connection on the north wall of the boiler room and through holes in the drywall ceiling where wiring is being fed through.

Air leakage at these locations can be remedied relatively easily. For the holes through the ceiling, ideally we'd like to see conduits installed for the wire to be fed through. The conduit should be sealed to the drywall it is penetrating, and the remaining void conduit should be filled with spray foam. If conduit isn't installed, spray foam can be used to fill in the open space of the holes around the wiring. Just spray foaming around the wiring may not be as reliable but would help in decreasing or eliminating air leakage there completely if done sufficiently. As for the drywall wall to ceiling connection, a closer examination, which may require partial removal of the plywood panel, should be made to ensure that is in fact the source of the air leakage. If it is as simple as an unsealed drywall joint, installing a bead of caulk in the wall to ceiling corner to fill the gap between the drywall that is allowing air to move through. For the flue pipe and duct work penetrations, use fire rated sealant to seal around the edges of where the flue pipe meets the metal pan at the ceiling, and also around the perimeter of the metal pan where it meets the drywall. The other leaking ductwork should be sealed around the perimeter where the metal meets the drywall. For the leaking pipes, use caulk to seal around the entire perimeters, ensuring there is no gaps or voids.

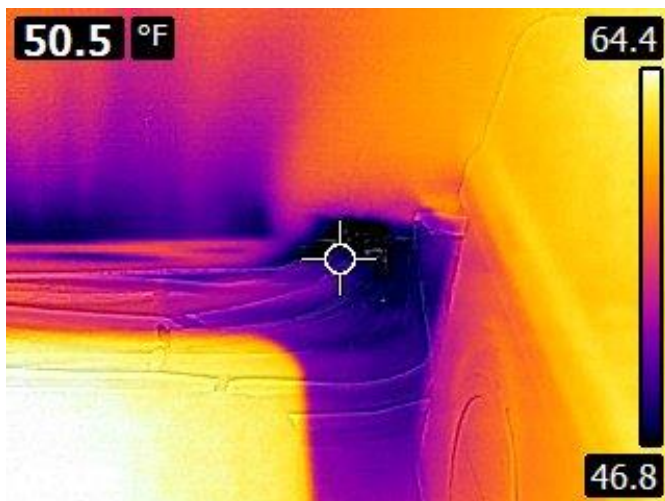
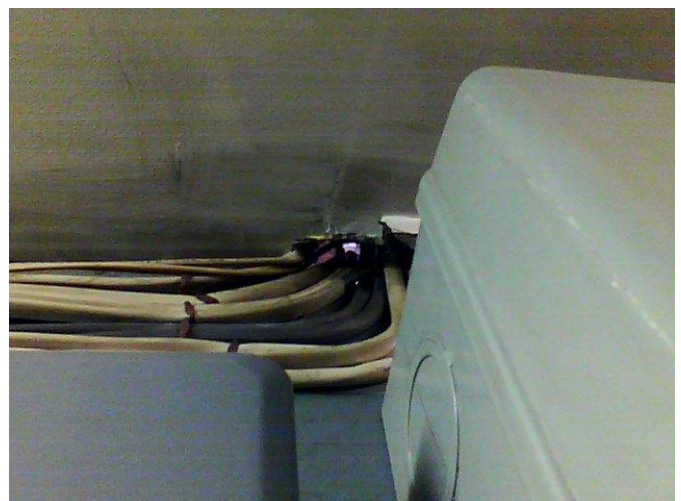
Air leakage through a hole made for wiring in the drywall ceiling of the boiler room and through the wall to ceiling connection.

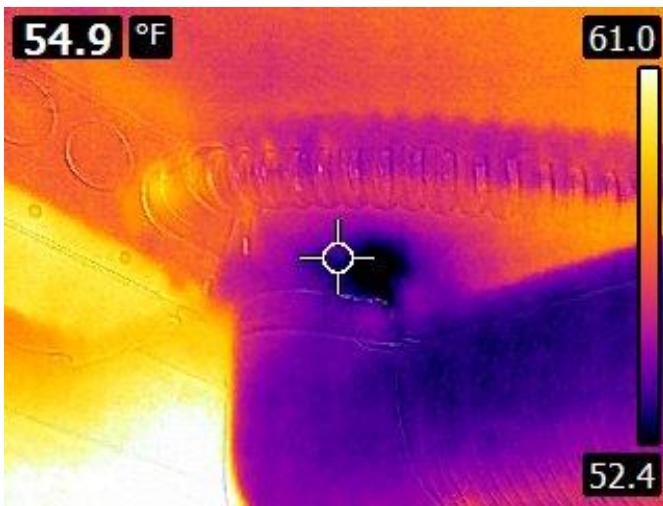
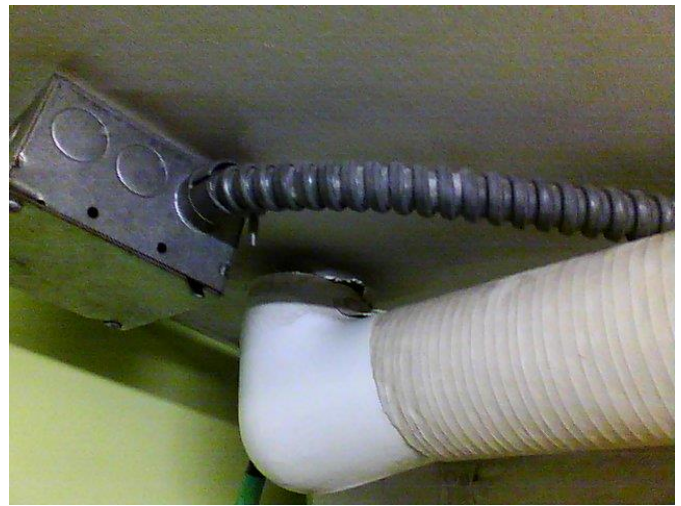
Air leakage around a pipe penetration through the ceiling in the boiler room.

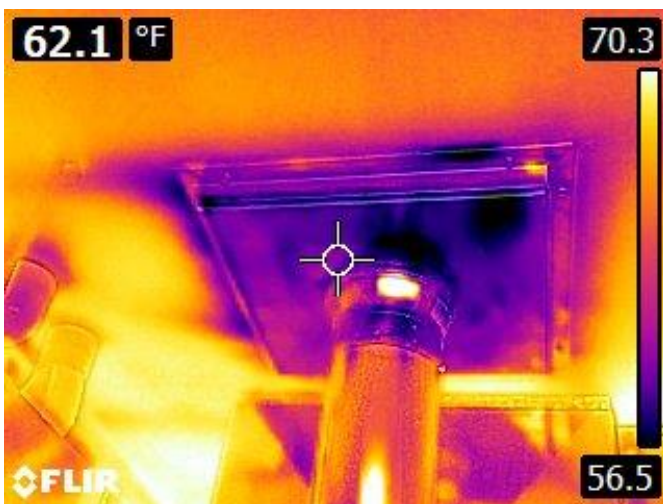
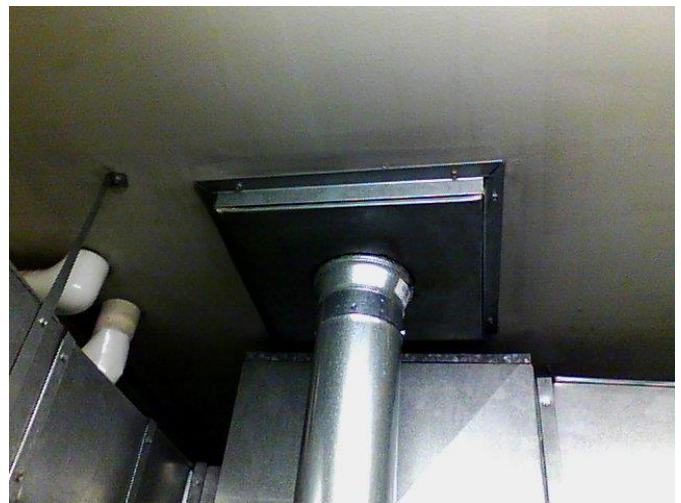
Air leakage around the exhaust flue pipe and around the perimeter of the metal pan.

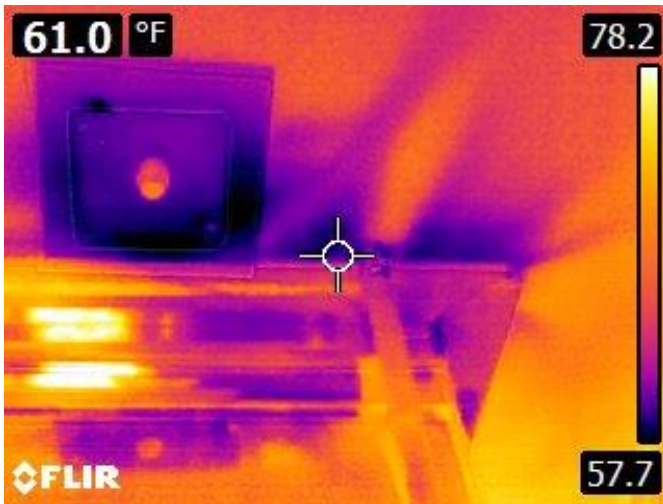
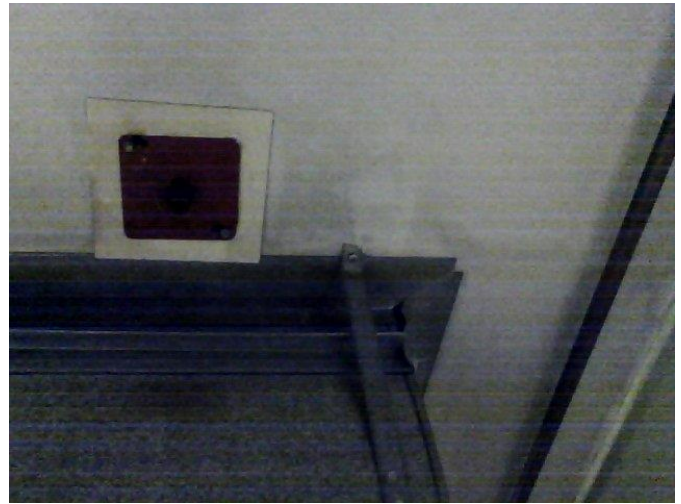
Air leakage around ductwork where it penetrates the ceiling in the boiler room.

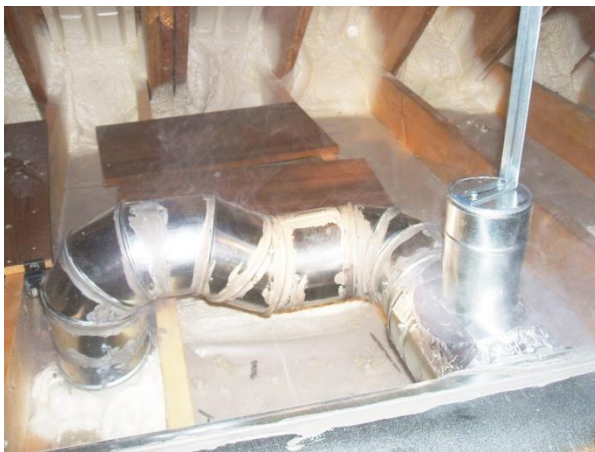
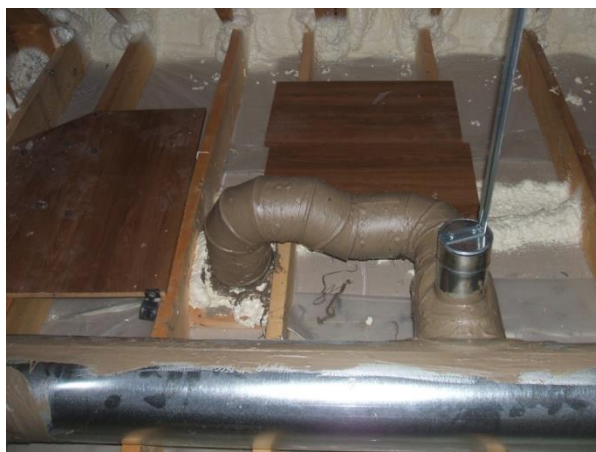
Ducts with typical mastic still leak but a thick coat of mastic performs well. Using either insulated jackets to wrap the ductwork or spray foaming them completely will provide increased and consistent R-value around them.

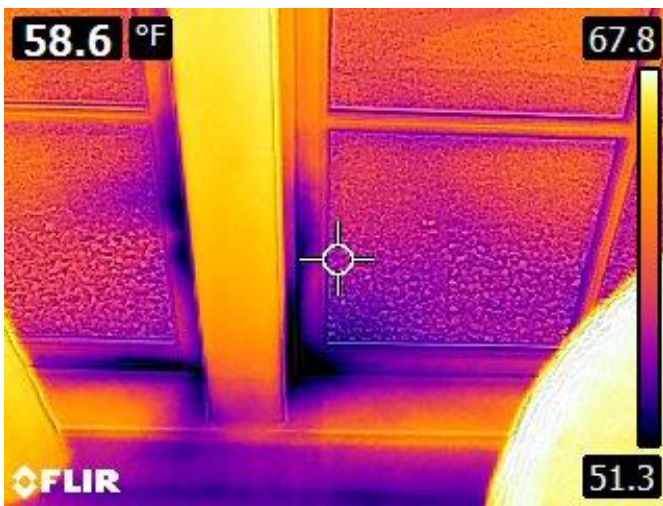
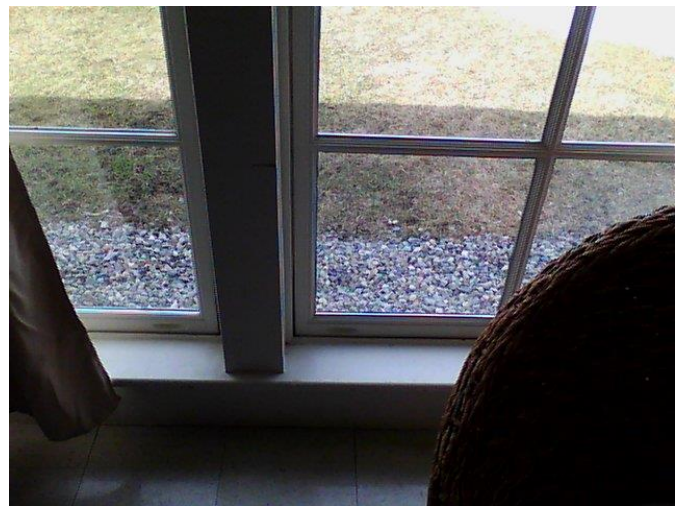
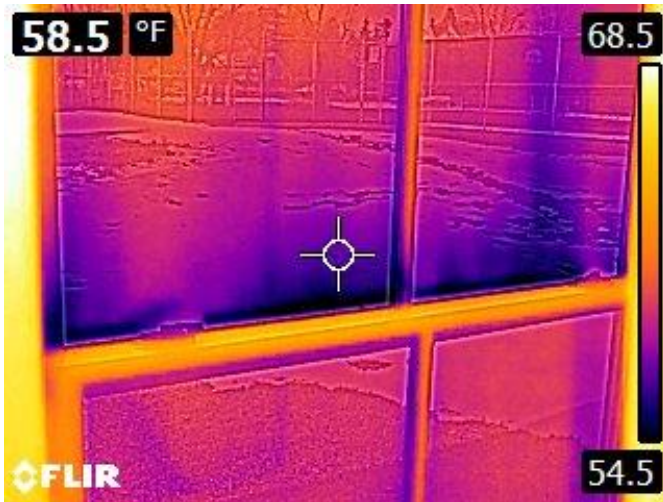
This image shows air leakage through the jambs and sills of two window units. This is an example of what was found at most units.

These wood windows appear to be original to the building as they show signs of aging and wear. It is worth noting that a few of the window unit frames contain noticeable rot at the exterior, which is discussed in greater detail under “Durability Concerns”. As mentioned in that section, where rot is present, replacement of window units in their entirety makes more sense from a durability standpoint. An extra investment for a tighter, higher R-value, window could then eliminate the need for the compression fit storm on the interior. A mix of interior storms and window replacements may be the most realistic scenario. However, since total window replacement is a recommendation derived from the perspective of durability, the costs of replacement are not reflected below as it would exacerbate the payback. The savings reflected assume the scenario which favors energy savings at the lowest cost which is to add interior storms to *all* window units.

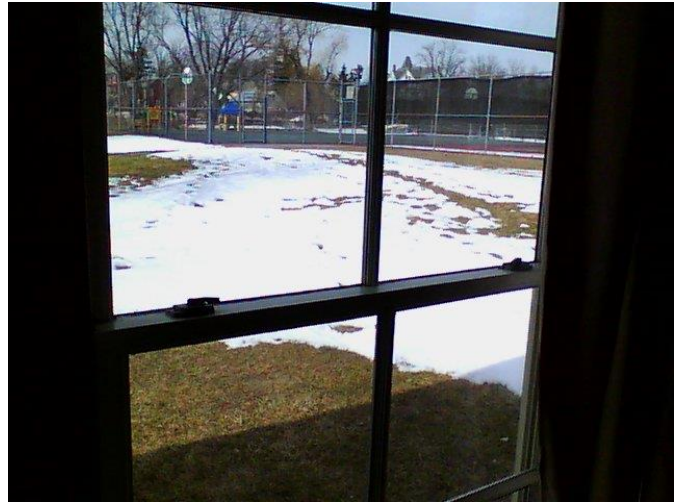
This image shows air leakage through the meeting rail of a window unit on the west elevation. This is an example of what was found at most units.

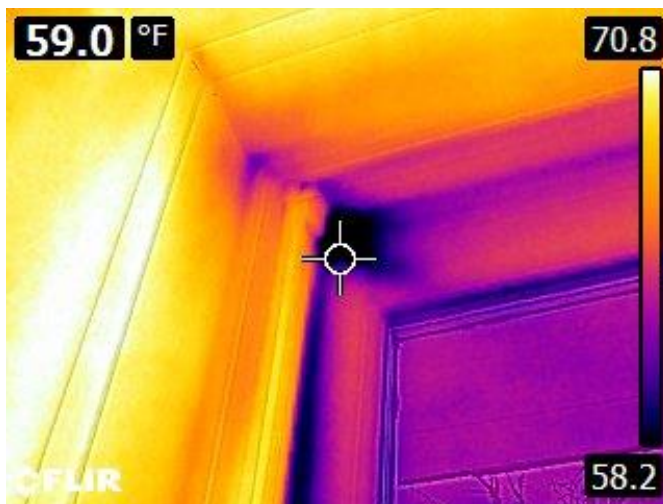
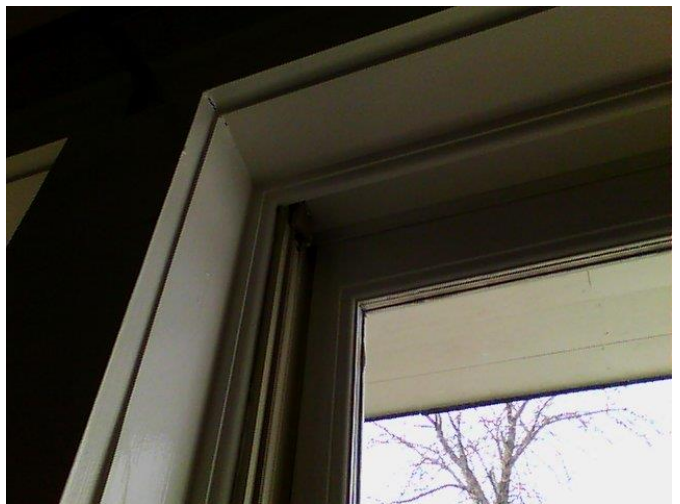
This image shows air leakage through the top corner of the upper sash of a window unit on the west elevation. This is an example of what was found at most units.

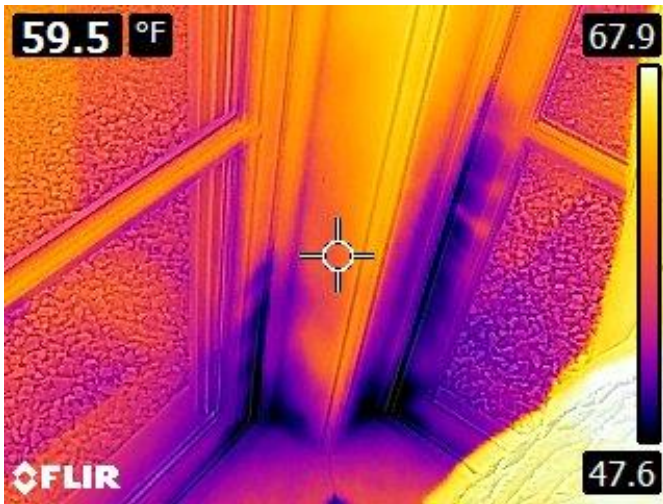
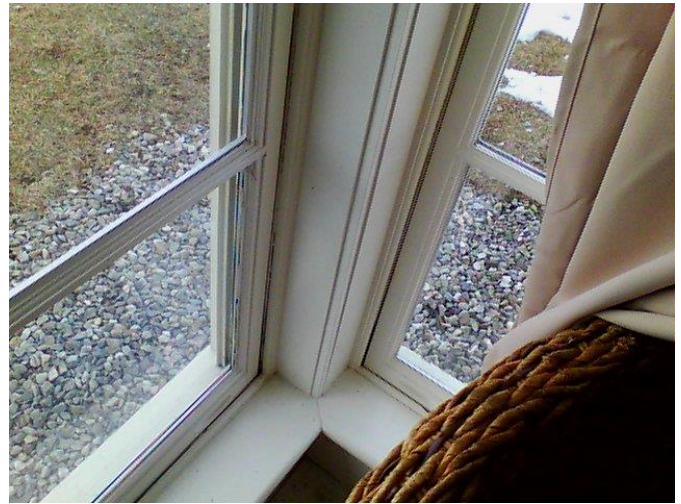
This image shows air leakage through the jambs and sills of two window units at the north and west elevation corner.

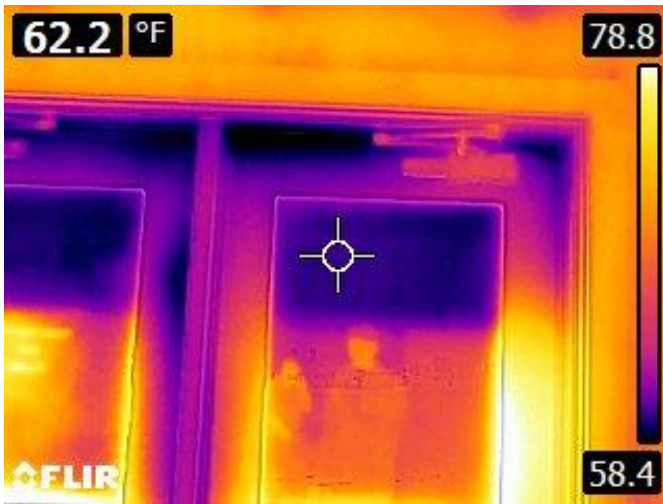
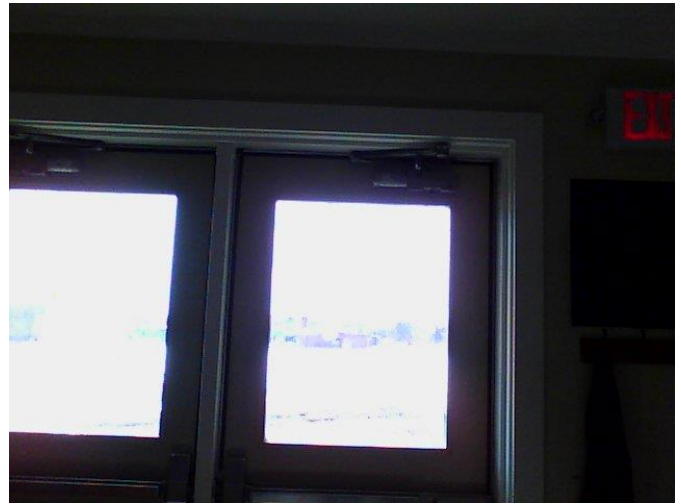
Air leakage at the head and jambs of the double doors on the south wall. Similar results were found at the double doors on the north wall.

Under depressurization, air could be seen and felt coming in around the two sets of double doors at the heads, jambs, and thresholds. The leakage that was found wasn't consistent around the entire perimeters of the doors but was spotty due to areas where the current weather stripping is missing or not making full contact with the door. For the most part, the doors' weather stripping appeared to be in good condition, so completely replacing it may not be necessary at the moment. What we recommend be done instead is an inspection of each door, adjusting the weather stripping as necessary so that it is making full contact with the door when it is shut. In spots where the weather stripping is cut short, often in corners, replace as needed so that a weather-stripping runs the full length of the jamb or head. You will know you have it tight when the doors are closed and you cannot see daylight at the weather-stripping. On doors that are still in good shape the most cost-effective measure is to check the thresholds, sweeps, and weather-stripping of all the exterior doors and hatches once a year and replace as needed. Replacement parts from the original manufacturer are ideal if still available. Even old doors can serve very well if the weather stripping and sweeps are in good shape.

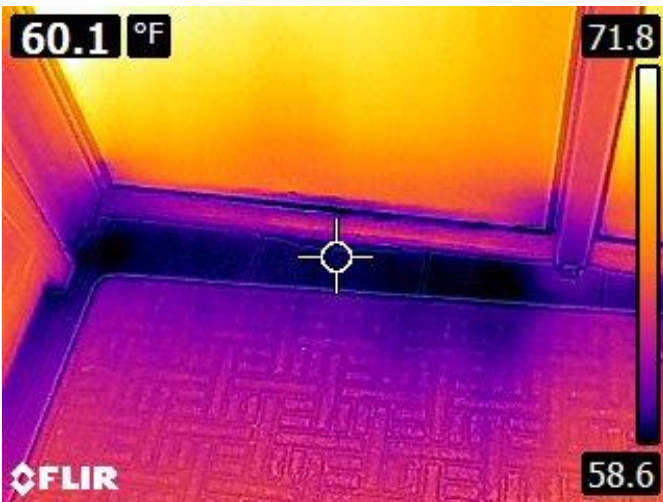
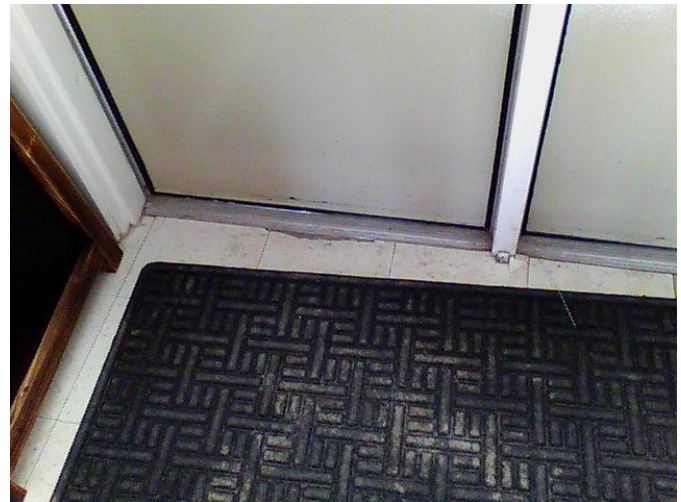
Air leakage at the threshold of the double doors on the south wall. Similar results were found at the double doors on the north wall.

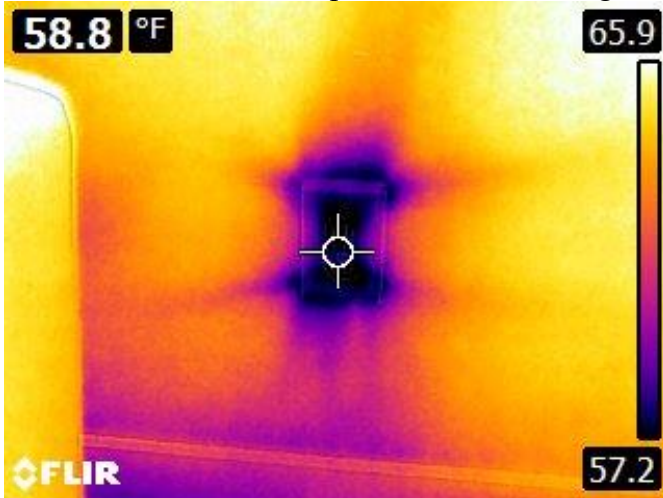
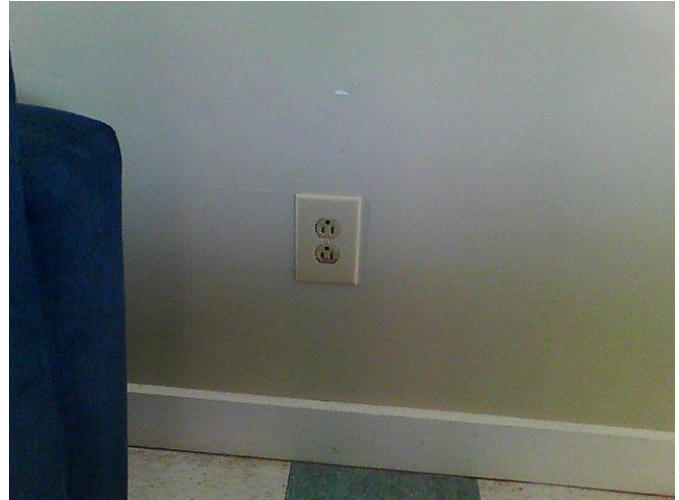
Air leakage through an electrical outlet on the west exterior wall.

1. Kill power to the switch/outlet
2. Remove the escutcheon cover and pull the switch/outlet (leave wiring attached)
3. Caulk the electrical box to the sheetrock
4. Caulk seal open punch outs in the box
5. Seal the location(s) where the wiring enters the box with wiring compatible duct putty or caulk
6. Replace the escutcheon cover.

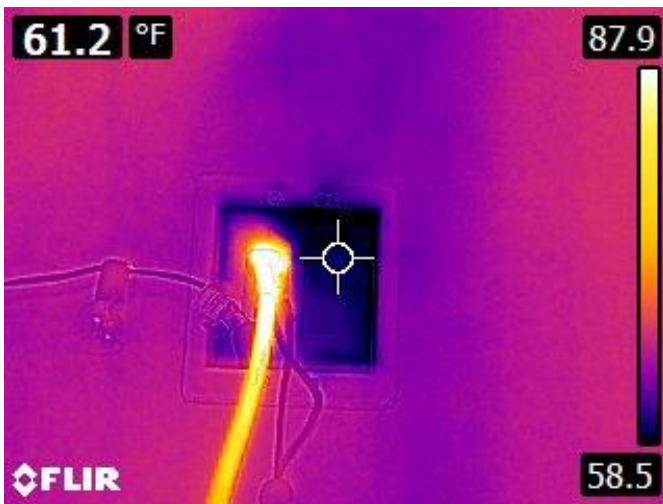
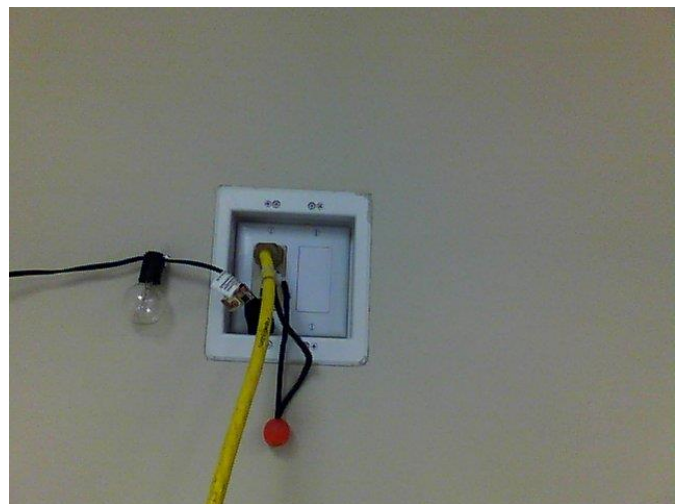
Air leakage through an electrical outlet on the south exterior wall of the open space room.

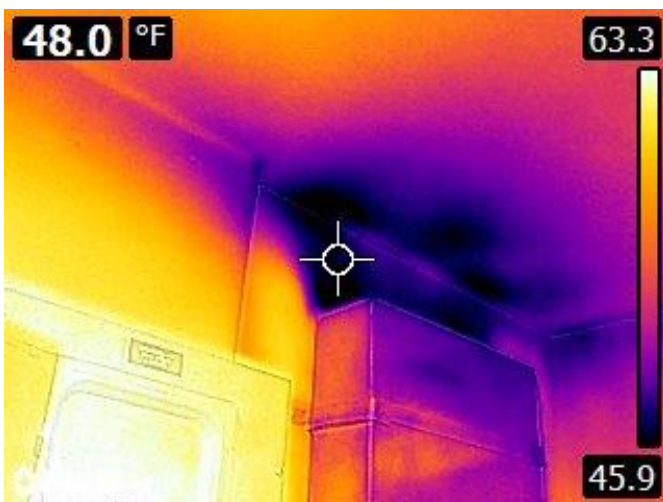
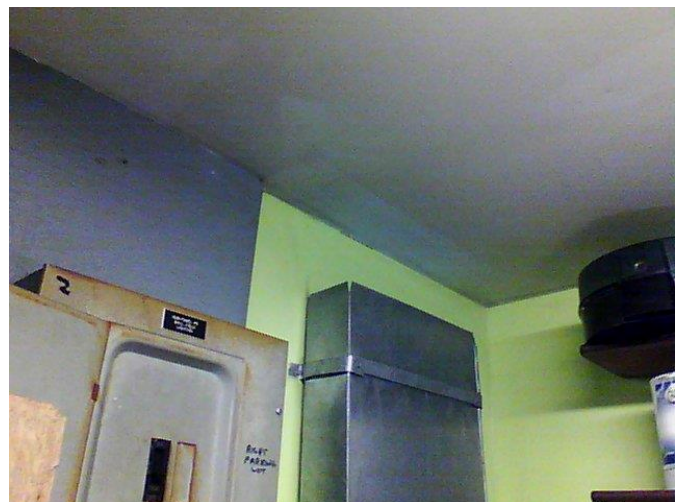
Another miscellaneous source of air leakage was identified in the boiler room. A short line of ductwork that appears to be the combustion make-up air for the furnace, penetrates through the north exterior wall of the boiler room and is open ended on the interior side. When the building was depressurized, large amounts of cold outdoor air was pulled through this ductwork into the open space of the boiler room. This indicates that the ductwork is in fact connected to the outdoors and that it also does not have a working damper, if one at all. If combustion make-up air is not necessary for the furnace and serves no other purpose, we recommend removing the ductwork and sealing the off the hole left from the penetration. If this ductwork is being used to draw in necessary combustion make-up air, then it is important that it remains, but some modifications may be possible. One possible solution to eliminating the unwanted air infiltration and leakage through the ductwork when the combustion air is not needed is to run the ductwork directly to the burner. Ask the boiler service company if an outside combustion air boot can be retrofit directly to the burner. This significantly reduces the possibility of back draft and would allow for a rather significant hole in the wall, namely the combustion air intake, to be generally closed off from the rest of the building. An alternative option may be to install a damper in the ductwork that would close off the “hole” through the exterior wall when the burner doesn’t immediately need the make-up air. An HVAC specialist should be consulted before implementing any of these possible retrofits to ensure that they won’t conflict with the operation and safety of the furnace system.

Air leakage through what is believed to be the combustion make up air ductwork in the boiler room.
