Zero by Degrees LLC

Building Energy Plan

RE: March 15th & 27th, 2018 Energy Audit at the Middlebury Teen Center- Middlebury VT

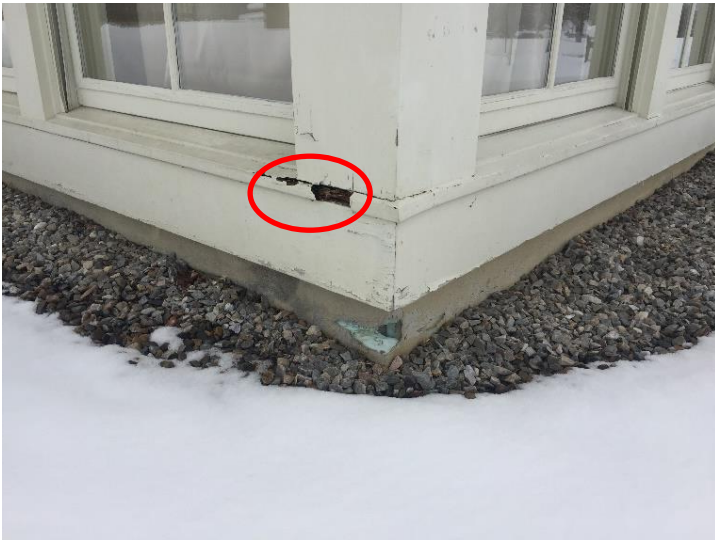
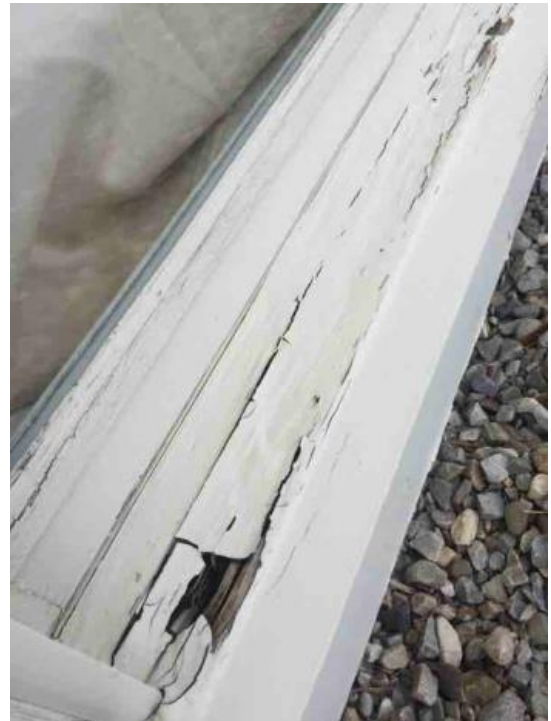
1. The first concern is the window units which are rotting at the wood frame, as briefly mentioned above in ECM #2. These wood framed windows have been exposed to considerable amounts of water and moisture over time resulting in areas of rot and deterioration. The areas of rot seem to be at the sill and other horizontal members that may be acting as a shelf for water to sit on for extended periods of time.

Seen here is a section of rotten wood and damaged EIFS at the north west corner of the building. Wood rot at the frame of a window sill.

These areas that have already started to experience varying degrees of rot will only get worse and could potentially lead to new moisture related problems in the surrounding wall assembly if not

addressed. Where window frames are already comprised by rot, we recommend consideration be given to total window replacement. This is being recommended primarily for durability reasons rather than energy, but considering both, keep the following things in mind:

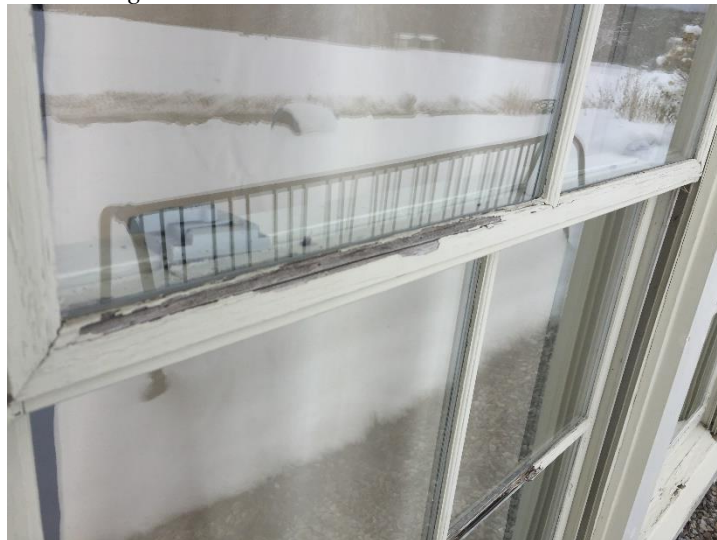
Horizontal surfaces which are not rotted are at risk for future rot where paint is peeling or missing.

4. Lastly, the building is simply in need of scraping and painting. Aside from where rot is already occurring. Much of the paint is starting to peel. Spot priming and repainting will add longevity to the finishes of the building which are still in decent condition.

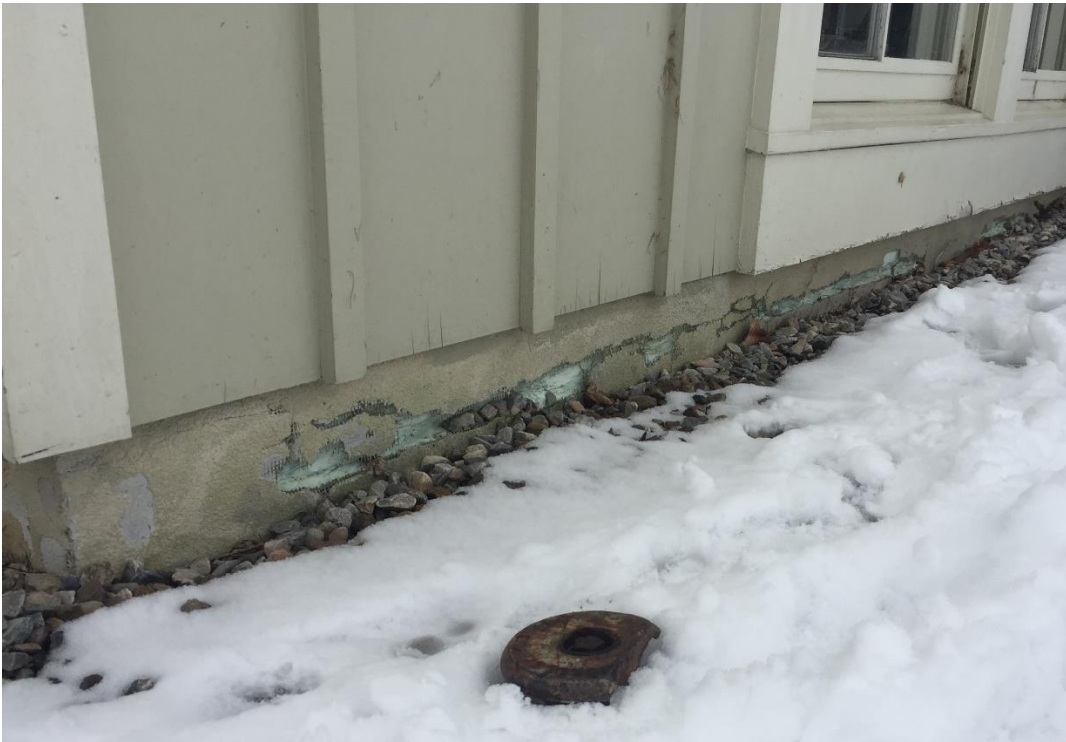
2. The second durability concern is around the exterior of the foundation at the XPS insulation and stucco finish. In areas where this system is present, damage to both the stucco and insulation is present in varying degrees. Some areas look ok while others have chunks of insulation exposed or missing. We suspect much of this damage is from surrounding outdoor work and typical wear and tear that public buildings suffer from. These areas where the XPS is damaged and/or missing decrease the foundations R-value. We recommend replacing the sections of the damaged stucco and insulation. You can also get protective coated XPS that can be attached with masonry anchors for a higher price but a faster install. Of course, this may not match with the rest of the existing insulation.

This image shows the damaged EIFS at the foundation on the north elevation. Seen here is exposed, damaged, and missing XPS (blue material.)

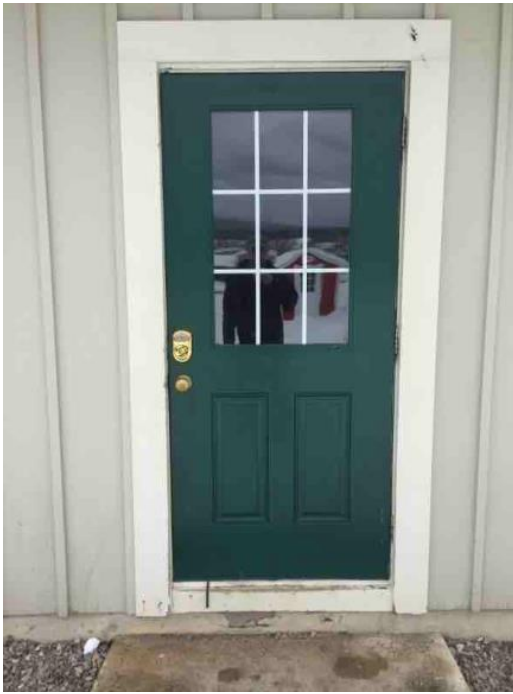
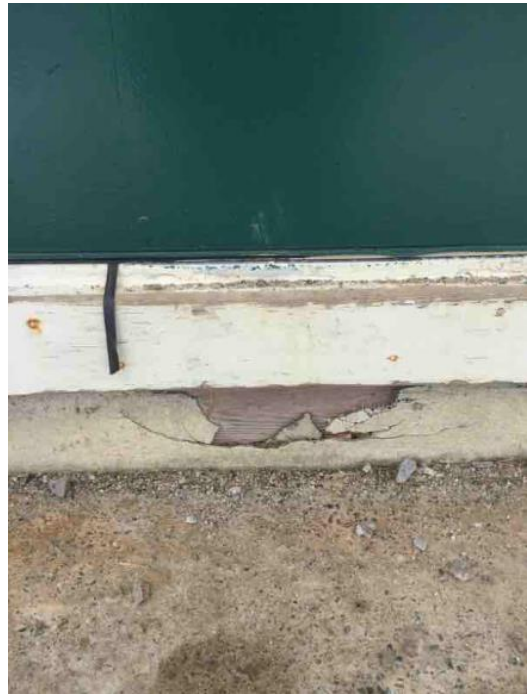
Damage to the stucco under the door on the east elevation.

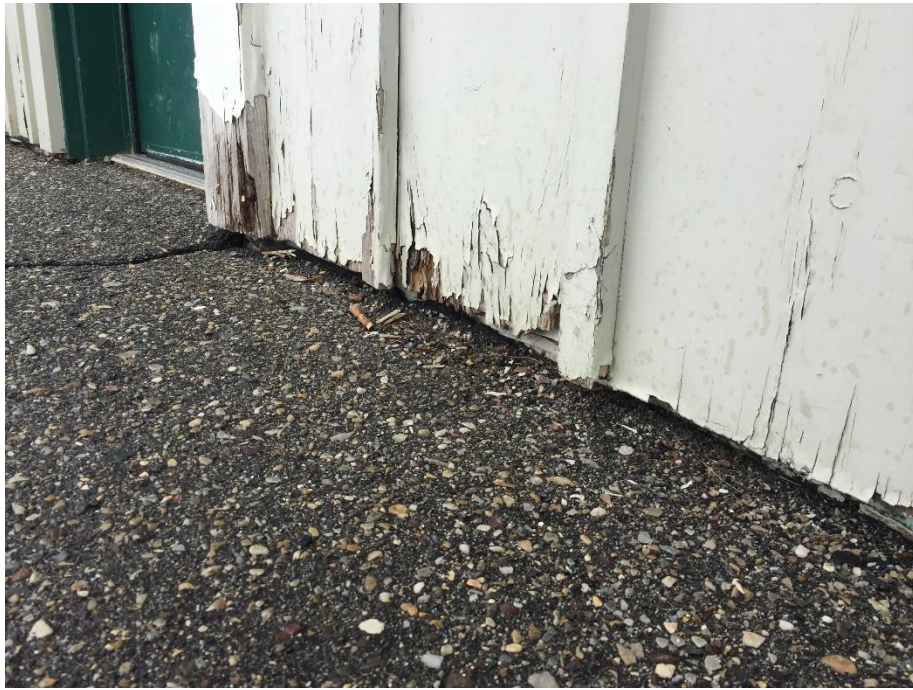
3. There are several areas where the bottom of the board and batten siding and other wood sections are rotted as a result of over exposure to water and lack of drying. This rot is primarily on the south side. Despite large overhangs, we suspect the cladding is subject to some degree of back splash on this south end, especially where pavement exists. The surrounding land is generally flat, but with snow on the ground it was difficult to assess how well graded the land is around the building to divert water away from it. If snow build up, or rain/melt run-off is diverted toward the building, then the water level could rise just high enough to make some prolonged contact with the cladding, which extends quite low to the ground on some elevations. The south is one example, where there is also less ability for water to drain due to the paved walkway. While elevations other than the south are not without some cladding concerns, the cladding overall *is* in better condition, which we believe is largely due to the $\frac{3}{4}$ " drainage stone reducing splashback and facilitating drainage. The one exception is locations where the cladding comes in contact directly with the stone, such as near the southwest building corner. Lastly, we noted that there was no evidence that any of the boards had been primed before they were painted, which increases risk of water absorption and premature rot.

This is the section of the board and batten siding on the south elevation that has experienced rot damage due to how close it is to the pavement walkway.

rotted cladding around the building, and replace it. You can use the photos below as a benchmark for determining what should be replaced. It is important that the cladding be primed on all sides, especially the bottom edge at the end-grain. This is the end of the wood which is most absorbent and also most subjected to the most moisture.

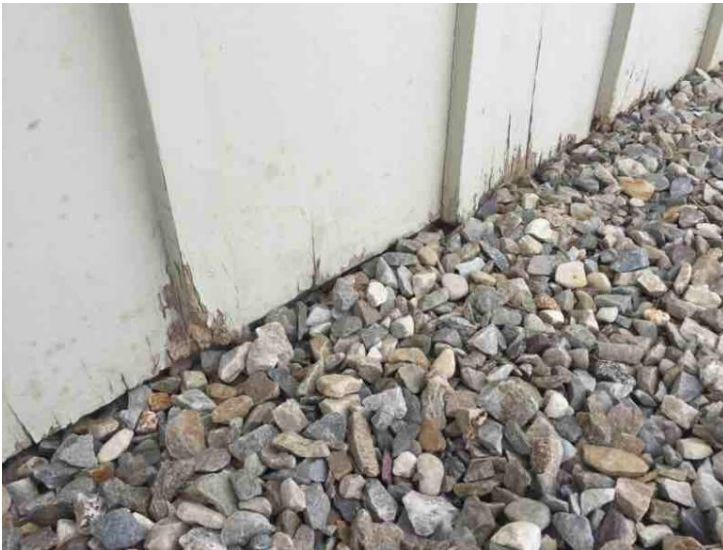
Moisture damage at the bottom of the siding on the south elevation. Note that even though there is drainage stone here, because the siding is touching the stone it is able to absorb the water.

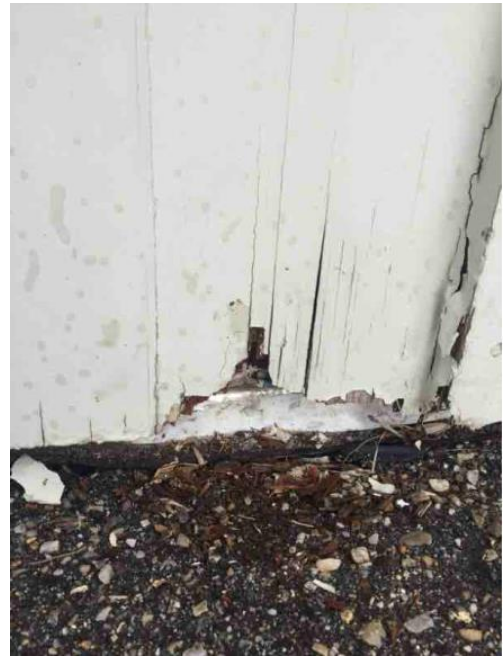
Moisture damage at the bottom of the siding on the south elevation over the pavement.
