# CONSTRUCTION OBSERVATION REPORT

<b>Date:</b> July 20, 2021	<b>Time On Site:</b> 12:45 PM	<b>Time Off Site:</b> 2:45 PM
<b>Project:</b> Middlebury River Flood Resiliency Project (15032.00002)		
<b>Observed By:</b> Brian Cote		
<b>Weather:</b> Partly sunny, $\pm 80^{\circ}\text{F}$ , flows elevated after recent rain

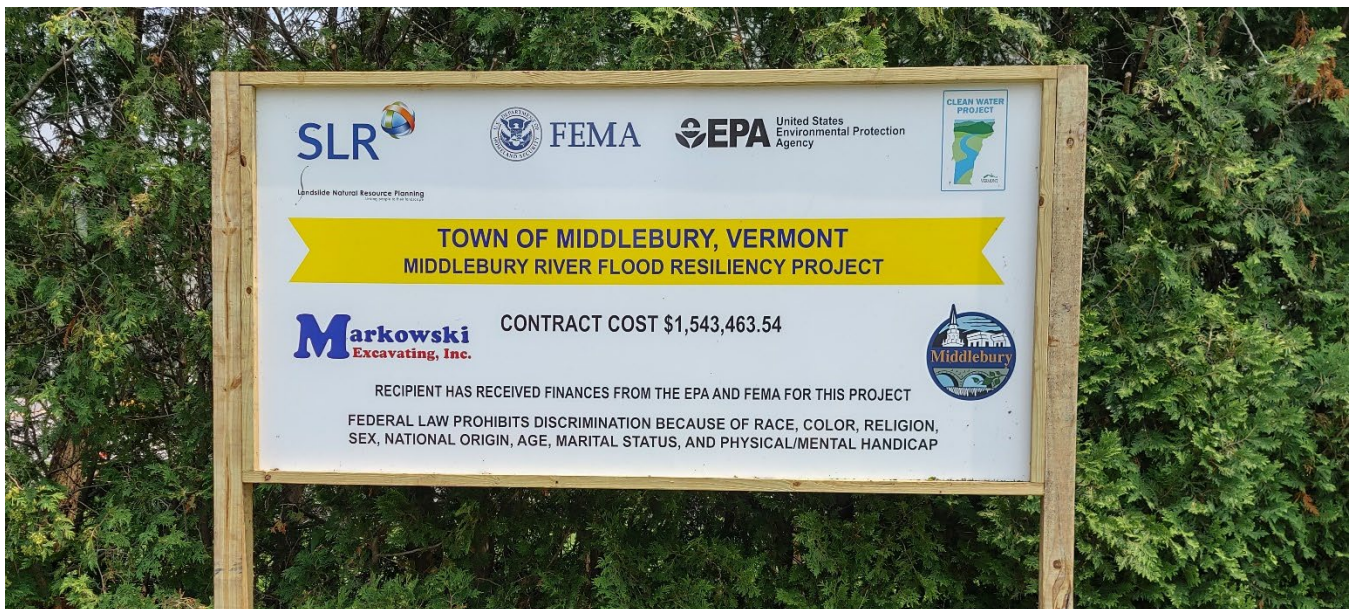
- The project sign has been installed at the end of Grist Mill Road in the eastern R.O.W. along the existing cedar hedgerow. Sign is visible to traffic on Route 125.

**Figure 1: Project Sign installed at the corner of Grist Mill Road and Route 125**

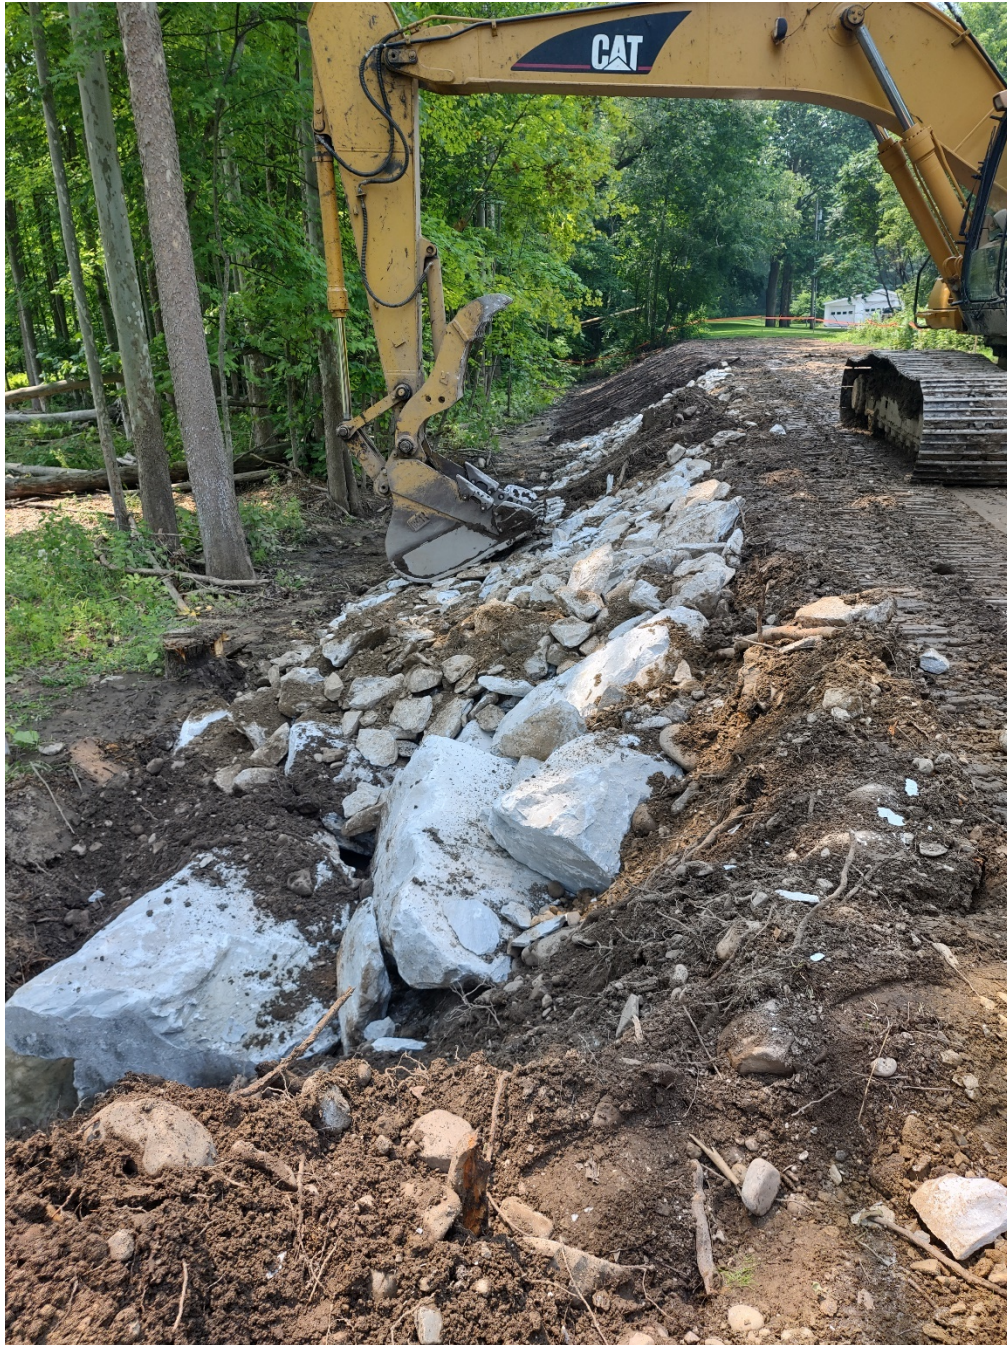
- Installation of stone armoring underway at Ossie Road Berm near the Murray parcel. Contractor noted that bottom of the keyway has been set approximately 1-foot below the channel bed elevation.

- Large armoring stone chinked with smaller material being installed, working from downstream to upstream. Stockpiled grubblings and topsoil being used to cover installed armoring.

***Figure 2: Installation of stone armoring along the Ossie Road Berm near the Murray parcel***

- Gravel bedding to be used when armoring sections directly adjacent to the river. Intention is to use gravel excavated from the nearby sediment bars and flood chutes for bedding to minimize import.

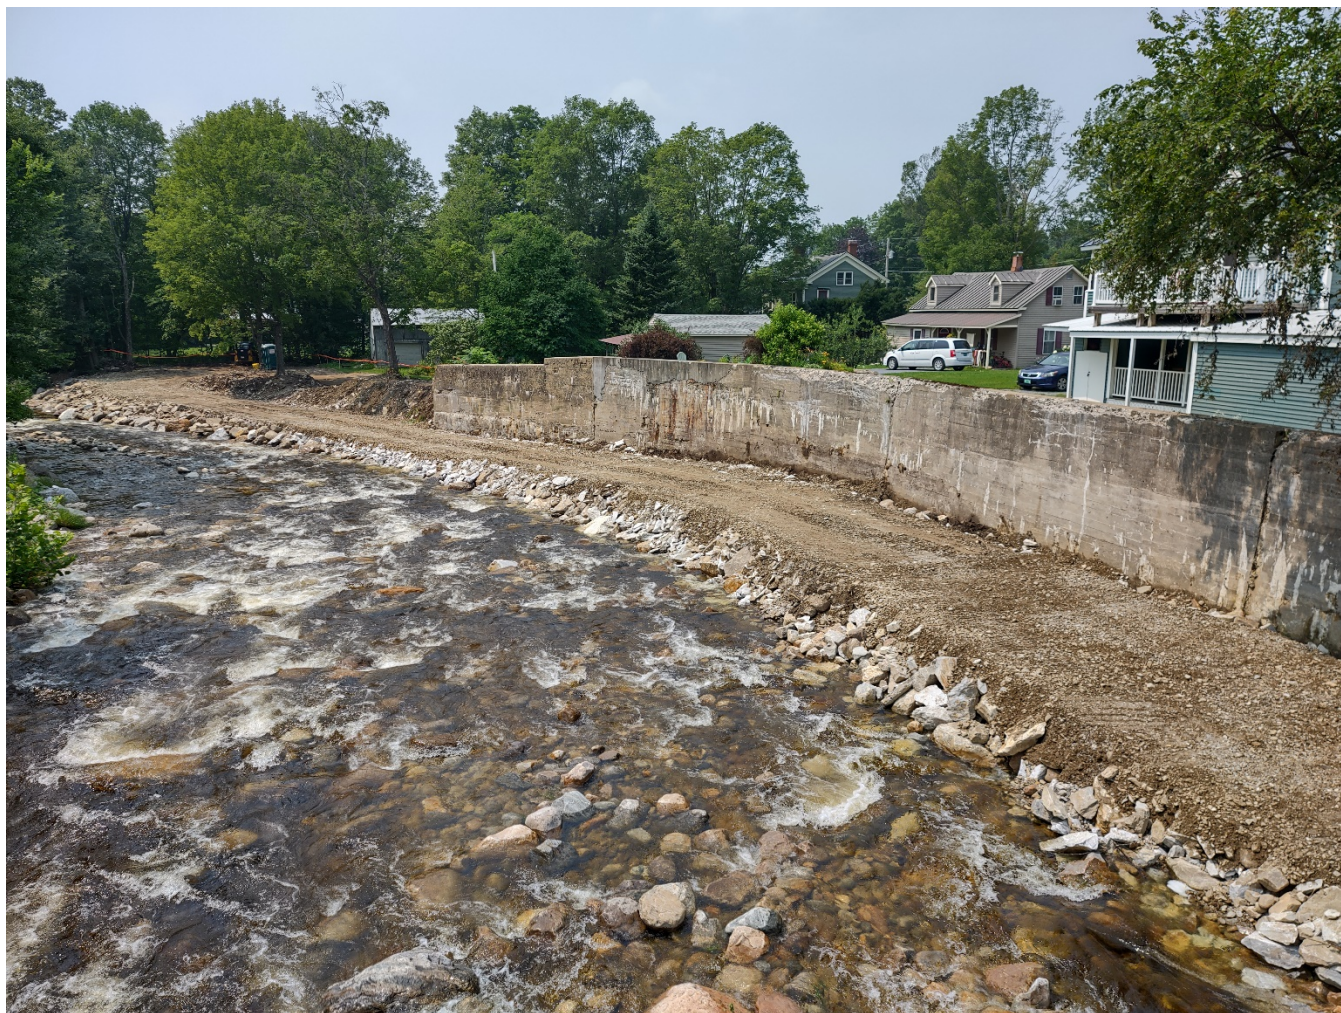
- Access road along flood wall properly built and pushing river south. Edge armored with large existing stone near wall and access road topped with gravel. No turbidity in river.
- Existing floodwall prepped and ready for coring.
- Berm downstream of existing flood wall has been largely removed. Flood contingency plan is to pull up road material or import large boulders to reform berm if large flood is predicted.
- Alternative ground anchors design has been submitted and approved by SLR. Submittal returned to Markowski on July 19<sup>th</sup>. Additional submittals to be reviewed when received.
- Contractor would like to remove the two remaining maple trees at the Marcus property. Contractor noted that removal would likely need to happen in mid-August to allow work on new floodwall. Contractor seeking price for two largest maples to replace.

***Figure 3: Access road along the flood wall looking downstream from the Grist Mill Road bridge***

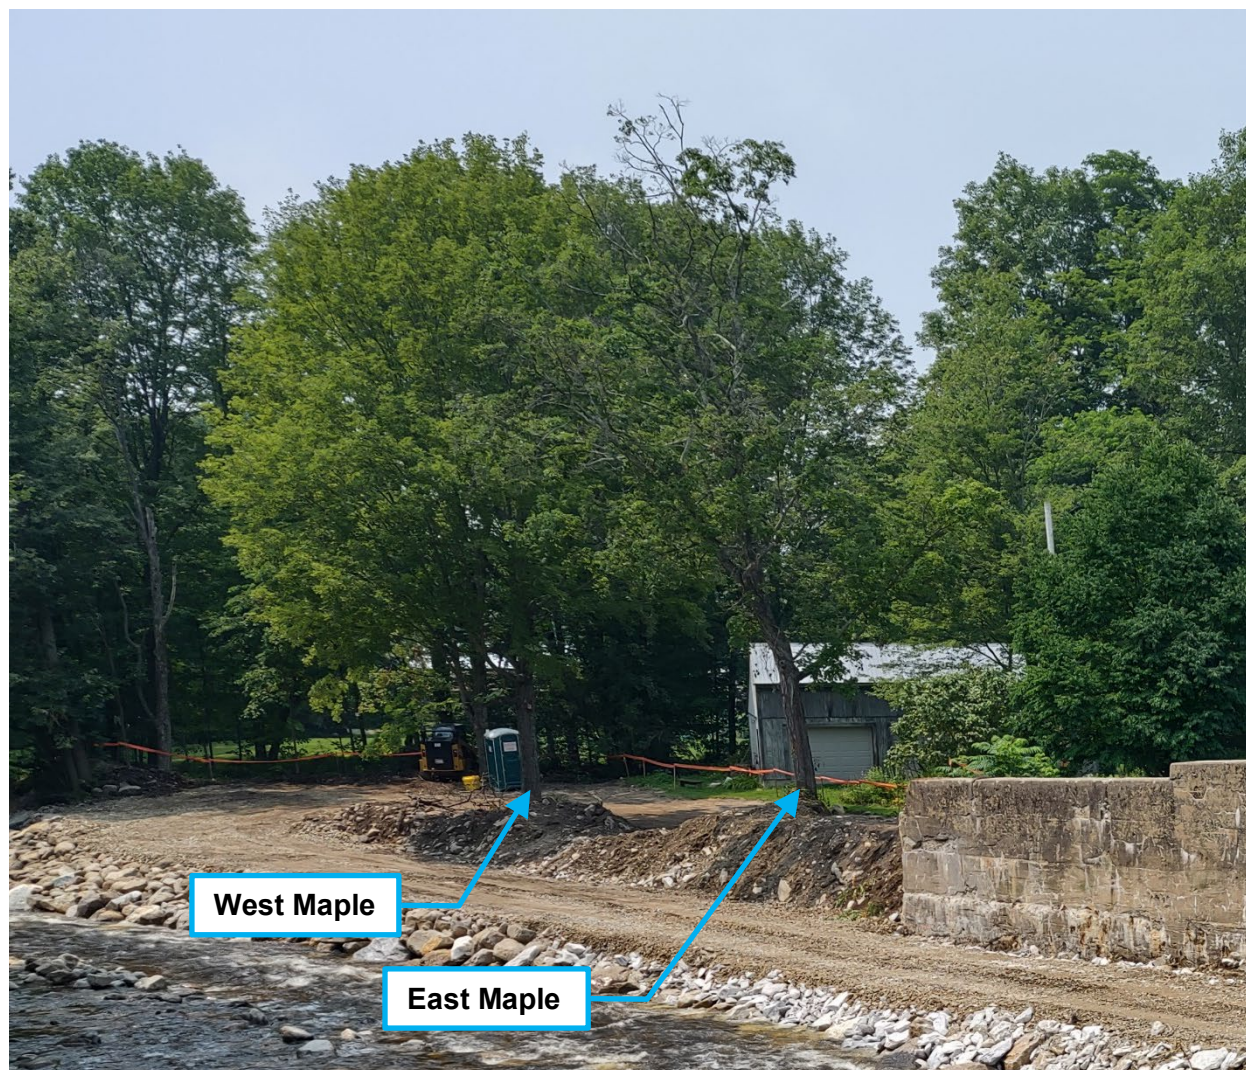
- Discussed two remaining maple trees at the Marcus property, the eastern-most tree appears to be in poor condition or diseased. The western-most tree is leaning towards the existing garage, the concern is

that when excavation for the new floodwall takes place, root system will be undermined and could compromise the stability and health of the tree.

**Figure 4: View of two remaining maple trees located near the proposed floodwall extension**

- Markowski to coordinate with landscaping contractor to seek pricing for replacing the two maples. The largest tree recommended for replacement by the landscaper is a 4-inch diameter tree. Cost for trees larger than that would increase significantly due to the need for special transport permitting. Markowski to check in on the approximate height of a 4-inch diameter replacement tree.
