CONSTRUCTION OBSERVATION REPORT

Date: July 29, 2021	Time On Site: 1:45 PM	Time Off Site: 4:30 PM
Project: Middlebury River Flood Resiliency Project (15032.00002)		
Observed By: Brian Cote		
Weather: Rain, $\pm 70^{\circ}\text{F}$, flows above normal

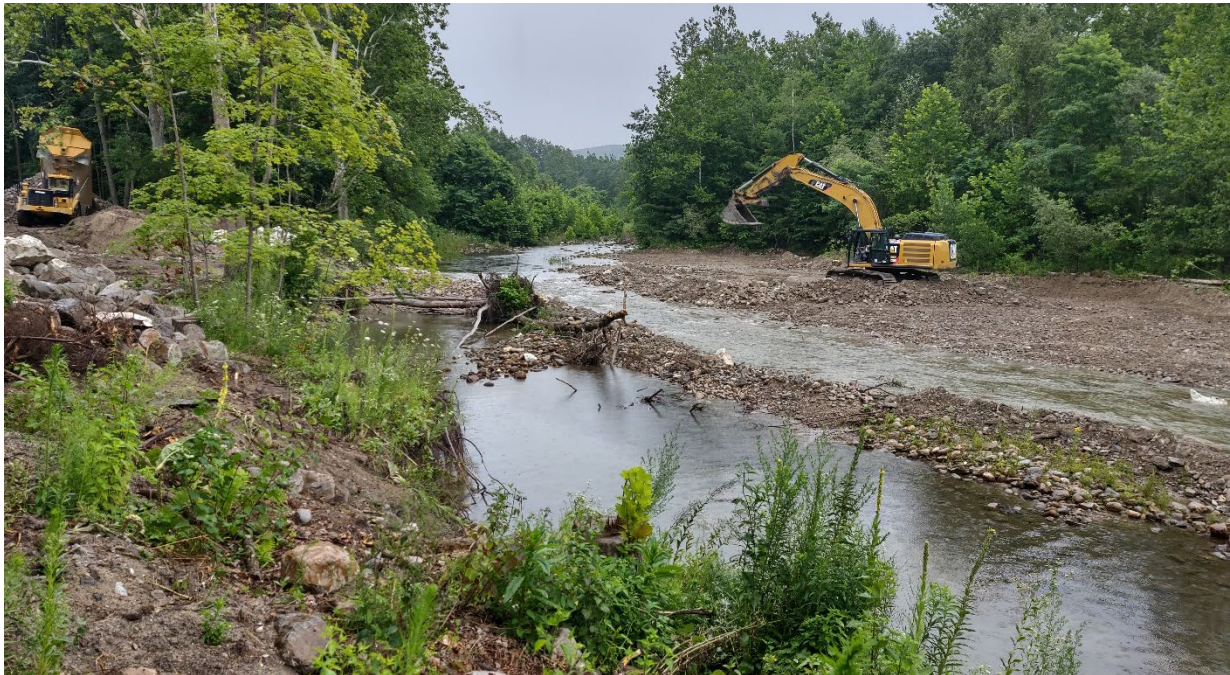
Figure 1: Sediment removal underway at gravel bar on the opposite side of river from Ossie Road berm, temporary isolation berm to keep flow from berm armoring work area visible in center of photo.

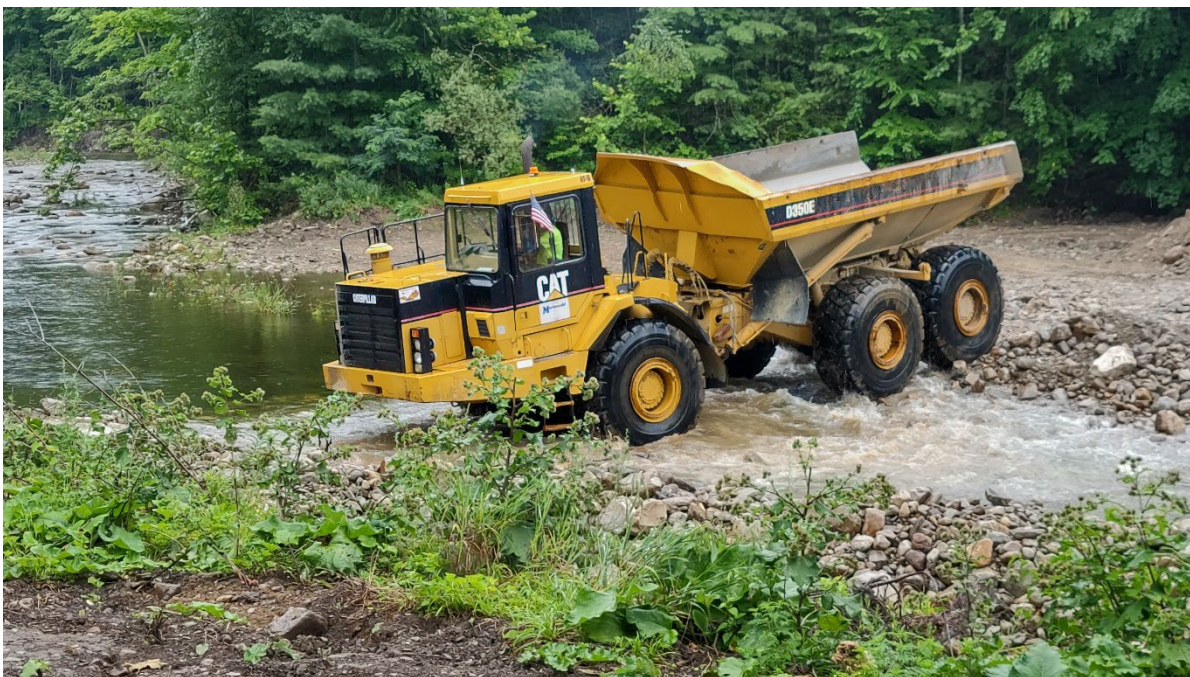
- The ford water crossing to access the gravel bar and flood chutes is working well, contractor has shaped to minimize buildup of water upstream.
- Off-road haul unit easily able to cross river, traveling a short distance to offload excavated sediment on top of the fill area at the Murray parcel, where it is then loaded into on-road dump trucks and hauled to the Brandon recycling facility. Minor discharges were observed when the haul unit crossed.

Figure 2: Haul unit crossing (reversing) at ford, discharge at crossing limited to fines washing off of tires that quickly dissipates before reaching end of work area.

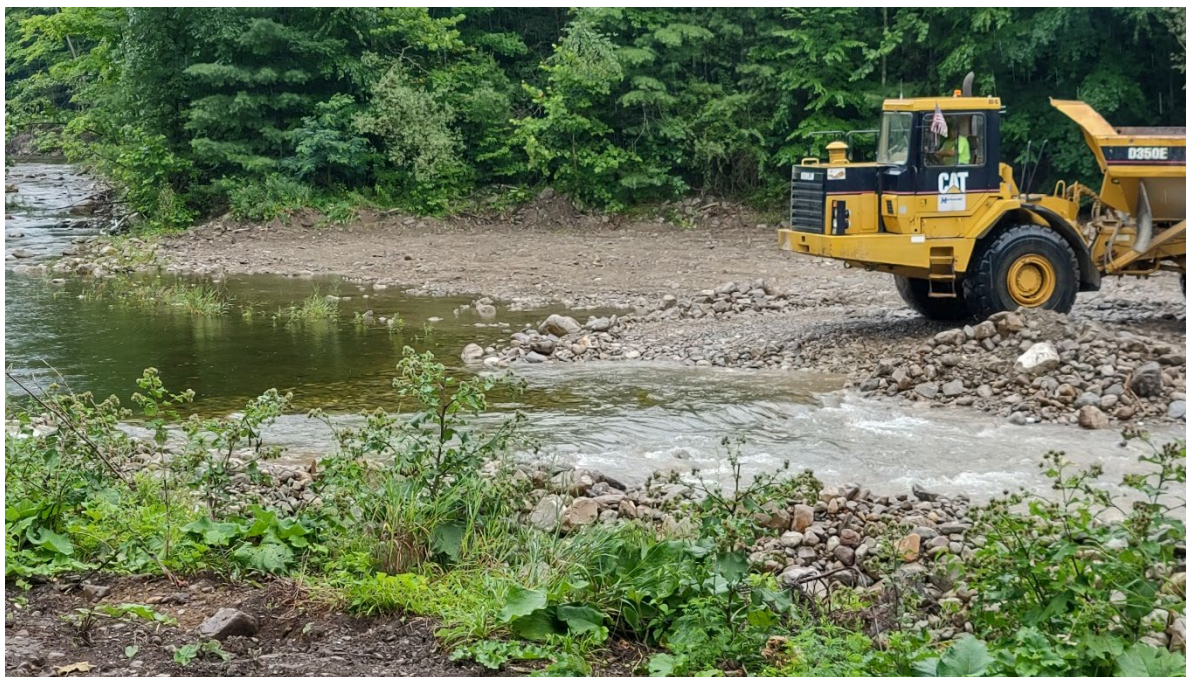
Figure 3: Flow has largely cleared within a minute after haul unit crossing.

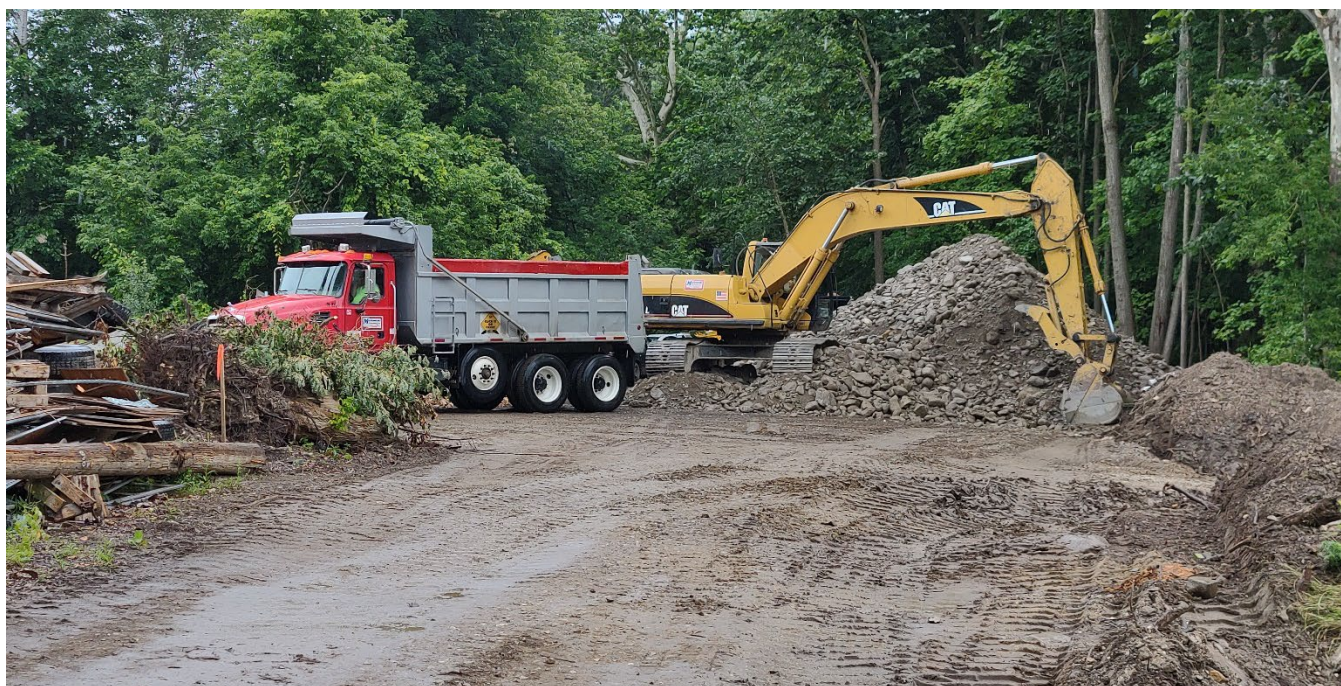
Figure 4: Excavated sediment being loaded into on-road dump trucks at the Murray parcel fill area.

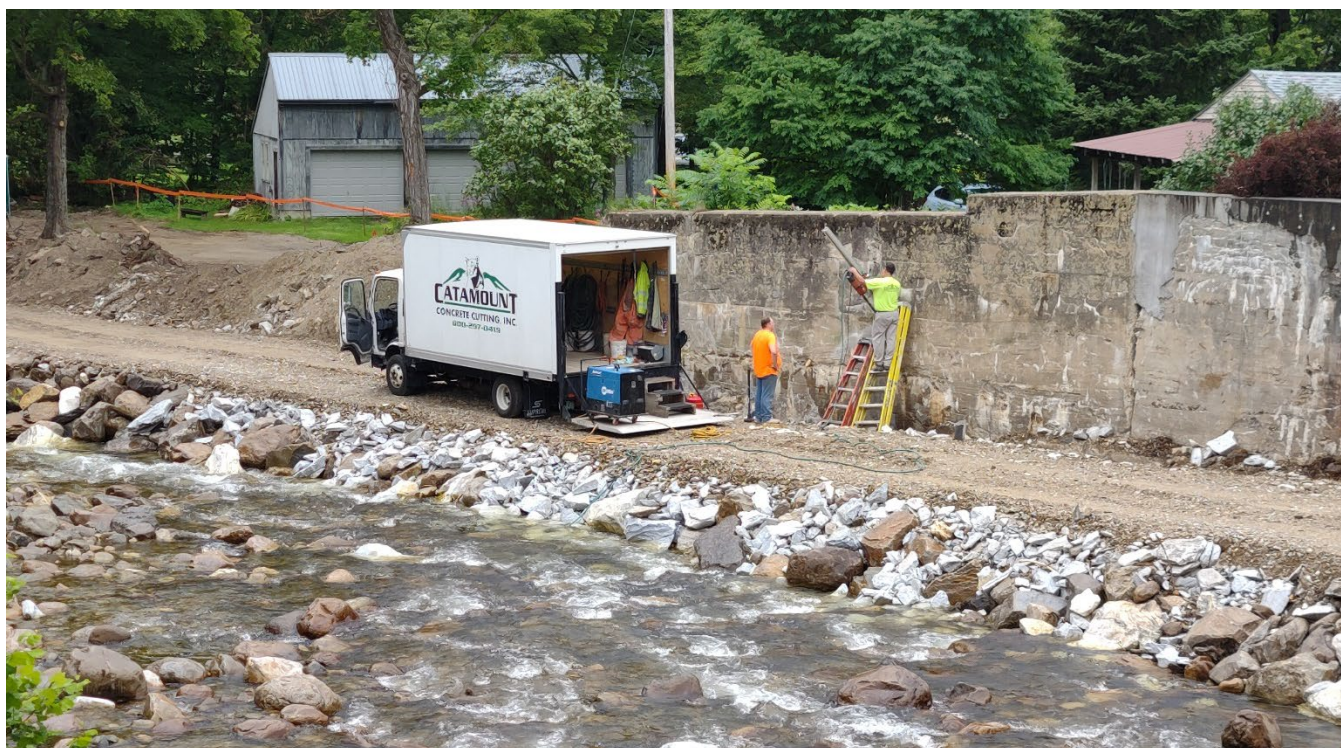
- Reminded the Contractor that the flow must remain in the main channel of the river during and after work is complete.
- Coring of the floodwall is moving slower than anticipated. By the end of day on Thursday July 29th, the first hole had advanced a little over 7 feet, however not completely through the wall.

- The concrete in the floodwall contains river cobble that was used in the mix, when the coring bit hits a cobble, coring can slow significantly.
- The first few holes at the downstream end of the wall are lower, where the wall may be thicker also.

Figure 5: Coring operation underway at the Grist Mill Road floodwall.
