CONSTRUCTION OBSERVATION REPORT

Date:August 3, 2021Time On Site:9:45 AMTime Off Site:2:00 PMProject:Middlebury River Flood Resiliency Project (15032.00002)Observed By:Brian CoteWeather:Sunny, ±70°F, flows above normal and dropping

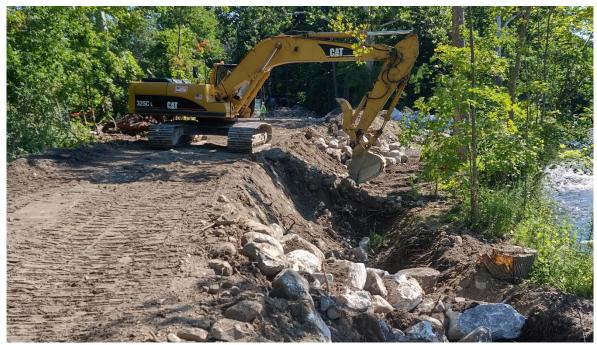
- Installation of stone armoring along the river edge is complete, alignment to follow existing berm that turns away from the river.
- Contractor installed several root wads with log into the stone armoring, root wad set at the waterline.

Figure 1: Stone armor installation at the Ossie Road Berm near the Murray Parcel.

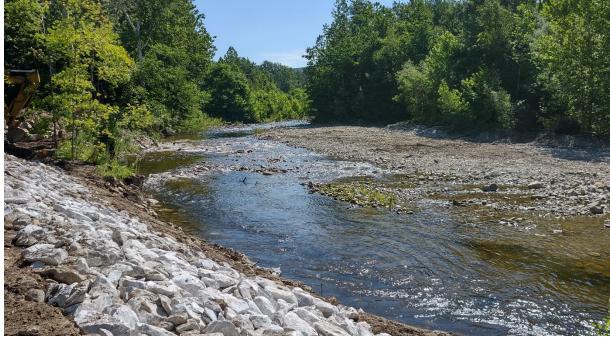
- Sediment on Gravel Bar A, B, and C and at Flood Chute 1A and 1B has been removed down to the water level. Contractor moving excavator over to Goodro Lumber to begin prepping the work area.

Figure 2: View of gravel bar after sediment removal looking upstream, flows remain higher than average, stone armoring in the foreground to be covered with grubbings, seed and mulch, and joint plantings.

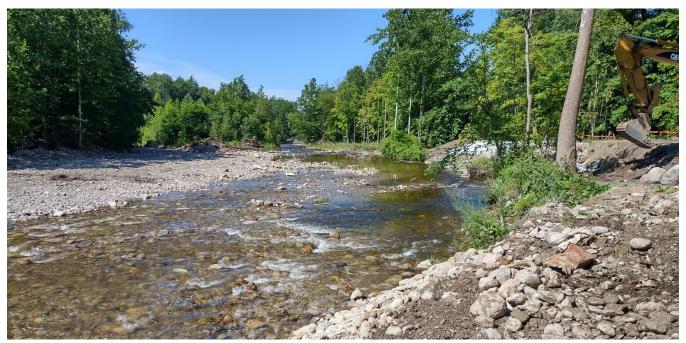
Figure 3: View of gravel bar after sediment removal looking downstream, flows remain higher than average for this time of year, with water flowing on the remaining edge of gravel bar.

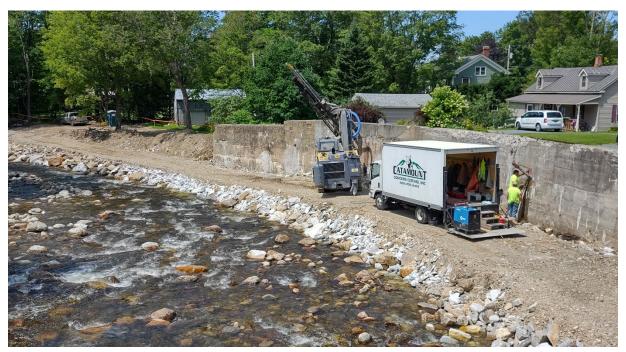
- Rock driller delivered to the Grist Mill Road floodwall to continue work coring through the existing wall. A combination of concrete coring and rock drilling underway.

- Concrete coring operation being used to core 1-2 feet into the wall to create a pilot hole, then rock driller completes the remainder of the hole.
- While on site, 9 holes were underway at various stages of completion. 3 holes were thru the wall and complete and a 4th was underway, and 5 pilot holes were complete with the 6th underway.

Figure 4: Concrete coring and rock drilling operation set up at the Grist Mill Road floodwall..

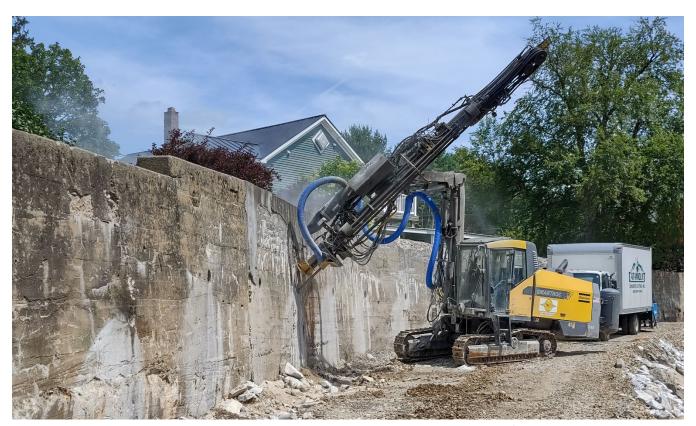
Figure 5: Rock driller completing holes at the Grist Mill Road floodwall.
