# **CONSTRUCTION OBSERVATION REPORT**

Date: A	ıgust 11, 2021	Time On Site:	9:45 AM	Time Off Site:	2:00 PM
Project: Middlebury River Flood Resiliency Project (15032.00002)					
<b>Observed By:</b> Brian Cote, accompanied by Kishor Patel					
Weather	Partly Cloudy, ±80°F	, flows above nor	mal, rain over night

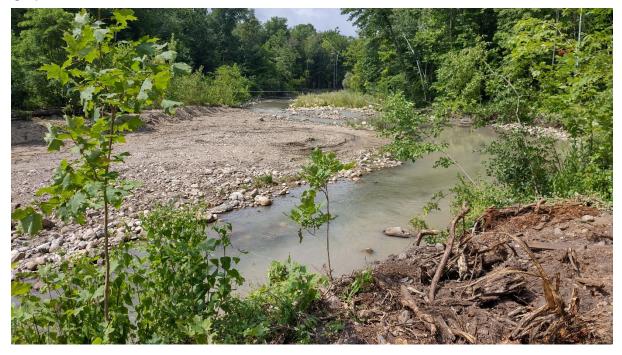
- Sediment removal at Bar D underway near Goodro Lumber. Sediment loaded into the haul unit, transported across the river at a water crossing / ford, then stockpiled on the berm. Front-end loader then used to load sediment into on-road dump trucks for transport to the Brandon disposal site.
- While on site, the haul unit hit a spot of soft material under the river gravel causing discharge of turbid water. The contractor was immediately asked to stop crossing and to move the crossing away from the problem spot. After moving, discharges were minimal once again.
- Work installing stone armoring along the Ossie Road berm near the Murray parcel is complete. Topsoil and grubbings have been placed over the top of the armored slope. Seed has been spread and the site is awaiting mulch. Rutting remains on top of the berm at the downstream most end of the work area and will need to be smoothed.

Figure 1: Sediment removal from Sediment Bar D, discharge of turbidity due to soft spot at water crossing visible in photo. Water crossing adjusted to avoid soft spot and minimize discharges.

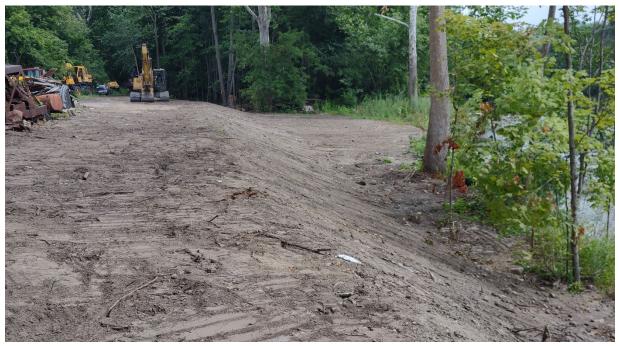
Figure 2: View of armored Ossie Road berm at the Murray parcel, topsoil and grubbings placed over the stone armoring, site awaiting mulch, live stakes to be planted at a later date.

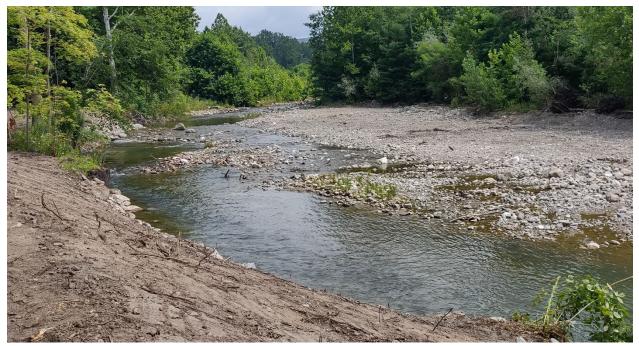
Figure 3: Gravel bar after sediment removal at the Ossie Road berm work site near the Murray parcel.

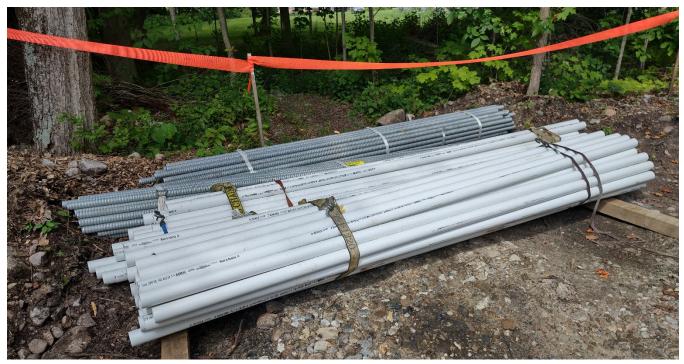
*Figure 4: Ground anchor rods and PVC piping staged at the Grist Mill Road floodwall awaiting installation.*
