# CONSTRUCTION OBSERVATION REPORT

<b>Date:</b> August 17, 2021	<b>Time On Site:</b> 10:15 AM	<b>Time Off Site:</b> 2:45 PM
<b>Project:</b> Middlebury River Flood Resiliency Project (15032.00002)		
<b>Observed By:</b> Brian Cote		
<b>Weather:</b> Cloudy with periodic rain, $\pm 75^{\circ}\text{F}$ , flows above average

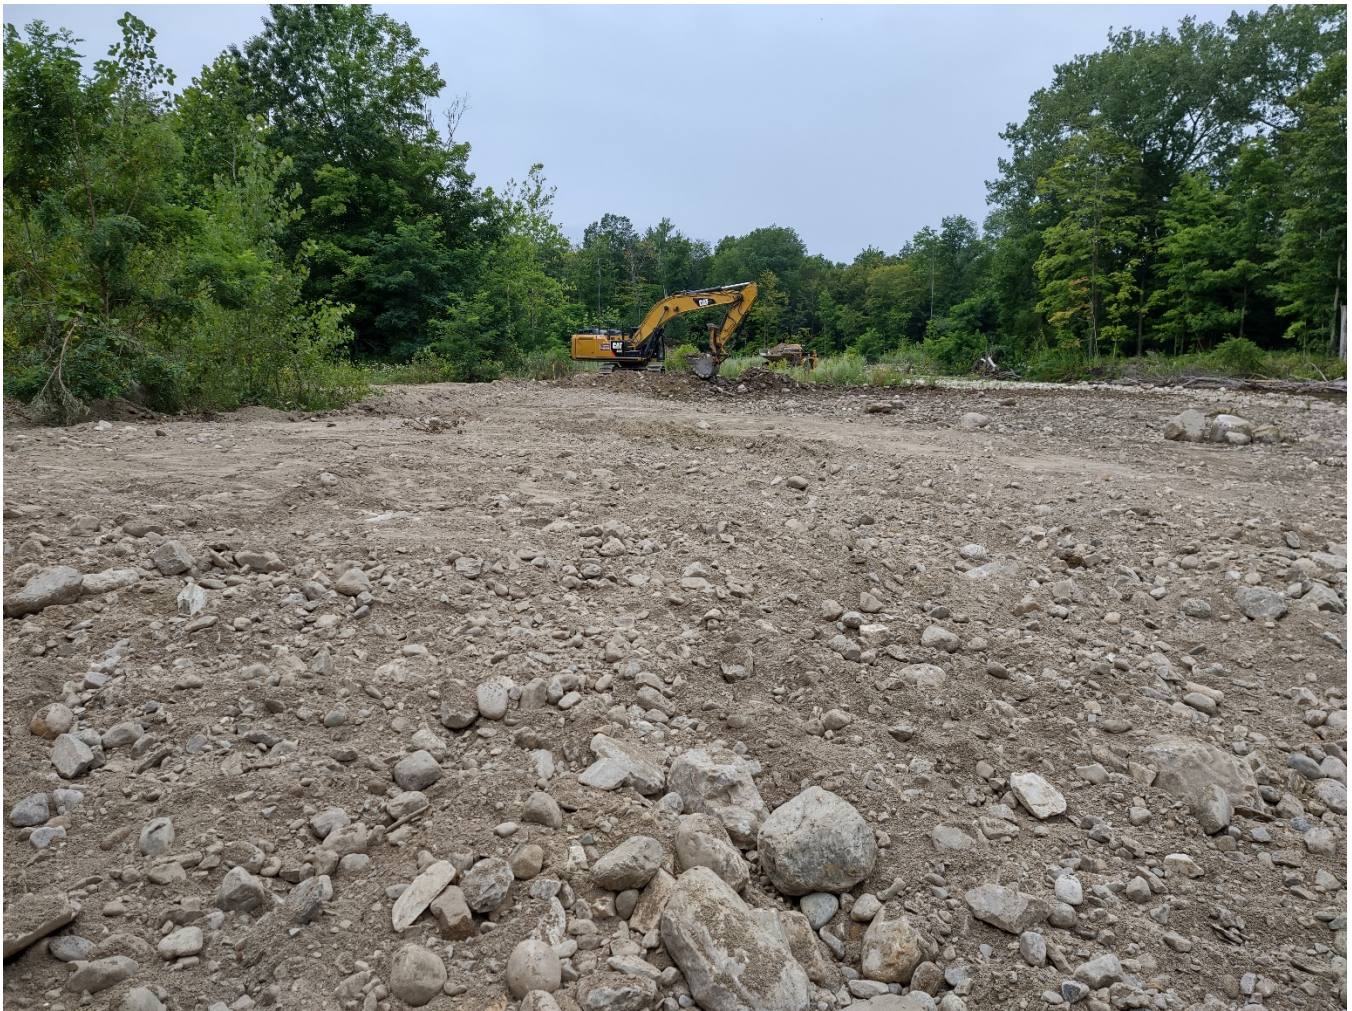
- Reviewed the sediment removal at Bar F with the Contractor, discussed the removal work that remains and limits of removal. Also reviewed layout and extent of sediment removal to open Chute 3A.

**Figure 1: Gravel removal underway at Sediment Bar F.**

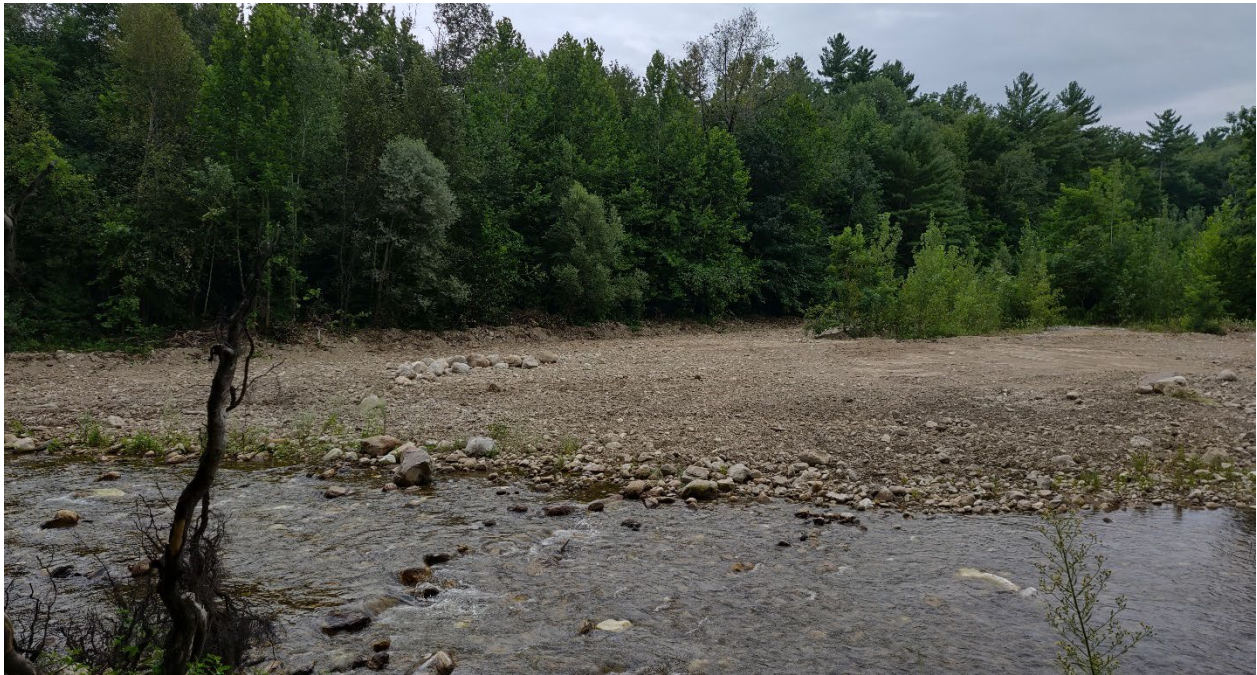
**Figure 2: View of completed Flood Chute 3B and portion of Sediment Bar F.**

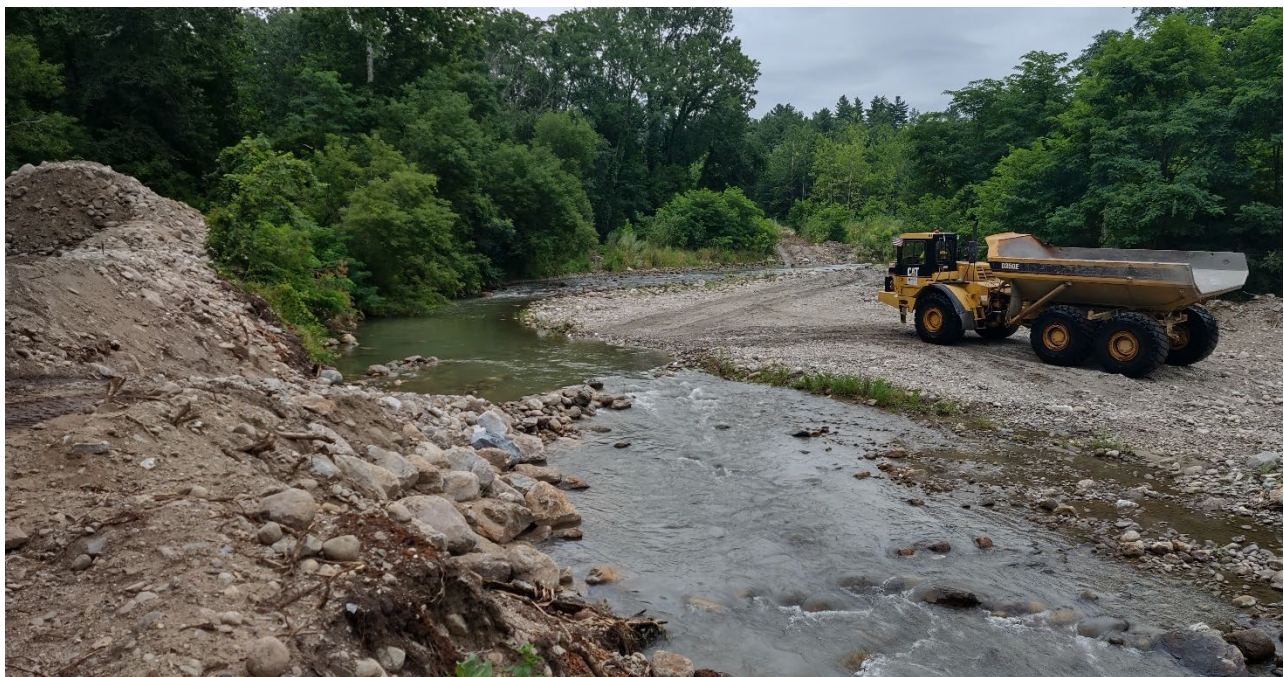
- Water crossings continue to work well to minimize discharge of turbidity to the extent practicable. Contractor is monitoring the crossings and making adjustments or repairs as needed so that crossings continue to limit discharge.

**Figure 3: View of water crossing at the Goodro Lumber work site, two haul units transporting excavated sediment so that excavation work can be completed as soon as possible, and river crossings restored.**

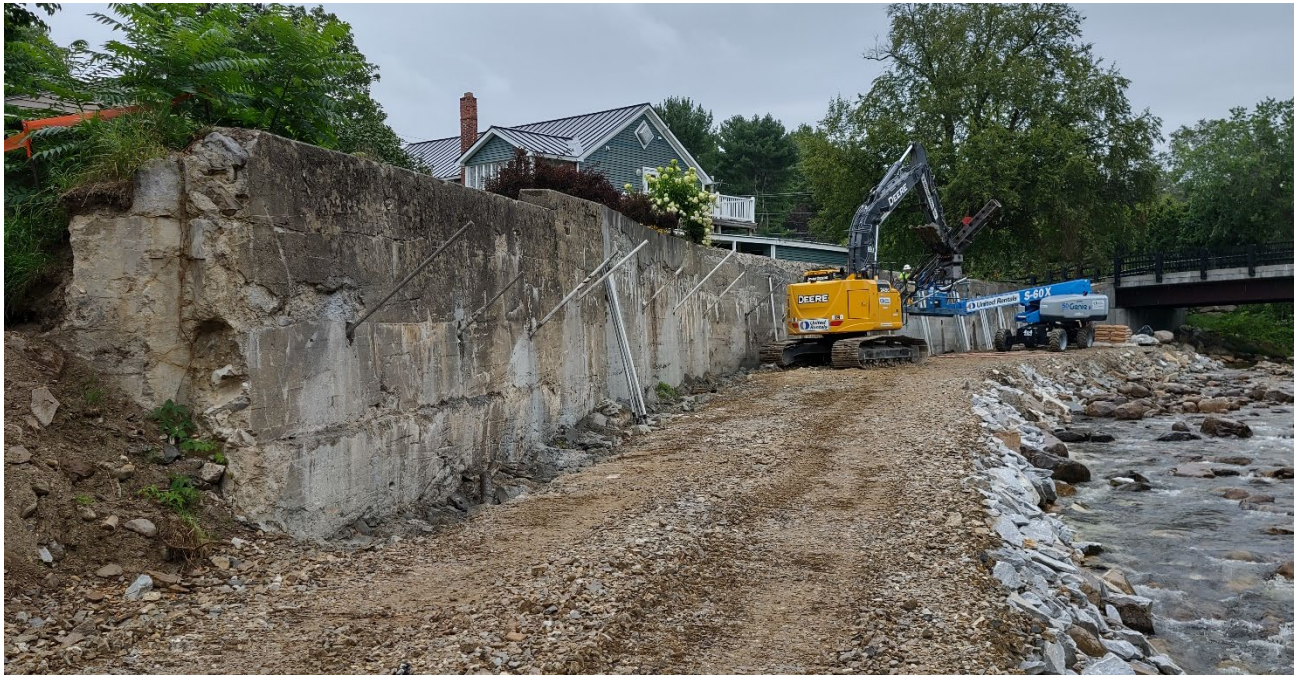
- Ground anchor installation continues, Contractor was working on 11<sup>th</sup> anchor installation out of 18 total prior to leaving the site.
- On Friday August 13<sup>th</sup>, the rig installing the ground anchors had an equipment failure and had to be repaired. As a result, one of the anchors fell into the hole they were work on (5<sup>th</sup> hole from the downstream end of the existing wall). SLR Engineers are working with the Contractor to determine if there is a solution that will maintain the designed stability, however there is a chance that a new hole will need to be cored through the wall and a ground anchor installed.

***Figure 4: ground anchor installation underway at the Grist Mill Road Floodwall.***

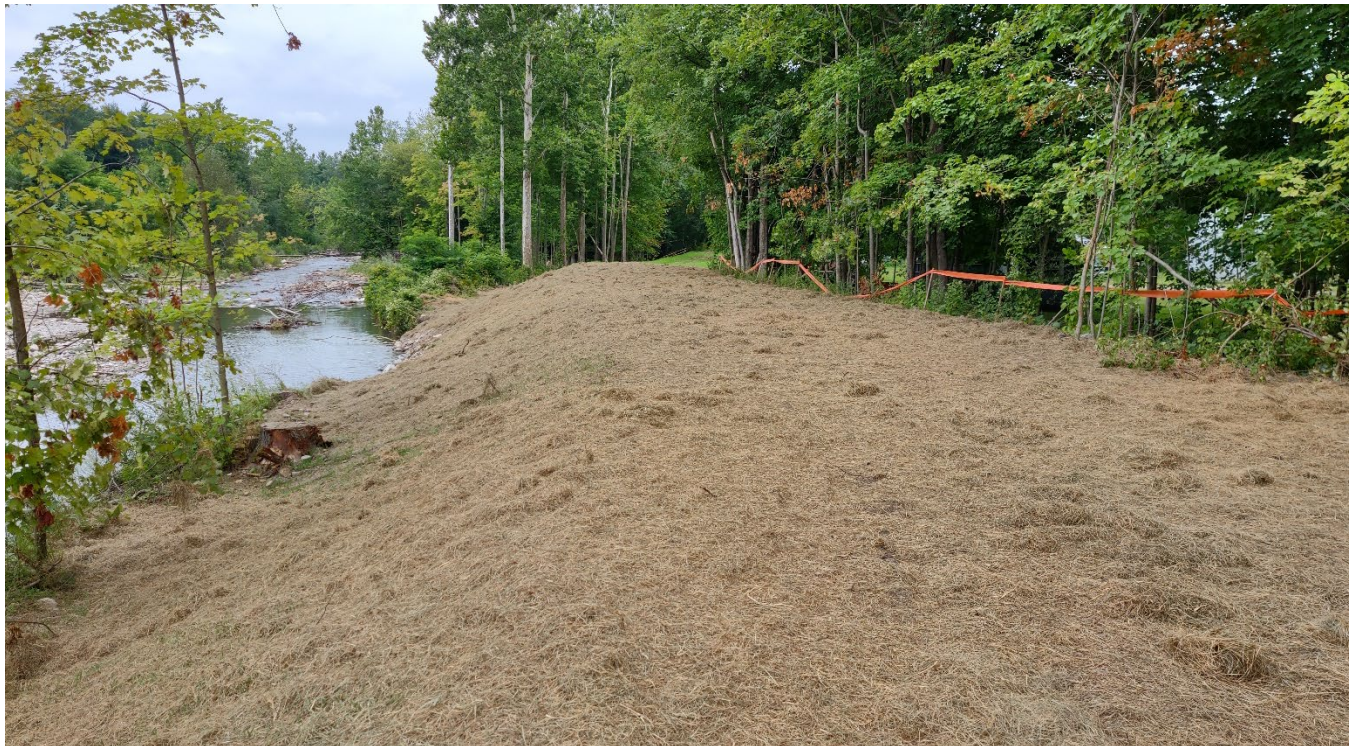
- Disturbed areas at the Ossie Road Berm near the Murray parcel have been seeded and mulched. The portion of the berm that had been rutted has been smoothed, reseeded, and mulched. Live stakes along the armored berm near the river will be planted later this fall.

***Figure 5: Work area at the Ossie Road Berm near the Murray parcel has been seeded and mulched.***
