# CONSTRUCTION OBSERVATION REPORT

<b>Date:</b> September 2, 2021	<b>Time On Site:</b> 4:00 PM	<b>Time Off Site:</b> 4:45 PM
<b>Project:</b> Middlebury River Flood Resiliency Project (15032.00002)		
<b>Observed By:</b> Roy Schiff		
<b>Weather:</b> Partly Sunny, $\pm 75^{\circ}\text{F}$ , flows average

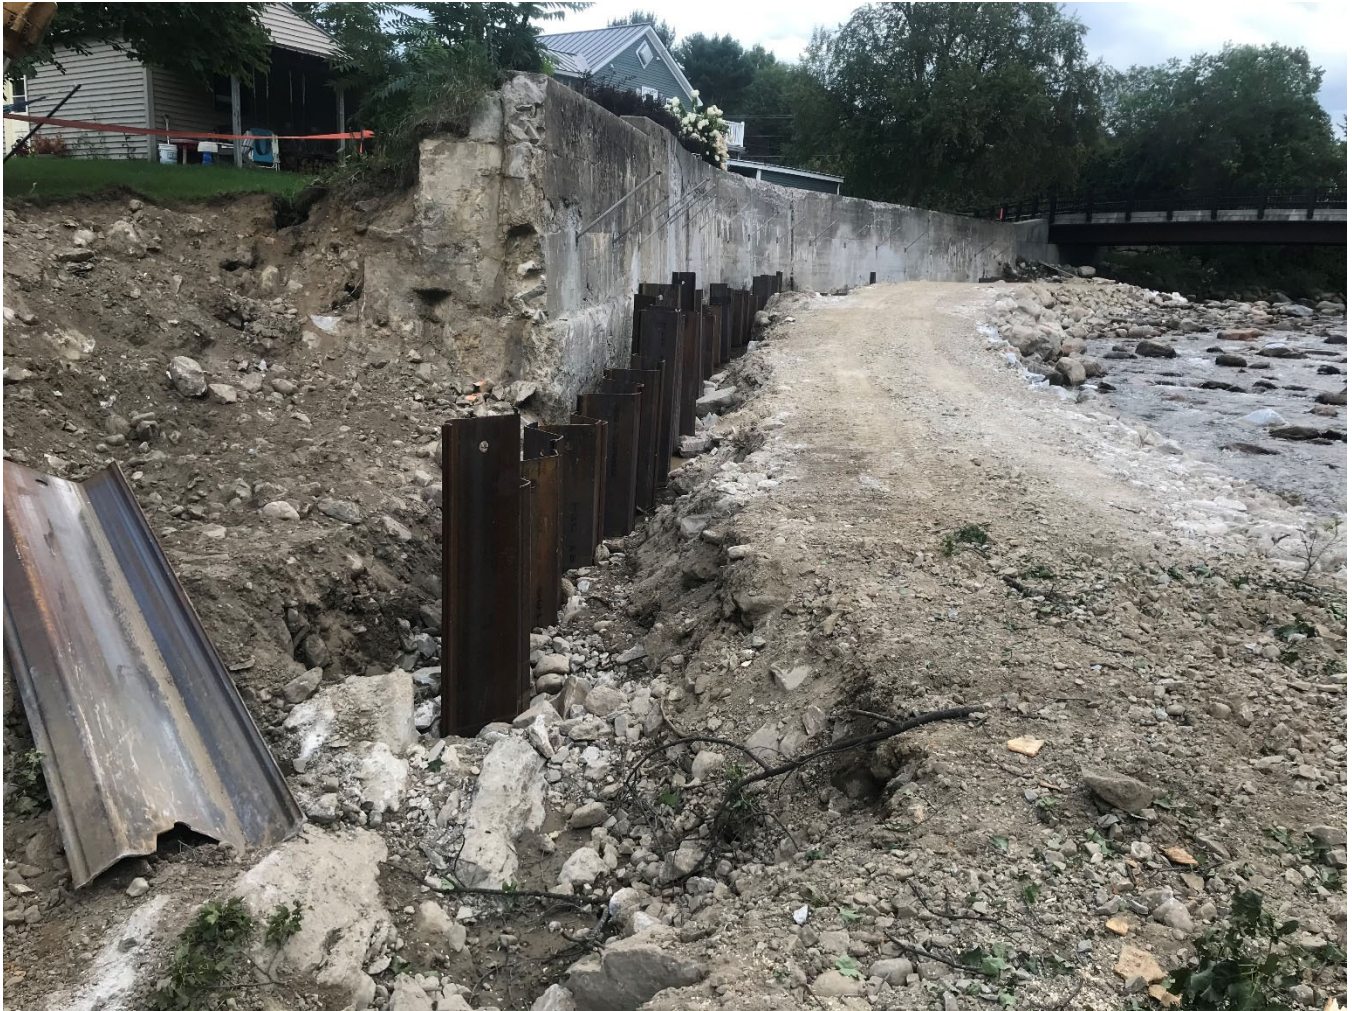
**Figure 1: Driven sheeting.**

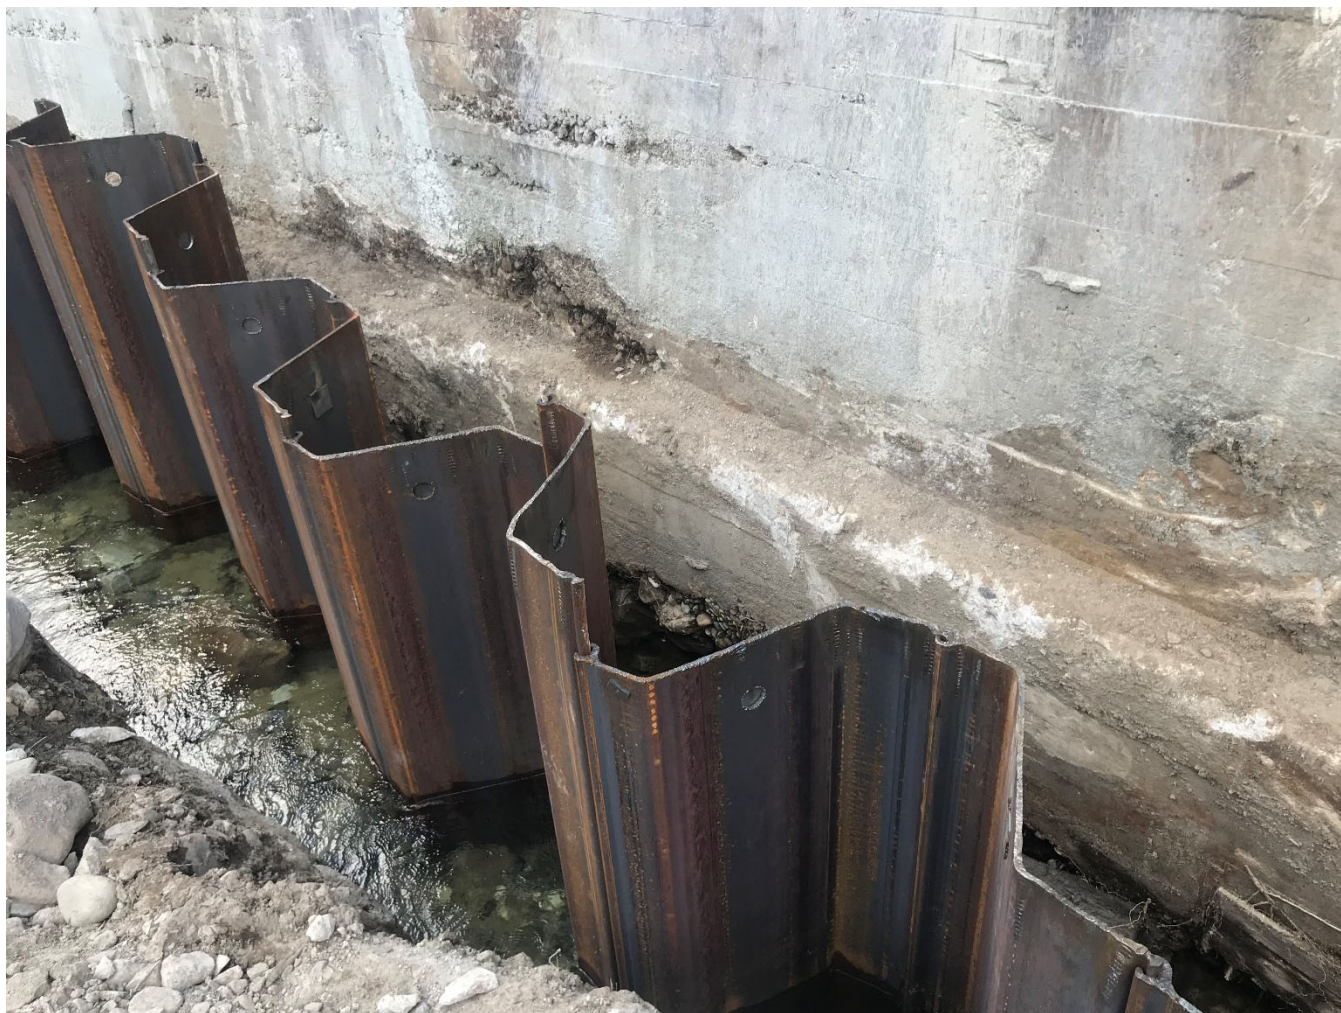
***Figure 2: Close-up of driven sheeting.***
