# CONSTRUCTION OBSERVATION REPORT

<b>Date:</b> September 14, 2021	<b>Time On Site:</b> 9:00AM / 3:00PM	<b>Time Off Site:</b> 10:00AM/ 4:00PM
<b>Project:</b> Middlebury River Flood Resiliency Project (15032.00002)		
<b>Observed By:</b> Roy Schiff		
<b>Weather:</b> Partly Sunny, $\pm 75^{\circ}\text{F}$ , flows normal

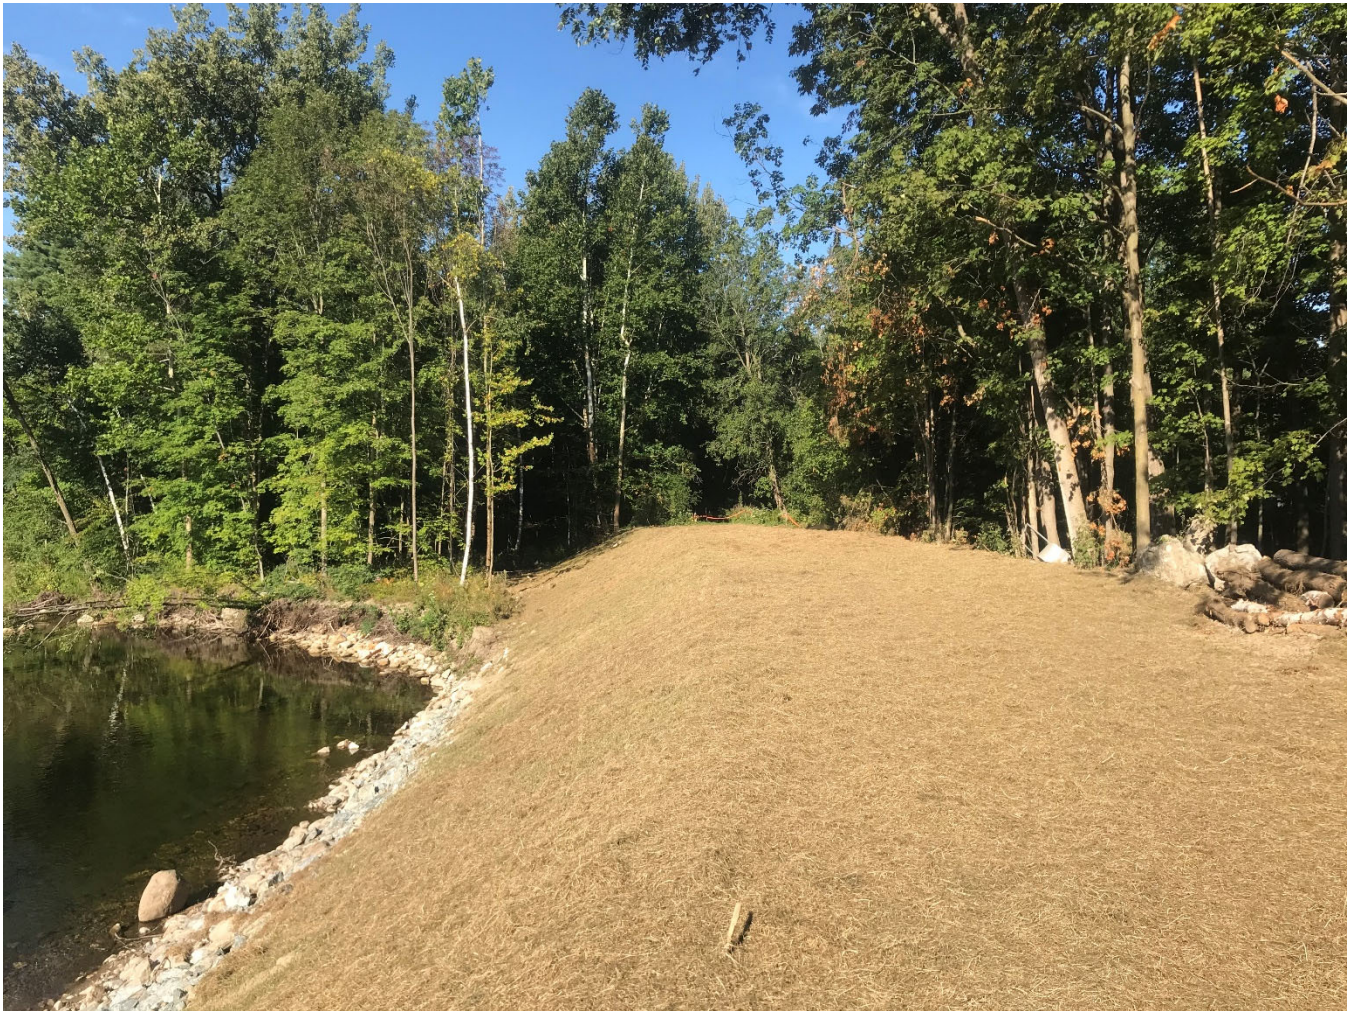
***Figure 1: Seed and mulch at Goodro's site.***

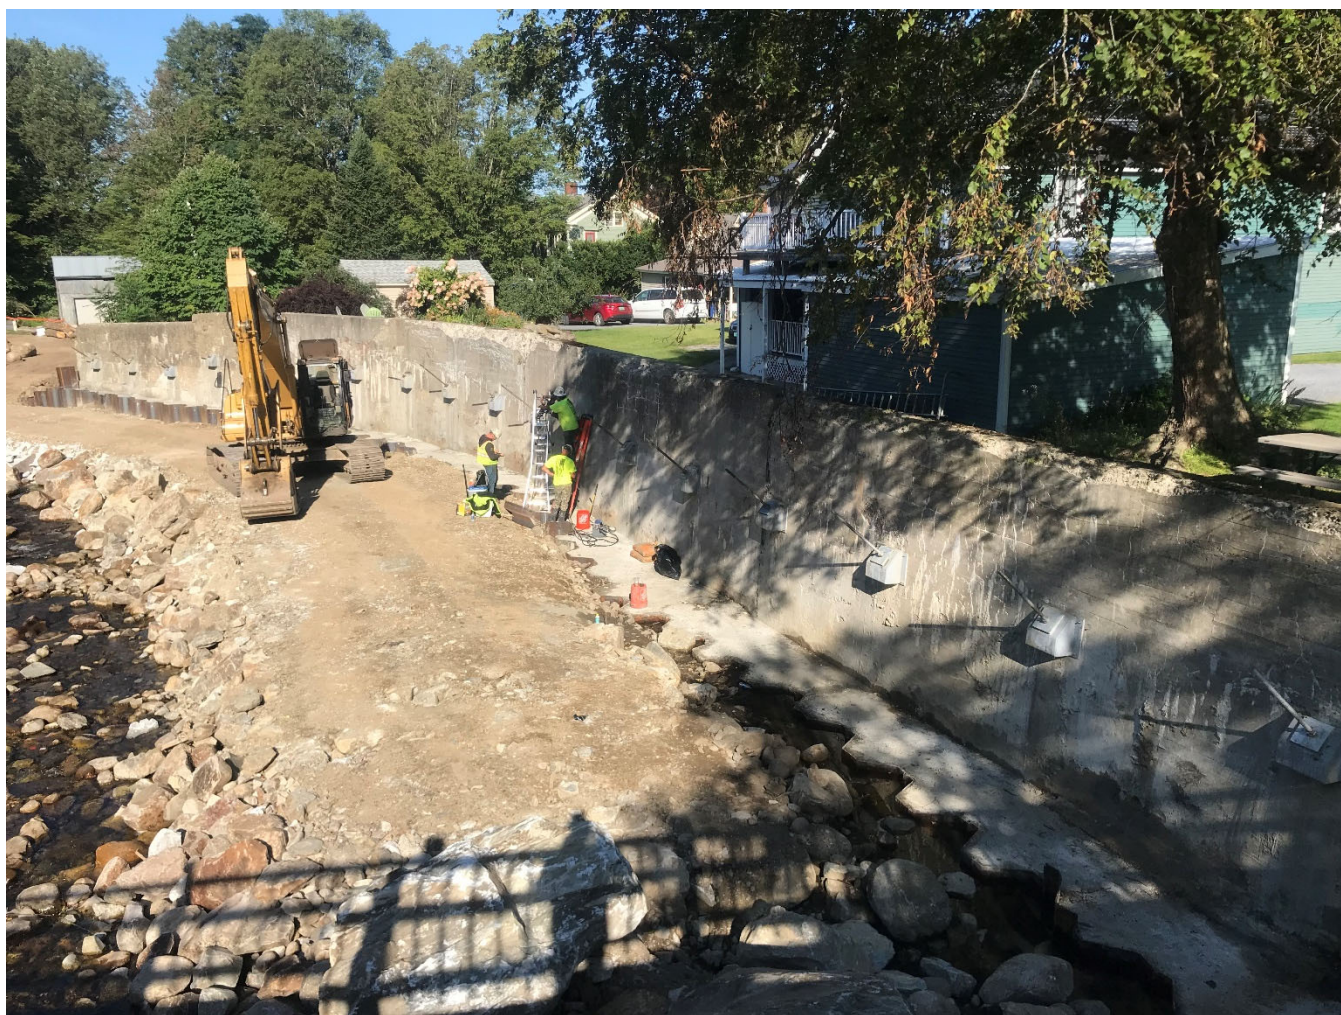
**Figure 2: Ground anchor testing.**

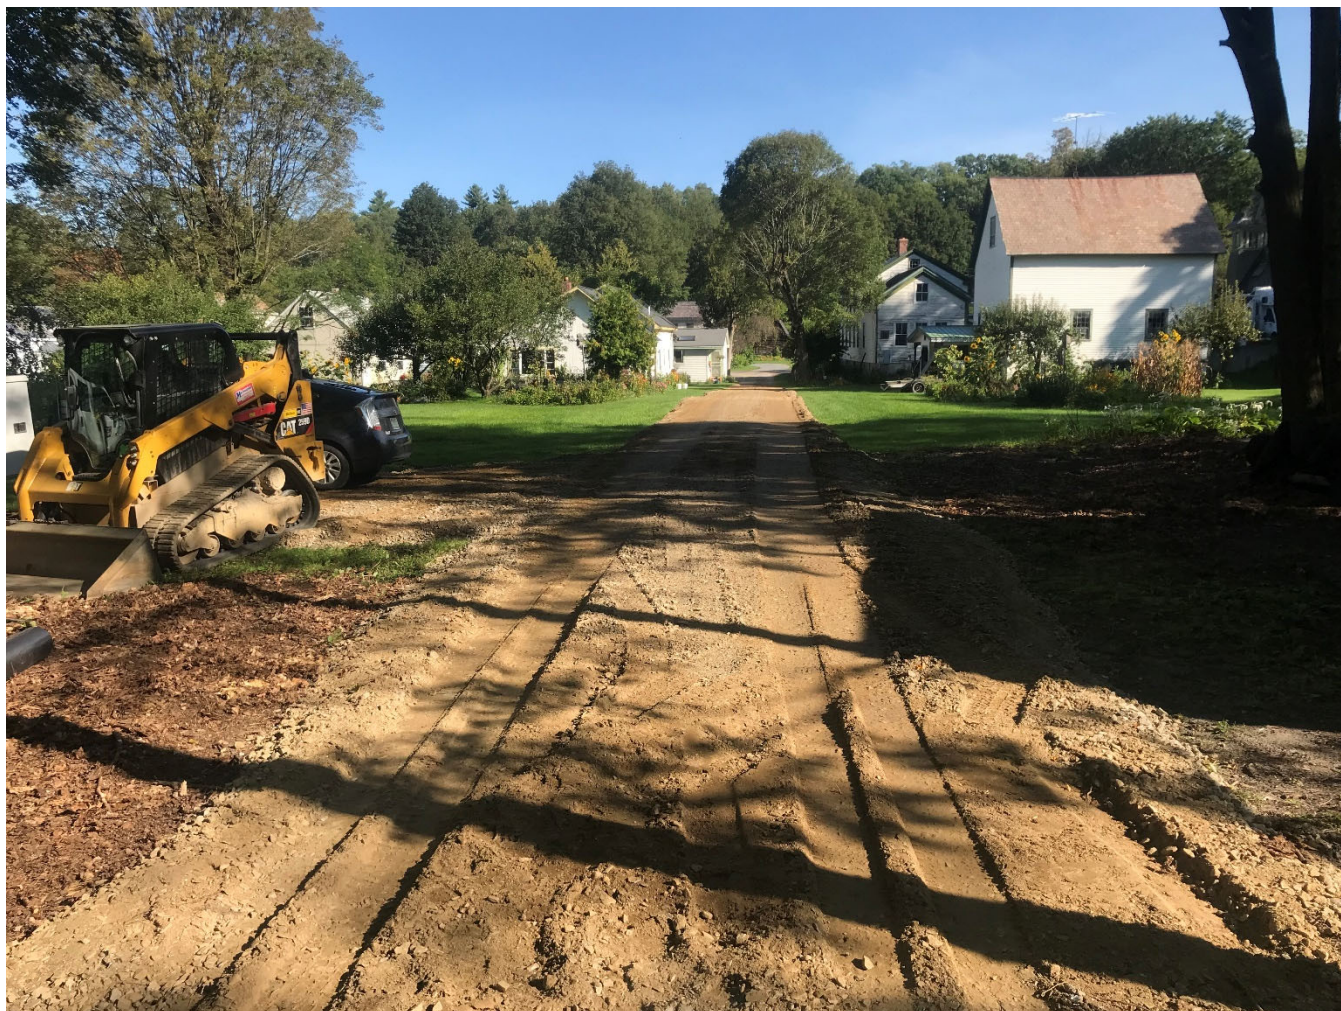
***Figure 3: Access road at upstream site.***

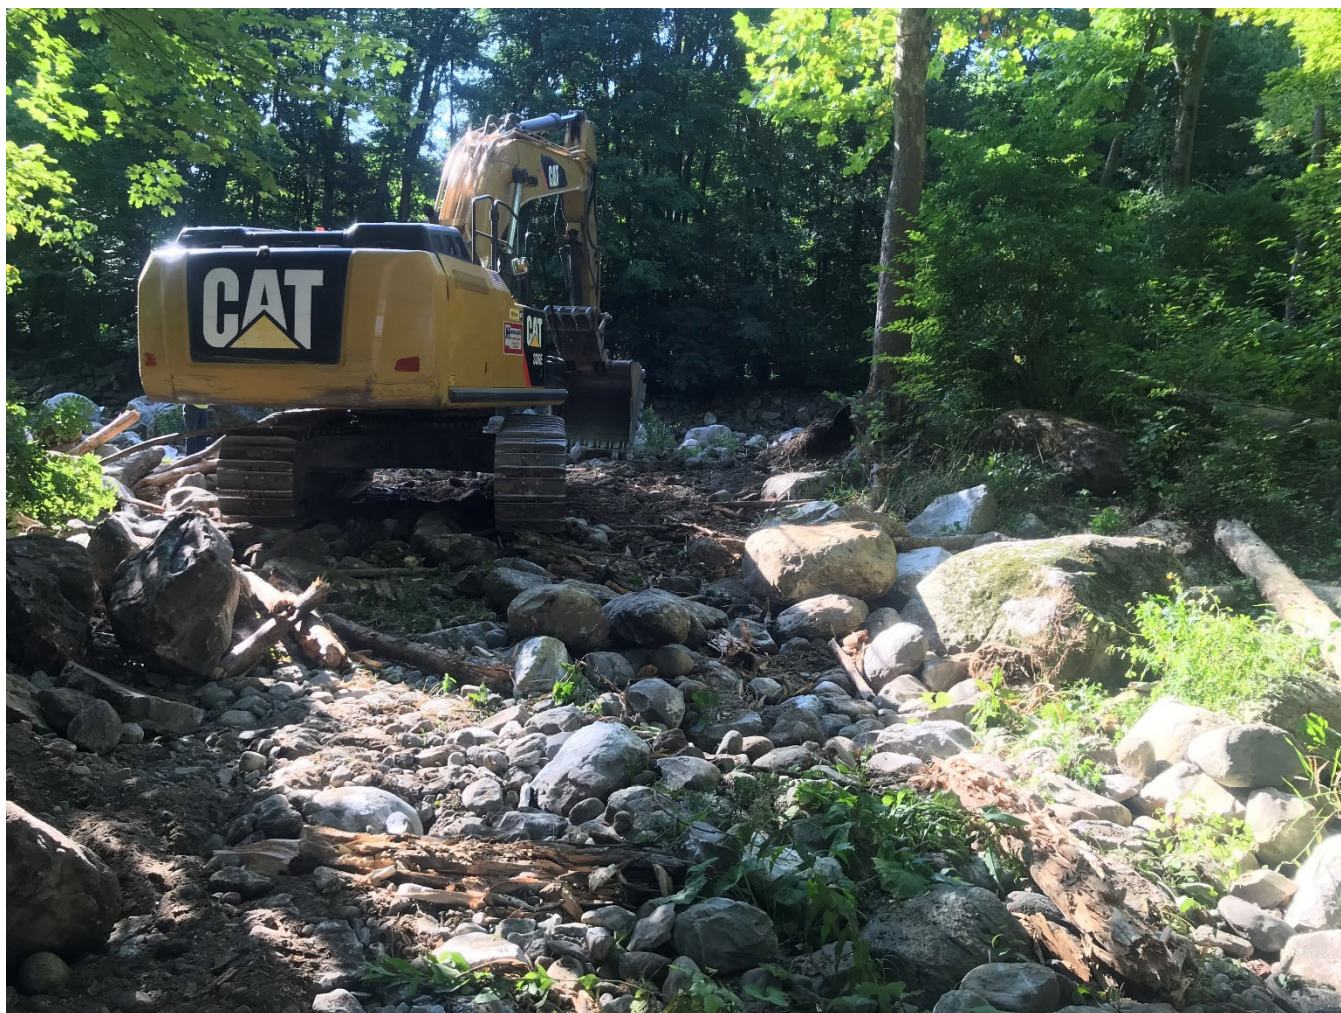
***Figure 4: Cleaned out upstream flood chute.***

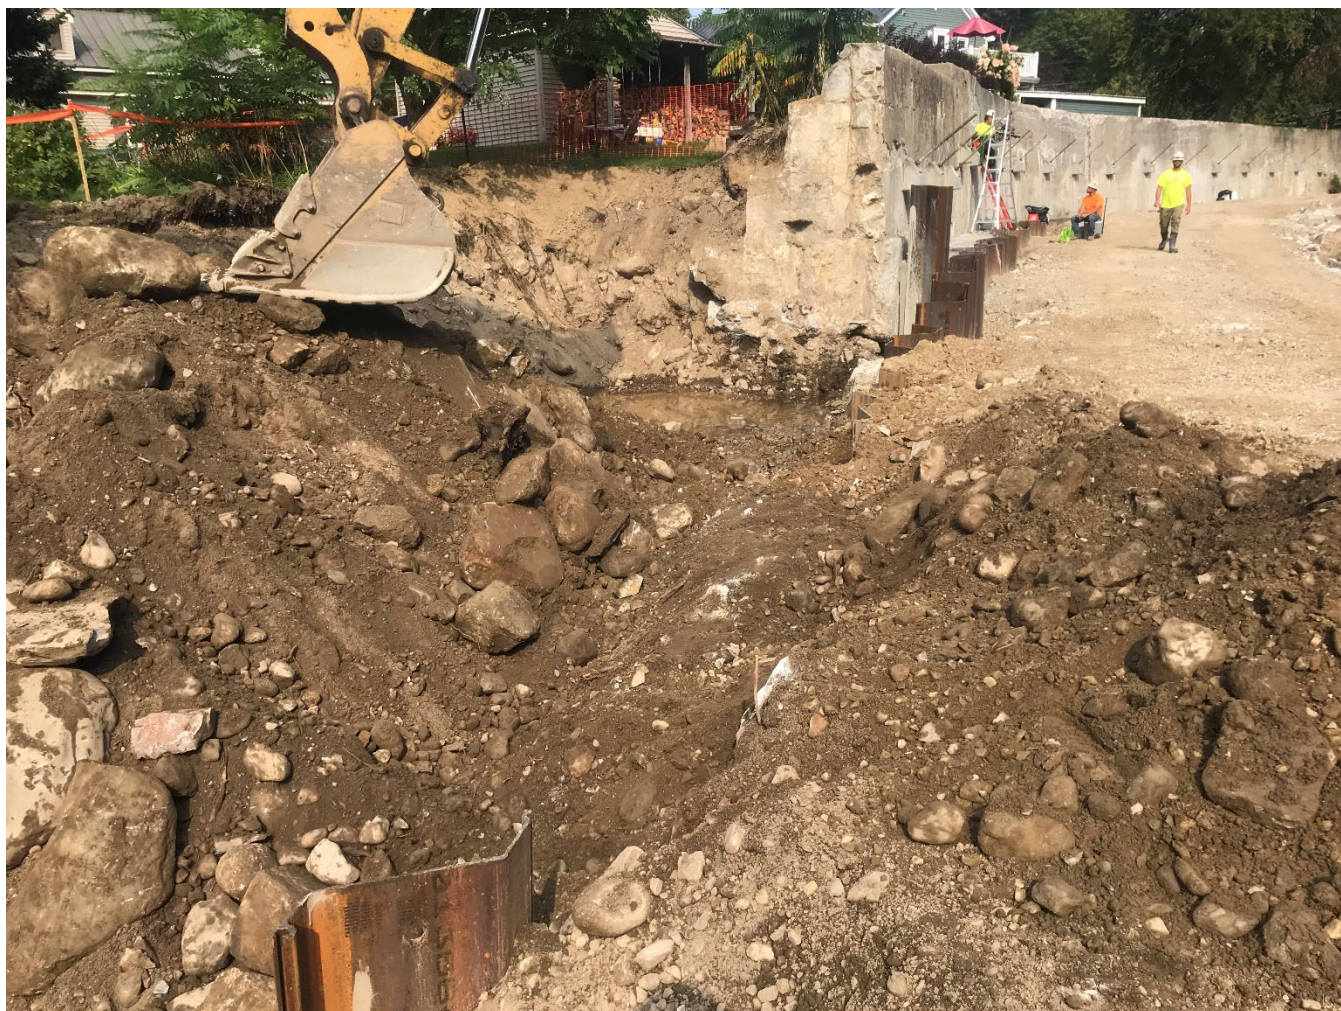
- Goodros site about complete. Final items include:
  - Remove port-a-potty; and
  - Remove construction tape.
- All of tested ground anchors have passed. 4 remain to be tested.
- 17-foot section of concrete in the way at the proposed flood wall that cannot be excavated. SLR structural engineer to come up with plan for this section.
- Upstream site flood chute properly cleaned out. Discussed keeping chute entrance at existing elevation to not invite flood water towards the properties. Chute will be cleaned out so if it does flood it will be less likely to snag debris.
- Reviewed plan to armor flood chute bank along homes.

***Figure 5: Sheet piling installed for new flood wall section, minus the area with concrete that cannot be excavated.***
