CONSTRUCTION OBSERVATION REPORT

Date: September 30, 2021	Time On Site: 8:15 AM	Time Off Site: 10:00 AM
Project: Middlebury River Flood Resiliency Project (15032.00002)		
Observed By: Roy Schiff		
Weather: Drizzle, $\pm 50^{\circ}\text{F}$, flows normal

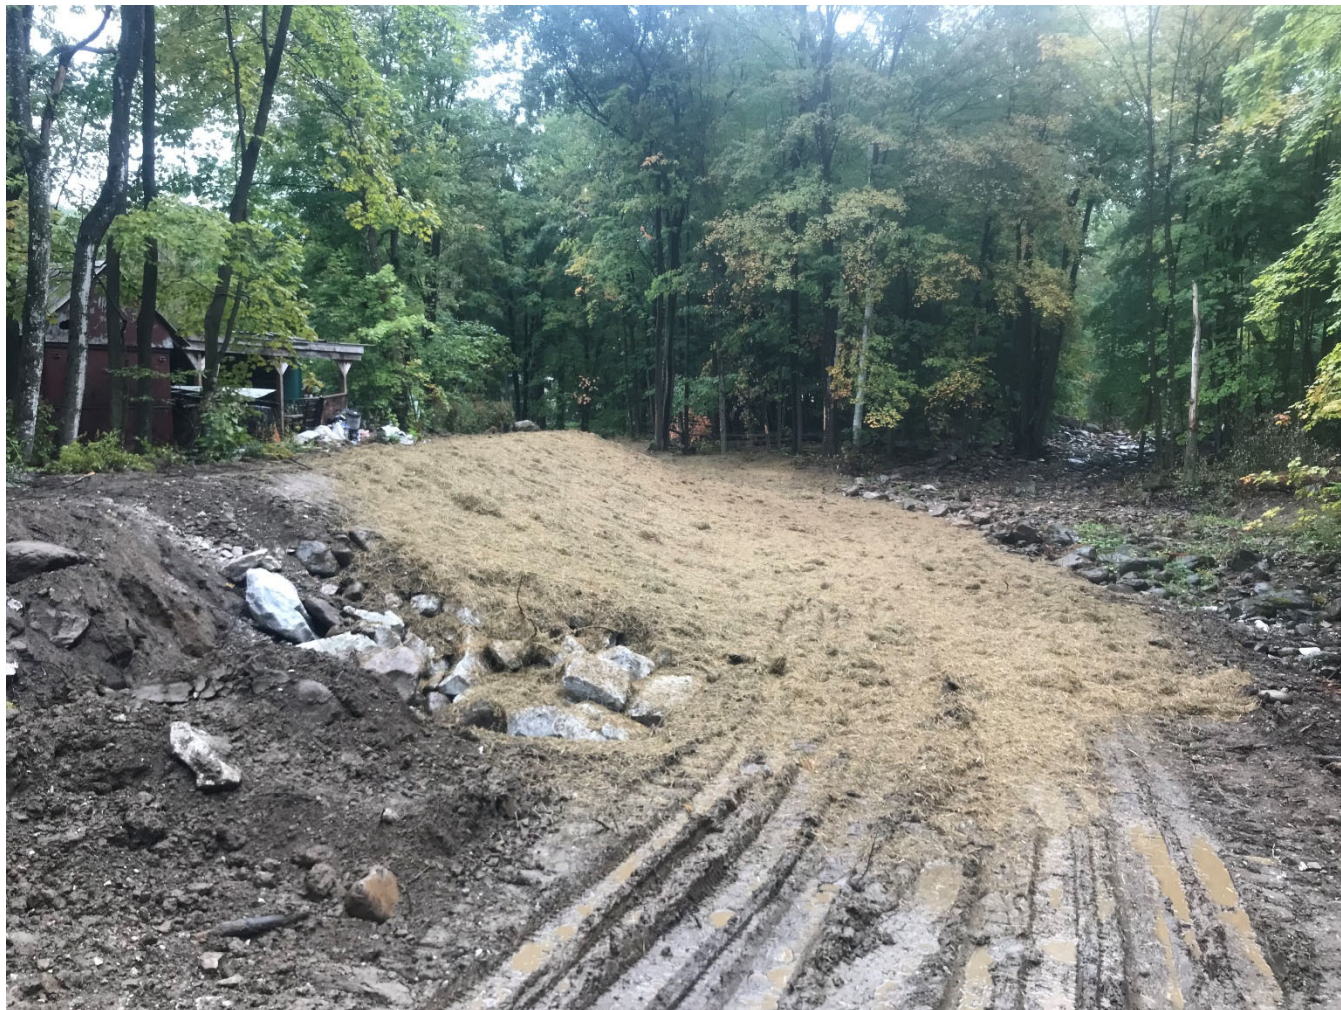
Figure 1: Seed and mulch applied to upstream portion of the site near the Welch property.

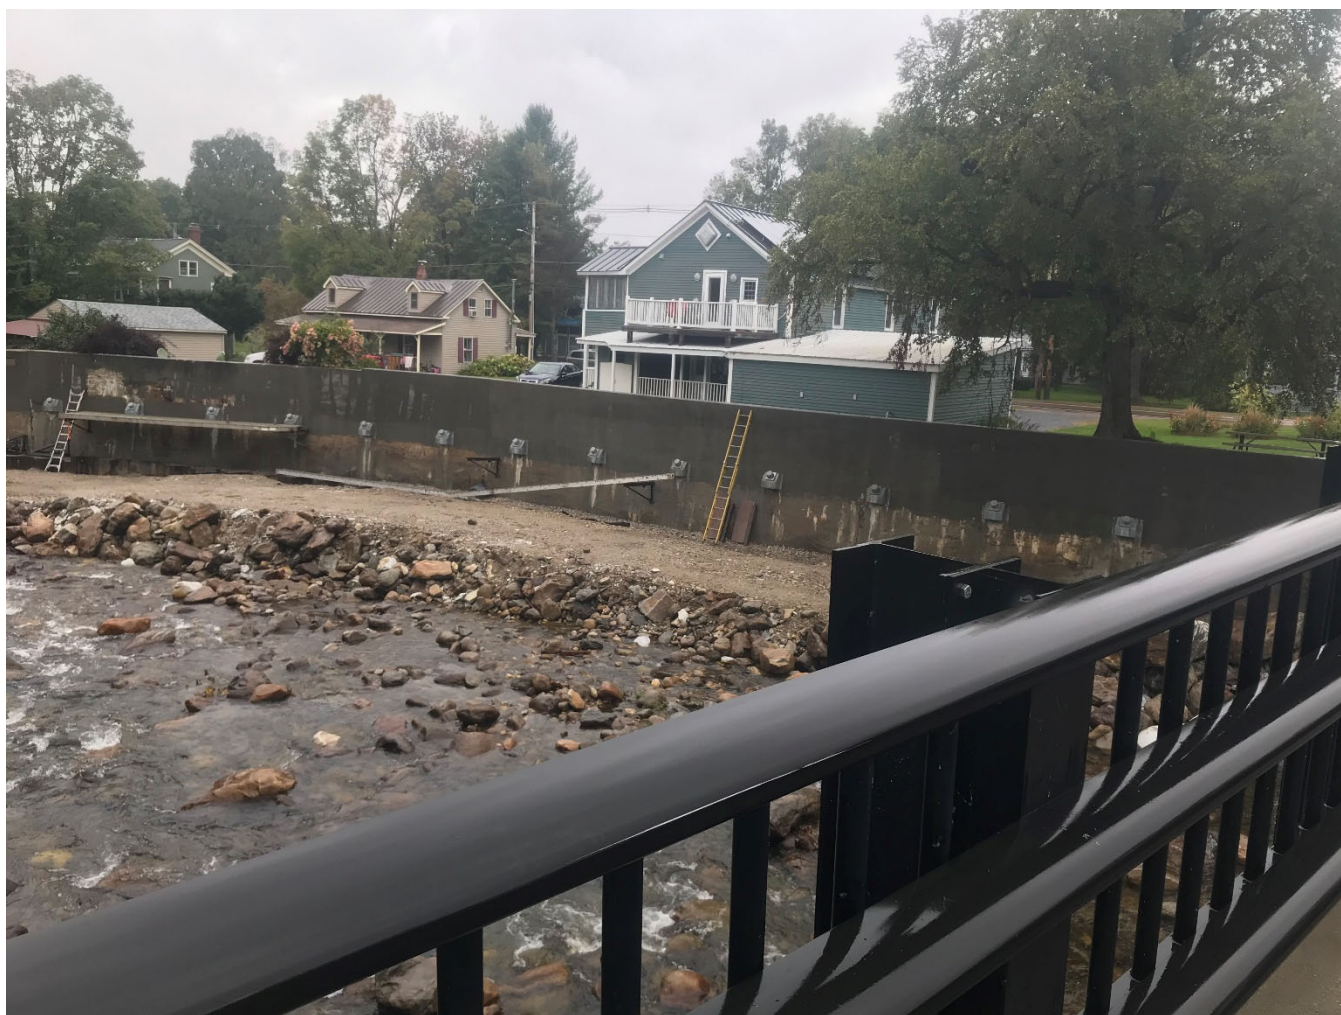
Figure 2: Repair of the existing floodwall nearing completion.

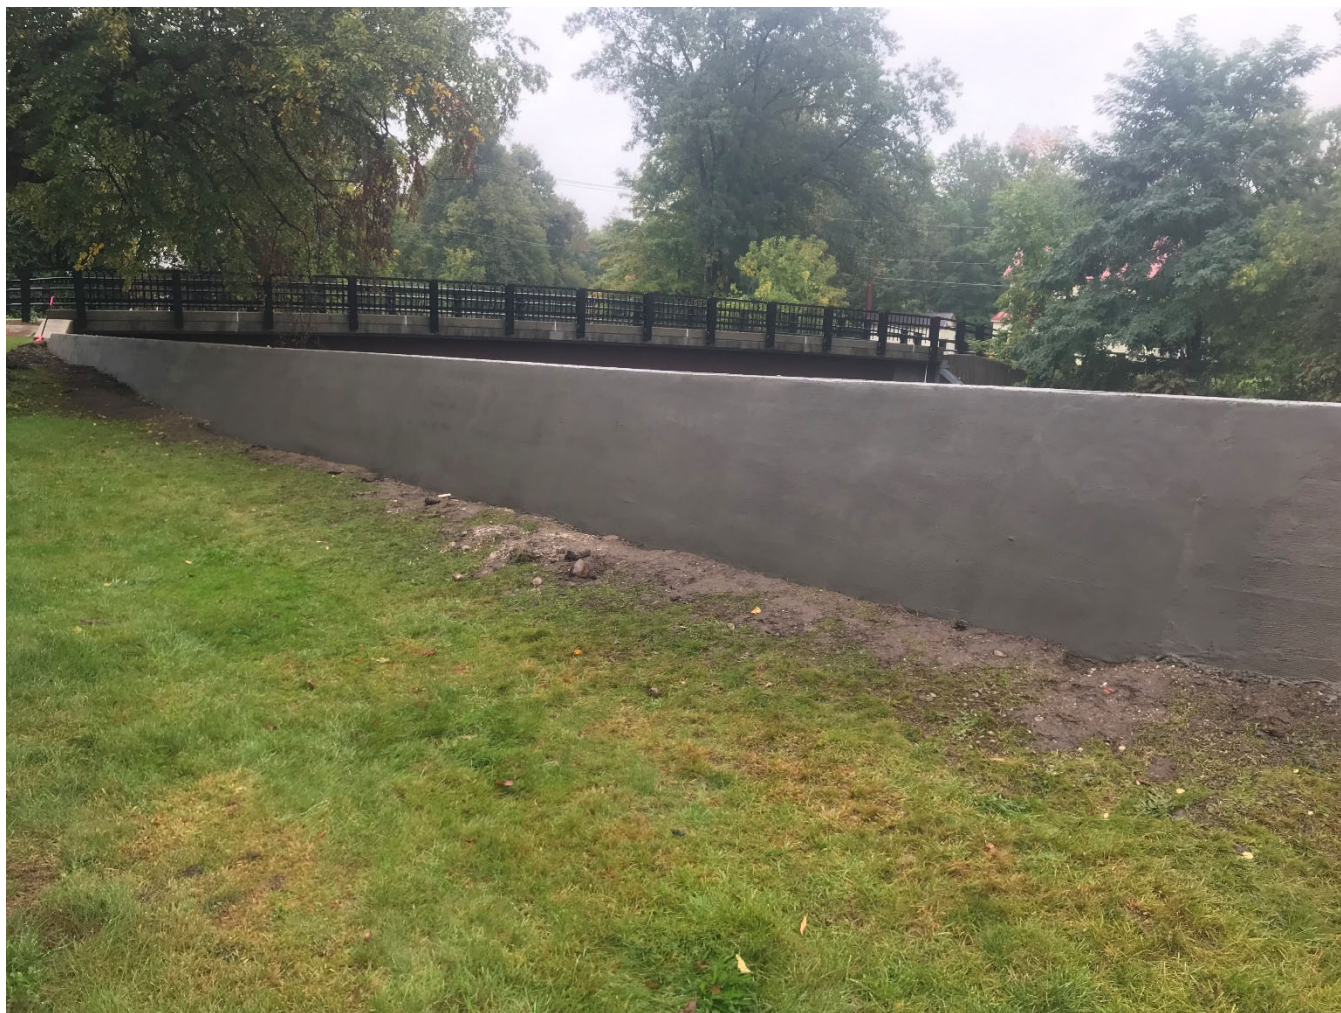
Figure 3: Skim coating repair on the back of the flood wall.

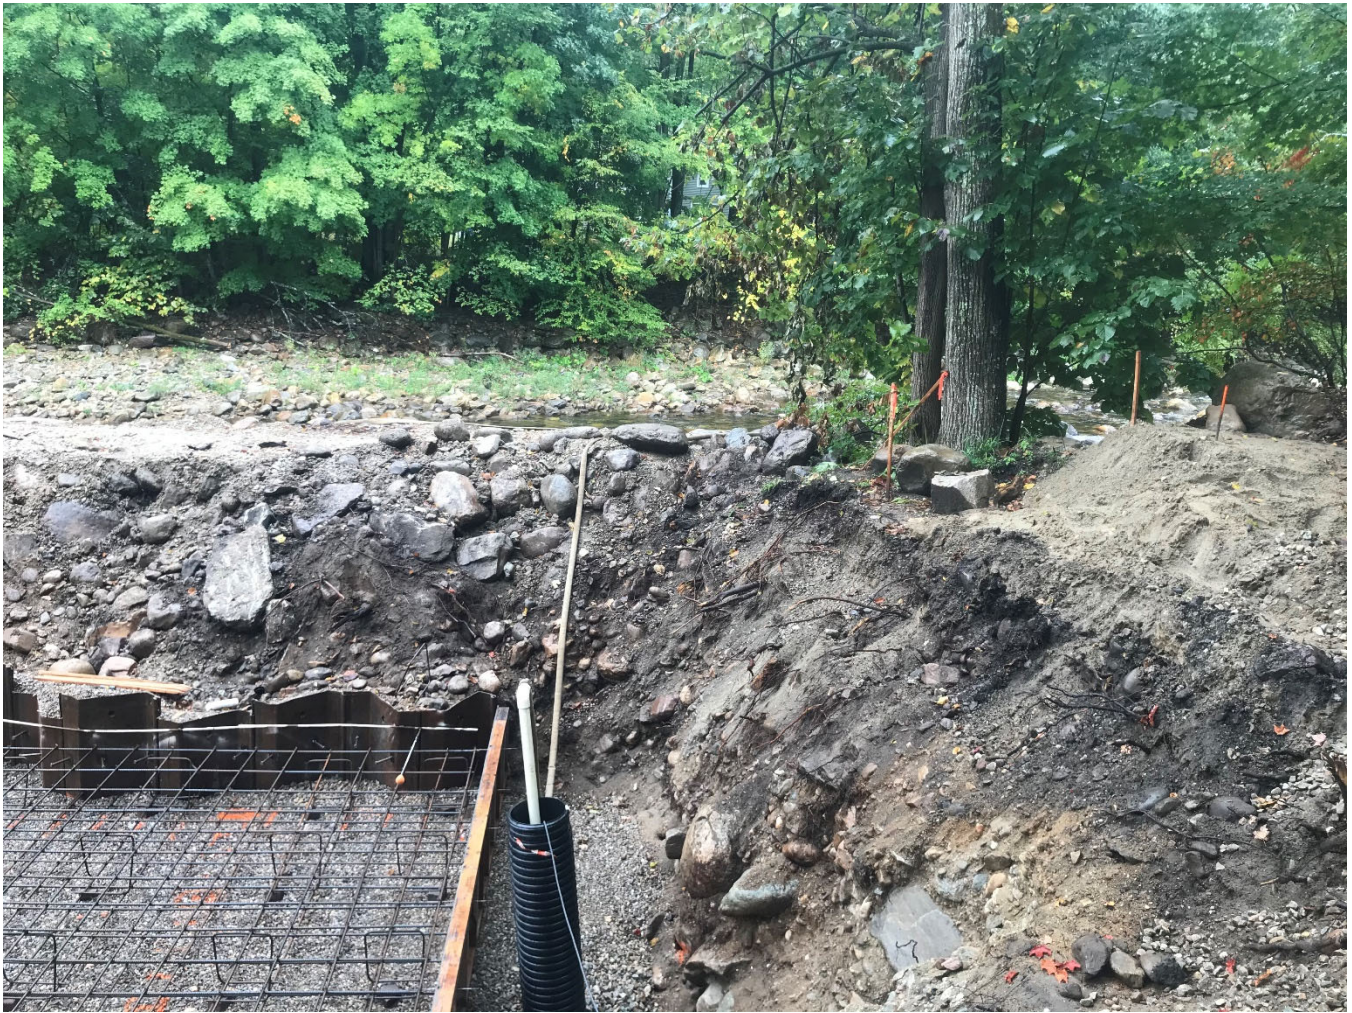
Figure 4: Proposed gap between flood wall (white steel bar with cap) and tree to be 13.5 feet.

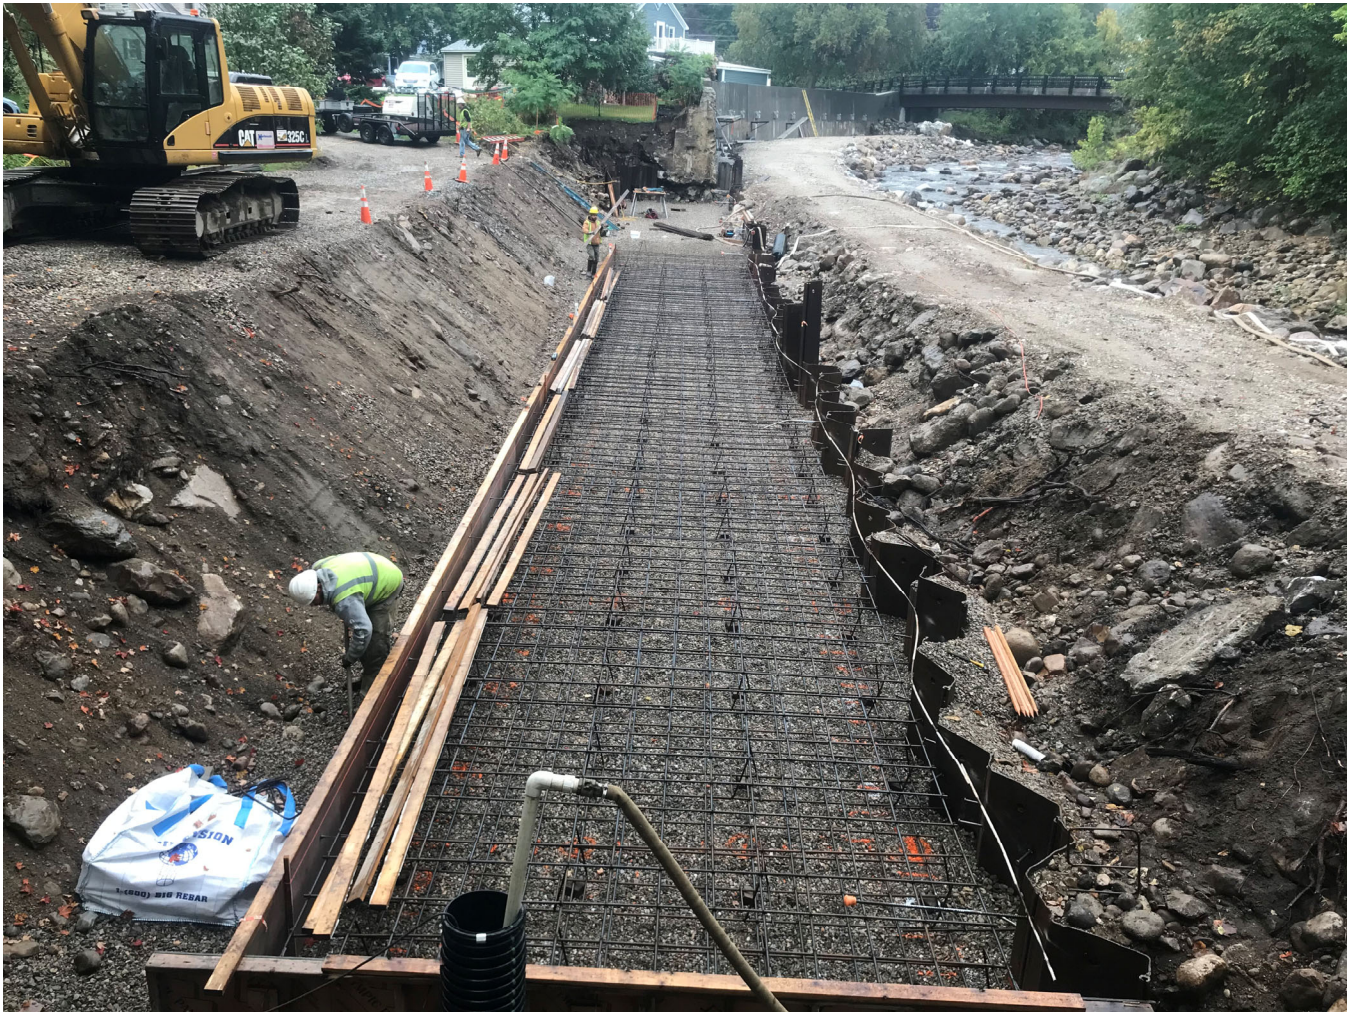
Figure 5: Rebar installation and forming in preparation of concrete pouring in downstream portion of proposed flood wall.
