# CONSTRUCTION OBSERVATION REPORT

<b>Date:</b> October 8, 2021	<b>Time On Site:</b> 1:15 PM	<b>Time Off Site:</b> 2:15 PM
<b>Project:</b> Middlebury River Flood Resiliency Project (15032.00002)		
<b>Observed By:</b> Roy Schiff		
<b>Weather:</b> Sunny, 60°F, flows normal

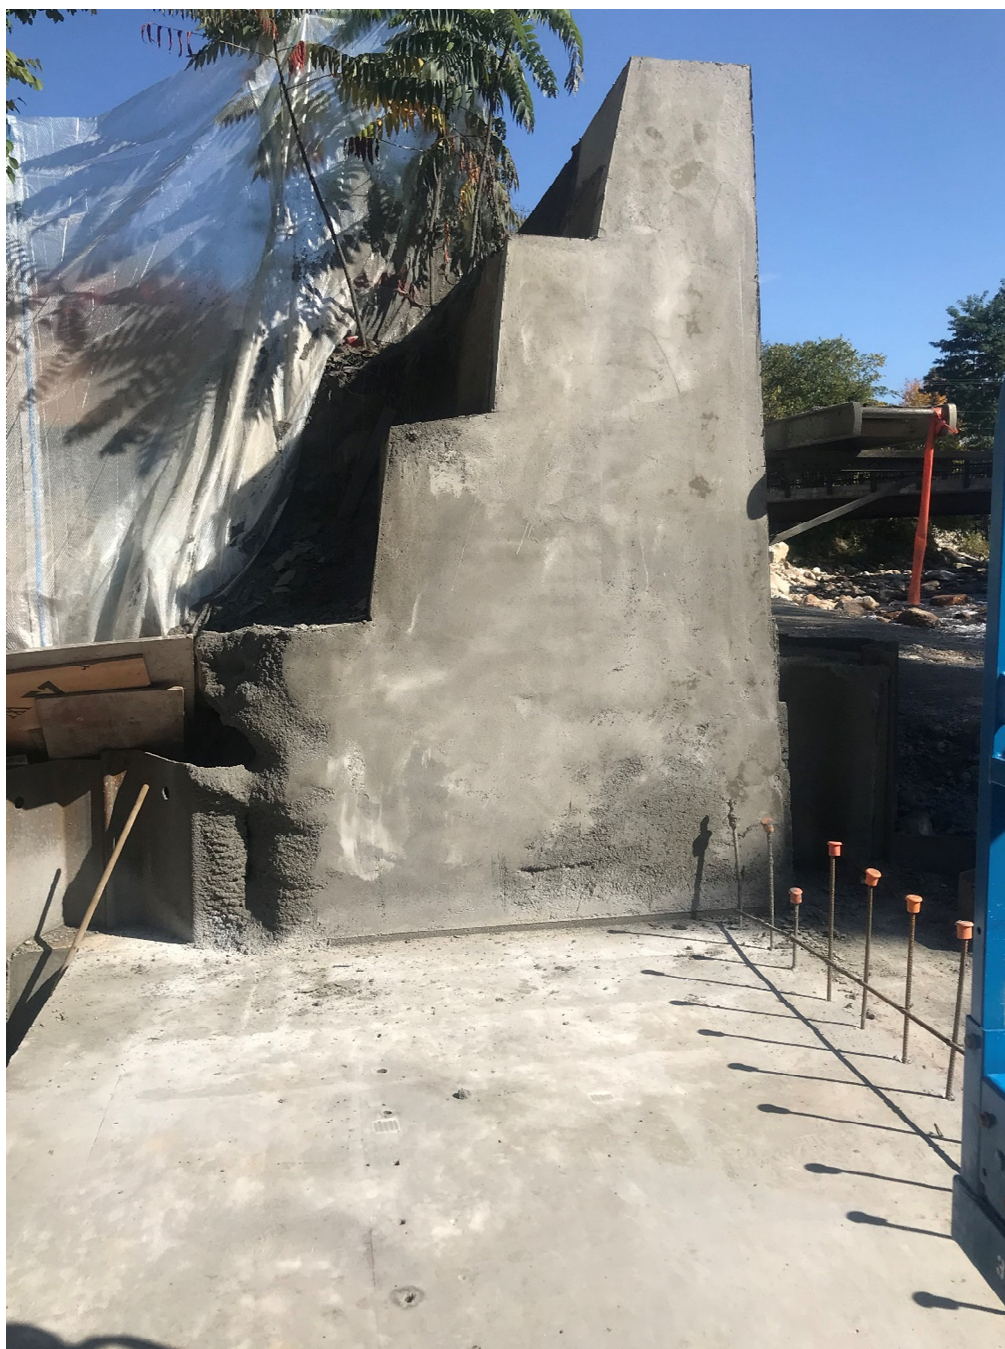
***Figure 1: End of existing wall smoothed for connection to proposed wall via expansion joint.***

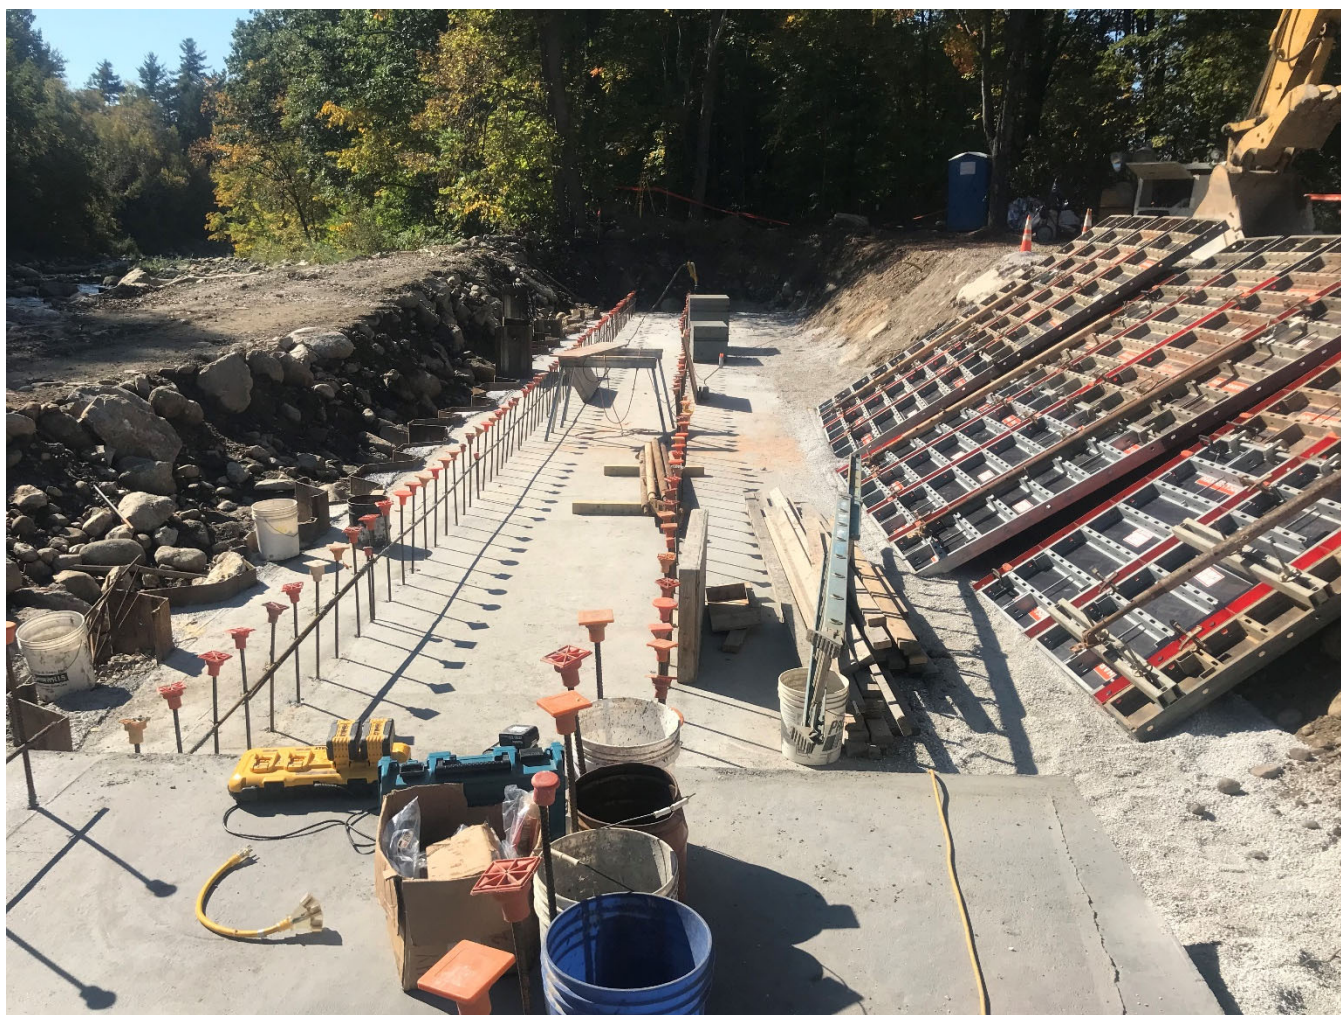
**Figure 2: Curing foundation with rebar for flood wall.**

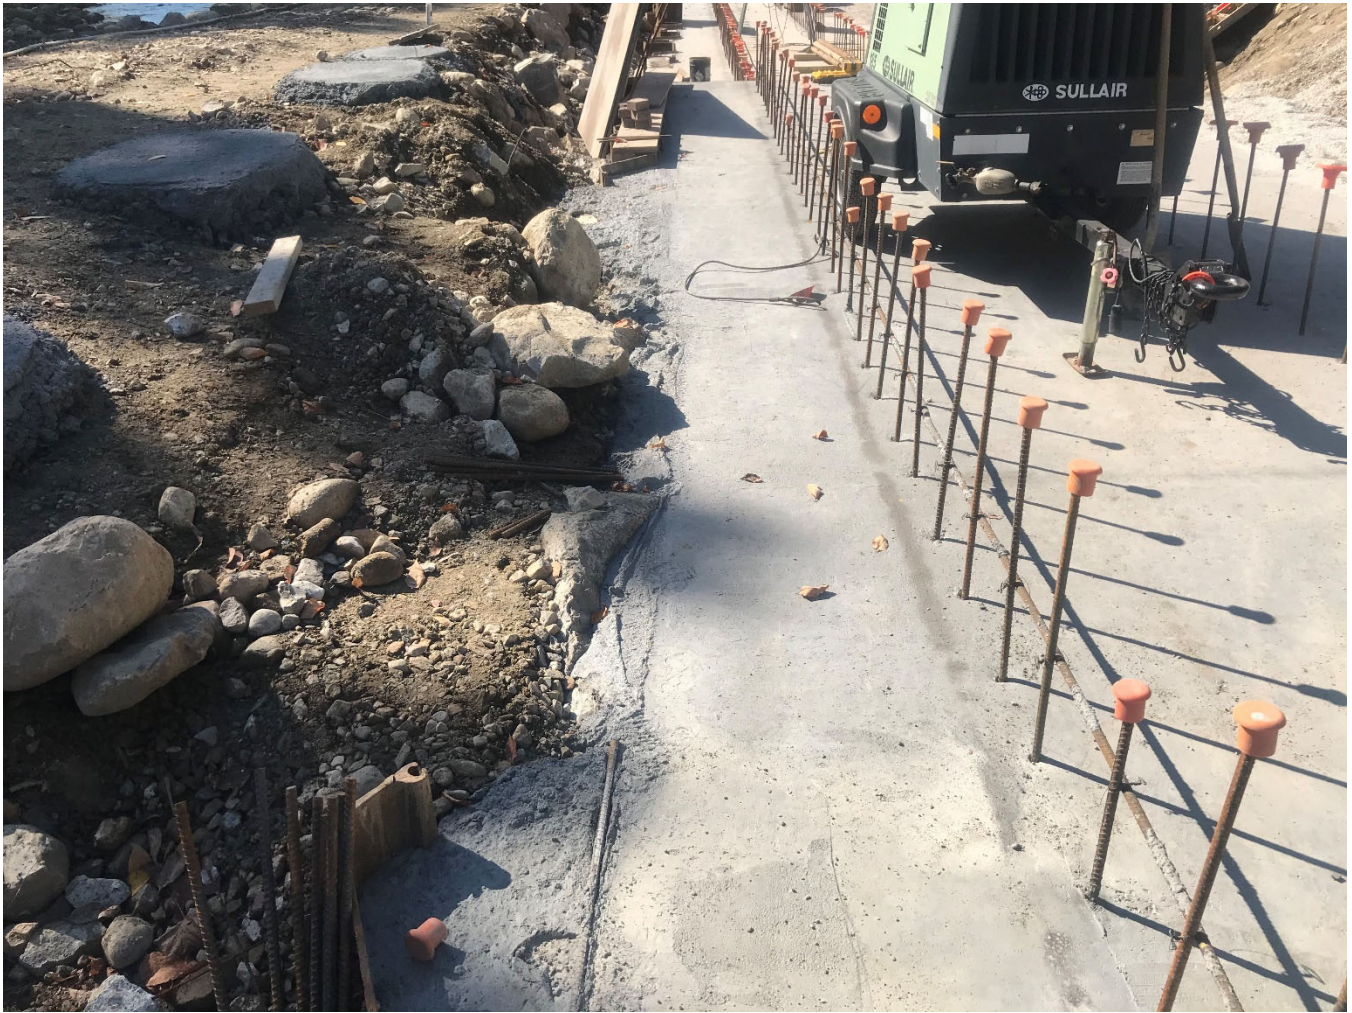
***Figure 3: Gap in sheeting where the wall is pinned to existing concrete and boulders.***

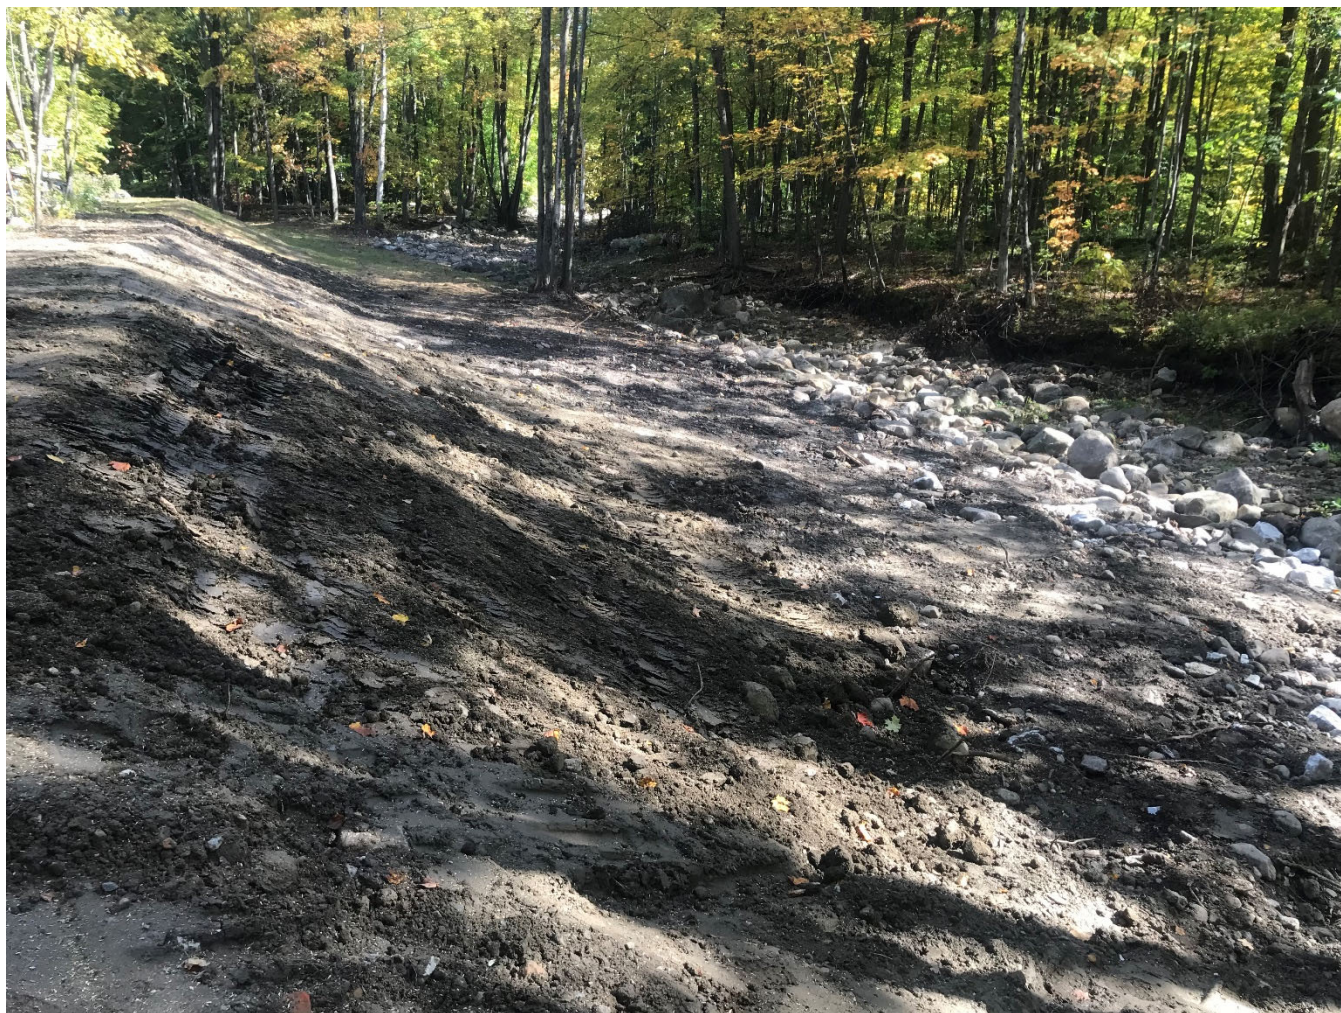
***Figure 4: Completed stone armor with soil and seeding at the upstream site awaiting mulch.***
