CONSTRUCTION OBSERVATION REPORT

Date: November 17, 2021 Time On Site: 3:00 PM Time Off Site: 4:00 PM

Project: Middlebury River Flood Resiliency Project (15032.00002)

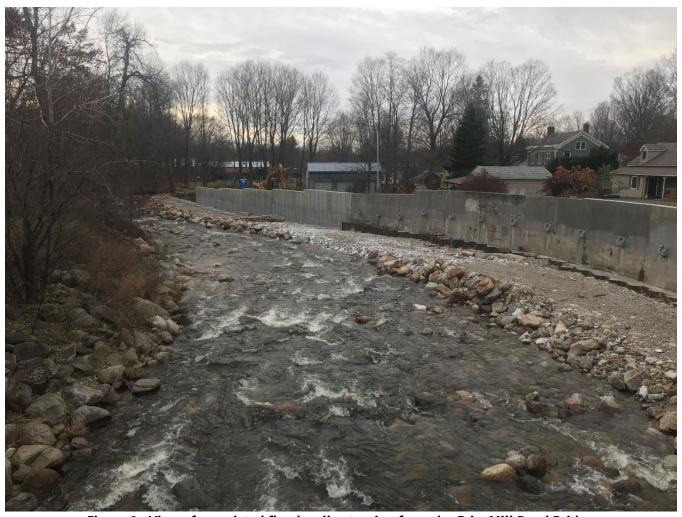
Figure 1: View of completed flood wall extension from the Grist Mill Road Bridge.

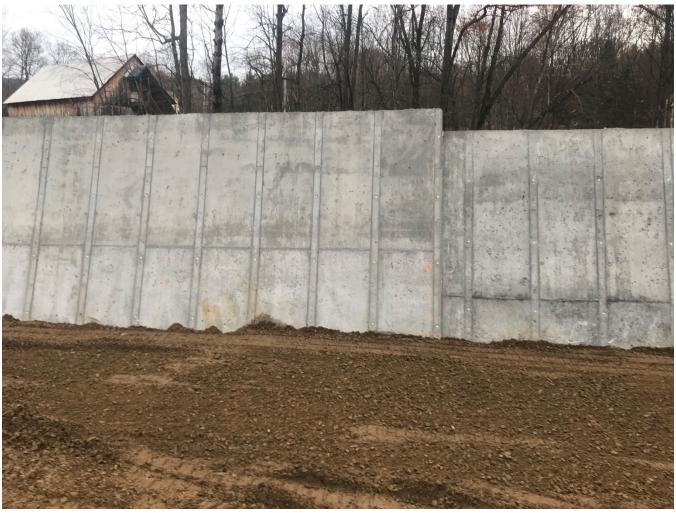
Figure 2: Filling behind wall with gravelly material.

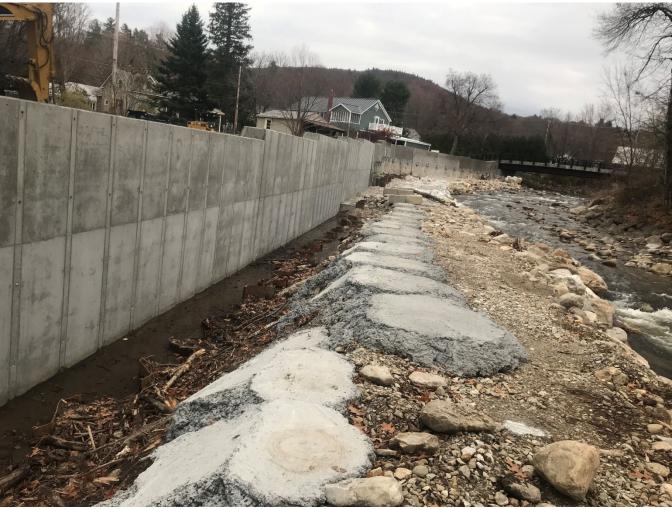
Figure 3: Concrete pads to be removed from site when access road material will be moved to the wall to protect new foundation.
