Mitigation Visit Report Creek Road Middlebury, VT
DR-4330

October 23, 2017

By: Richard N. Downer, FEMA Mitigation

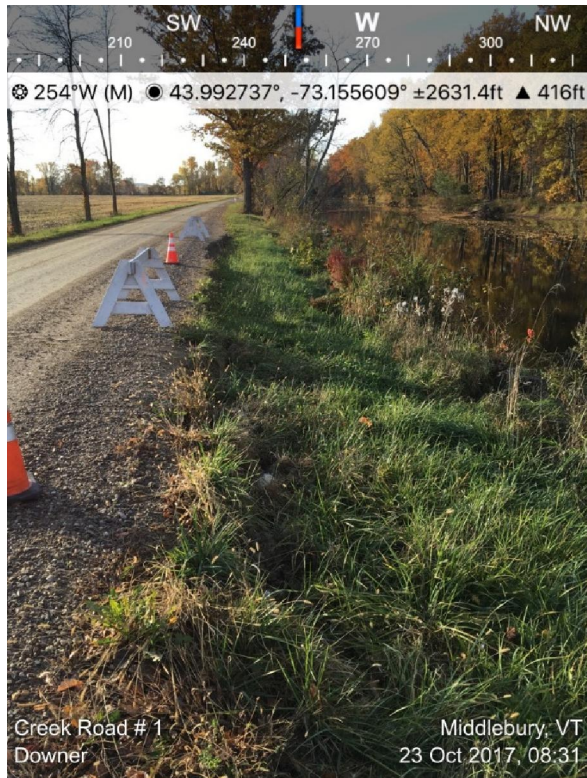
Site 1 “H”

◀ Grassed section of the bank rotated downward about 8 inches. Note that there are no trees on this section. The shoulder of the road did not move.

The bank material does not contain sufficient internal friction to support itself when saturated. The stone riprap added additional weight that that could not be supported.

Do not add more stone or weight. Repair using mechanically stabilized bio-engineering techniques. Insert geotextile, geogrids or geocell layers to add internal friction. Place large rip below water level to protect the bank toe.

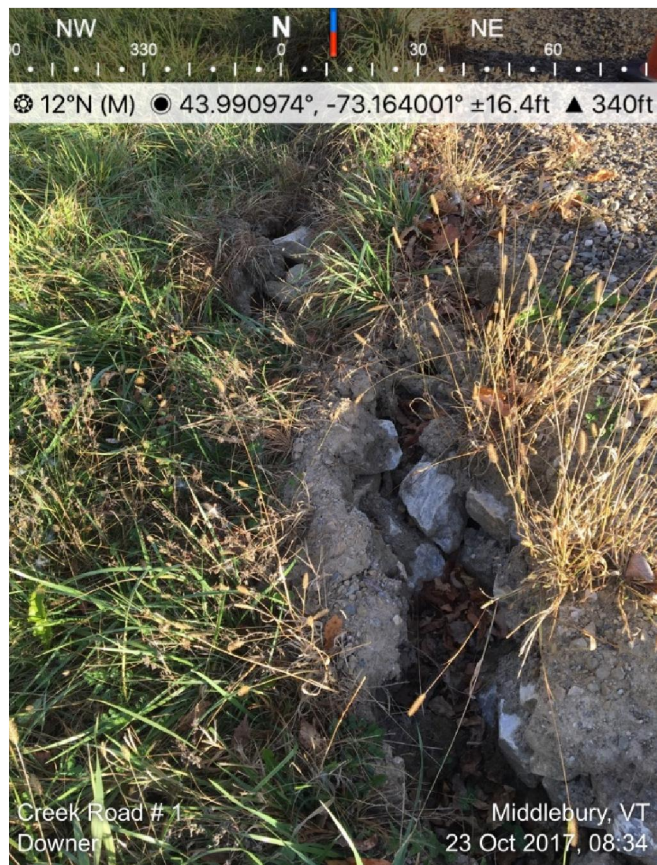
This section was previously armored with 6-inch stone. The stone is clearly visible in one of the tension cracks. ▼

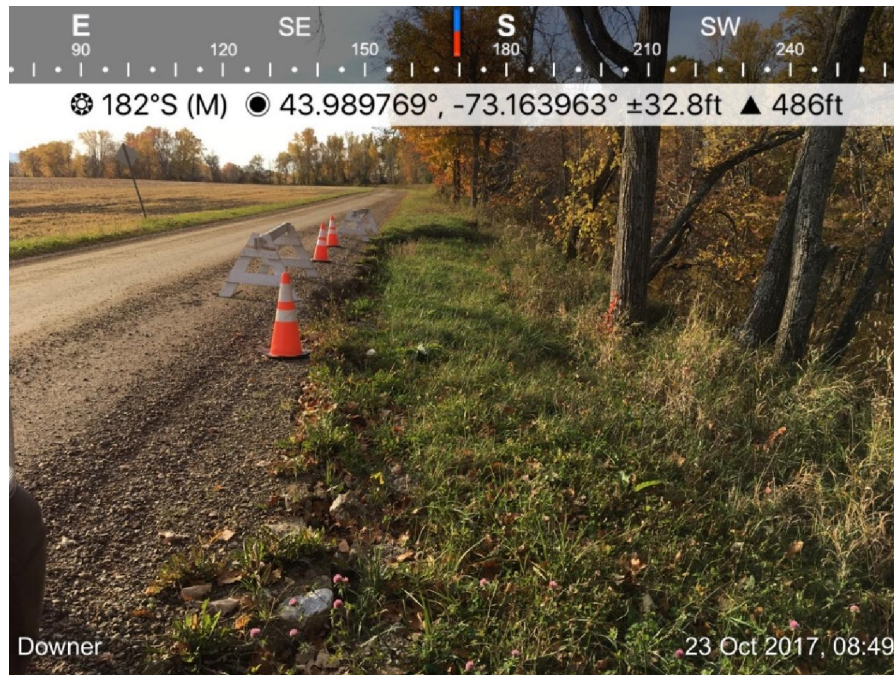
Site 2 "I"

◀ Bank section is tree-lined. Some trees are leaning toward the creek. The shoulder of the road did not move.

Cut leaning trees, but do not remove root balls. Do not add more stone or weight.

Repair using mechanically stabilized bio-engineering techniques. Insert geotextile, geogrids or geocell layers to add internal friction.

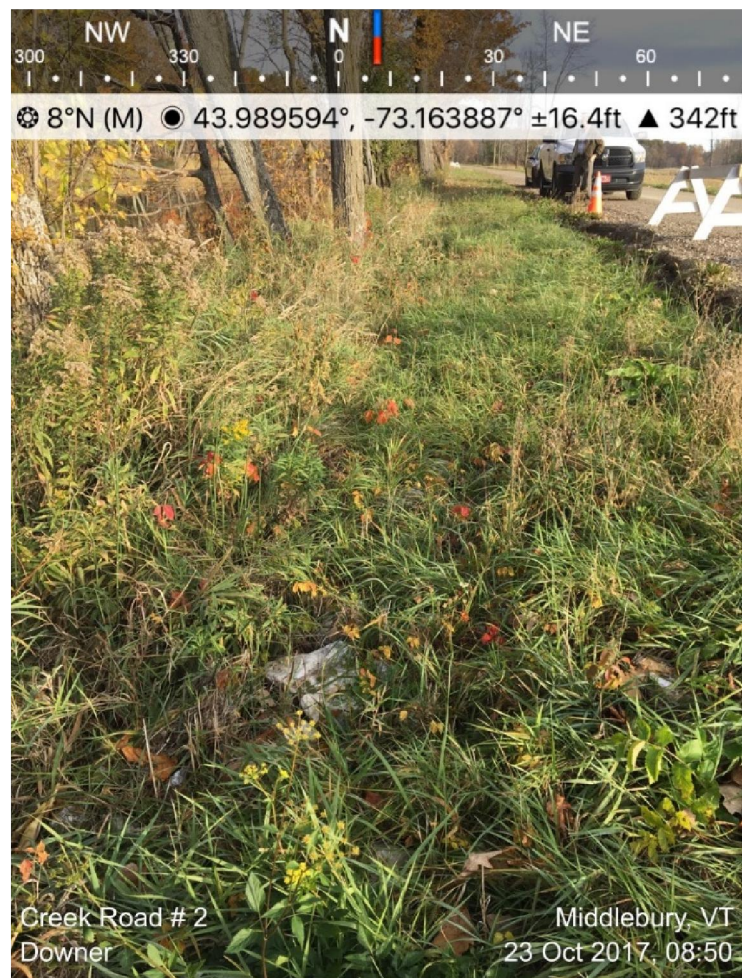
Not clear if this section was previously ripped between the shoulder edge and the trees. Some large stones were visible in the grass. ►

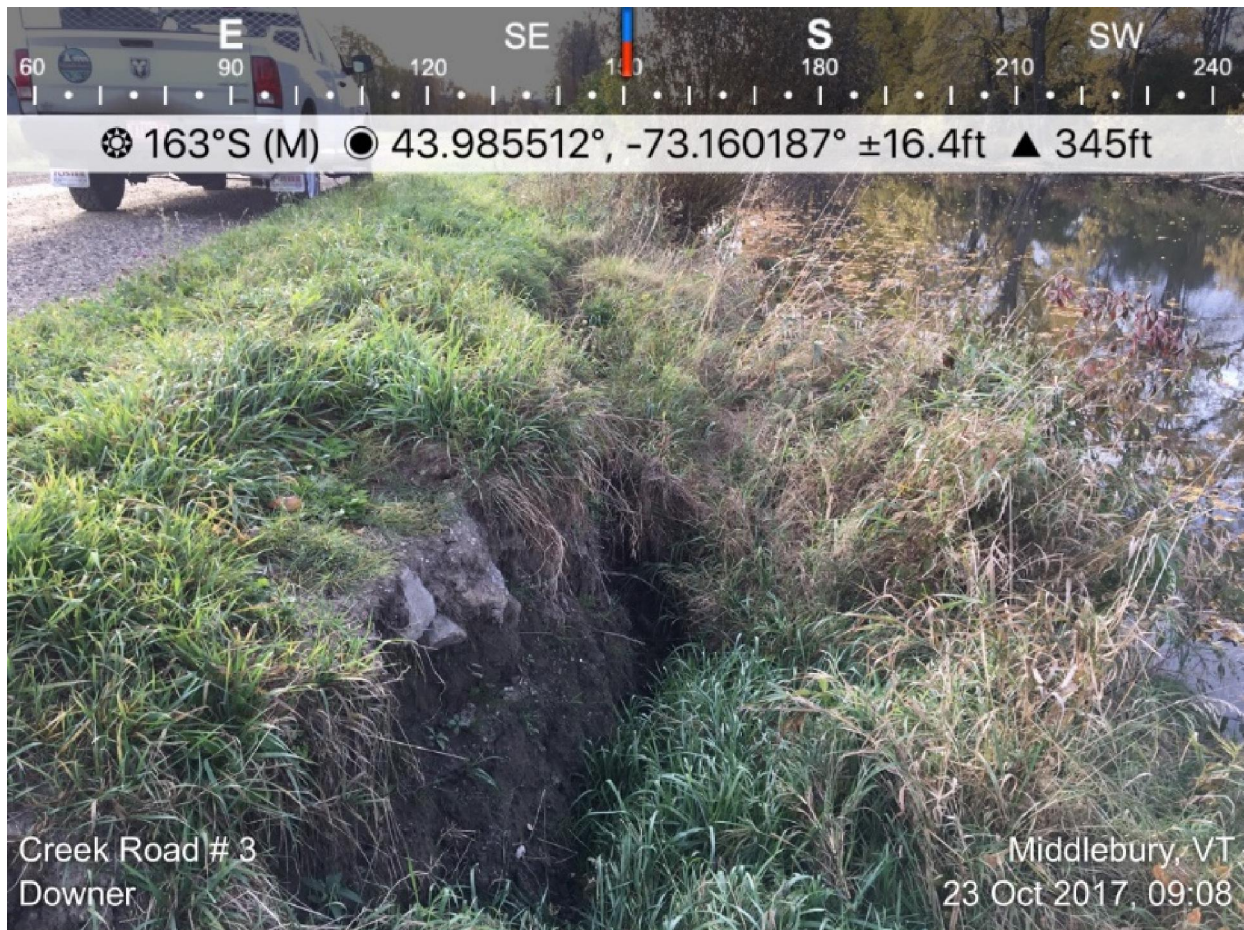
Site 3 “J”

About 6 feet of the bank slipped. The fact that there are no trees on this failed section and that riprap is exposed near the surface suggests the section was previously surface riprapped. ▼

Do not add more stone or weight.
Repair using mechanically stabilized bio- engineering techniques.

Insert geotextile, geogrids or geocells layers to add internal friction. Use thick geotextiles that add internal drainage or insert thin layers of free-draining crushed rock. Place large rip below water level to protect the bank toe.

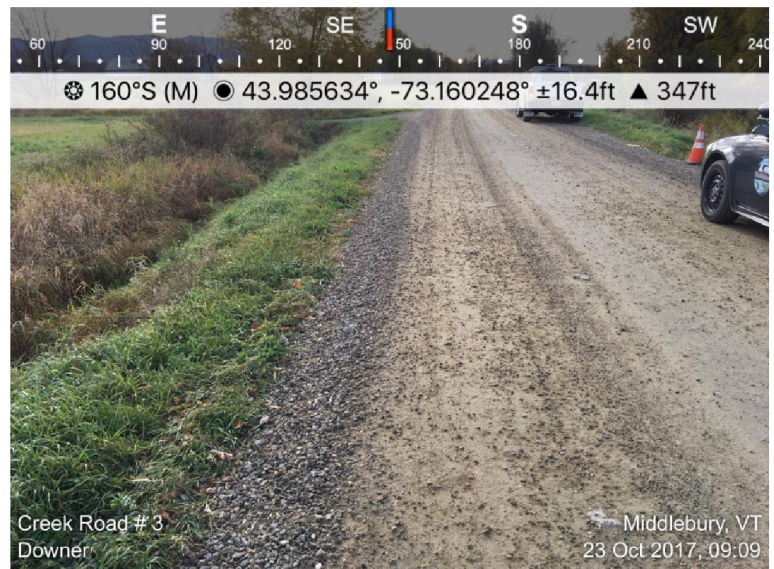
The deep ditch on the east side of the road encourages saturation of the road embankment. ►

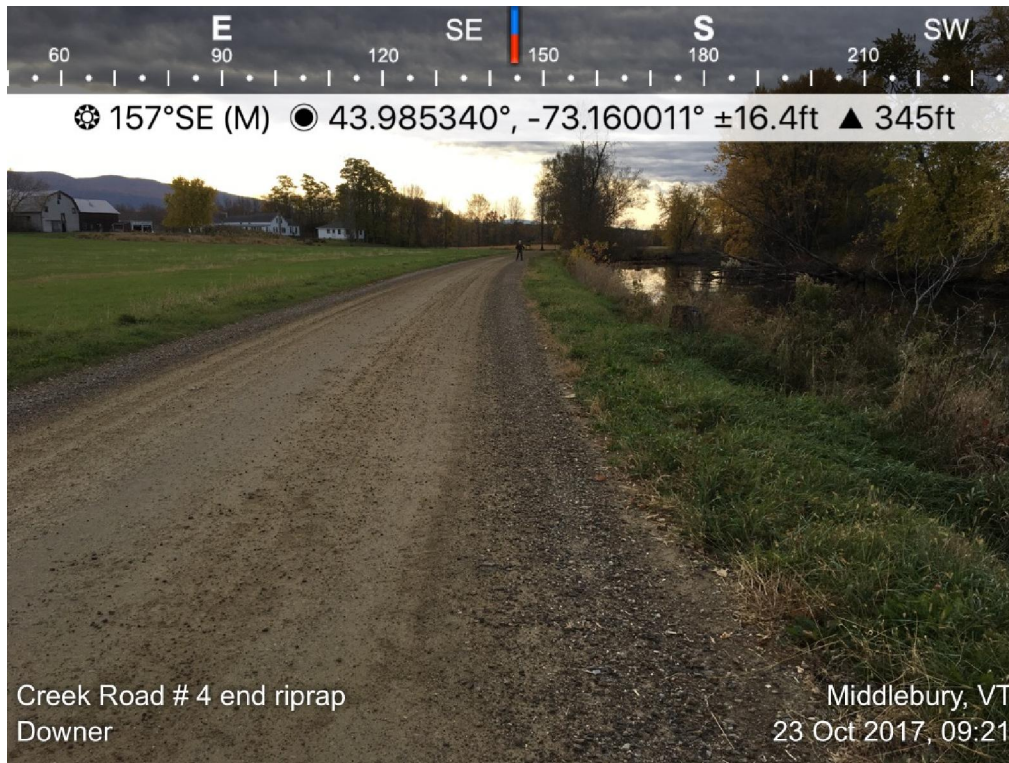
Site 4 "K"

◀ Section was previously cleared of trees and riprapped.

Do not add more stone or weight. Repair using mechanically stabilized bio-engineering techniques.

Insert geotextile, geogrids or geocells layers to add internal friction. Use thick geotextiles that add internal drainage or insert thin layers of free-draining crushed rock. Place large rip below water level to protect the bank toe.

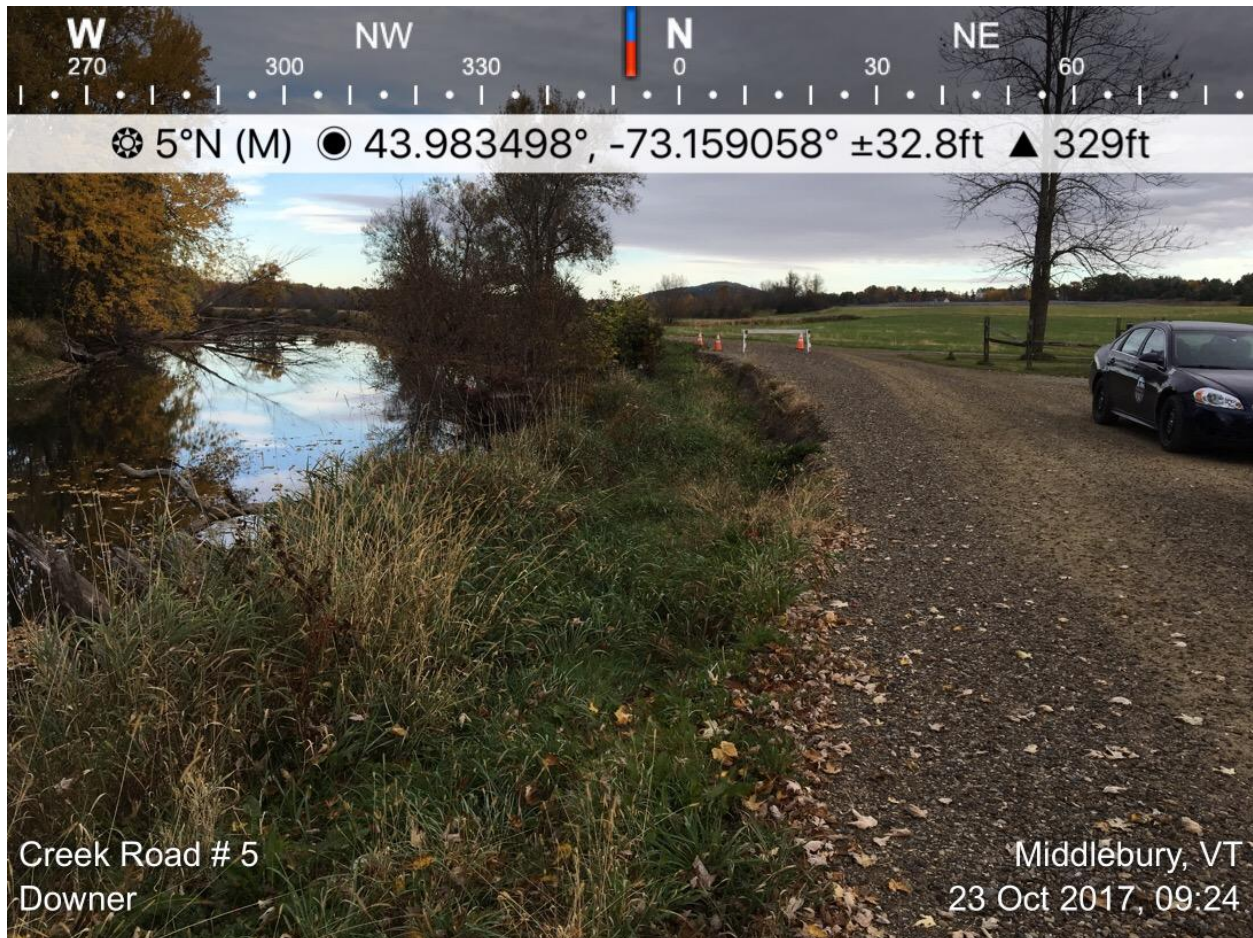
Site 5 “L”

This section of bank slipped downward about 2 feet. The slightly back sloping of the grassed area suggests a rotational failure occurred; probably resulting from saturated soils coincident with erosion at the bank toe.

Cut leaning trees, but do not remove root balls. Do not add more stone or weight.

Repair using mechanically stabilized bio- engineering techniques. Insert geotextile, geogrids or geocell layers to add internal friction. Place large rip below water level to protect the bank toe.
