November 7, 2022

Re: Visual Structural Assessment  
Hydeville Mill  
108 Hydeville Road  
Stafford, Connecticut

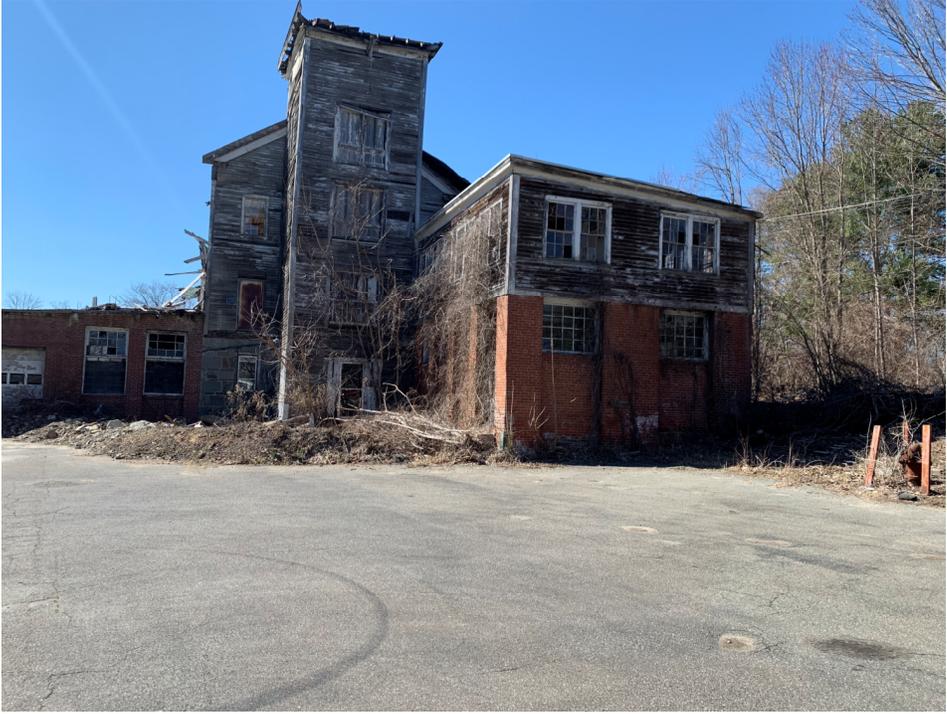
<b>Photo</b> <b>1</b>	<b>Date:</b> 3/31/2021

Building No. 3 is an L-shaped building and is located between Building No. 1 and No. 4 (Appendix B – Photographic Log; Photos 1 and 4). Building No. 3 consists of timber wall and gable roof construction. At the front of Building No. 3, there is a four-story tower with a side building which is two stories high, most of the building structure is three stories high. There is an additional one-story wing at the southwest end of Building No. 3.

<b>THE MILL AT STAFFORD BUILDINGS</b>		
<b>Description:</b> East Elevation (Looking West)

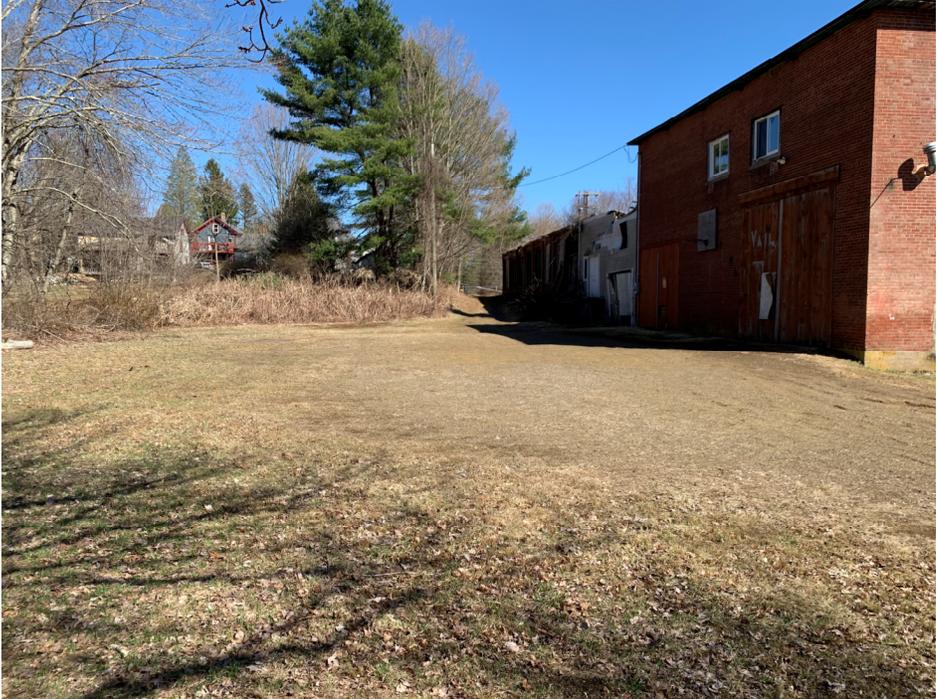
<b>Photo</b> <b>2</b>	<b>Date:</b> 3/31/2021

the site which has a second floor constructed of timber wall and a flat roof timber framing as well as second floor timber framing (Appendix B – Photographic Log; Photo 2).

Buildings 1 and 2 were observed to be in the best condition of all the structures (Appendix B – Photographic Log; Photos 2, 3 & 10). The first-floor wall framing second-floor framing were observed to be intact, but access to the second floor was not possible at this time. Access into Building 1 and 2 could be possible in the future if the collapsing roof at Building No. 3 could be demolished or stabilized.

<b>THE MILL AT STAFFORD BUILDINGS</b>		
<b>Description:</b> North Elevation (Looking Southeast)

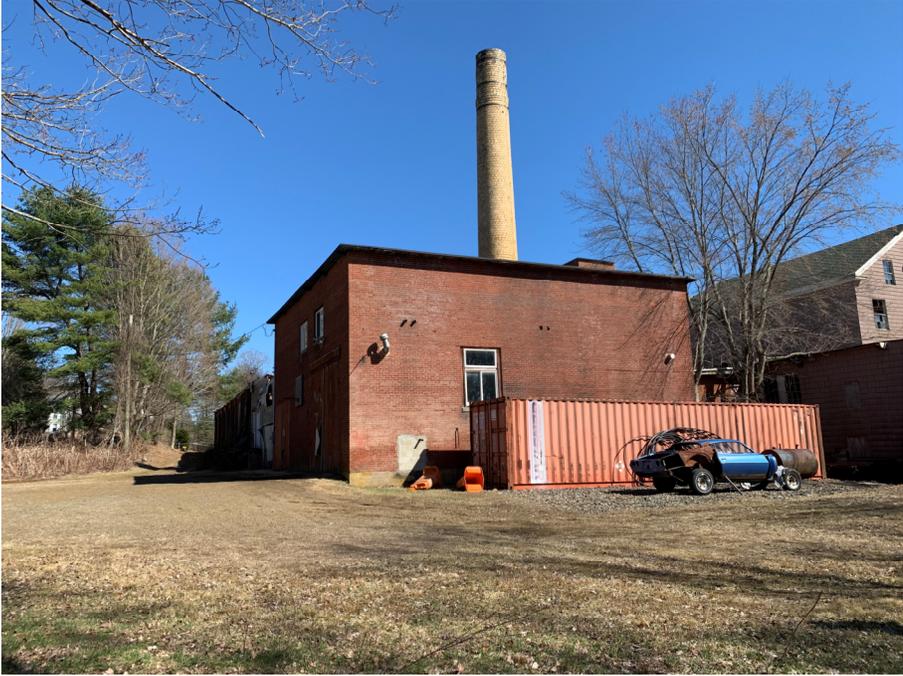
<b>Photo</b> <b>3</b>	<b>Date:</b> 3/31/2021

The Building No. 2 is a square structure with a chimney stack toward the southeast corner of the building (Appendix B – Photographic Log; Photo 3). Building No. 2 also consisted of timber framing at both the walls, floors and the flat roof with an exterior brick face.

<p><b>THE MILL AT STAFFORD BUILDINGS</b></p>		
<p><b>Description:</b> West Elevation at Building Nos. 2 and 1 (Looking East)</p>

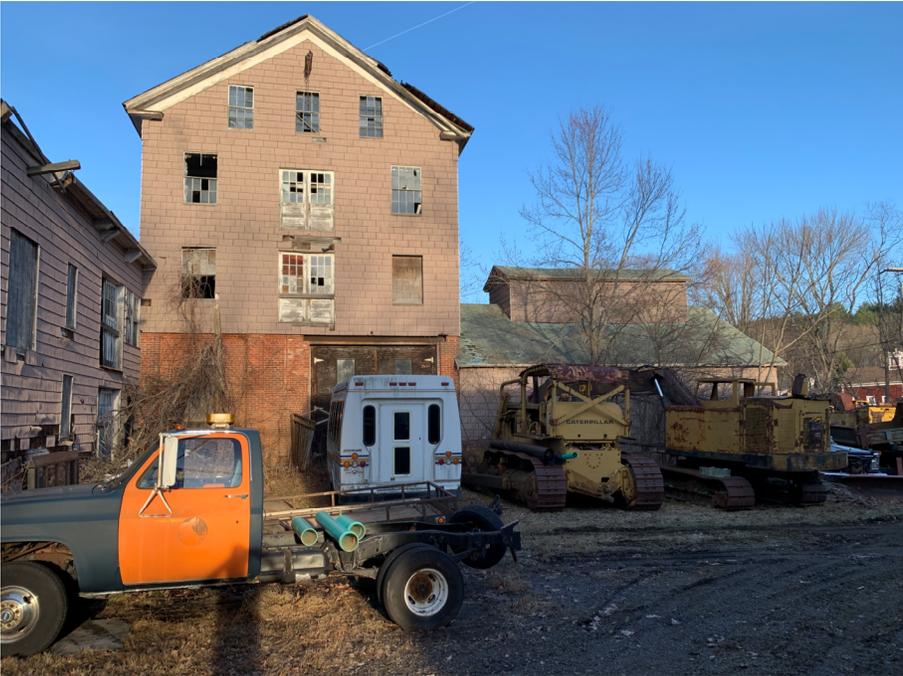
<b>Photo</b> <b>4</b>	<b>Date:</b> 3/31/2021

<p><b>THE MILL AT STAFFORD BUILDINGS</b></p>		
<p><b>Description:</b> West Elevation Building No. 3 (Looking East)</p>

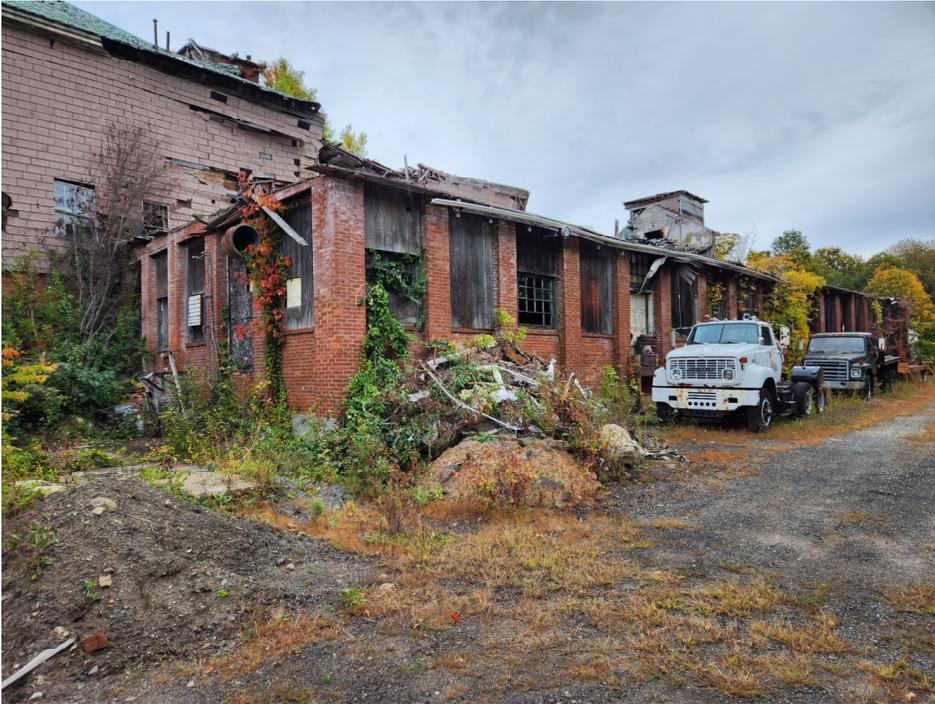
<b>Photo</b> <b>5</b>	<b>Date:</b> 10/3/2022

Building No. 4 is located at the south side of the property (Appendix B – Photographic Log; Photo 5). Building No. 4 is a single-story building and consists of timber wall and flat roof framing, with brick face at the exterior of the building. Access into any of the buildings was not possible at the time of the inspection.

All buildings were in poor structural condition. Building No. 3 is in the worst condition, with the roof framing having partially collapsed into the structure from the east side of the building to the west side (Appendix B – Photographic Log; Photos 5-7). Due to the failed roof framing for the majority of Building No.3, the remaining buildings should not be accessed until, at the very least, Building No. 3's collapsing roof can be demolished or stabilized so as not to fall on the adjacent buildings.

<p><b>THE MILL AT STAFFORD BUILDINGS</b></p>		
<p><b>Description:</b> South Elevation (Looking Northeast)</p>

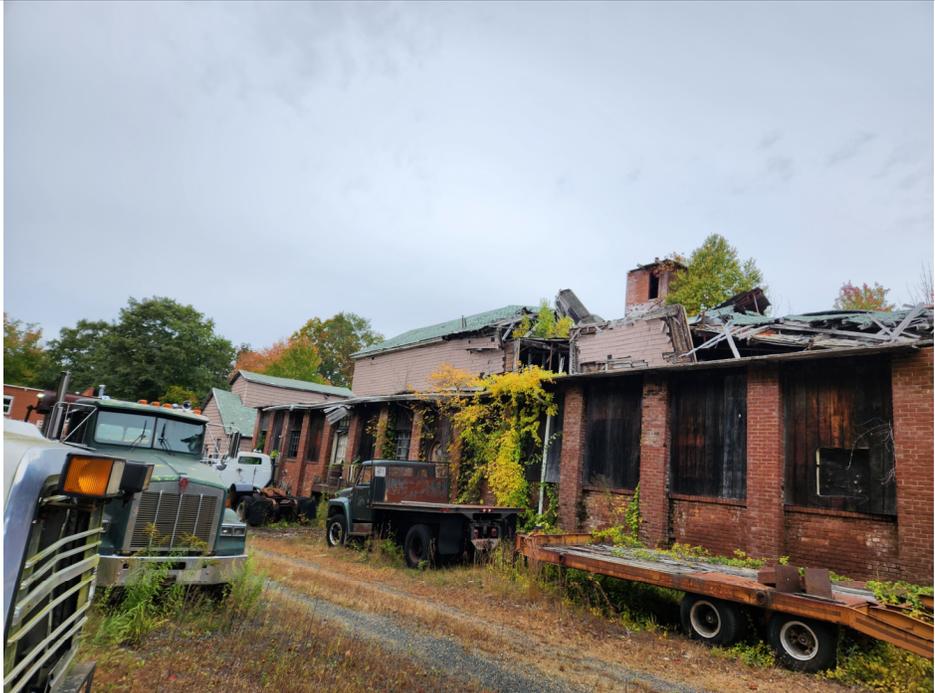
<b>Photo</b> <b>6</b>	<b>Date:</b> 10/3/2022

<p><b>THE MILL AT STAFFORD BUILDINGS</b></p>		
<p><b>Description:</b> South Elevation (Looking Northwest) Note: Collapsed Portion of Building No. 3 Roof and third floor south exterior wall.</p>

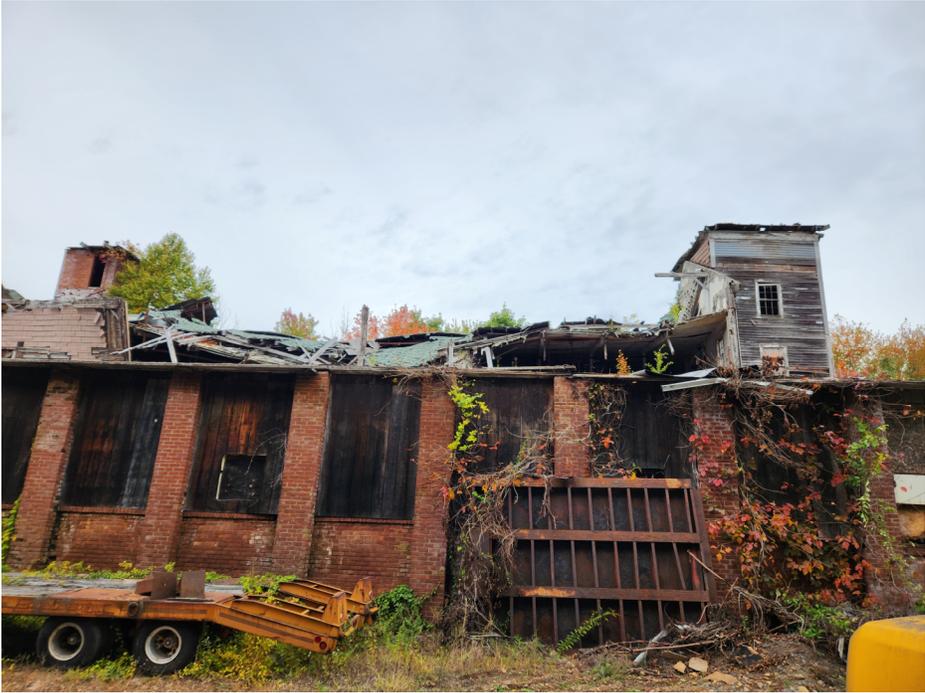
<b>Photo</b> <b>7</b>	<b>Date:</b> 10/3/2022

<b>THE MILL AT STAFFORD BUILDINGS</b>		
<p><b>Description:</b> South Elevation at East Side of Building No. 3 and 4. (Looking North) Note: Majority of Building No. 3 Roof and Third floor south wall has collapsed into the Third floor of the Building No. 3.</p>

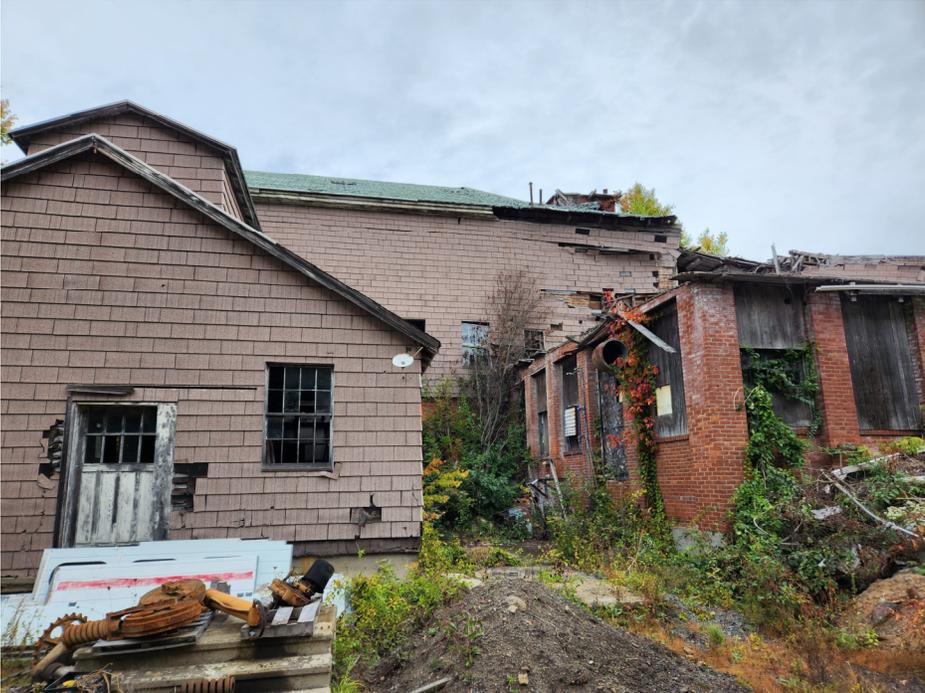
<b>Photo</b> <b>8</b>	<b>Date:</b> 10/3/2022

<b>THE MILL AT STAFFORD BUILDINGS</b>		
<p><b>Description:</b> South Elevation Exterior at West End of Building No. 3 and 4 (Looking North) Note: Broken and Boarded up Windows, Partial Collapsed Roof and Exterior wall at Building No. 3 Holes at Building No. Exterior Walls West End of Building No. 3</p>

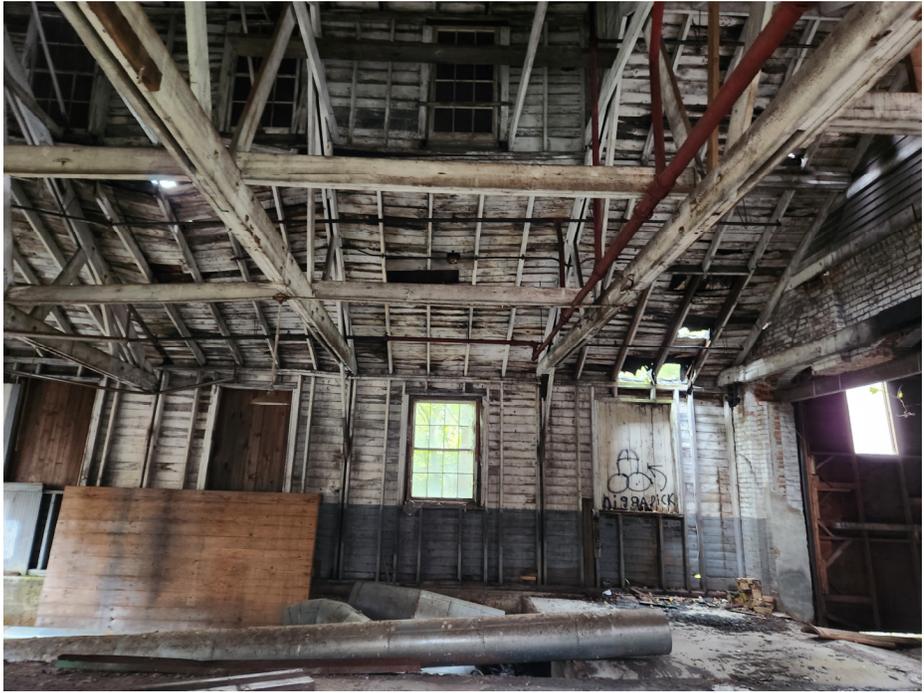
<b>Photo</b> <b>9</b>	<b>Date:</b> 10/3/2022

<p><b>THE MILL AT STAFFORD BUILDINGS</b></p>		
<p><b>Description:</b> Building No.3 (Looking west) Interior at L leg of Building. Note: Timber Wall and Timber Roof Truss Framing. Collapsed and Deteriorated Plywood Roof and Timber Roof Framing Sections</p>

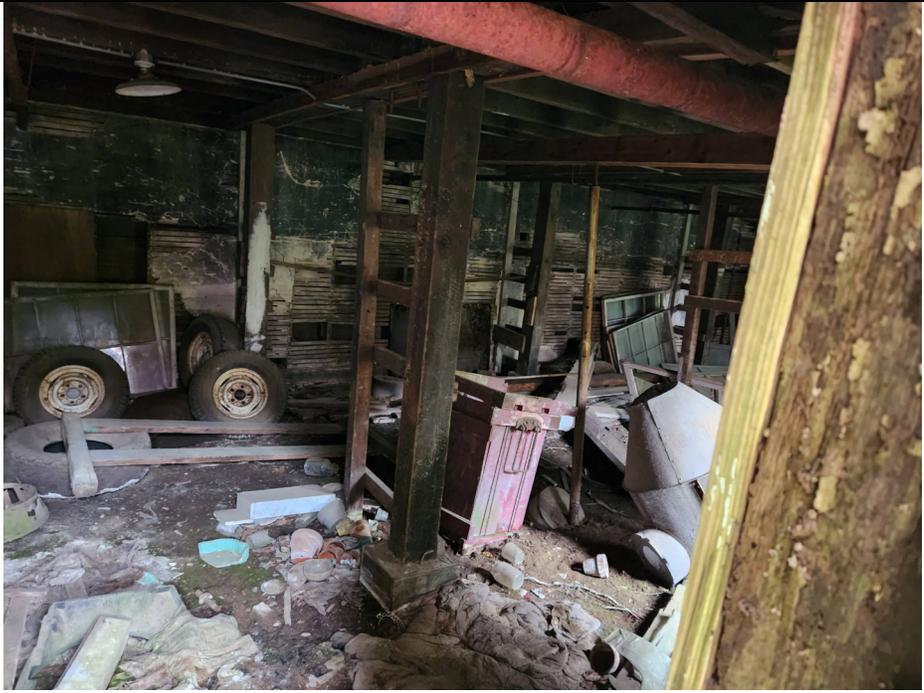
<b>Photo</b> <b>10</b>	<b>Date:</b> 10/3/2022

<p><b>THE MILL AT STAFFORD BUILDINGS</b></p>		
<p><b>Description:</b> Building No. 1 – Interior of Building (looking South) Note: Timber Framed Walls and Second Floor. Lathing falling off walls.</p>
