April 28, 2021

**RE: Report of Hazardous Building Materials Investigation  
Former Earl M. Witt School  
20 Hyde Park Road  
Stafford, Connecticut**

Photo Log  
December 22, 2020

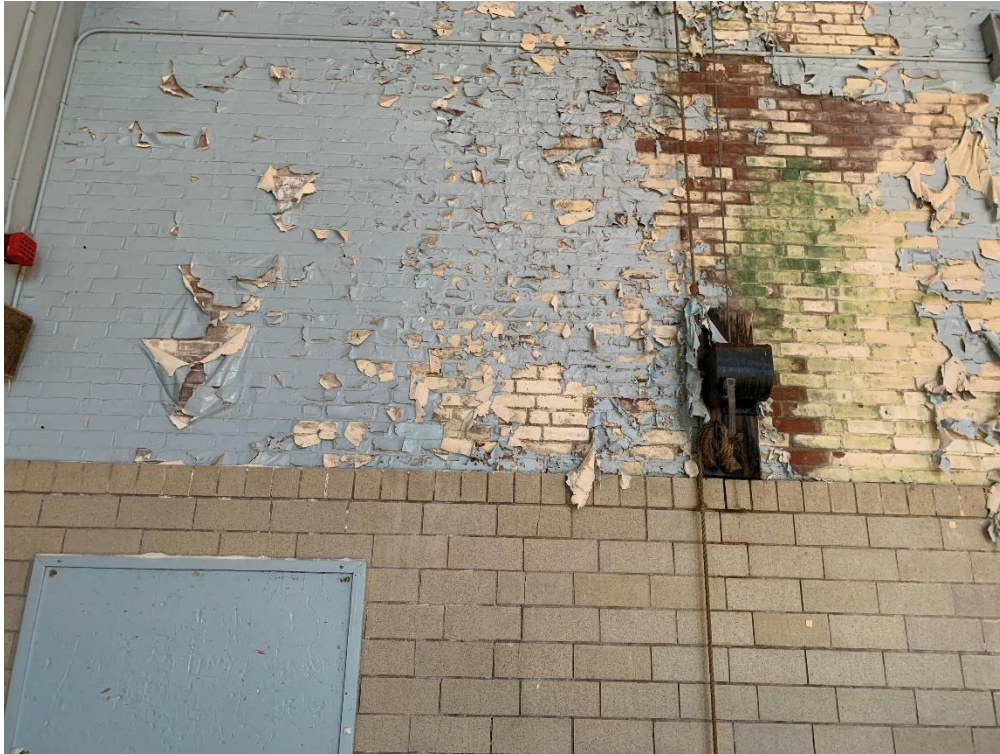
December 22, 2020: View of the paint and wall condition in the gymnasium

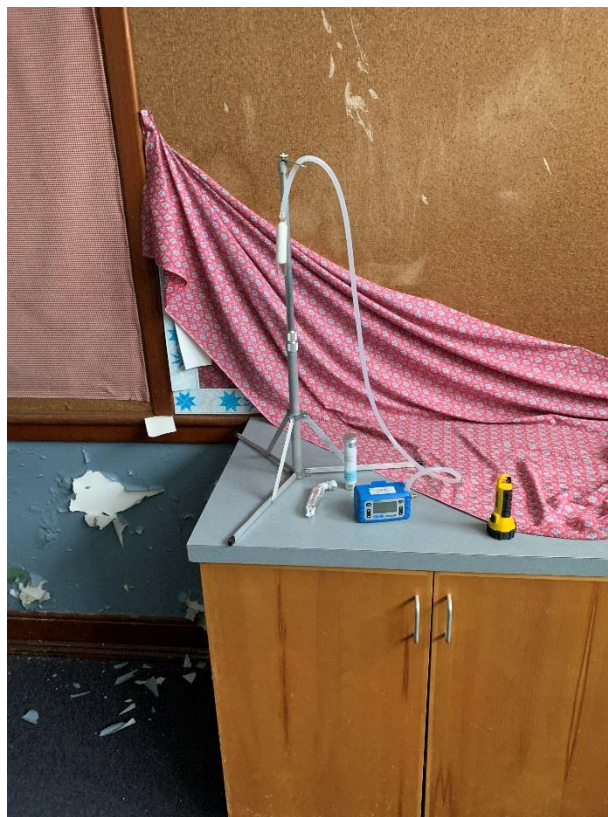
December 22, 2020: View of the PCB in air sampling setup – Room 223

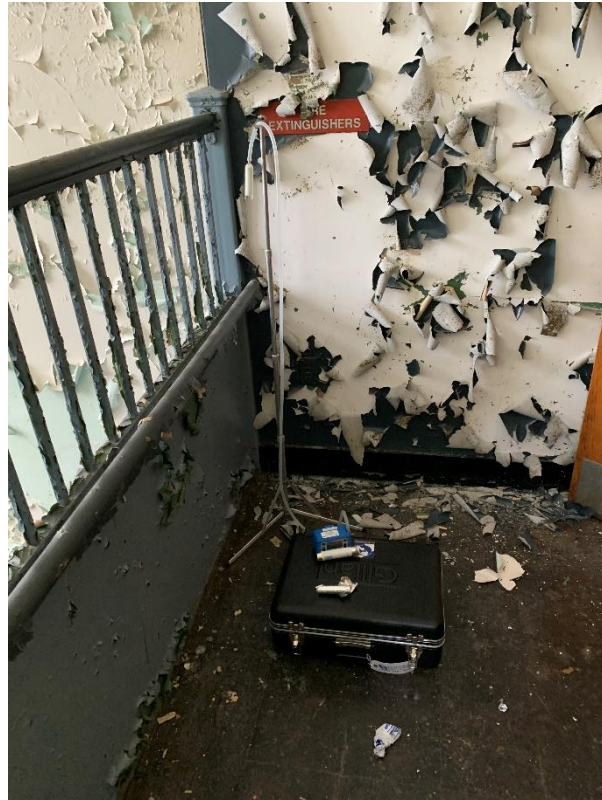
December 22, 2020: View of the PCB in air sampling setup – north stairwell 2<sup>nd</sup> floor

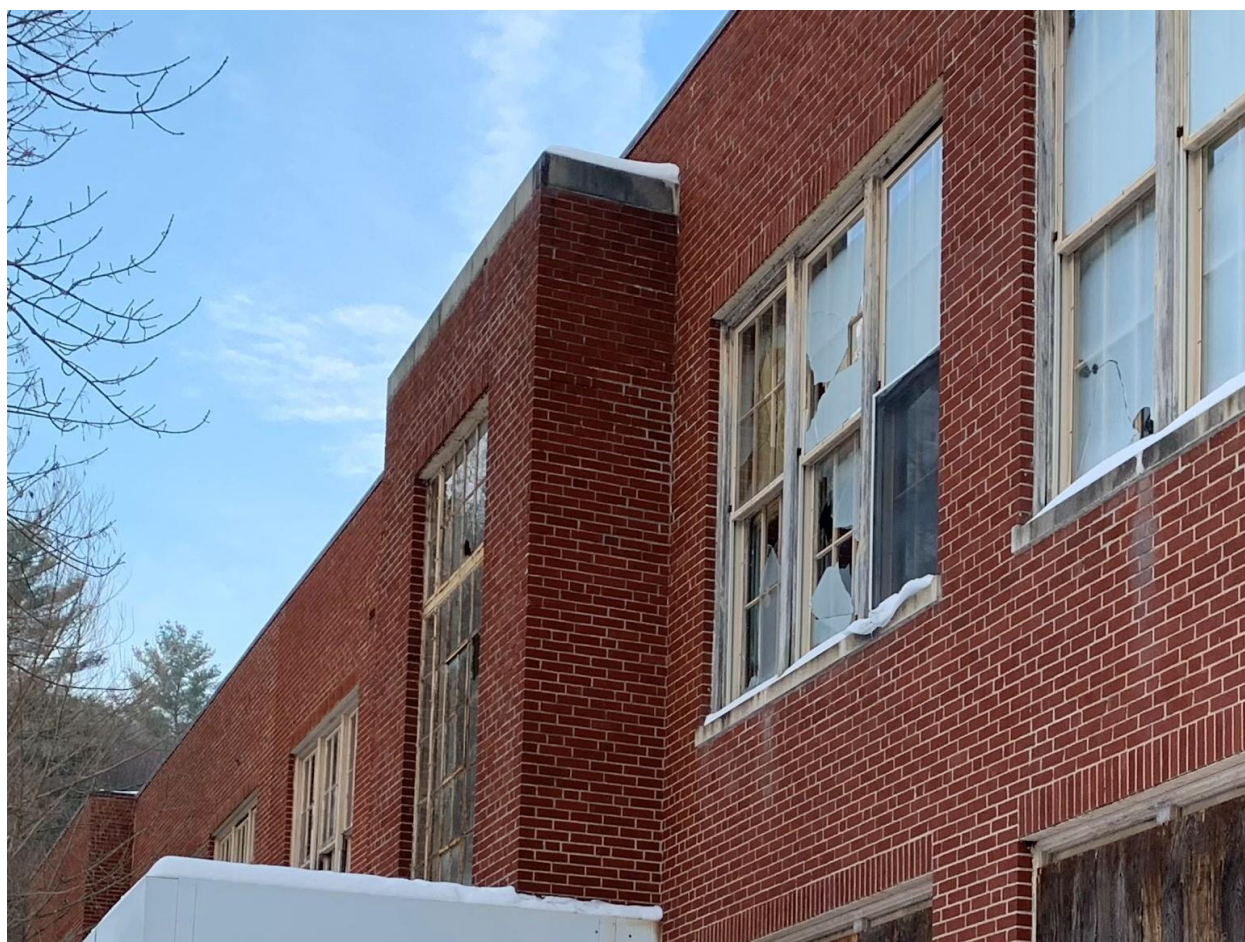
December 22, 2020: Broken windows

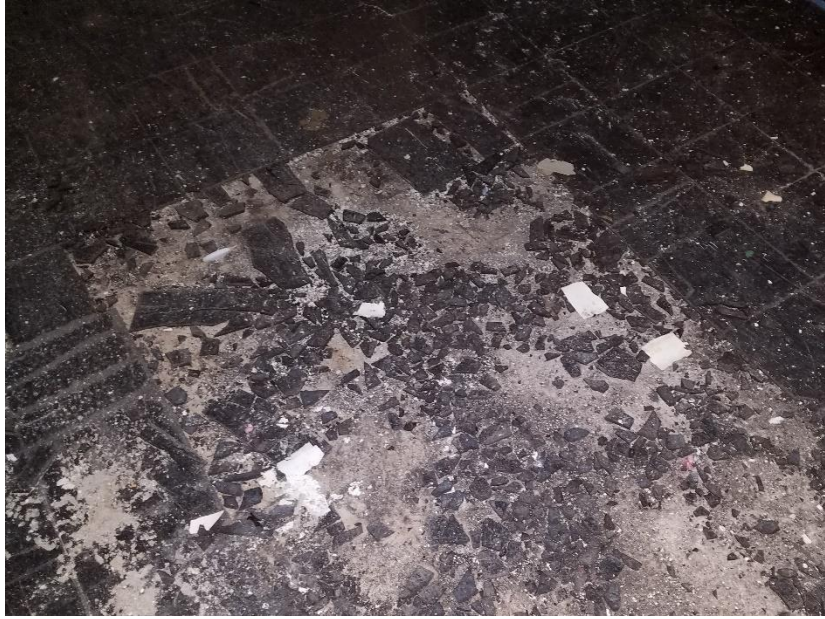
The water has damaged known ACM within the building. Specifically, approximately 300 square feet of floor tile in the ground floor hallway and plaster in several rooms on upper floors. If the building remains unoccupied, we recommend restricting access and activity in any areas where damaged ACM is present. Ultimately the damaged ACMs will require abatement and/or repair as part of any building rehabilitation.

December 22, 2020: Broken floor tile first floor

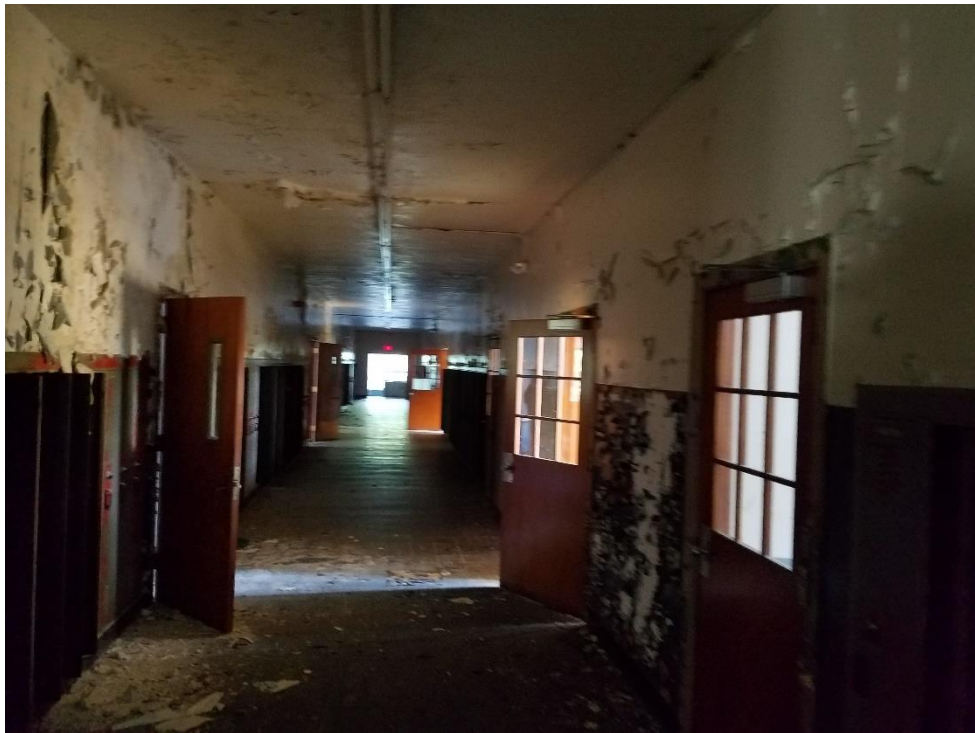
Significant amounts of damaged/peeling paint was observed within the building that will require removal and disposal as part of any redevelopment of the property. Due to the age of the paint and the potential for PCBs in the paint, Weston & Sampson performed background/screening air sampling for PCBs within the structure to evaluate if PCBs were present that may pose a risk to future occupants.

December 22, 2020: Delaminating paint in hall

Air sample results indicated sources of PCBs are present within the building. Based on current data, should renovation of the building occur, Weston & Sampson recommends that suspect PCB-containing materials to be removed (e.g., flaking paint, etc.) should be abated, handled, and disposed of as PCB bulk product waste. Prior to re-occupancy of the structure, indoor air samples should be collected to determine that the risk has been addressed for the future use of the structure.

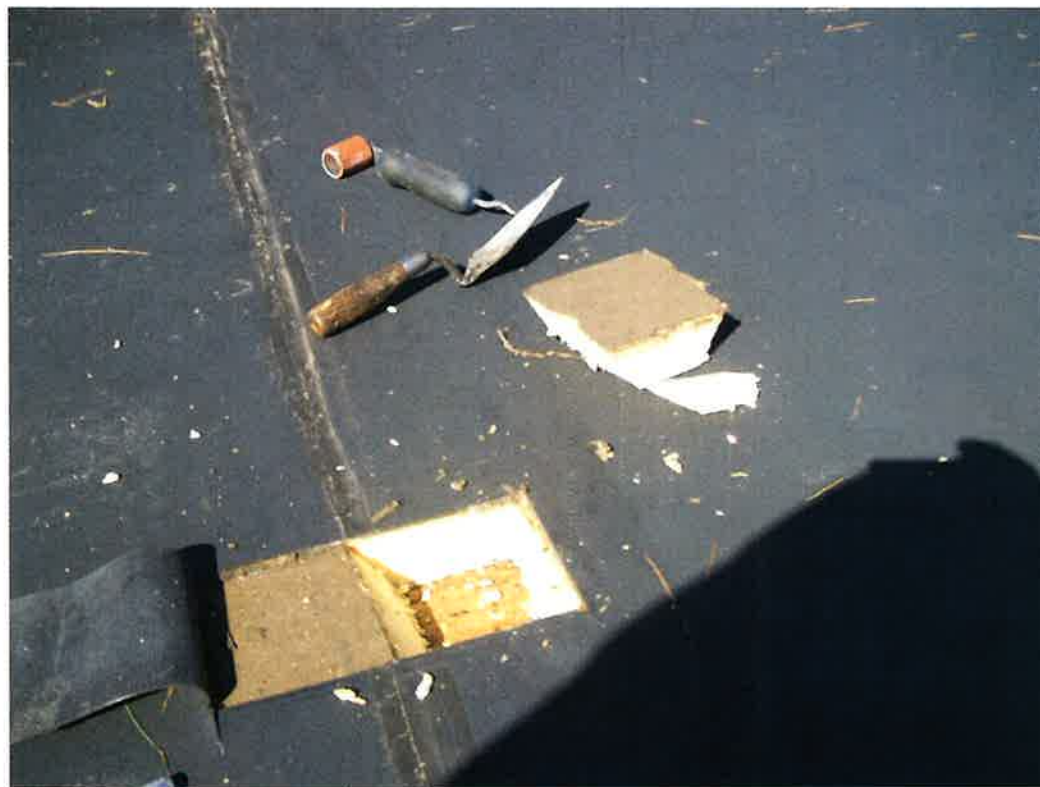
Gym Roof layers-wood decking exposed

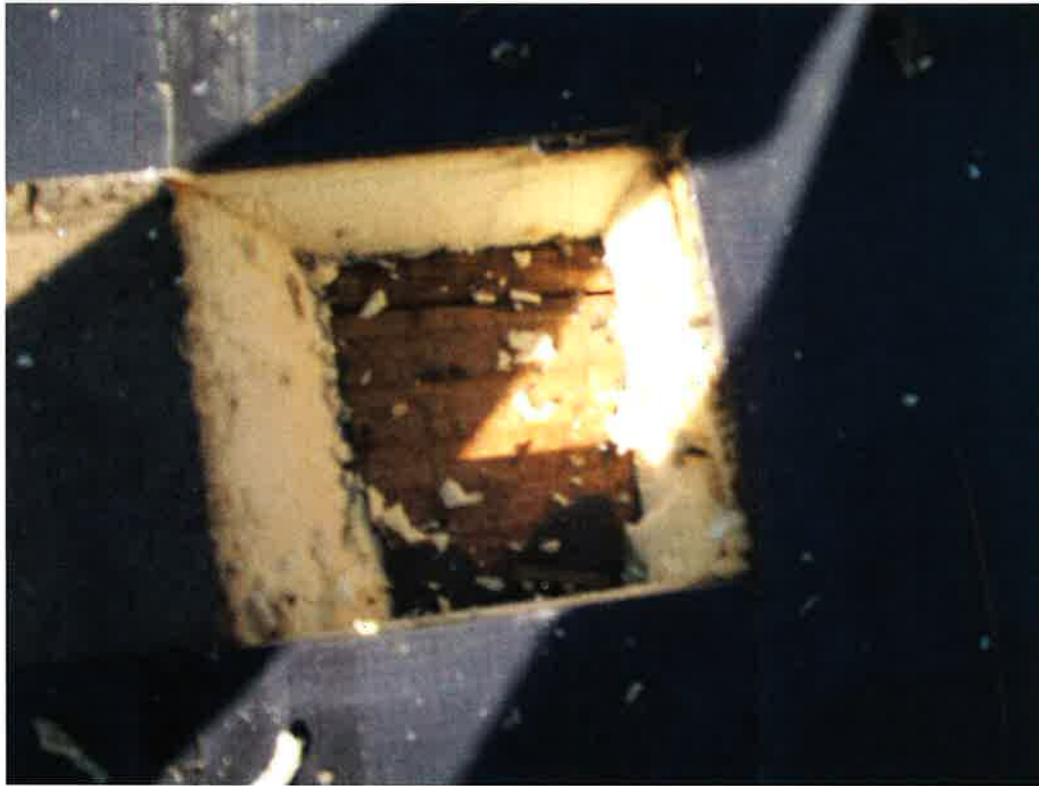
Gym roof layers-wood decking exposed

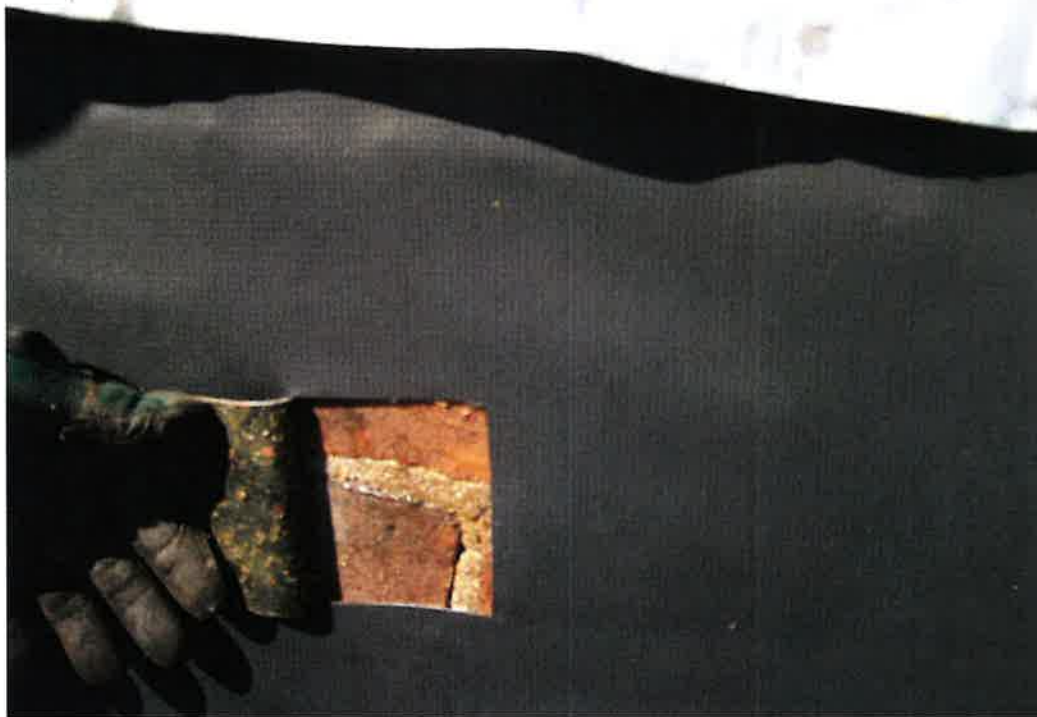
Exposed brick behind rubber membrane on gym parapet wall

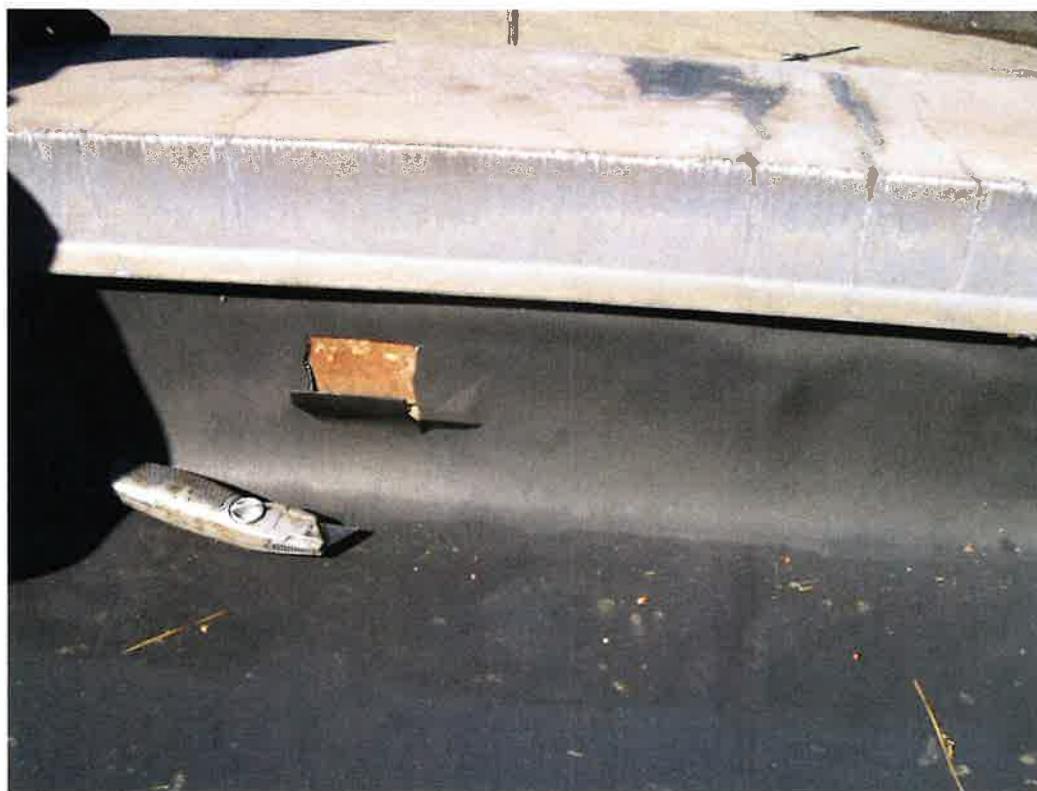
Low roof parapet wall adjacent to Gym (West side) – exposed brick behind membrane

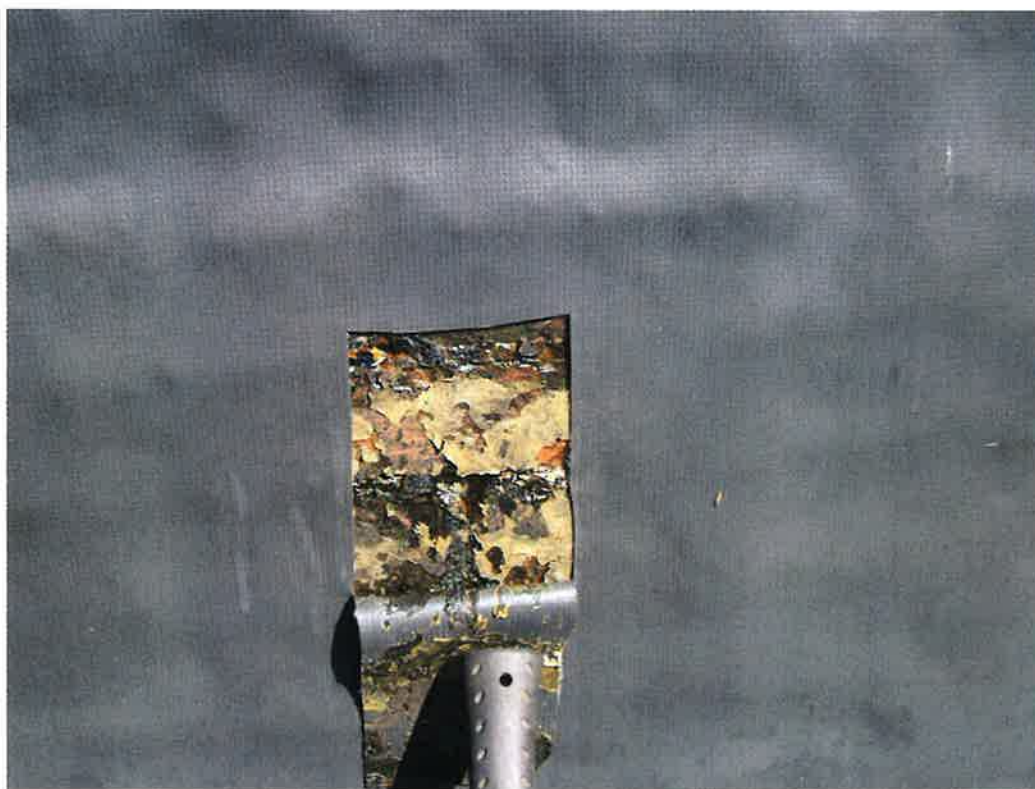
1953 Parapet wall-exposed brick and adhesive behind membrane

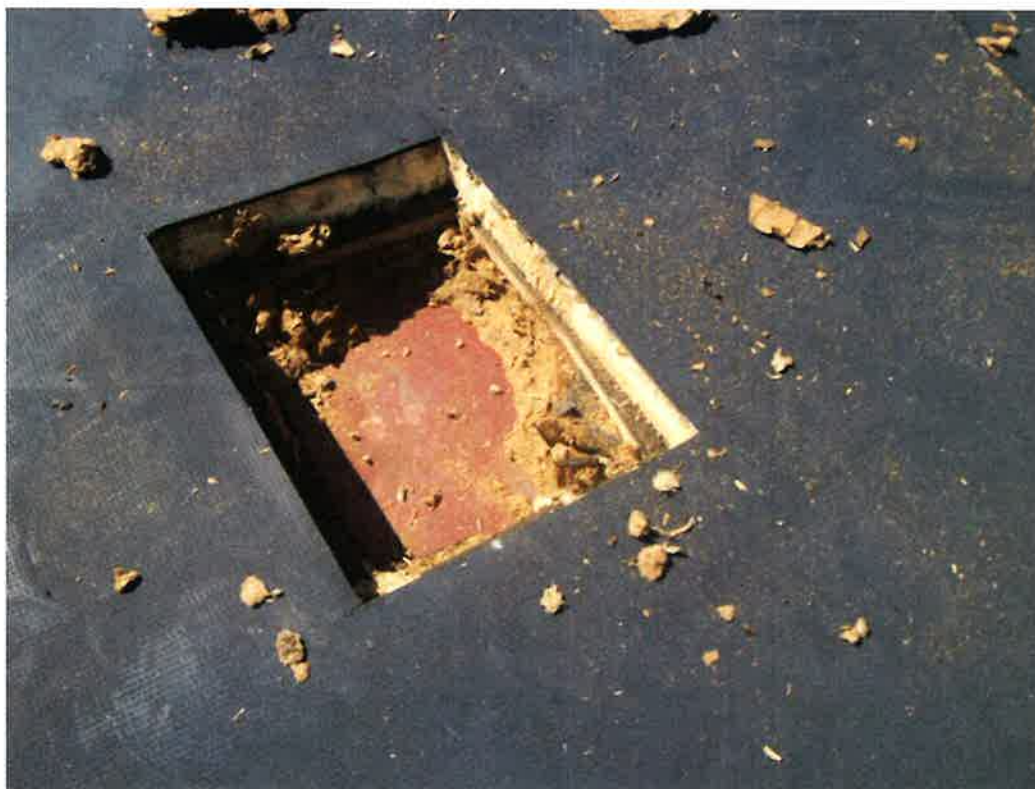
1953 Built up roofing layers and exposed deck

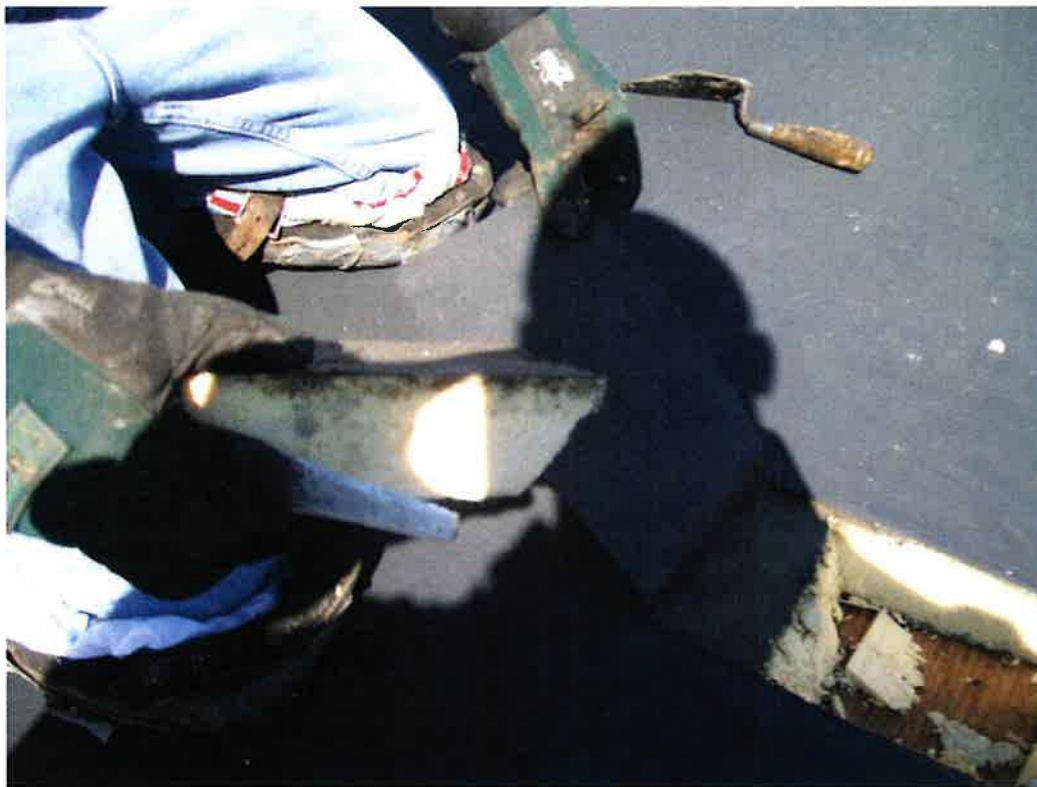
1953 Built up roof-wood deck exposed, "Poly iso" is in hand

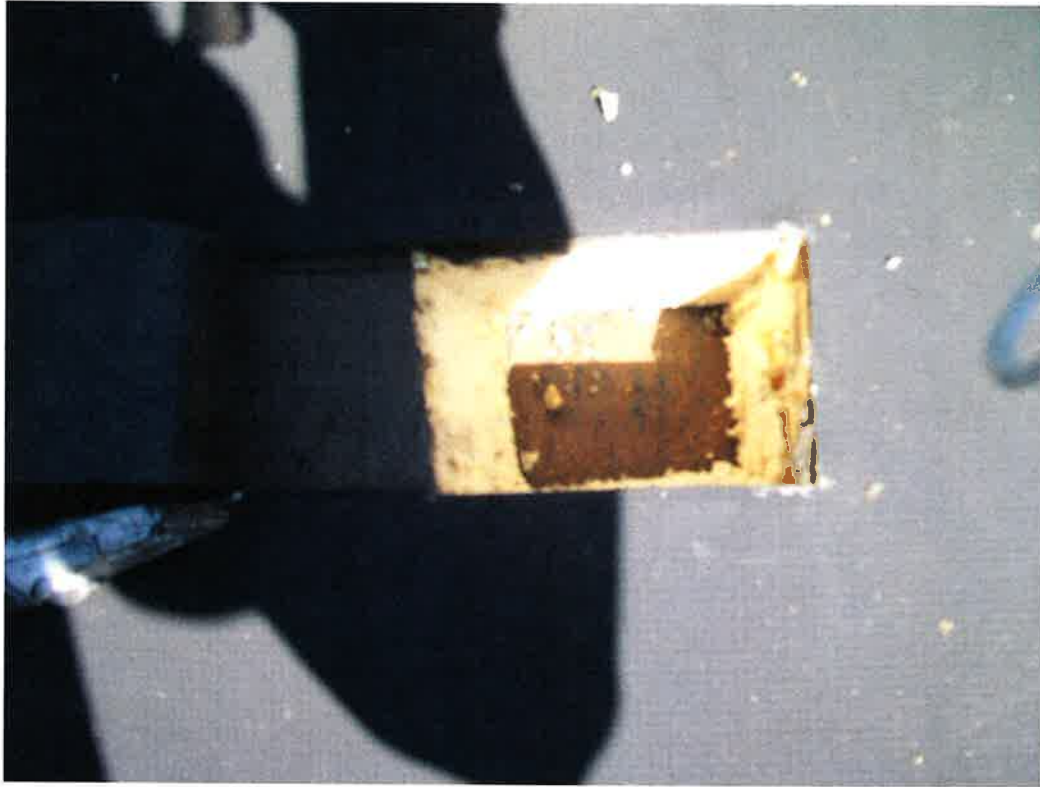
1937 Section-Built up roofing-wood deck exposed

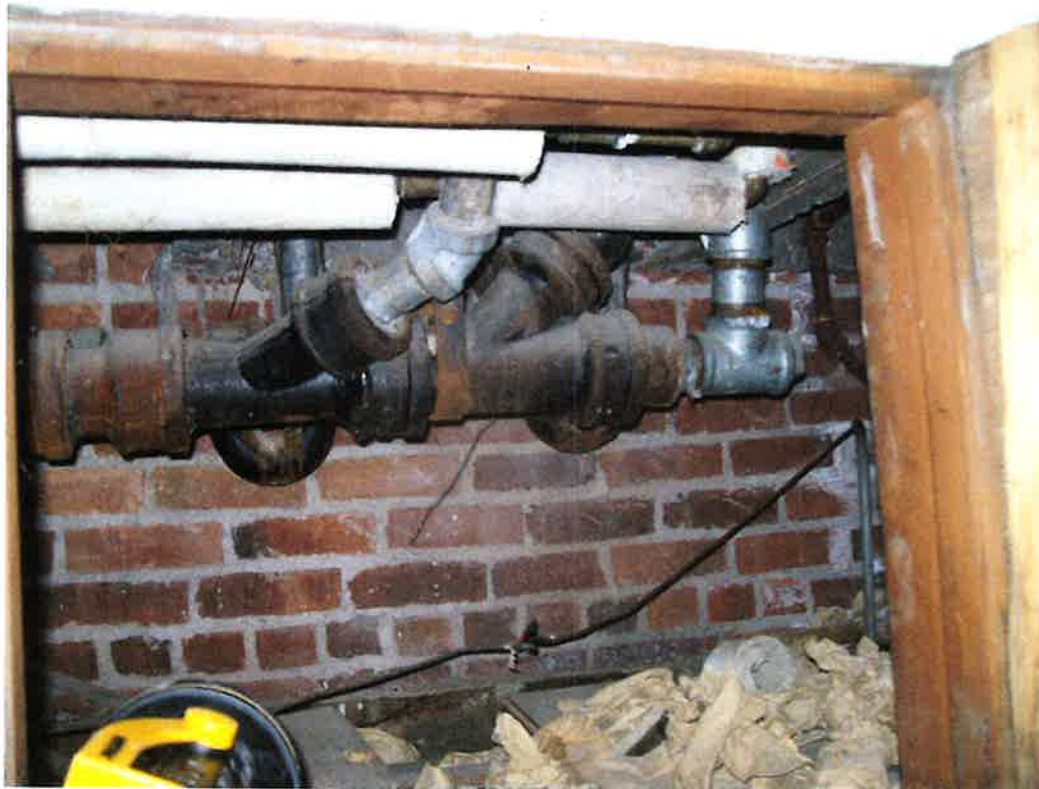
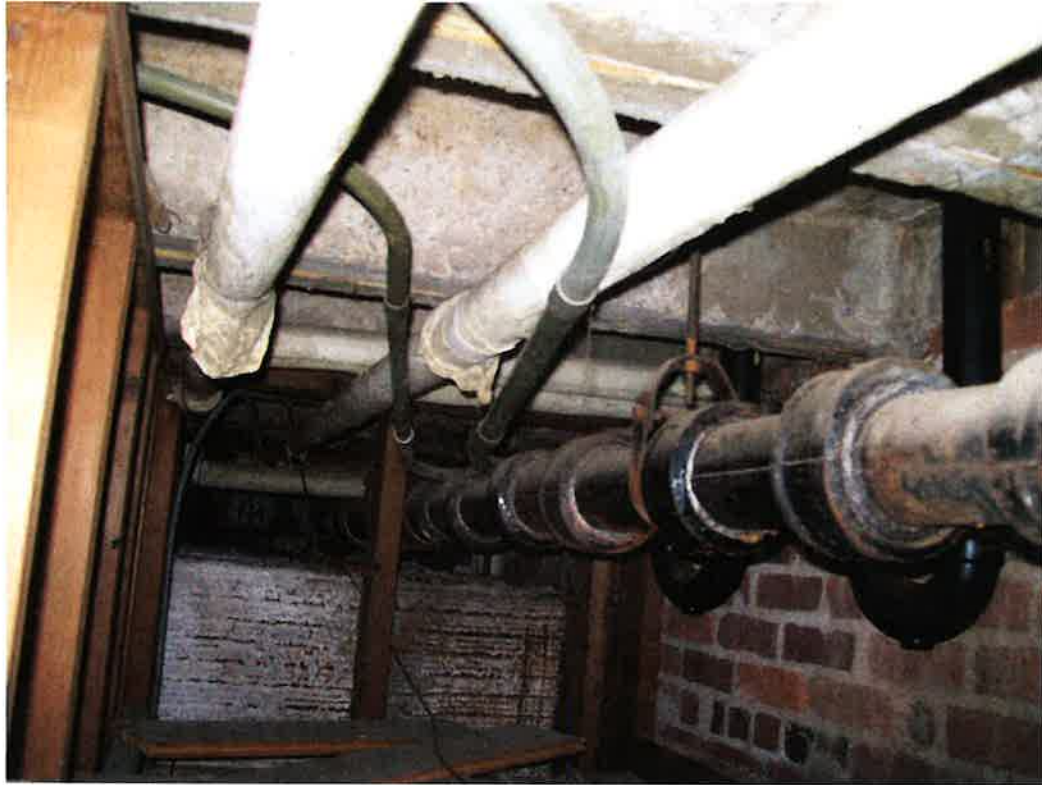
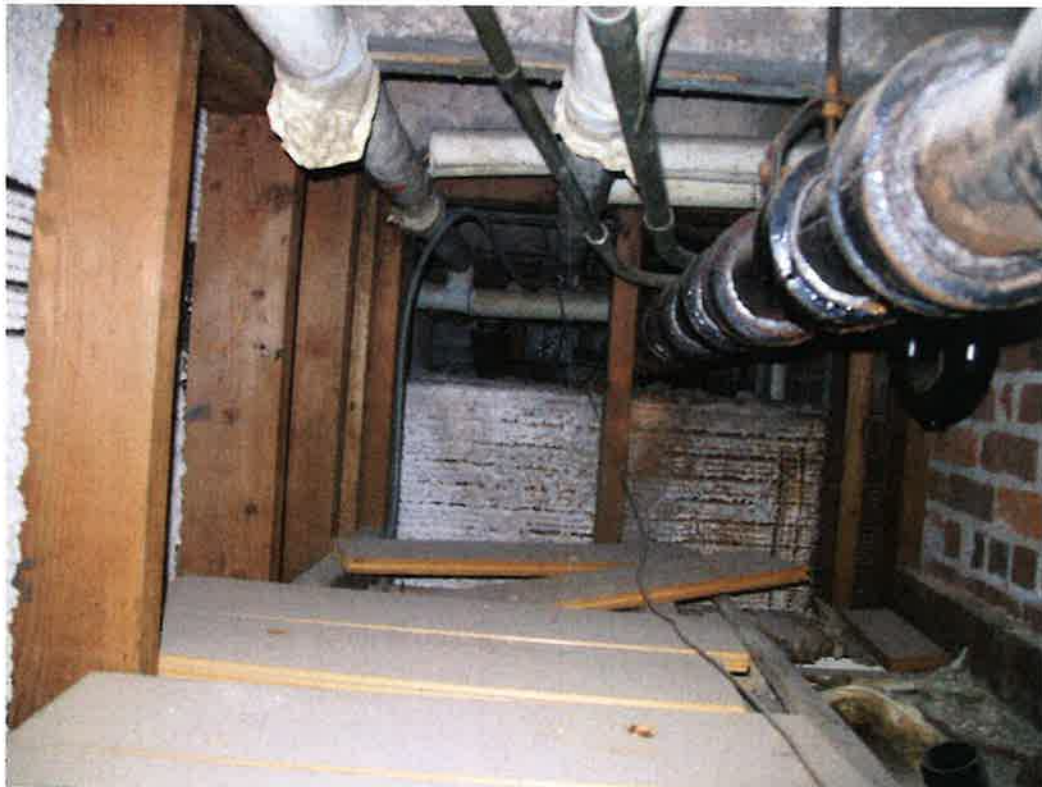
Pipe ACM inside wall cavity of first floor boy's room-hatchway entrance

Pipe ACM inside wall cavity (as seen from 1<sup>st</sup> floor boys' room)

Pipe ACM inside wall cavity of 1<sup>st</sup> floor boys' room
