MARINA RE-DEVELOPMENT VULNERABILITY ASSESSMENT

November 2021

TASK ORDER No. 19-07-GP/ENV(S)
ENVIRONMENTAL SERVICES PROJECTS
PROJECT No. 21077-119

PREPARED FOR: CITY OF ST. PETERSBURG

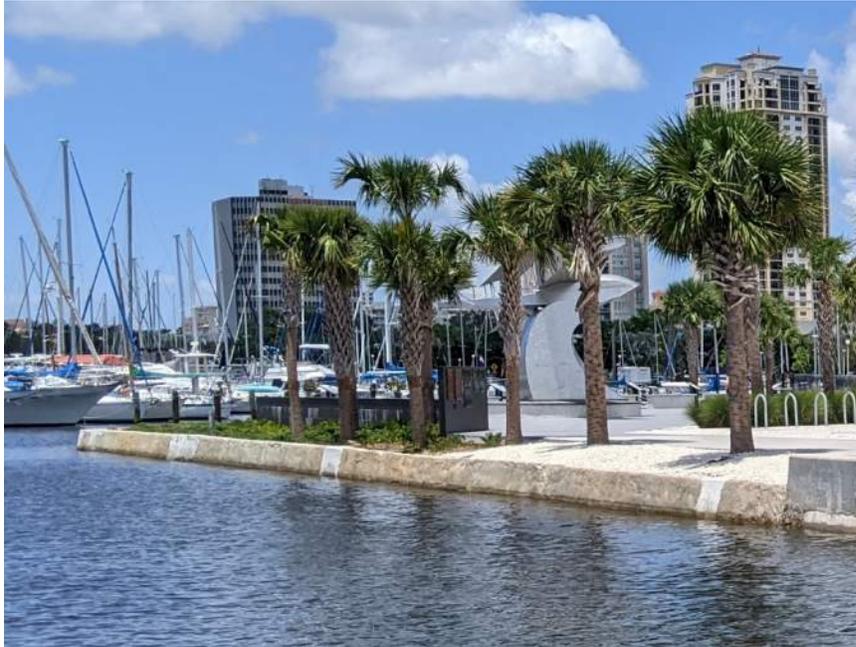
This area consists of two different wall types. At the east end, the wall is a concrete seawall of unknown construction. Heading toward the west, the wall turns towards the north and changes to a concrete sheet pile wall at the next bend point. Original construction plans are not available for either section of wall.

Figure 4: East end of wall

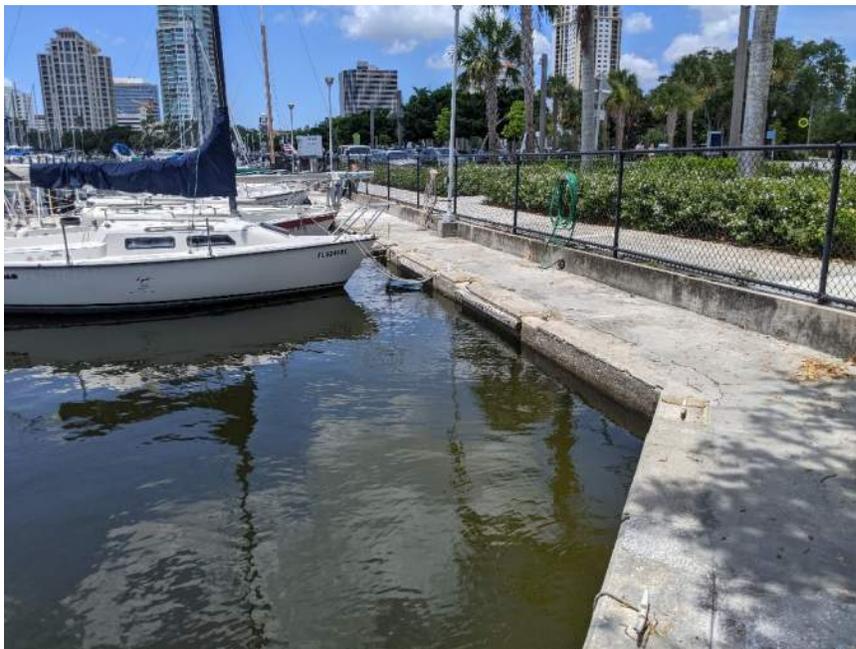
Figure 5: West end of wall

The 2021 Annual Marina Structures Inspection Condition Assessment Report (Project No. 21070-119), prepared by Moffatt & Nichol, includes assessments of the walls throughout the Central Basin. The east end of the Central Basin (Pier) is assessed as being in “poor” condition with patches and exposed reinforcement. The report assesses the west side of the wall as having the concrete cap in “poor” condition (due to cracking, spalling, and exposed reinforcement) and the concrete sheet piles in “fair” condition. This was confirmed during our site visit. Both sections of wall appear to be stable without significant signs of movement.

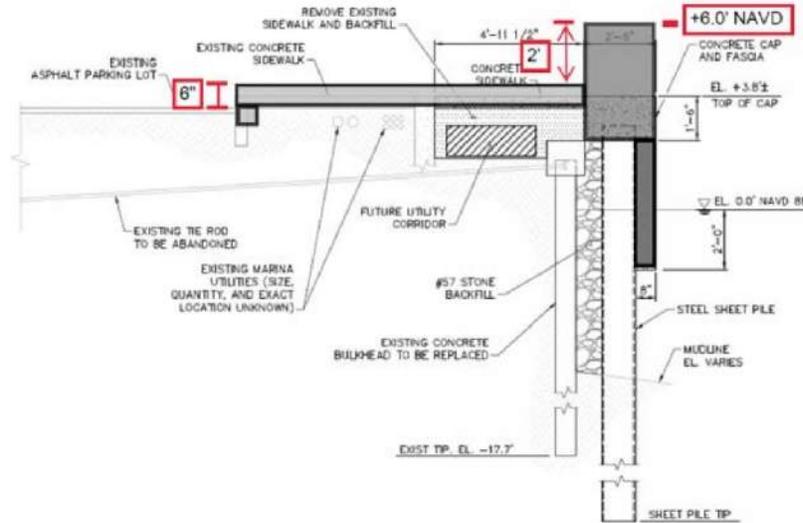
The proposed modifications to this area are shown in Figure 9. This detail, provided to GPI by the City, is similar to a proposed replacement alternative included in the March 30, 2018 technical memorandum by Moffatt & Nichol (St. Petersburg Bulkheads at Pier Approach). The original detail shows a new sheet pile wall installed in front of the existing concrete sheet pile wall, which is to be abandoned. This concept raised the top of the wall from EL +2.3' to EL +3.8' with the cap and adjacent sidewalk raised to the same elevation as the upper sidewalk to the left. Overlaid onto the original detail is the current concept of further raising to top of the cap to 2 ft above the sidewalk to EL +6.0.

Figure 9: Proposed modifications to Central Basin (Pier)

There are few physical conflicts present that would prevent construction of the proposed modifications. No overhead obstructions were noted that would prevent driving sheet piles. Portions of the North Docks in proximity to the wall will need to be removed, and any utilities extending from land to the docks will need to be relocated during construction (Figure 10). Pile driving can be accomplished with equipment positioned along 2nd Ave NE, or from barges to keep the pier fully available to the public.

Design of the new steel sheet pile wall will need to consider the ramifications of using anchors or dead men. Retaining approximately 13 ft of soil, a sheet pile wall designed without an anchor will require a relatively large section. Potential cost savings could be achieved by designing the wall with an anchor in order to reduce the sheet pile section and required embedment. However, use of a tie rod and dead man, as in the existing construction, would require excavation of numerous sections of 2nd Ave NE. Alternatively, tie backs could be drilled from the front face of the wall and anchored with concrete grouted from the same location. This would require thorough utility coordination to ensure no existing facilities are damaged.

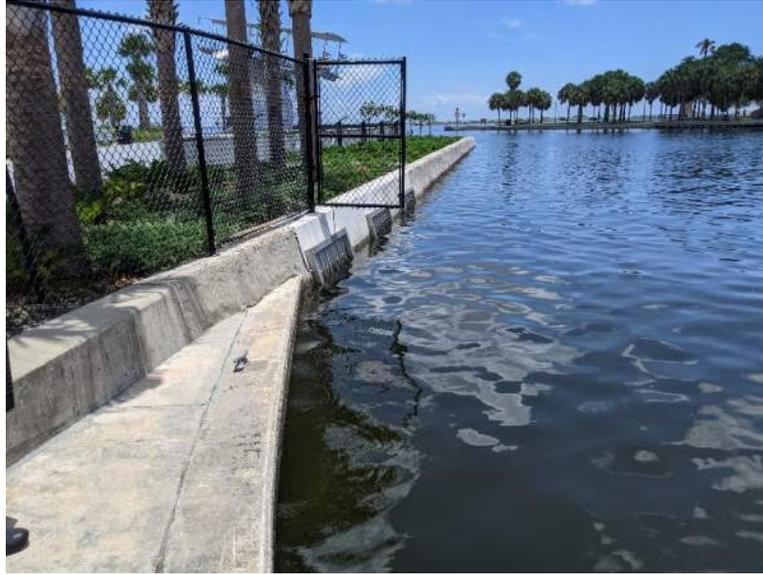
few conflicts to driving sheet piles in front of the existing wall. It is anticipated that pile driving from barges will be more desirable in this area due to the presence of sidewalks and landscaping along this entire length of wall that would require restoration after pile driving is completed. There may be large rubble riprap that will need to be moved to allow for pile driving. Additionally, there are three drainage pipe outlets at the end of the wall, where wall type changes to concrete sheet piles, that will need to be accommodated by the new wall (Figure 11).

Figure 11: Pipe outlets at end of concrete seawall

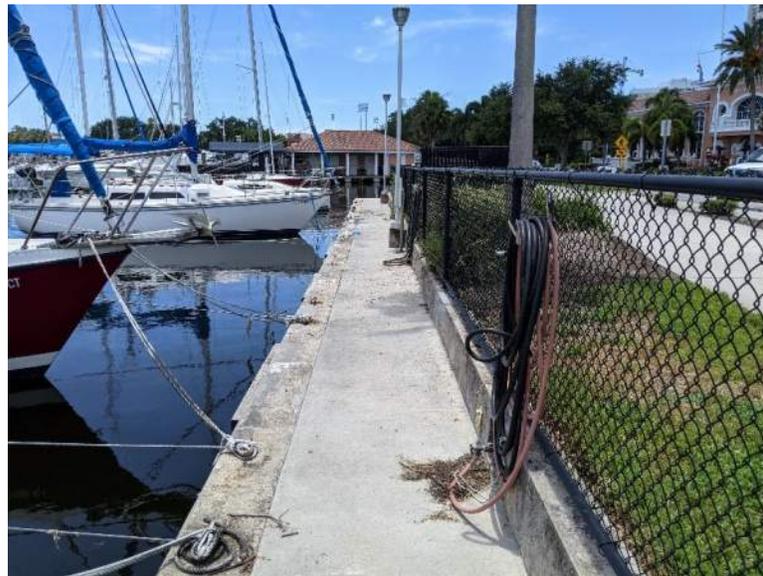
The 2021 Annual Marina Structures Inspection Condition Assessment Report assessed the West Quay Wall as having the concrete cap in “poor” condition due to cracking, spalling, and exposed reinforcement and the concrete sheet piles in “fair” condition. The report does not assess the pier area. The stated condition of the West Quay Wall cap was confirmed during our site visit, and the pier area was found to be in similar condition. Both sections of wall appear to be stable without significant signs of movement.

Figure 13: Central Basin (West Quay Wall)

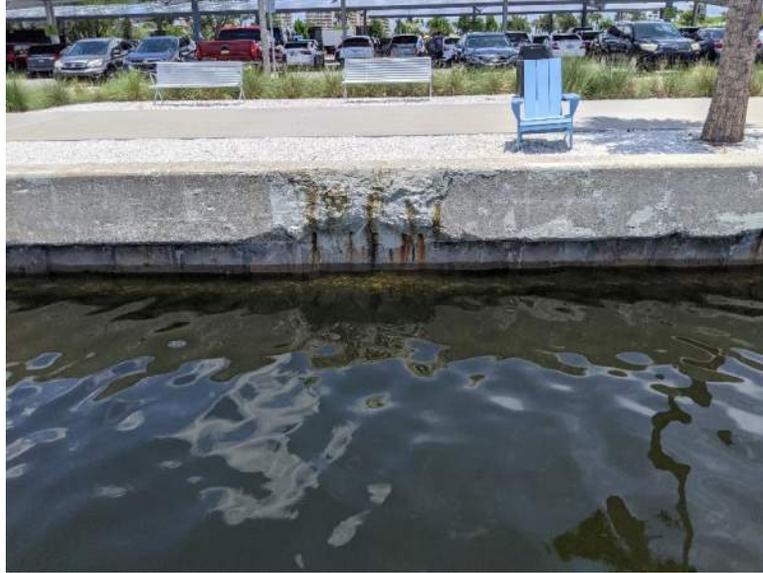
The proposed modifications to these areas consist solely of repairs to the existing bulkhead caps. Based on the assessment in the 2021 inspection report, this appears to be an acceptable approach at this time. While the concrete sheet piles are in “fair” condition, the concrete caps display cracks, spalls, and corrosion stains at existing patch repairs (Figure 14). These are signs of advanced corrosion in the cap reinforcement.

Figure 14: Multiple patch repairs and corrosion stains at Central Basin (East Pier) wall

Based on the condition of the concrete caps, it is recommended that repairs should consist of full cap replacement as opposed to localized repairs. The signs of corrosion indicate high chloride concentrations in the cap concrete, and localized repairs will likely result in accelerated corrosion in areas surrounding the patches, referred to as the “halo effect”. This effect is the result of high pH concrete in a repair passivating the reinforcement within the repair while the reinforcement within the adjacent, lower pH concrete remains unaffected. The large difference in the corrosion potential of the reinforcement and the presence of the chloride contamination accelerates corrosion around the patch area. While the halo effect can be mitigated by installing galvanic anodes in patch repairs, this will only protect the area of the patch and areas in proximity. Galvanic anodes placed in patches will not sufficiently polarize the steel to establish cathodic protection and will only slow the progress of corrosion in areas where corrosion has already begun.

Replacement of the concrete cap should consider several additional factors. Both sections of wall are believed to have either tie rods or concrete beams that extend to deadmen that provide support to the top of the walls. These must be protected during demolition / construction and appropriate limits to activities along the wall must be established to maintain its structural stability. Just as corrosion is present in the caps, it may be discovered during demolition that the tie rods / beams are similarly corroded or damaged. Repair details for these components should be prepared during design to prevent delays during construction.

Design of the cap replacements should consider reinforcement with Fiberglass Reinforced Polymer (FRP) rebar in lieu of carbon steel. Utilizing FRP, the service life of the caps will be extended considerably by removing the possibility of future corrosion. FDOT and GPI have implemented FRP reinforcement in several bulkhead cap replacements throughout the State with excellent outcomes and relatively low additional cost.

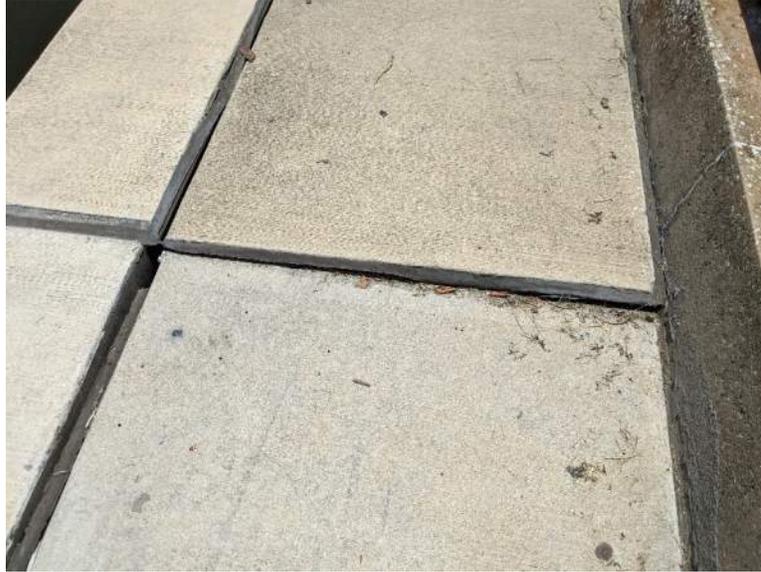
The wall directly to the north of the West Quay Wall was repaired approximately 5 years ago with a cap and sidewalk replacement. During our site visit, settlement was noted in the sidewalk as was visible loss of fill behind the sheet piles (Figure 15). During construction of repairs to the concrete caps, additional mitigation measures should be implemented to seal the joints between sheets and prevent loss of fill material.

Figure 15: Sidewalk settlement and joint failure at recent repairs north of West Quay Wall due to loss of fill behind sheet piles

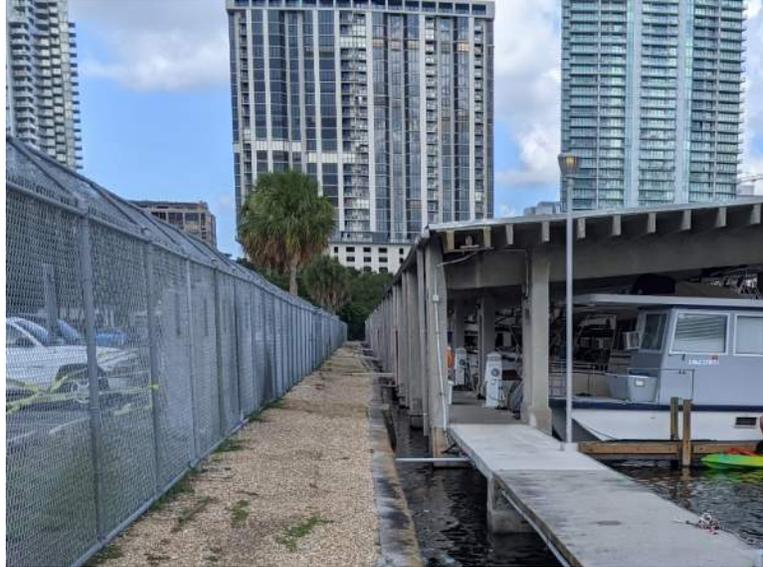
Figure 16: South seawall at Central Docks

The 2021 Annual Marina Structures Inspection Condition Assessment Report assessed the Central Basin (Demens) walls as being in “serious” to “fair” condition. The report assessed the concrete seawall as being in “poor” condition with moderate to severe abrasion, lateral movement, full depth cracking, and areas of subsidence behind the wall. The reconstructed section of wall is identified as a steel sheet pile wall and is assessed as being in “fair” condition. The northern sheet pile wall is assessed as being in “serious” condition with severe corrosion of the sheet piles. The field assessment confirmed the evaluation of each area to be accurate.

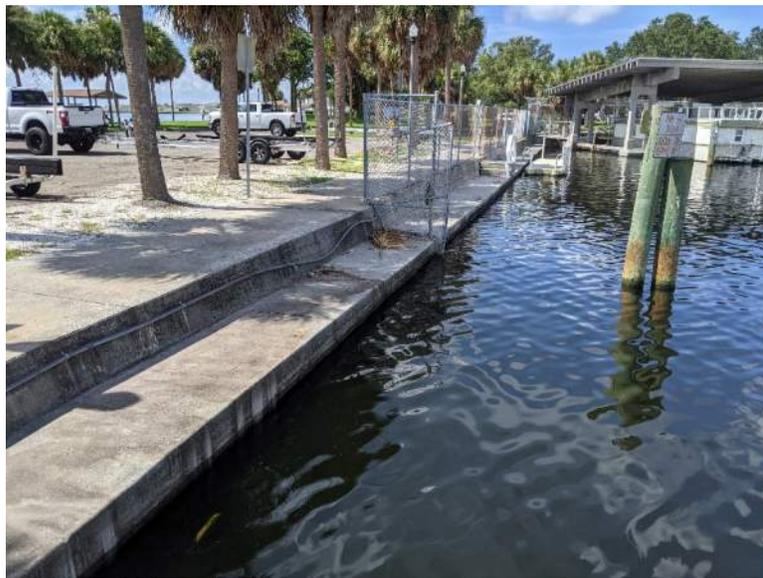
Figure 17: Reconstructed section of East Quay Wall south of boat ramp

No proposed modifications were provided for the other two sections of wall. The section to the south of the boat ramp is in “fair” condition and does not require any immediate action. However, the condition of the bulkhead to the north of

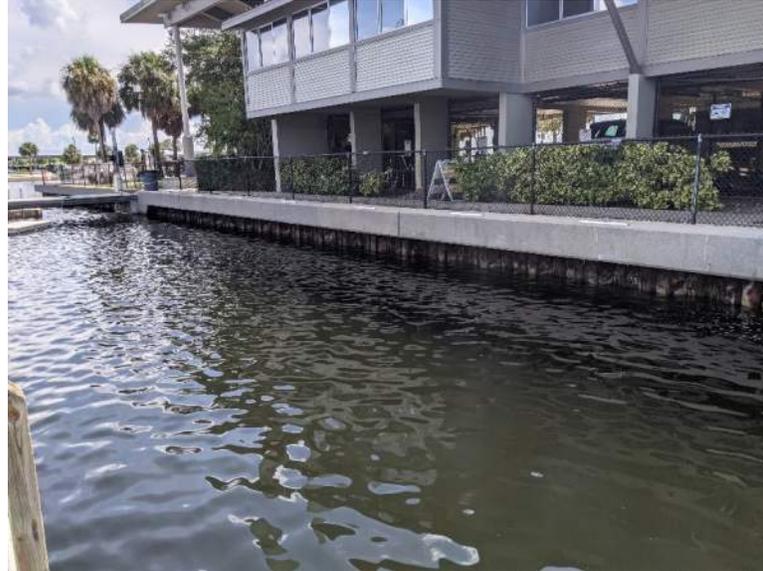
The area that extends across the southern limits of the central basin consists of three different wall types. The sections of seawall that run east-west appear to be of similar construction to the concrete seawall at Central Basin (Pier) (Figure 16). The southern end of the section that runs north-northeast (East Quay Wall) appears to have been reconstructed relatively recently, possibly at the same time as the reconstruction of the adjacent boat ramp to the north (Figure 17). The northern end of the section that runs north-northeast is a steel sheet pile wall (Figure 18).

Figure 18: East Quay Wall north of boat ramp

the boat ramp should be addressed. Several alternatives exist for rehabilitation of the wall: spot repairs of the steel sheets by welding reinforcing plates, concrete facing installation, or encapsulation with FRP panels and placement of inert material between the panels and the wall. Selection of a rehabilitation method requires a detailed inspection and assessment of the sheet piles and is outside the scope of this report.

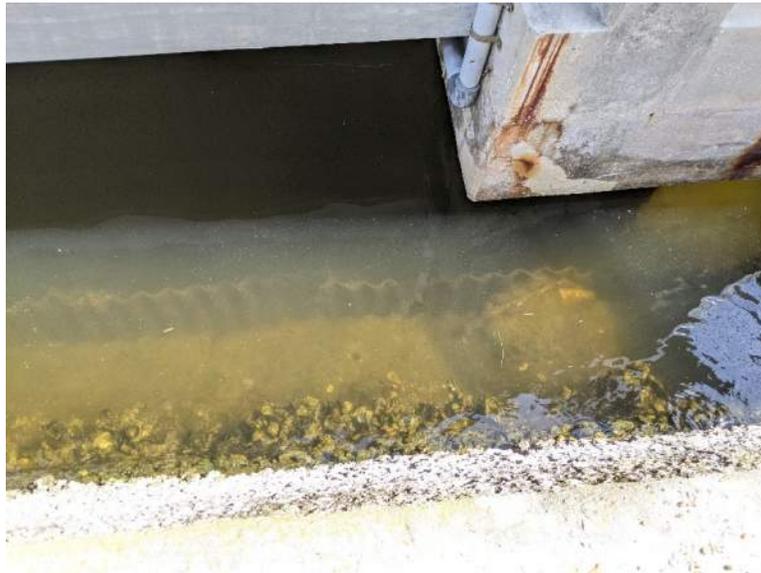
Numerous physical conflicts to the proposed modifications are present along the concrete seawall. Utilities and walkways extend from the seawalls to the covered Central Docks; however, the docks themselves will need to be demolished to allow for construction of the modifications. The edge of structure supporting both the walkway that is parallel to the seawall and the roof system for the docks runs directly over the corrugated steel sheet pile toe-wall (Figure 20). In addition, 12-inch piles supporting the structure are within a foot of the toe-wall. In order to drive the proposed steel sheet piles, the roof and walkway will need to be demolished and the conflicting piles will need to be removed. There is also a wooden deck, which is property of the City of St. Petersburg, at the SC bathroom and laundry room, near Slip SC-1, that extends over the wall and will need to be removed (Figure 21).

Figure 20: Conflict between dock platform and corrugated steel toe-wall

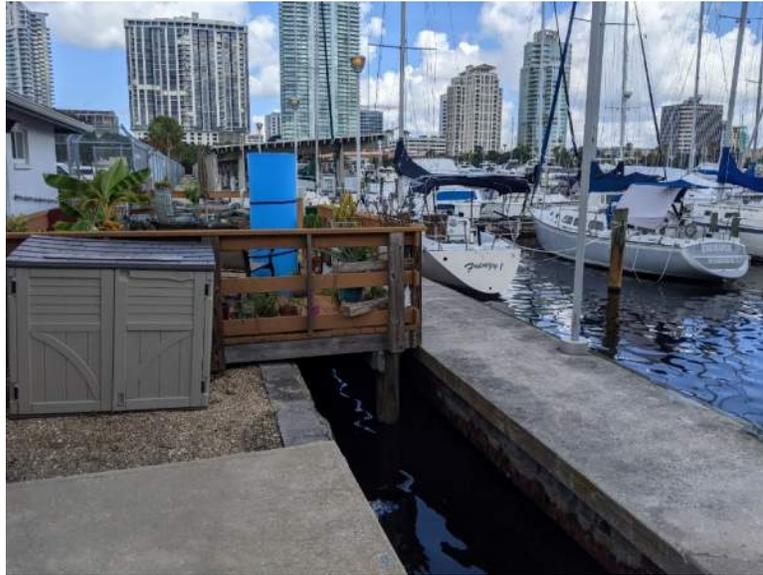
Figure 21: Wood deck at bathrooms in conflict with seawall

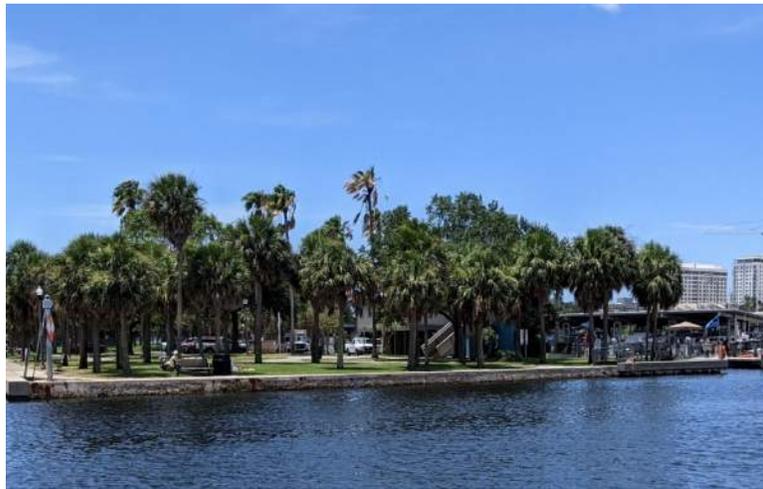
Pile driving along the seawall at the entrance to the Central Basin presents slightly more complications (Figure 22). Driving the sheet piles from land may require removal of some trees to accommodate equipment and restoration following construction. Driving sheet piles from barges will restrict the entrance to the Central Basin. Both are viable but will require close coordination with the City and the marina to determine the most desirable option. Prior to pile driving in this area, large rubble riprap will need to be relocated.

Figure 22: Seawall along marine vessel entrance to Central Basin

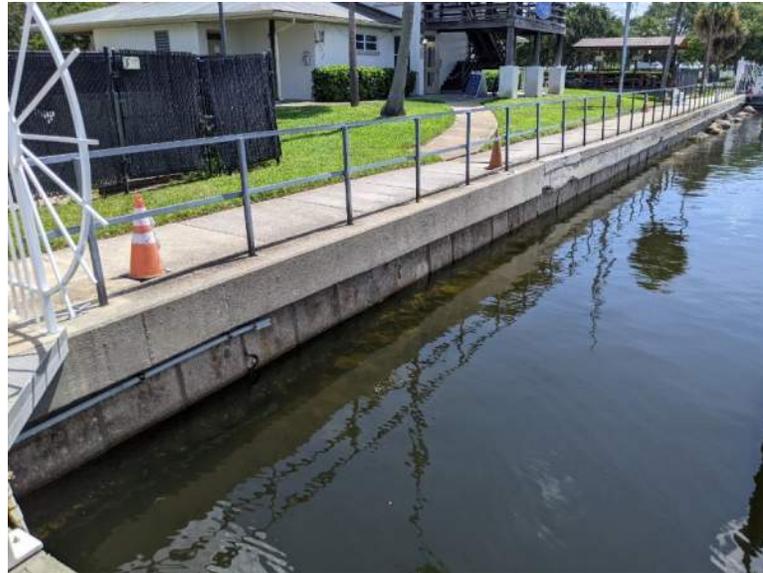
Figure 23: South Basin concrete sheet pile wall

The 2021 Annual Marina Structures Inspection Condition Assessment Report indicates conditions along the wall range between “fair” and “serious”. Noted conditions include cracking, spalling, delaminations, rust staining, exposed sheet pile joints, and areas of subsidence in the sidewalk behind the wall. These conditions were verified as accurate during the site visit.

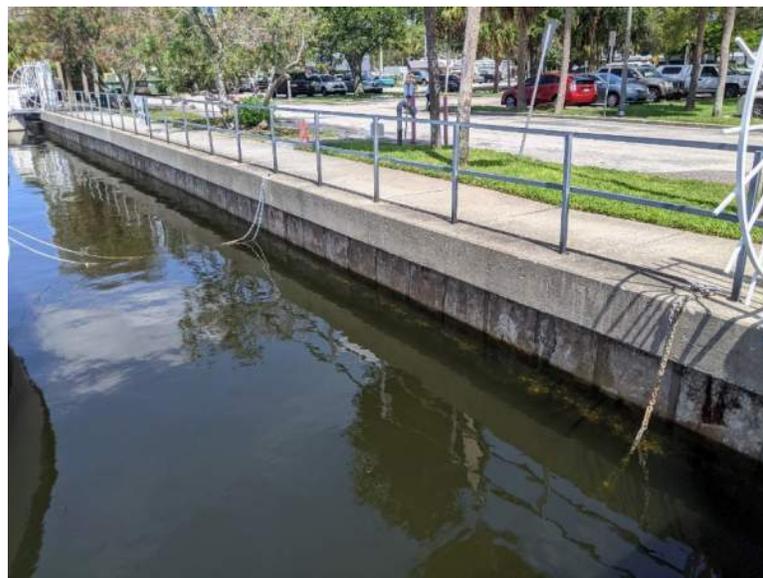
While the proposed modifications are feasible, they are not recommended. The condition of the concrete sheet piles, both noted in the inspection report and verified during the GPI site visit, show extensive corrosion throughout the sheet piles. Spot repairs along the sheet piles would both be too numerous to be cost effective and generally not desirable due to the "halo effect" described in the Central Basin (West Quay Wall / East Pier) section. Cathodic protection measures to halt the progression of corrosion in the wall are not advisable due to the high cost associated with protecting a wall showing advanced deterioration. It is recommended that the sheet piles wall in this area be replaced.

Figure 26: Exposed corroding reinforcement, corrosion stains, and efflorescence at the South Basin concrete sheet pile wall
