# Fishway Assessment and Cost Analysis Report

ROYAL RIVER, YARMOUTH ME

**PREPARED FOR THE NATURE CONSERVANCY  
FINAL – JULY 2017**

**INTER-FLUVE  
P.O. BOX 236  
DAMARISCOTTA, ME 04543**

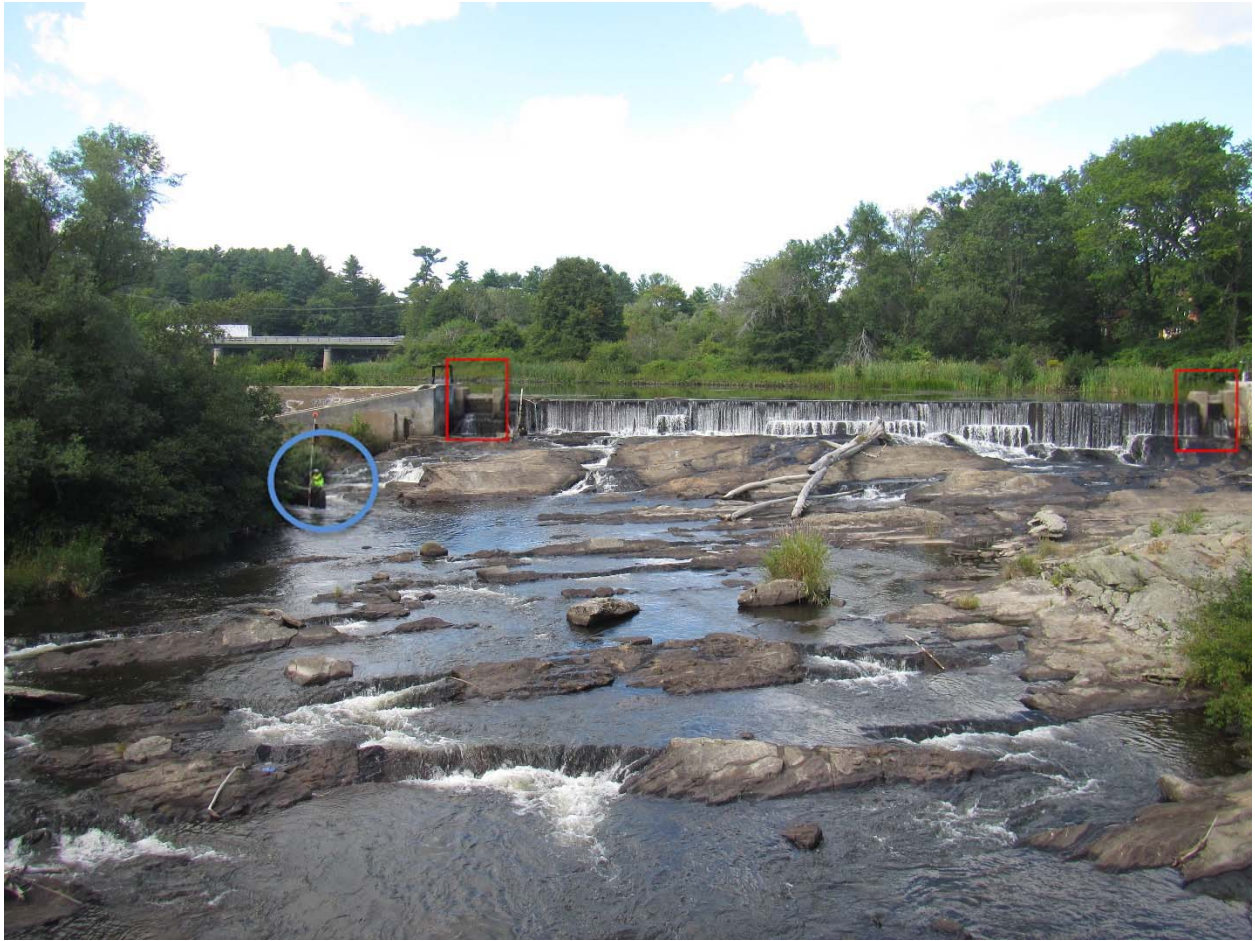
**Figure 4:** View looking upstream at Bridge Street Dam. Stop log weirs are indicated within the red squares and fishway entrance is indicated with a blue circle. Note surveyor for size. Flow direction is toward viewer.

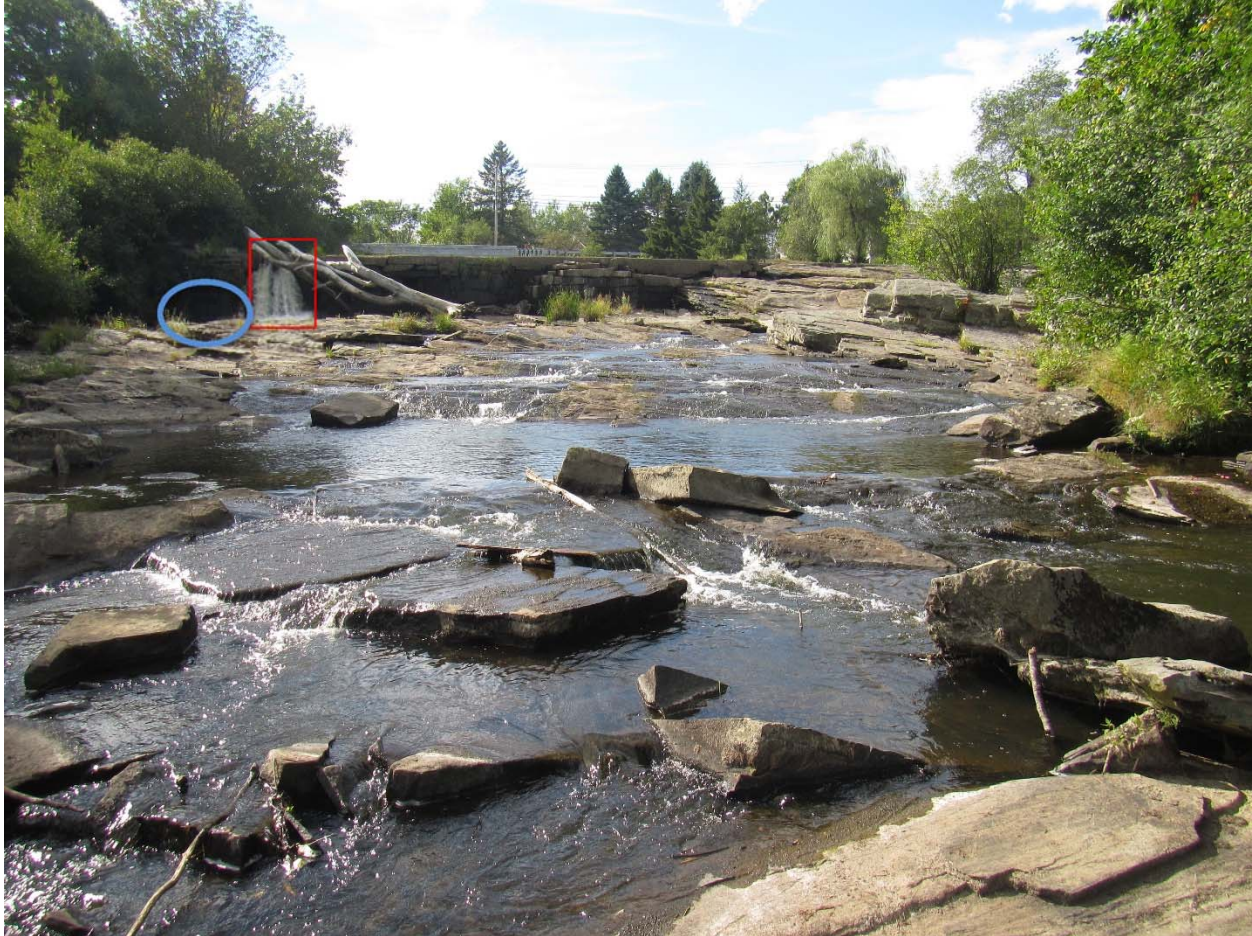
**Figure 5:** View looking upstream at East Elm Street Dam. Stop log weir is indicated within the red square and the fishway entrance is indicated with a blue circle. Flow direction is towards viewer.

There is a stop log weir adjacent to the spillway that is also non-functional with several pieces of large woody debris blocking the opening and preventing its operation, though the majority of flow was through this weir at the time of the assessment. In addition to the facilities at the dam, a bypass channel (referred to as the foundry channel) drains from the impoundment approximately 250 feet upstream of the fishway exit, upstream of the East Elm St. bridge, and re-enters the river approximately 475 feet downstream of the dam. Flow downstream of the spillway splits around Gooch Island, with the associated ledge outcrop close to or at the spillway elevation approximately 2/3 of the distance across the irregular crest from river right to left.

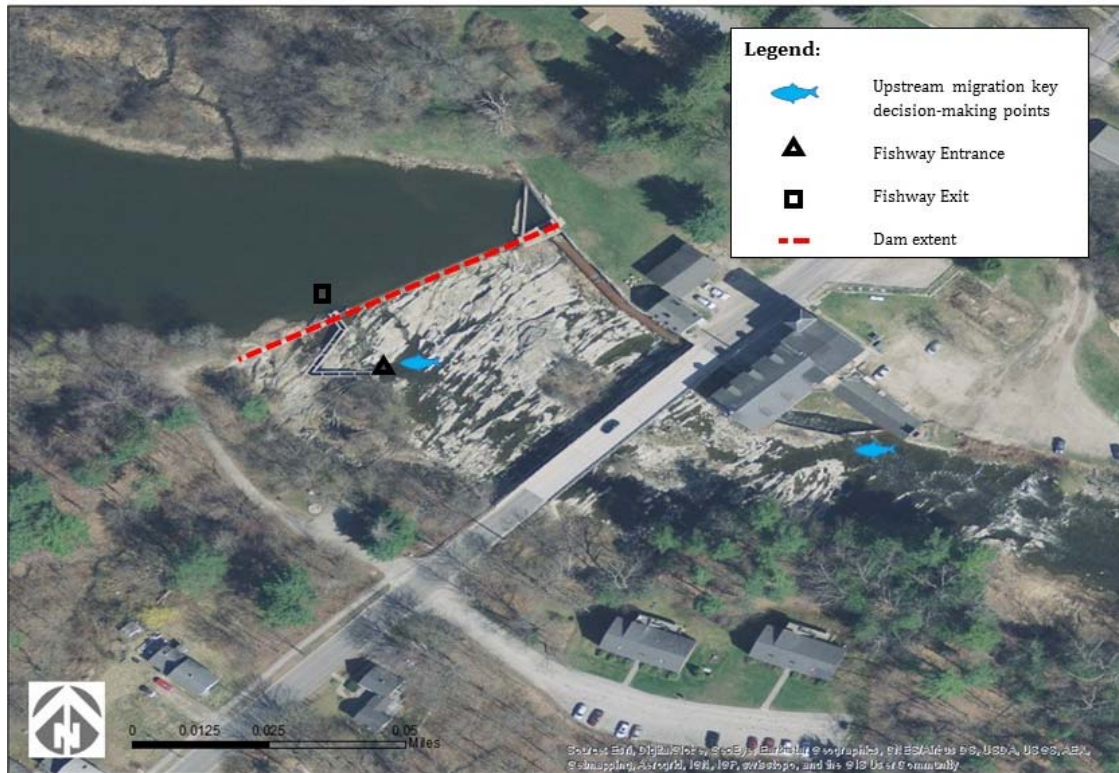
As upstream migrating fish approach the zone of passage, they first encounter the tailrace of the Sparhawk hydroelectric facility (Figure 7). During periods of operation, with maximum diversion capacity of approximately 250 cfs, this outflow could cause a competing signal for upstream passage as it equates to a substantial proportion of the total river flow over much of the fish passage operational range (Table 6 and Figure 6). However, the current operational status and future plans are unknown. At the time of the field assessment, the hydroelectric facility did not appear to be in active generation. If only modest generation were to occur, this competing attraction signal will be less of a concern.

Upstream of the tailrace, fish encounter the beginning of the ledge outcrop and the bridge. Based on the review of the available high resolution aerial photography and previous topographic survey results (Titcomb 2013), the predominant flow patterns downstream of the spillway over the ledge outcrop tend to orient to the river right margin, with several primary streams converging in the vicinity of the fishway entrance (Figure 8). During the highest flows, there is a secondary flow pathway on river left but based on review of the aerial photos, this appears to be a shallower, less substantial flow alignment. As fish migrate closer to the fishway entrance, however, they will encounter several competing signals during many flow conditions, with the exception of the lowest flows (Figure 7 and Figure 8). These patterns may present challenging far-field attraction conditions for upstream migrating fish over a notable portion of the fish passage operational range. This trend is exacerbated by the relatively modest discharge that is able to be passed through the fishway while still operating in the target flow condition for upstream passage (discussed in more detail below).

**Figure 7: Site map of the Bridge Street site indicating key decision points for upstream migrating fish. Date of imagery is March 31, 2012. Flow direction is left to right.**

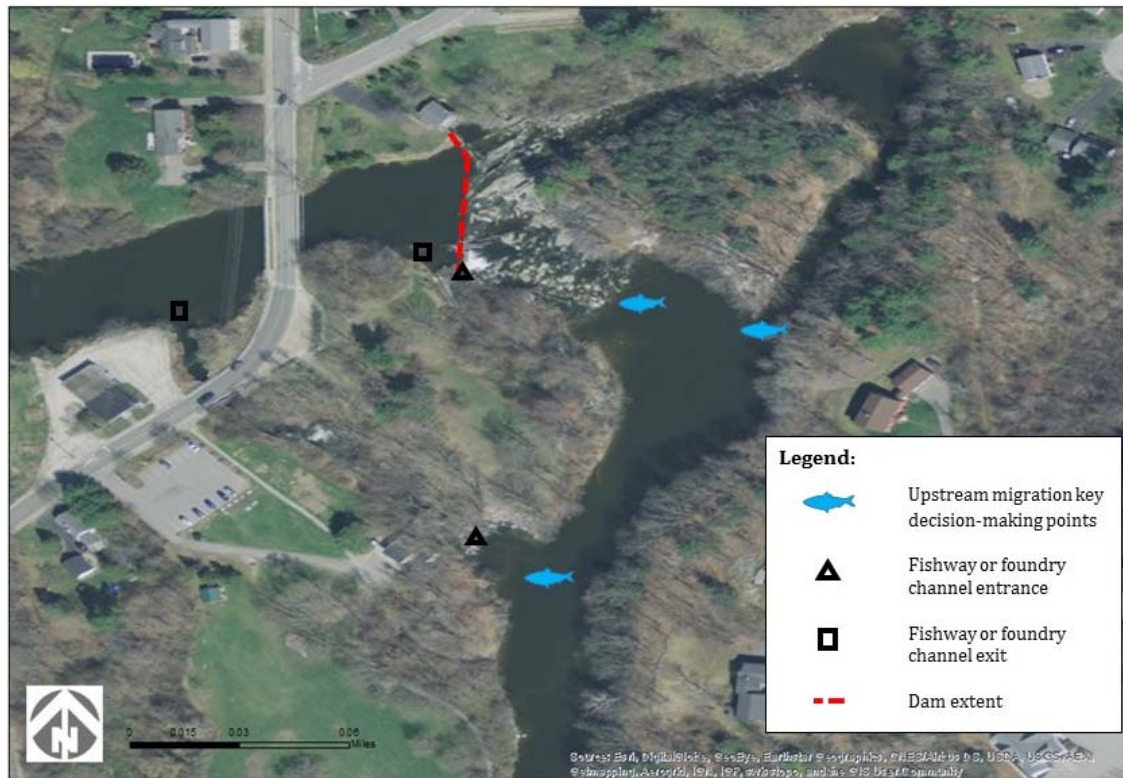
As upstream migrating fish approach the zone of passage, they first encounter the outlet of the foundry channel (Figure 9). Based on review of the aerial photography, the flow out of the foundry channel does not appear to create a substantial attraction cue (Figure 10), although the flow analysis reported in the next section suggests that the channel could convey a substantial proportion of the total flow particularly in the lower half of the fish passage flow range. The foundry channel does not appear to offer a passage pathway at present as the downstream confluence is over a relatively steep confluence fan with minimal depths of flow. In addition, there is a substantial vertical drop greater than 3 feet in height located in the upper 1/3 of the foundry channel where it flows over a former mill foundation or control structure.

**Figure 9: Site map of the East Elm Street site indicating key decision points for upstream migrating fish. Date of imagery is March 31, 2012. Flow direction is left to right at top of figure.**

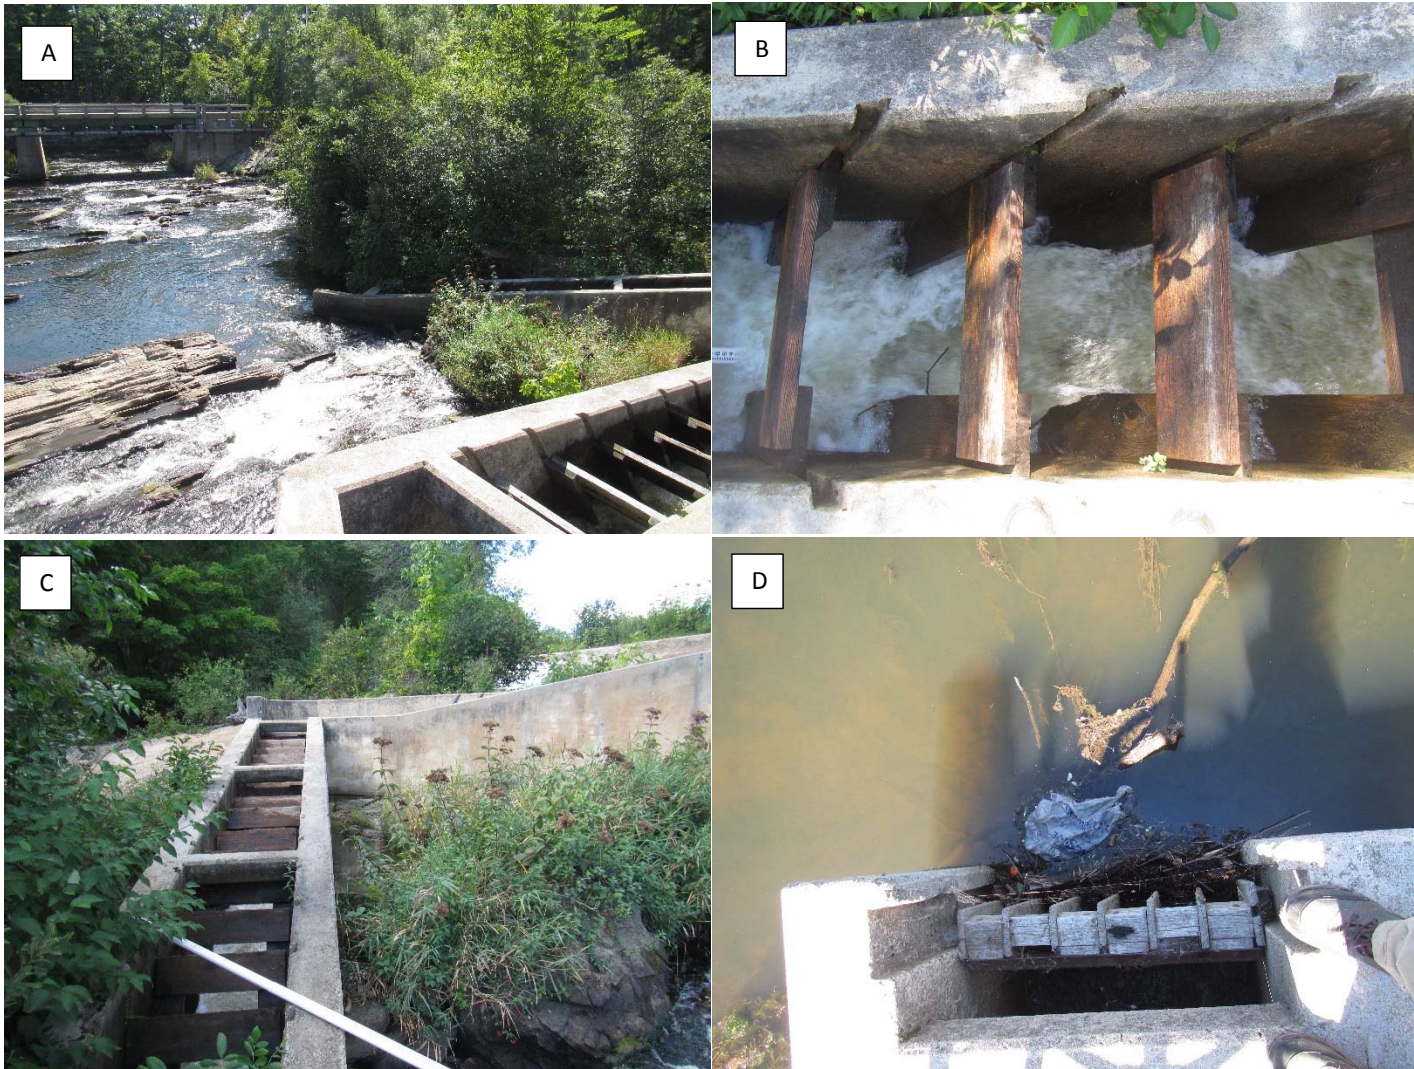
- Qualitative Assessment of Denil Fishway:
  - *General Condition:*
    - Presently operational but requires maintenance and continuous upkeep to successfully provide passage for target species at target populations, and thus regain full functionality. Currently is unable to meet requirements for shad passage. Status of headgate operability is unknown.

- *General Comparison to prevailing design standards:*
    - Steeper, narrower, and angle of turning pool more acute than recommendations.
    - Shad Passage: several deficiencies– does not meet recommended minimum width or maximum slope, contains turning pools angled greater than 90 degrees.

**Figure 17: Selection of photos of Bridge Street Dam Fishway. (A) View is downstream at fishway entrance on river right. (B) View at a sample baffle section showing turbulent streaming flow. Flow is from right to left. (C) View is upstream towards first baffle section, with second baffle section extending towards the right. (D) Exit of fishway into impoundment showing trash and debris blockage.**

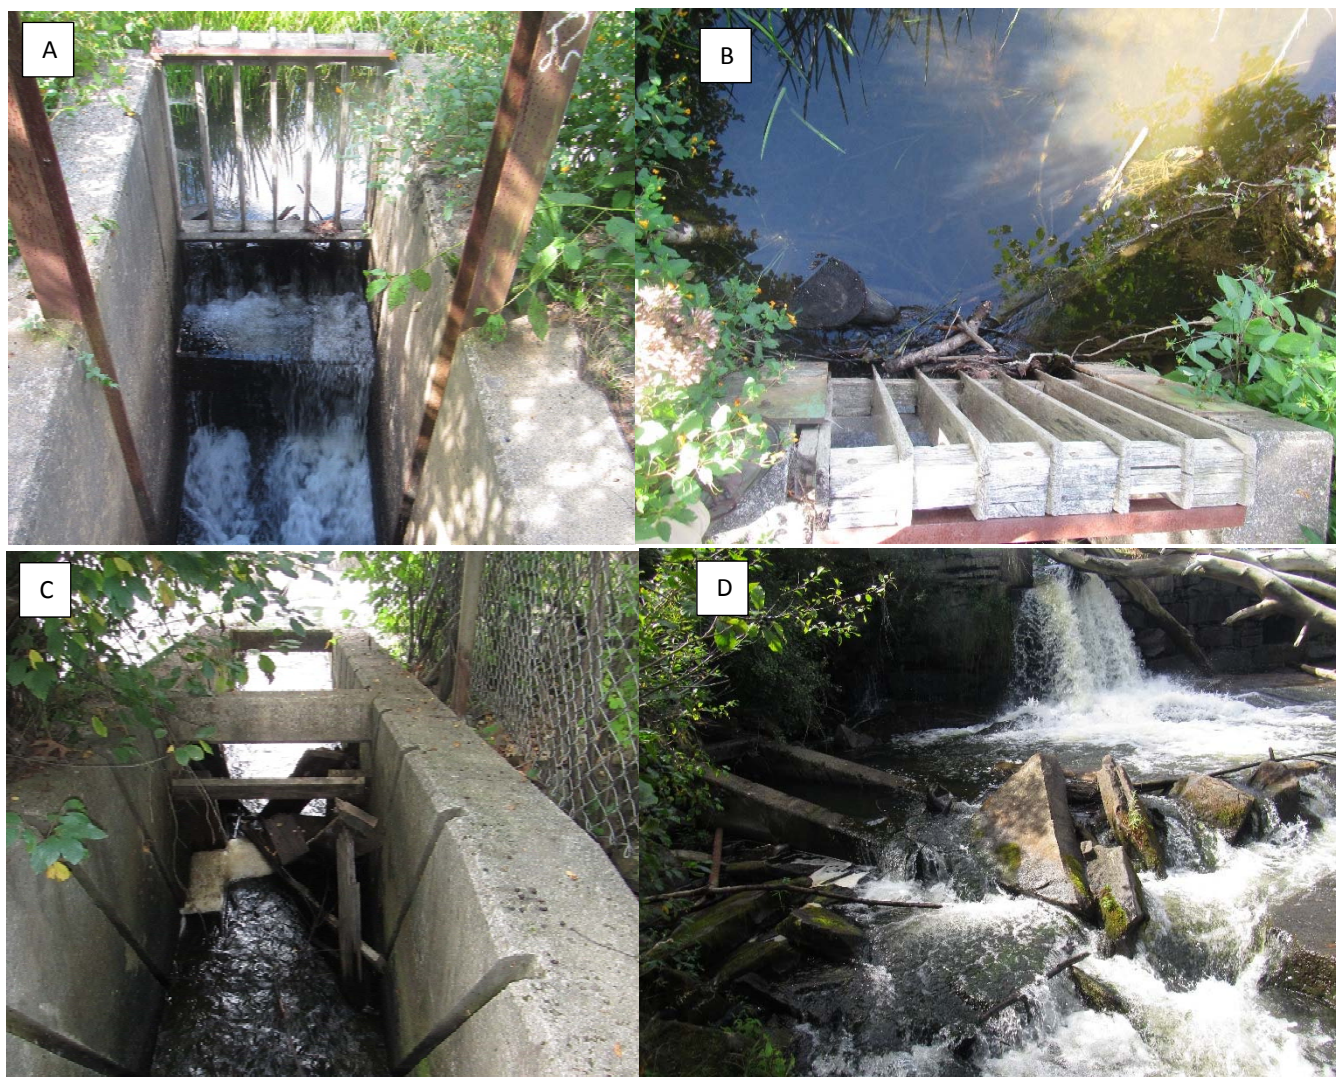
- Qualitative Assessment of Denil Fishway:
  - *General condition:*
    - Presently non-functional and requires complete rehabilitation to regain operability and functionality, including replacement of all weirs, gates, trash racks and control structures.

- The Entrance Channel is completely blocked with boulders and the adjacent river channel would require modification to provide suitable entrance conditions and minimize transverse water flow across the entrance.

**Figure 18: Selection of photos of East Elm Street Dam Fishway. (A) View is upstream at fishway exit into impoundment; (B) view of trashrack blocked by debris; (C) view is downstream at second baffle section blocked by broken baffles and debris; (D) entrance to fishway blocked by large wood and rubble.**
