## **APPENDIX A:**

### Mill Creek Restriction Sections

**APPENDIX C:**  
FIELD ASSESSMENT PHOTOS –  
OUTFALLS

### Stormwater Retrofit Assessment Reports

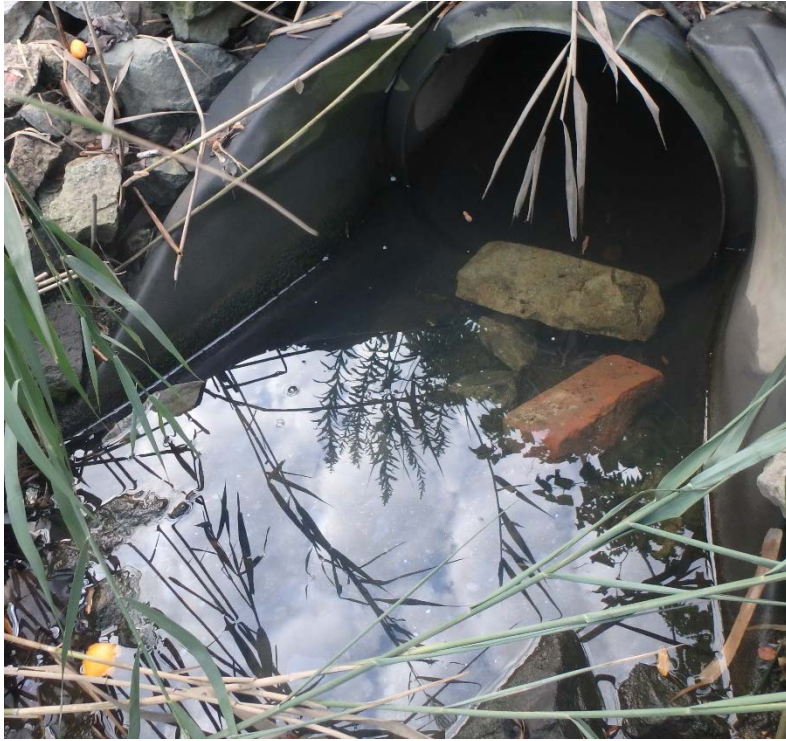
**Photo 1:** Photo at Outfall 1

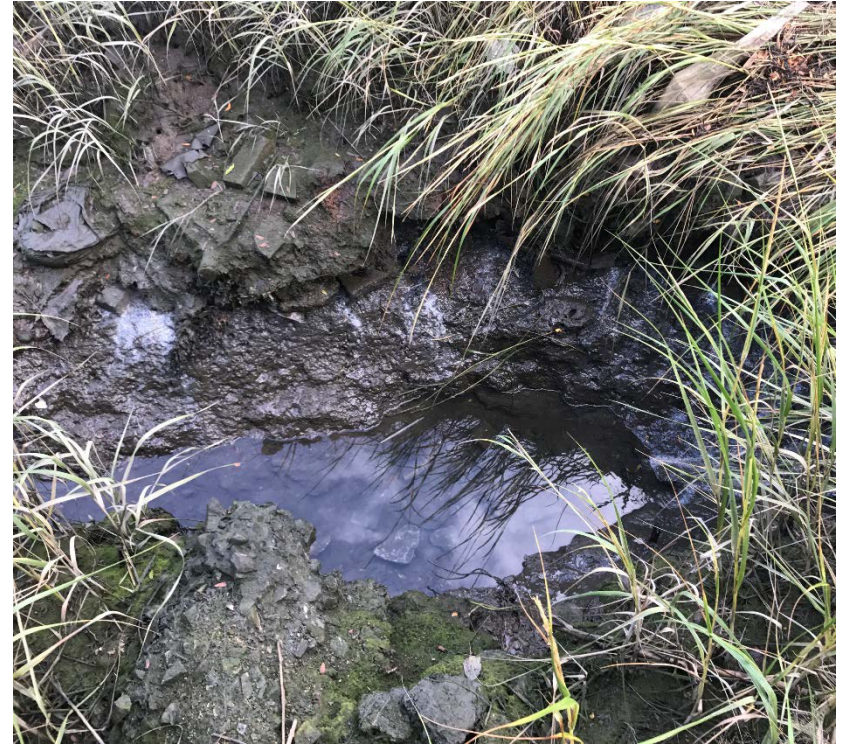
**Photo 2:** Photo of scour at Outfall 1

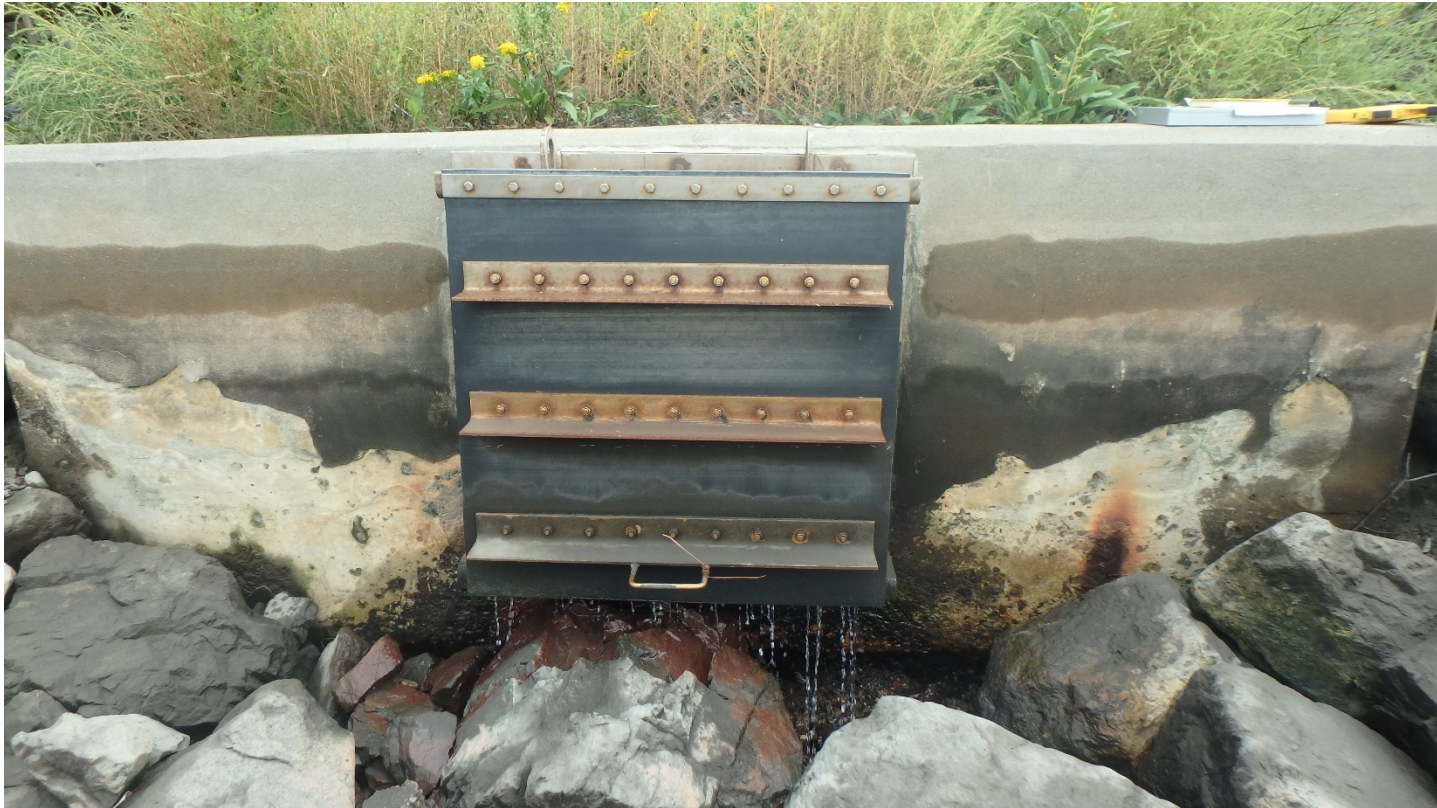
**Photo 3:** Photo of Outfall 2

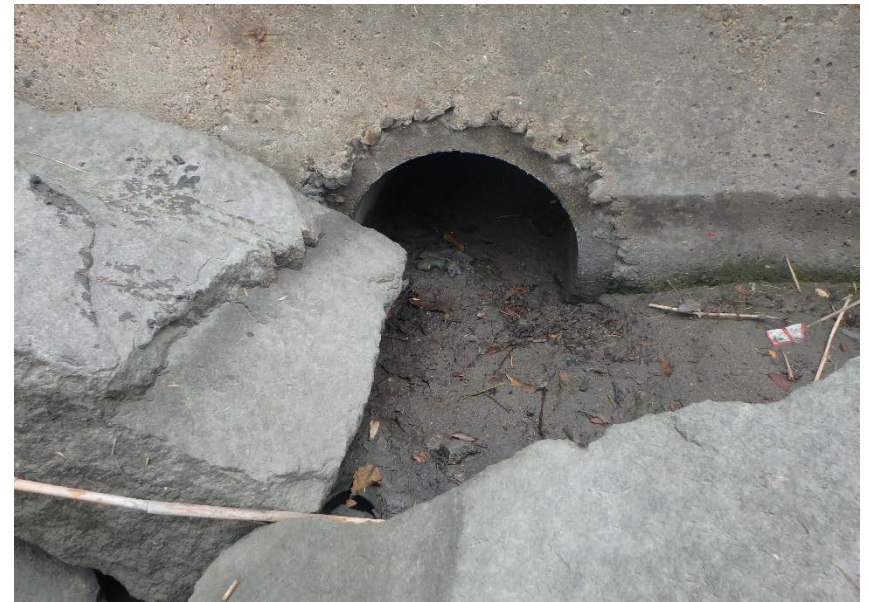
**Photo 9:** Photo of Sediment in Outfall 5

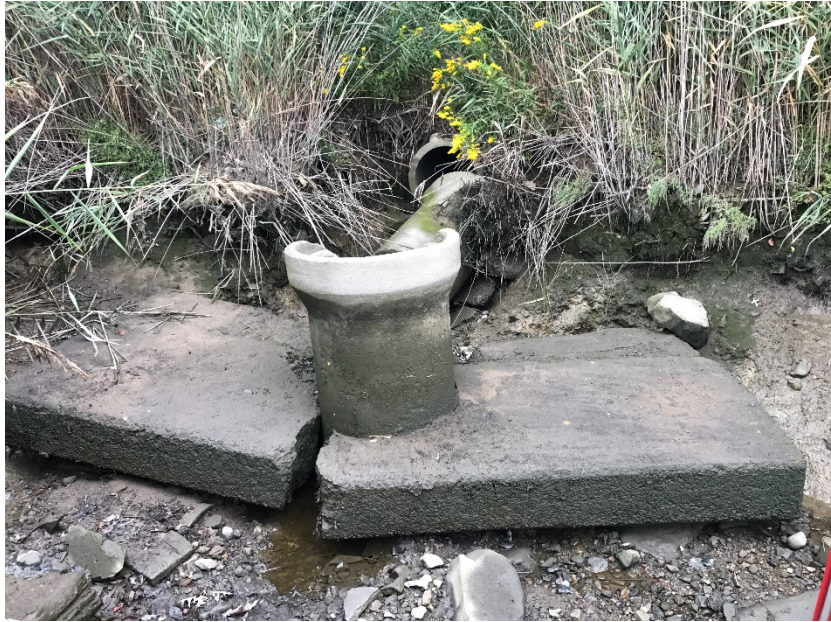
**Photo 16:** Photo of Outfall 9 (collapsed headwall)

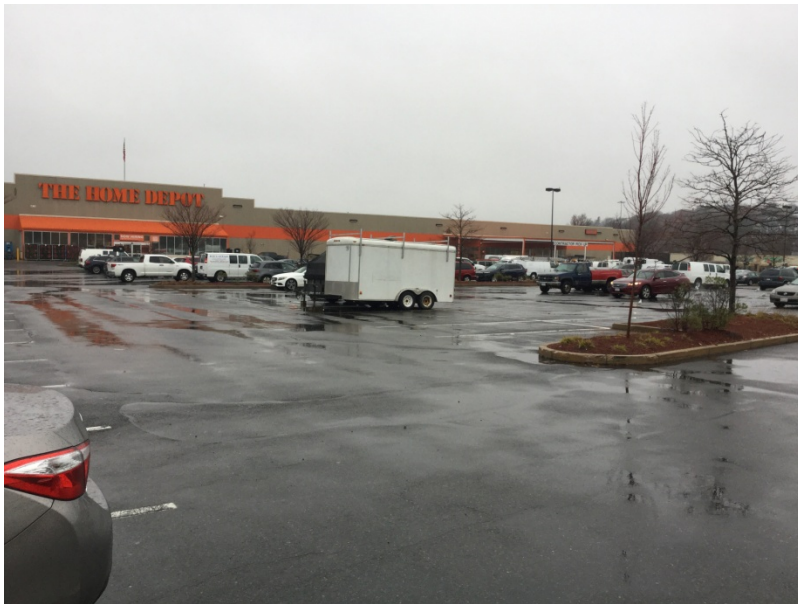
<b>Site Description:</b> Large parking lot at shopping plaza; raised landscape areas could be used for BMP; possibly reduce road and drive lane width to increase space for BMPs. Potential for larger subsurface BMP.
		<b>Ownership:</b> Private
		<b>Primary Land Use:</b> Parking Lot , Commercial
		<b>Primary Pollutants:</b> Oil/Gas (sheen)
<b>Sidewalk Width:</b> <5'	<b>Road Width:</b> 25'	<b>Parking Lot Dimensions:</b> 17'x8', >100 spaces
<b>Site Overview Picture:</b>

<b>Site Overview Caption:</b> Ponding in parking lot		
<b>PROPOSED BEST MANAGEMENT PRACTICE</b>		
<b>Type:</b> Dry Swale		
<b>Primary BMP Benefit:</b> Water Quality		
<b>Primary Observed Site Conflict:</b> Entrances/Driveway		
<b>Primary Non-Structural Control:</b> Street/Parking Lot Sweeping

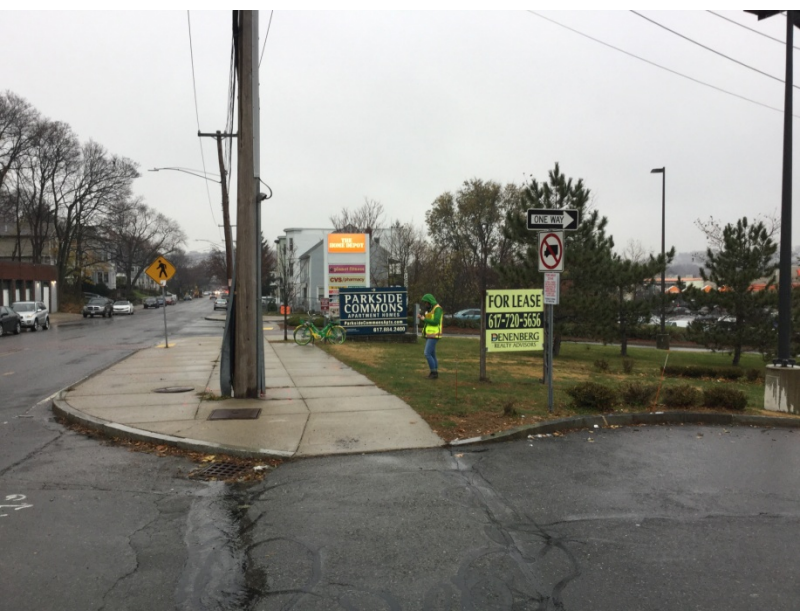
<b>Site Description:</b> Large sidewalk at the entrance to the parking lot bordering grassed open space; CB on one side. Overhead utilities and underground utilities (communication, electricity) present. Remove impervious area, if possible.
		<b>Ownership:</b> Public (City-owned)
		<b>Primary Land Use:</b> Road/ROW
		<b>Primary Pollutants:</b> Leaves , Debris
<b>Sidewalk Width:</b> >10'	<b>Road Width:</b> N/A	<b>Parking Lot Dimensions:</b> N/A
<b>Site Overview Picture:</b>

<b>Site Overview Caption:</b> Large sidewalk with CB on one side		
<b>PROPOSED BEST MANAGEMENT PRACTICE</b>		
<b>Type:</b> Remove Impervious Surface		
<b>Primary BMP Benefit:</b> Water Quality		
<b>Primary Observed Site Conflict:</b> Underground Utilities , Overhead Utilities		
<b>Primary Non-Structural Control:</b> Street/Parking Lot Sweeping

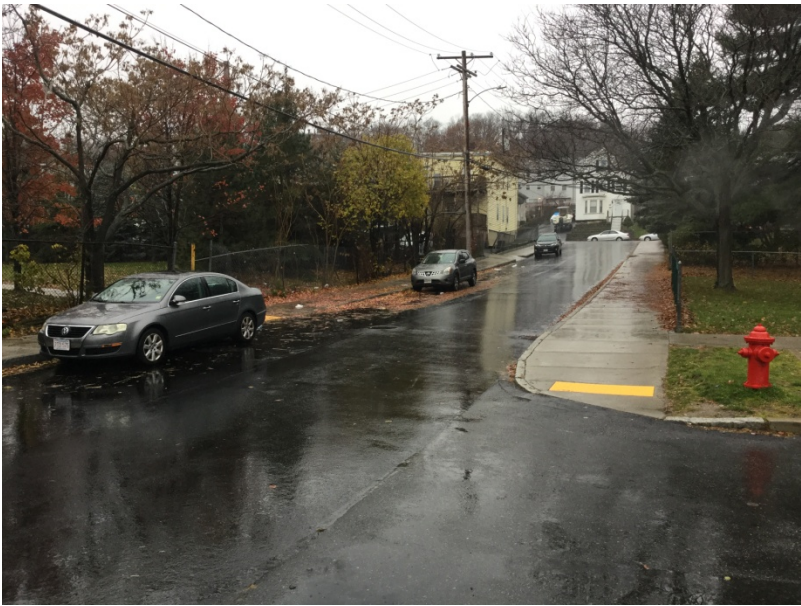
<b>Site Description:</b> Low traffic street at entrance to housing development; one CB for the entire street; ponding and debris on side of the road; no underground utility conflict observed. Bumpout possible at low point in street or anywhere along end of street.
		<b>Ownership:</b> Public (City-owned)
		<b>Primary Land Use:</b> Road/ROW
		<b>Primary Pollutants:</b> Oil/Gas (sheen) , Debris , Leaves , Trash
<b>Sidewalk Width:</b> 9'	<b>Road Width:</b> 24'	<b>Parking Lot Dimensions:</b> N/A
<b>Site Overview Picture:</b>

<b>Site Overview Caption:</b> Install stormwater bumpout on opposite side of CB		
<b>PROPOSED BEST MANAGEMENT PRACTICE</b>		
<b>Type:</b> Bumpout		
<b>Primary BMP Benefit:</b> Water Quality		
<b>Primary Observed Site Conflict:</b> Overhead Utilities		
<b>Primary Non-Structural Control:</b> Street/Parking Lot Sweeping

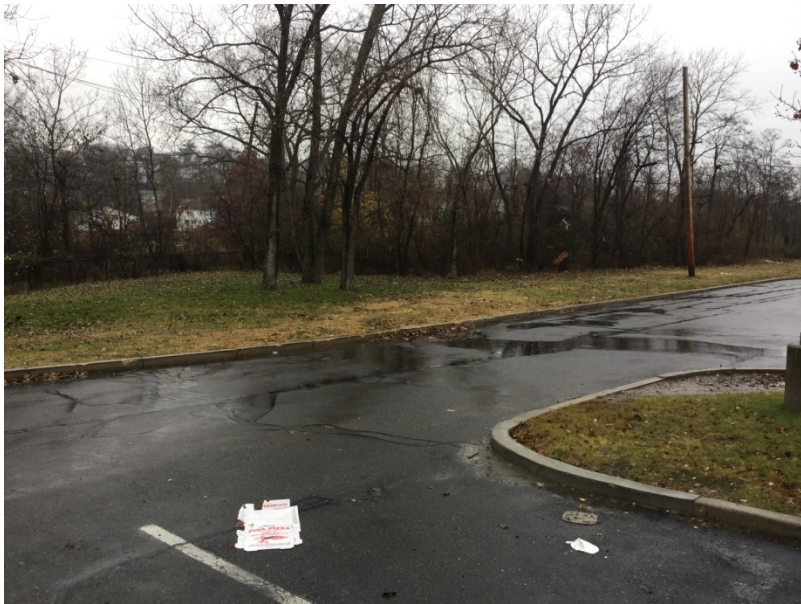
<b>Site Description:</b> Large open space between Mill Creek and Home Depot parking lot at bottom of watershed; CB right next to open space; minimal overhead utilities (communications). Trees are set back so canopy is avoidable. Bioretention area recommended in low spot.
		<b>Ownership:</b> Public (City-owned)
		<b>Primary Land Use:</b> Open Space/Wetland
		<b>Primary Pollutants:</b> Leaves , Debris , Trash
<b>Sidewalk Width:</b> <5'	<b>Road Width:</b> N/A	<b>Parking Lot Dimensions:</b> N/A
<b>Site Overview Picture:</b>

<b>Site Overview Caption:</b> CB at low point next to open space		
<b>PROPOSED BEST MANAGEMENT PRACTICE</b>		
<b>Type:</b> Bioretention		
<b>Primary BMP Benefit:</b> Water Quality		
<b>Primary Observed Site Conflict:</b> Street Trees/Canopy		
<b>Primary Non-Structural Control:</b> Street/Parking Lot Sweeping , Trash Management

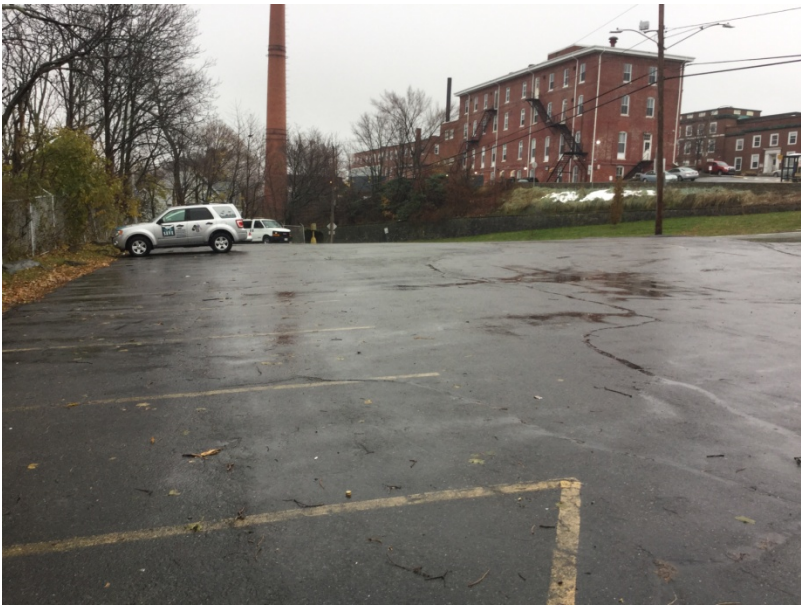
<b>Site Description:</b> Overflow parking for hospital mostly empty at site visit; large impervious area on top of the hill next to steep slopes; no CBs observed. Water appears to be running overland onto slope; Potentially replace some of the impervious area with pavers or pervious area.
		<b>Ownership:</b> State owned
		<b>Primary Land Use:</b> Parking Lot
		<b>Primary Pollutants:</b> Leaves
<b>Sidewalk Width:</b> N/A	<b>Road Width:</b> N/A	<b>Parking Lot Dimensions:</b> 9'x17', 35 spaces
<b>Site Overview Picture:</b>

<b>Site Overview Caption:</b> Large parking lot (overflow parking)		
<b>PROPOSED BEST MANAGEMENT PRACTICE</b>		
<b>Type:</b> Pervious Surface		
<b>Primary BMP Benefit:</b> Water Quality		
<b>Primary Observed Site Conflict:</b> Steep slopes		
<b>Primary Non-Structural Control:</b> Street/Parking Lot Sweeping

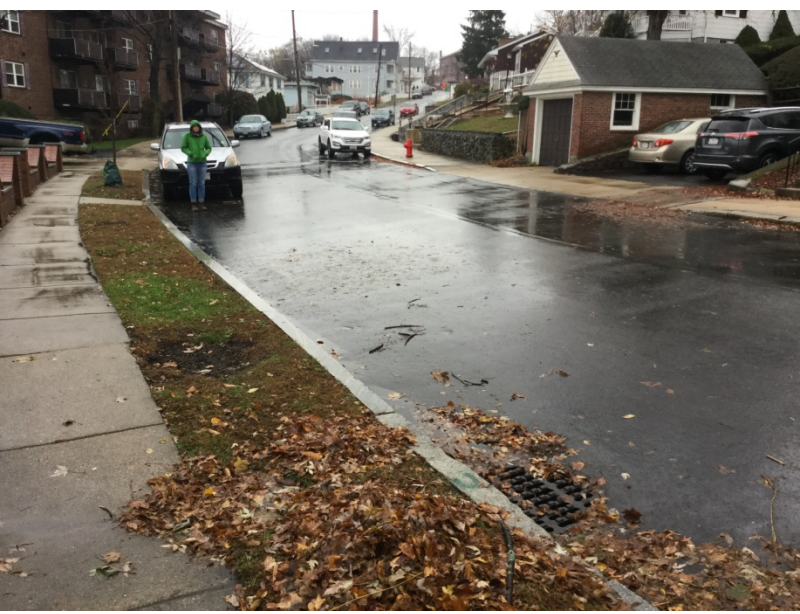
<b>Site Description:</b> CB in residential street low spot is taking runoff from both sides of Warren Avenue. Leaf litter is clogging CB, but is being partially removed by residents. Location is the only flat area on Warren Avenue. Bumpout or subsurface chambers possible.
		<b>Ownership:</b> Public (City-owned)
		<b>Primary Land Use:</b> Road/ROW
		<b>Primary Pollutants:</b> Leaves , Trash
<b>Sidewalk Width:</b> <5'	<b>Road Width:</b> 30'	<b>Parking Lot Dimensions:</b> N/A
<b>Site Overview Picture:</b>

<b>Site Overview Caption:</b> Leaf litter in CB		
<b>PROPOSED BEST MANAGEMENT PRACTICE</b>		
<b>Type:</b> Bumpout/Subsurface Chamber		
<b>Primary BMP Benefit:</b> Water Quality		
<b>Primary Observed Site Conflict:</b> Steep slopes , Overhead Utilities		
<b>Primary Non-Structural Control:</b> Street/Parking Lot Sweeping

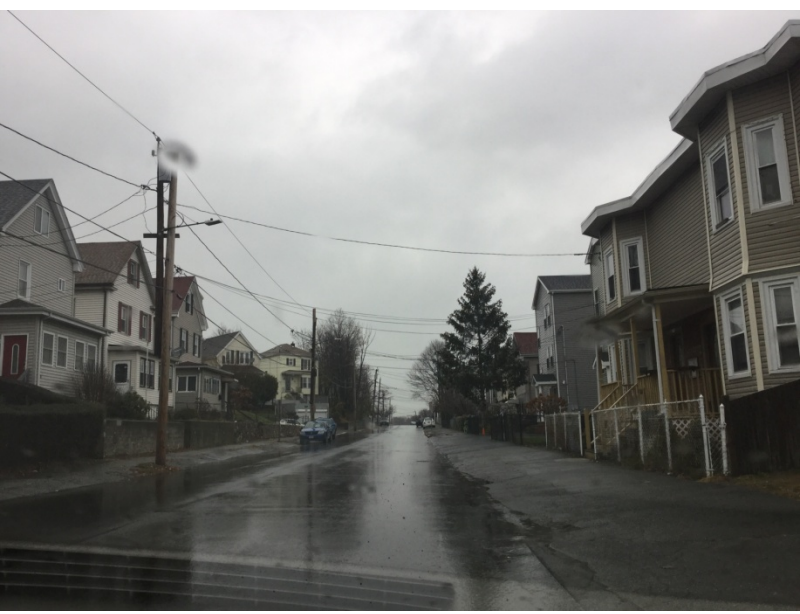
<b>Site Description:</b> Very large impervious area through combined road width and uncurbed sidewalks that can be parked on. Residential area with street parking on both sides, but many houses have more driveway parking. Create pervious area by installing green space and curb street.
		<b>Ownership:</b> Public (City-owned)
		<b>Primary Land Use:</b> Road/ROW
		<b>Primary Pollutants:</b> Leaves
<b>Sidewalk Width:</b> 10'	<b>Road Width:</b> 30'	<b>Parking Lot Dimensions:</b> N/A
<b>Site Overview Picture:</b>

<b>Site Overview Caption:</b> No curbs on street		
<b>PROPOSED BEST MANAGEMENT PRACTICE</b>		
<b>Type:</b> Remove Impervious Surface		
<b>Primary BMP Benefit:</b> Water Quality		
<b>Primary Observed Site Conflict:</b> Entrances/Driveway		
<b>Primary Non-Structural Control:</b> Street/Parking Lot Sweeping

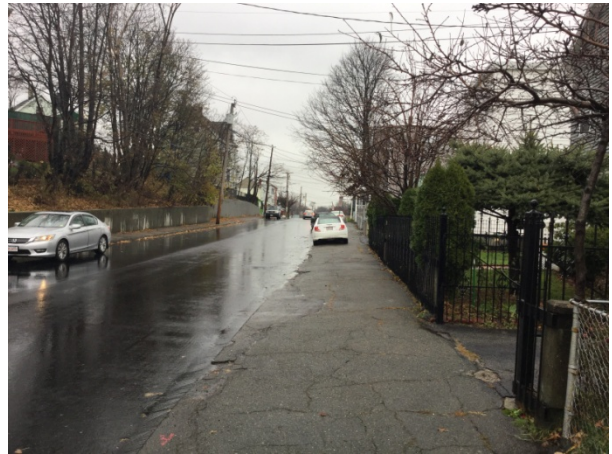
**Additional Photo Caption:**  
Cars parked on slanted 'sidewalk'

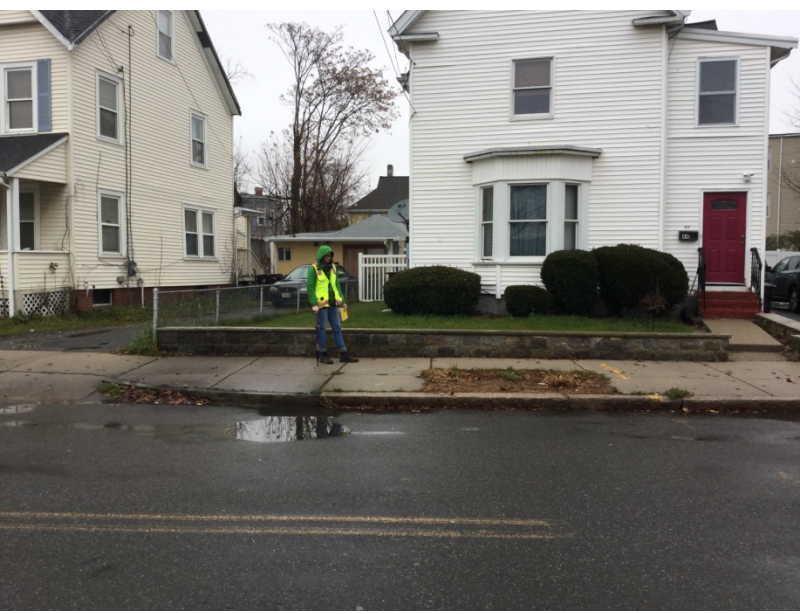
<b>Site Description:</b> Empty tree pit could be transformed into 5'x12' tree trench between gas line and drive way; water access line would need to be dealt with; overhead utilities demand low growth tree; no CB.
		<b>Ownership:</b> Public (City-owned)
		<b>Primary Land Use:</b> Road/ROW
		<b>Primary Pollutants:</b> Leaves
<b>Sidewalk Width:</b> 9'	<b>Road Width:</b> N/A	<b>Parking Lot Dimensions:</b> N/A
<b>Site Overview Picture:</b>

<b>Site Overview Caption:</b> Empty tree pit		
<b>PROPOSED BEST MANAGEMENT PRACTICE</b>		
<b>Type:</b> Tree Trench		
<b>Primary BMP Benefit:</b> Water Quality		
<b>Primary Observed Site Conflict:</b> Overhead Utilities , Underground Utilities , Entrances/Driveway		
<b>Primary Non-Structural Control:</b> Street/Parking Lot Sweeping

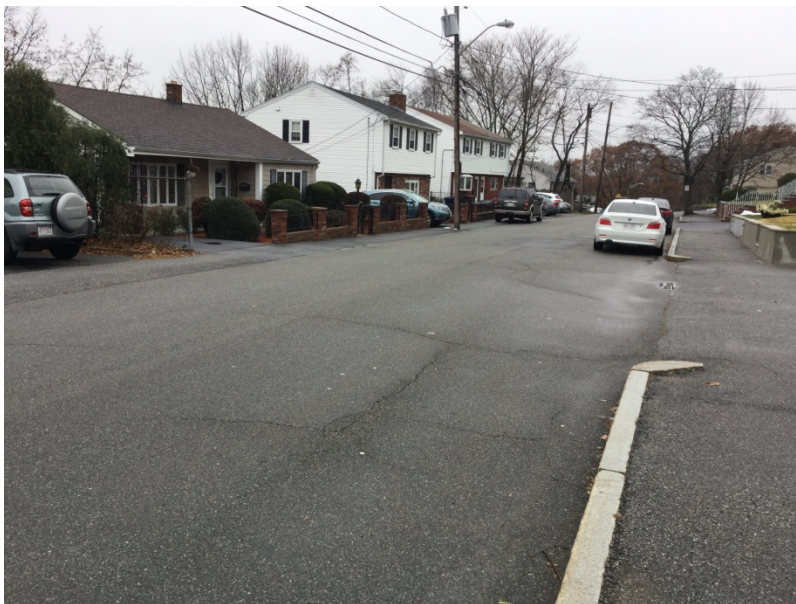
<b>Site Description:</b> Side-walk on one side of Ridge Road is not curbed. Provide opportunity for removal of impervious area and creation of open space. No CBs or overhead utilities. Located at top of the watershed. Pervious pavement could be an option.
		<b>Ownership:</b> Public (City-owned)
		<b>Primary Land Use:</b> Road/ROW
		<b>Primary Pollutants:</b> Leaves
<b>Sidewalk Width:</b> 7'	<b>Road Width:</b> 25'	<b>Parking Lot Dimensions:</b> N/A
<b>Site Overview Picture:</b>

<b>Site Overview Caption:</b> No curb on south side of Ridge Road		
<b>PROPOSED BEST MANAGEMENT PRACTICE</b>		
<b>Type:</b> Permeable Pavement		
<b>Primary BMP Benefit:</b> Water Quality		
<b>Primary Observed Site Conflict:</b> Overhead Utilities		
<b>Primary Non-Structural Control:</b> Street/Parking Lot Sweeping
