# 2022 Water Reliability Study and General Plan

## VILLAGE OF DECATUR

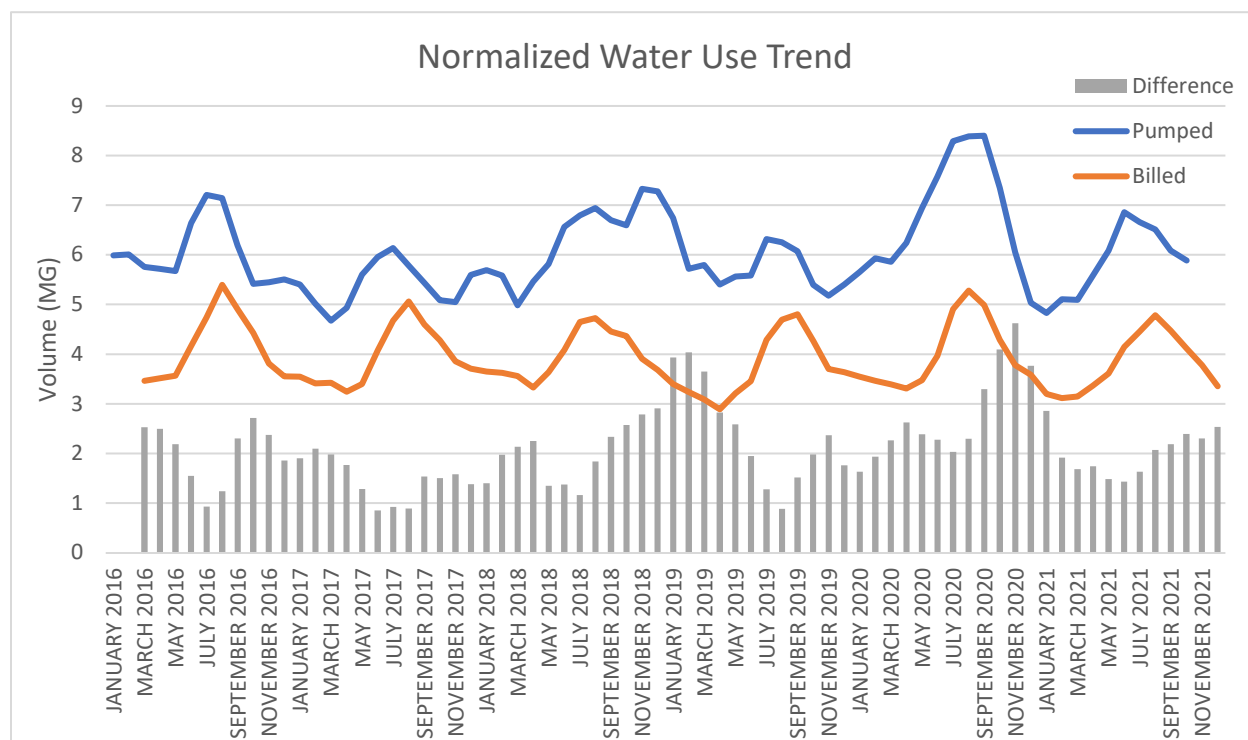
If the average loss is calculated into gallons per minute:

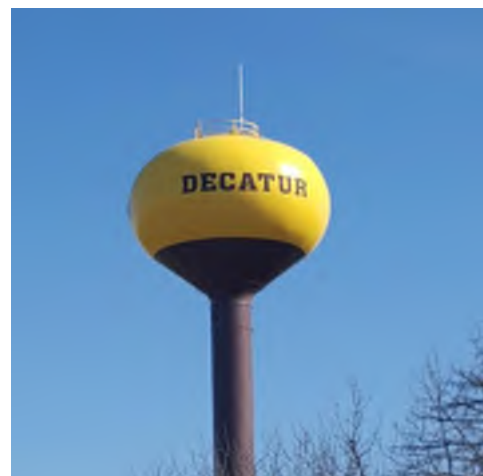
## Water Quality Data

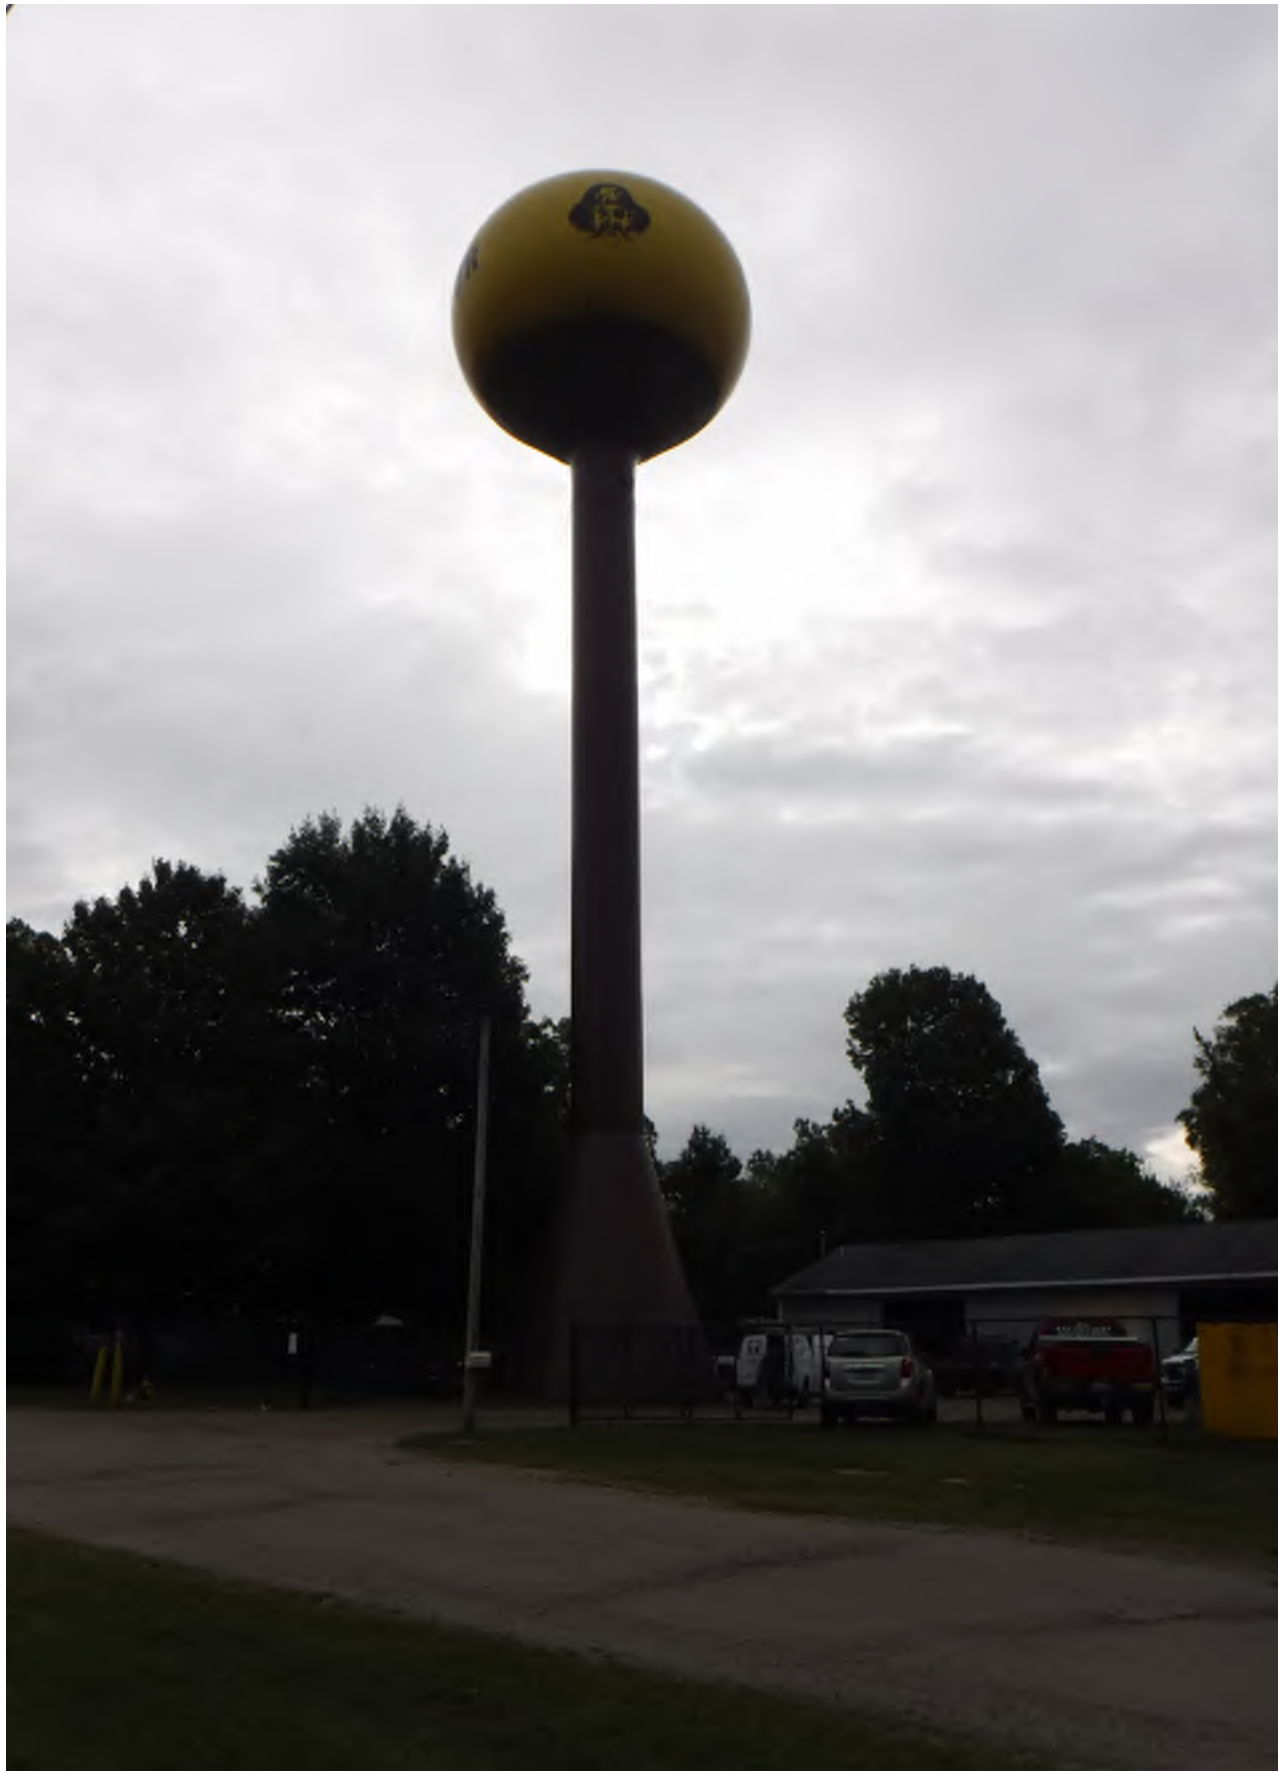
200,000 gallon spheroid located in the Village of Decatur, Michigan.

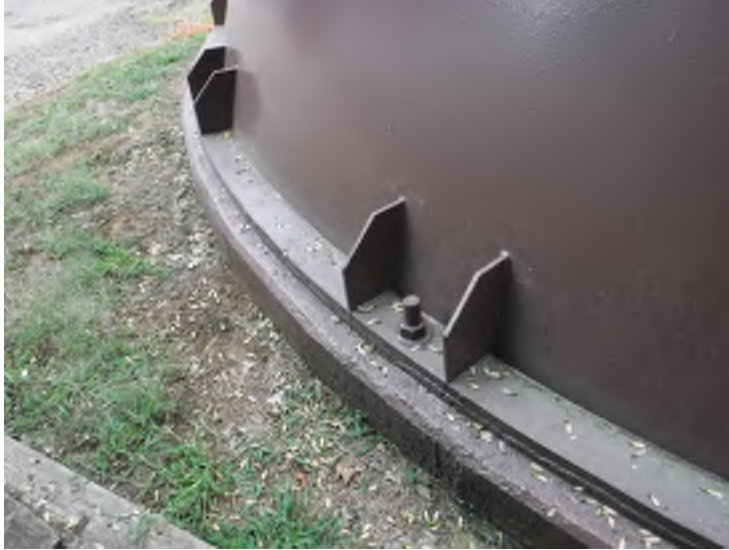
1) The foundation is in good condition.

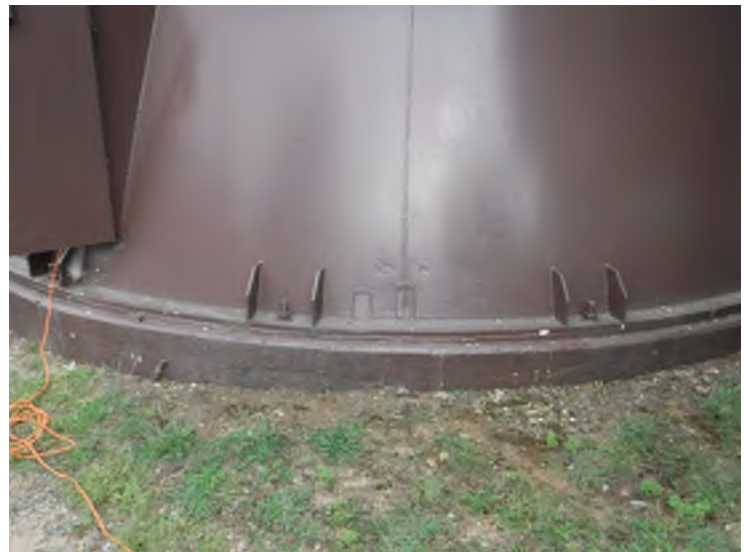
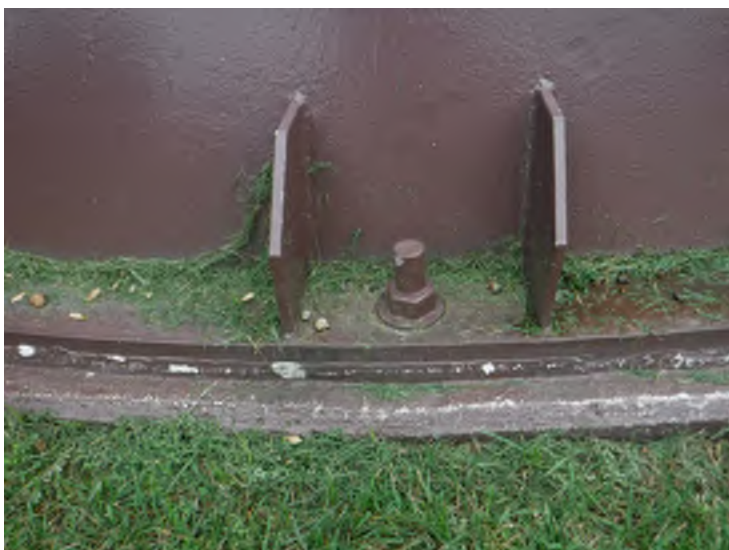
3) Typical anchor bolt is in good condition.

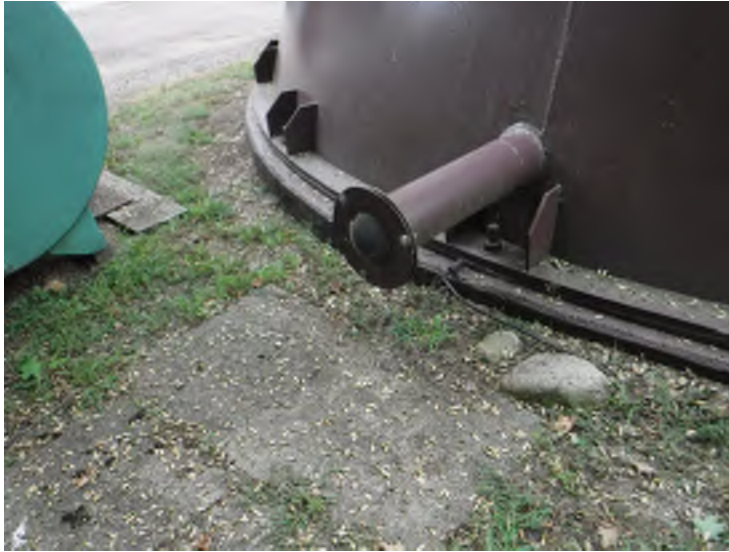
4) The overflow pipe discharges to a concrete splash pad.

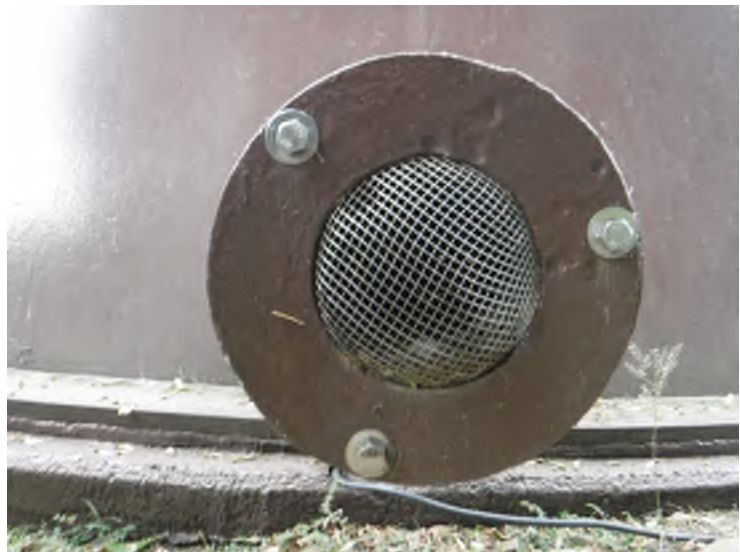
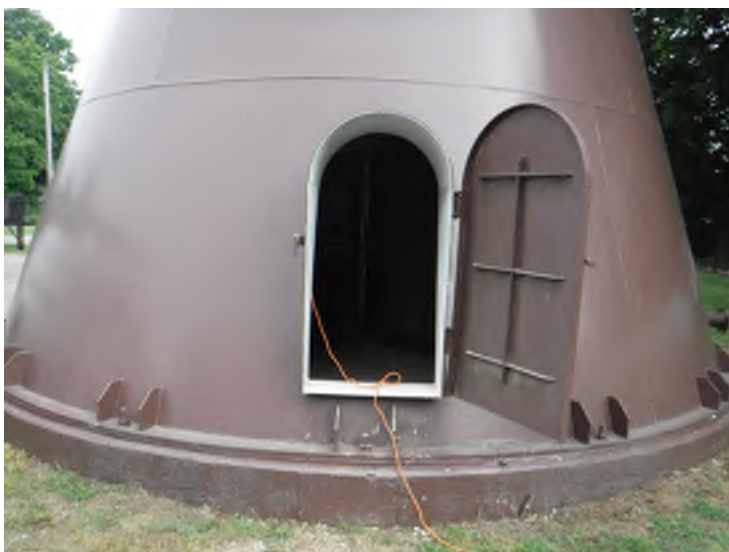
6) The basebell door is in good condition.

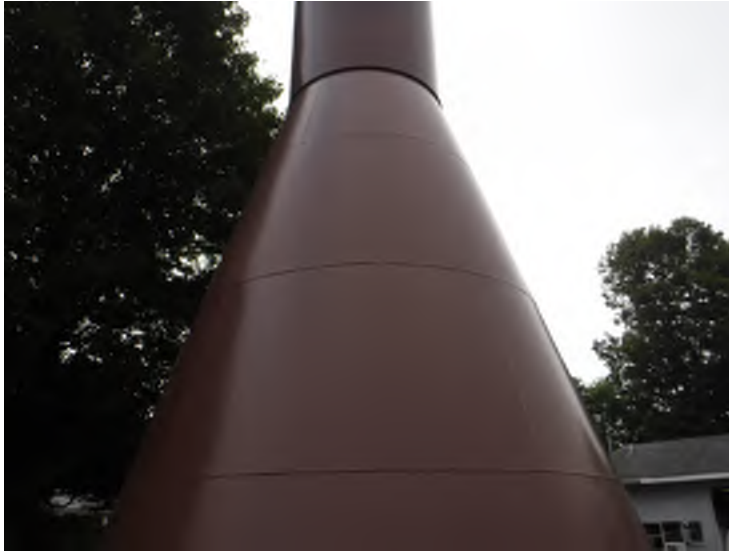
7) The basebell coating is in good condition with no significant failures.

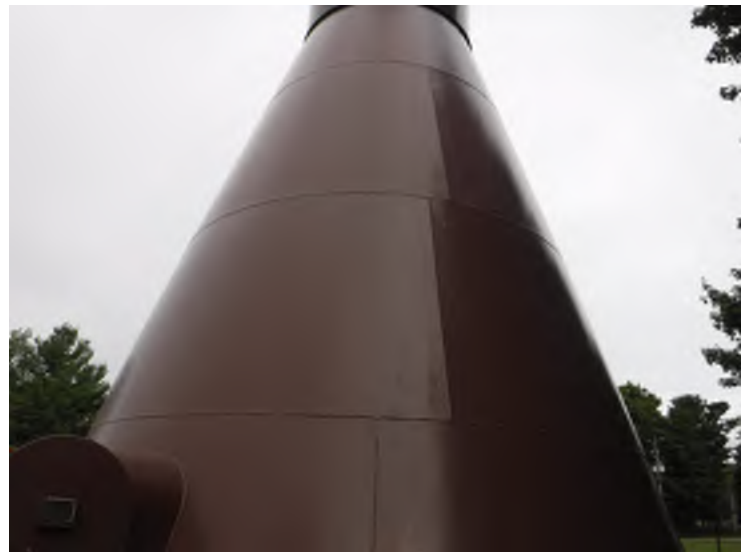
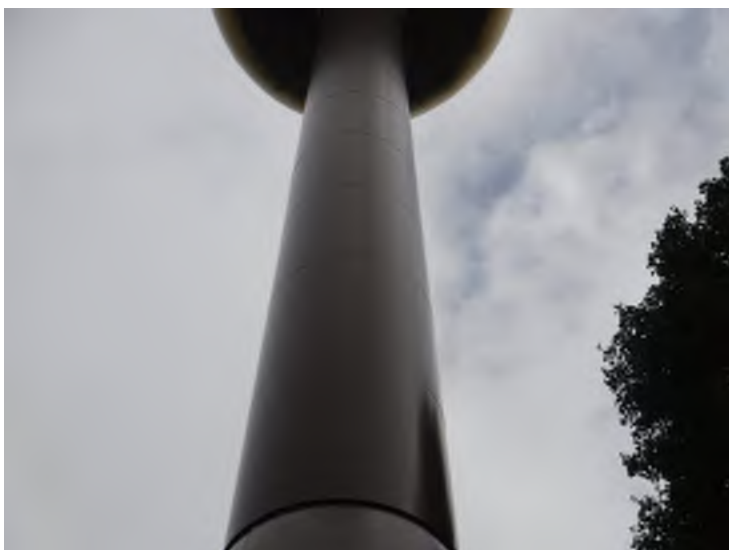
9) The riser coating is in good condition with no significant failures.

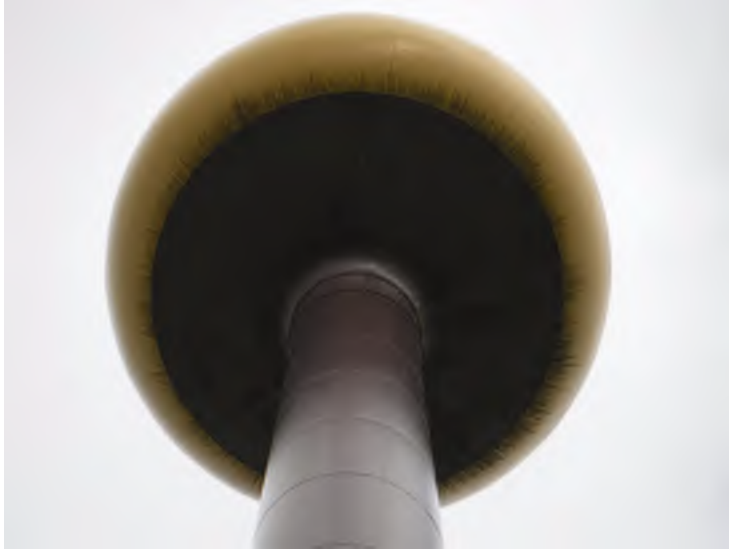
10) The bowl is covered with light mildew growth.

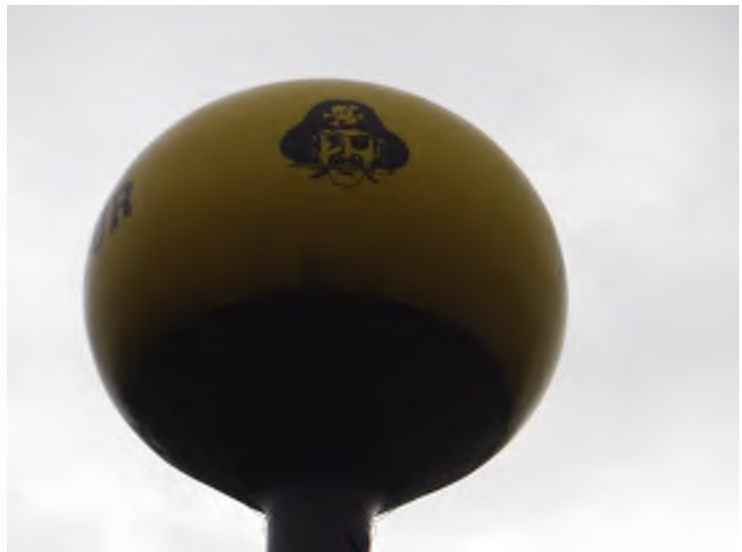
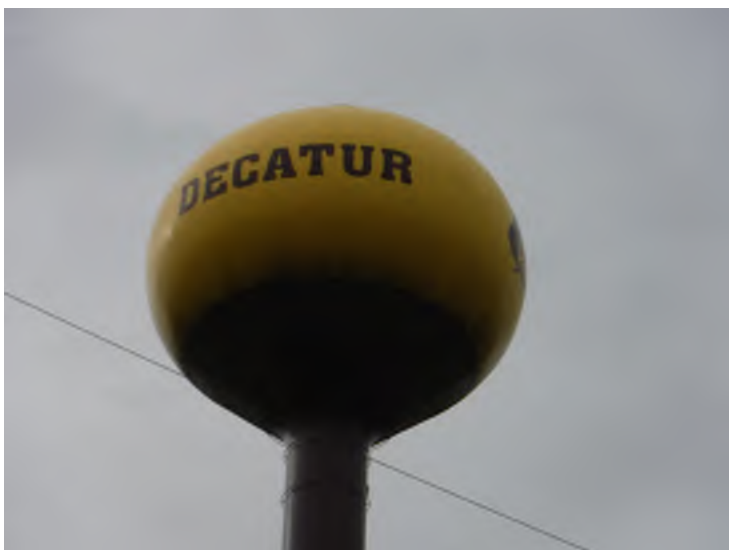
11) The sidewall coating is in good condition with no significant failures.

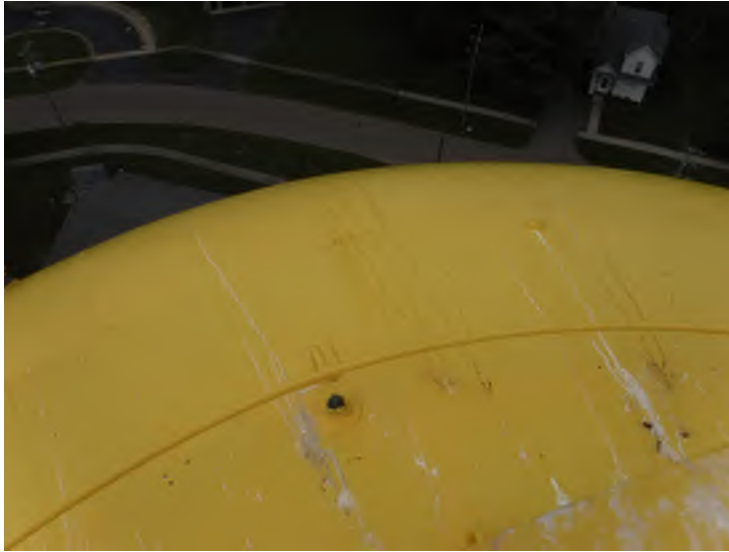
13) The roof coating is in good condition overall.

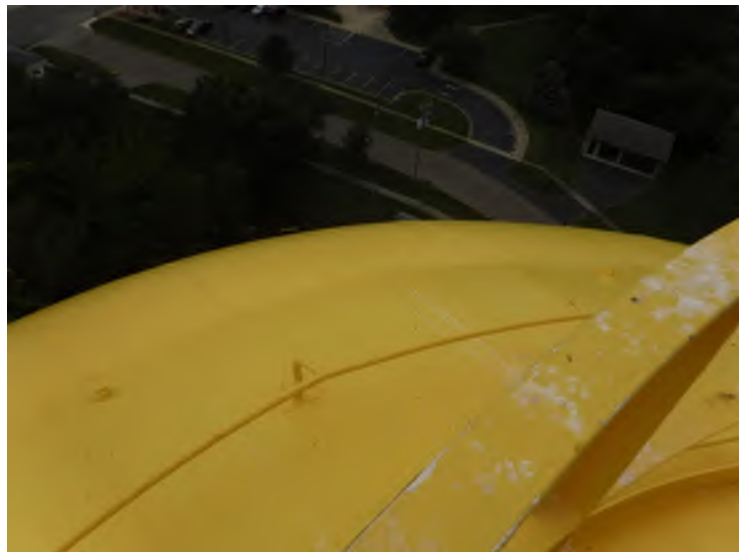
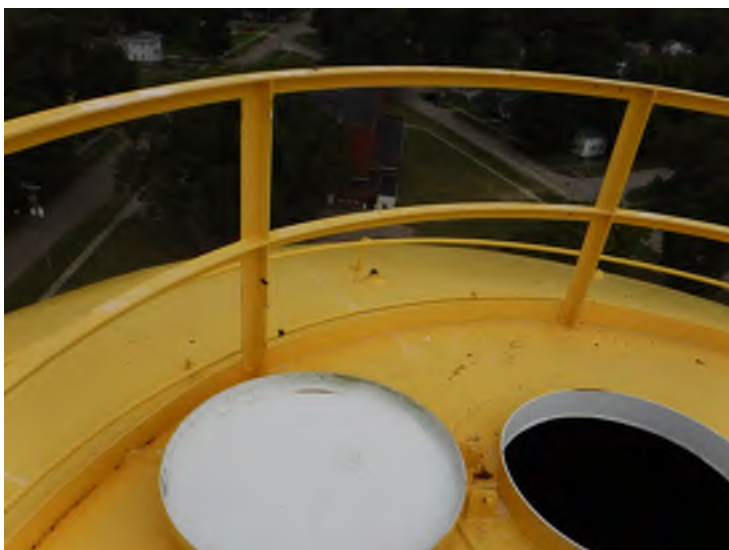
15) The roof handrail is in good condition.

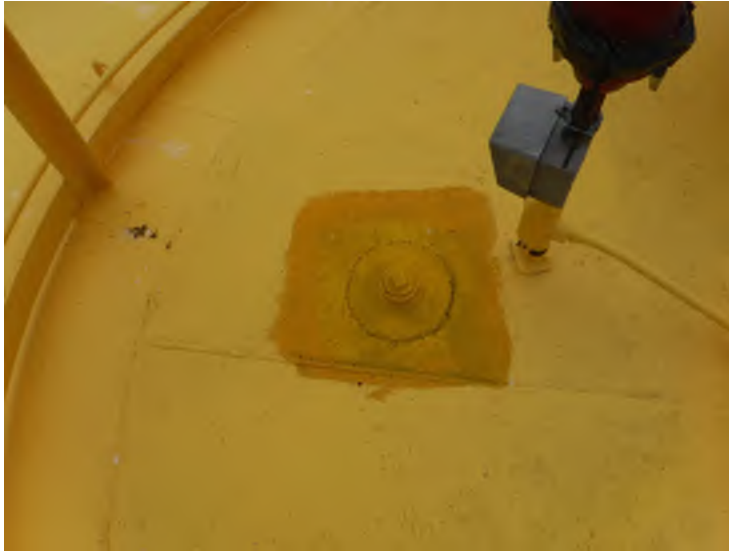
16) Typical rigging coupling is in good condition.

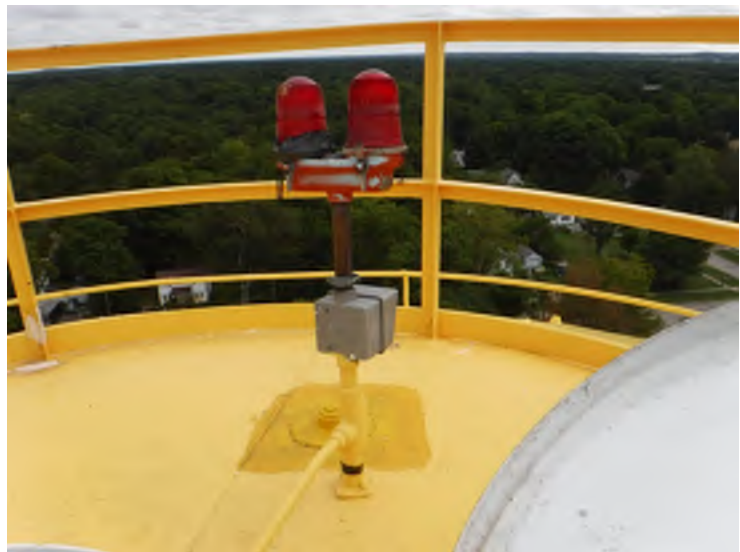
17) One of the aviation light globes is being held in place with electrical tape.

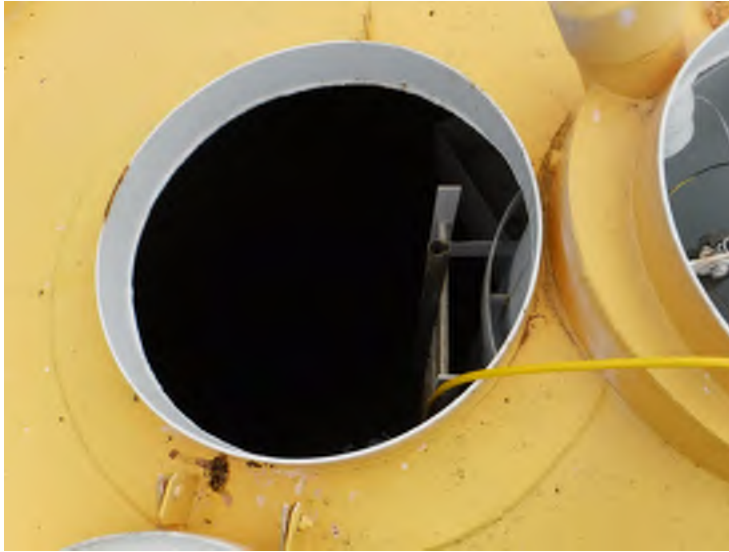
19) There is no gasket on the wet interior hatch.

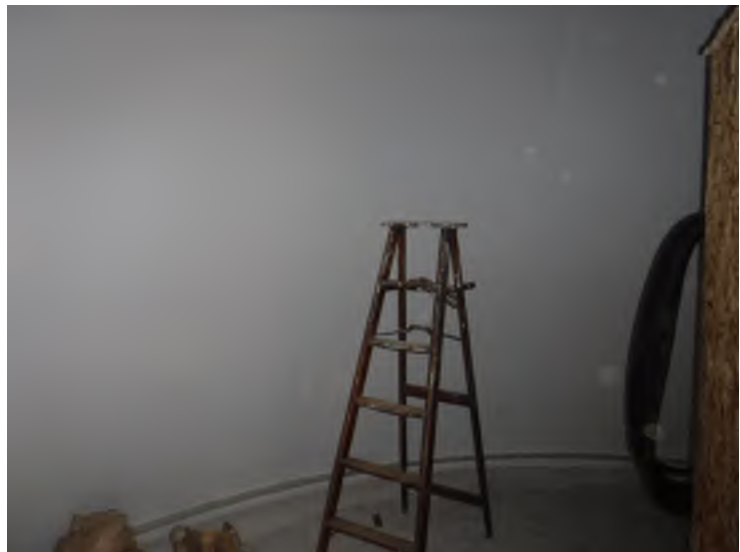
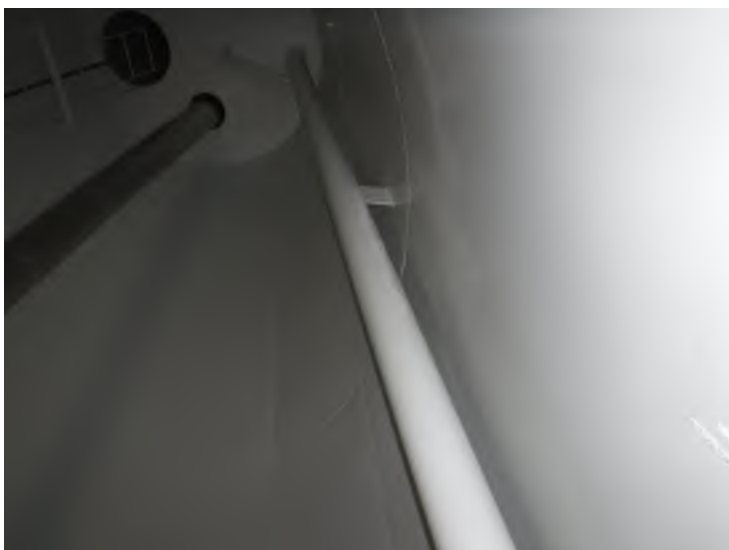
20) The basebell coating is in good condition with no significant failures.

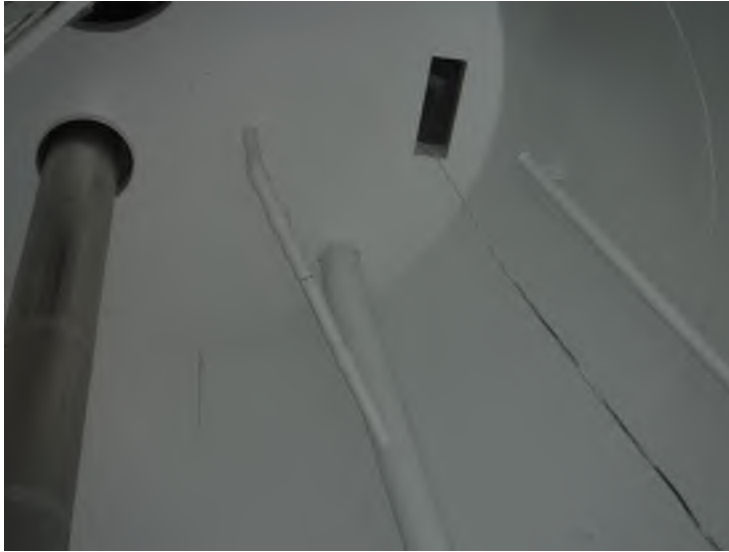
25) The condensate drain routes to the overflow pipe and is in good condition.

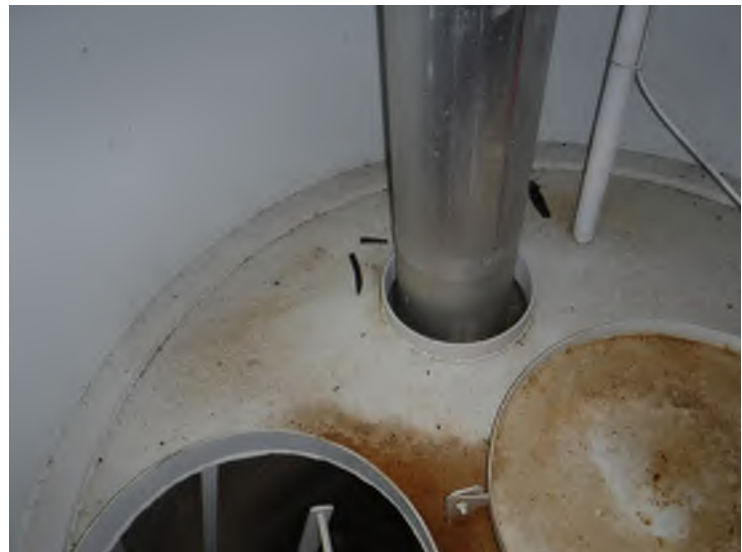
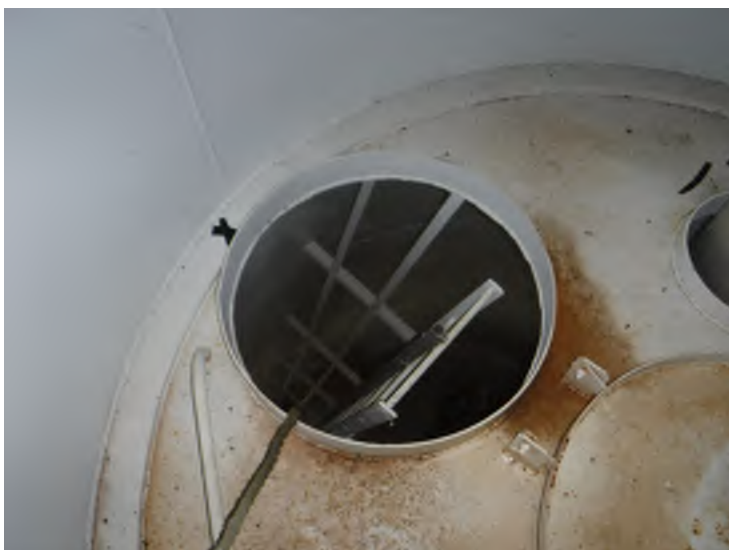
27) The condensate platform opening and cover are in good condition.

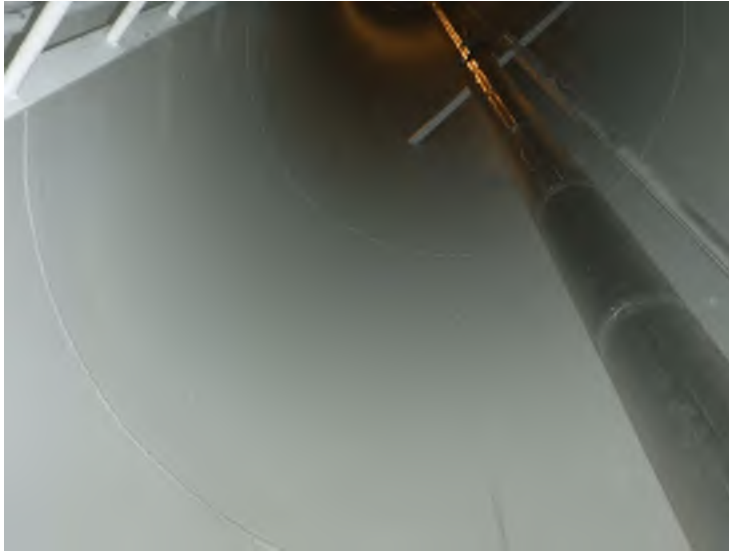
28) The riser coating is in good condition with no significant failures.

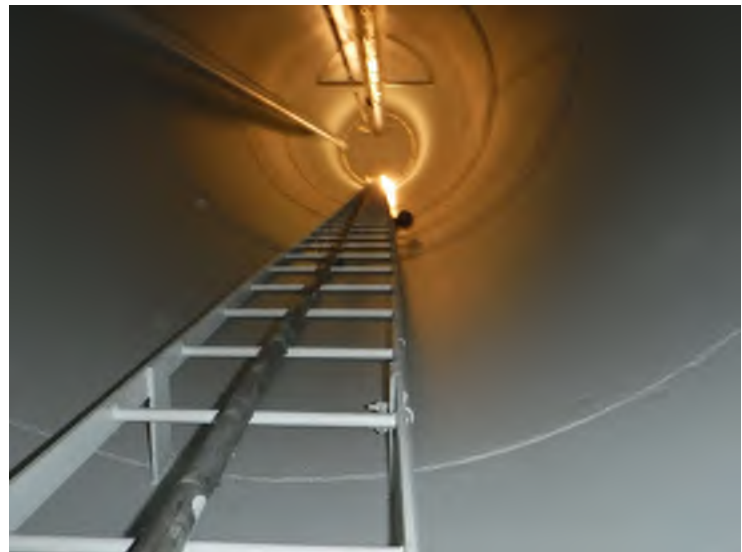
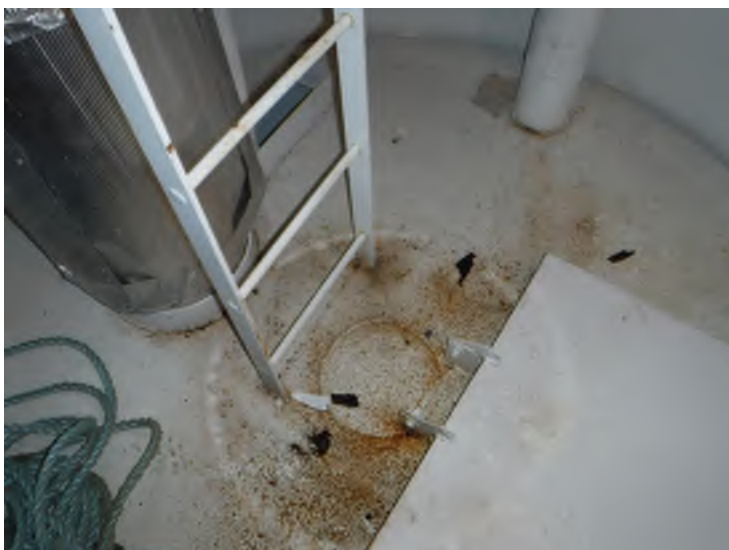
30) Minor coating failures on the top platform. The top platform opening and cover are in good condition.

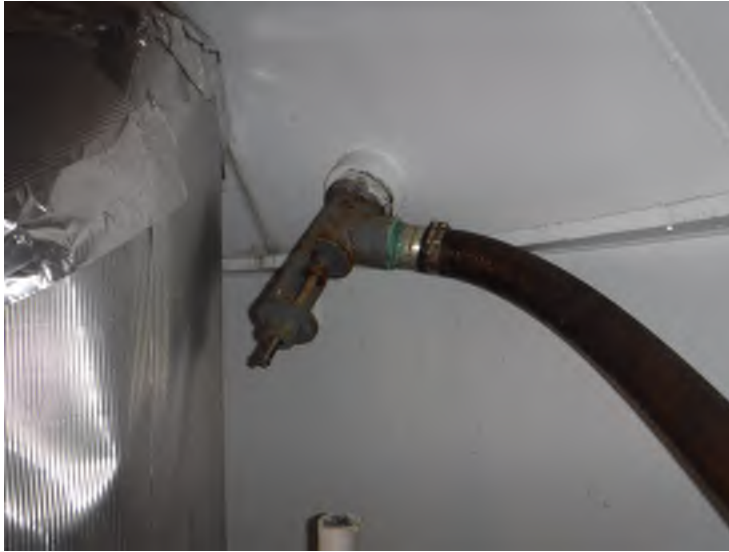
31) The mud valve appears to be in good condition.

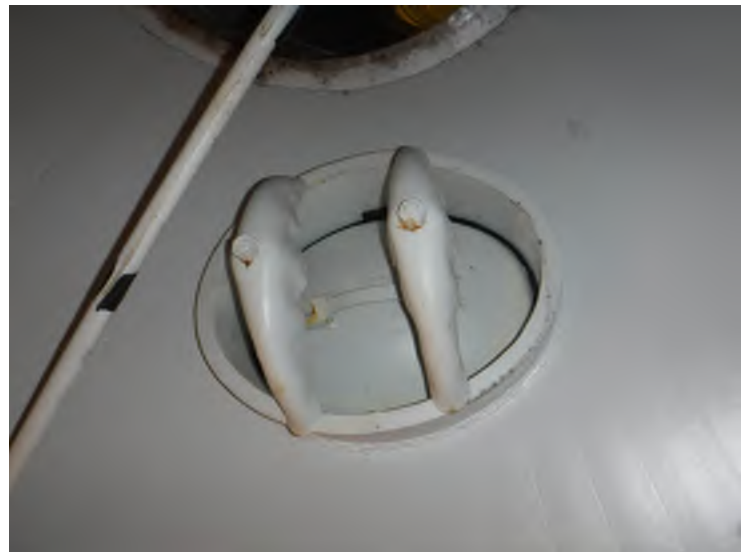
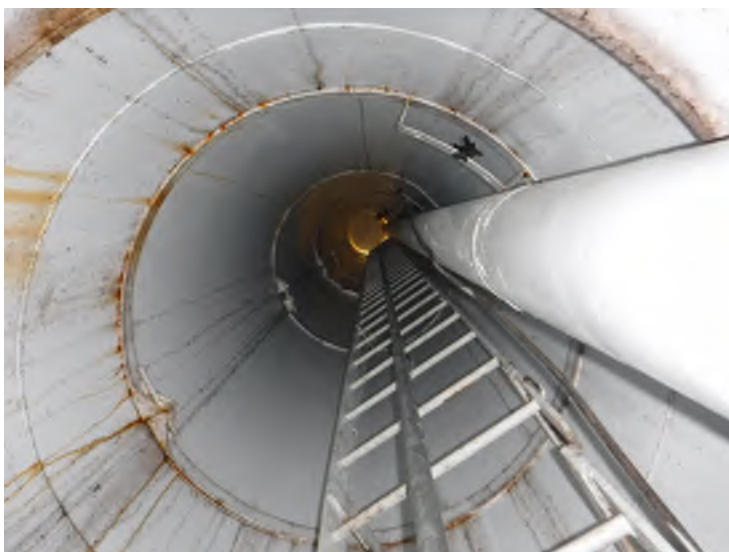
33) There is rust bleedthrough and streaking at the antenna cable attachment brackets in the access tube.

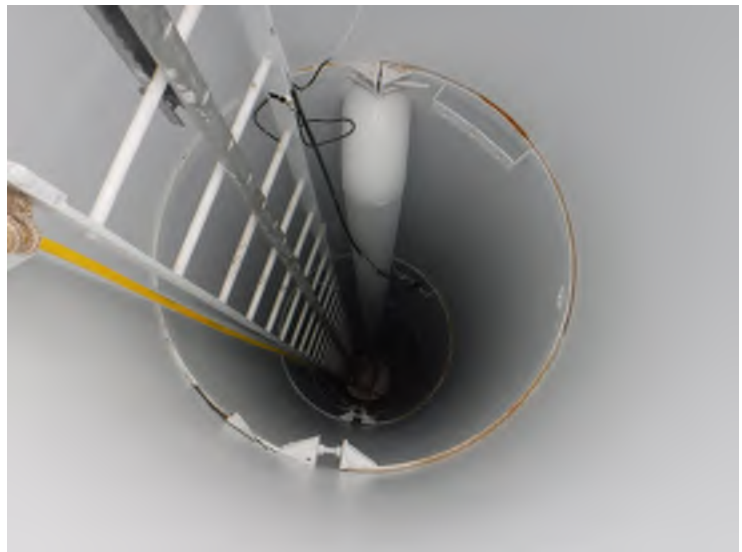
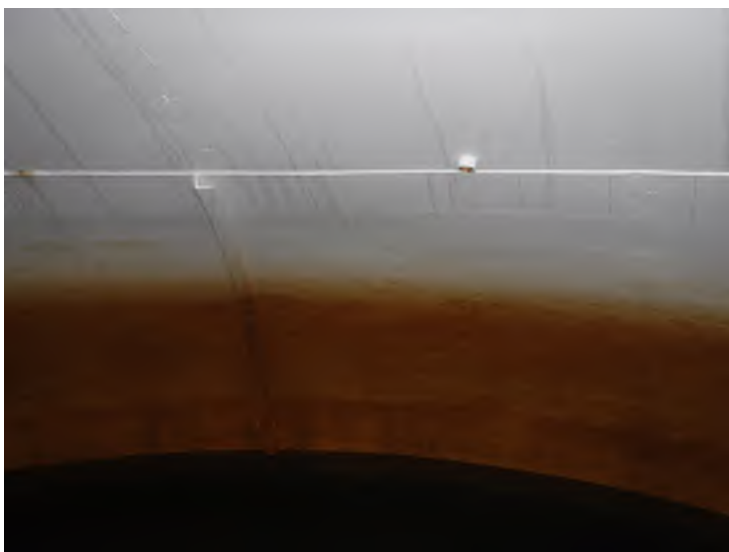
36) The wet interior roof coating is in good condition overall.

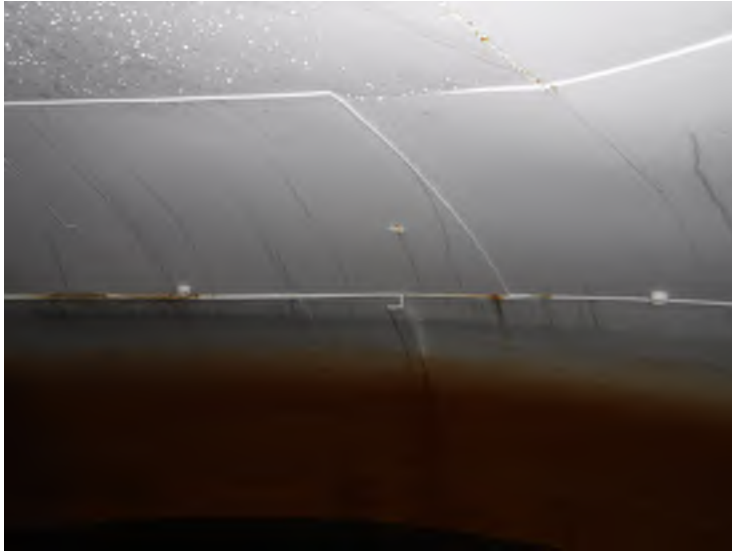
37) There is minor corrosion at the open lap seams.

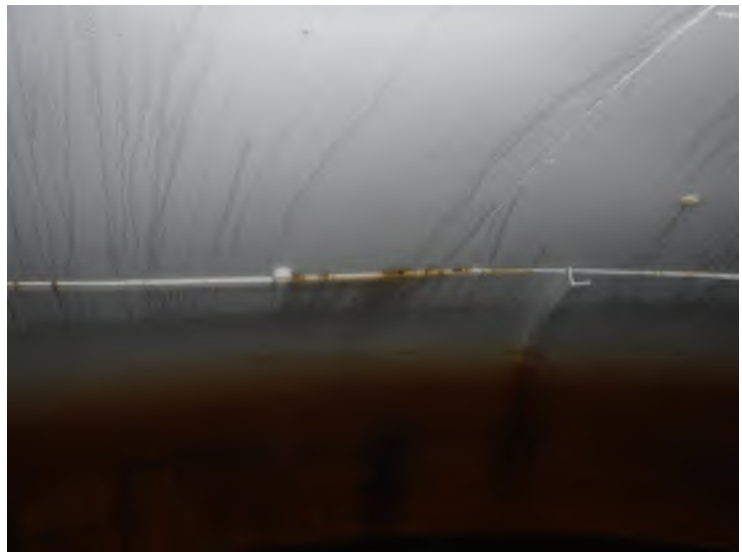
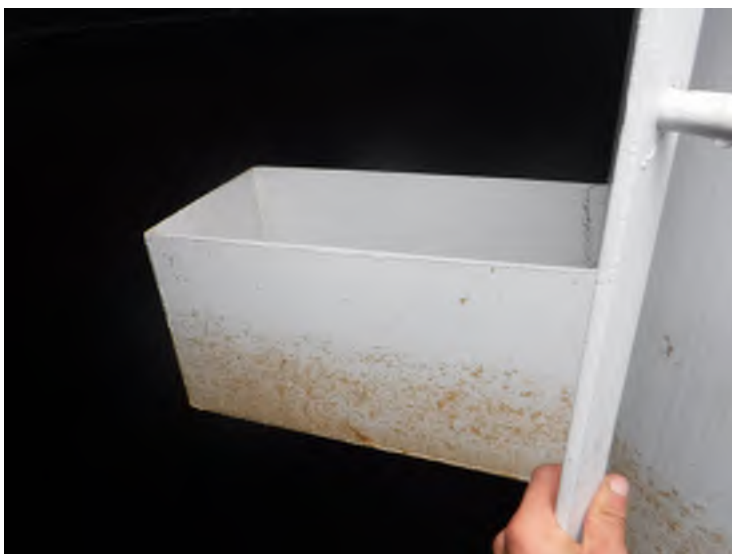
39) The overflow weir box is in good condition.

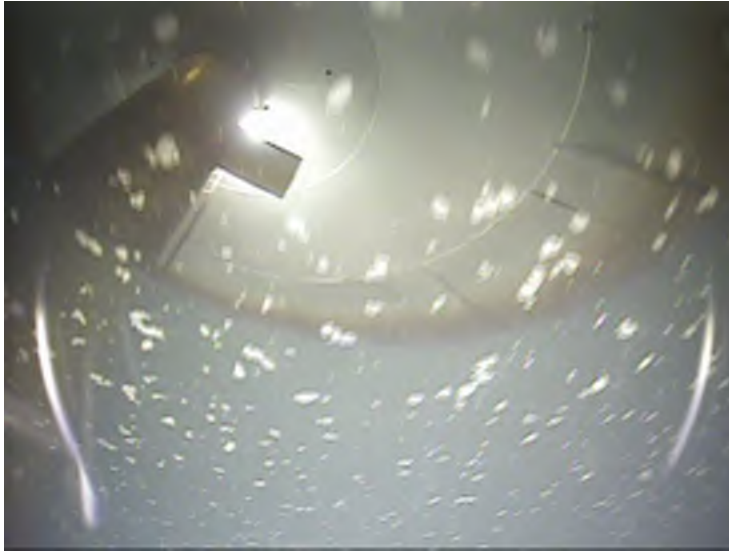
40) The roof viewed from the ROV.

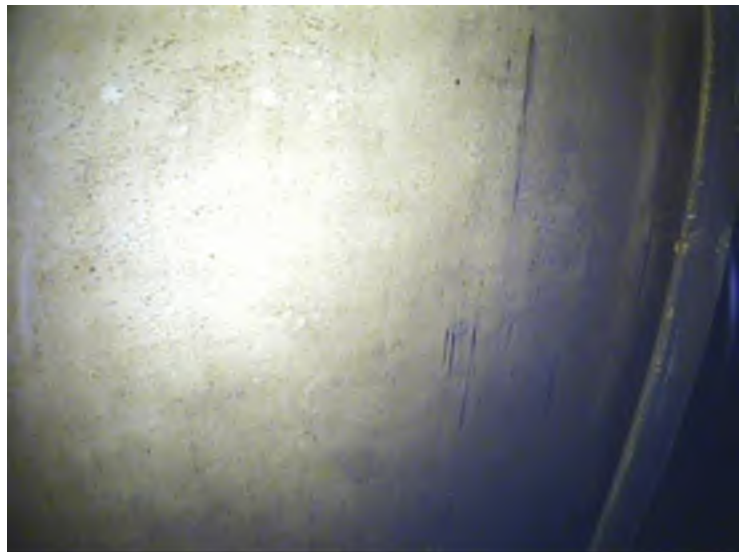
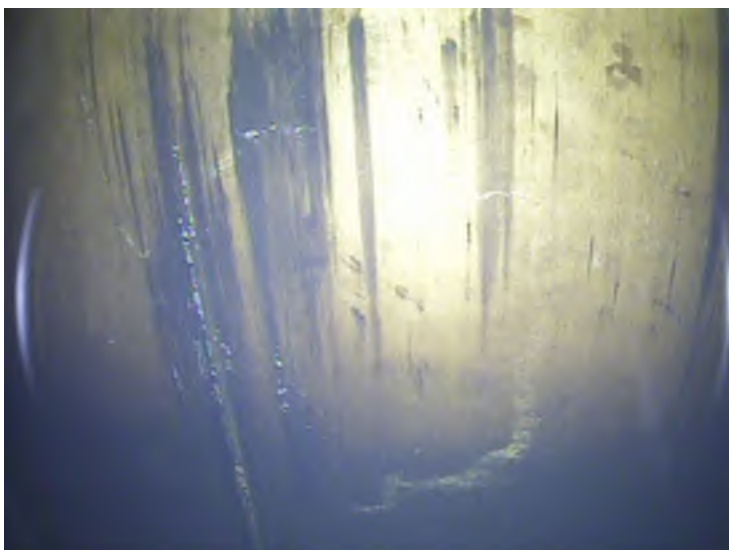
42) Pinhole coating failures on the sidewall.

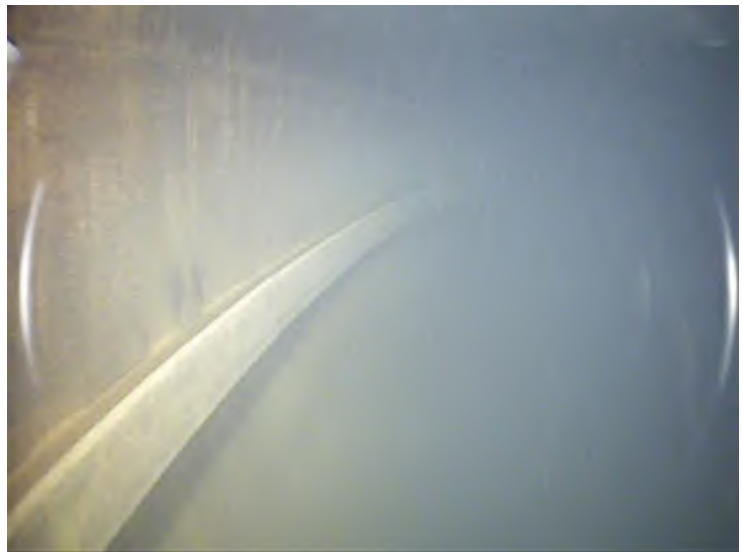
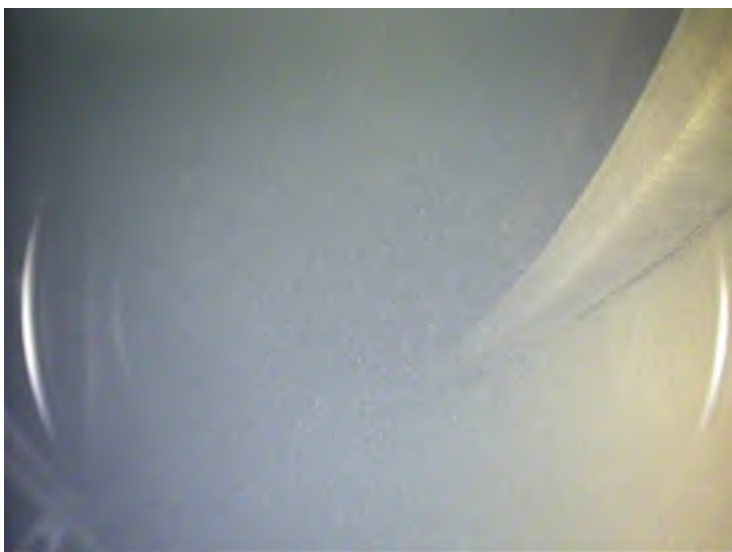
44) The sidewall stiffener is in good condition.

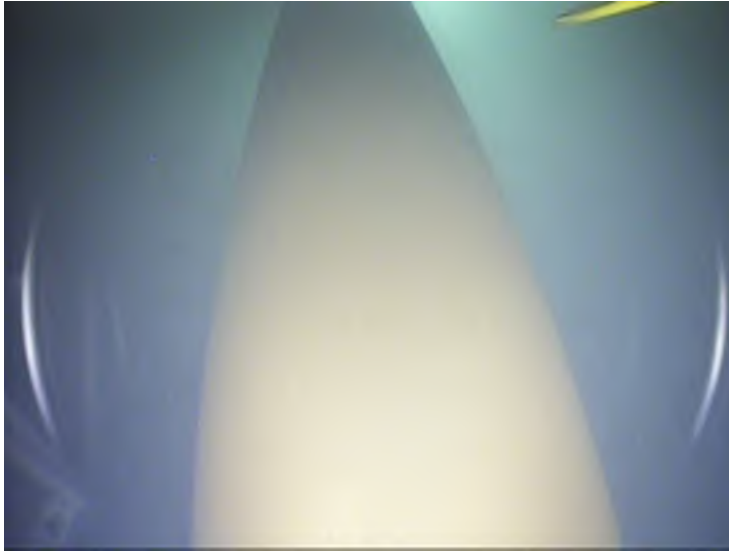
46) The access tube coating is in good condition with no significant failures.

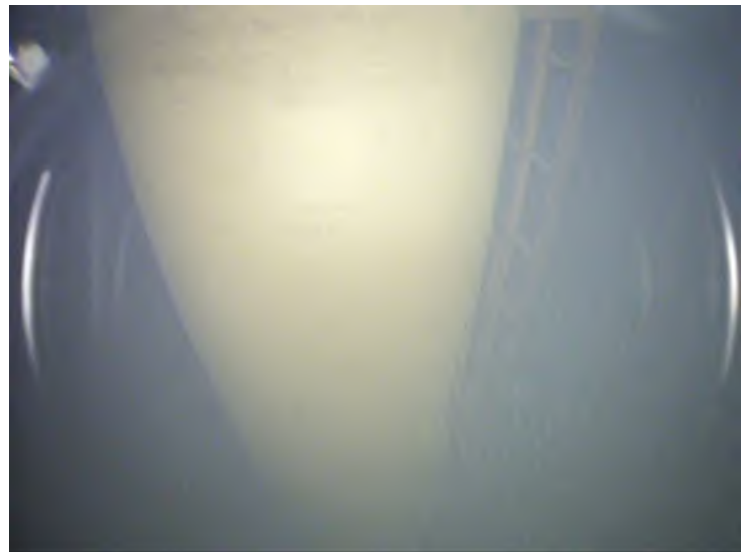
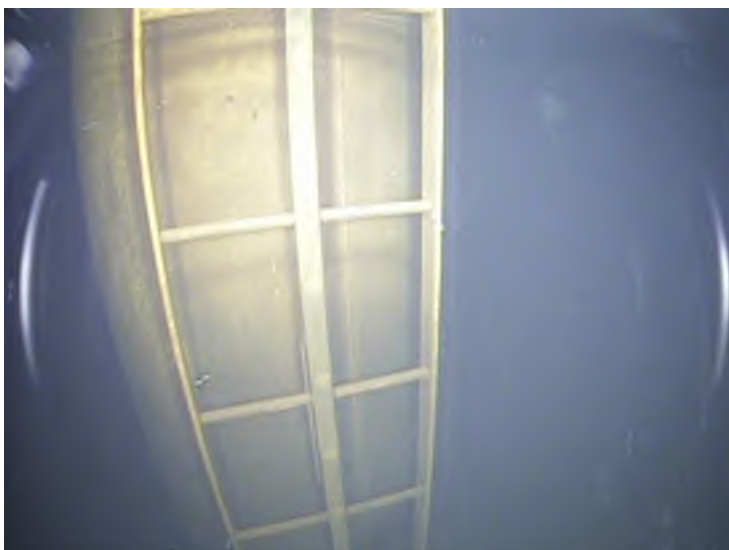
48) The wet interior ladder is in good condition. The ladder is equipped with a fall prevention device.

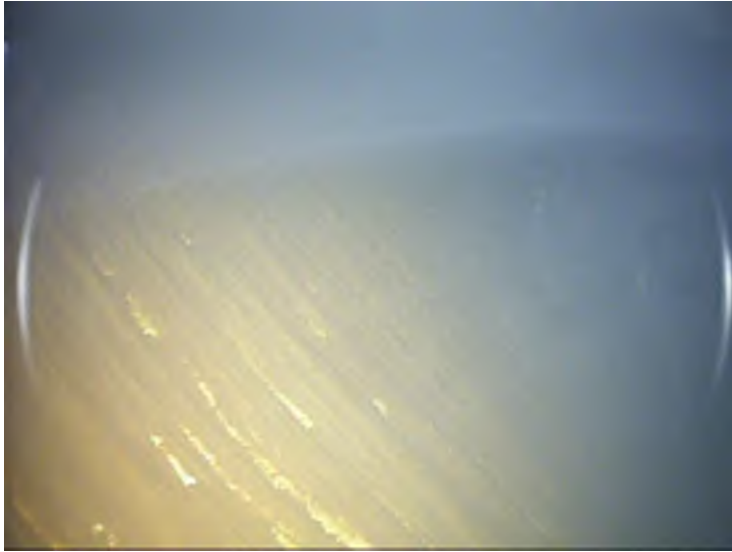
49) There is sediment accumulated on the lower sidewall and bowl.

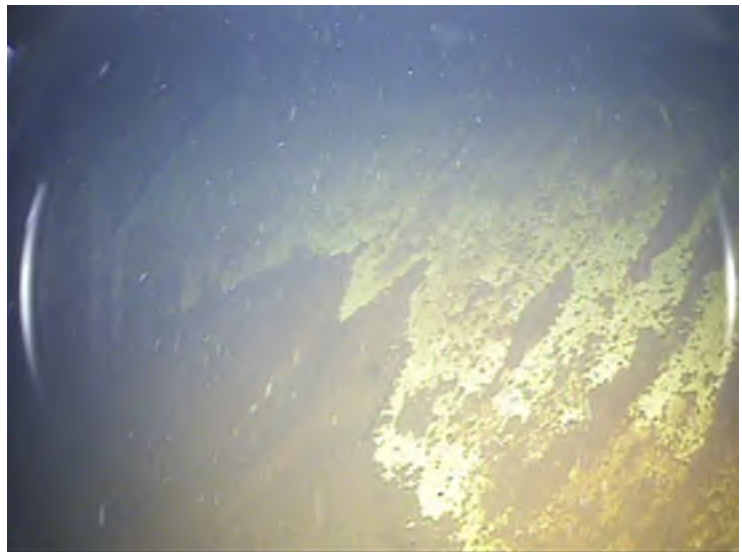
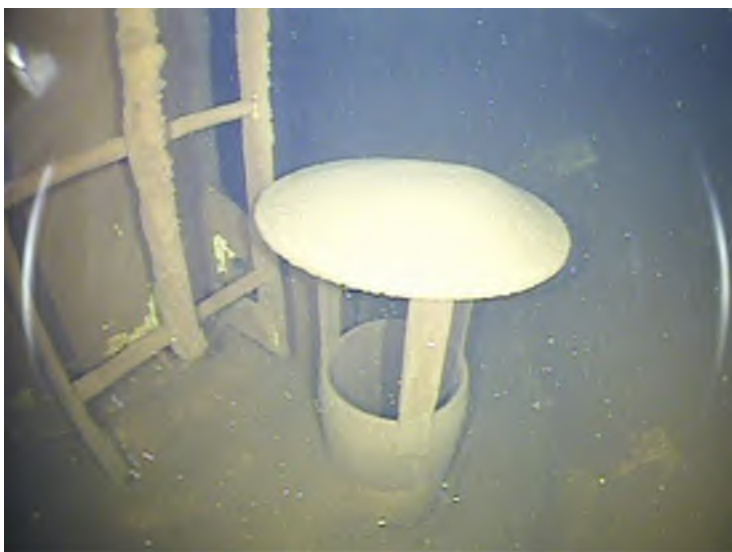
51) The fill/draw pipe is in good condition. There is a deflector plate at the end of the pipe.
