July 30, 2018

Re: Feasibility Study Report Middlebury Police – Control Building Re-use EV# 18276

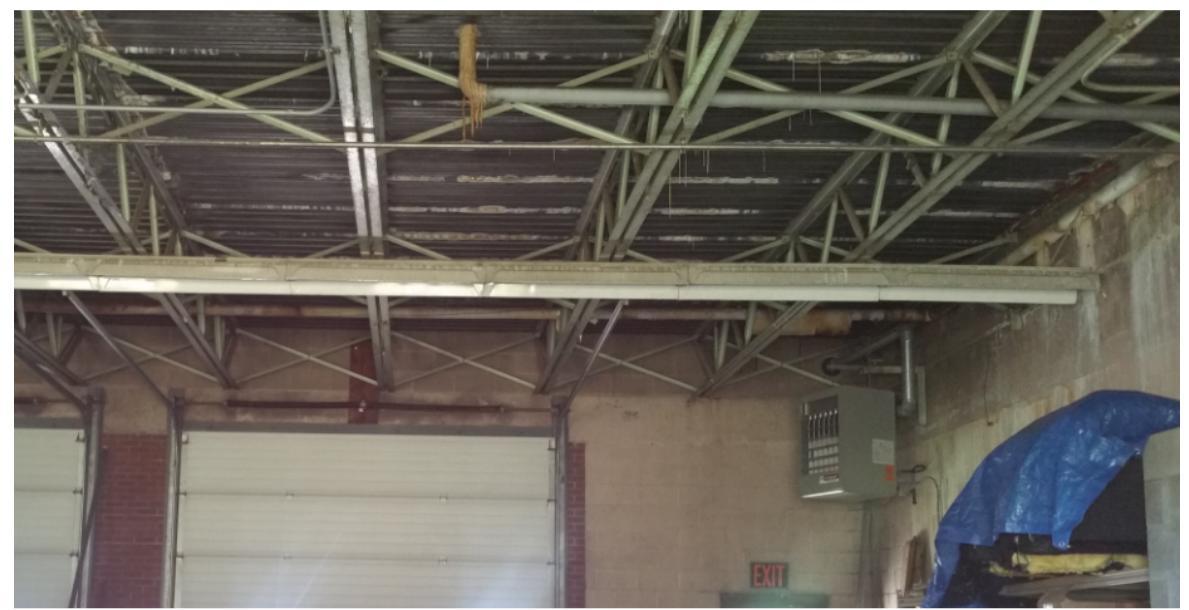
Figure 1: Existing Interior Framing

There is evidence of water damage throughout the entire structure. The steel deck and framing had

rusted in many places. Roof drains have deteriorated over time and were letting water into the building, see Figure 1. Significant buildup of white deposits on the deck and walls were noted. At low spots on the concrete floor pools of water had accumulated. Condition of concrete in these areas could not be determined.

- The existing steel roof is to be removed and replaced. We anticipate new roof framing to include open web steel joists spanning east to west. The new trusses will be 24" deep K or LH series and will be top chord bearing. This will require the addition of embedded plates in the new CMU wall extension or concrete bond beam. Joists to be designed to accommodate framing required for new garage doors. A 1.5B steel deck will be required for both vertical and lateral capacity of roof. The deck will be fastened to supporting members with pins or screws at a spacing to be determined.

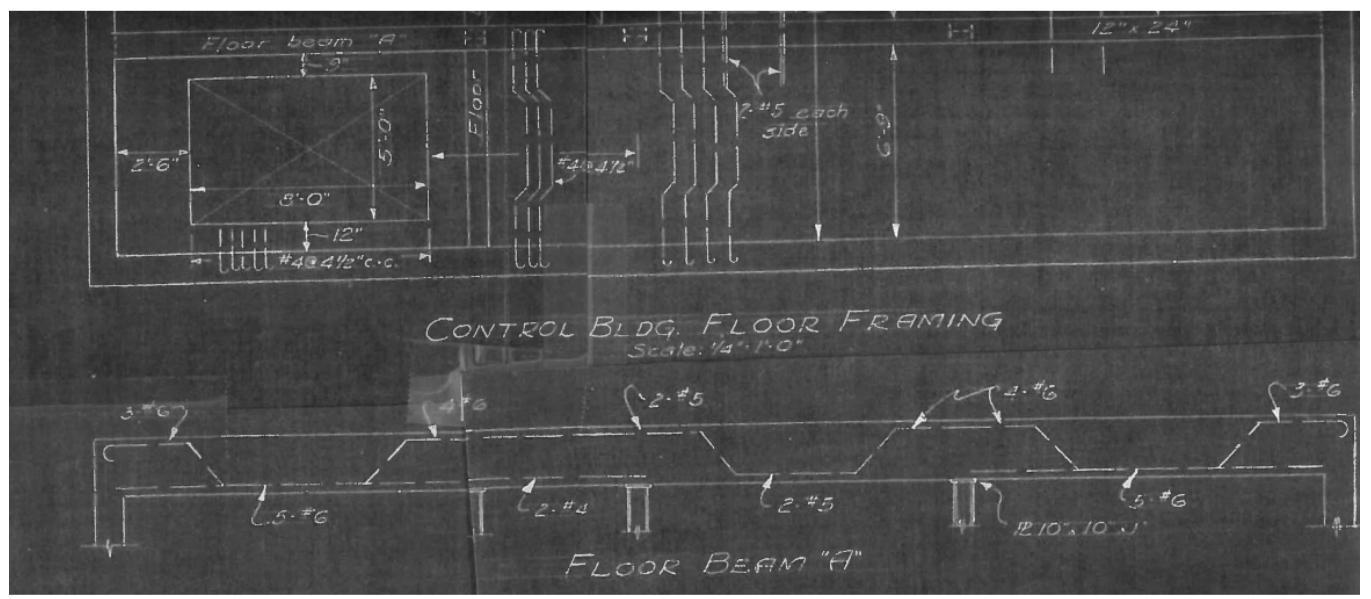
Figure 4: Existing Concrete Beam at Corridor

- New interior reinforced CMU wall to be constructed on old southern corridor wall line. This wall is to align with the existing drop beam in elevated floor, see Figure 3. The existing concrete beam has capacity to support this new vertical load, see Figure 4.

- New interior CMU wall will now take lateral loads down to the foundation. To accommodate
 this lateral load, we recommend adding a 10' wide (min) concrete shear wall and footing in
 basement level. This would be doweled into the existing concrete beam. It might be
 desirable to have a continuous wall here to separate this area from the existing. As an
 alternate it may be preferred to transfer lateral loads through the elevated slab into the
 adjacent concrete foundation wall. This would require further analysis to determine extent
 of reinforcements required.
