# 1208<sup>th</sup> Street

## INTRODUCTION

1208<sup>th</sup> Street is a local road in the Town of Oak Grove. It directly serves 68 residential units as well as loops into another development of 57 residential units. While 1208<sup>th</sup> Street has seriously deteriorated pavement, is too narrow, and has non-compliant horizontal and vertical curves, the problem is even more serious. 1208<sup>th</sup> has a drainage overflow across the surface of the roadway! Whenever there is a rainfall event any significance or during the spring snowmelt event, water runs

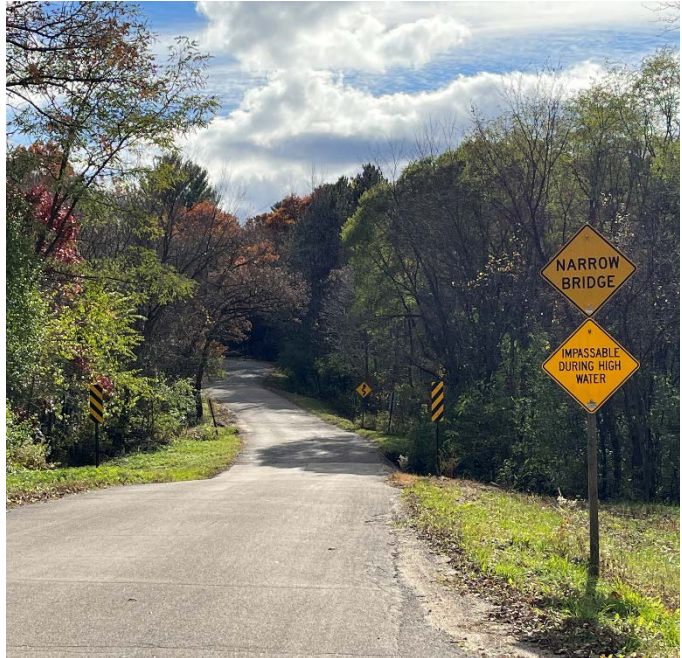
over the road. Back in the early 1980s, the road washed out and residents along 1208<sup>th</sup> Street were stranded for almost two days. To alleviate this issue, the Town completed the final connection to 497<sup>th</sup> Avenue in the late 1990s so residents at least had another option to get out of the development. However, the overflow remains over the road surface to this day.

The overflow tends to be very icy in the winter and impassible in the spring. At least three cars have been washed off of the road at the overflow area. The spillway was repaired in 2018 to address the voids under the concrete slab. The repair consisted of pumping foam into the voids as a temporary solution. The Town would like to look for a permanent solution.

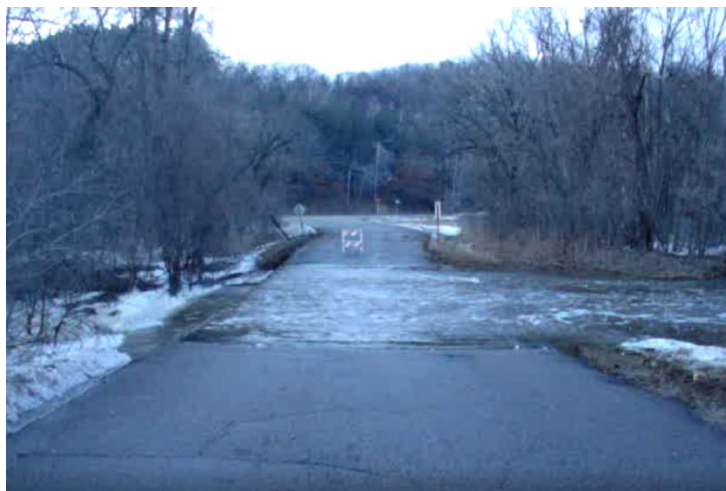
The vertical and horizontal curves do not meet design standards. The side slopes in many areas are steeper than 3:1, which is the maximum recoverable slope allowed on a rural road according to AASHTO's Roadside Design Guide. The surface spillway needs to be removed and replaced with drainage structures under the roadway to address the flooding and icing.

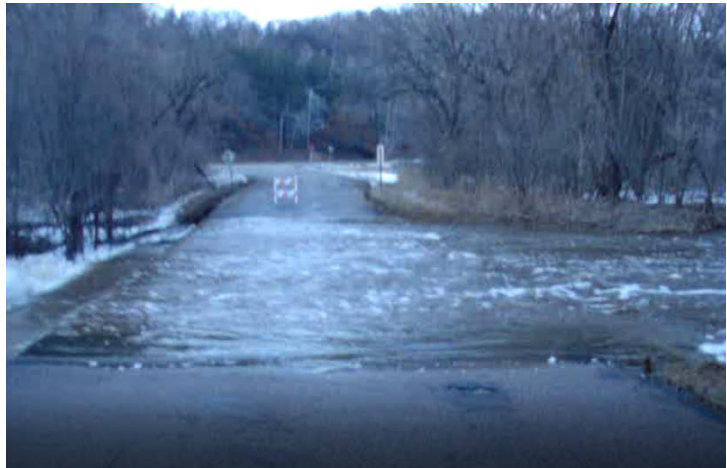
1208<sup>th</sup> Street is not safe. The spillway, substandard widths, non-compliant horizontal and vertical curves, and steep side slopes all contribute to the Town's concerns. With the narrow road width and steep side slopes, it is very difficult to recover if a driver moves too close to the road edge. In the area of the spillway, the Town has

posted signs warning of “Impassable During High Water” at the spillway, sharp curves, and steep hills. The speed limit has already been reduced to 25 mph. While these help from an informational standpoint, the road is still very unsafe. The Town is in dire need of improvements to address the spillway, the narrow drive lanes (currently 20-feet wide with no shoulders), correct the vertical and horizontal curves, and improve side slopes. Attached you will find a listing of texts, emails, and letters from the adjacent Town residents begging to have the road fixed. As you will read, there are stories of accidents or near accidents that were experienced on 1208<sup>th</sup> Street. Also attached is a letter from the Prescott Area Fire and Ambulance Association that addresses their safety concerns about 1208<sup>th</sup> Street. They have outlined that the road conditions delay their response time by as much as 15 minutes which is far outside of the standard. Given these grave concerns, we are hopeful to be considered for the grant.

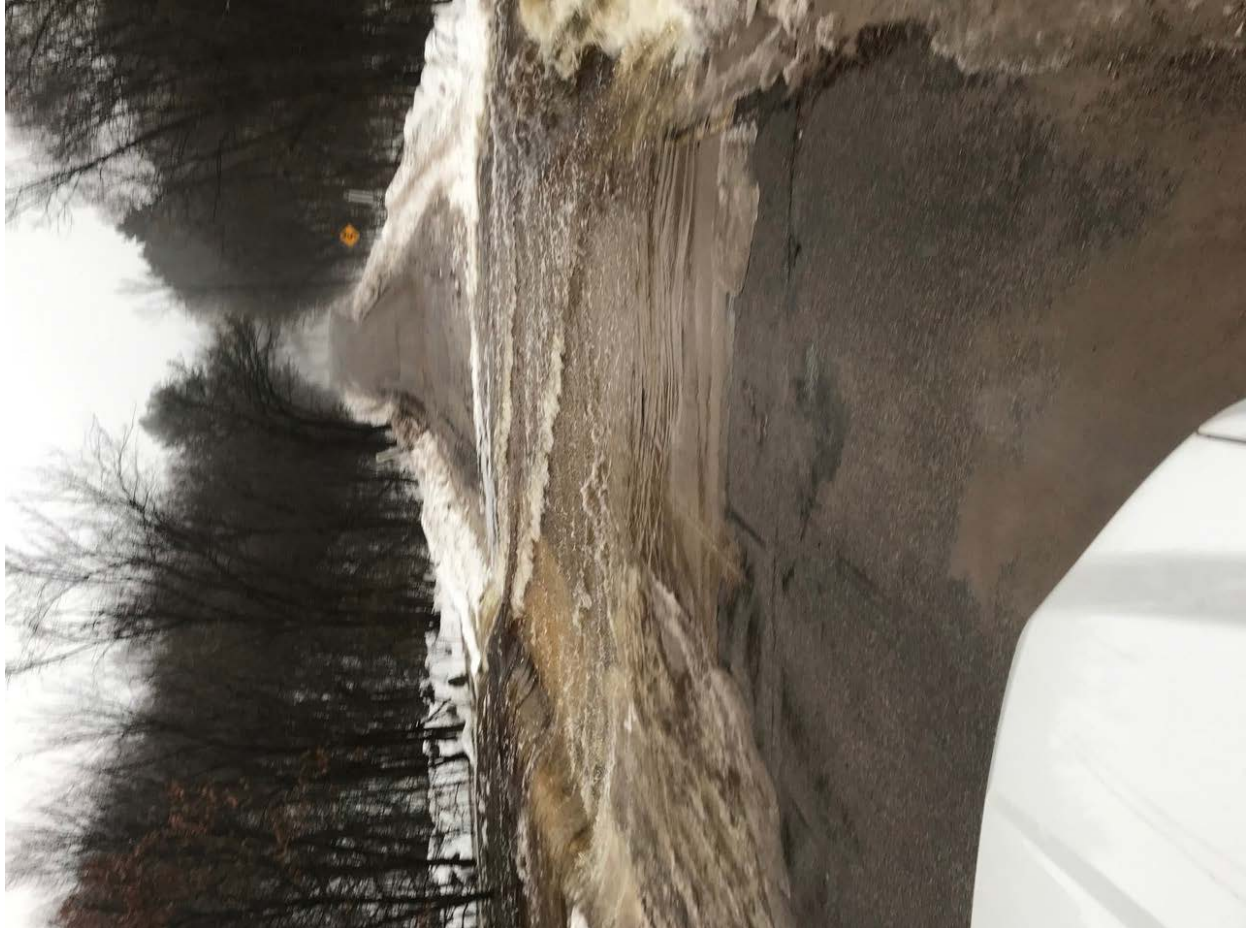
This photo was taken March 14th 2019. If you look at the edges of the road you'll notice the windrow of snow the snowplow pushed up. That spring the plow drivers did not wing the snow far enough right away which created a dam that held the water on the road creating a large ice patch with water underneath. I took a shovel and made some holes in it. I wasn't going to brave working on the one on the left side of this pic. Looks like a second spillway.  
I think it was later that spring I inspected the lower side and noticed the the water had undercut the spillway side and reported to Gary Huppert, Think he called the state who sent out an engineer.  
later the summer someone was hired to inject high density foam to keep it from collapsing.  
Jeff

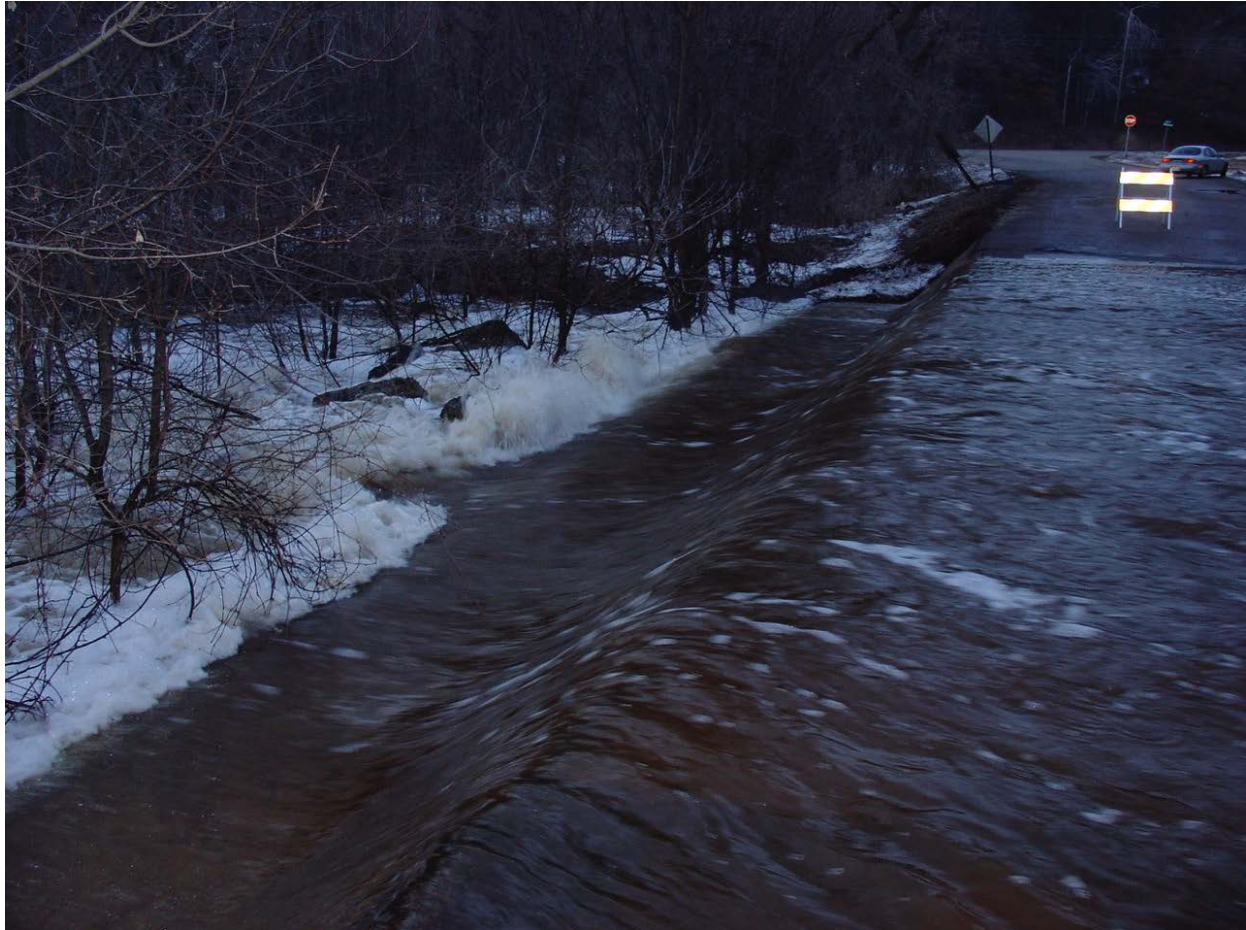
I will attach photos and video of water going over the road at 1208th Street. Size of these will determine how many emails. My wife also had a spinout on the curves up the hill, luckily no one else was using the road at that time. Her car did a 360°.
