# **INTRACOASTAL WATERWAY DEEPENING BROWARD COUNTY, FLORIDA**

**17th Street Bridge to 4,000 Feet North of the  
Las Olas Blvd. Bridge**

## **HARD CORAL RELOCATION SUMMARY REPORT**

**MAY 2016**

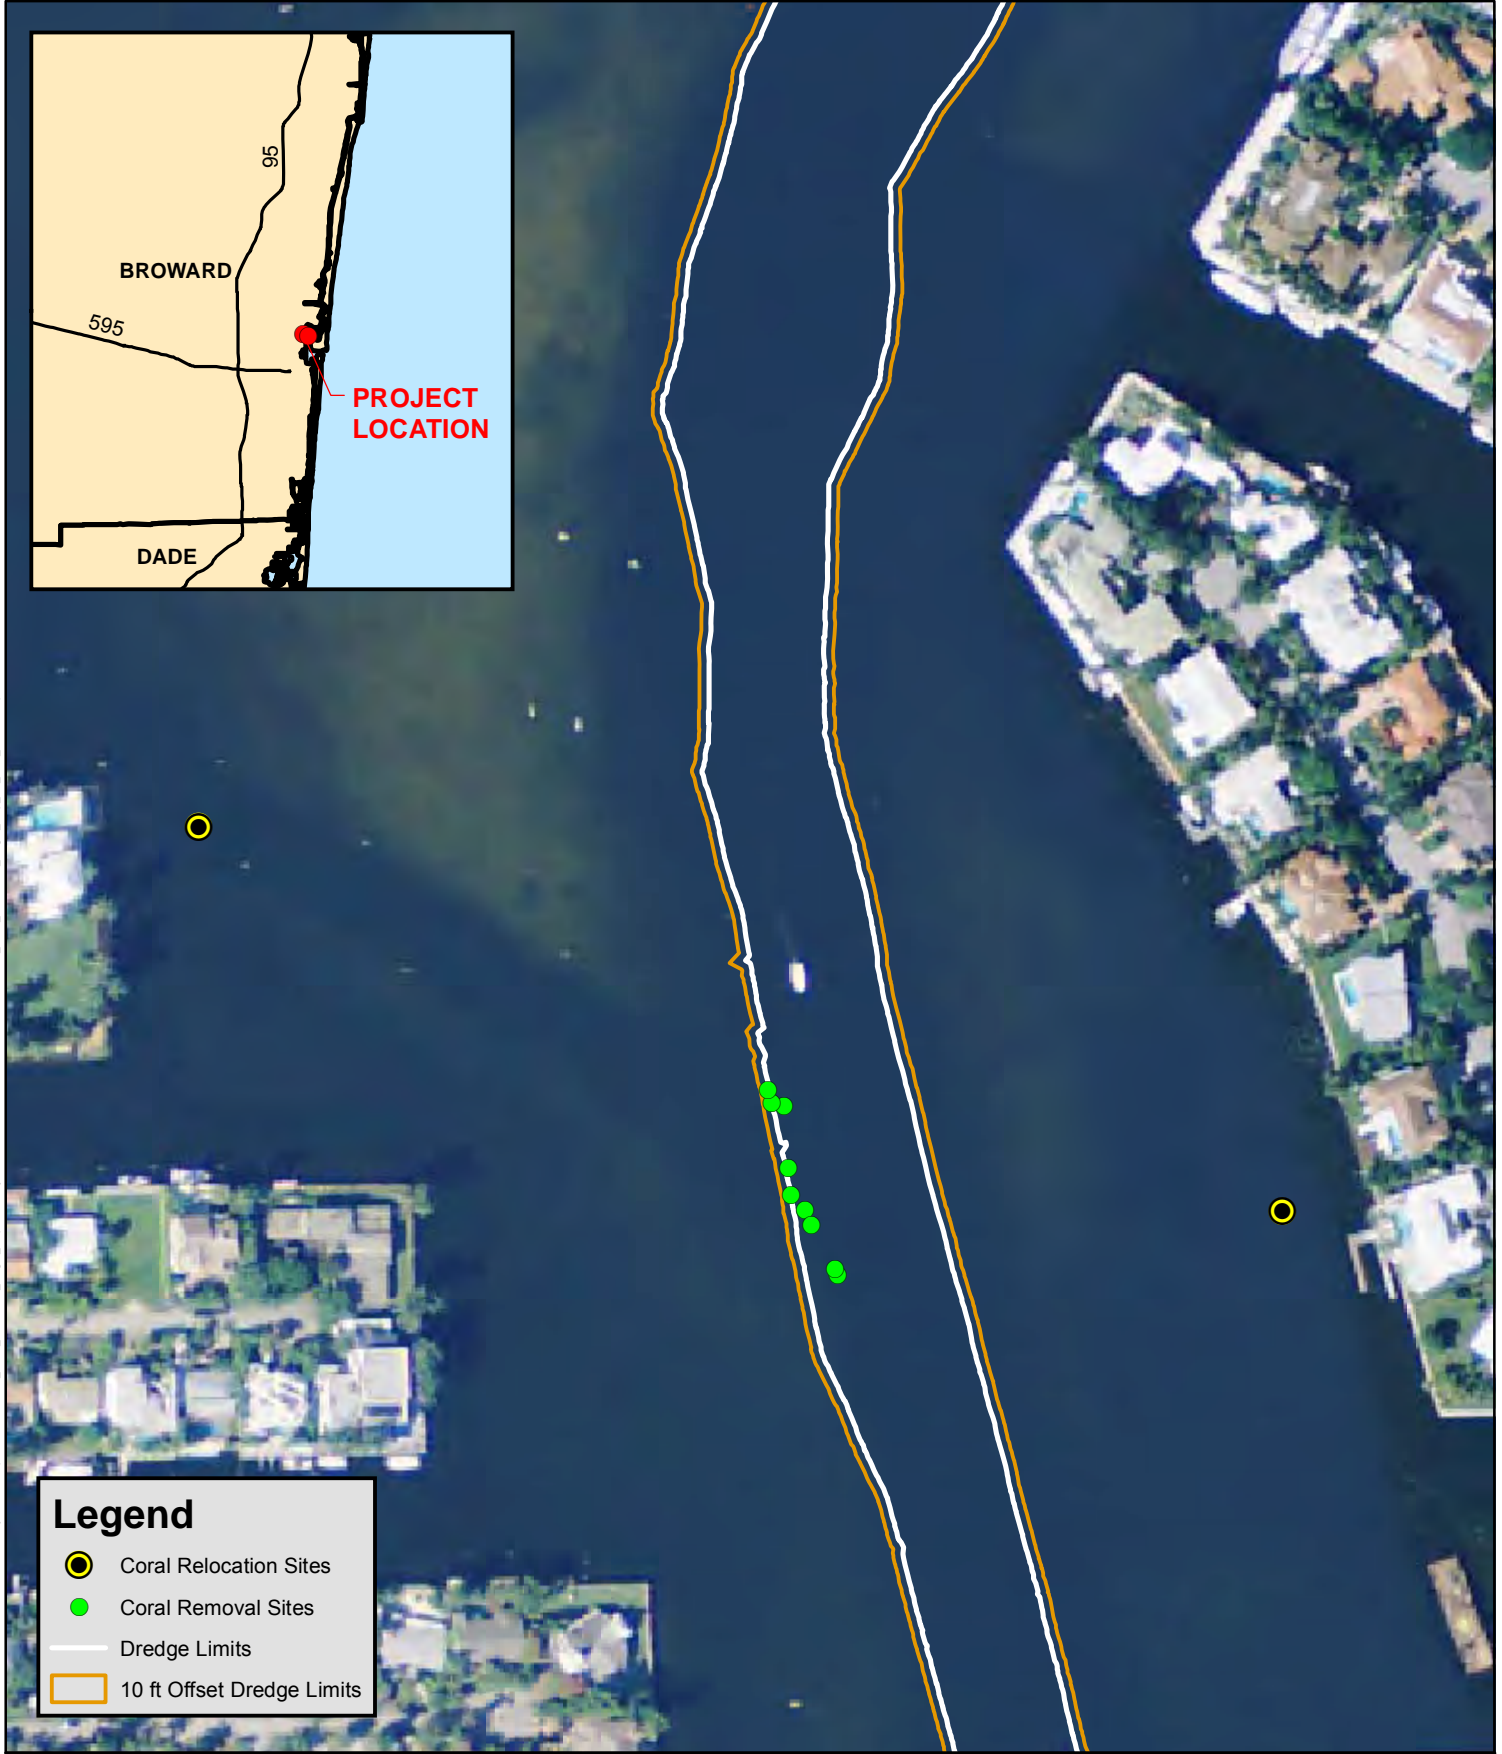
## Figure 1 - Coral Relocation Map

The second relocation site was located approximately 110 meters east of the ICWW channel dredge limits (**Figure 1**). It consists of an estimated one (1) meter tall ledge, which is undercut, in ten (10) feet water depth in close proximity to private residence. The ledge is encrusted with dense macroalgae and sponge coverage and existing hard corals. One (1) *O. Diffusa* colony and three (3) *Siderastrea* sp. colonies were successfully re-attached to the ledge at the east site.

Scientific divers, experienced in coral identification and coral relocation protocols, conducted the coral relocation effort on April 29, 2016. The relocation was conducted in accordance with the Florida Keys National Marine Sanctuary Coral Relocation Protocols (FKNMS 2008). The eight (8) hard corals were identified and removed from the sites depicted in **Figure 1**. Two (2) relocation sites were selected. The first site was located approximately 200 meters west of the ICWW channel dredge limits along the southern edge of a navigational channel that is potentially owned by the Fort Lauderdale Yacht Club (**Figure 1**). Water depths were estimated at 8 ft. The habitat consisted of large boulders (typically 0.5-1.5 meters in diameter) surrounded by sand. The boulders were encrusted with dense macroalgae and sponge coverage and existing hard coral colonies. The dive team was confronted by Yacht Club compliance staff while the initial re-attachment efforts were being completed. The Yacht Club expressed its concerns about relocating the corals in its channel. As such, a second relocation site was sought. Two (2) *O. Diffusa* colonies and two (2) *Siderastrea* sp. colonies were successfully re-attached to the boulder substrate at the west site.

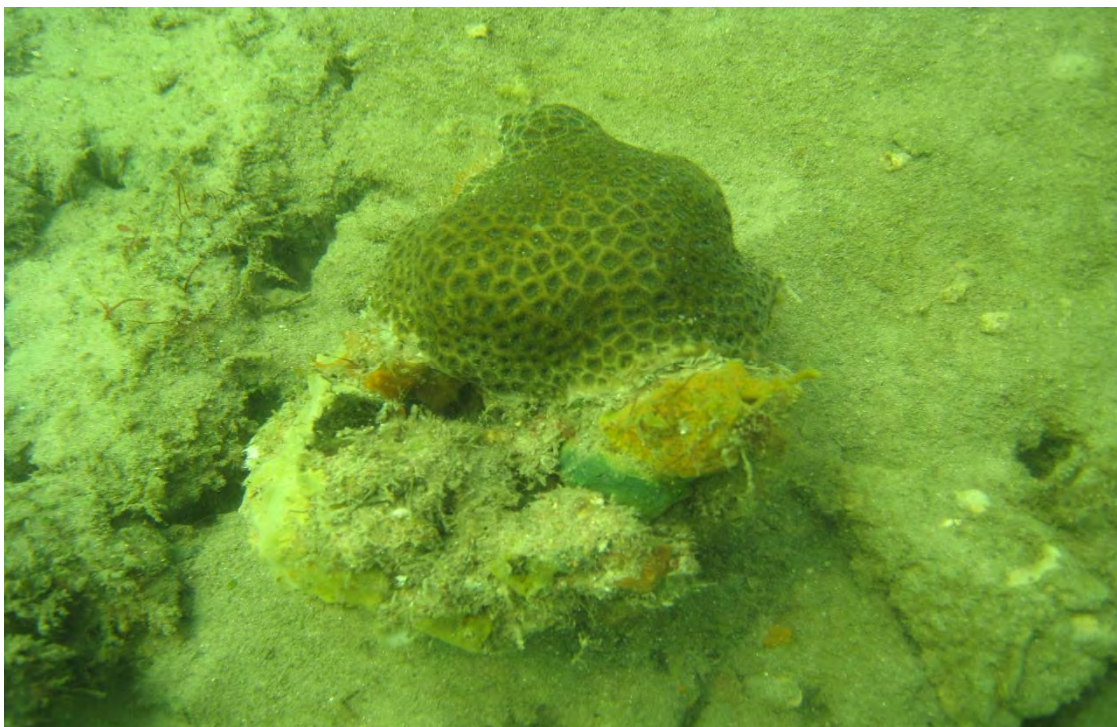
Photo 1: Typical view of *Siderastrea siderea* prior to relocation.

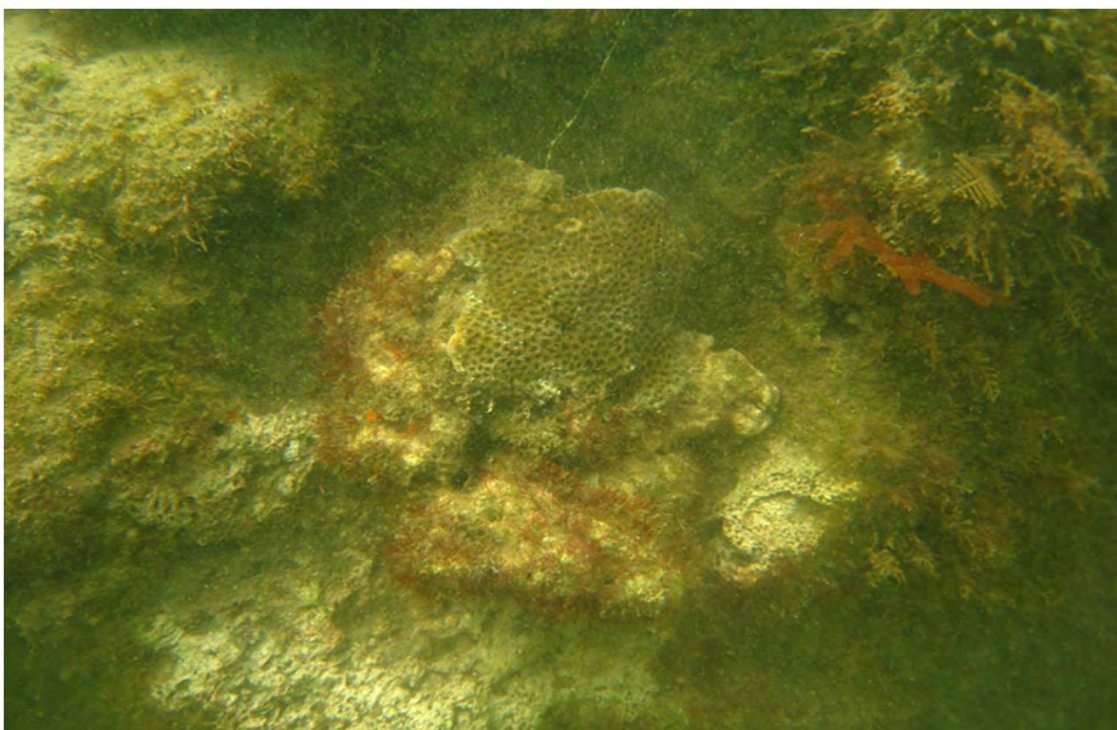
Photo 2: Typical view of *Siderastrea radians* prior to relocation.

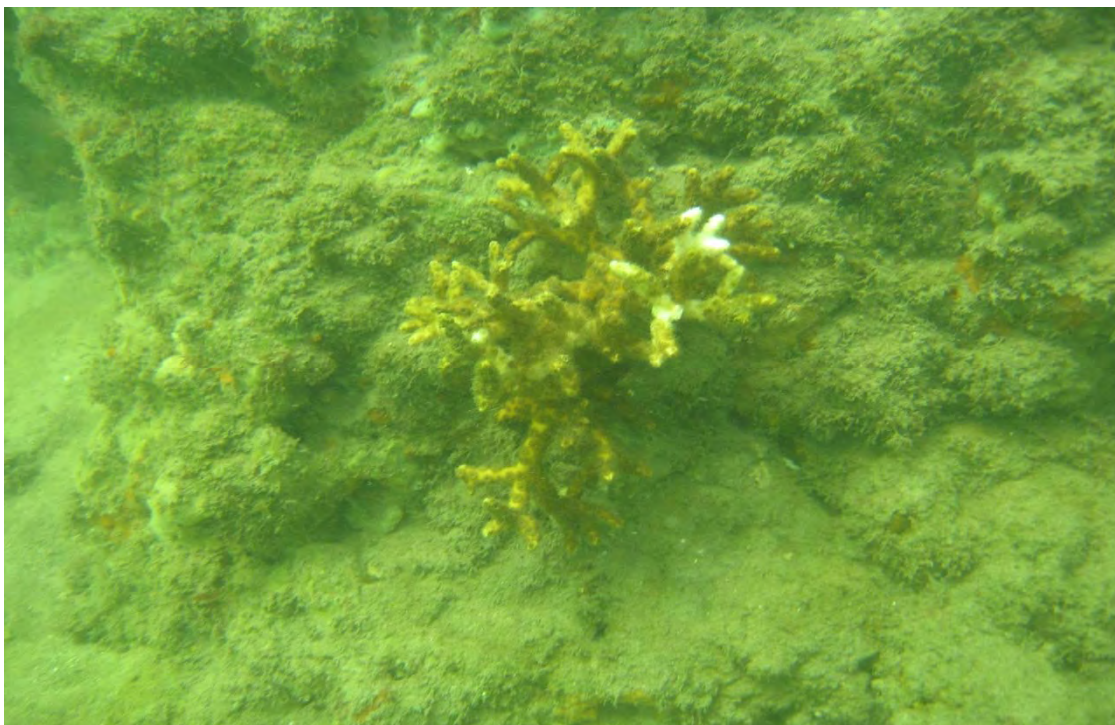
Photo 3: Typical view of *Oculina diffusa* prior to relocation.

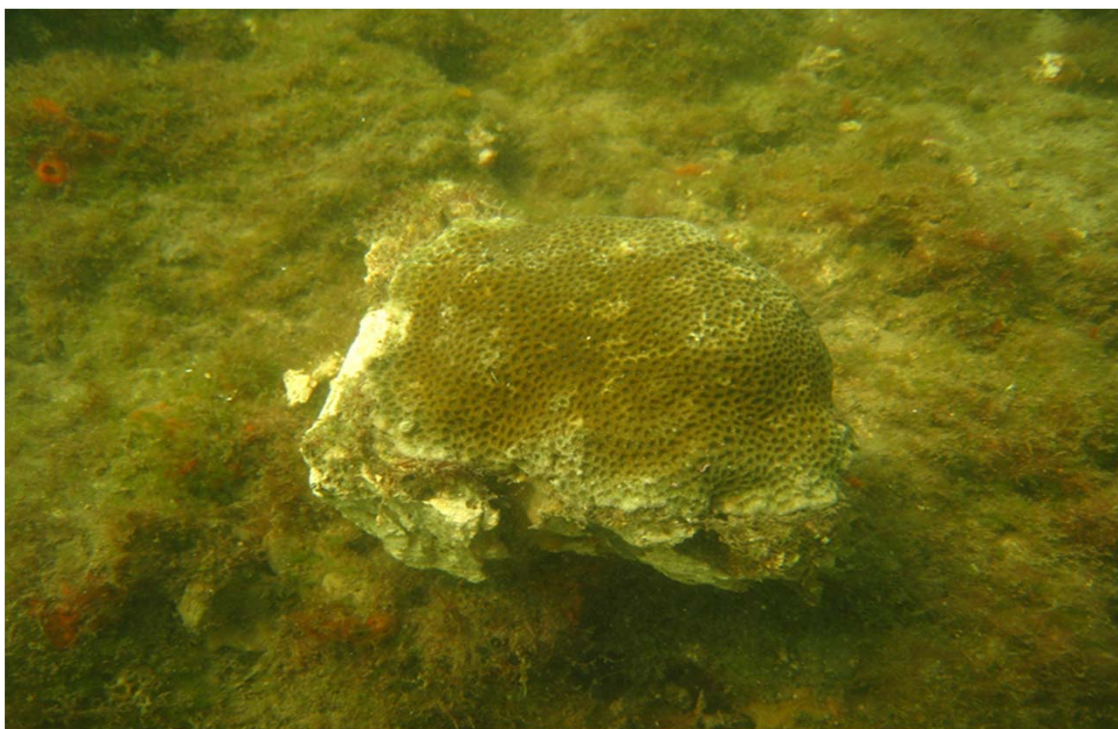
Photo 4: Typical view of relocated *Siderastrea* spp. post relocation.

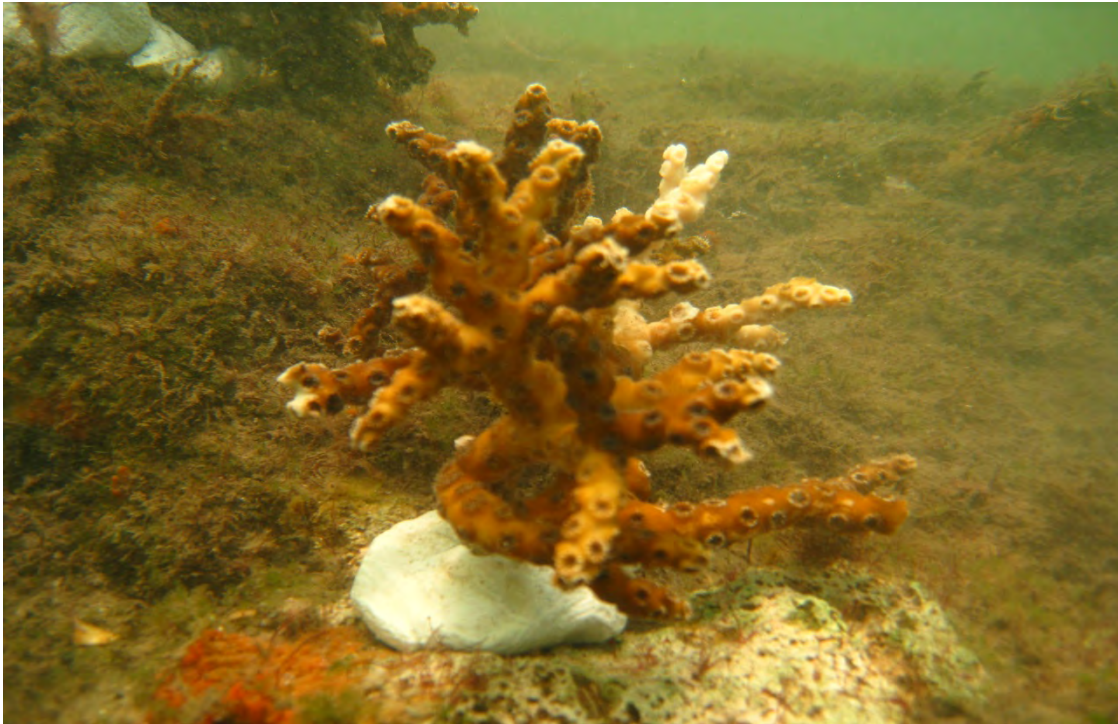
Photo 5: Typical view of relocated *Oculina diffusa* post relocation.

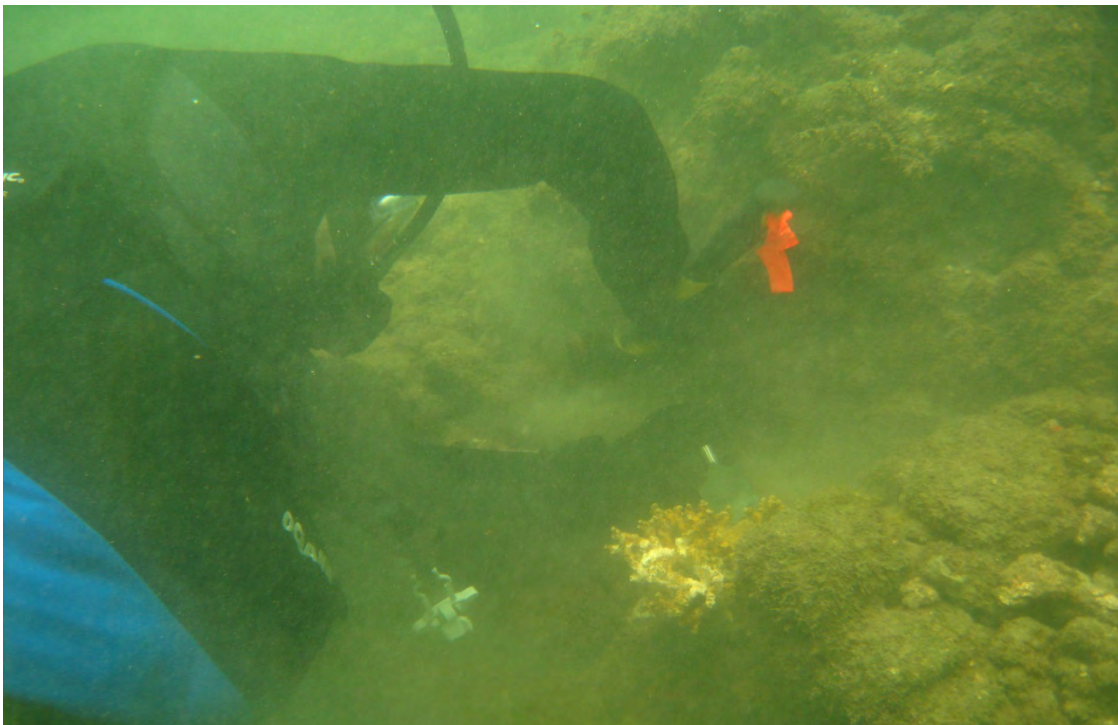
Photo 6: Typical view of coral relocation removal activities
