Crossroads of the Intracoastal Waterway and Okeechobee Waterway Maintenance Dredging Project in the Vicinity of the St. Lucie Inlet

Pre-Construction Benthic Survey

October 2016

DOCUMENT NO. CSA-FIND-FL-16-80132-3025-03-REP-01-FIN

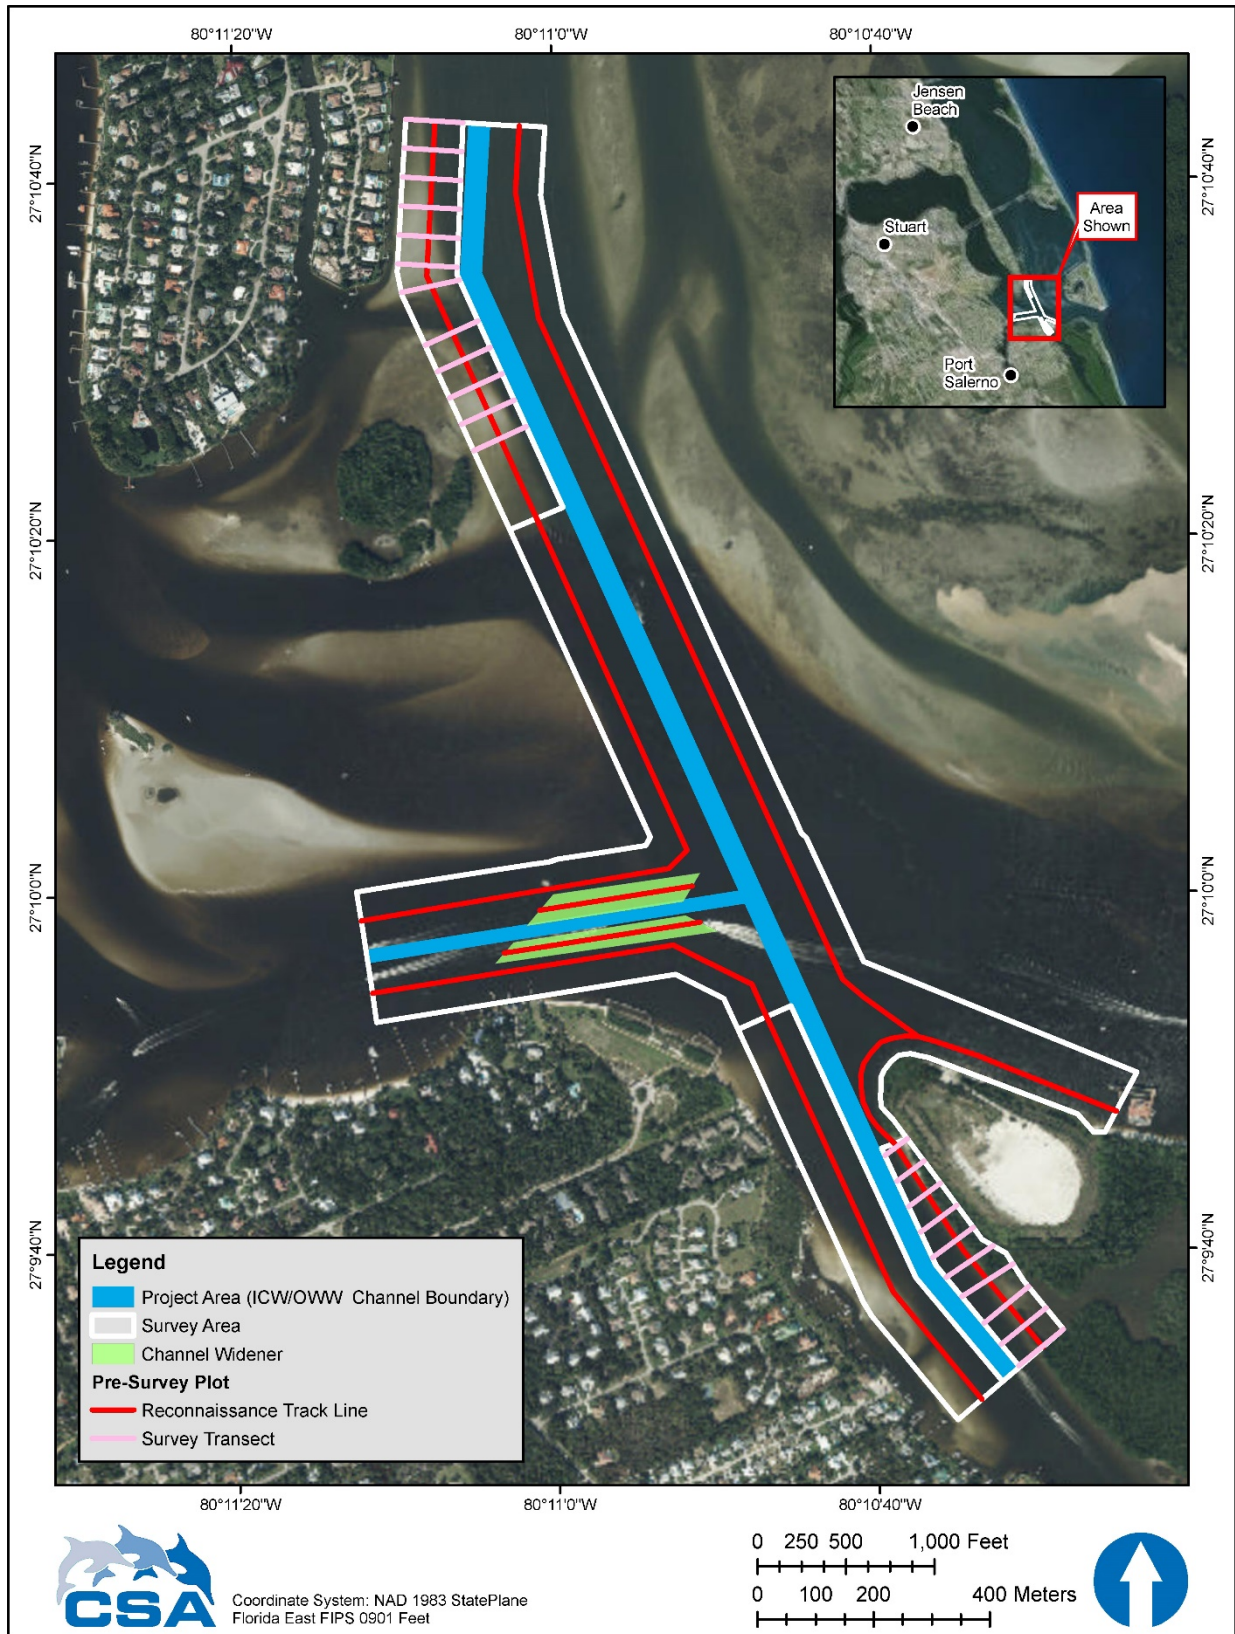
Figure 1. Crossroads survey area in the vicinity of the St. Lucie Inlet.

To confirm the current 2016 survey area, CSA contacted Taylor Engineering, Inc. (Taylor), FIND's engineering contractor managing the project. In an e-mail (July 13, 2016) from Mr. Bill Aley, a Professional Geologist with Taylor to Ms. Anne McCarthy (CSA), Taylor confirmed the survey area boundaries and added the two channel widener track lines (dimensions to which the channel may be widened) within the survey area. The project area, survey area, and survey transects for the St. Lucie ICW Crossroads survey are shown in **Figure 1** and included the following:

- Project area (ICW/OWW channel boundary)
- Survey area
- Visual reconnaissance track lines within the survey area and within proposed channel wideners; and
- Quantitative survey transects.

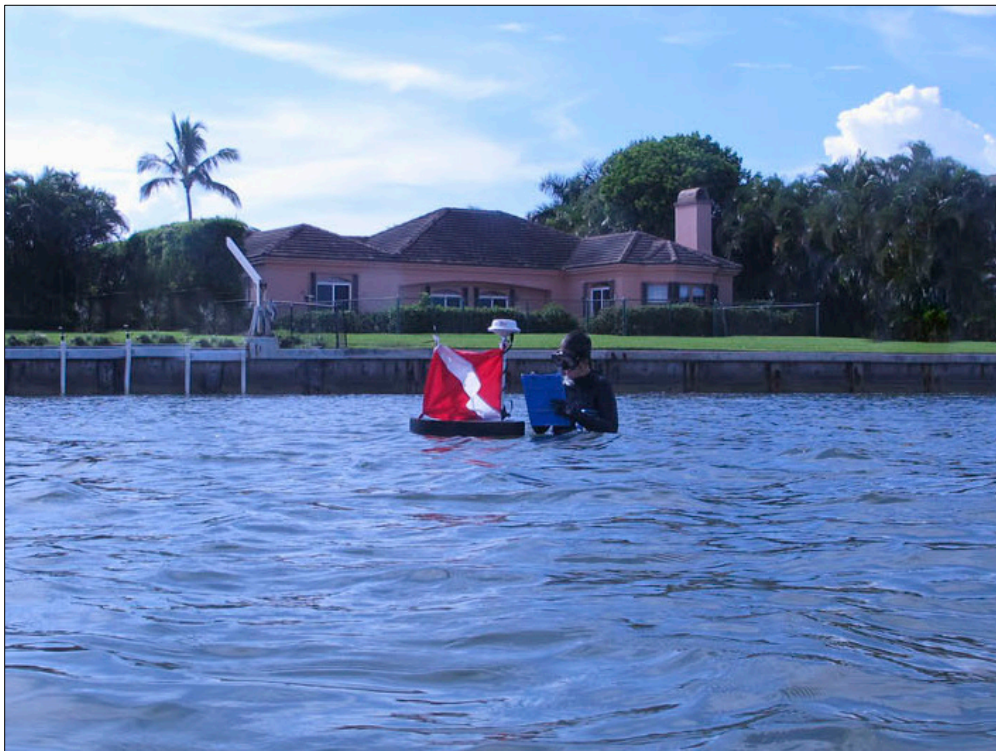
Photo 1. Scientific diver and the radio telemetry buoy.

Line intercept data sampling was conducted to delineate seagrass extent (distances along transect where seagrass cover started and stopped; sum of transect length where seagrass occurred yields percent cover) were collected by a scientific diver towing the radio telemetry buoy (**Photo 1**); divers also recorded the seagrass species composition. Again, survey data logging for each transect began on the shoreward side and continued towards the project area. The DGPS position of the radio telemetry buoy was recorded at the beginning (start) and end (stop) of any seagrass habitat encountered. The diver also recorded the qualitative estimate of the width (in meters), as far as seagrass could be visually observed perpendicular to the transect of the seagrass habitat, a visual estimate of relative coverage (i.e., sparse, dense) and seagrass species composition, particularly the presence or absence of *H. johnsonii*.

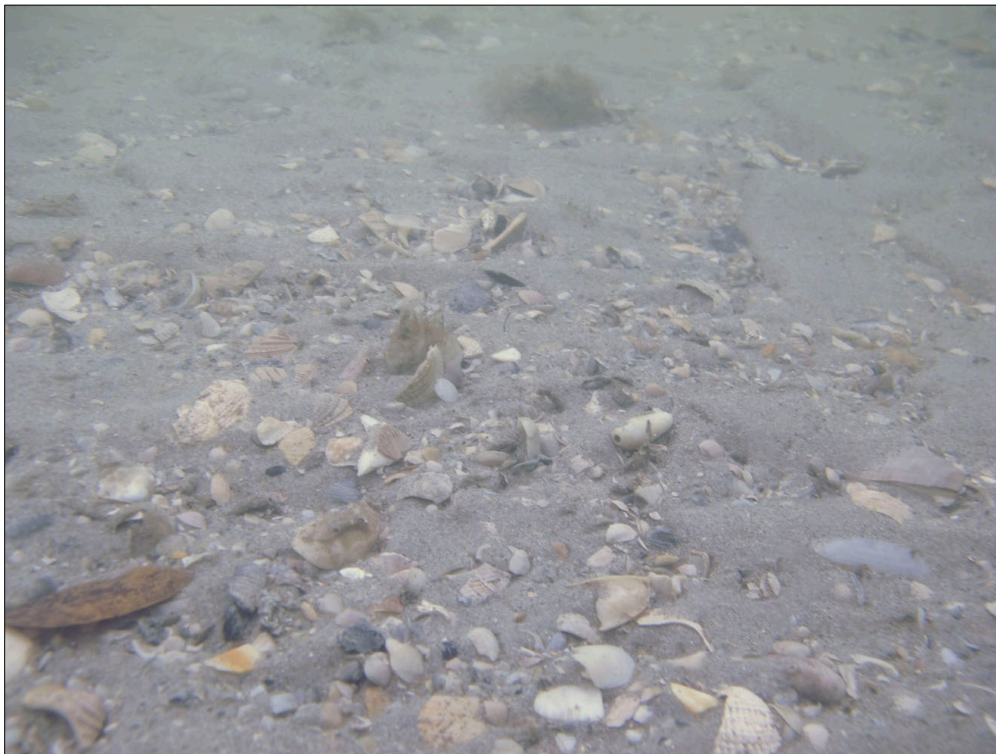
Photo 4. Coarse sand and shell hash observed within the channel widener areas during the reconnaissance swims.

Seagrass habitat was not observed within the project area or within the channel widener areas. These areas devoid of seagrass generally had deeper water depths than areas with seagrass and with presumably limited sunlight penetration, high wave energy from wind and vessel traffic, or a combination of these conditions. Hydroids and macroalgae were also occasionally observed in deeper waters throughout the reconnaissance swims (**Photo 3**). Within the channel widener areas, coarse sand and shell hash were the primary sediments noted (**Photo 4**). Substrate varied throughout the survey area but was primarily composed of coarse and fine sand, with occasional shell hash and rubble noted. A large piece of debris (possibly a vessel or shipping container) was identified at the southeast intersection of the survey area. As the divers continued south along the southeastern shoreline, the substrate was composed of large rubble which was continuous with rip rap associated with shoreline protection within the survey area.

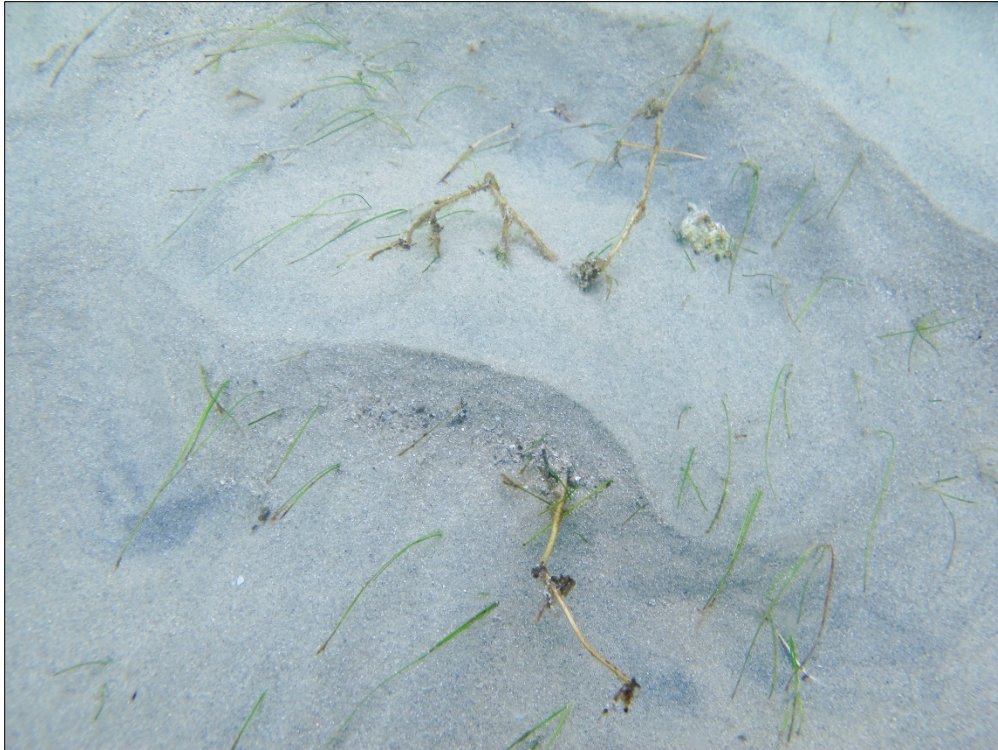
Photo 6. *Halodule wrightii* located within the Northwest transects during the pre-construction benthic survey.

Seagrass within the Northwest transects was described as very sparse and patchy with a low percent cover for both species. *H. wrightii* (**Photo 6**) and had a slightly higher percent cover (1.8%) than *H. johnsonii* (1.2%) (**Table 4**). Although seagrass within the Northwest transects had low percent coverages, the frequency of occurrence was higher (66.1%) as compared to the Southeast transects (20.2%). The eastern edge of the seagrass habitat within the Northwest transects began approximately 100-150 ft (30.5-45.7 m) from the project area in maximum water depths of approximately 4 ft (1.2 m). Coarse sandy sediment was the primary substrate type noted (**Photo 7**).

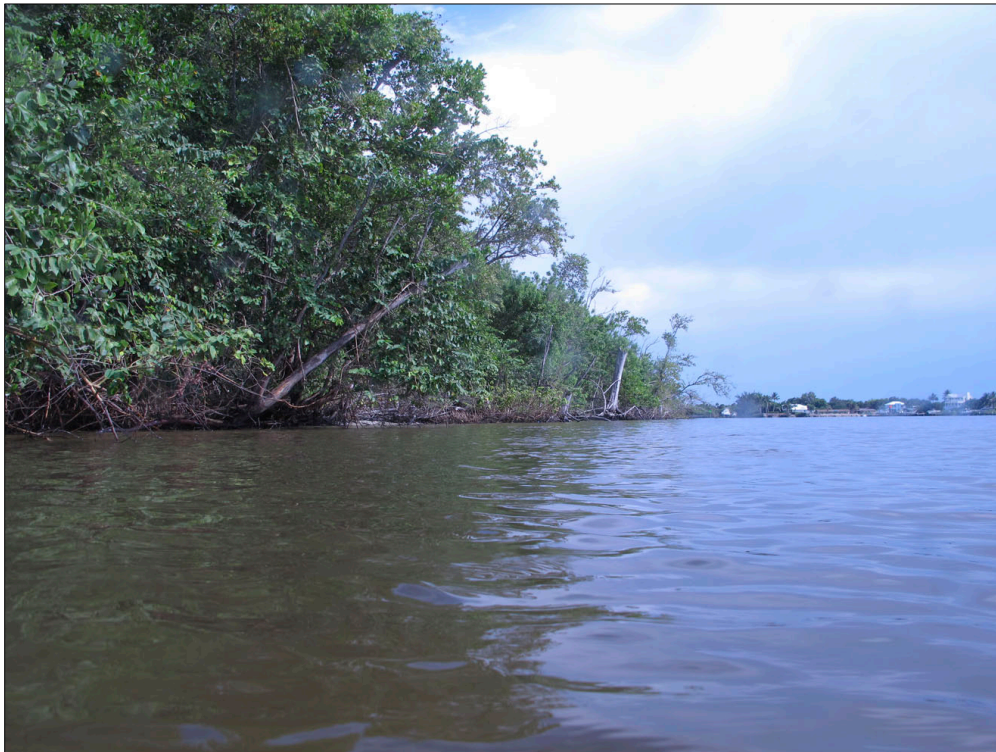
Photo 8. Mangrove habitat encountered on the east side of the Southeast transects during the pre-construction benthic survey.

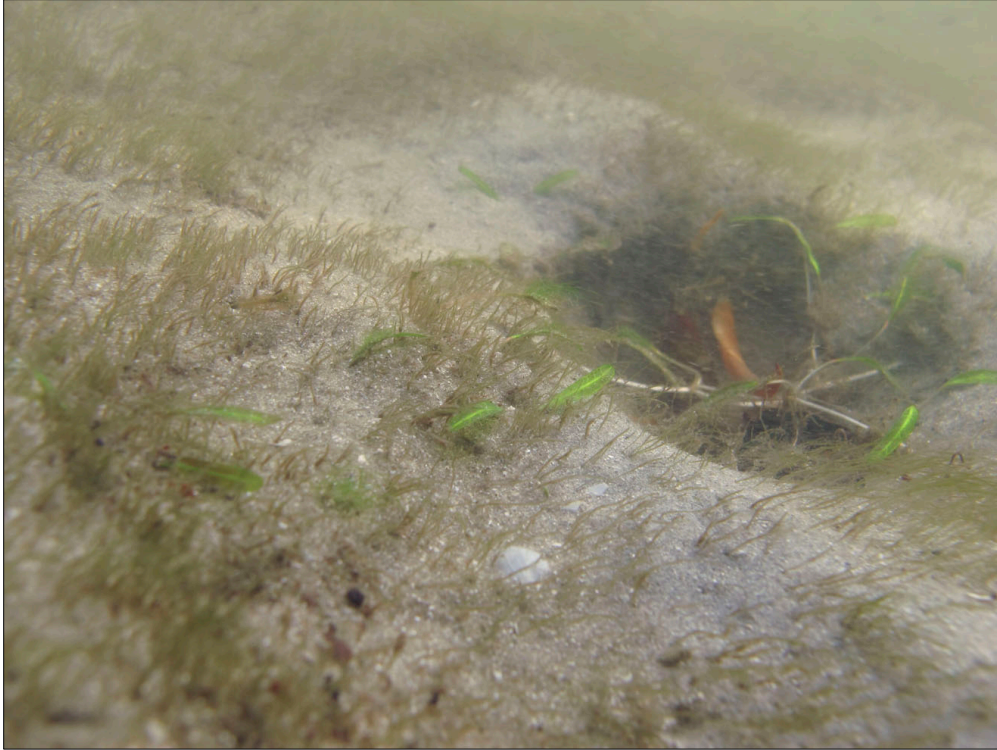
Photo 9. *Halophila johnsonii* (bright green leaves) and turf algae within the Southeast transects during the pre-construction benthic survey.

The Southeast transects were located on the southeast portion of the survey area and were composed of 10 transects (**Figure 4**). A total of 37,039 ft² (0.9 acres) of seagrass was mapped in the Southeast transects, and the majority of the seagrass was mixed *H. johnsonii* and *H. wrightii* (31,591 ft² [0.7 acres]) (**Table 3**). Divers began data collection at the eastern shoreline (**Photo 8**) and continued west towards the project area until seagrass habitat was no longer encountered. Seagrass within the Southeast transects was sparse with a low frequency of occurrence (20.2%) (**Table 4**). Where seagrasses occurred, *H. johnsonii* and *H. wrightii* had low percent coverages (<1% for each species) and discontinuous patches were recorded in shallow waters near the eastern shoreline (**Photos 9 and 10**). Fine sand was the primary sediment type observed throughout this area.

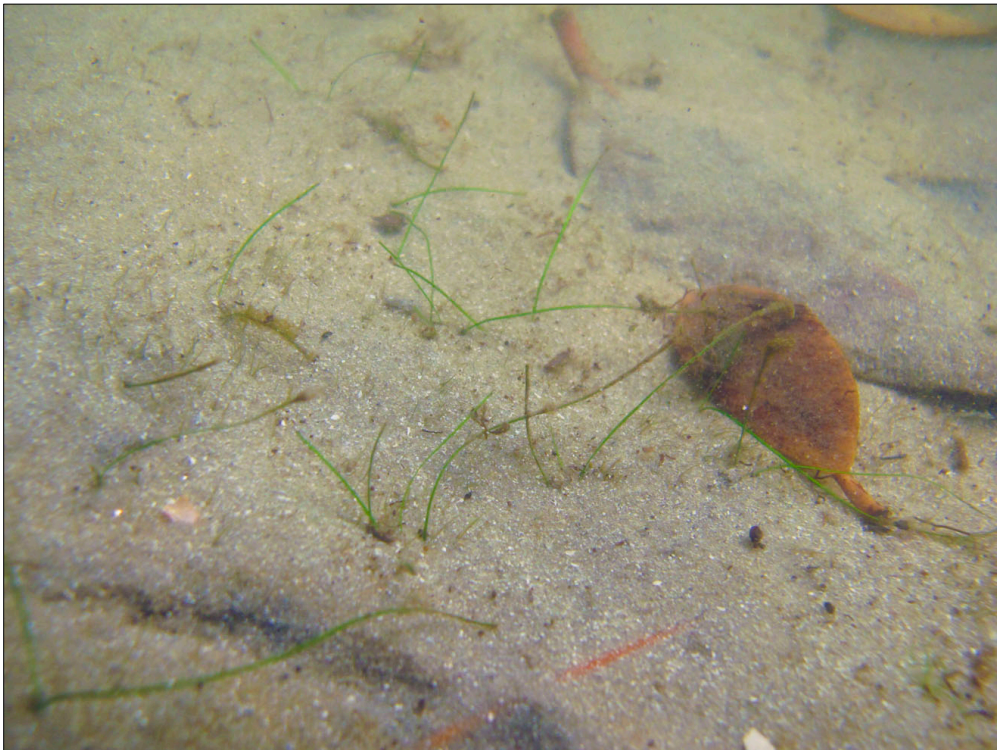
Photo 10. *Halodule wrightii* within the Southeast transects during the pre-construction benthic survey.
