TIME & PLACE IN BENNINGTON

*A Handbook for the Central Bennington
Historic District*

Town of Bennington Historic Preservation Commission

Prepared By
WILLIAM HIGGINS & COMPANY, INC.
New York, NY
William J. Higgins
Elise M. Quasebarth
In Association With
Stracher Roth Gilmore Architects
Schenectady, NY

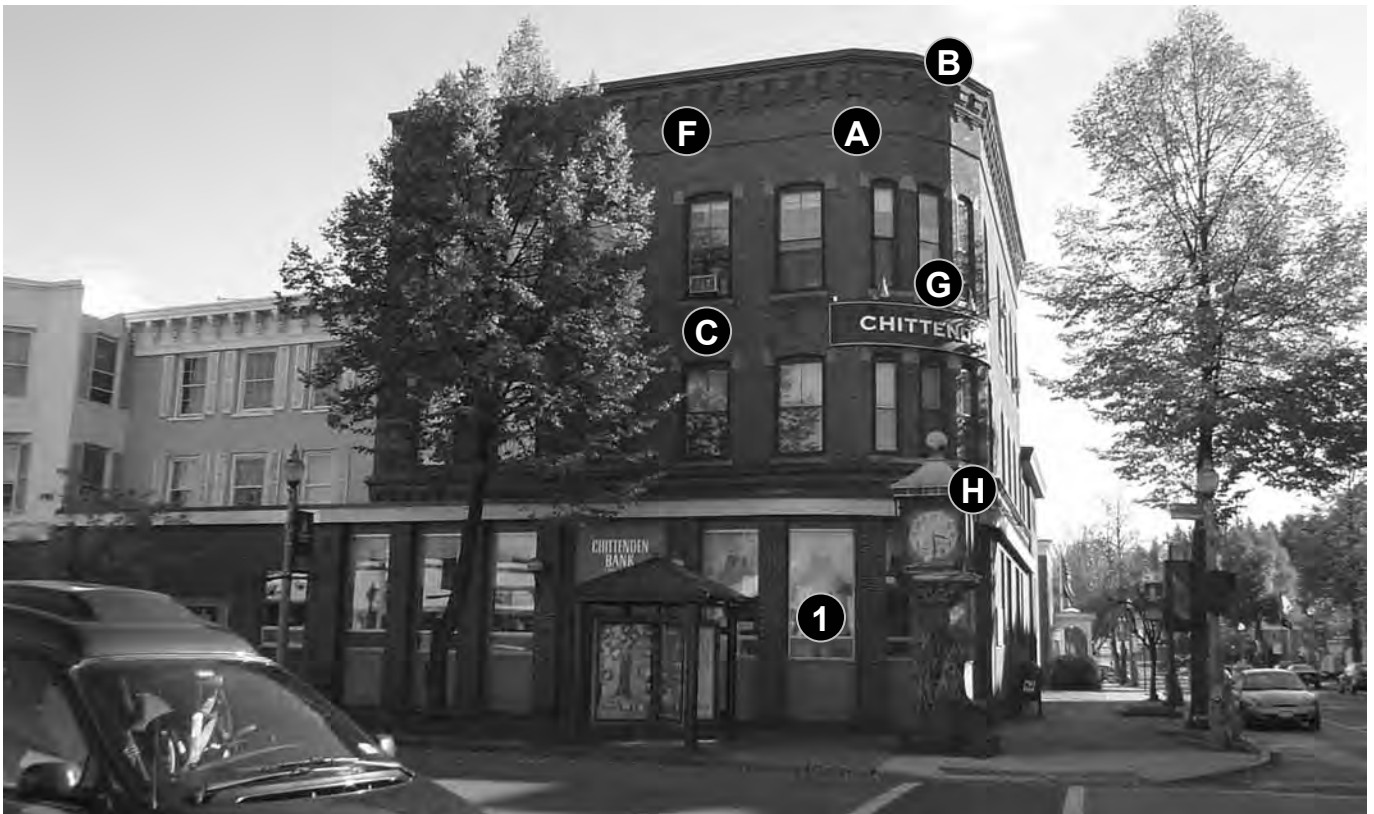
*Photo: Chittenden Bank building at the corner of Main Street and South Street, Putnam Square.
(See next page for key legend.)*

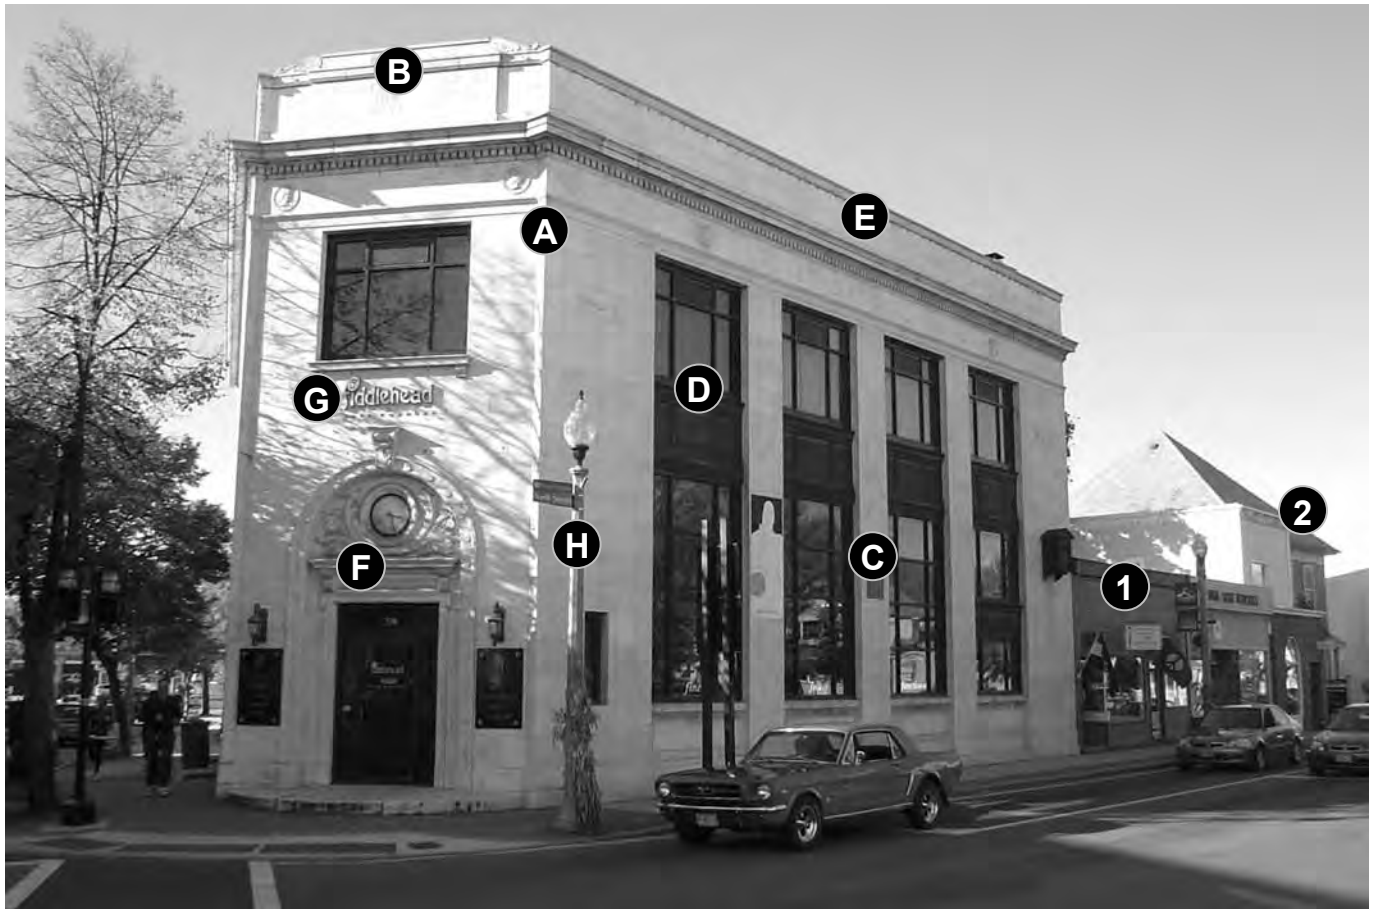
Contributes to sense of place & history

- A Scale and materials reflect the building's prominence on the corner.
- B Building shape emphasizes corner location.
- C Rhythm of window openings creates continuity.
- D Original window design is preserved.
- E Cornice emphasizes roofline and building shape.
- F High quality of exterior materials and detail.
- G Sign design integrated with building architecture.
- H Historic design for street lighting.

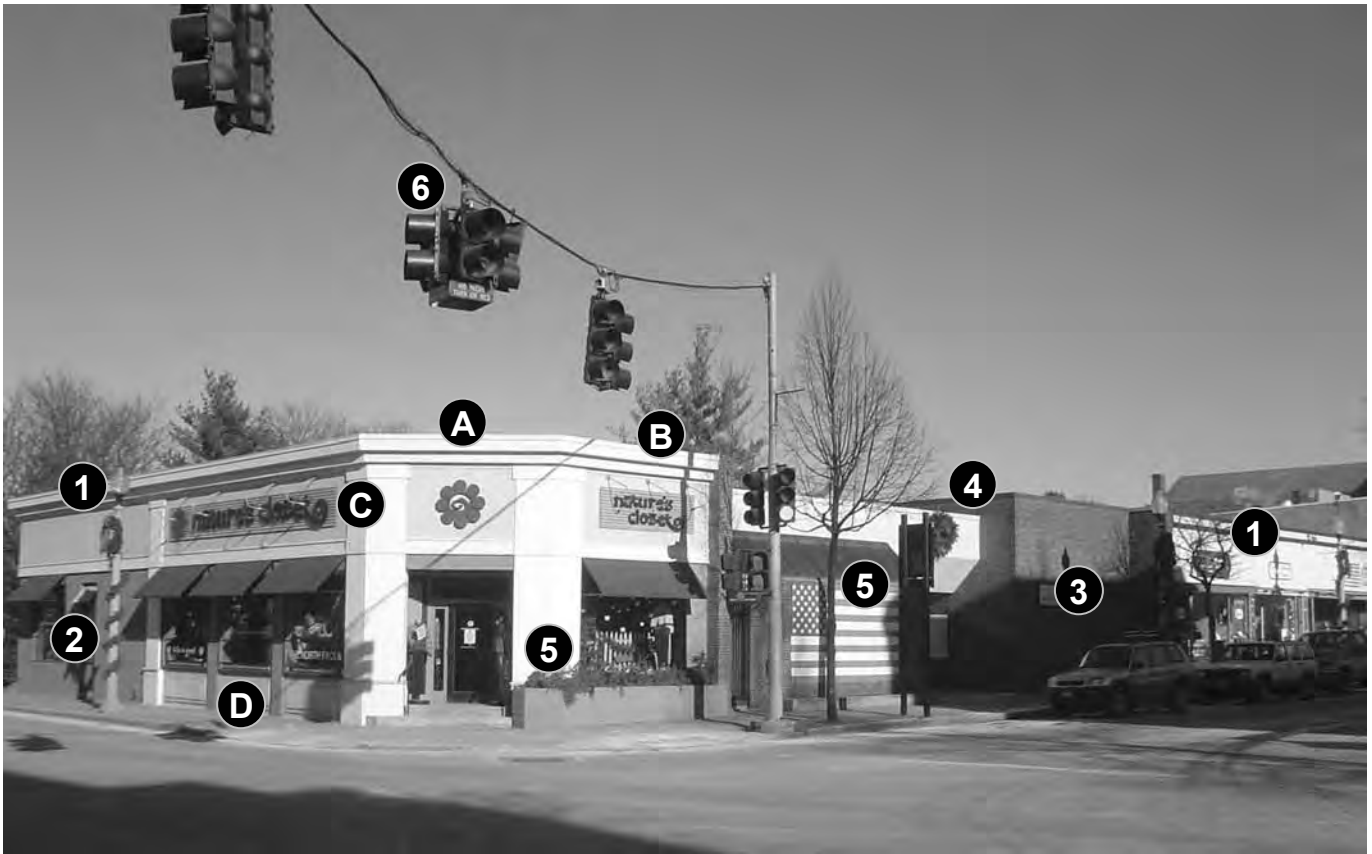
Contributes to sense of place & history

- A** Building shape emphasizes corner location.
- B** Cornice emphasizes roofline and building shape, though could be stronger.
- C** Sign design integrated with building architecture.
- D** Rhythm of storefront windows creates continuity.

Detracts from a sense of place & history

- 1** One story height weakens prominent corner location and is not in keeping with the buildings on the other corners.
- 2** Rhythm and proportions of openings contrast with buildings on the other corners.
- 3** Blank wall areas isolate building from the street.
- 4** Roofline is weakened by lack of a strong cornice.
- 5** Materials not in keeping with historic character such as modern brick, sheet metal or External Insulation Finish System.
- 6** Busy street intersection has obtrusive signage, lighting and traffic signals.

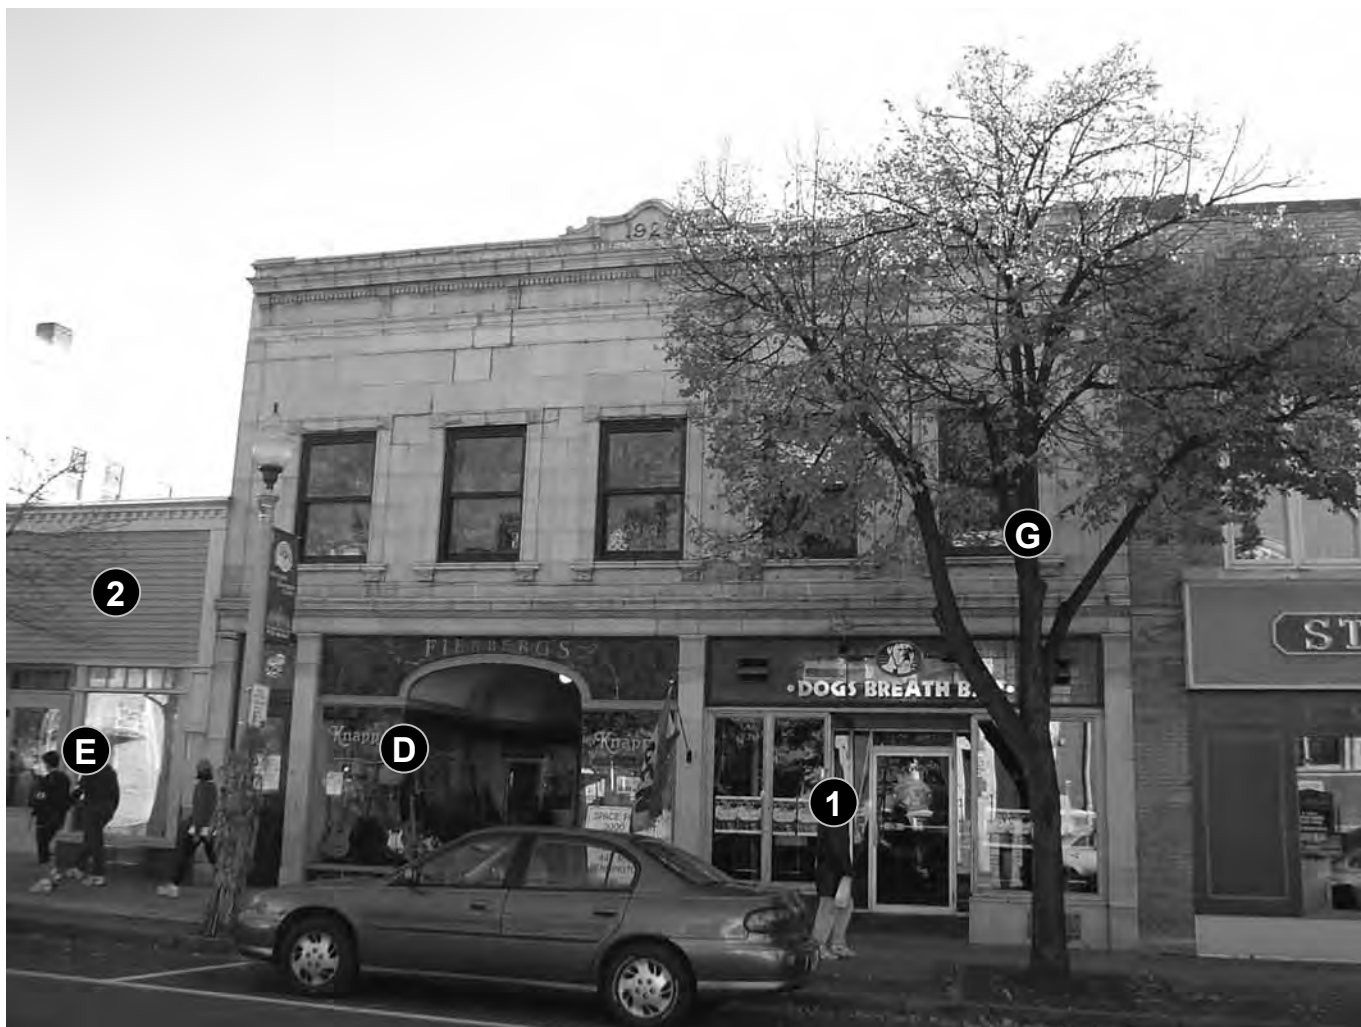
Photos: 447-449 Main Street (above); 457 Main Street (previous page, top); 532 Main Street (previous page, bottom).

Contributes to sense of place & history

- 1** Some storefront windows, awnings and canopies not in keeping with building's overall character.
- 2** Large areas of unarticulated walls or lack of cornice design detract from depth and 3-dimensional character of surrounding buildings.
- 3** Some buildings re-clad in modern materials which detract from sense of quality and character.
- 4** Some windows and ornament on upper floors out of scale with the rest of the street.

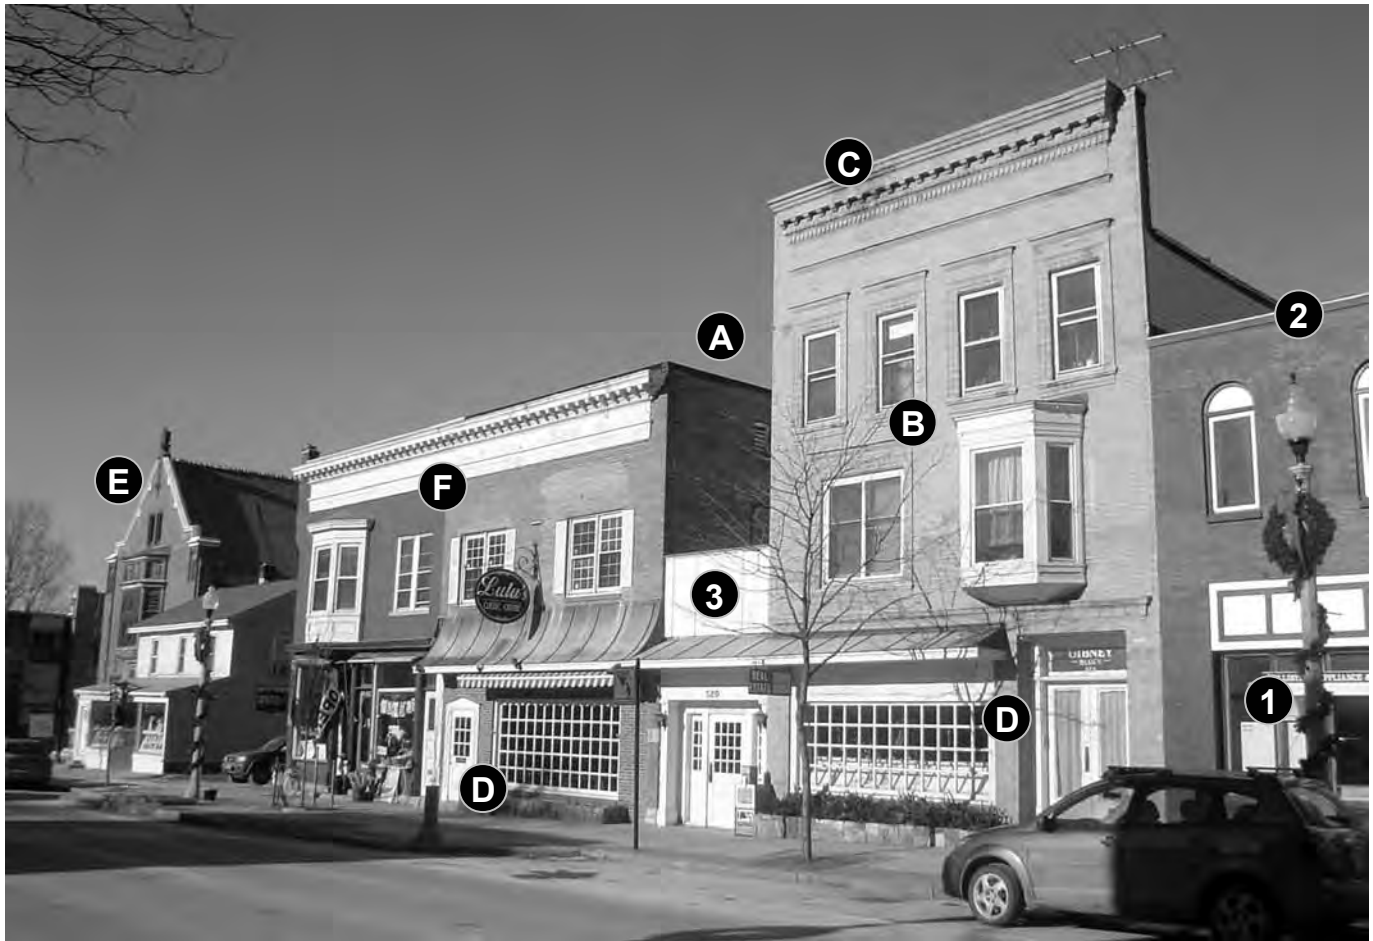
Contributes to sense of place & history

- A** Buildings maintain a consistent street wall, but with a sense of variety in height, shape and materials.
- B** Many buildings retain original materials and designs above the ground floor.
- C** Many buildings retain original cornices.
- D** Some original storefronts and entrances remain.
- E** Special buildings such as churches, schools and government buildings are an exception to the street-wall continuity, and are set back farther from the street to highlight their importance in the community.
- F** Different building designs sometimes work together to have common cornice lines or similar features.

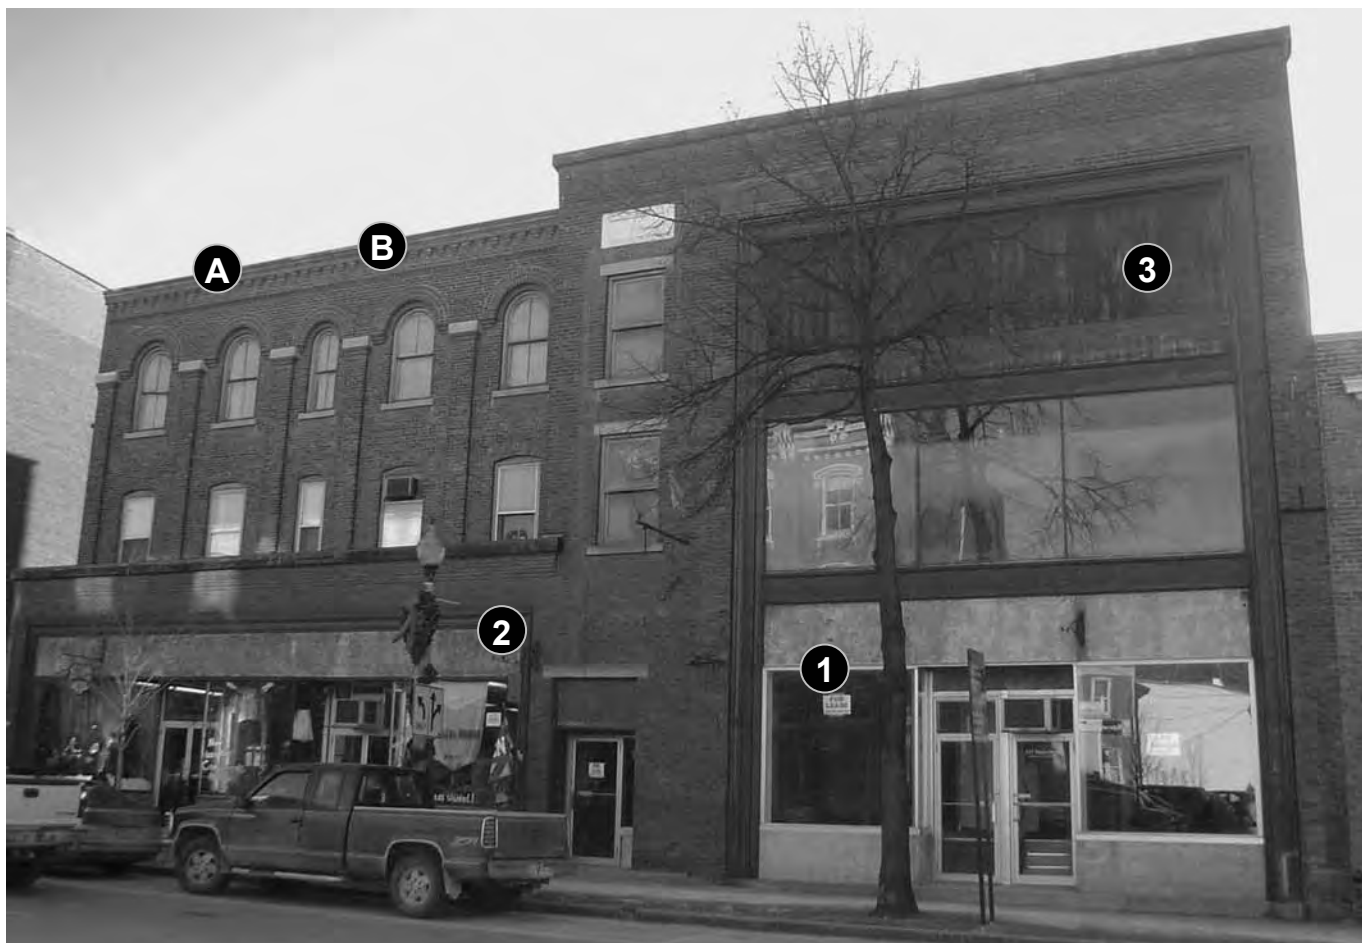
Photos: 337 Main Street (top); 332 Main Street (bottom).

Contributes to sense of place & history

- 1 Some storefront windows, awnings and canopies not in keeping with building's overall character.
- 2 Some original features removed or covered by later storefronts or cladding.
- 3 Some buildings clad in modern materials which detract from sense of quality and character.

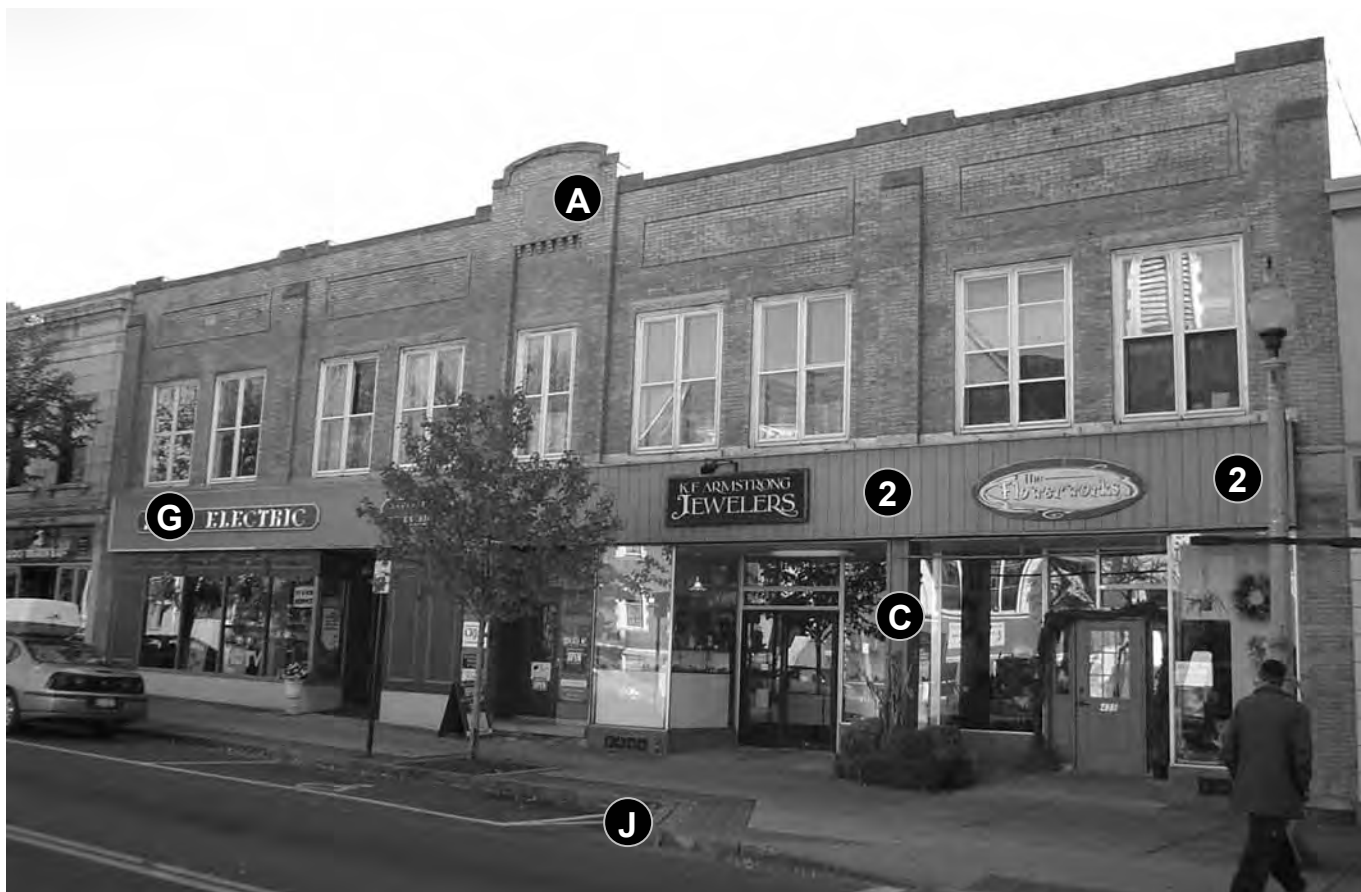
Photos: 437 Main Street (top).
Previous page: 469 Main
Street (top); 497 Main Street
(bottom left); 489 Main Street
(bottom right).

Contributes to sense of place & history

- A** Cornices with brackets and decorative details.
- B** Original windows and related details on upper floors.
- C** Basic rhythm of historic storefront openings maintained.
- D** Original storefront transoms and columns.
- E** Original entrance with paneled doors and semi-circular transom.
- F** Some 20th century storefront features (1930s Carrara glass panels for example) add interest.
- G** Store signs placed in transom panels or other historic locations.
- H** Original brickwork carefully cleaned and repaired.
- I** Modern storefront infill maintains scale, rhythm and materials of original.
- J** Street trees, original steps and variety of sidewalk paving add interest and human scale.

- 1** Recent aluminum doors keep basic shape of openings, but bare aluminum and modern hardware contrast with historic color and texture.
- 2** Some original storefront features removed or covered by signs or panels.
- 3** Replacement windows do not match scale or character of the rest of the building.

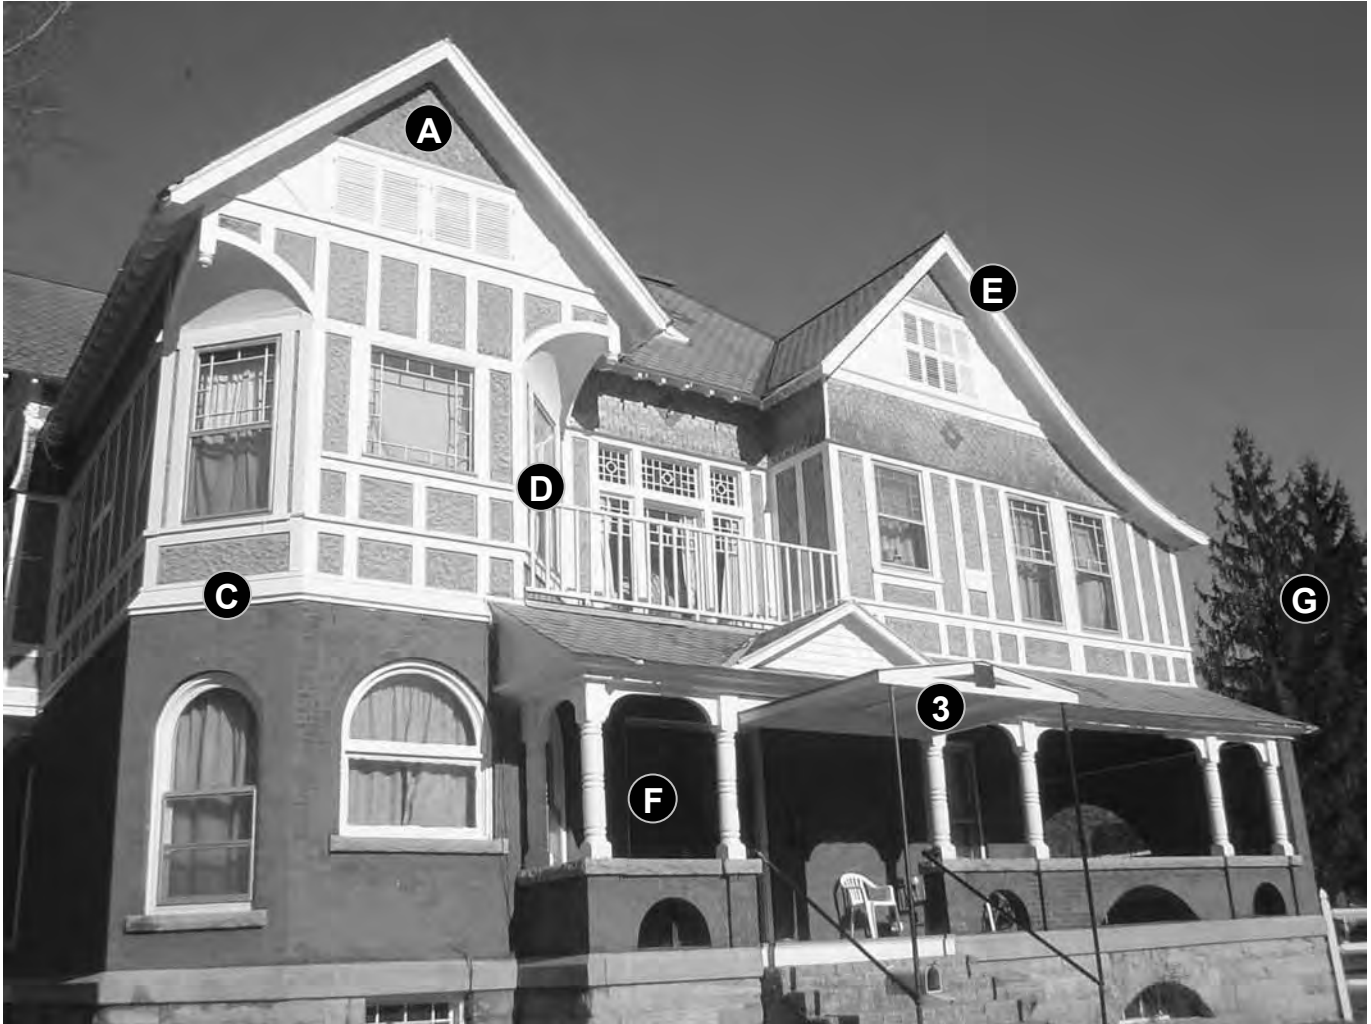
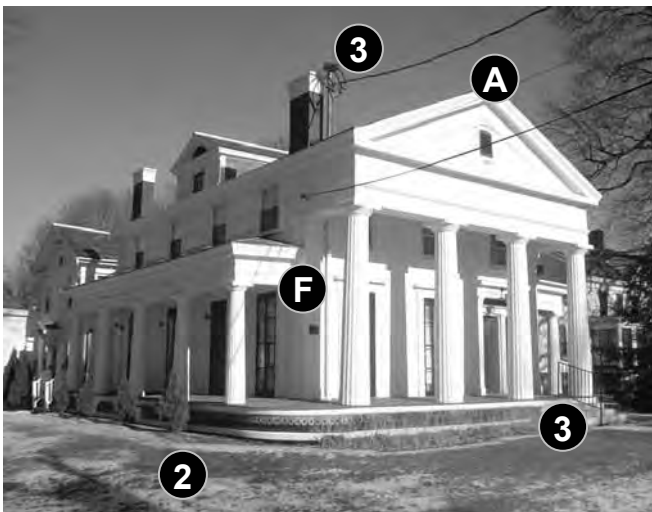
Photos: 212 Pleasant Street (top); 300 Pleasant Street (bottom).

Contributes to sense of place & history

- A Slate roof and brick chimney.
- B Strong cornice line.
- C Later addition uses compatible foundation materials and details to original building.
- D Prominent porch.
- E Bay window – an historic later addition.
- F Deep front yard with mature plantings.
- G Original marble walks still in use.

Detracts from a sense of place & history

- 1 Aluminum siding.
- 2 Unpainted aluminum storm windows and storm door.
- 3 Later addition does not have roof design compatible with original building.
- 4 Original fence missing.
- 5 Portions of original marble walks in need of repair.

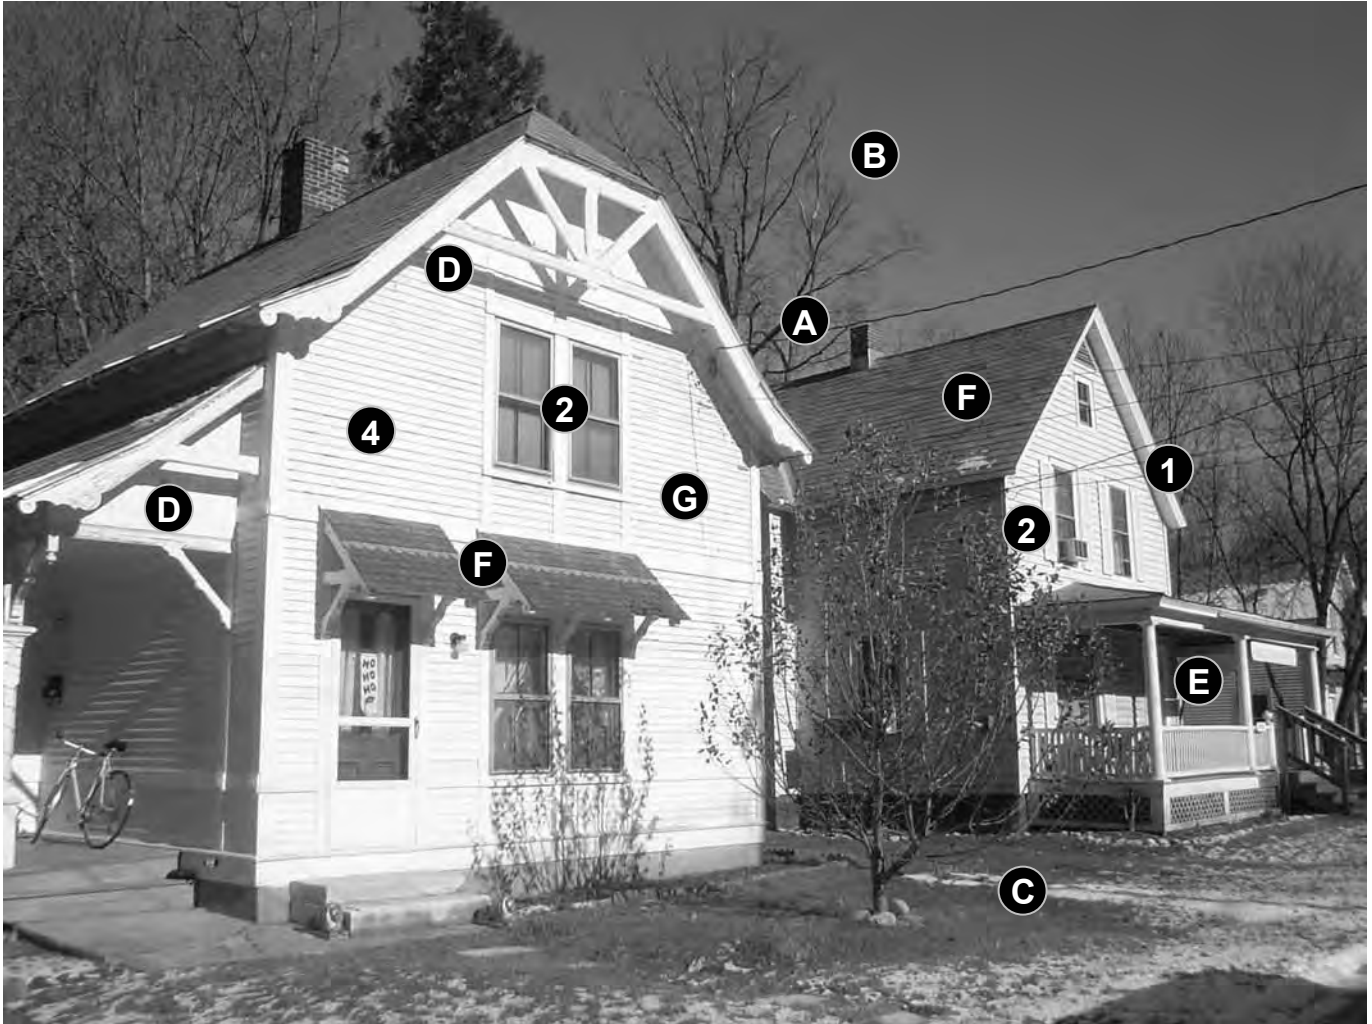
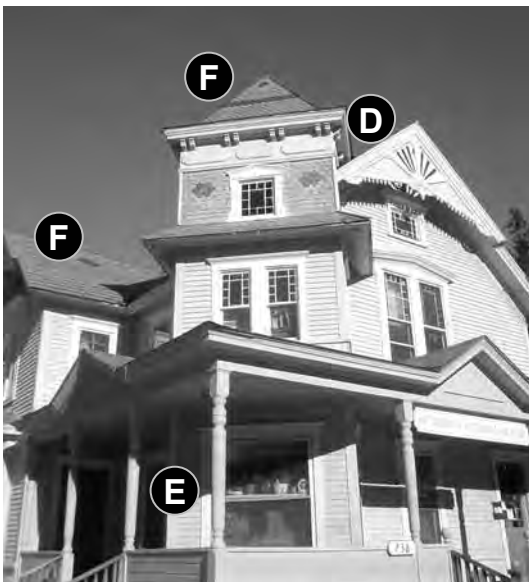
Photos: 242 Union Street (top); 238 Union Street (below).

Contributes to sense of place & history

- 1** Synthetic siding on some walls and cornices.
- 2** Artificial shutters and unpainted aluminum storm windows.
- 3** Some porches enclosed in ways which are not in keeping with historic designs.
- 4** Some exterior areas in need of repairs or painting.

- A** Original roof form and massing preserved.
- B** Original slate roof, cornice and decorative window trim retained.
- C** General maintenance very good.
- D** Historic porch with decorative details retained.
- E** Original double-hung windows retained.
- F** Original doors retained.
- G** Original siding and trim design maintained in good condition.
- H** Painted aluminum storm windows upstairs, properly installed and recessed within wood window trim.

- 1** Aluminum storm door conceals most of original door.
- 2** Bare aluminum storm windows used downstairs.
- 3** New stair railing materials and design inconsistent with original design.

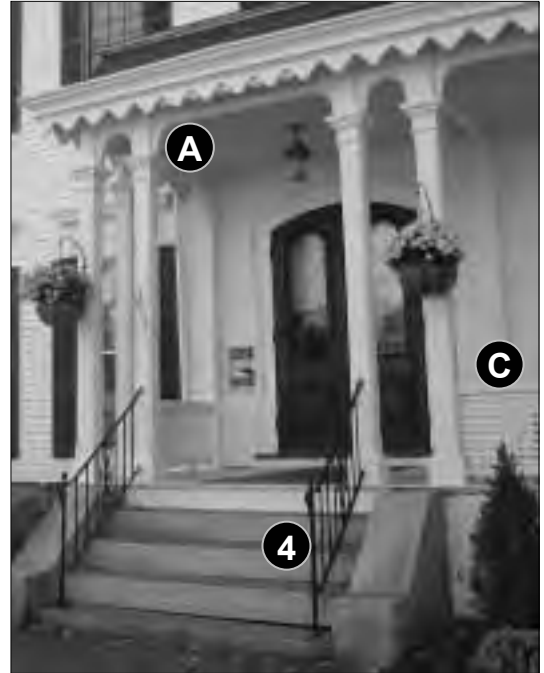
Fig. 5-1: 213 Main St. The ornamentation has been retained along the eaves, columns and porch railings, but the stair railings have been replaced with wrought iron.

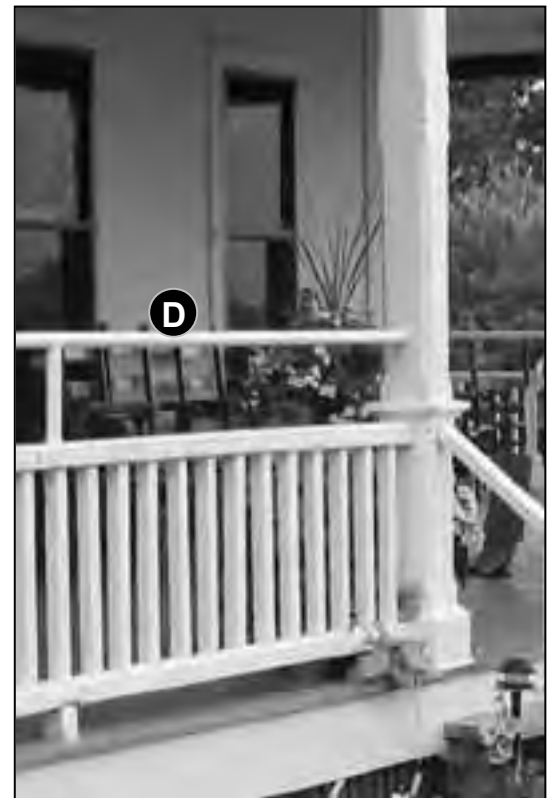
Fig. 5-2: Grand Isle Lake House, Grand Isle, VT. Original porch railings were very low, but new pipe has been added along the top to meet code requirements while still preserving the original scale of the railing design. Photo by Meg Cambell.

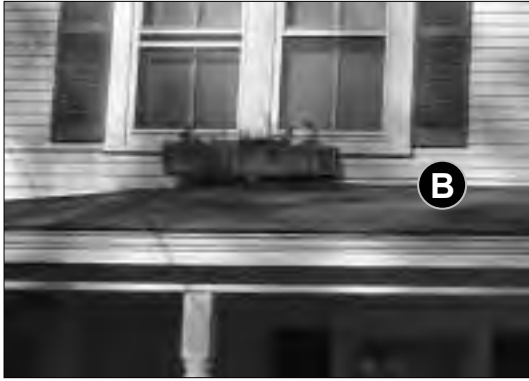
Fig. 5-3: 206 Main St. Porch roofs should be flashed properly and kept at least 10" below any windows to help prevent snow and water build-up at the window sill.

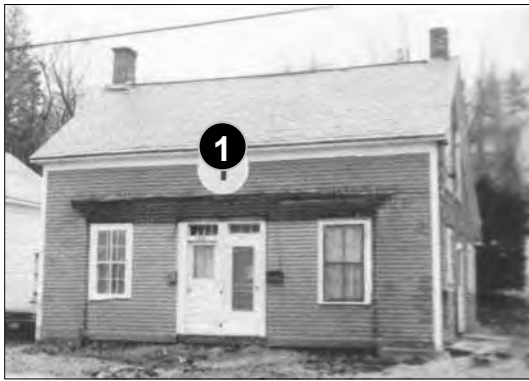
Fig. 5-5: The removal of this front porch completely changes the scale and character of the original home. [Date unknown.]

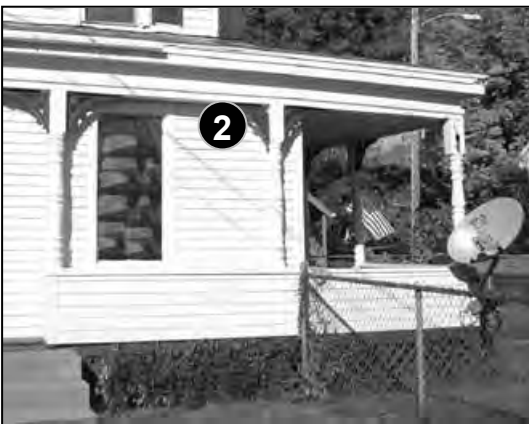
Fig. 5-7: 138 River St. The front porch of this structure has been partially filled-in with an addition.

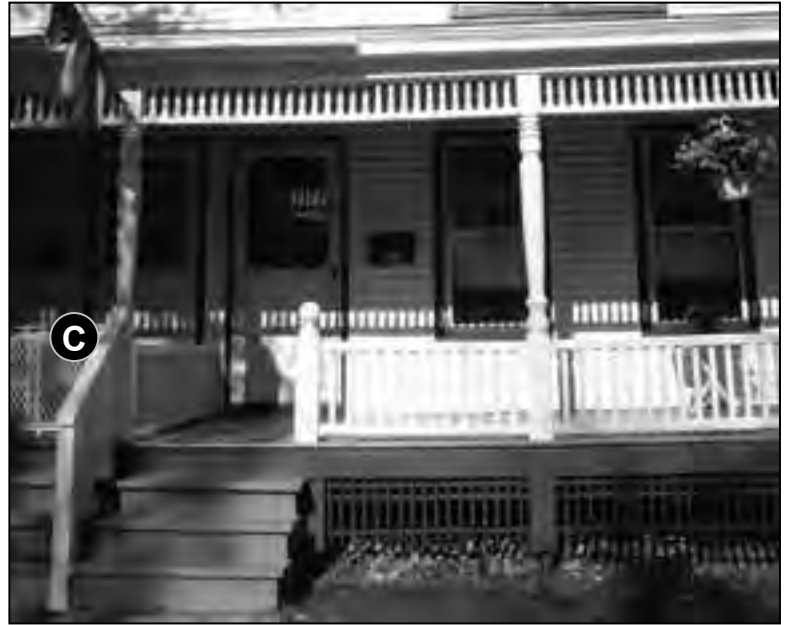
Fig. 5-4: 202 Main St. The front steps and railings up to this porch are similar to the style and character of the porch overall, and are painted to match. The underside of the porch is concealed with grillwork which allows the structure underneath to breathe.

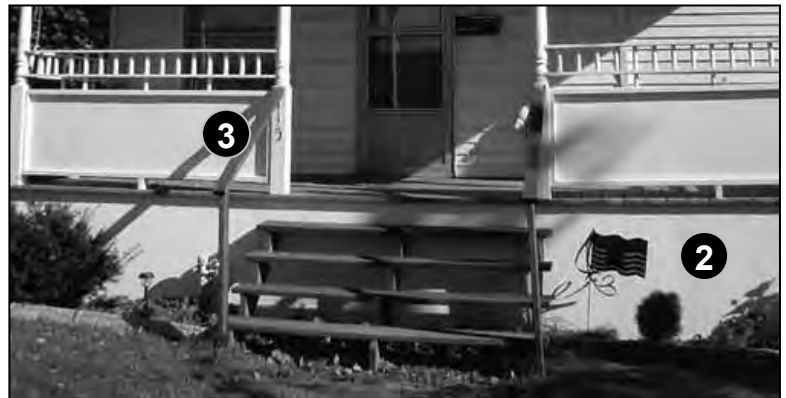
Fig. 5-6: 115 McKinley St. The front steps and railings up to this porch do not match the original porch design, and are instead constructed of standard framing lumber. The porch railings have themselves been replaced with blank wood panels which changes the scale of the facade. The underside of this porch has been completely enclosed as well, and likely does not provide enough ventilation to prevent moisture buildup and rot.

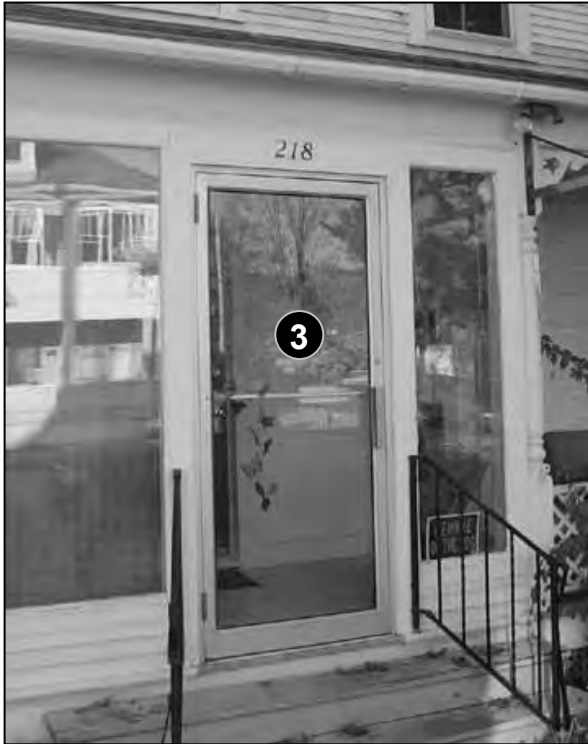
Fig. 5-12: 218 Park St. The commercial storefront door shown here is not appropriate on a residential structure.

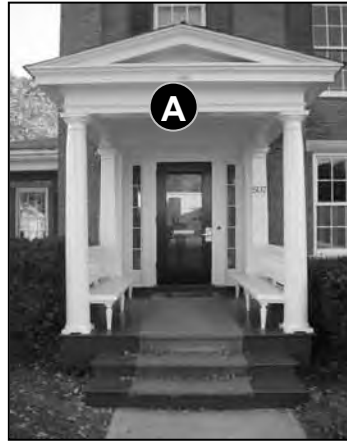
Fig. 5-8: 507 Main St. This existing entry has been maintained in its original design.

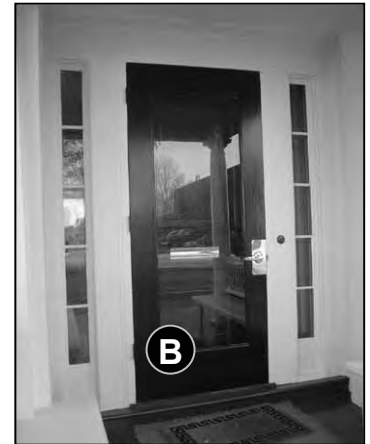
Fig. 5-9: 507 Main St. The storm door which has been added here is designed to match and reveal the original front door behind it.

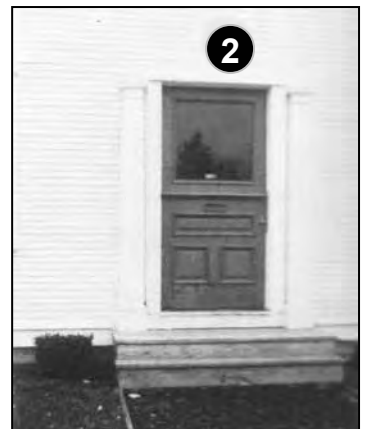
Fig. 5-11: This entryway has been altered by the removal of the original woodwork found above the door. [Date unknown.]

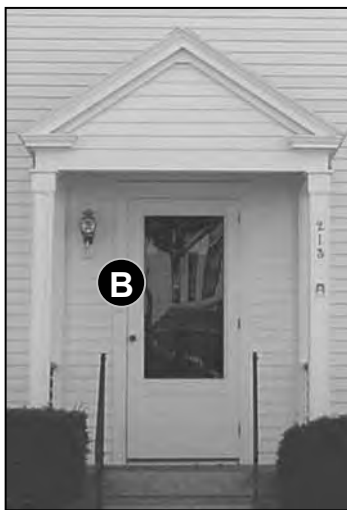
Fig. 5-13: 213 Washington St. The painted wood storm door on this entry blends in with the entry design.

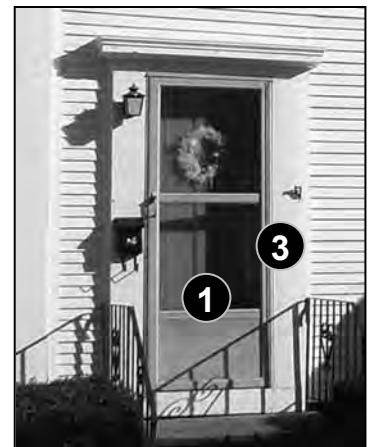
Fig. 5-14: 102 Jefferson St. The bare aluminum storm door here would blend in with the architecture of the doorway more if it were recessed slightly, and painted.

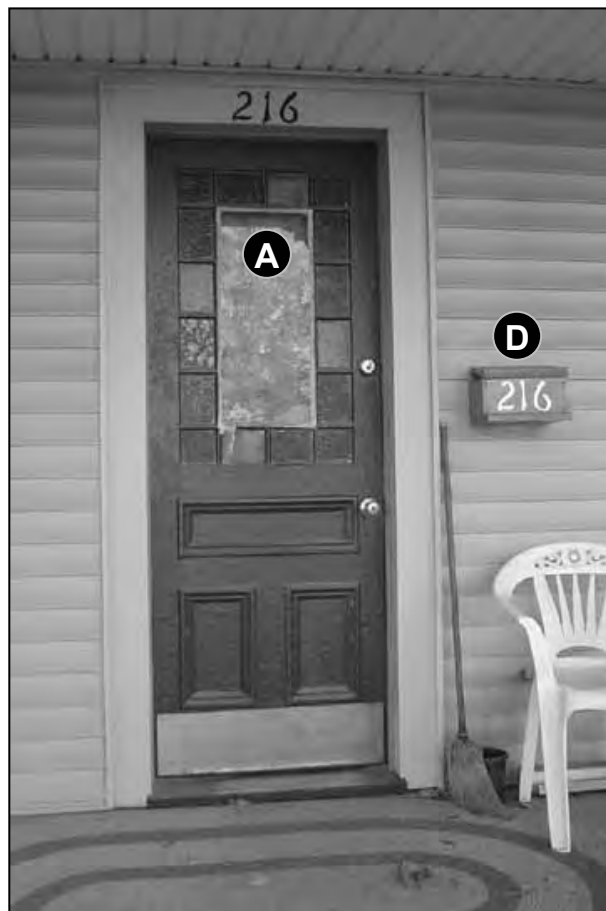
Fig. 5-15: 216 Park Street. The existing colored glass doorway on this house has been preserved and left visible, however the metal kick-plate on the bottom could be painted to match the door to make it less obvious.

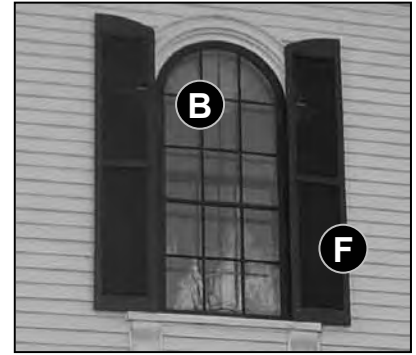
Fig. 5-16: 213 Main St. Custom wood storm windows and working shutters match the design and blend nicely with the historic architecture.

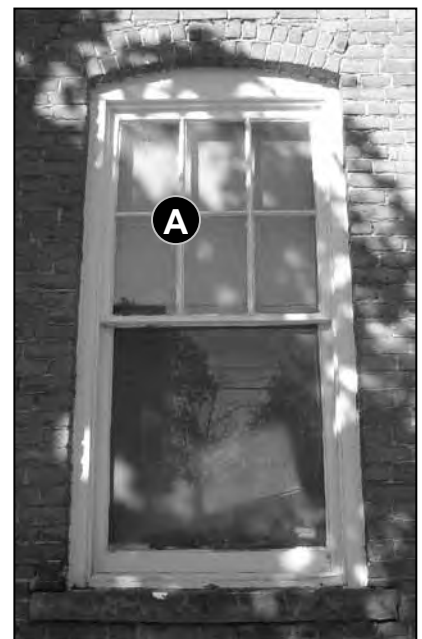
Fig. 5-17: 120 Benmont Ave. It is best to try to repair existing historic windows before replacing them altogether.

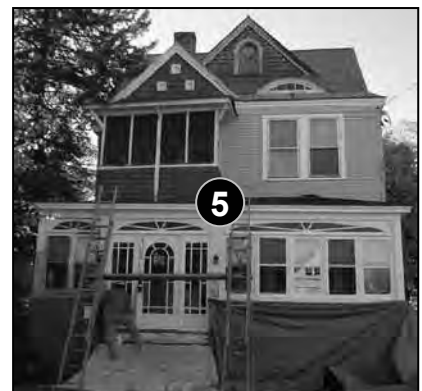
Fig. 5-20: 217 Washington St. Many different window types and sizes can make a façade appear confusing.

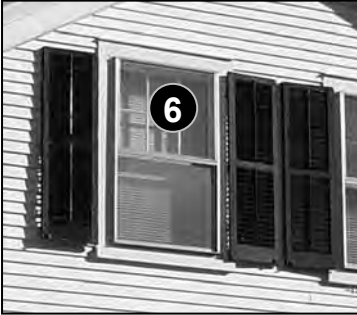
Fig. 5-21: 102 Jefferson St. Bare metal storm windows are mounted onto and covering the window trim, which is not ideal. Also, shutters are not consistently mounted to the windows.

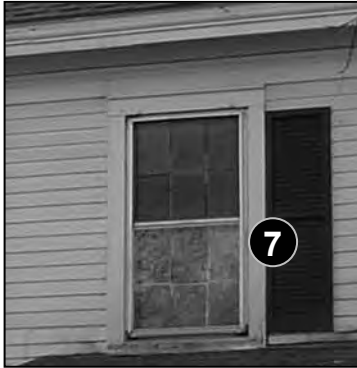
Fig. 5-22: 105 Holden St. Window shutters should be used realistically and consistently on a façade. The imitation window shutters like the one shown here are often seen used on only one side of a window, or on alternate sides of a pair of windows. Such installations are not historically accurate.

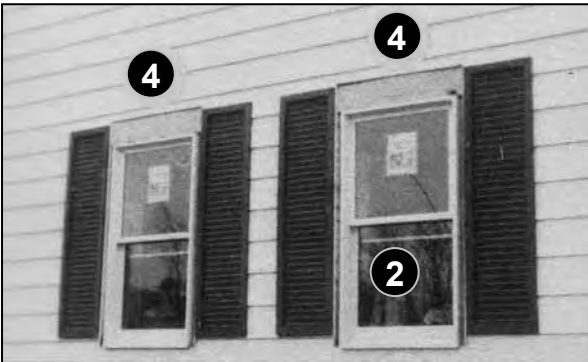
Fig. 5-23: The original historic windows have been removed in this picture and replaced with smaller vinyl clad windows. [Date unknown.]

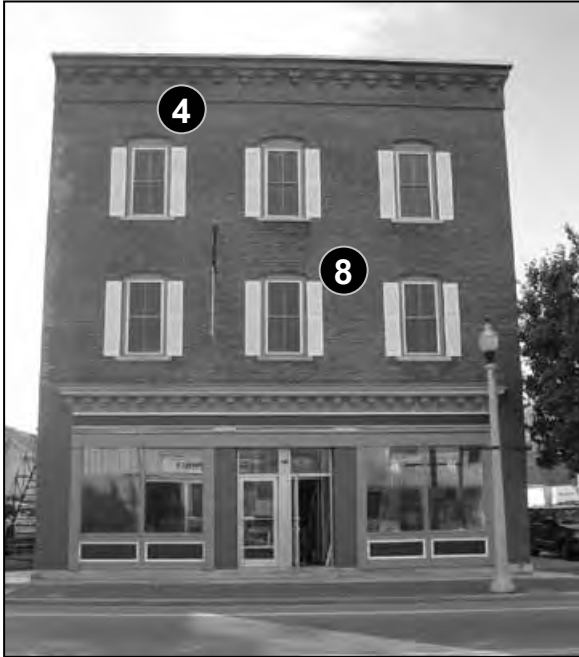
Fig. 5-25: 198 North St. The original windows have been removed and replaced with smaller ones without the arched top. The original windows of this building never had shutters, yet new vinyl ones have been added here. This does not match the original design, and doesn't even match the windows on the side of the building, as shown in Fig. 5-26.

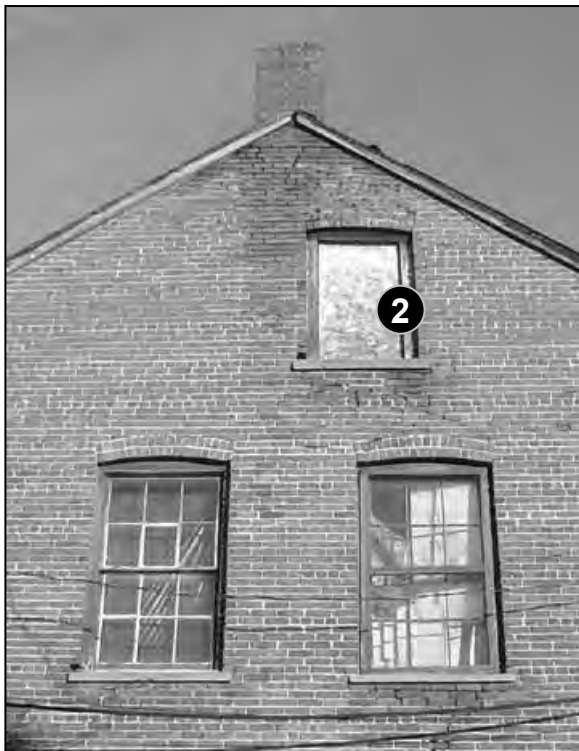
Fig. 5-28: 512 Main St. Windows that are no longer used should not be boarded up or filled in on the outside. Instead, the wall can be in-filled on the inside, leaving the existing window to remain on the outside.

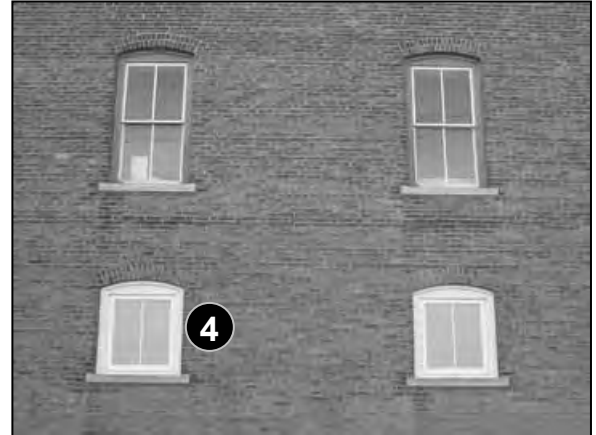
Fig. 5-26: 198 North St. The original arched top windows have been replaced with smaller, flat-top windows, and don't match from the second to the third floor.

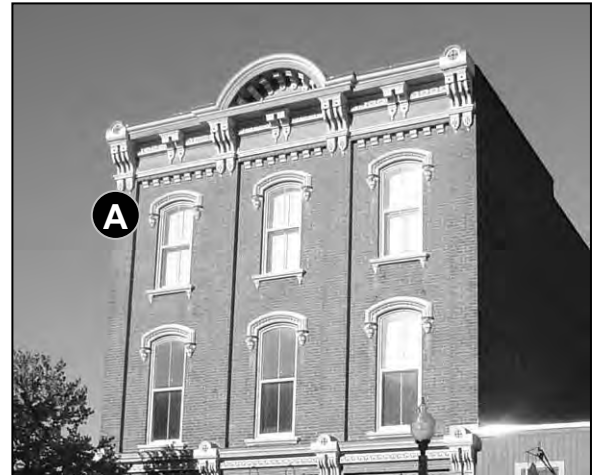
Fig. 5-27: 332 Main St. The original arched top windows have been maintained.

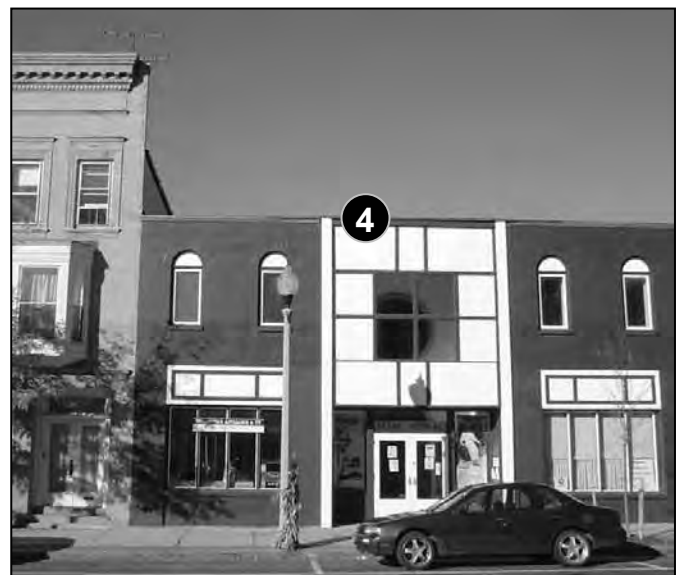
Fig. 5-29: 532 Main St. The original building façade here has been replaced with a large, post-modern window in the center which is inconsistent with the building and its surroundings.

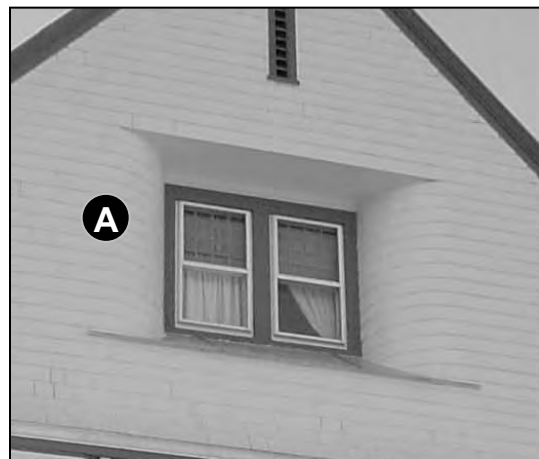
Fig. 5-30: 124 Elm St. Original curved shingles are used here to highlight the sculptural nature of the façade enclosure.

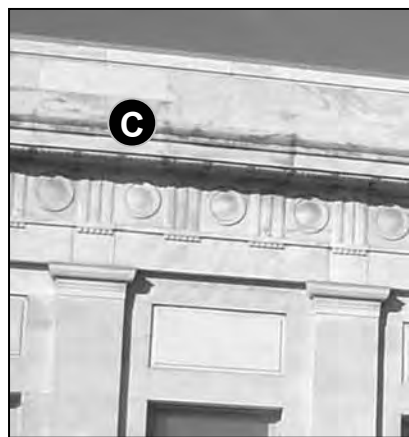
Fig. 5-32: 118 South St. Light colored stone surfaces such as this often need to be cleaned, but the cleaning process should never permanently change the appearance of the materials.

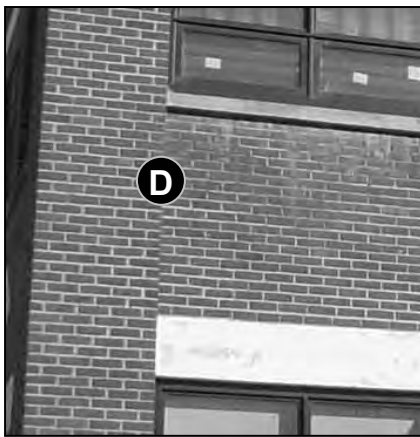
Fig. 5-33: When cleaning masonry surfaces, avoid using harsh or abrasive cleaning agents that can permanently discolor the surface.

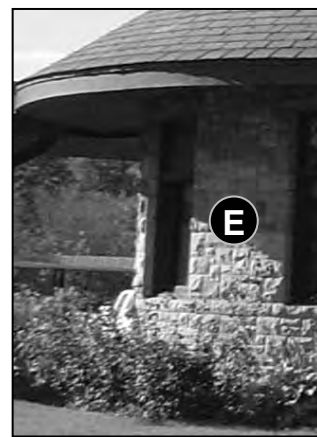
Fig. 5-34: 150 Depot St. This rough ashlar masonry wall surface adds texture and depth to the façade.
