TIME & PLACE IN BENNINGTON

*A Handbook for the Central Bennington
Historic District*

Town of Bennington Historic Preservation Commission

Prepared By
WILLIAM HIGGINS & COMPANY, INC.
New York, NY
William J. Higgins
Elise M. Quasebarth
In Association With
Stracher Roth Gilmore Architects
Schenectady, NY

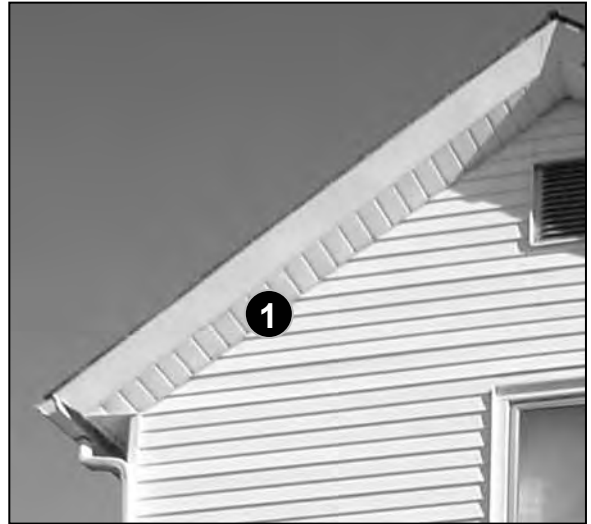
Fig. 5-33: 115 McKinley St. Vinyl siding hides the original wood trim that gives a façade definition and scale.

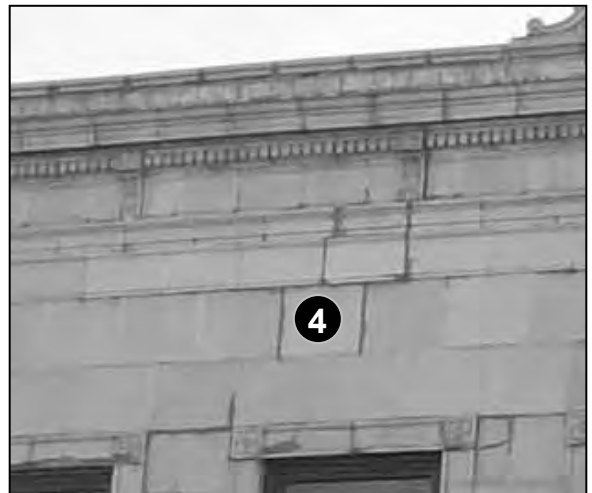
Fig. 5-35: 449 Main St. Joint repair which uses the wrong mix or mortar can result in highly visible joints. Be sure that test-mixes are tried before real work commences.

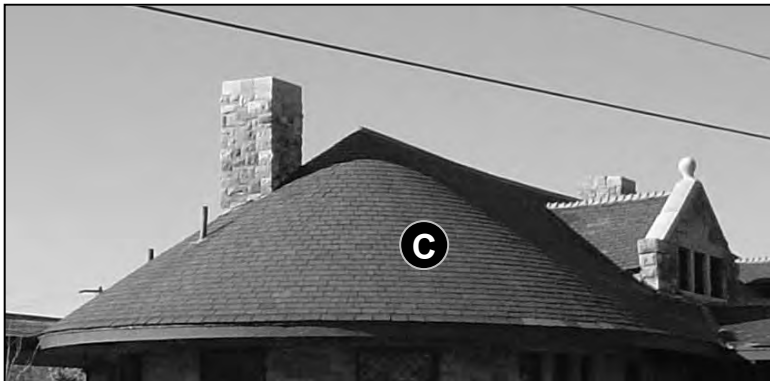
Fig. 5-37: 150 Depot St. The sweeping curve of this roof defines much of the character of the building, and should not be changed or added to.

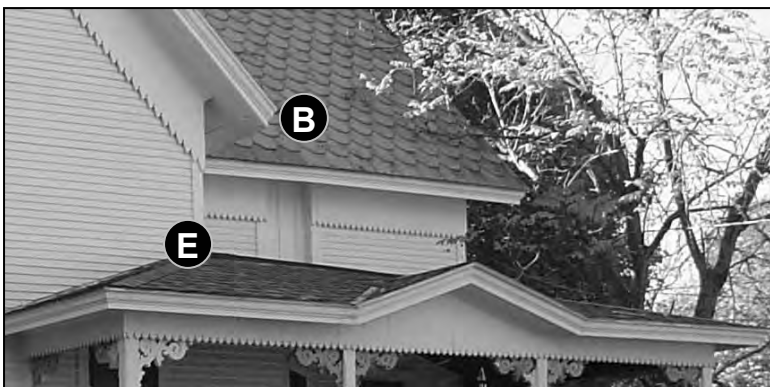
Fig. 5-39: 125 Jefferson St. New slate has been used here to replace portions of the roof that have been damaged.

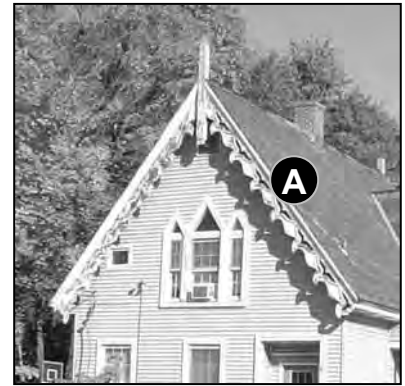
Fig. 5-36: 207 Depot St. The intricate trim details of this eave define much of the character of the entire home, and should be preserved whenever possible.

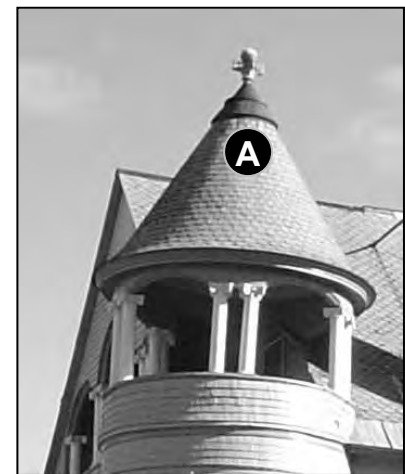
Fig. 5-38: Corner of Elm & Washington. The tower roof on this house, although difficult to maintain, largely defines the architectural character and style of the residence.

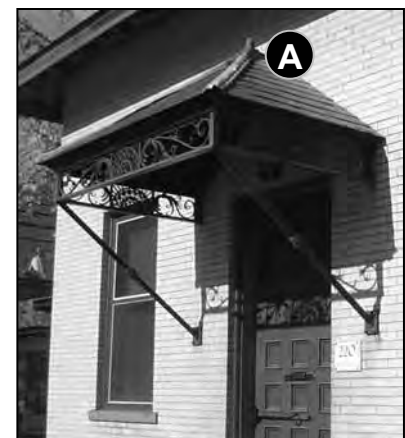
Fig. 5-40: 220 Main St. Intricate metal roof design.

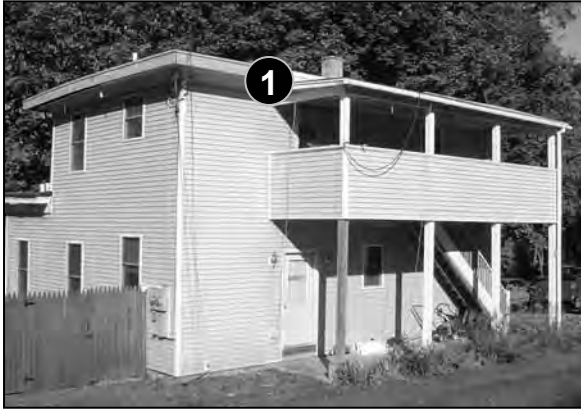
Fig. 5-41: Corner of Weeks & Jefferson. This flat roof design is not in keeping with the historical roof forms of the residential neighborhood.

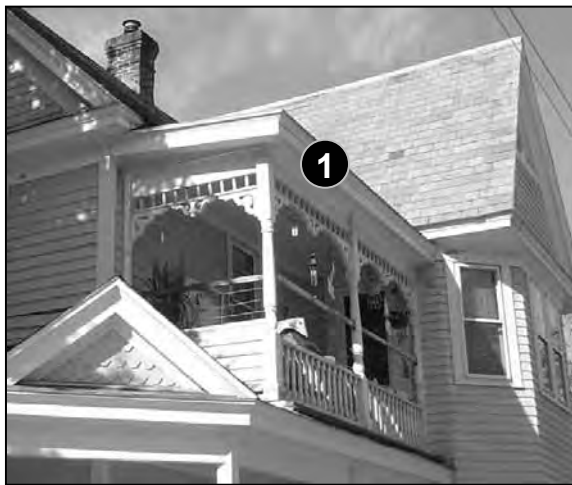
Fig. 5-42: 128 Main St. This small porch has been added to the front of the house which can alter the shape and scale of the structure.

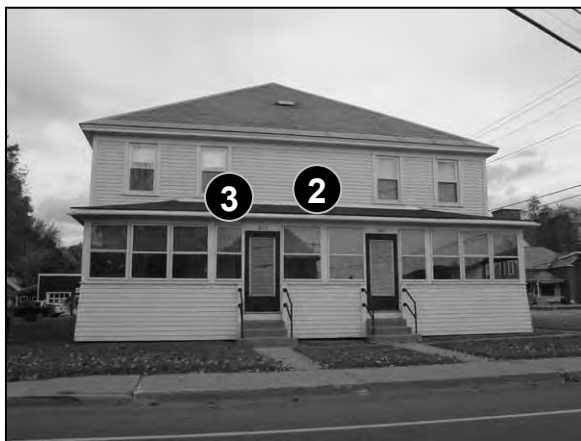
Fig. 5-46: 501 North St. The porch roof here has been replaced with newer materials which don't match the look and feel of the original slate roof.

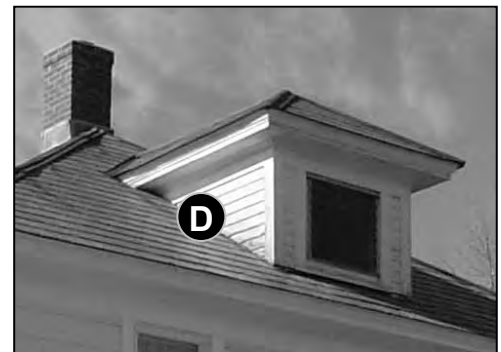
Fig. 5-45: 206 Main St. The appearance of this original slate roof has been tarnished by the rust from nails and splattered paint.

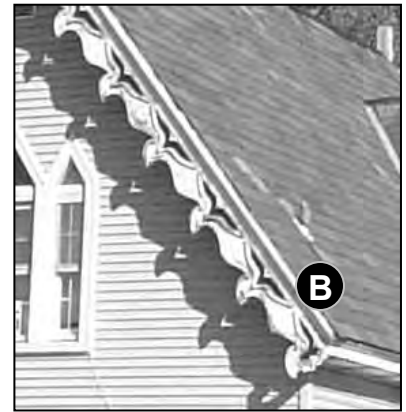
Fig. 5-49: 207 Depot St. The intricate eave on this house defines much of the architectural character, and should be protected.

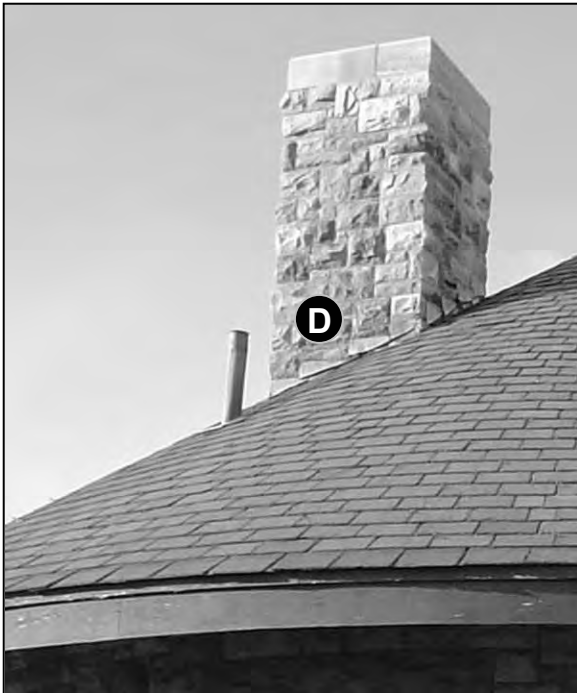
Fig. 5-50: 150 Depot St. The original soft-metal flashing along the bottom of this chimney remains in good condition, and has weathered to match the color of the stone.

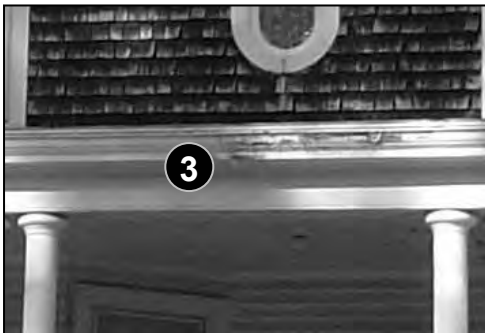
Fig. 5-53: 133 Elm St. The wood trim here is showing signs of moisture damage, and will get worse if left un-repaired.

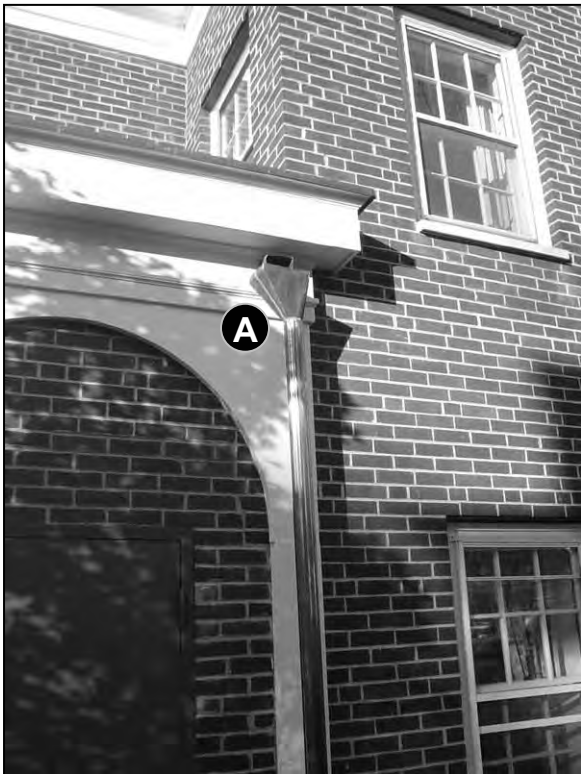
Fig. 5-54: 116 South St. A new copper downspout has been installed here to match the original materials.

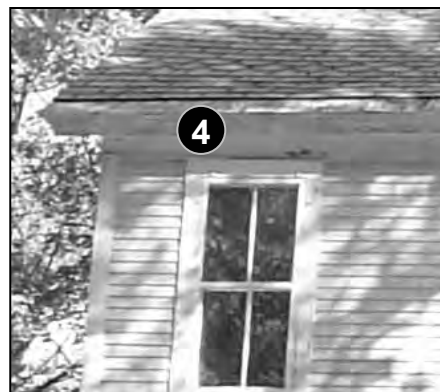
Fig. 5-55: 220 Silver St. The original copper eave flashing still remains along the edge of this roof.

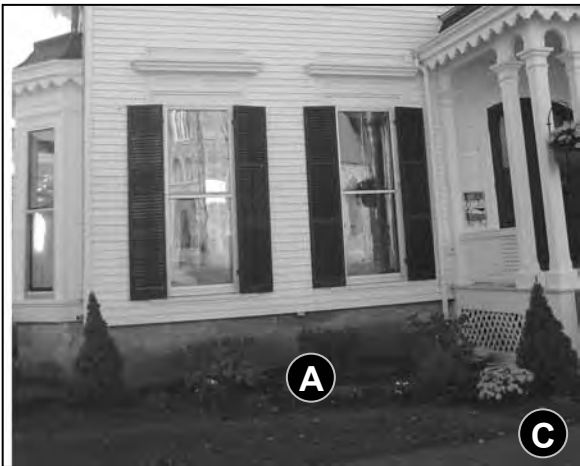
Fig. 5-57: 213 Main St. Small shrubs along the foundation of the building still allow sunlight, ventilation and access for maintenance.

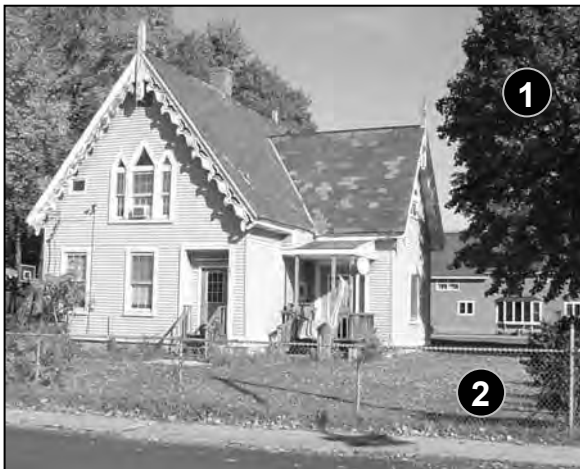
Fig. 5-59: 207 Depot St. The chain link fence here does not match the character of the house. A wooden picket fence would be more appropriate.

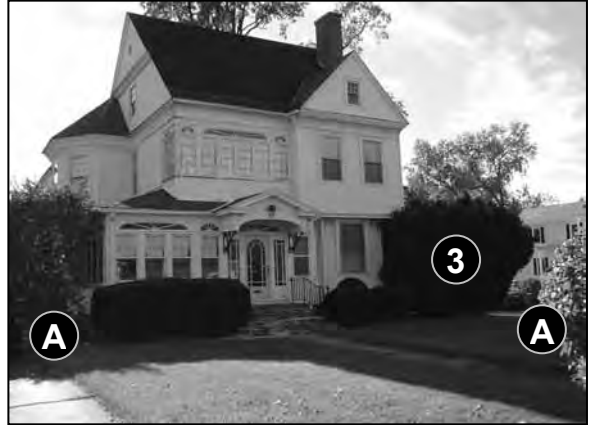
Fig. 5-56: 217 Main St. The large bush to the right of this house has overgrown and may cause moisture damage to the exterior.

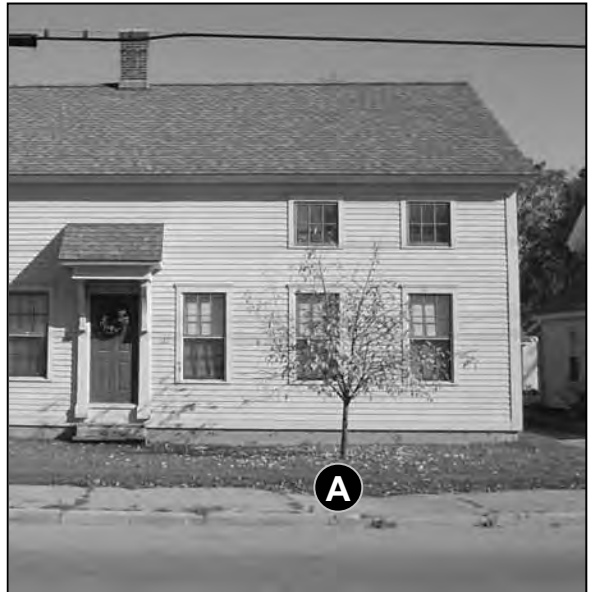
Fig. 5-58: 137 Benmont Ave. When larger trees cannot be saved, new ones should be planted to replace them.

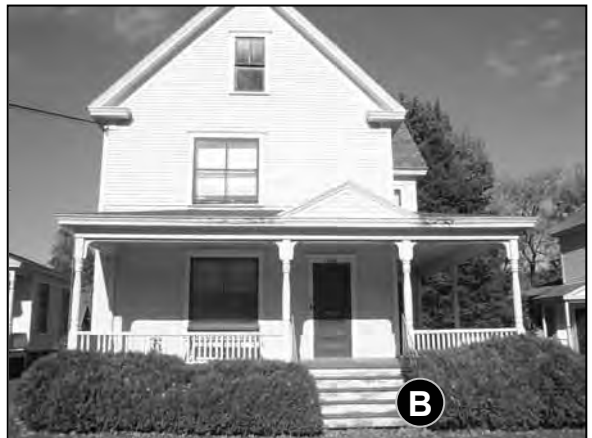
Fig. 5-60: 204 Main St. These hedges have been trimmed to keep from overwhelming the porch, but could be trimmed more in the back to prevent water damage to the porch.

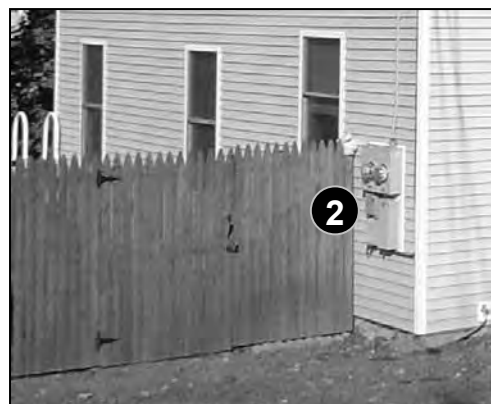
Fig. 5-63: Corner of Weeks & Jefferson. Although the electric meter has to be accessible, it doesn't need to be so visible.

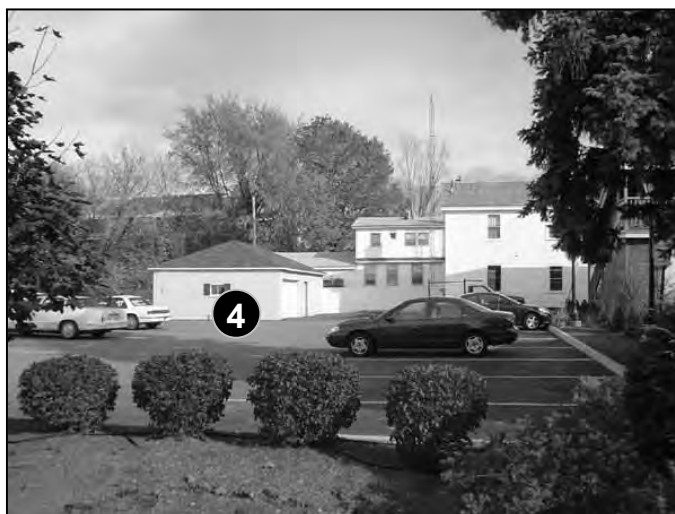
Fig. 5-64: North St. This large parking lot is clearly visible from the sidewalk, and should be screened more properly.

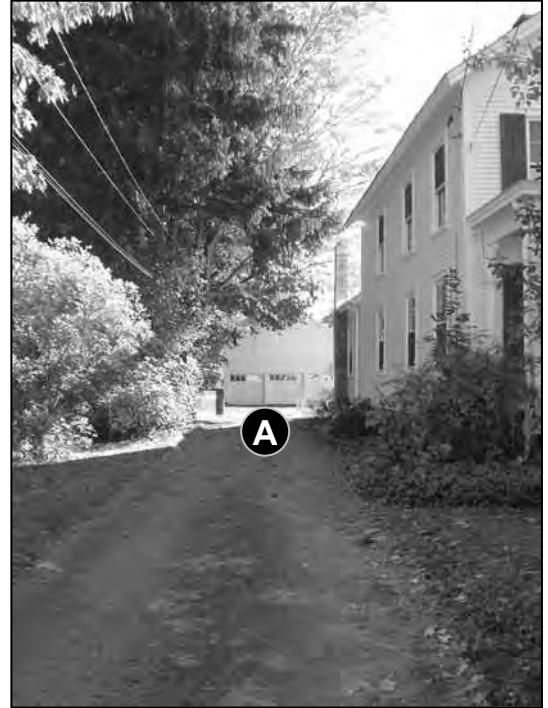
Fig. 5-65: 216 Elm St. The garage here is set way in the back behind the main building, allowing it to take on a more secondary role and keeping the large garage doors out of sight from the street.

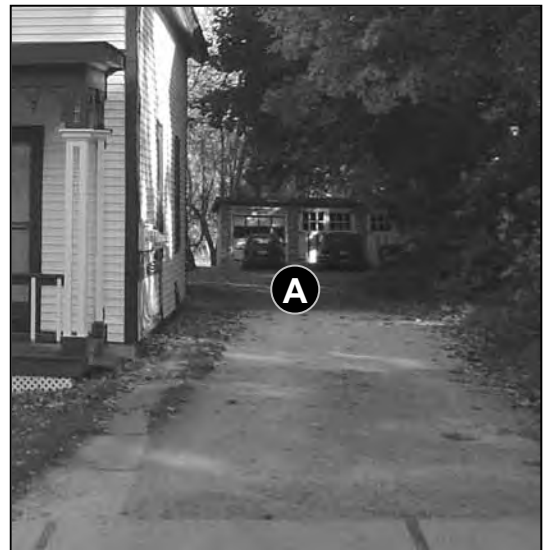
Fig. 5-66: 126 Jefferson St. Sheds, garages and similar utilitarian structures are best kept away from the primary building whenever possible and shielded behind the primary building.

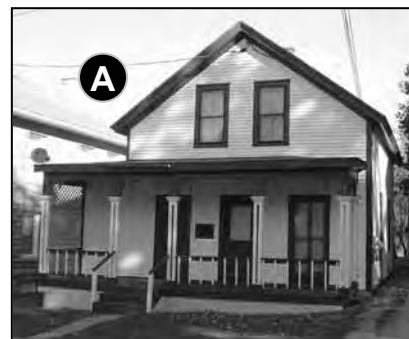
Fig. 5-72: 126 Jefferson St. The strong use of contrast in the paint colors of this building highlight the trim work.

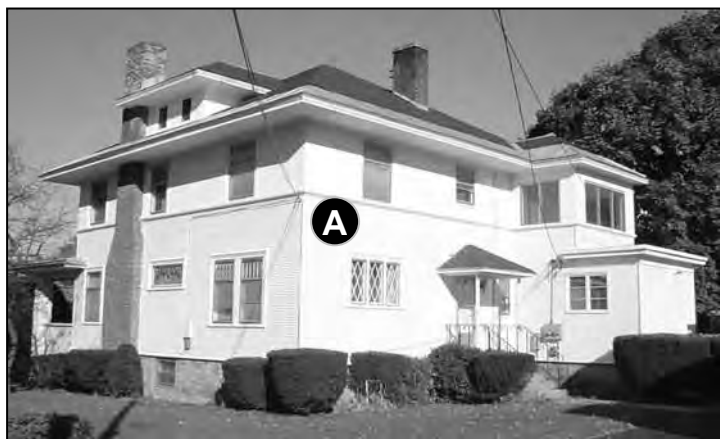
Fig. 5-73: Corner of Jefferson & Elm St. This house uses only a single paint color for all façade elements which is typical of more modern structures.

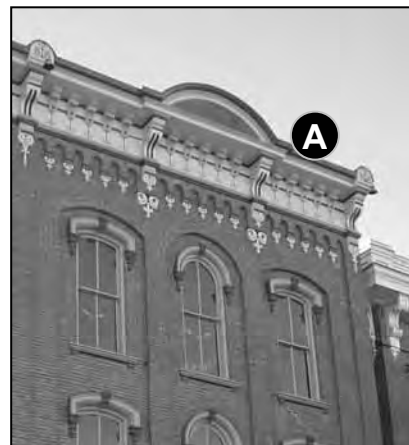
Fig. 5-74: 113 South St. The cornice of a multi-story building can be its most impressive design element, and is often where most color is used.

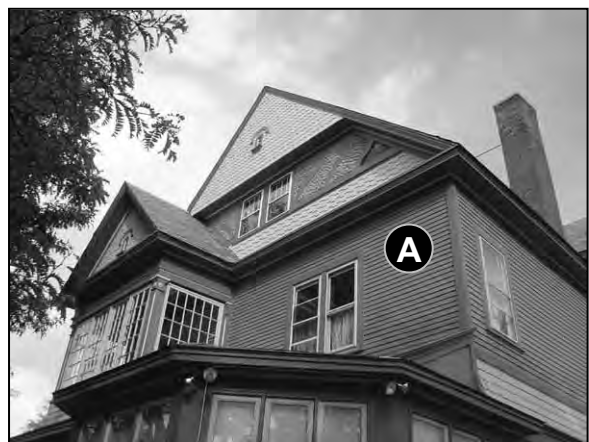
Fig. 5-75: 185 North St. Different paint colors are used consistently to distinguish clapboards, shingles and stonework on this building.

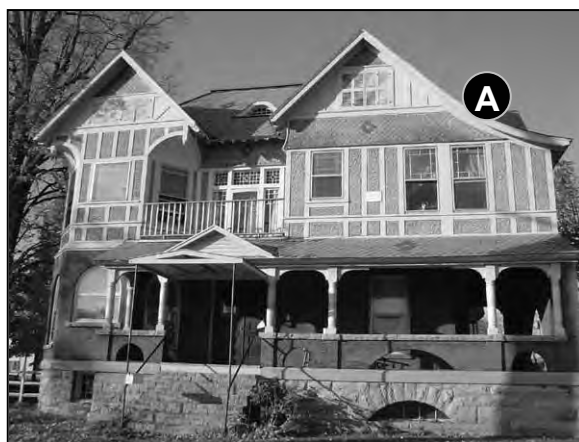
Fig. 5-76: 12 Pleasant St. Paint colors are used here to highlight the different facade materials in this Tudor style house.

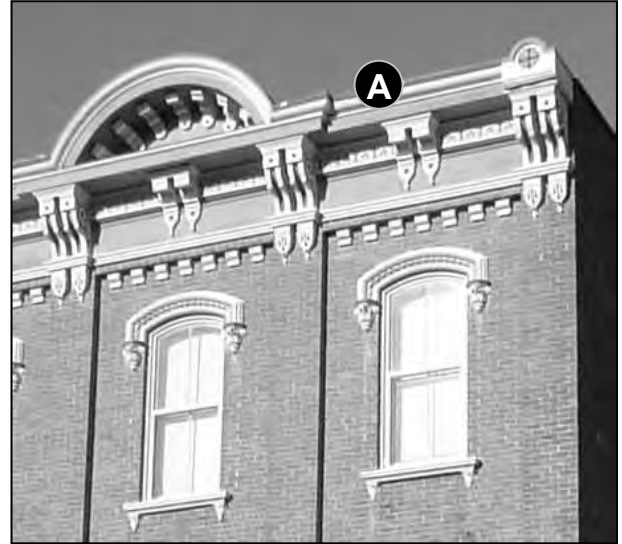
Fig. 5-77: 332 Main St. Subtle uses of color add intricacy and added depth to the cornice of this building.

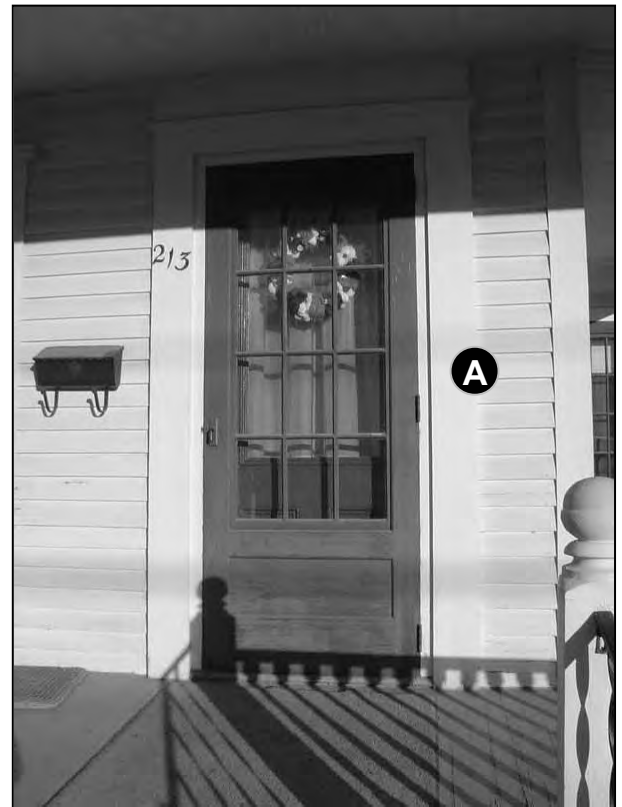
Fig. 5-78: 213 Park Street. The darker color of the door adds contrast to the overall paint scheme, and draws the eye toward the entry. Here, the storm door has been painted to match the front door beyond.

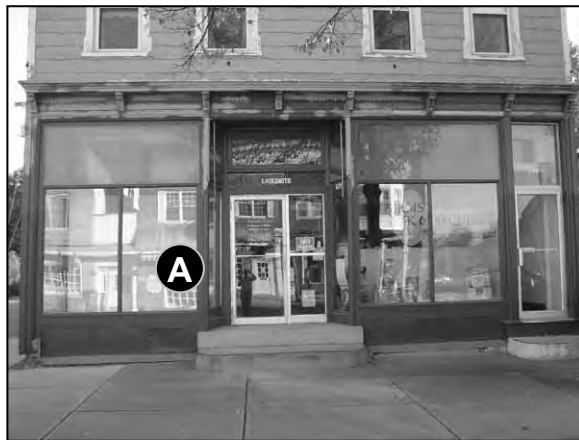
Fig. 5-79: 497 Main St. Original storefront still exists.

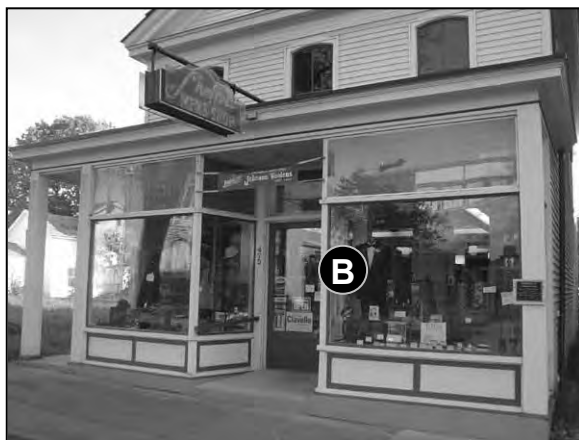
Fig. 5-80: 475 Main St. Original storefront design has been preserved.

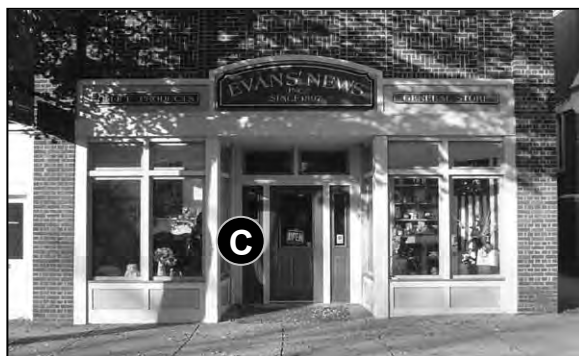
Fig. 5-81: 432 Main St. Compatible new storefront.

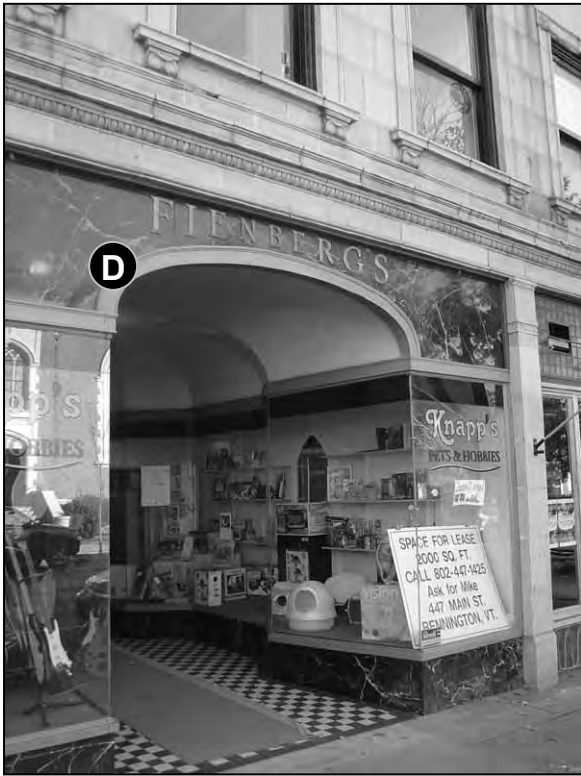
Fig. 5-82: 447 Main St. Historic storefront and sign have been preserved even though the business has changed.

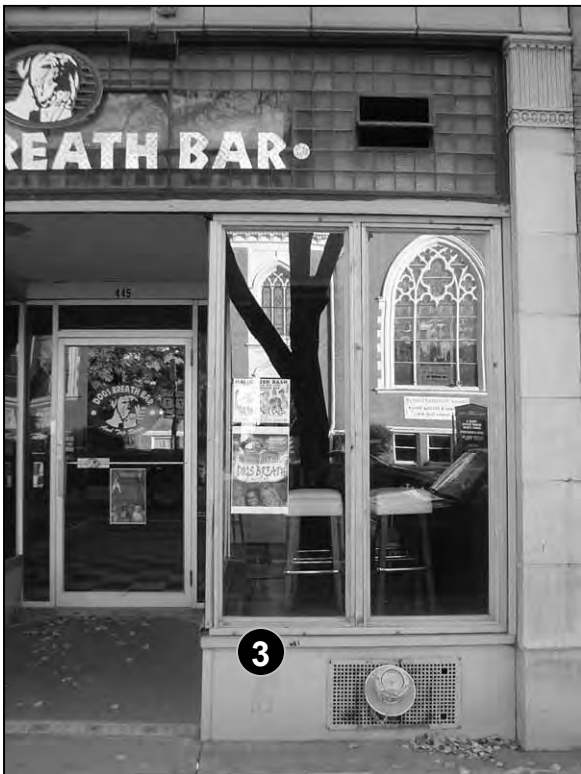
Fig. 5-83: 449 Main St. Bare lumber framing for the storefront windows is not in keeping with historic designs.

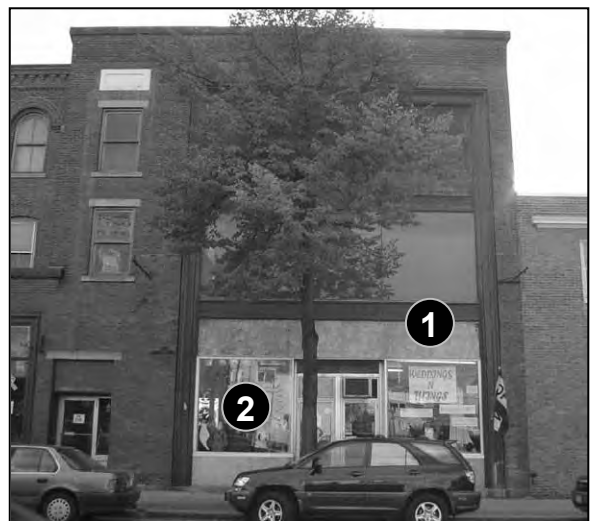
Fig. 5-84: 337 Main St. Original storefront has been replaced with bare aluminum framed picture windows and blank, unfinished panels.

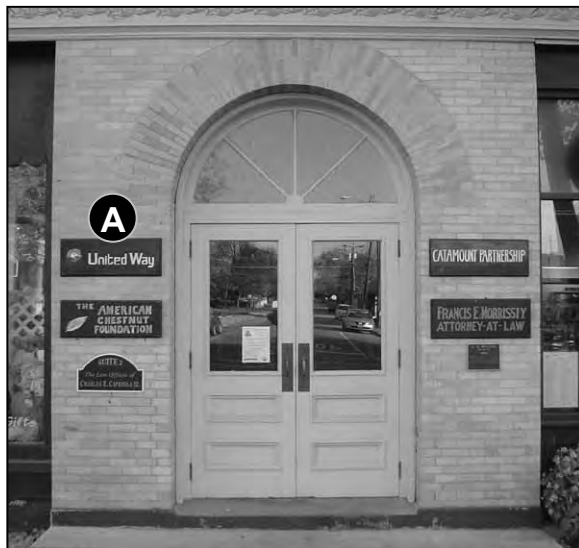
Fig. 5-85: 469 Main St. These small signs work together by being similar in size, shape and color.

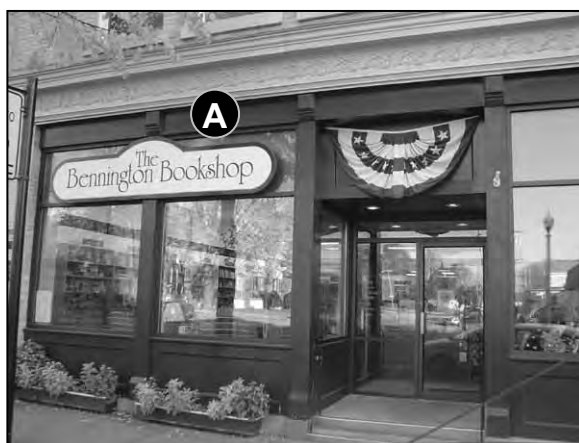
Fig. 5-86: 467 Main St. Sign is designed to blend in with the storefront materials and is framed by the structure.

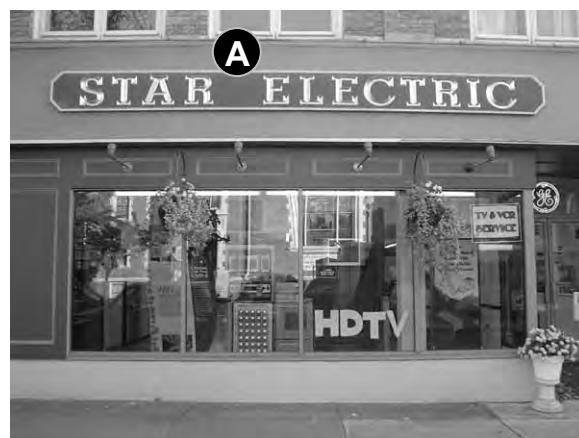
Fig. 5-87: 441 Main St. Example of simple yet effective sign which is in keeping with the historic character.

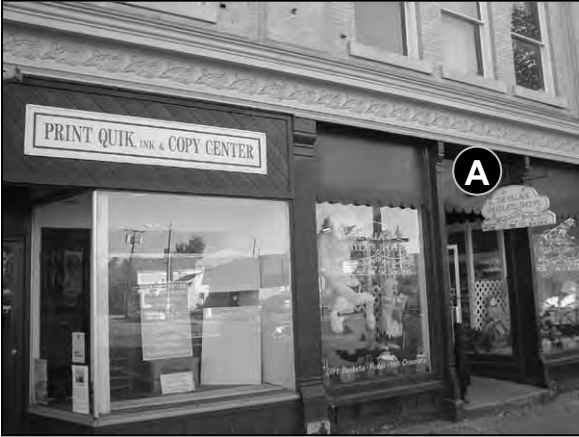
Fig. 5-88: 471 Main St. Hanging signs like this often are the least obtrusive to the architecture of the original façade.

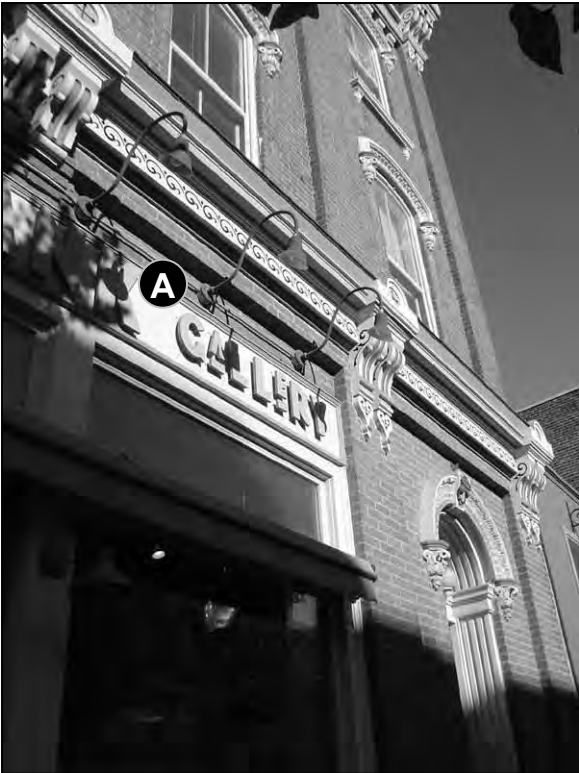
Fig. 5-84: 332 Main St. Applied lettering framed within the design of the façade is often the cleanest solution.

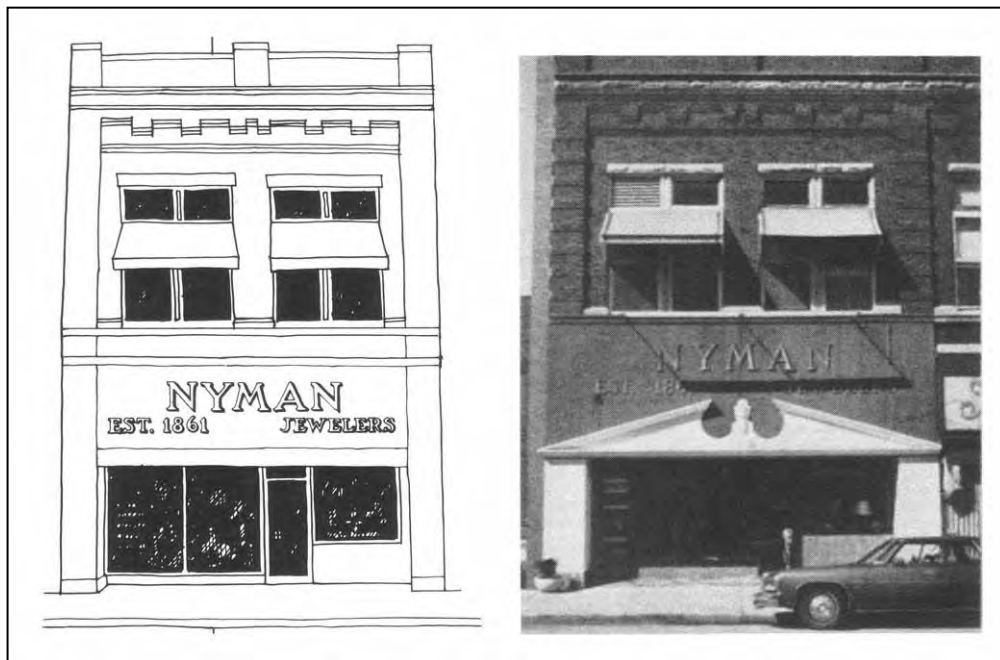
Fig. 5-85: On this storefront, the existing sign is too large, overpowering the building and its neighbors. The large colonial pediment detracts from the store name and is inconsistent with the building's architectural style. Removing this element and the paneling that extends to the second-story windows reveals more of the building fabric. A better proportioned sign that reuses the individual letters from the earlier sign can be placed in this space.

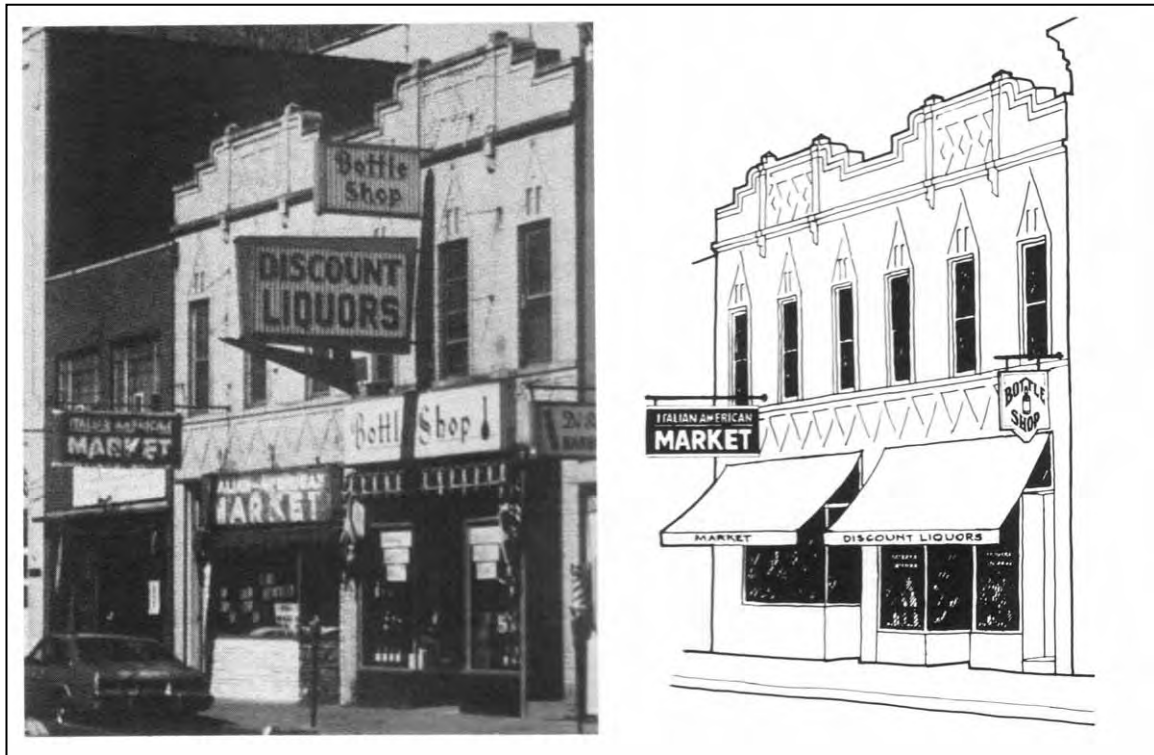
Fig. 5-87: If too numerous or too large, signs hung at right angles can easily overwhelm the proportions of a building, obscure its details and create a cluttered appearance along the street. In this illustration, the neon market sign has been moved closer the facade, the overscaled liquor signs have been removed and replaced by a smaller projecting sign and secondary information has been placed on awnings for both stores.

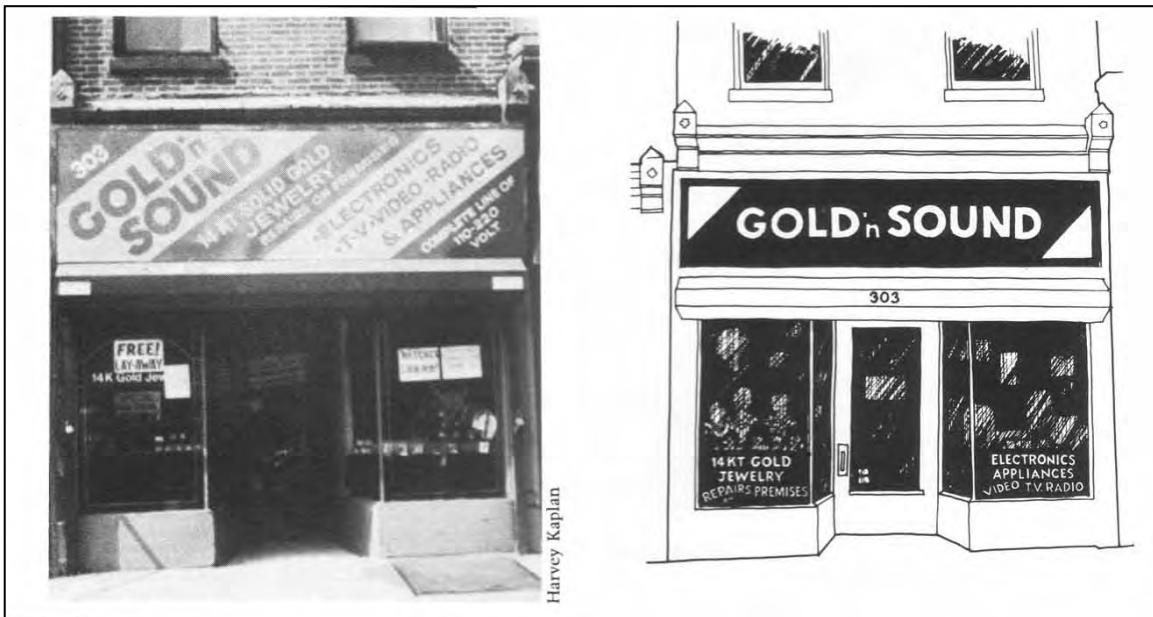
Fig. 5-91: Signs with too much information can be confusing. Keep the message clear and direct so that the name is easy to read. In the drawing, the shop name is the only message on the sign, and its lettering has been clarified, particularly the "G" in Gold. Secondary information appears in the lower third of the window, filling a void created by the raised window display. Other places for secondary signs include doors, awning valances, bulkheads and inside display windows.

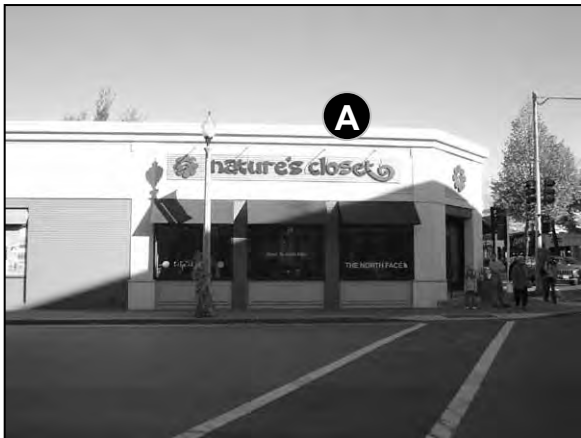
Fig. 5-93: 400 Main St. Although this building would be better as two or three stories, exterior renovations have helped to improve the facades dramatically.

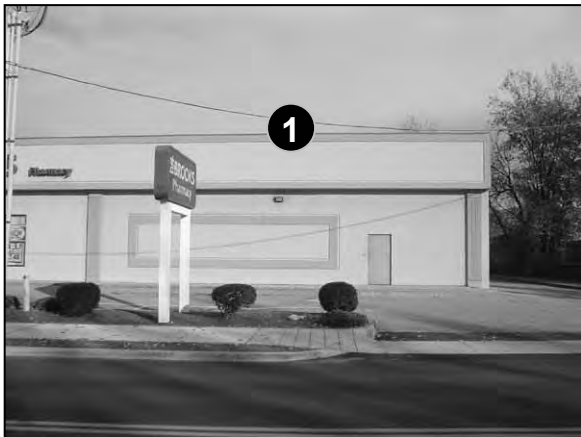
Fig. 5-95: 194 North St. The large blank wall facing the street is not in keeping with the historic neighborhood.

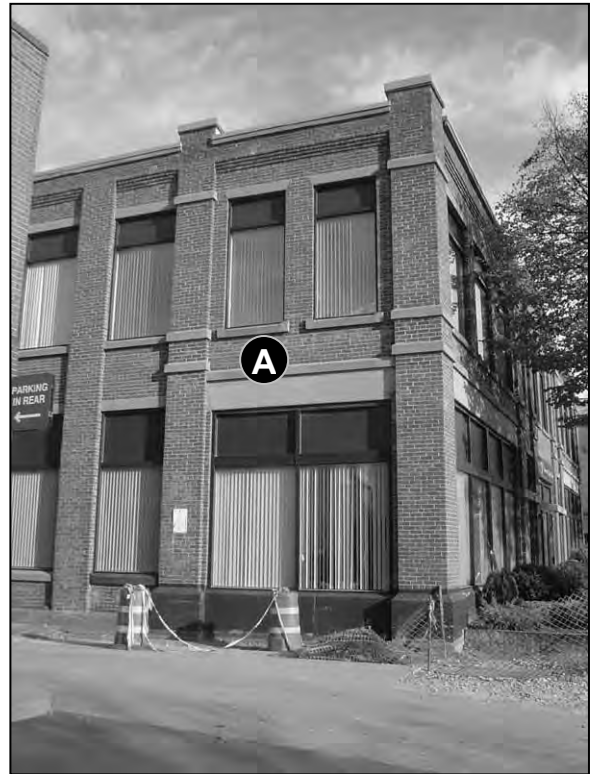
Fig. 5-92: 324 Main St. Adaptive re-use of this older building has maintained the exterior facades while modernizing the interior.

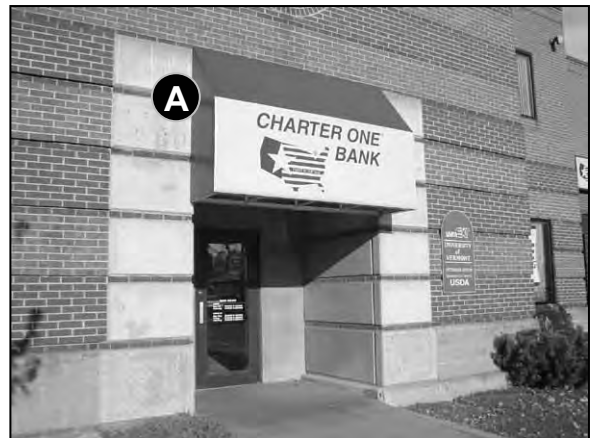
Fig. 5-94: 338 Main St. Simple details like the concrete cornerstones at this entry help to evoke earlier design styles.

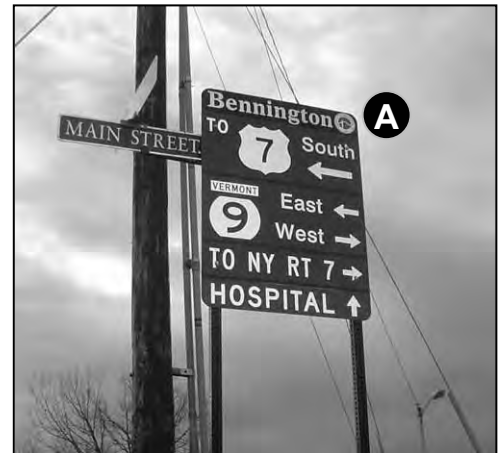
Fig. 5-102: New signage system.

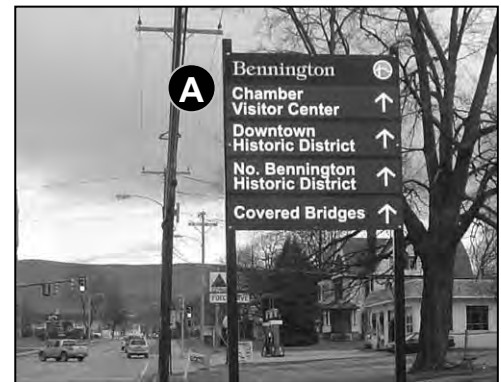
Fig. 5-103: New signage system.

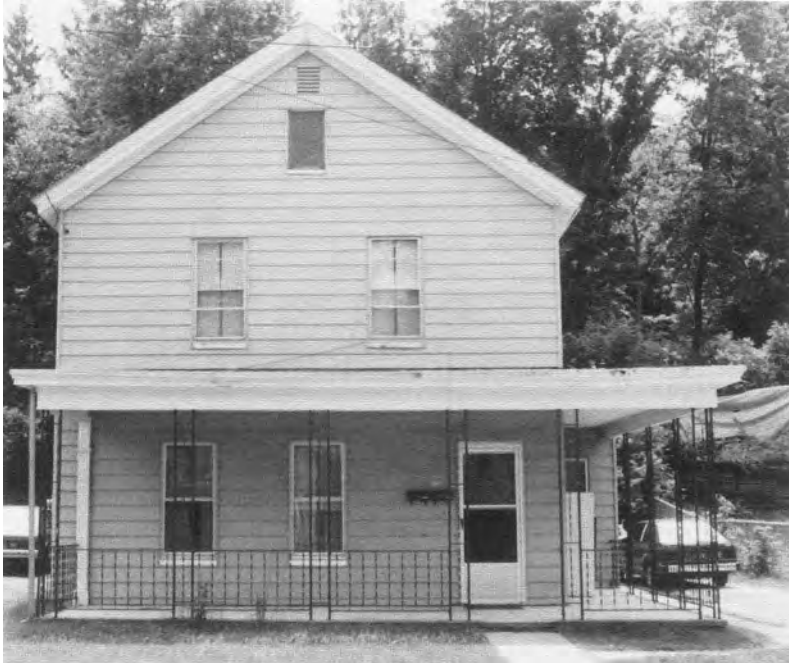
Existing Conditions

Exterior walls are covered with aluminum siding; all trim around windows and at corners of the building has been removed or covered; cornices on the main roof and porch roof are covered with aluminum siding; the original wood porch columns and railing have been replaced with wrought iron. [Photo: Union Street c. 1990]

Aluminum siding has been removed and replaced with new clapboard to match the original; the wood trim is restored around the windows and at corners; aluminum siding is removed from cornices on main roof and porch roof, wood cornices are restored; original wood porch columns and railing are restored - the new wood columns and railing are of simplified design, reflecting the original proportions and materials but not necessarily duplicating all moldings and details.

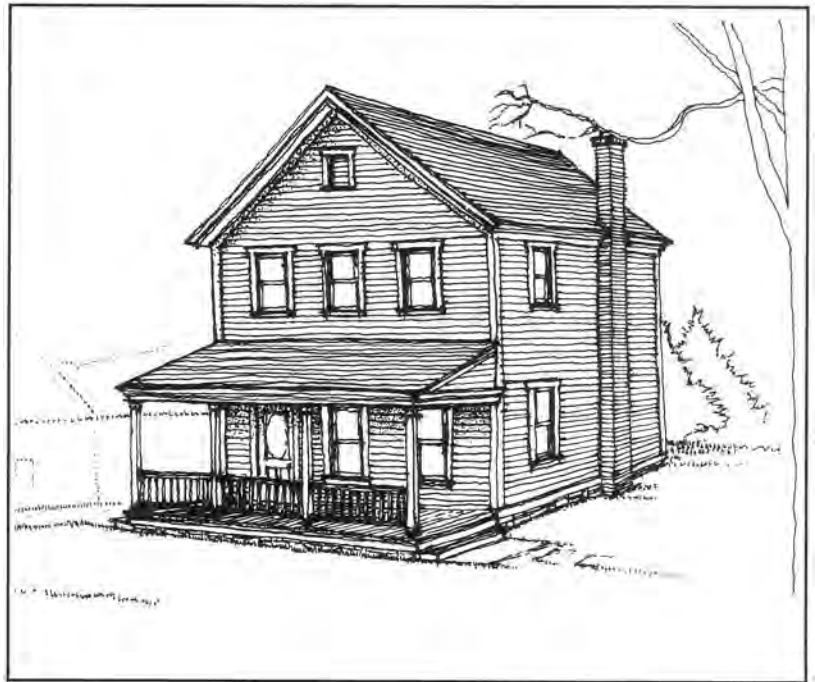
Rehabilitation - Successful

The exterior is rehabilitated to reflect historic materials, scale and proportions. By removing the large windows, replacing them with three smaller ones, and adding the clapboard siding, the overall scale of the structure has been significantly reduced and returned to a more historic character. Although it does not necessarily duplicate all original moldings and details, the overall spirit of the historic detail is expressed.

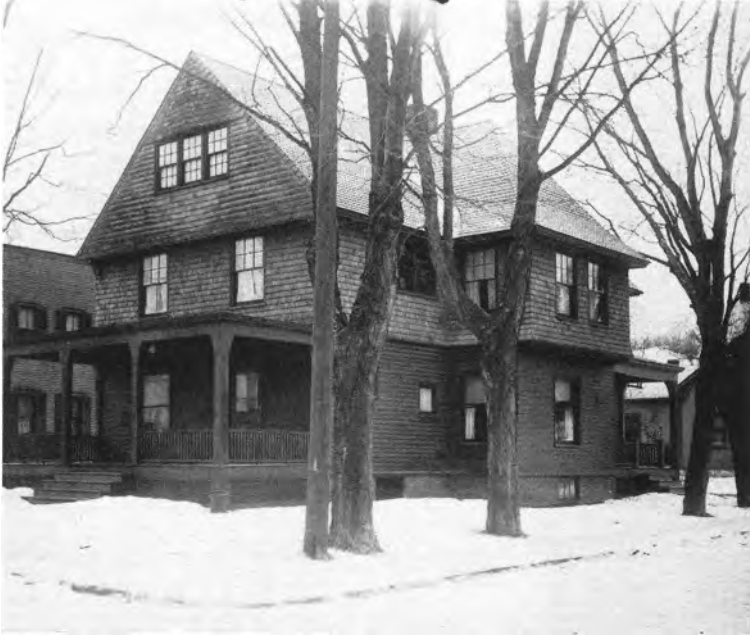
Historic Conditions

Historical photo showing building in original condition, with all windows, shingles, porches and other features in place. [Photo: Corner of Union and Silver Streets – 1904]

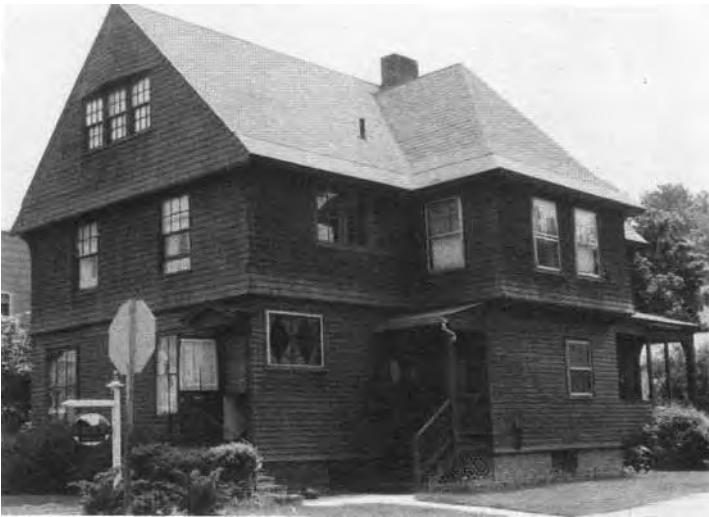
Later Conditions

Original front porch has been removed; side window converted to door; new stairs and door hoods are installed; some window sash and openings are altered. [Photo: c. 1990]

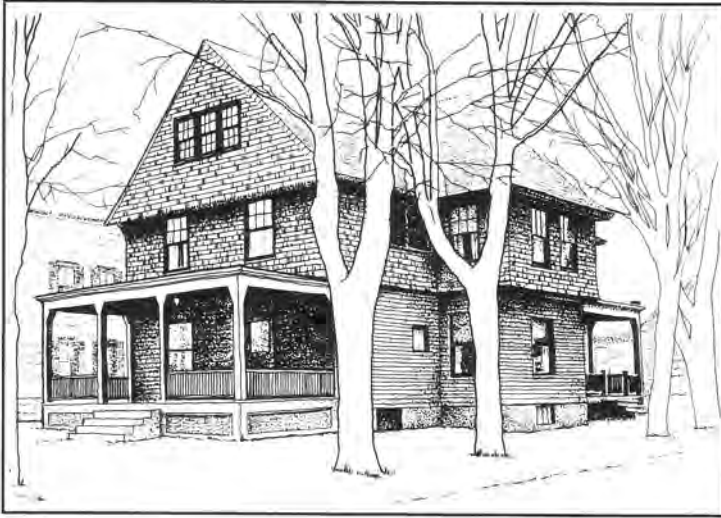
Rehabilitation – Successful

The front porch is restored and side entry returned to its original window configuration, based on historical photograph; all exterior shingles, roofing, windows, etc. are repaired using same materials as original.

NOTE: An alternate rehabilitation, also successful, would be to keep the existing side entry. Even though this entry is a change from original conditions, it has been carefully done: the new door, stairs and porch roof are compatible with the building's original design and materials.

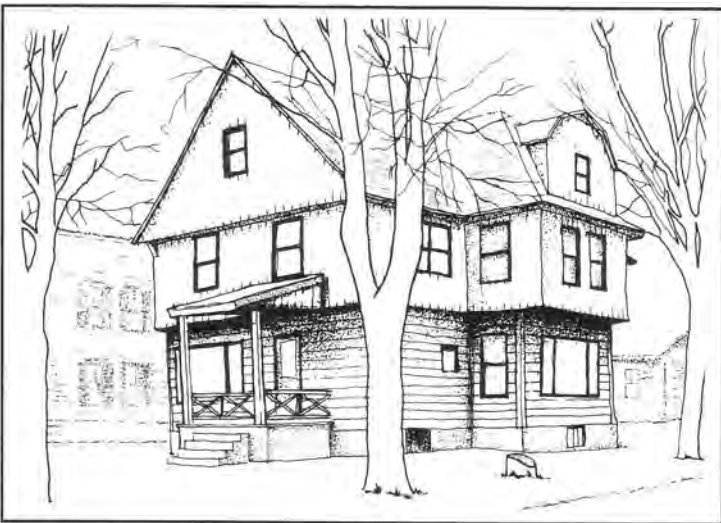
Rehabilitation – Unsuccessful

All exterior shingles are removed and replaced with horizontal aluminum siding (first floor) and vertical wood siding (second floor); Front porch is out of scale and poorly designed; all multi-pane windows are removed and replaced with single-pane windows and picture windows; an inappropriate dormer is installed on the side of the building: it is too large, and its roof shape is not in keeping with the original.

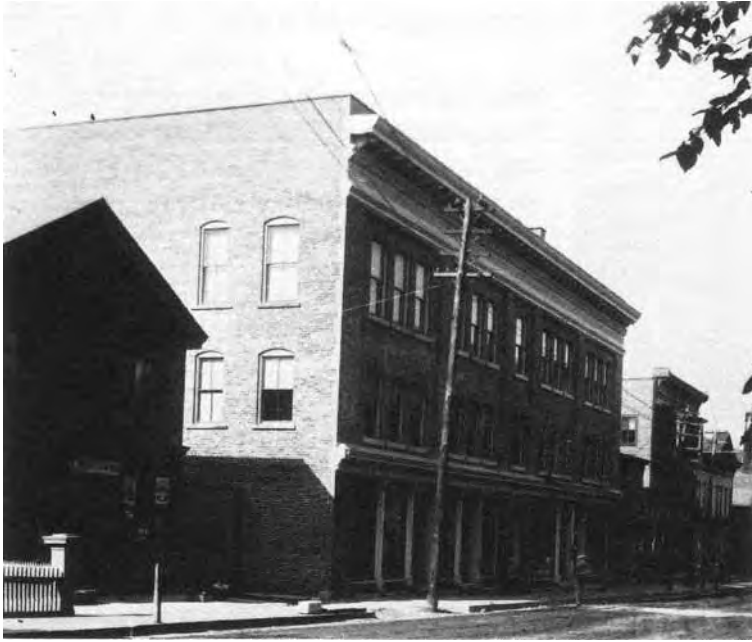
Historic Conditions

Historic photo provides clues to the original design of storefronts and entries. The storefronts had tall plate glass windows between iron columns, with a decorative metal cornice above and narrow wood panels below. [Photo: 469 Main Street - c. 1900]

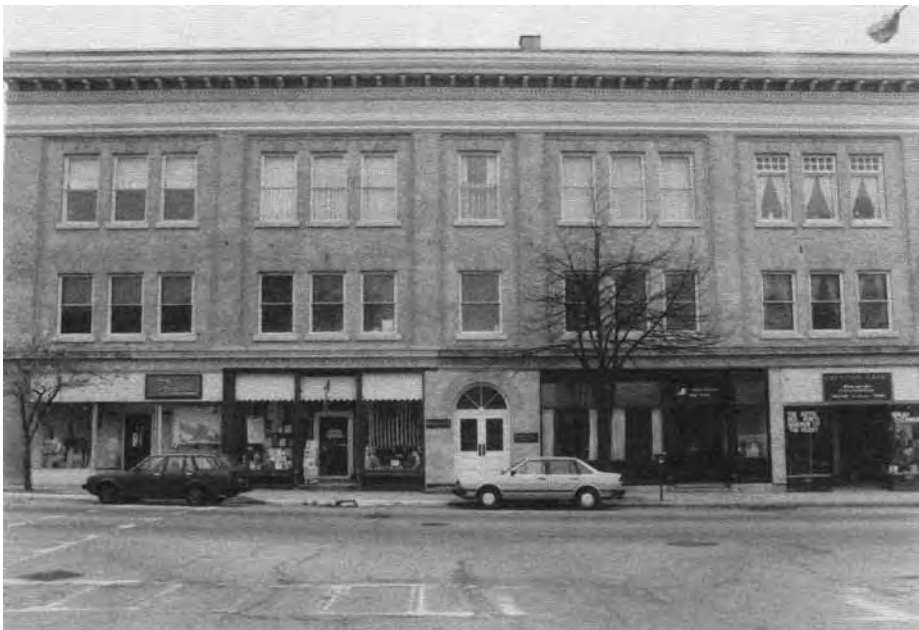
Later Conditions

The existing storefronts combine surviving original material with later changes. Some changes cover or remove original materials (especially left of the main entry at the center of the building). Others include successful contemporary design which reflects the basic materials and character of historic storefronts without duplicating all details (storefront to right of main entry). In the far right storefront, recent changes are combined with earlier changes of c. 1930-40, which have historical significance of their own. Original brickwork, windows, cornices and other details have been preserved and maintained. [Photo: c. 1990]

This successful storefront rehabilitation combines several approaches: original conditions are restored in all openings left of the main entry; the well-designed recent storefront remains to the right of the main entry; and the basic materials and proportions of the significant 1930-40 storefront are restored. Original brickwork, windows, cornices and other details continue to be preserved and maintained.
