TIME & PLACE IN BENNINGTON

*A Handbook for the Central Bennington
Historic District*

Town of Bennington Historic Preservation Commission

Prepared By
WILLIAM HIGGINS & COMPANY, INC.
New York, NY
William J. Higgins
Elise M. Quasebarth
In Association With
Stracher Roth Gilmore Architects
Schenectady, NY

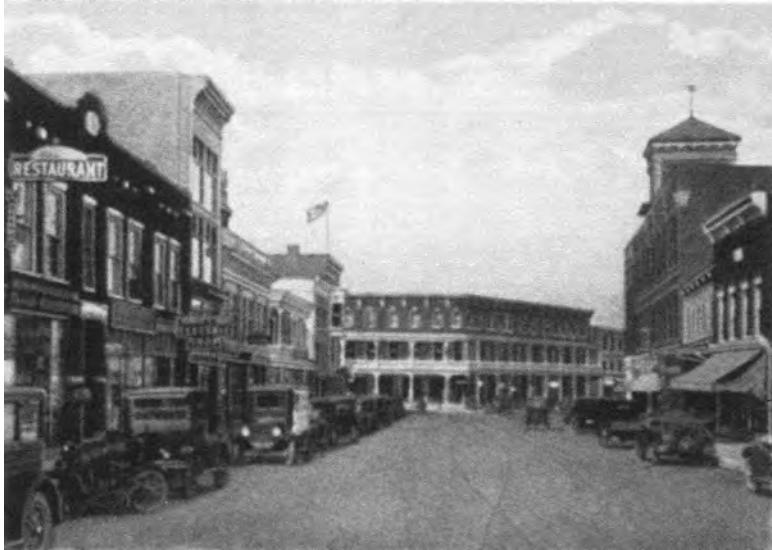
Historic Conditions

Careful study of an historical postcard of c. 1925 provides clues to the original design of the building (left – foreground). Storefronts included leaded-glass panels above plate-glass display windows. Entrances appear to have been at the center of each storefront. Also note that the second floor had one wide window in each opening.

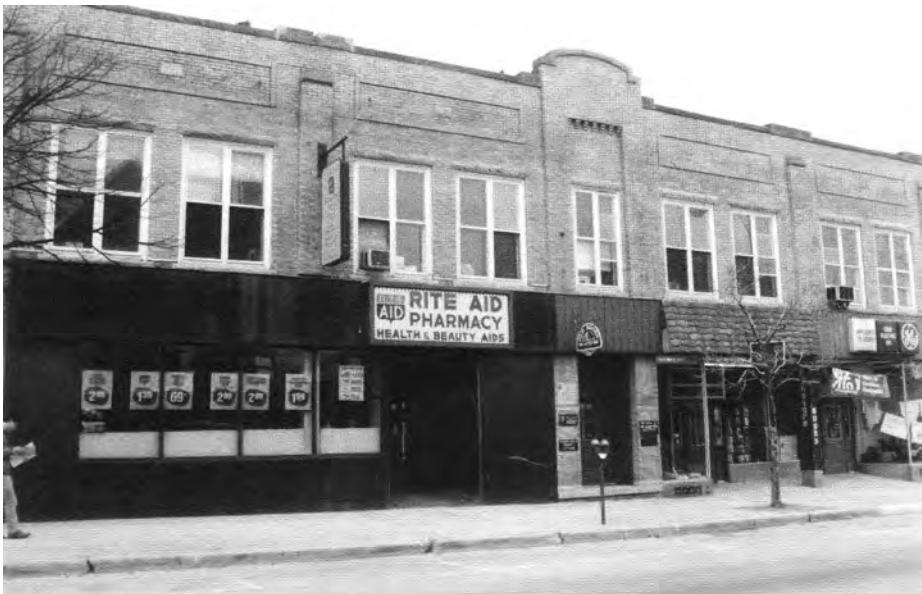
Later Conditions

The historic storefronts are largely covered or removed; existing storefronts have been altered with materials and design differing substantially from the original. Note that the second floor windows have been changed: there are two windows in each opening rather than one. [Photo: c. 1985]

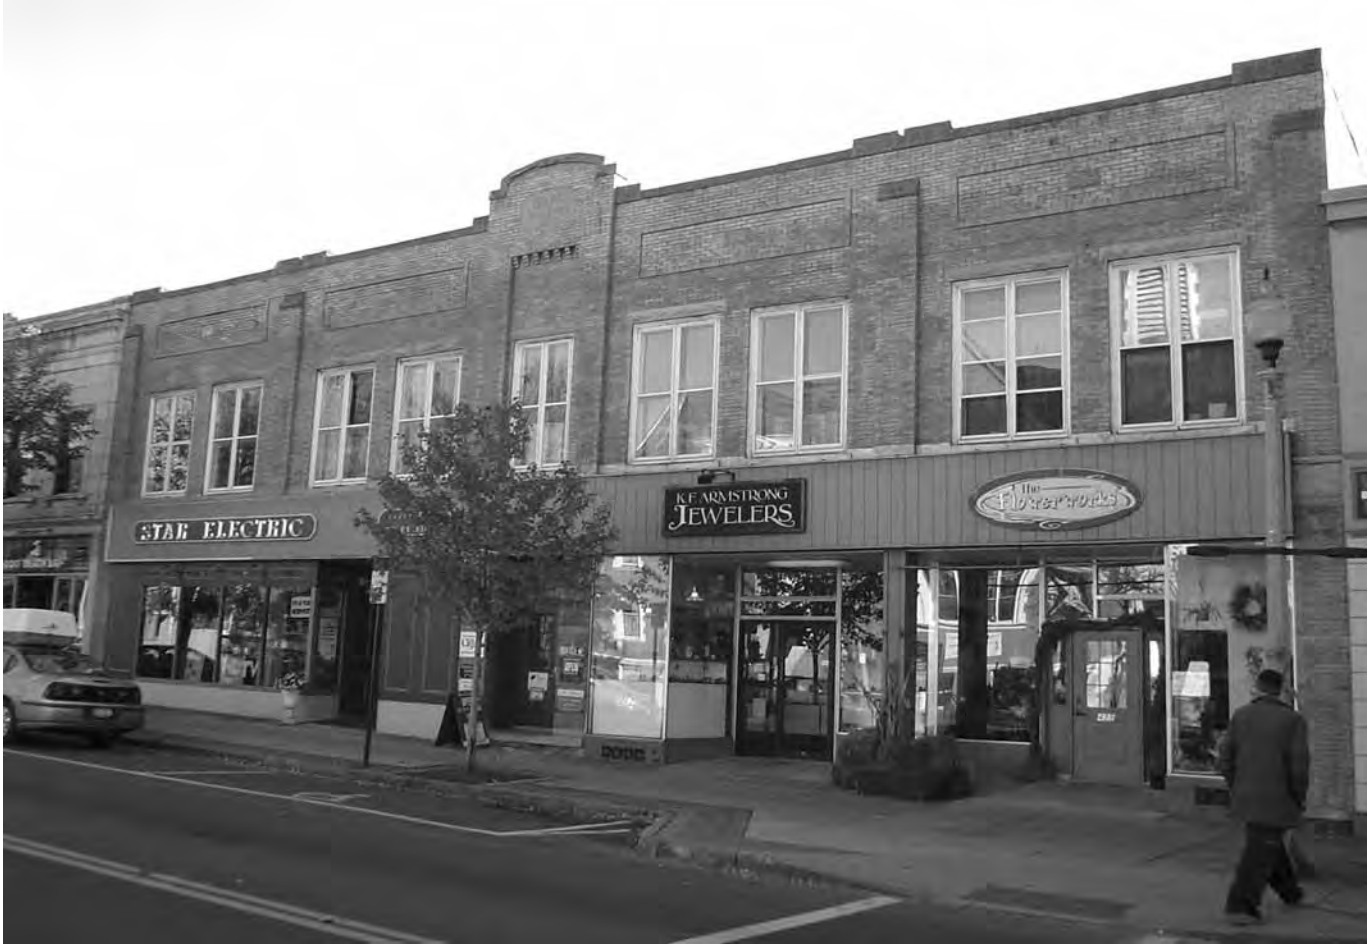
Existing Conditions (top)

The original leaded glass above the storefronts has now been covered over completely by a long strip of vertical wood siding to act as a sign backdrop.

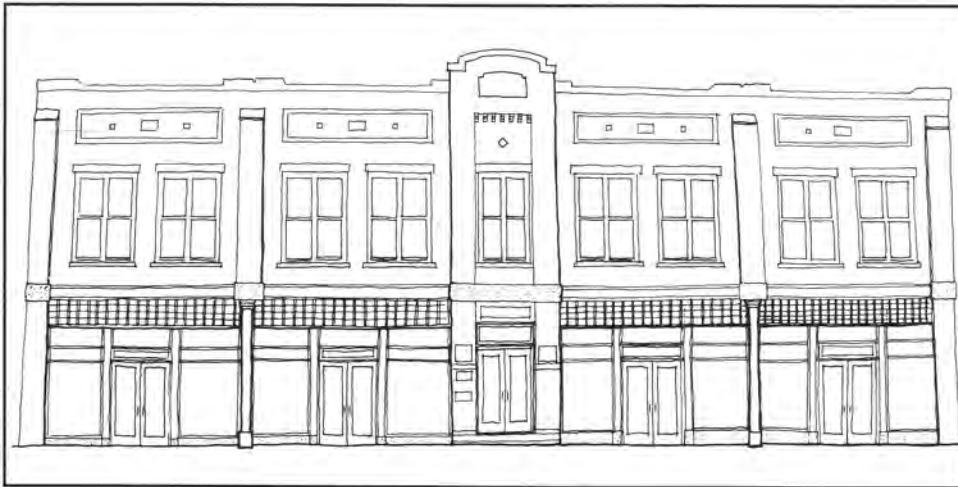
Rehabilitation – Successful

Recent storefronts are removed, with the original proportions and design restored. Note that the leaded glass is restored based on the historical photograph; areas not shown in the photo (entry doors, for example) have modern doors which are simple but in keeping with historic character. The double windows on the second floor are not restored to original; an alternate rehabilitation treatment, also successful, would be to replace the existing windows with single windows like those shown in the historic photo.

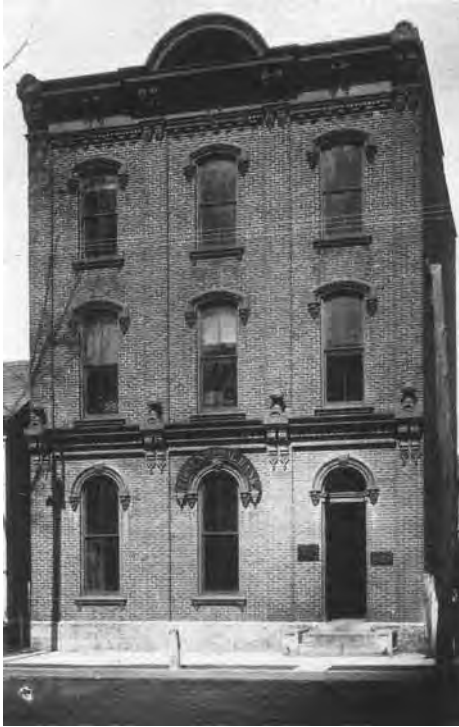
Historic Conditions (left)

Historical photo showing original condition. Note the two windows on the ground floor, left of the entrance; and the decorative details in the cornice between first and second floors. [Photo: c. 1895]

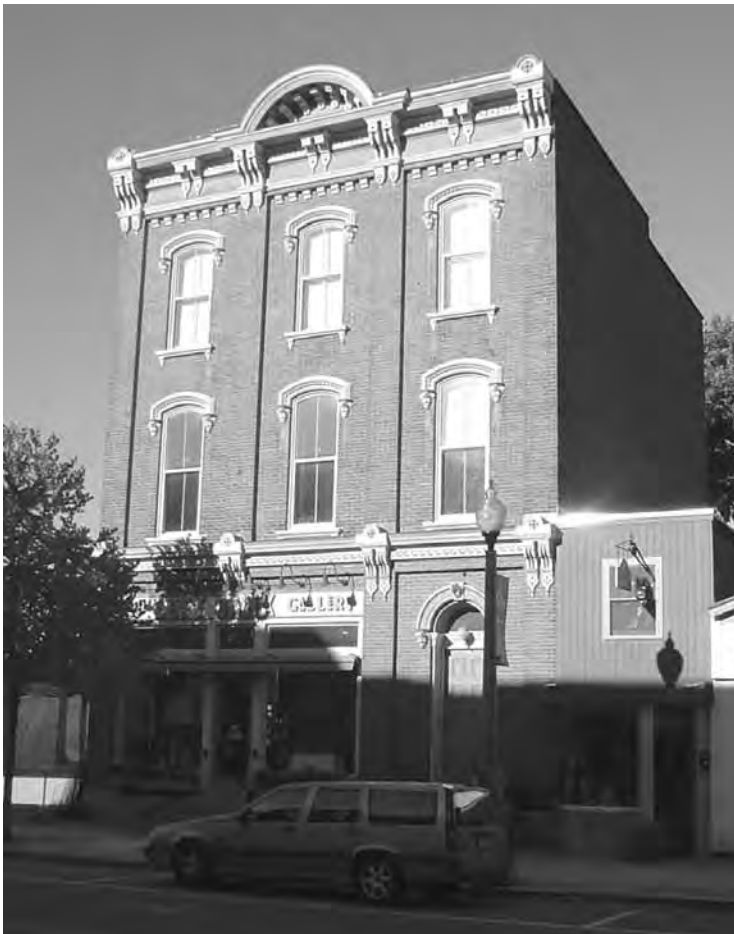
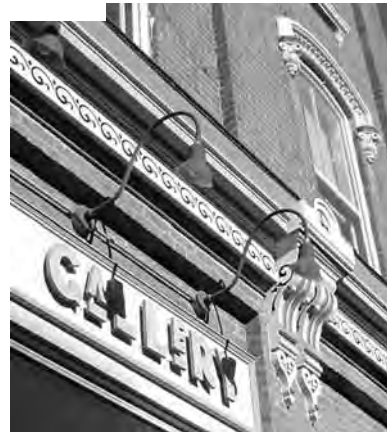
Existing Conditions (left and above)

Most of the original woodwork has been restored, including the cornice above the storefront. Trim work has been painted in a detailed color scheme that accentuates its three-dimensional appearance.

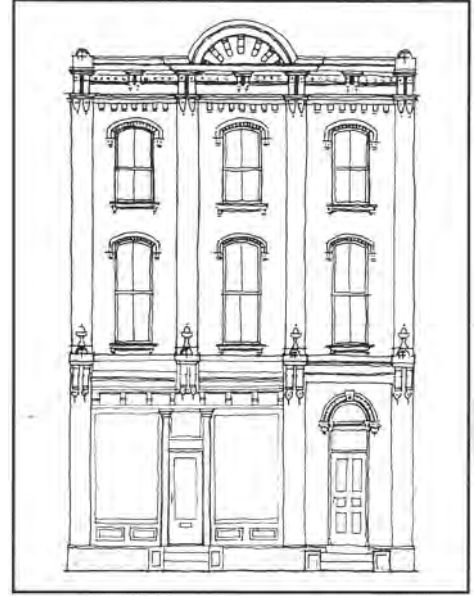
Rehabilitation - Successful

An alternative treatment, also successful, keeps the storefront but changes its proportions and details to bring it closer to the building's original design. Missing parts of the original cornice above the storefront are restored. All other original material is repaired and preserved.

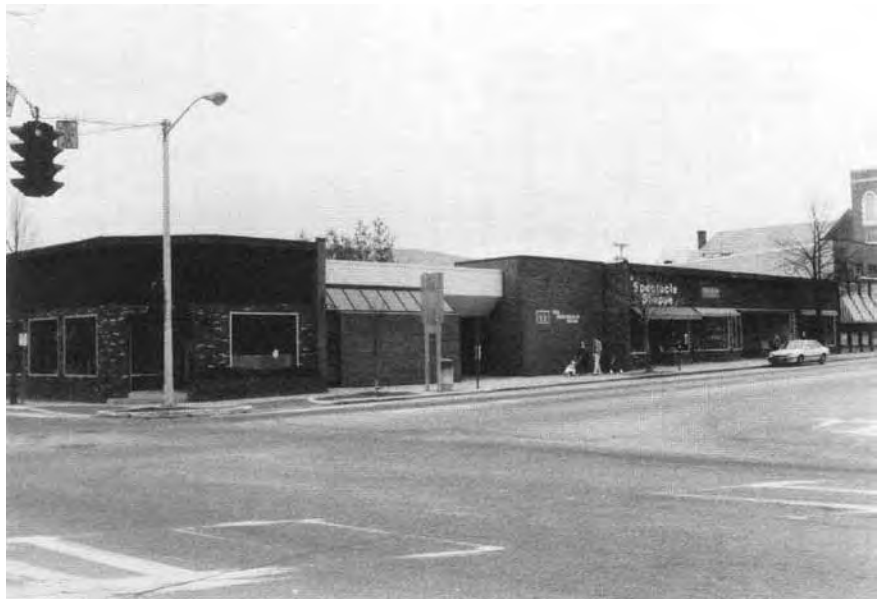
Existing Conditions

The new one-story building at the corner is remodeled to improve its exterior appearance. Improvements include the expression of structural bays or pilasters on the exterior, and a more traditional cornice design.

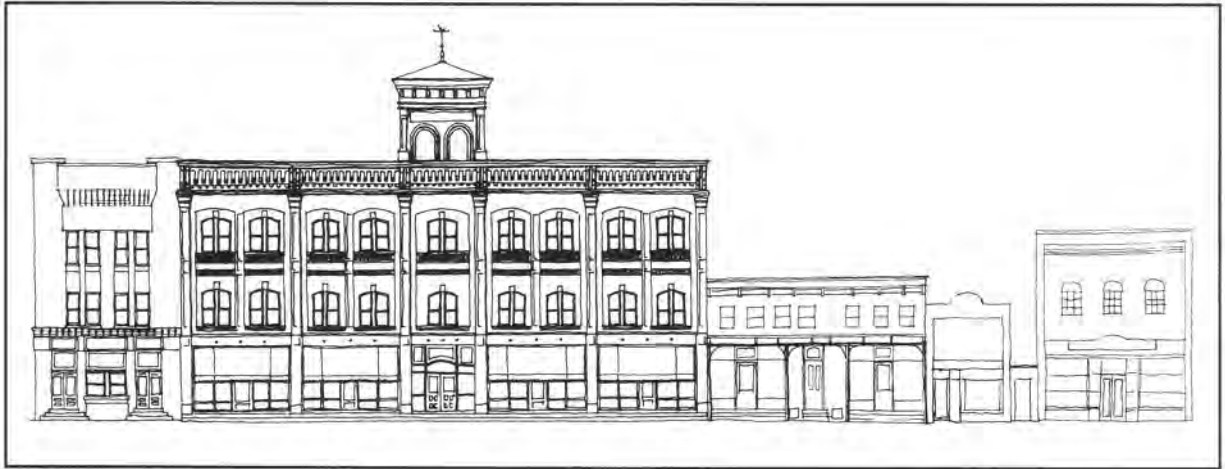
New Construction - Successful

New buildings duplicate the scale, materials and detail of historic buildings, based on evidence from the photograph. The prominence of the corner site is regained.

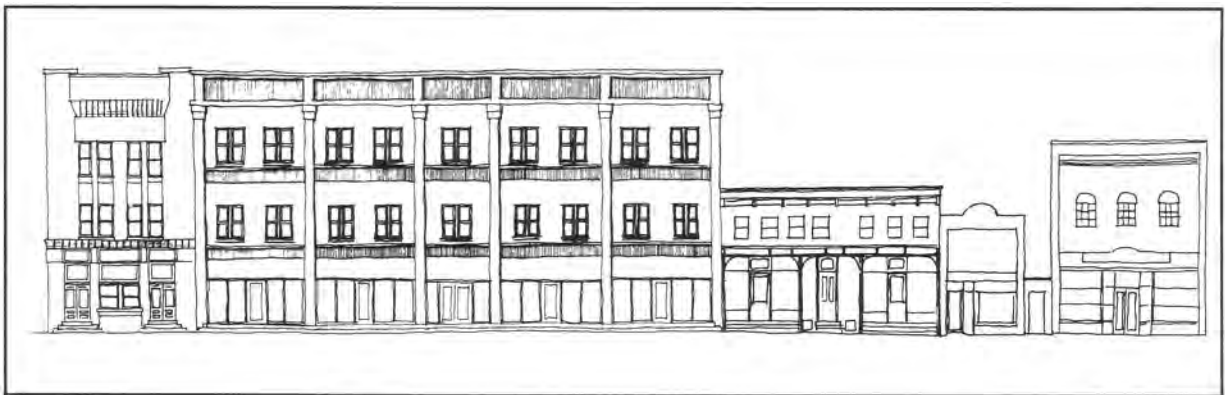
New Construction - Successful

An alternative treatment reproduces the basic scale and materials of the historic buildings, but detail is simplified and more modern. This treatment is less ornate and expensive than the first, but still fits successfully with the site and surroundings.

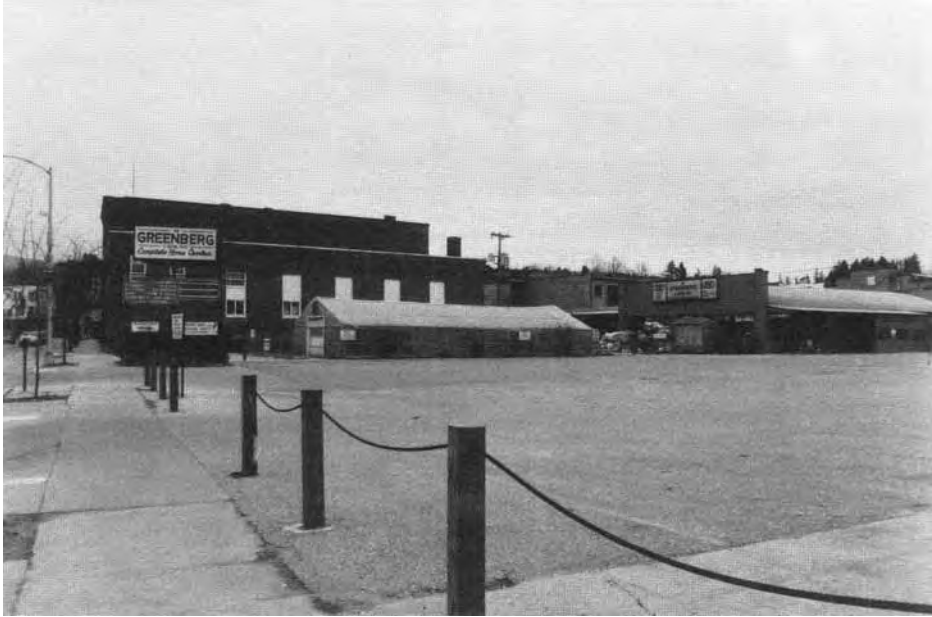
Existing Conditions

The existing buildings at the center of the photo are lower in scale than the historic buildings to the left, and not related to them in detail or design character. They are set back from the street, in a large parking lot which breaks the line of the street wall established by the historic buildings. [Photo: c. 1990]

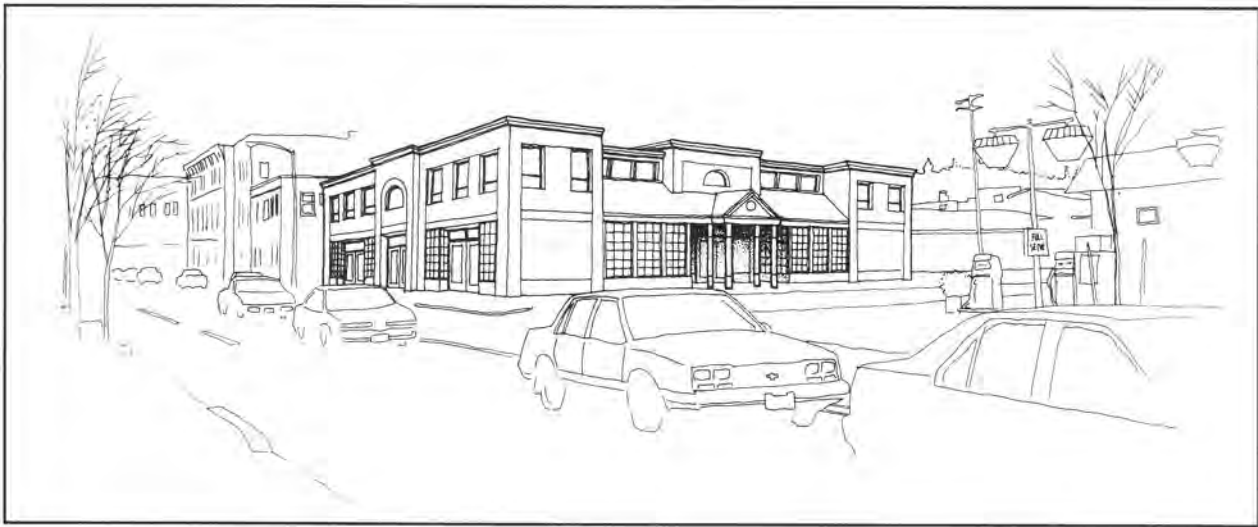
New Construction - Successful

A new commercial building is contemporary in character, but reflects the scale, materials and general detail of its historic neighbors. Note that the walls are divided into varying planes and layers to provide variety and human scale; material is brick, typical of the district; size and rhythm of window openings reflect that of nearby historic buildings, without imitating them exactly; the cornice at the top of building provides unity and emphasizes the new building's scale and street wall.

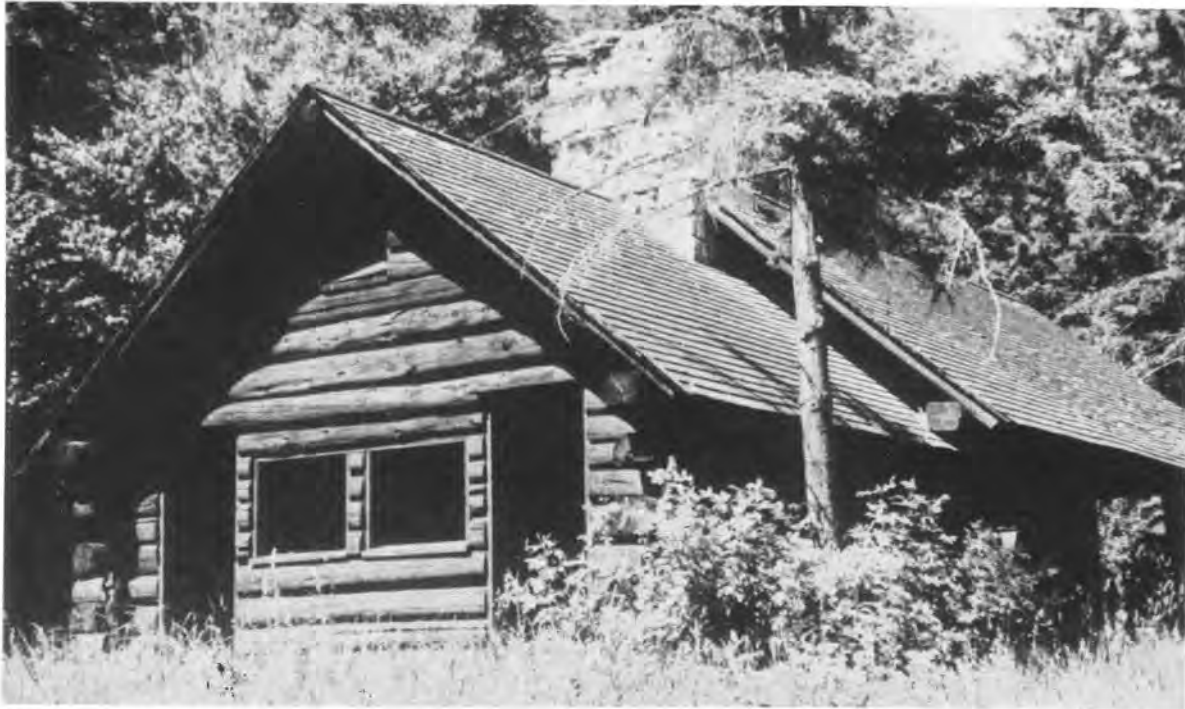
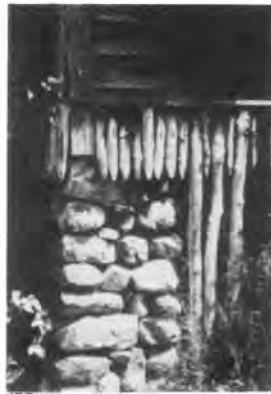
ADIRONDACK RUSTIC

Rustic, late 19th century log camps in the Adirondack Mountains and images of log cabins in a variety of publications were the models for vacation homes and recreational structures built in scenic areas of Vermont during the first third of the 20th century. These buildings were designed to blend into forests and tree-shaded lakeshores, with their log or log veneer walls, wood-shingled roofs, rough fieldstone foundations or chimneys, and imaginative “rustic” ornament made of tree branches and applied to porches, window surrounds, gable peaks, and other surfaces.

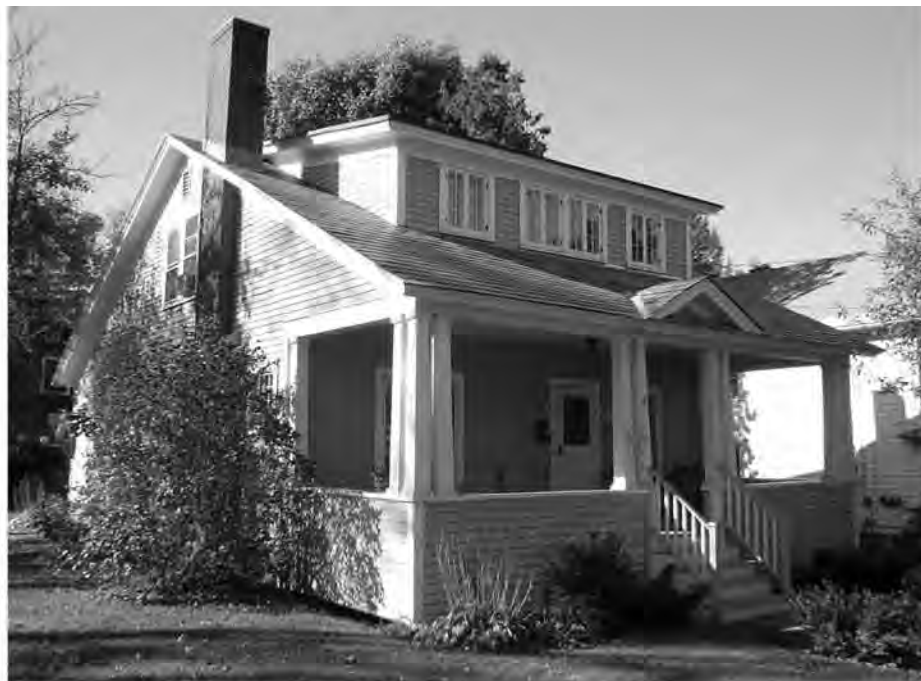
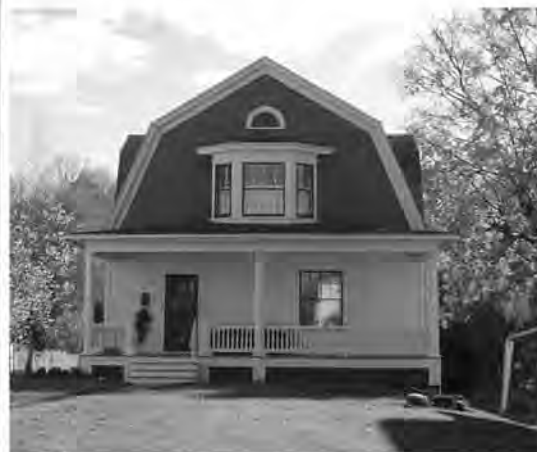
BUNGALOW

The characteristic broad, low roofs of bungalows, often interrupted by dormer windows, have deep overhanging eaves that are supported by large, open, wooden braces or brackets. Stretching across the front of these homes are ample, shaded porches with battered or Colonial Revival style columns that often rest on tall pedestals covered with wood shingles or cobblestones. Chimneys, which were built on exterior walls, are fieldstone, cobblestone, or brick laid in decorative patterns. Clapboard and wood shingle sidings are the most frequently used, but brick, stucco, or cast stone examples may also be found. Windows—multi-paned sashes over a large single sash, picture windows topped by transoms, Colonial Revival style Palladian windows, and small, square stained glass sashes—are asymmetrically placed,

adding pleasing variety to wall surfaces. Some bungalows are also ornamented with distinctive “Japanesque” style trellises and flared eaves.

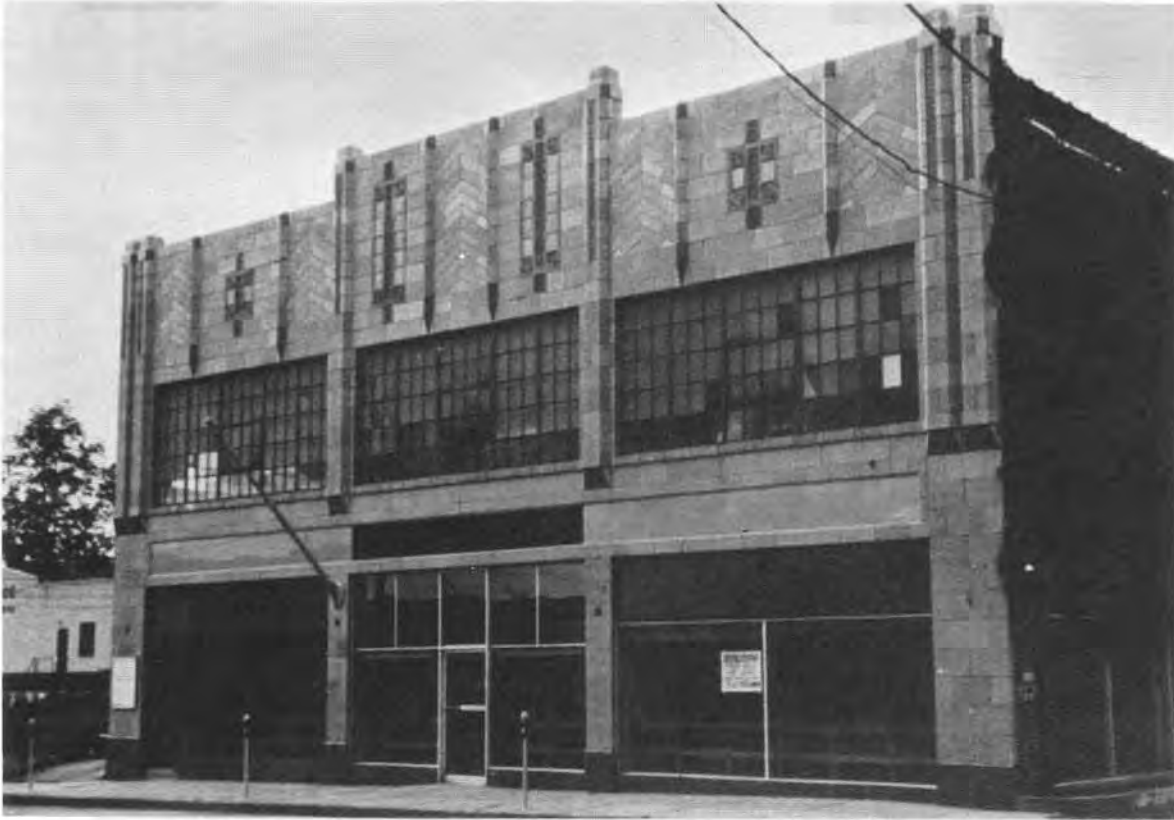
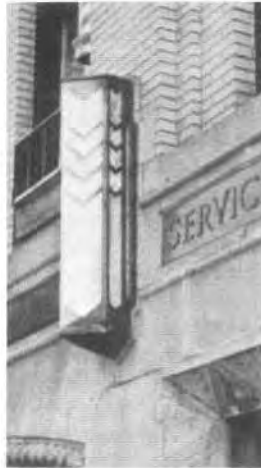
ART DECO

The Art Deco style became popular throughout the United States soon after it was introduced to an international audience by the *Exposition des Arts Décoratifs* held in Paris in 1925. Art Deco buildings in Vermont, although relatively rare, were built in the decade and a half before World War II in the cities and larger villages. The style was used primarily for masonry commercial blocks—1 or 2 story automobile showrooms and movie theatres, and taller office buildings—to project an image of modernity in keeping with their modern interior uses. Ornament, made of carved stone, colorful glazed terra cotta, intricate brickwork, or neon for movie marquees and store signs, consists of shallow, geometric, angular patterns. It is often used at rooflines and building corners, and around windows and entryways.

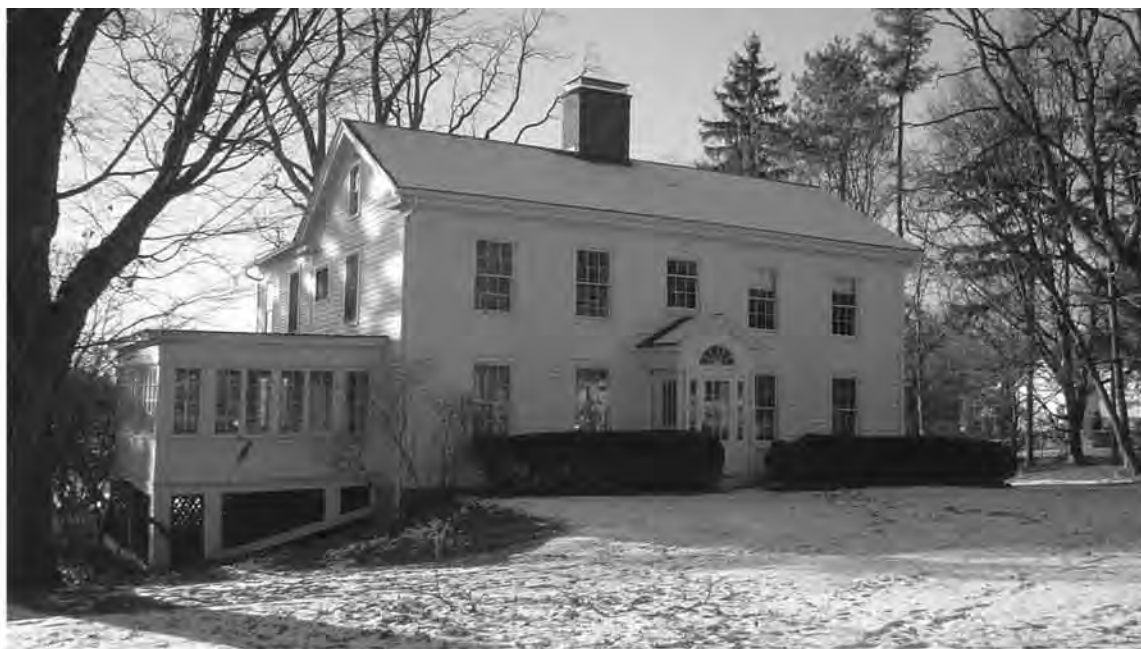
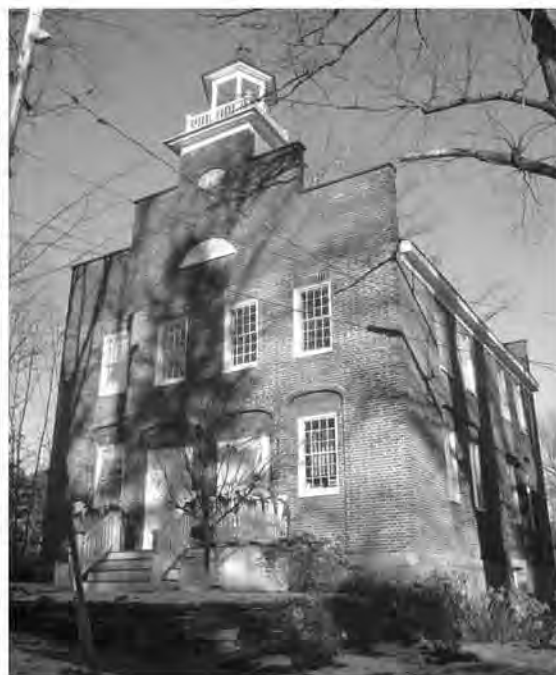
FEDERAL

The Federal style, with its light and delicate detailing derived from the classical architecture of ancient Rome, was the first major style in Vermont and was widely used from the late 1700s through the 1830s. Elements of the style trim the symmetrical gable, hip, or gambrel roof houses of the period and grace the standard New England church form like frosting on a cake. The main stylistic focus is on the central entryway: a paneled door usually flanked by sidelights and thin columns or pilasters, and crowned by a semi-elliptical fan or fanlight, transom, or delicate entablature. Palladian windows may be centered above on the second floor.

Ornament on Federal style buildings ranges from delicate and sophisticated carving to naive interpretations of pattern book details. The thinly stretched columns and pilasters that decorate doorways, wall surfaces, and Palladian windows are usually plain or fluted, and often have Ionic or Corinthian capitals. Running under eavelines and over doors and windows are molded cornices that are sometimes enriched with dentils, and entablatures trimmed by intricately carved floral and swag motifs, fretwork, triglyphs, or other classical details. Curved lines made of wood or thin strips of lead trace weblike patterns in the glass of doorway fanlights, sidelights, and Palladian windows, while inset wall panels spring across brick facades in subtle arcing.

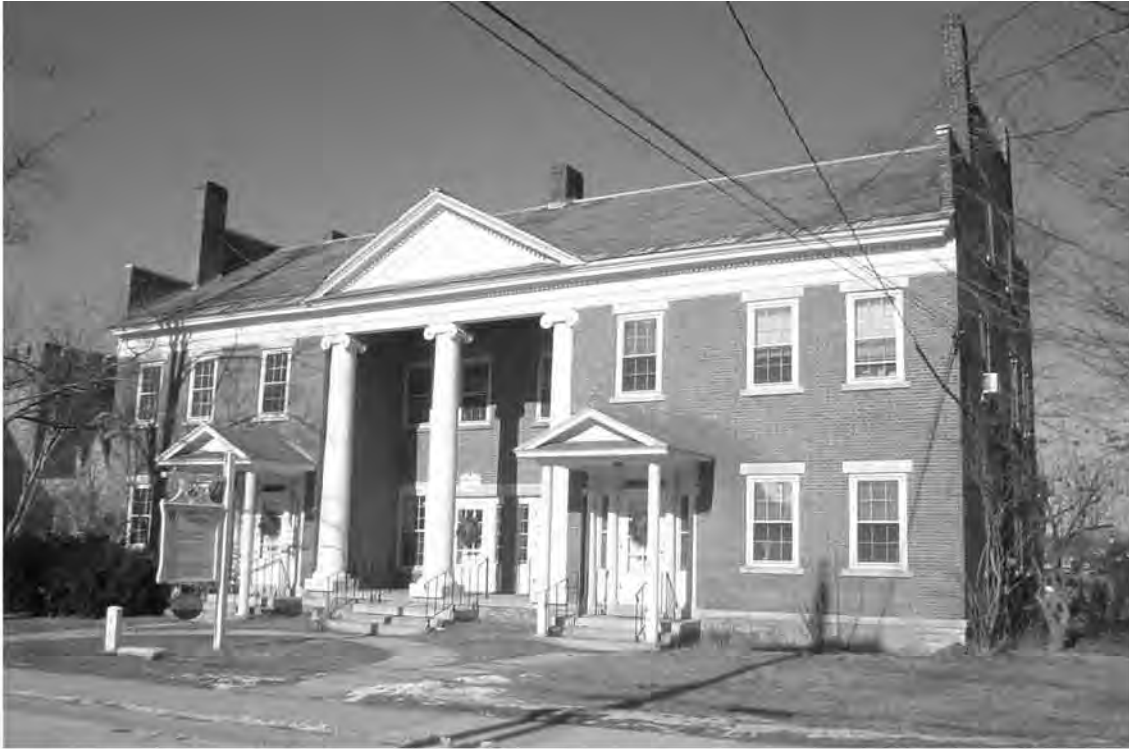
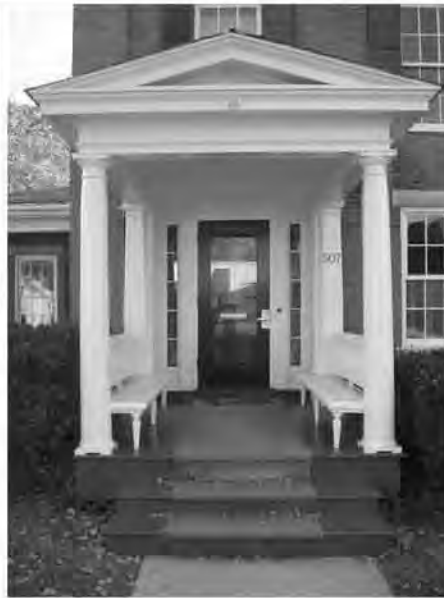
COLONIAL REVIVAL

The Colonial Revival style, popular for buildings of all kinds across the country from the late 1800s through the 1930s (and still in use today), was derived from American architectural styles first used in the 18th century. Building forms vary and range from the traditional Georgian plan for houses to central pavilions with sprawling ells for large institutional structures. Decorative features are based on details from the earlier styles but can be distinguished from them by their large scale and often unusual placement on the building facade. Among the most typical details are Palladian windows, porches with classical columns, doorways topped by fanlights or pediments, and full entablatures under the eaves.

Other Colonial Revival style features include entablatures with large dentils, modillion blocks, or ornamental swags; beltcourses; balustrades with bulbous turned balusters crowning rooflines; doors with sidelights and topped by transoms, fanlights, or pediments; quoins or pilasters on building corners; and by the 1910s cupolas and weather vanes. One or two of these details, usually a Palladian window or porches with columns, were also used during the period for simple gable front homes, Foursquares (popular into the 1920s), and to update older buildings.

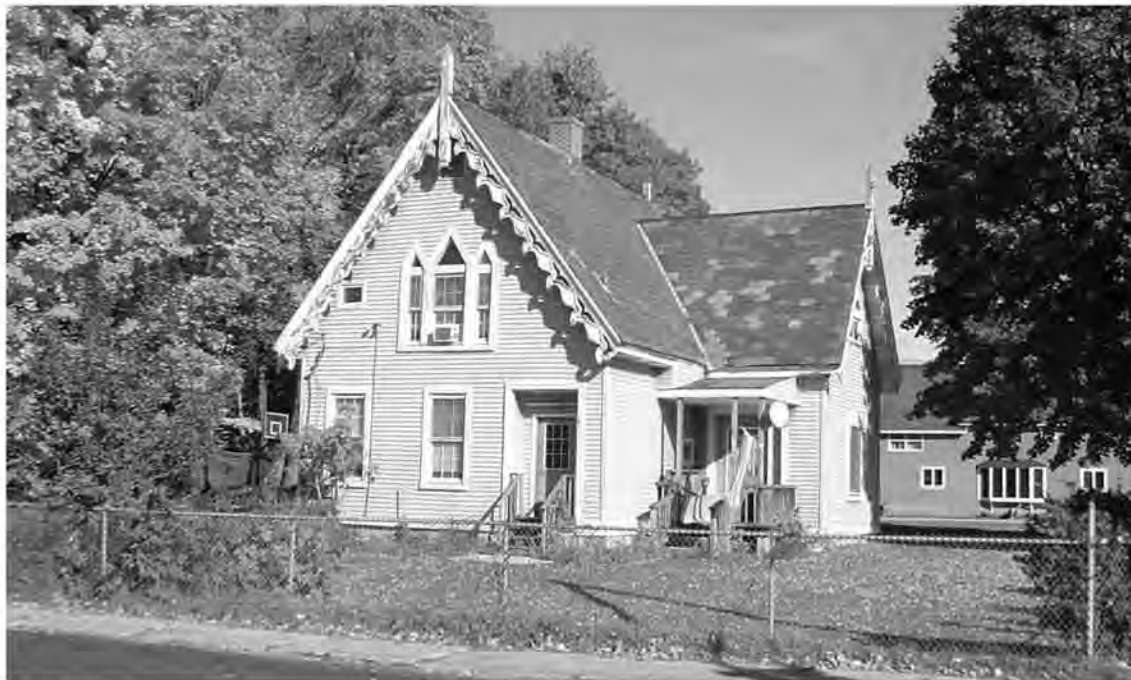
GOTHIC REVIVAL

The Gothic Revival style with its irregular forms and pointed details was used for churches in Vermont from the 1820s to 1840s, adding a note of medieval picturesqueness to an established landscape dotted with classical Federal and Greek Revival style buildings. Built in the common New England meetinghouse form, these churches were made Gothic by the use of such elements as pointed arch windows with small diamond-shaped panes, and pinnacles and cresting atop belfry towers. By the 1850s and 1860s the style was also being used for houses, although it was never as popular as the Greek Revival style. Whether a symmetrical Classic Cottage or a structure irregular in form, the Gothic Revival style house usually has a steeply pitched roof and wall dormer ornamented along eavelines by carved or scroll sawn bargeboards, decorative porches, and molded label lintels over window and door openings.

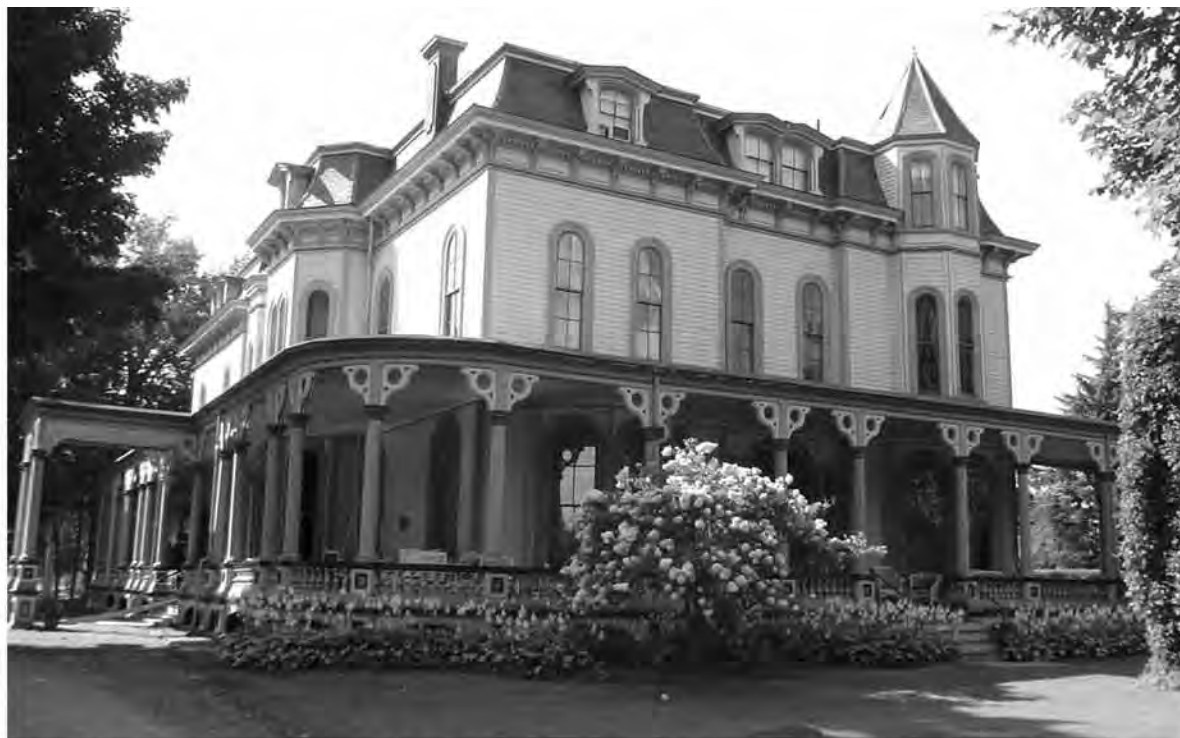
FRENCH SECOND EMPIRE

Mansard roofs top all French Second Empire style structures — residences, public buildings, and commercial blocks. Popular in Vermont during the 1870s and 1880s, this elegant style shares many characteristics of the Italianate style, including cubical forms, prominent eaves supported by curved brackets, paired windows, and sweeping verandas with chamfered posts and matching brackets.

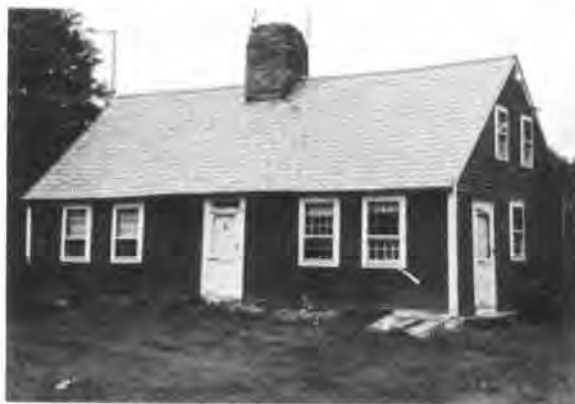
Cape Cod (Clarendon)

Cape Cod type houses were among the earliest and most common dwellings built in Vermont. The term for this distinctive New England house was first used by the Rev. Timothy Dwight, president of Yale College, who noted it in his diary while on a trip through Cape Cod in 1800. Cape Cods were built in Vermont in the late 1700s and early 1800s. They are characteristically 1½ stories tall, five bays wide across the eaves side with a central entry, and have eaves with little or no overhang. While most have gable roofs, there are some with gambrel roofs. Inside, the two large front rooms and several smaller rear rooms are grouped around a massive central chimney. Most Cape Cods are stylistically plain, but some are ornamented with such Federal style details as fanlights, sidelights, pilasters framing the doorway, and door or eavesline cornices, which are occasionally enriched with dentils or modillions. Variations include half plans, only three bays wide across the eaves side with the door in the left or right bay, and three-quarter plans, four bays wide with the door in the second or third bay.

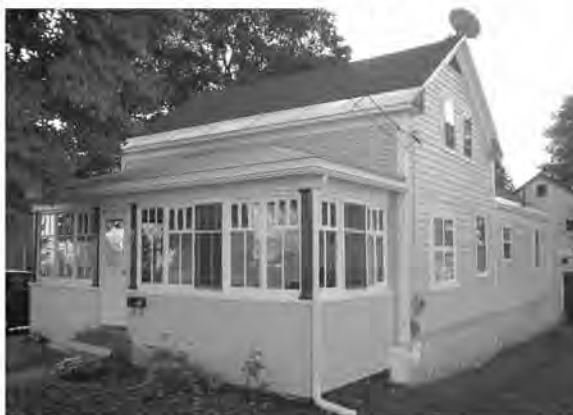
Classic Cottages, built during the second and third quarters of the 19th century, were a popular house type in Vermont. They are so-named because they often are ornamented with classical details commonly used in the Greek Revival style. Some also were built with or later altered by the addition of Gothic Revival style features. Five bays wide across the eaves side with a central door, these 1½ or 1¾ story tall houses usually have gable roofs and are characterized by a high kneewall (the wall area between the eaves and tops of the first floor windows) and small stove chimneys, often placed symmetrically along the ridgeline. Inside, two large front rooms generally flank a small central hall with smaller rooms located in the rear. They were often expanded by building attached wings or ells. Variations include half plans, only three bays wide across the eaves side with the door in the left or right bay, and three-quarter plans, four bays wide with the door in the second or third bay.

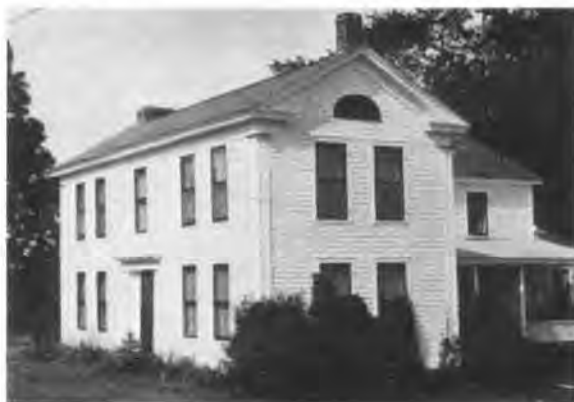
*I-House (Danby)*

I-houses are 2 or 2½ stories tall and five bays wide across the eaves side with a central doorway, but unlike Georgian plan houses are only one room deep instead of two. They usually have gable roofs, and more rarely hip roofs. Built in many parts of the country, they were first identified and named by scholars studying the type in Louisiana who noticed that many builders of these narrow houses in that state originally came from Iowa, Indiana, and Illinois. I-houses were most commonly built in Vermont from the late 1700s to the mid 1800s, and sometimes were ornamented with Federal and Greek Revival style details. Variations include half plans, only three bays wide across the eaves side with the door in the left or right bay, and three-quarter plans, four bays wide with the door in the second or third bay.

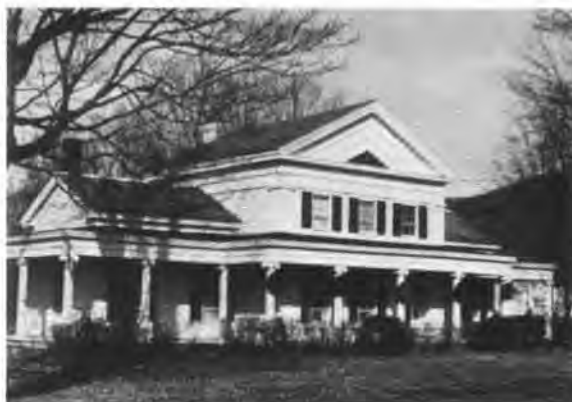
*Pavilion with ells (Wells)*

Pavilion with ells plan houses, not often found in Vermont, were built here from the 1830s through the Civil War period. This plan was derived from the symmetrical architecture of the 16th century Italian architect Andrea Palladio, which was revived in the 18th century. It was popularized in America by a design in an influential 1832 handbook published by Minard Lafever, an accomplished New York City architect and builder of Greek Revival style structures. Pavilion with ells plan houses consist of a main block, usually gable front and 1½, 2, or 2½ stories tall, with flanking matching ells. Roofs are either gabled or hipped. Although some are relatively plain, others are ornamented with Federal and, more commonly, Greek Revival style features. A few late examples were built in the Italianate style.

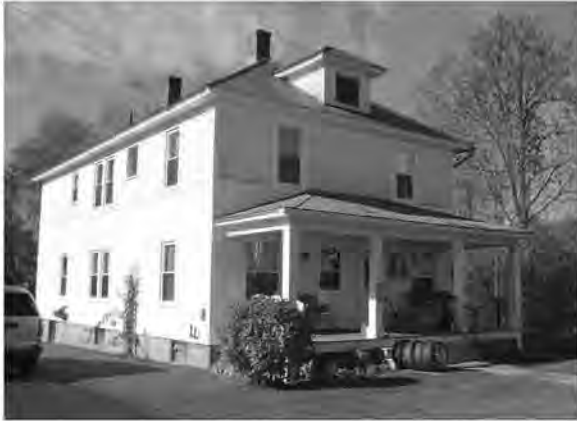
Foursquares are large 2 story houses, nearly square in size, with hip roofs, full width front porches, and usually a central dormer. They were popular especially in the cities and suburban areas of Vermont from the early 1900s through the 1920s. Although simple in form, many are varied by the use of a mix of clapboard, wood shingle, masonry, stucco, or concrete blocks for wall surfaces, and are ornamented with Colonial Revival style details.

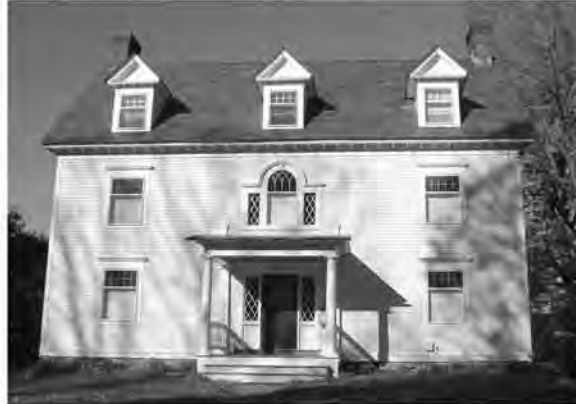
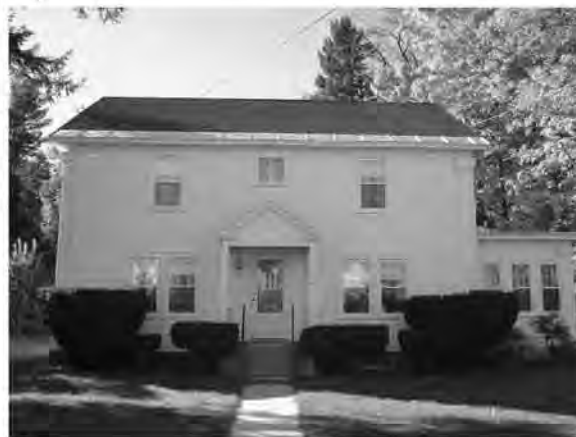
GEORGIAN PLAN

Georgian plan houses, named after the formally symmetrical architecture of 18th century England during the reign of the three King Georges, were first built in Vermont in the late 1700s. These 2 or 2½ story houses are five bays wide across the eaves side with a central doorway and usually have their chimneys near the gable ends. Most Georgian plan houses have either gable or hip roofs, while some later 19th century examples may have Mansard roofs. Inside, the center hallway is flanked on each side by a front and rear room. The term is also used in this publication to mean houses of the same form but with a central chimney. In the earliest Georgian plan houses, the tops of the second story windows are often located right under the eaves. This popular house type was in continual use from the late 1700s through the mid 1800s, and was revived again in the early 1900s. Although some Georgian plan houses are plain with little or no ornament, many are embellished with Federal, Greek Revival, Italianate, and Colonial Revival style features. Variations include half plans, only three bays wide across the eaves side with the door in the left or right bay, and three-quarter plans, four bays wide with the door in the second or third bay.

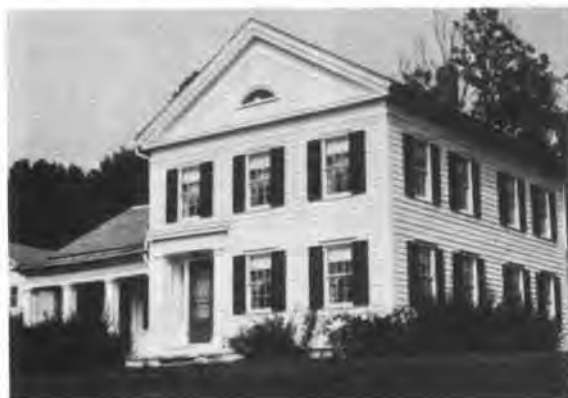
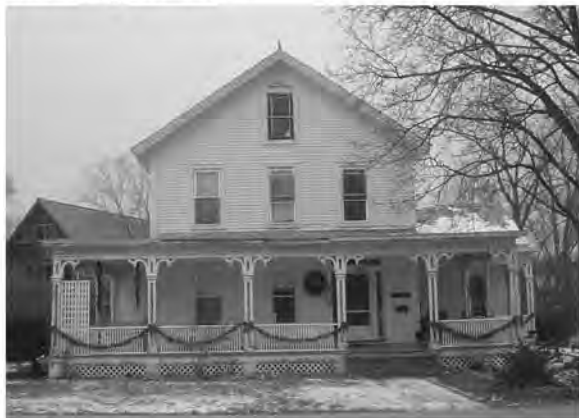
SIDEHALL PLAN

Sidehall plan (Pawlet)

Sidehall plan houses, built in Vermont throughout the 19th century, were particularly popular between the 1830s and 1870s. Characterized by their gable front facades, they are 1½, 2, or 2½ stories tall, and are so-named because the main door, located in the left or right bay, opens into a side hallway. While some sidehall plan houses are relatively modest, many others are ornamented with detailing from the Federal, Greek Revival, Gothic Revival, Italianate, and other 19th century styles. The houses were often expanded in size by building an ell to one side or an offset wing on the rear.

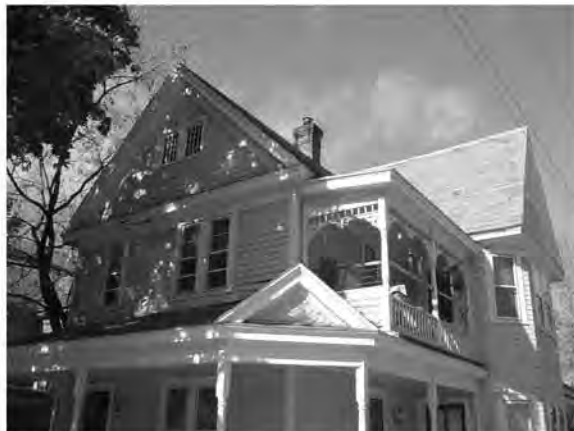
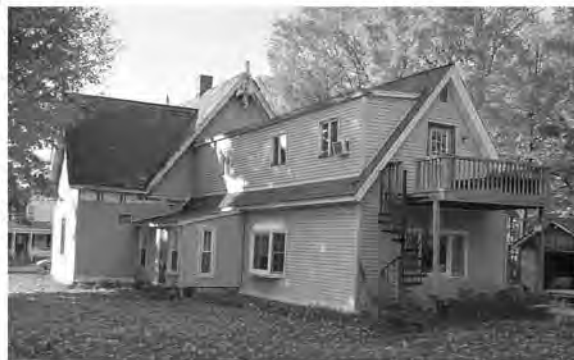
TRI-GABLE ELL

Tri-Gable Ell plan houses consist of a 1½, 2, or 2½ story gable front block with an ell that closely matches it in height. Popular in Vermont in the last quarter of the 19th century and the early 20th century, this plan gets its name today for its three exposed gable ends (two on the main block and one on the ell). Although some are modestly detailed, nearly all have porches and many are enriched with features from the Queen Anne, Shingle, and Stick styles.
