Town of Greenfield, MA Baseline Tree Inventory February 2014

A Sustainable Franklin County

Green Infrastructure Implementation Project

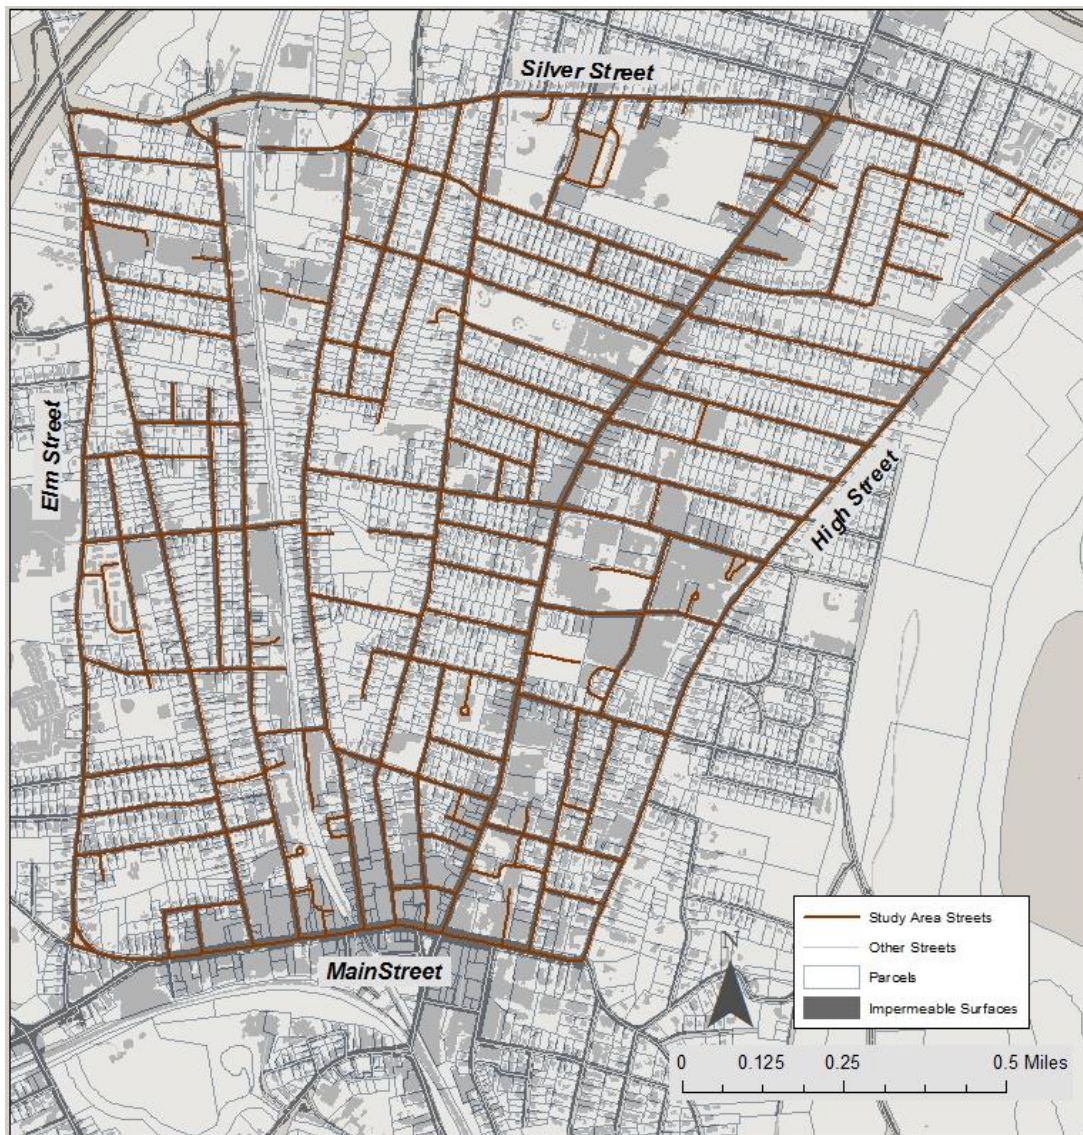
Project area: The project area was defined as all street trees located on or within the bounds of Silver, High, Main, and Elm Streets.*

* A phase 2 baseline inventory should include any densely populated areas on the perimeter of the project area

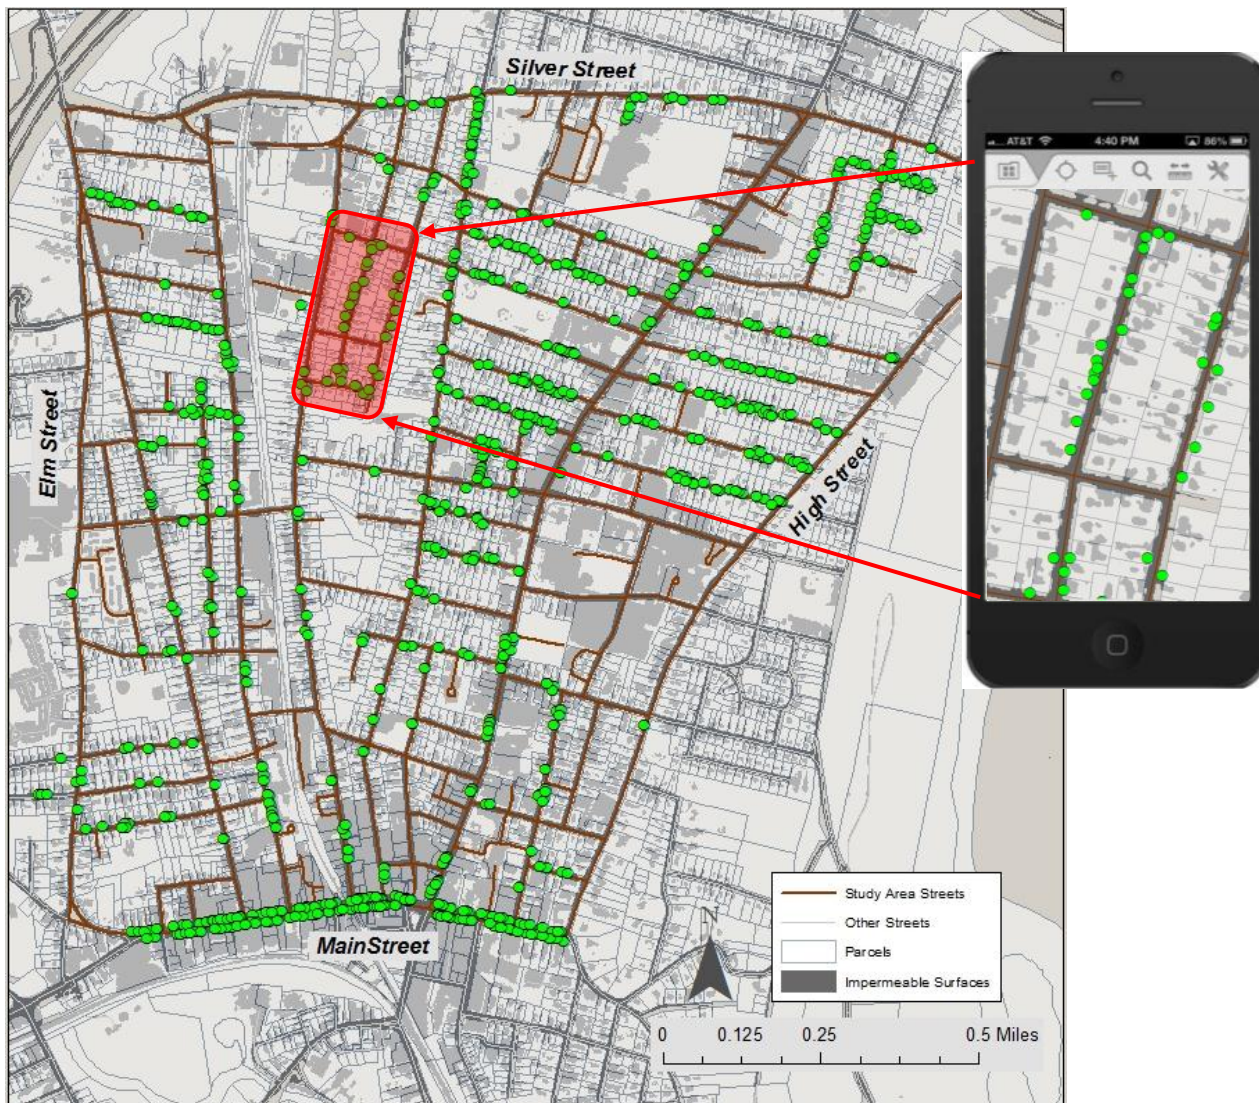
Data was collected using [Collector for ArcGIS](#) on an Android device. A GIS-based map which included a tree layer with data fields, a street base map, parcel data and impermeable surfaces was created and shared on ArcGIS Online. The map was accessed in the field with an Android phone. Each tree was inventoried and saved as a data point on the map, which was automatically synced with the online map.

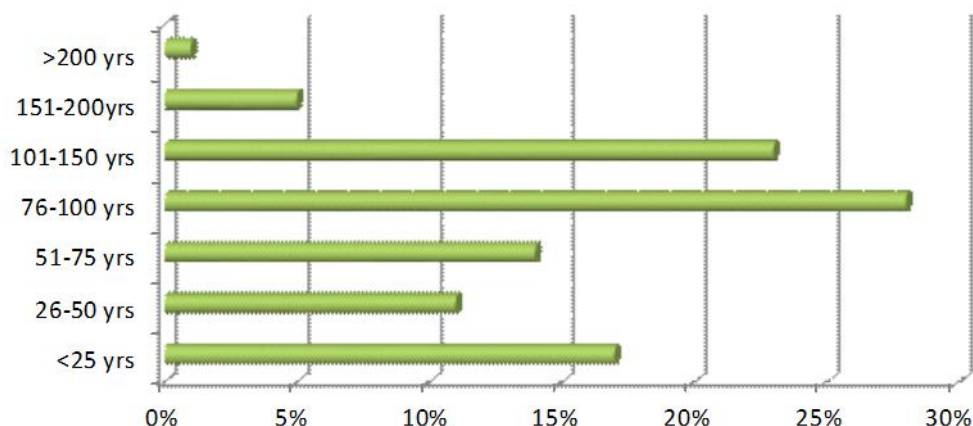
Tree Age: Percent of All Trees

71% of all trees are **over the age of 50.**

A low diversity of tree age—and a large percentage of older trees—means that trees could die out in large numbers as they reach the end of their lives and/or succumb to stressors common to street trees.

A population of street trees with diverse ages will only be achieved if the Town of Greenfield pursues an aggressive planting plan. Planting must outpace tree death / removal for many years to come in order for the Town to methodically address the lack of street tree age diversity.

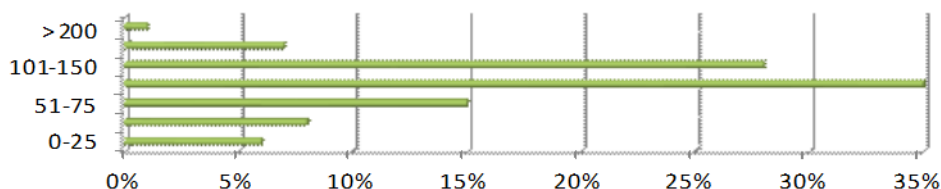
Tree Age: Percent of All Trees except Main St and north block of Davis Street

Factoring out Main and north Davis, **86%** of all trees are **over the age of 50**

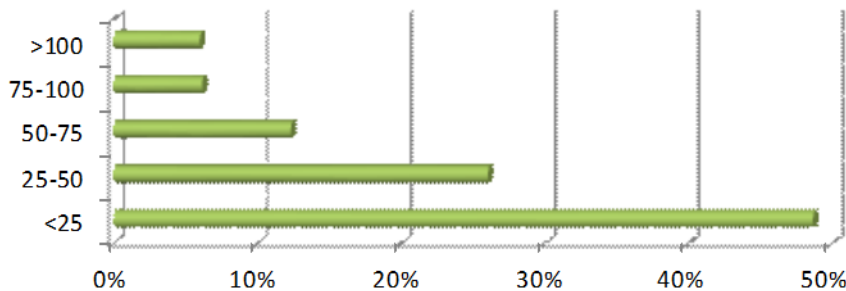
Tree Age: Percent of All Trees on Main St

76% of all trees on Main Street are **under the age of 50.**

Implications: With over 3/4 of all of Main Street’s trees under the age of 50, most do not achieve an adequate height or spread to provide significant green infrastructure benefits that larger trees provide, including reducing energy use, reducing stormwater runoff, improving air quality, providing habitat for pollinators and song birds, and enhancing human health and well-being. Challenges to Main Street’s trees longevity include poor soil quality, small tree pits, soil compaction, inadequate water, vandalism, and injuries caused by cars, bikes, and plows.

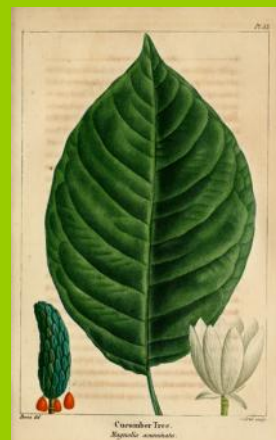
These trees are native to eastern North America and reach their greatest size in moist soils of slopes and valleys in the mixed hardwood forests of the southern Appalachian Mountains. They are widespread but not abundant. Unusual in urban settings, the (likely) sole cucumber tree in Greenfield is perched above a sidewalk across the street from the Davis Street School. The tree is so named because of its cucumber-shaped fruits, which develop after white flowers bloom singly at the ends of the tree’s branches. The massive cucumber magnolia on Davis Street is a stunning species and is worth a visit!

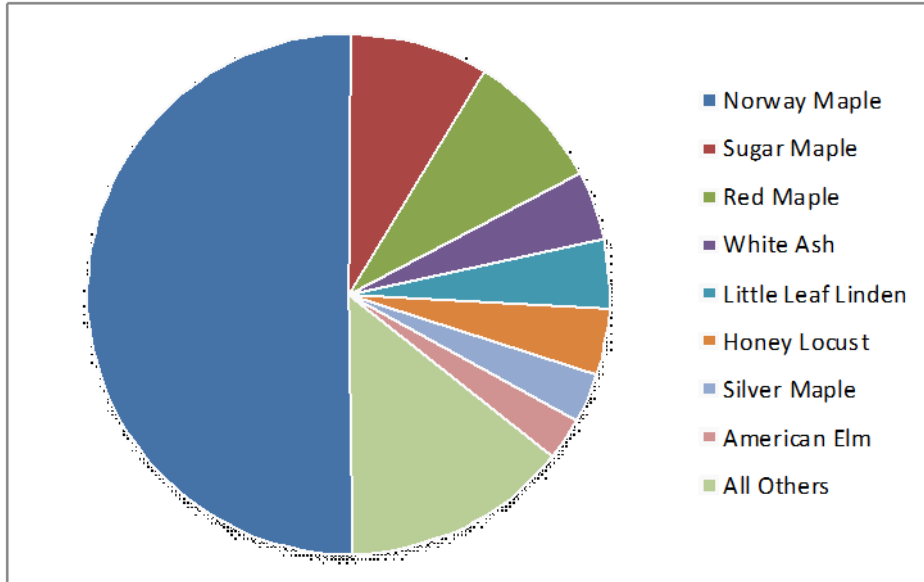
51% of all trees in the project area are **Norway maples**.

Implications: With over 1/2 of all trees in the project area identified as **Norway maples** (*Acer platanoides*), Greenfield's street trees lack a healthy species diversity. As seen throughout history, lack of tree species diversity can have catastrophic consequences. Historic photos of Greenfield show stately elms lining its streets. Because so many street trees were elms, Dutch Elm Disease, introduced into the states in the 1930s, had a devastating impact on the Town's stately elms, most of which succumbed to the disease. In the project area, only 20 American Elms (*Ulmus americana*) were identified.

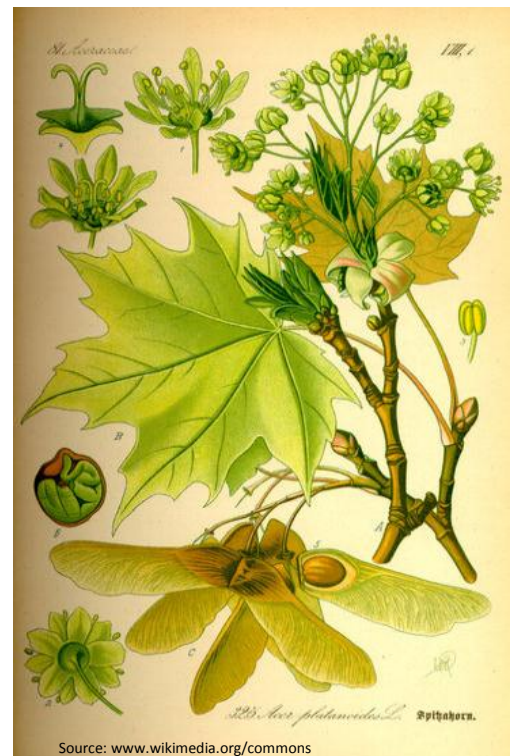
Norway maple (*Acer platanoides*), which makes of 51% of street trees in the project area, is on **Massachusetts Prohibited Plant List**.

In addition to the large percentage of Norway maples contributing to lack of tree species diversity in Town, they are also non-native trees and are considered invasive. They are listed on the MA Department of Agricultural Resources **Massachusetts Prohibited Plant List**, which prohibits the importation, sale, and trade of the plants. Individual trees can produce large quantities of seeds that are dispersed by wind and invade forests, forest edges, and urban areas alike. The dense canopy formed by Norway maple inhibits the regeneration of sugar maples and other diverse tree species, important to our mixed hardwood forests.

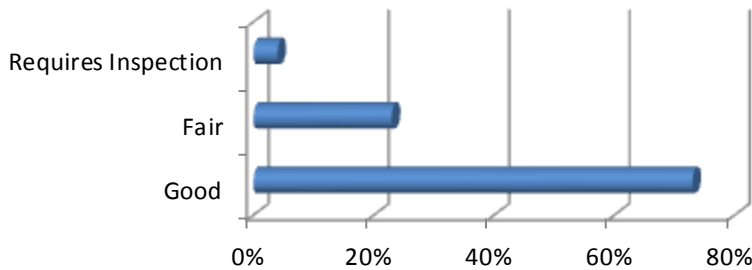
Tree Condition* - Percent of All Trees

*Tree condition was determined based upon an informal visual assessment. Actual condition should be determined by the Greenfield Tree Warden or other certified arborist.

An informal assessment was conducted of tree condition. While most trees were judged to be of good or fair condition, about four percent of trees were rated as needing an assessment by the Greenfield Tree Warden, due to visible signs of severe rot, deterioration, or dead or hanging limbs, potentially posing a risk to pedestrians. Many of the trees deemed fair were assessed as such due to heavy pruning, misshapen forms and other similar factors.

| Goals | Strategies | Responsible Group |
|---|--|---|
| | Utilize inventory results to help plan priority tree maintenance needs. Any trees receiving an “x” rating for condition should be prioritized to be formally assessed by the tree warden. | DPW; Tree Warden |

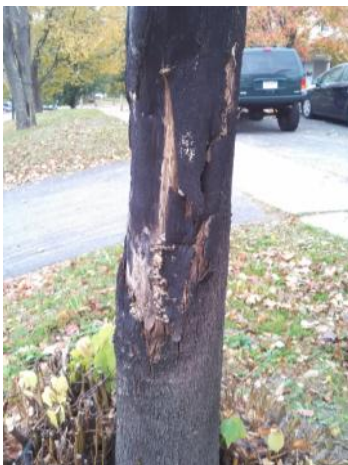
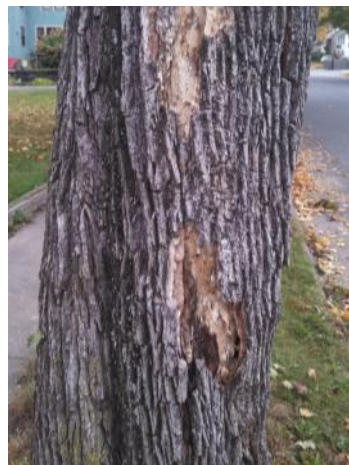
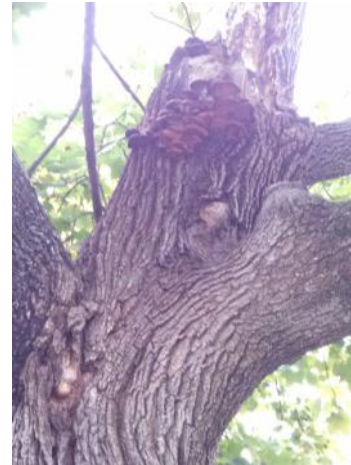
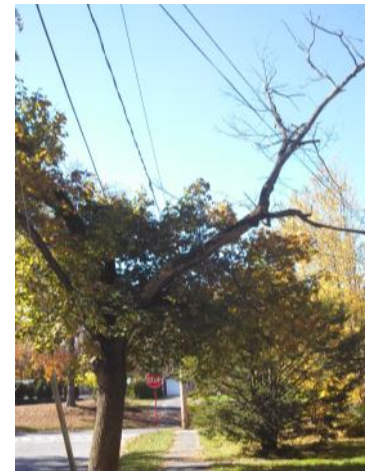
Trees with conditions rated as needing assessment by the Greenfield Tree Warden included those with substantial rot and broken and dead limbs.

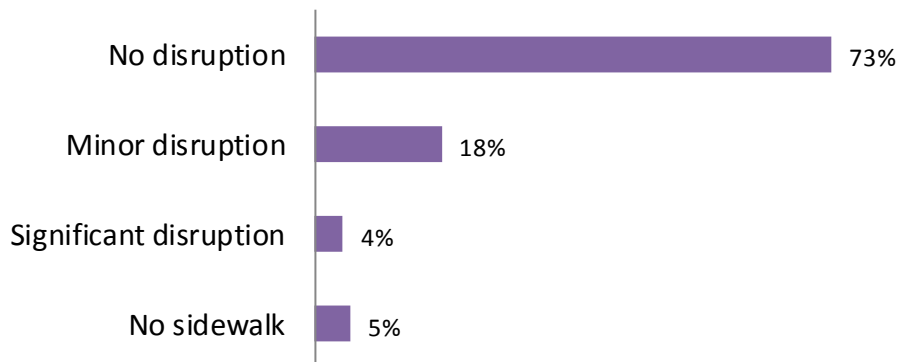
Sidewalk Disruptions

Sidewalks were assessed for damage or disruptions due to the proximity of trees and tree roots. Seventy three percent of street trees were adjacent to sidewalks that showed no disruption, eighteen percent were adjacent sidewalks with minor disruptions, and four percent were adjacent sidewalks with significant disruptions. Five percent were located where sidewalks were not present.
