CERTIFICATE OF LOCATION OF GOVERNMENT CORNER

North Quarter Corner of Section 17, Township 40 North, Range 23 West,
4th Principal Meridian, Kanabec County, State of Minnesota

SKETCH OF REFERENCE TIES

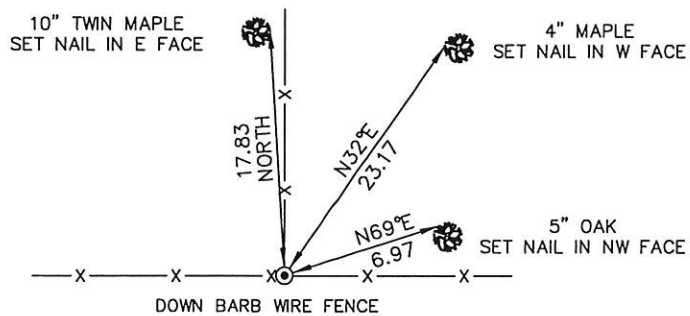
At the corner location shown on the sketch:
On 9/23/2014 set a 7/8" x 36" Rebar with Aluminum Cap.

NOT TO SCALE

On 9-23-2014, I made a search by checking with a magnetic locator and probing the ground with a machete. I found a down barbed wire fence running east-west and north. I found a rotten wooden fence post at the intersection of the fences. This location fit the DNR's distances within reason. I set a 7/8" x 36" Rebar with Aluminum Cap at the fence line intersection and established reference ties.
