# CONSTRUCTION OBSERVATION REPORT

<b>Date:</b> October 14, 2021	<b>Time On Site:</b> 10:00 AM	<b>Time Off Site:</b> 12:00 PM
<b>Project:</b> Middlebury River Flood Resiliency Project (15032.00002)		
<b>Observed By:</b> Roy Schiff		
<b>Weather:</b> Overcast, 60°F, flows up a little from rain

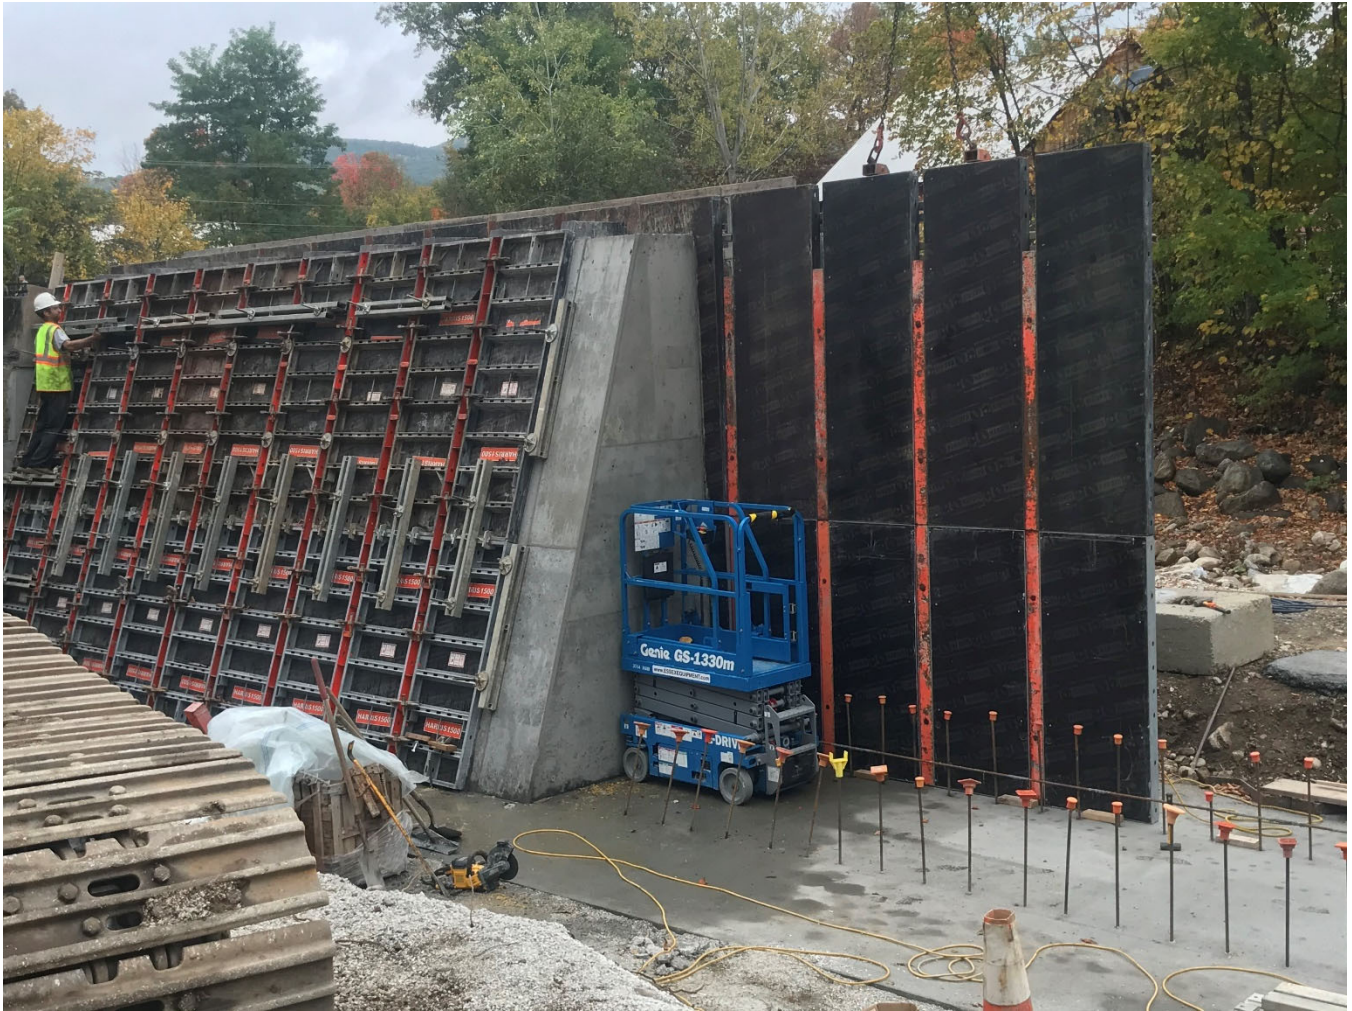
- First 28 feet of wall curing. Viewed end that looks good.
- Pumping operation continues and hole for wall is dry and clean. Discharge water is flowing clear.
- Met with Nancy and George Marcus to discuss landscaping. Plan to meet as group with landscape contractor when we walk full site to discuss plantings.

**Figure 1: First section of flood wall. Form on end removed to connect to back of next section that has small offset. Front form being installed.**
