CONSTRUCTION OBSERVATION REPORT

Date: November 22, 2021	Time On Site: 8:30 AM	Time Off Site: 10:00 AM
Project: Middlebury River Flood Resiliency Project (15032.00002)		
Observed By: Brian Cote		
Weather: Cloudy, 45°F, normal flows

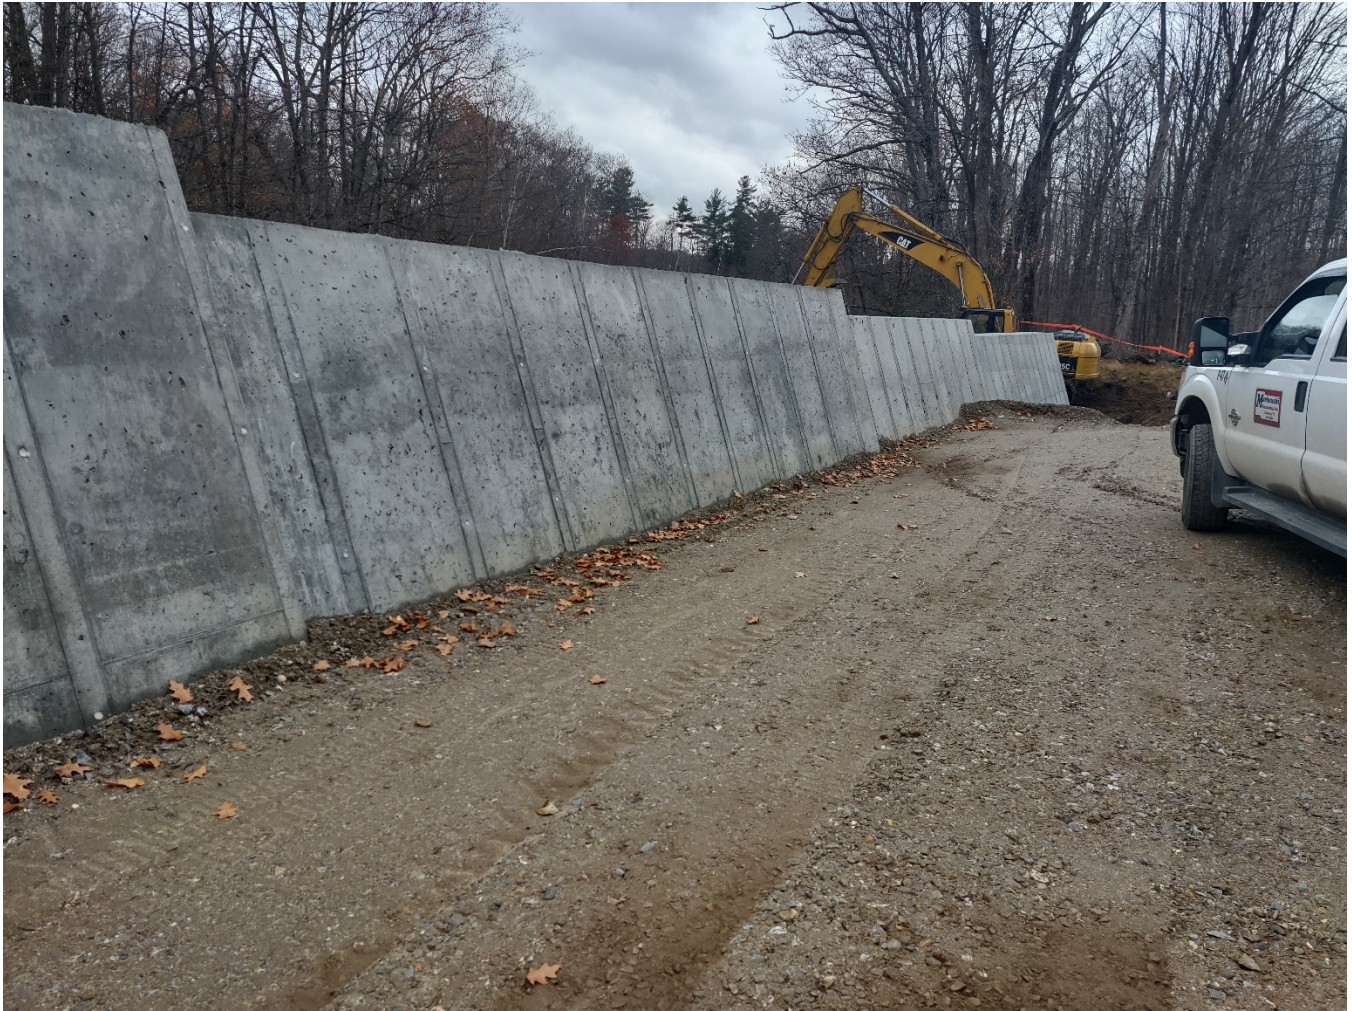
Figure 1: View of completed backfill behind new flood wall extension, only final section remains once concrete has cured enough to be backfilled.

- Backfilling complete except last section of new floodwall, concrete needs to cure properly prior to backfill placement. Ok to backfill on November 24th.

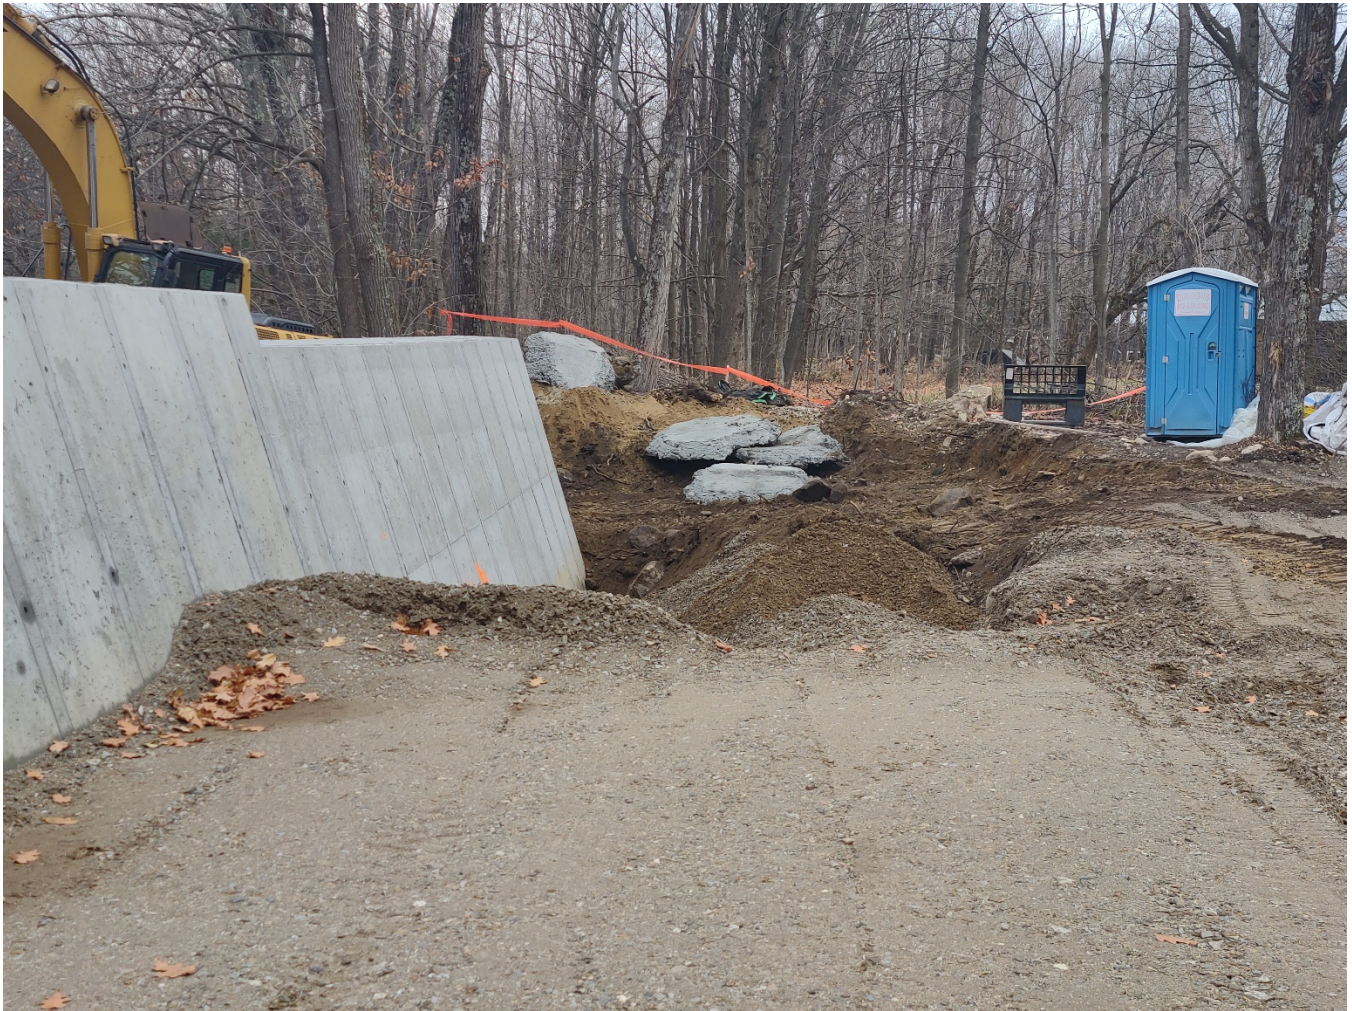
Figure 2: Concrete “pads” (visible in the background) and other miscellaneous trash being removed from the river prior to removing access road.

- Removal of concrete “pads” and other miscellaneous trash underway while on site.
- Removal of the access road along the river at the base of the new and existing floodwall to take place during the week of Nov. 22nd, restoring stone armoring at the base of the floodwall.
