# CONSTRUCTION OBSERVATION REPORT

<b>Date:</b> May 17, 2022	<b>Time On Site:</b> 12:00 PM	<b>Time Off Site:</b> 2:00 PM
<b>Project:</b> Middlebury River Flood Resiliency Project (15032.00002)		
<b>Observed By:</b> Brian Cote		
<b>Weather:</b> Mostly cloudy, periods of rain, 60°F, flows up after recent rain

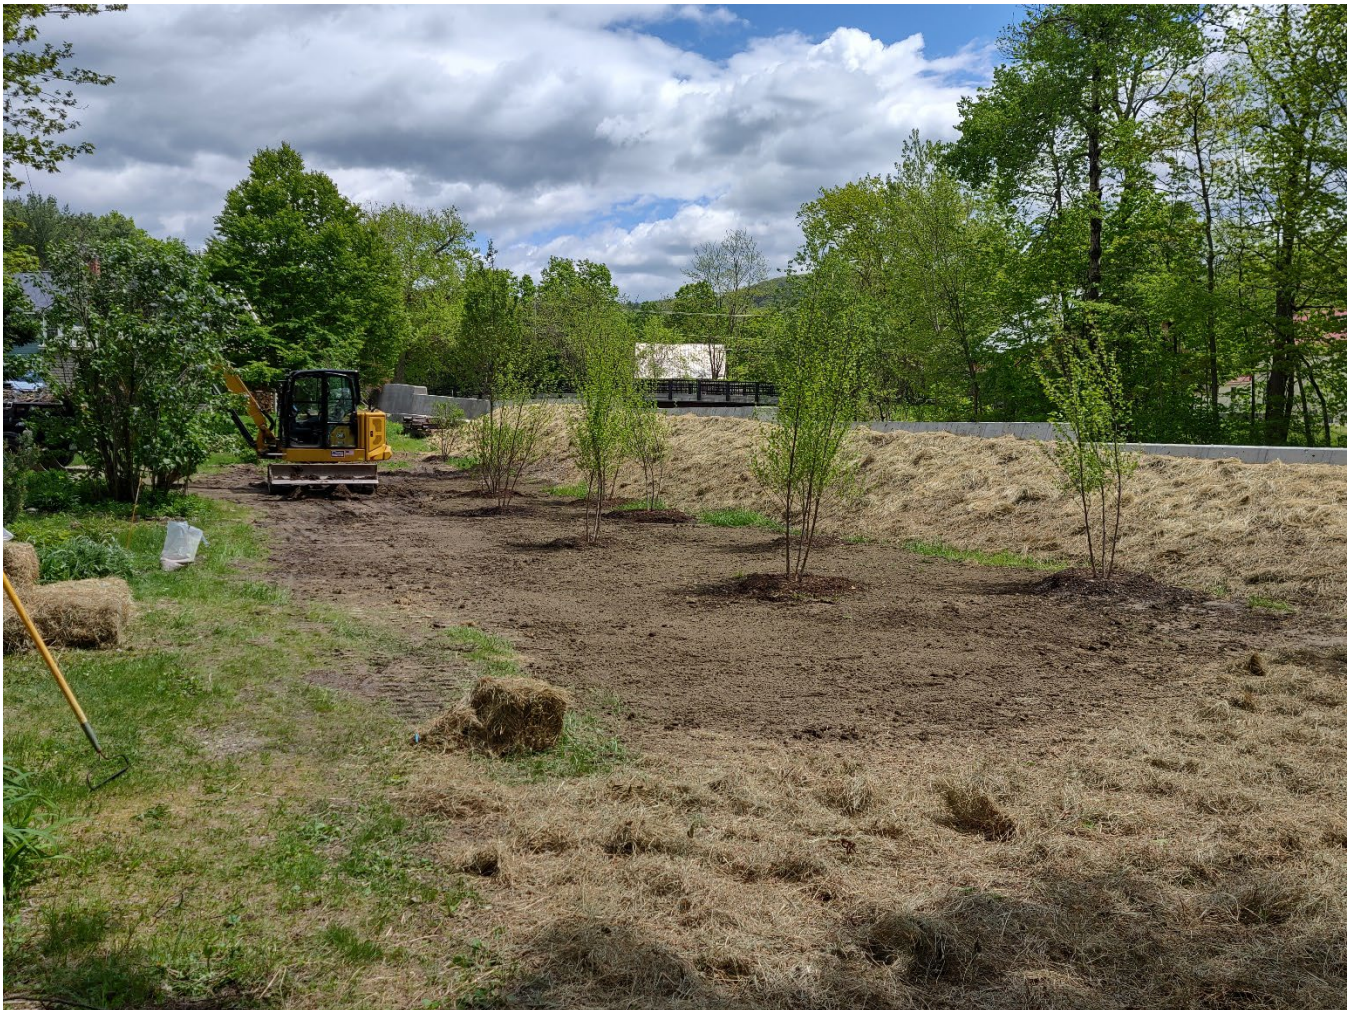
**Figure 1: Work underway to restore disturbed area at the new flood wall. Earthen slope behind new flood wall has been seeded and mulched. River birch clusters planted along the base of the earthen slope.**

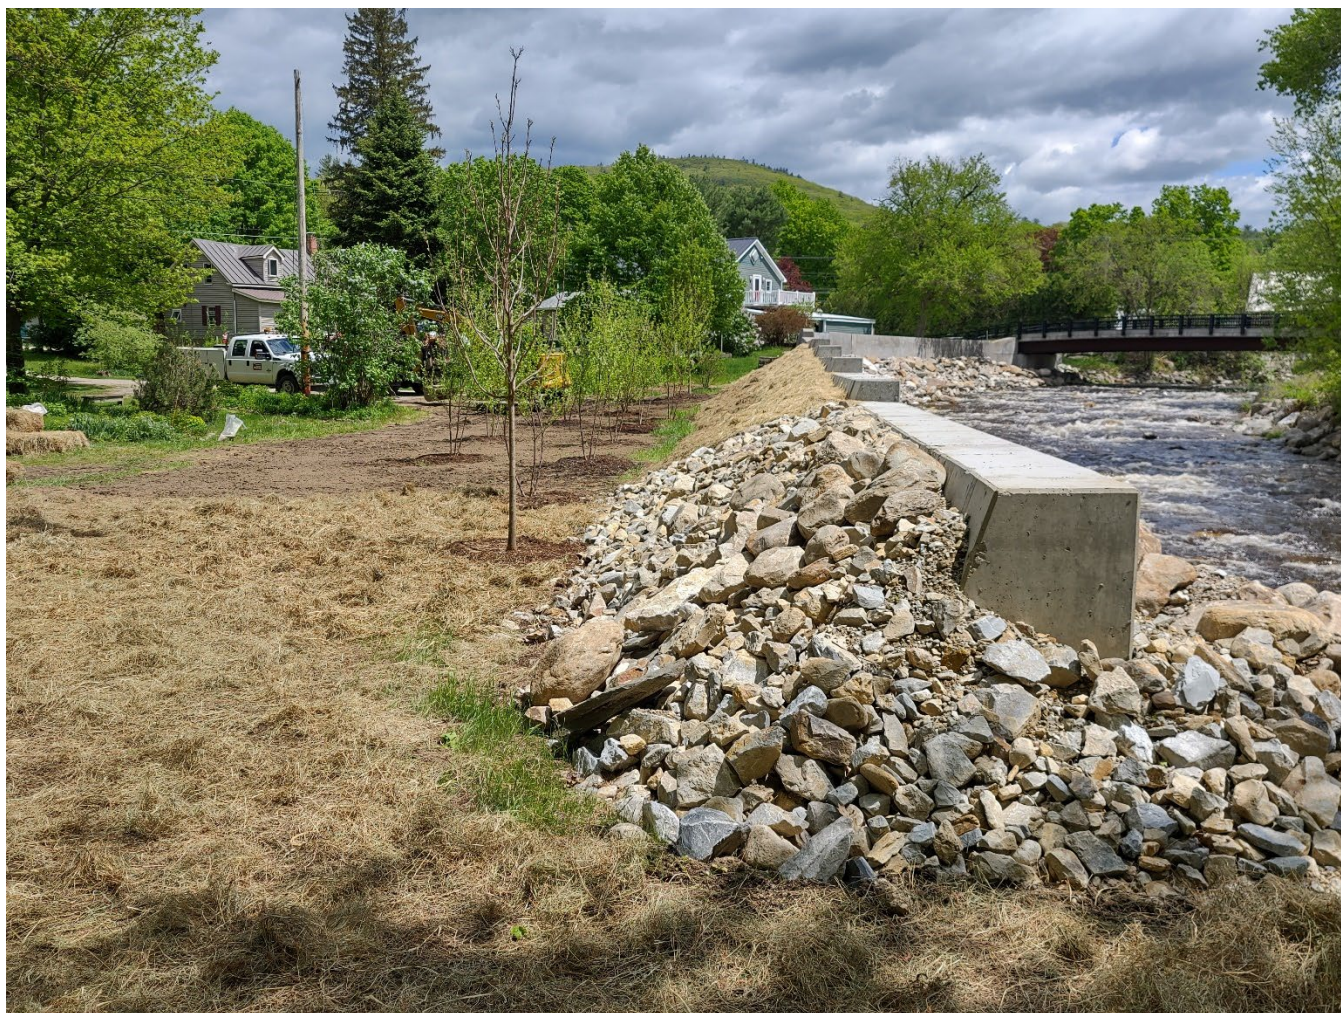
**Figure 2: Restoration underway at the new flood wall, planted maple visible at the base of the stone slope.**

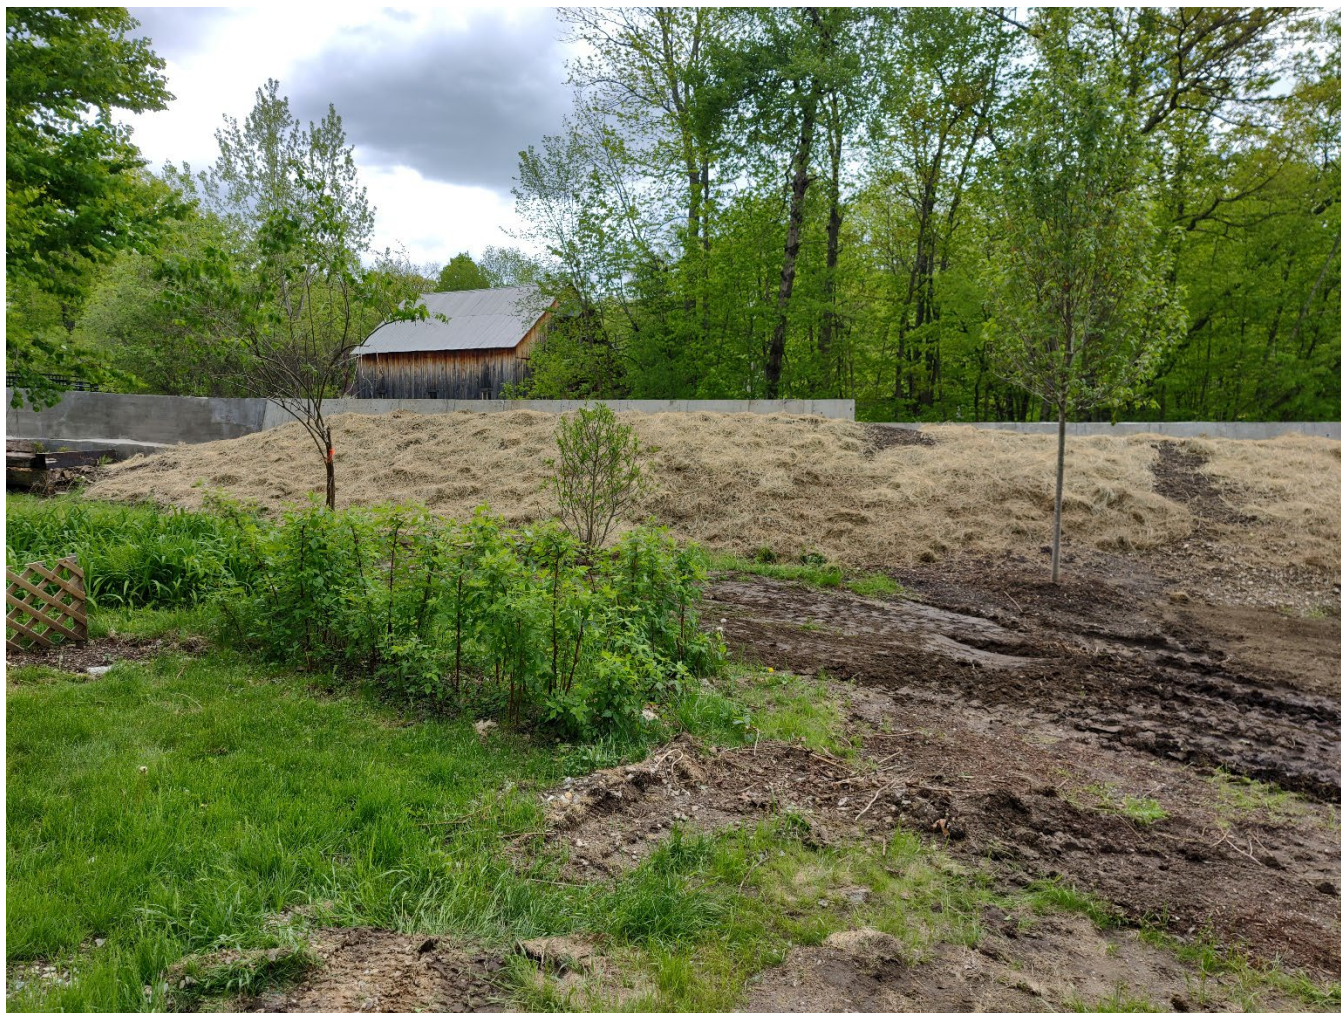
***Figure 3: Restoration work underway at new flood wall, planted maple tree, lilac, and relocated shrub visible in the background at the base of the earthen slope.***
