# 2014 Aquatic Macrophyte Survey Report

ALCYON LAKE, PITMAN, NJ

AUGUST 28, 2014

**REPORT FOR: Pitman Environmental Commission**

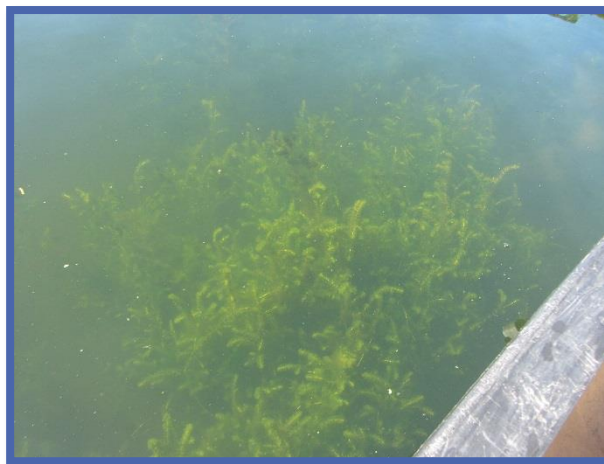
Figure 1: Alcyon Lake 2014 Macrophyte Survey - Dense Hydrilla at the Lake Surface

and often forms dense mats creating a monoculture with little or no value to the other lake biota (Fig 1). The moderate and dense abundance areas were concentrated in the southern half of the basin with large patches in the small cove just south of the launch and again along the eastern shoreline south of the cove. However, it should be noted that at least trace abundance was noted through most parts the basin.

Since hydrilla produces tubers (unaffected by herbicide), several consecutive years of Sonar applications are likely needed of this site to exhaust the tuber population in the sediment bank. We would expect repeating the Sonar treatments in 2016. In late 2016, Allied Biological recommends a repeat of the aquatic macrophyte survey, plus tuber monitoring, to determine the need for additional control methods in 2017 and beyond.

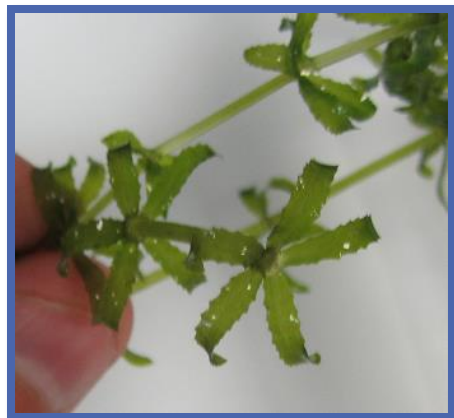
Figure 2: Hydrilla - Serrated edges and leaf whorls.

the boat launch in an area perhaps 0.5 acres in size. In two years, it has spread throughout much of the basin. Hydrilla is extremely invasive, and produces an overwintering tuber that can persist in the sediment for several years and remain visible. Allied Biological recommends aggressive herbicide use to target hydrilla in 2015. It should be noted that hydrilla can be easily confused with a native waterweed (*Elodea canadensis*). All samples of hydrilla were examined in the field and confirmed as hydrilla via serrated edges and leaf whorls (Fig 2). No tubers were found.

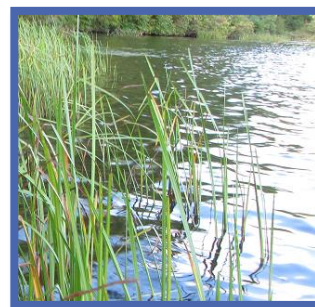
Common bur-reed (*Sparganium eurycarpum*), is an emergent reed found along the shoreline at Alcyon Lake, at the southern end of the basin. It was observed at one site, at trace density (Fig 3).

Figure 3: Alcyon Lake -  
Common Bur-reed

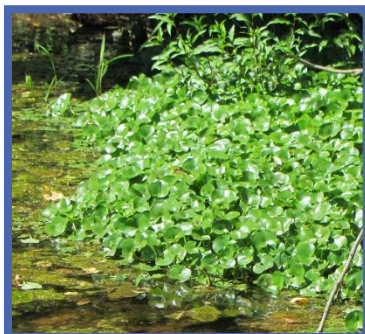
Three wetland terrestrial species were noted along the shoreline that should be mentioned; American frogbit (*Limnobium spongia*)(Fig 4), water pennywort (*Hydrocotyle spp.*)(Fig 5), and creeping water primrose (*Ludwigia peploides*)(Fig 6). Creeping water primrose is non-native while the others are native to the area. All three can be aggressive growers and quickly form large areas of dense growth along shoreline areas. The American frogbit was noted on either side of the boat launch area in two small patches. The water pennywort was scattered along the shoreline near the dam and scattered in smaller patches along both the eastern and western shorelines. Creeping water primrose was only noted at the north-east end of the basin adjacent to the dam in one small patch. These plants should be monitored moving forward and management strategies should be considered if they increase in density.

Figure 4: Alcyon Lake - American Frogbit

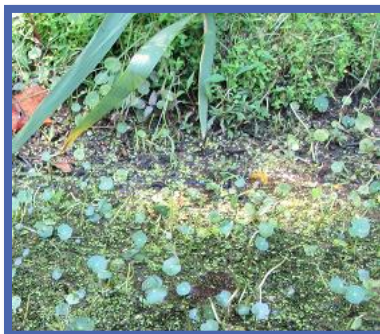
Figure 5: Alcyon Lake - Water Pennywort

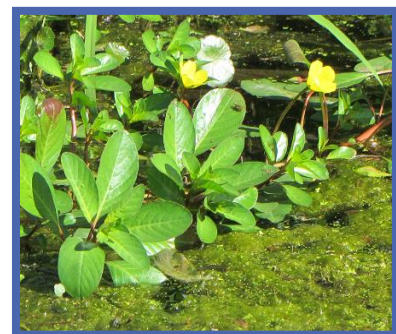
Figure 6: Alcyon Lake - Creeping Water Primrose

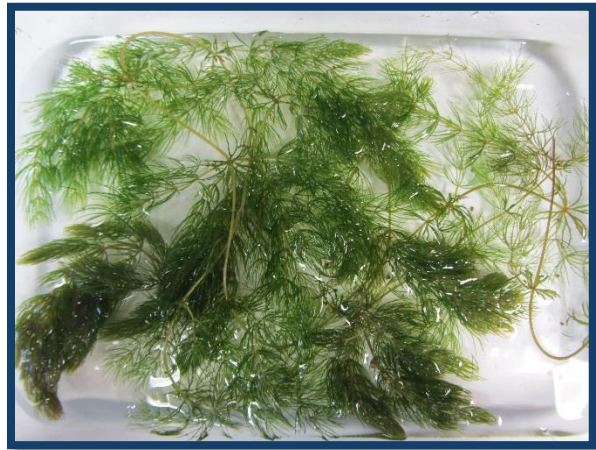
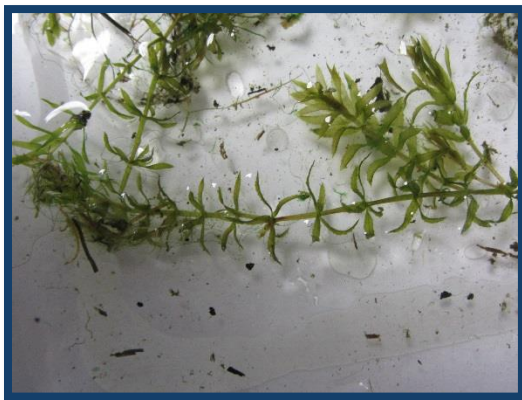
**Coontail** (*Ceratophyllum demersum*. Common Names: coontail, hornwort. **Native**): Coontail has long trailing stems that lack true roots, although it can become loosely anchored to sediment by modified leaves. The leaves are stiff, and arranged in whorls of 5-12 at each node. Each leaf is forked once or twice, and has teeth along the margins. The whorls of leaves are spaced closer at the end of the stem, creating a raccoon tail appearance. Coontail is tolerant of low light conditions, and since it is not rooted, it can drift into different depth zones. Coontail can also tolerate cool water and can over winter as a green plant under the ice. Typically, it reproduces via fragmentation. Bushy stems of coontail provide valuable habitat for invertebrates and fish (especially during winter), and the leaves are grazed on by waterfowl.

The dominant submersed aquatic macrophyte observed during the 2014 survey was coontail (*Ceratophyllum demersum*). Coontail was noted at 79 sites or 91% of sites surveyed. Nuisance level abundance was observed at 37% of the sites where the plant was present; 12 sites (15%) supported moderate abundance while 17 sites (22%) supported dense abundance. The heaviest densities were observed close to the launch area and north to the dam. Though a few sites supported moderate density in the southern portion of the basin, no sites supported

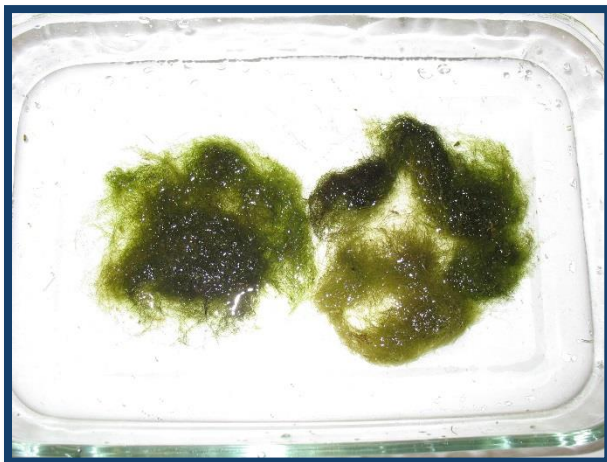
**Benthic Filamentous Algae:** Filamentous algae is a chain or series of similar algae cells arranged in an end to end manner. Benthic filamentous algae is attached to a hard substrate, such as logs, rocks, a lake bottom, or even other aquatic plants. When growing in heavy densities, benthic filamentous algae can appear as brown or green mats of vegetation that can reach the surface. When large pieces break off the bottom substrate they become floating filamentous algae

patches. Benthic filamentous algae can comprise an entire range of morphologies, but flagellated taxa are far less common.

Benthic filamentous algae (BFA) was observed at 32 sites (37%) during the survey. Six sites supported nuisance level growth, 7 (22%) were observed with moderate abundance and 1 site (3%) was observed with dense abundance. Sparse abundance was noted at the majority of sites, 16 sites (50%), most located adjacent to the shoreline. Eight sites (25%) supported trace abundance. Benthic filamentous algae was most often observed mixed with submersed vegetation.

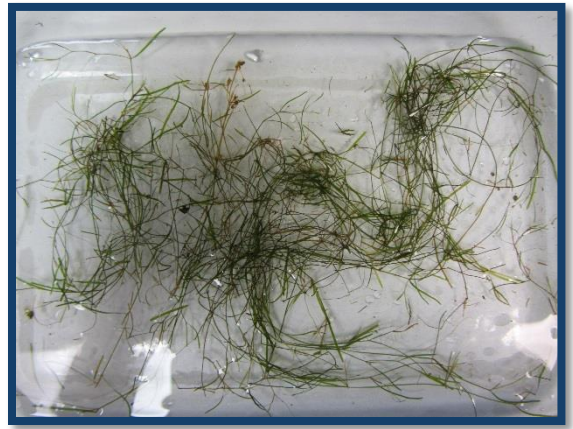
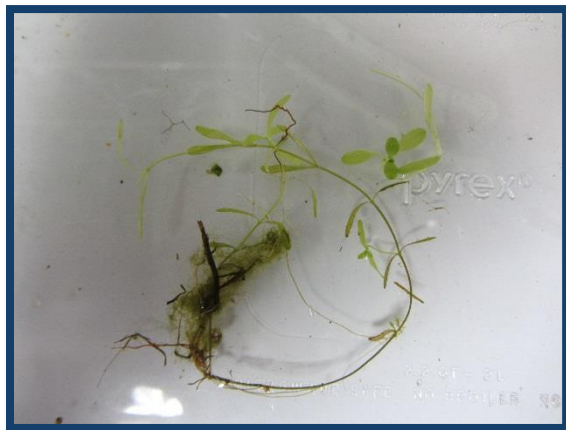
**Water-thread pondweed** - (*Potamogeton diversifolius*. Common Names: Variable-leaf Pondweed, variable-leaf pondweed, snailseed pondweed. **Native.**): Variable-leaf pondweed have freely-branched stems emerging from slender rhizomes. The submersed leaves are narrow and linear with one obvious midvein bordered by a row of hollow cells. The floating leaves are shaped like an ellipse, but are usually less than 4 cm long, Variable-leaf pondweed fruit spikes are produced in two distinct forms. It occurs in lakes, ponds, rivers and streams and prefers soft sediment and water less than 2 meters deep. Waterfowl graze on the fruit, and local fauna often graze on the stems and leaves.

Water-thread pondweed (*Potamogeton diversifolius*), another desirable native, was noted at 30 sites (34%) with most sites, 24 out of 30 (80%) supporting only trace or sparse abundance; 20 sites (67%) supported trace abundance and 4 sites (13%) supported sparse abundance. Moderate abundance was observed at 2 sites (7%) and dense abundance was noted at 4 sites (13%). The water-thread pondweed was most noted in the northern portion of the lake. The area that contained the heavier densities was in the central portion of the northern half of the basin.

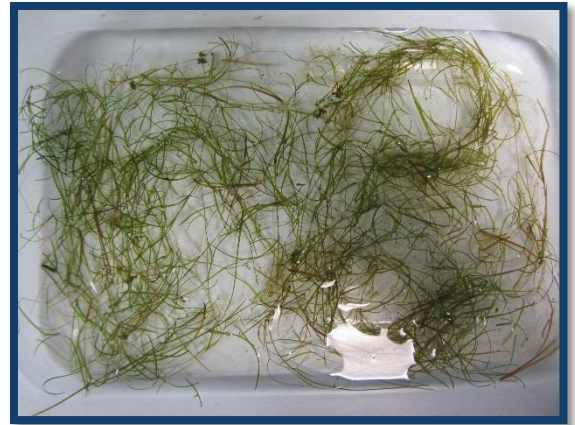
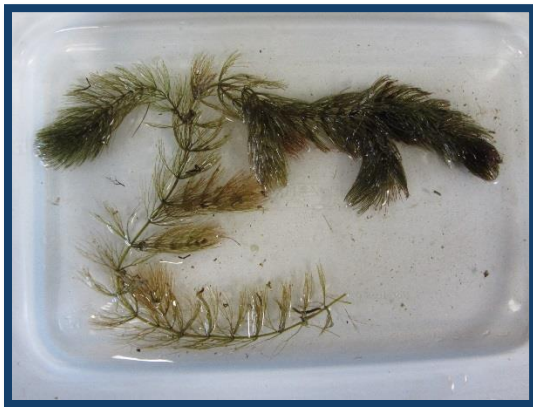
Leafy pondweed has freely branched stems that hold slender submersed leaves that become slightly more narrow as they approach the stem. The leaf contains 3-5 veins and often tapers to a point. No floating leaves are produced. It produces early season fruits in tight clusters on short stalks in the leaf axils. These early season fruits are often the first grazed upon by waterfowl during the season. Muskrat, beaver, deer and even moose also graze on the fruit. It inhabits a wide range of habitats, but usually prefers shallow water. It has a high tolerance for eutrophic conditions, allowing it to even colonize secondary water treatment ponds.

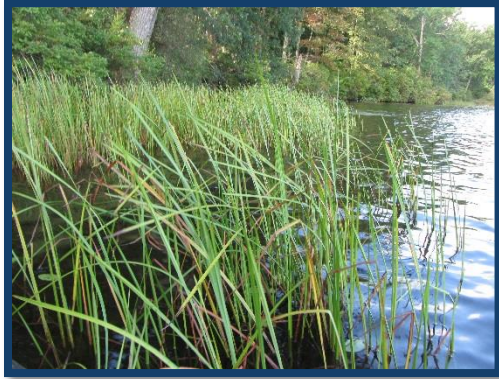
**Bur-reed** (*Sparganium* sp. Common Names: floating bur-reed. **Native**): Bur-reed is an aquatic perennial herb that grows from long rhizomes. The stems are usually submerged and can reach lengths up to 2 meters long. The leaves are alternate, limp, unkeeled and ribbon-like, and can reach 1 meter long, often floating on the surface. Leaves often originate from the base or lower portion of the stem. Only the flowering part of the plant pokes above the water. Bur-reeds often inhabit lakes,

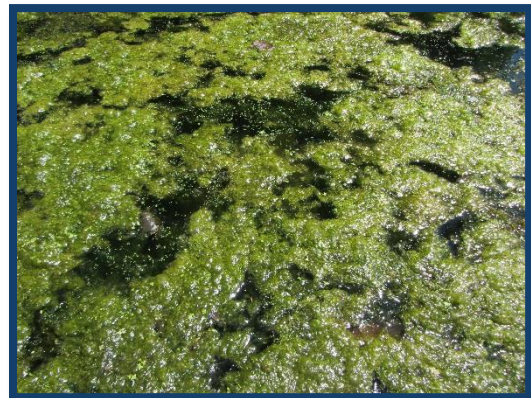
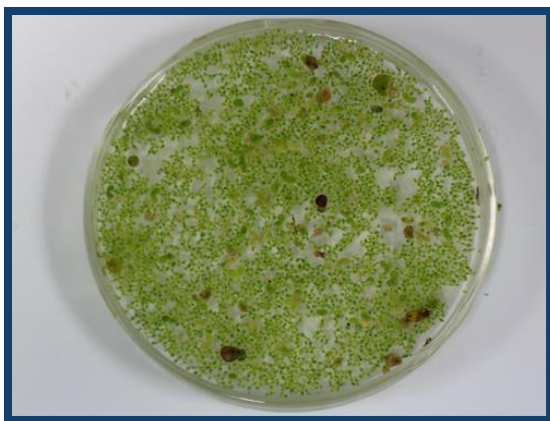
**Floating Filamentous Algae:** Filamentous algae is a chain or series of similar algae cells arranged in an end to end manner. Benthic filamentous algae is attached to a hard substrate, such as logs, rocks, a lake bottom, or even other aquatic plants. When growing in heavy densities, benthic filamentous algae can appear as brown or green mats of vegetation that can reach the surface. When large pieces break off the bottom substrate they become floating filamentous algae patches. Benthic filamentous algae can comprise an entire range of morphologies, but flagellated taxa are far less common.

**Common Watermeal** (*Wolffia columbiana*. Common Names: common watermeal. **Native**): Common watermeal appears as pale green globes of vegetative matter without roots, stems or true leaves. It's one of the world's smallest flowering plants, but flowers are rarely found and require magnification to see. Watermeal usually reproduces by budding. Watermeal is typically found on the surface, intermingled with duckweeds. Its drifts with the

water's current or wind, and therefore it grows independent of water depth, clarity or sediment type. In the fall it produces winter buds that sink to the bottom. In the spring, the buds become buoyant and float to the surface. Waterfowl, fish, and muskrats all include watermeal in their diets.

The floating macrophytes at Alcyon Lake were dominated by floating filamentous algae (FFA). FFA was observed at 54 sites in the basin or 62% of the sites surveyed. Twenty-six sites (48%) contained nuisance level density, with 17 sites (31%) supporting moderate abundance and 9 sites (17%) supporting dense abundance. The FFA was concentrated along the shoreline

Common watermeal (*Wolffia columbiana*) and small duckweed (*Lemna minor*) are both free floating plants that depend on vegetative matter to gather on the surface of a lake basin. The common watermeal was observed at 44 sites (51%) and was seen mostly in conjunction with surface level submersed macrophytes and FFA. Trace abundance was observed at 27 sites (61%) and sparse abundance was noted at 13 sites (30%), while moderate abundance was supported at 4 sites (9%). Small duckweed was observed at 43 sites (49%) with 25 sites (58%) supporting trace abundance, 17 sites (40%) supporting sparse abundance and 1 site (2%) supporting moderate abundance. No dense abundance was observed of either macrophyte.

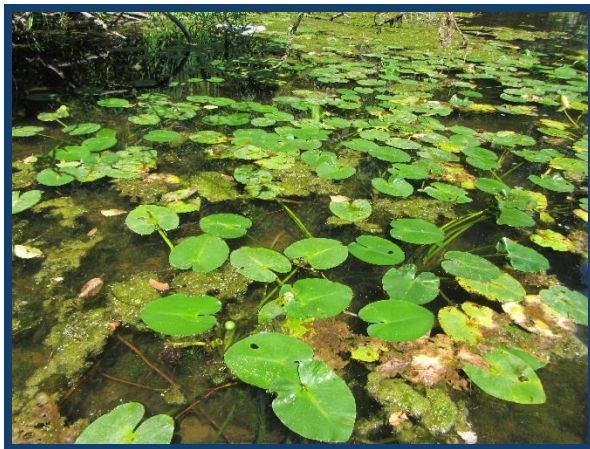
**Spatterdock** (*Nuphar variegata*. Common Name: yellow lily, yellow pond lily, bullhead pond lily. **Native.**): Spatterdock leaf stalks emerge directly from a submerged fleshy rhizome. The leaf stalk has a winged margin, which is a distinguishing characteristic. Spatterdock has heart-shaped leaves with a prominent notch. Flowers are globular in shape with five to six yellow sepals. Flowering occurs in the summer and the flowers open during the day and close at

night. Water lilies typically inhabit quiet water less than two meters deep, such as ponds, shallow lakes and slow-moving streams. The leaves offer shade and protection for fish, and the leaves, stems, and flowers are grazed upon by muskrats, beaver, and sometimes, even deer.

Spatterdock is the final floating macrophyte observed at Alcyon Lake. This native lily was observed at 8 sites (9%) within the basin, 6 sites supported trace density and 2 sites supported sparse density. No nuisance level areas were noted during the survey.

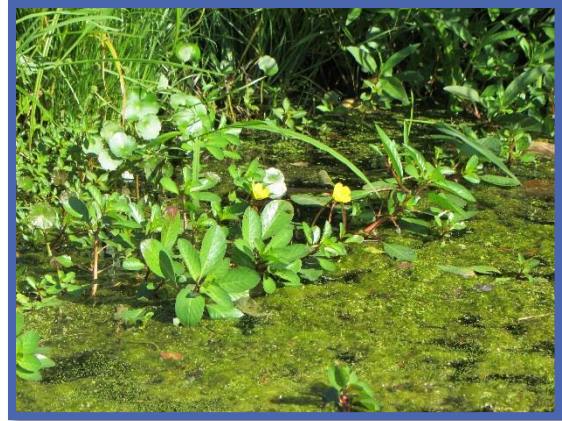
Common names: Floating water willow, floating primrose willow. **Invasive.** Creeping water primrose is native to South America, but has become introduced to many locations in the Northeast. The leaves are alternate can vary in shape from long and thin to round or egg-shape. They are dark green with a lighter green midrib. It has fleshy stems that can be emergent on mud flats, or a floating form.

Bright yellow flowers with five petals are produced. Its creeping stems and hardy nature classifies it as an aggressive spreader. It typically occurs in slow moving streams, canals, and along the margins of marshes and lakes.

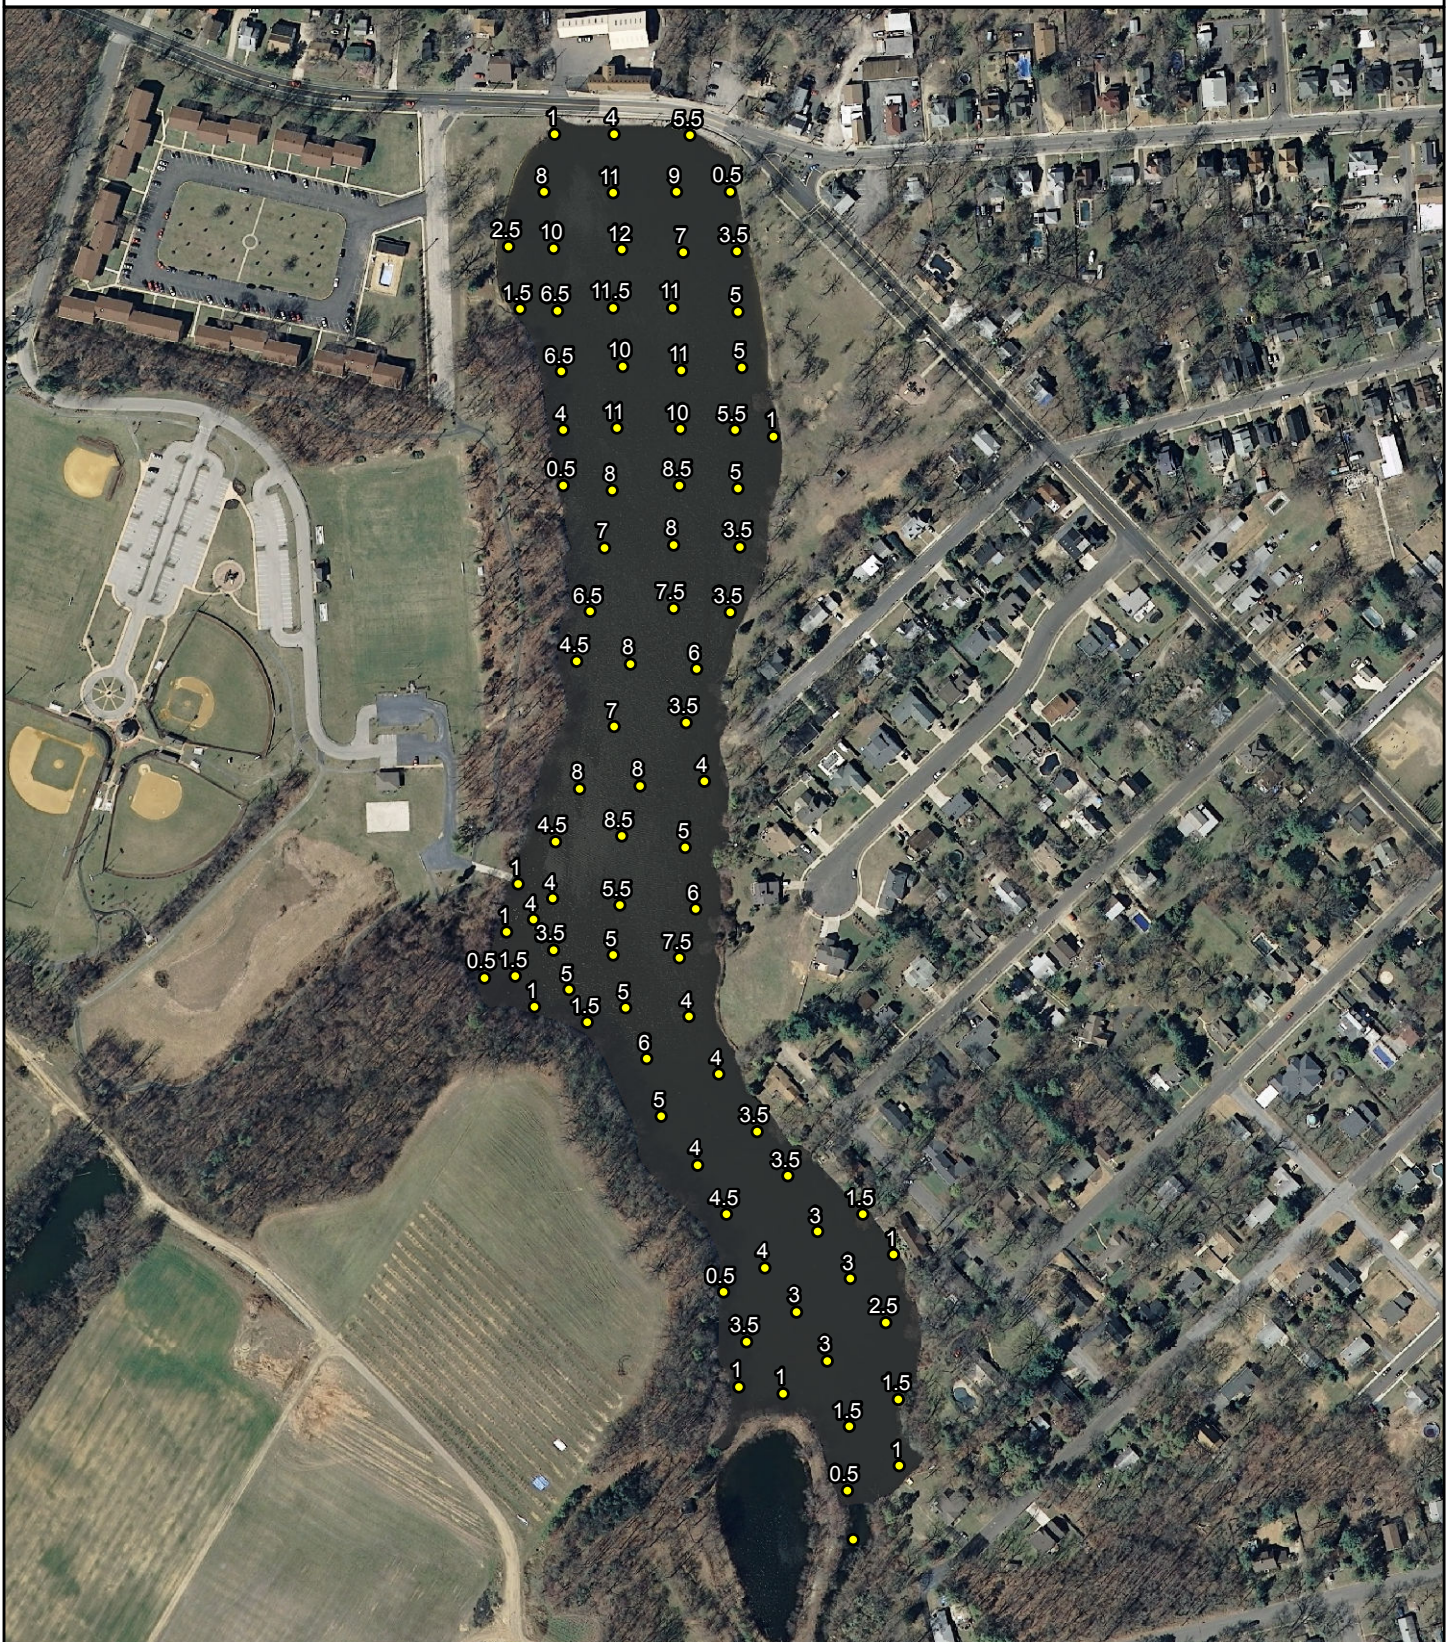
# Water Depth

Water depth was measured at each sampling location in Alcyon Lake. The maximum depth observed was 12 feet which occurred in the northern end of the basin. The minimum depth observed was 0.5 feet, this depth was observed in a number of location adjacent to the shoreline. The average depth of the basin, based on the data collected from all 87 sampling locations, was 4.79 feet.

**ALCYON LAKE**  
Aquatic Vegetation Survey  
August 28, 2014

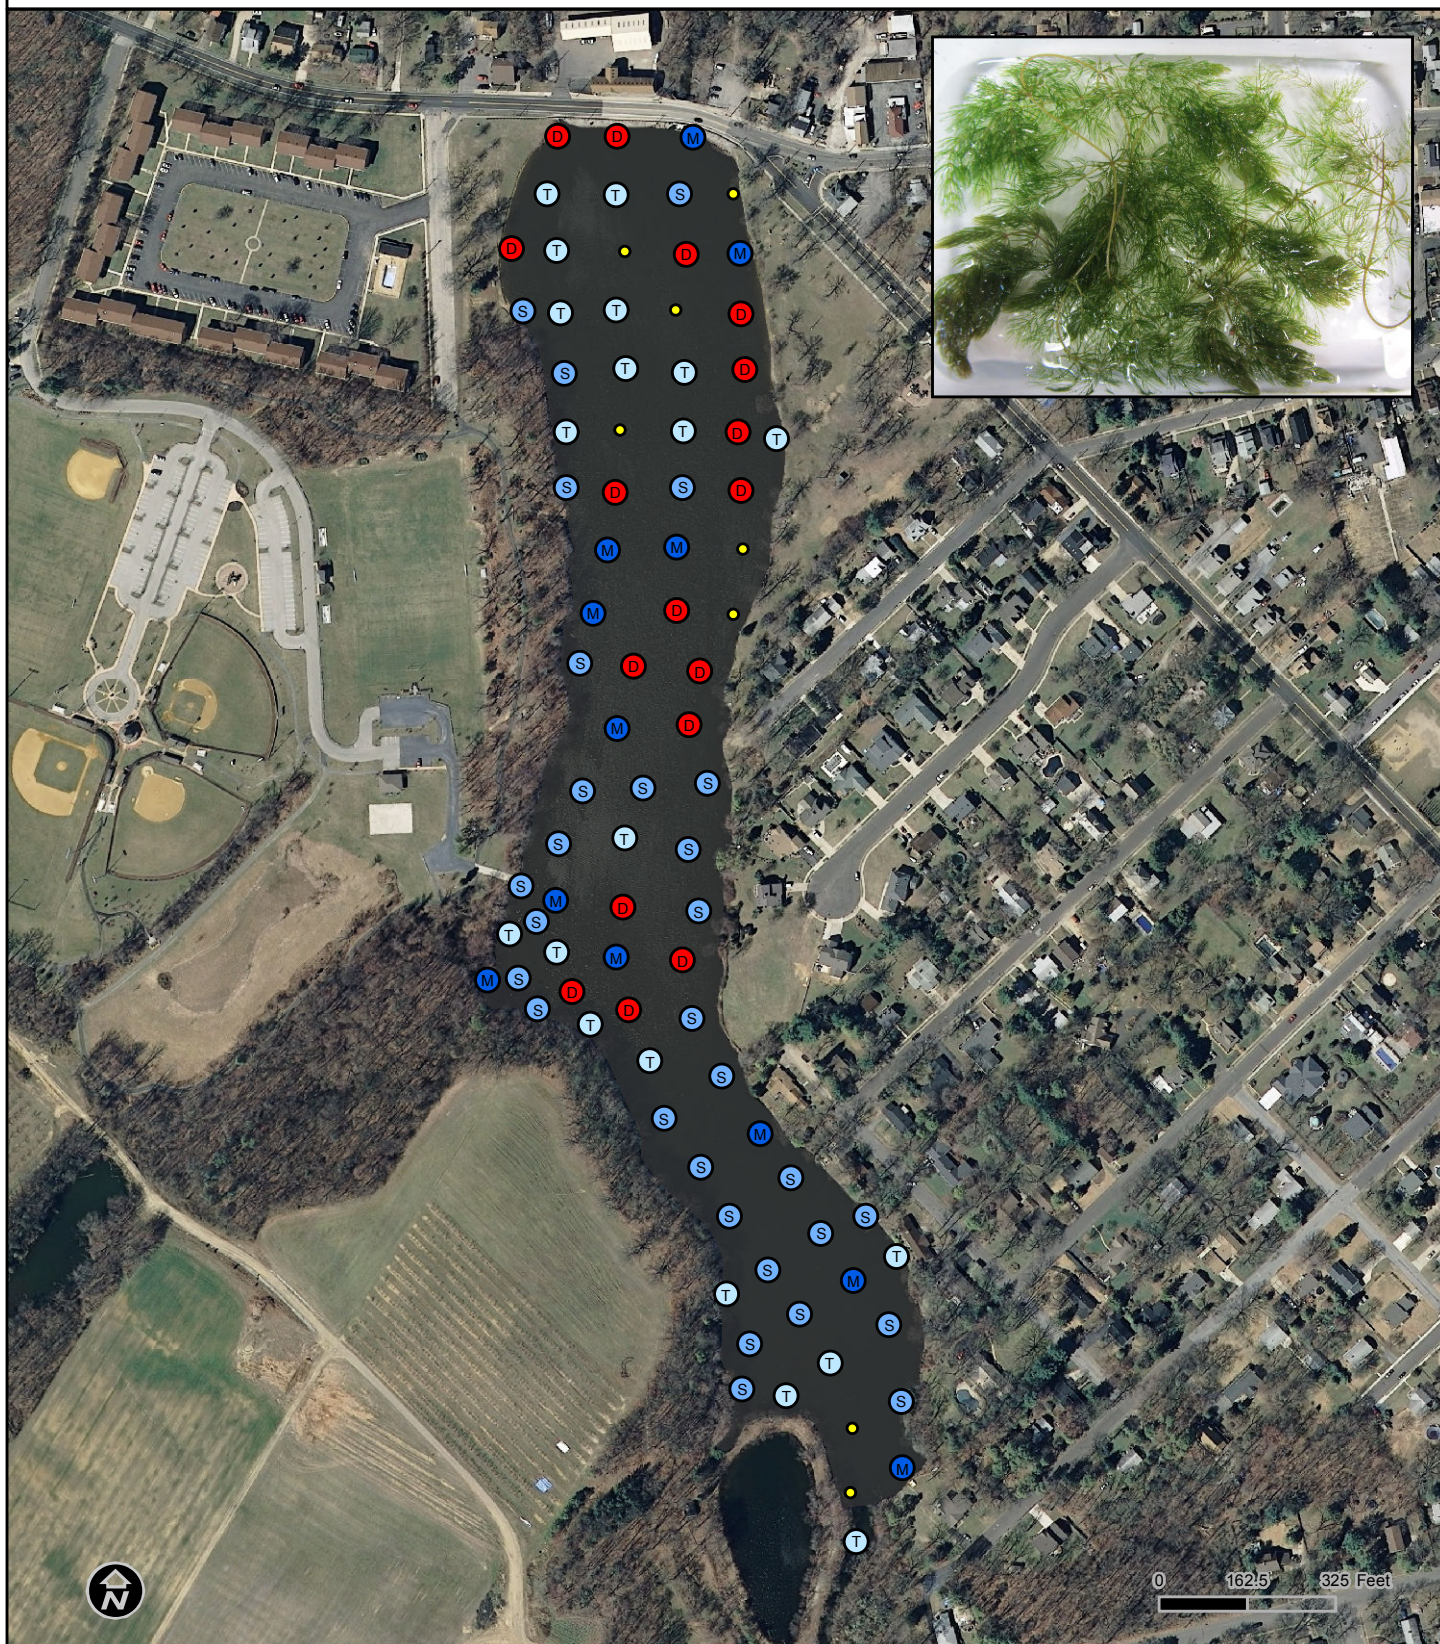
# Coontail (*Ceratophyllum demersum*) Distribution

Abundance	Sites	Percent
Total	79	91%
Trace	20	25%
Sparse	30	38%
Medium	12	15%
Dense	17	22%

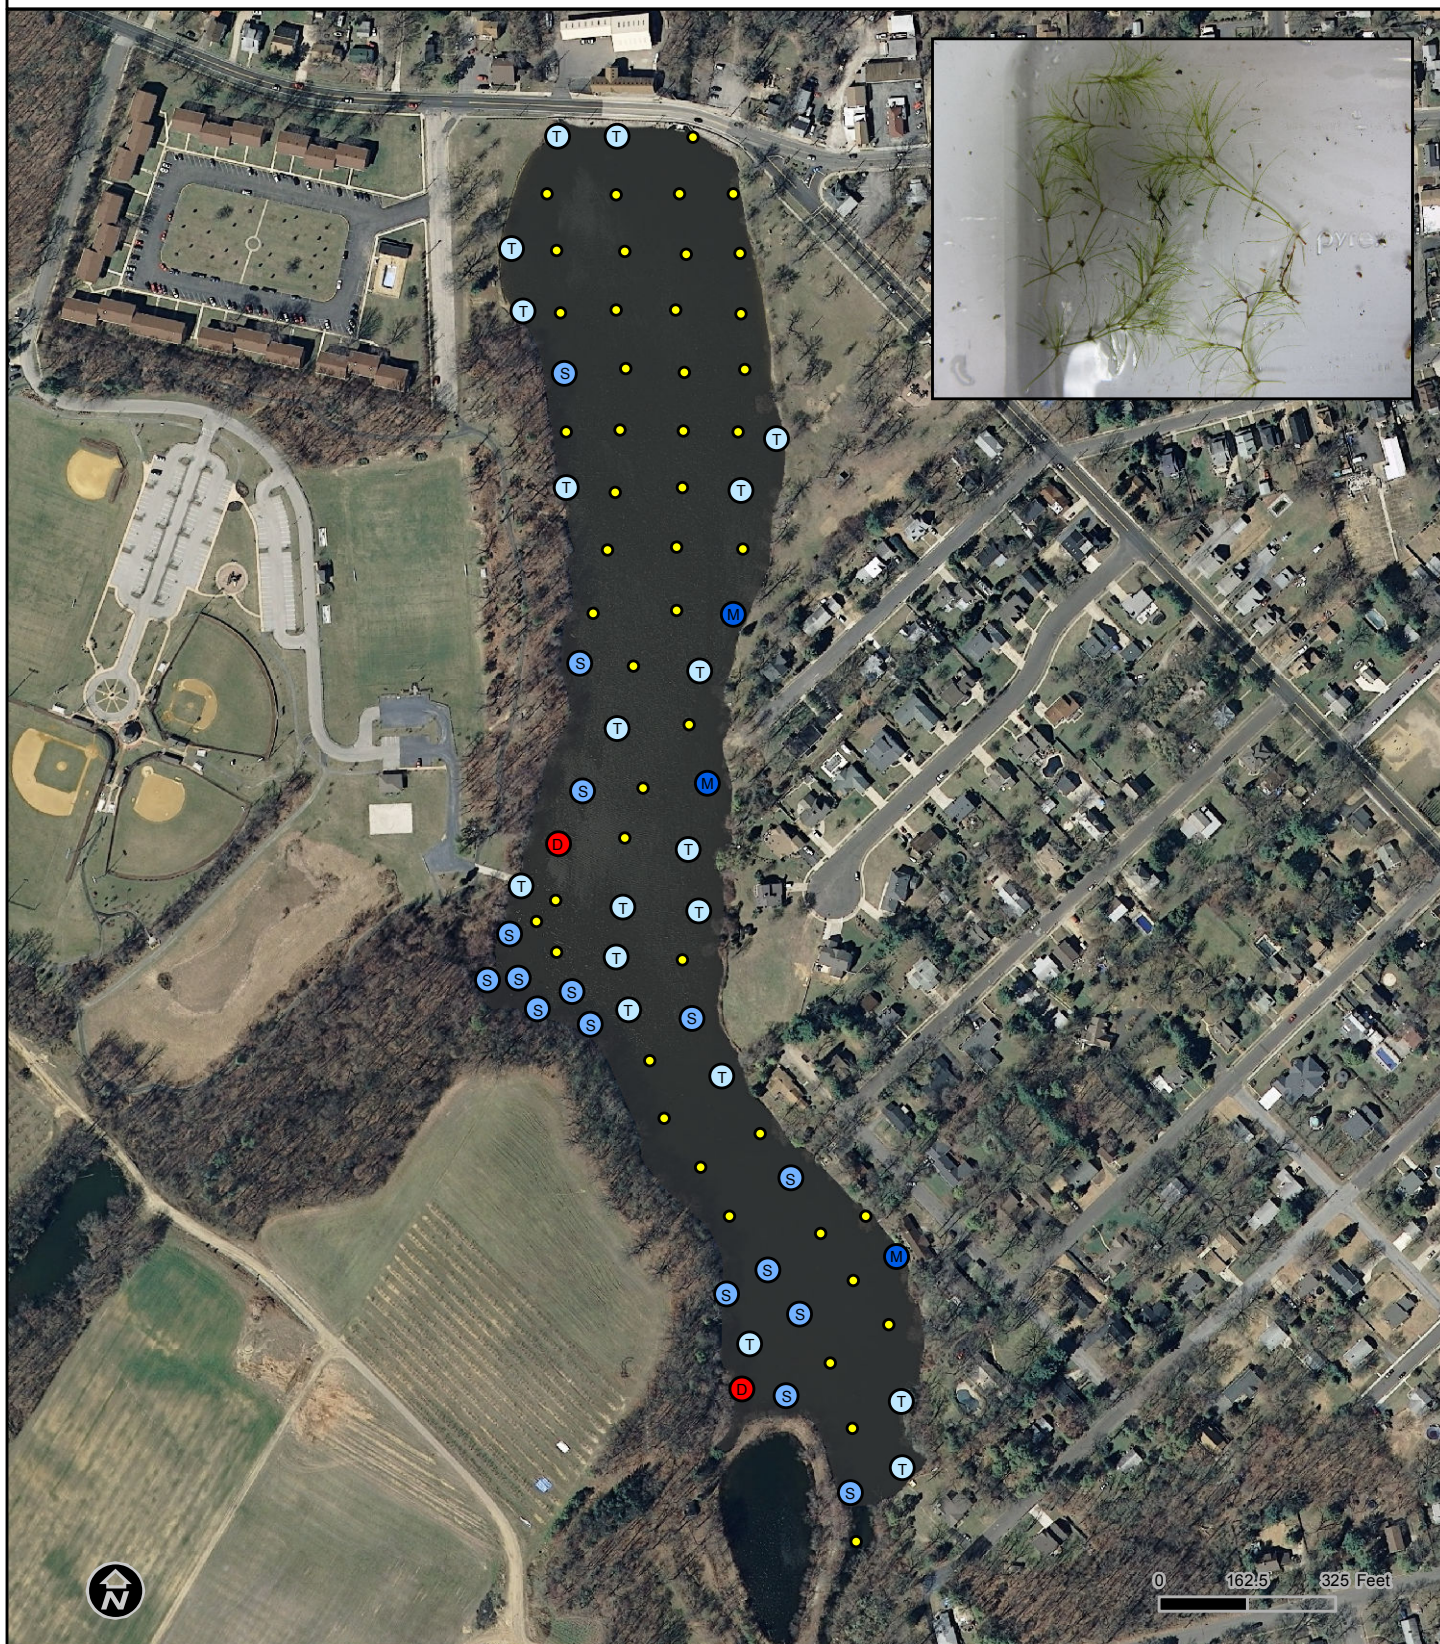
# Northern Naiad (*Najas gracillima*) Distribution

The next most abundant species was the desirable native, northern naiad (*Najas gracillima*). Northern naiad was observed at 40 sites (46%) throughout the basin but was more concentrated in shallow shoreline areas, and around the launch. The majority of sites

contained trace (48%) or sparse (40%) abundance with only five sites supporting heavy abundance, 3 (8%) medium and 2 (5%) dense. Northern naiad is a desirable, native plant species which supplies food for waterfowl and habitat for fish.

Abundance	Sites	Percent
Total	40	46%
Trace	19	48%
Sparse	16	40%
Medium	3	8%
Dense	2	5%

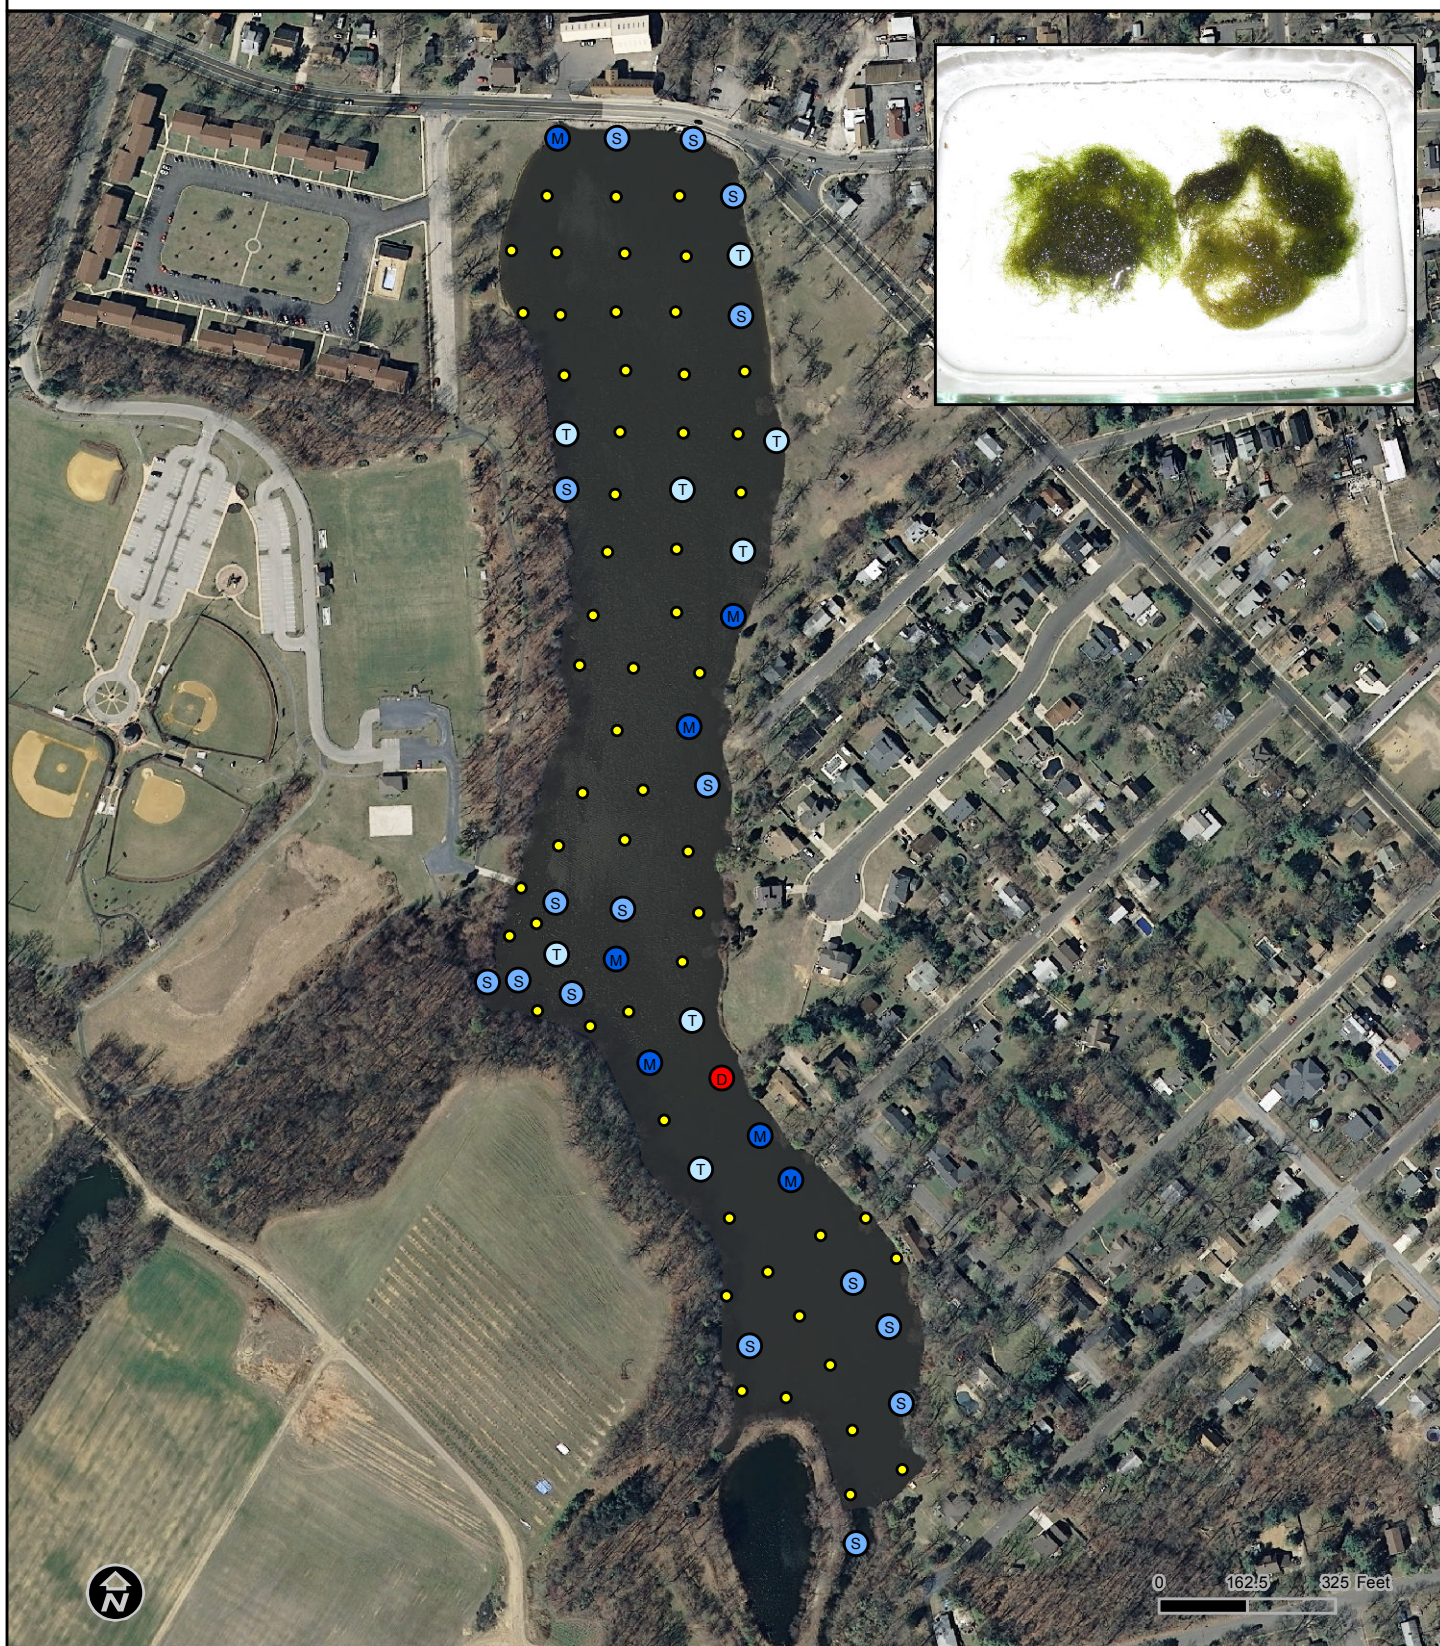
# Benthic Filamentous Algae Distribution

Abundance	Sites	Percent
Total	32	37%
Trace	8	25%
Sparse	16	50%
Medium	7	22%
Dense	1	3%

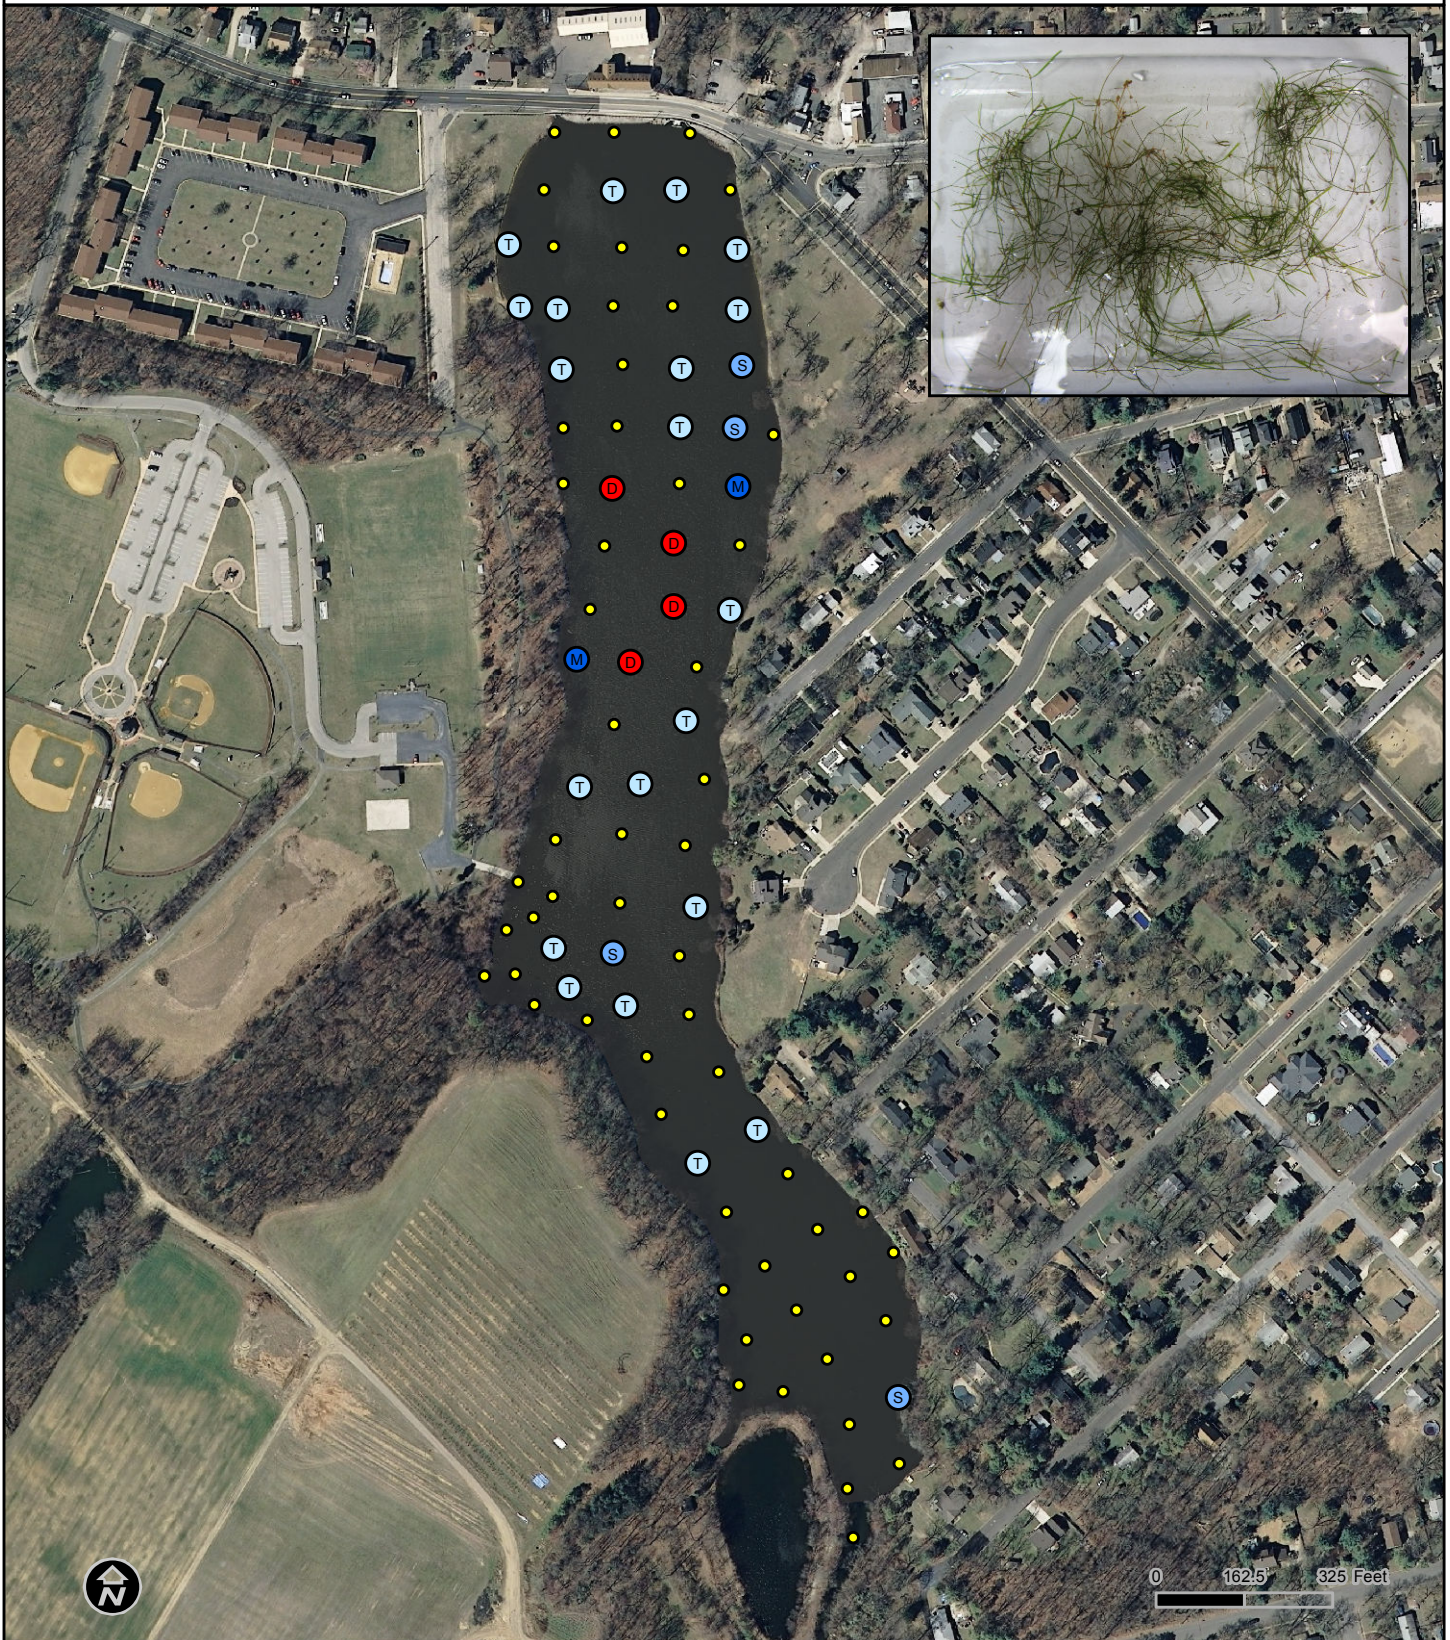
# Water-thread Pondweed (*Potamogeton diversifolius*) Distribution

Abundance	Sites	Percent
Total	30	34%
Trace	20	67%
Sparse	4	13%
Medium	2	7%
Dense	4	13%

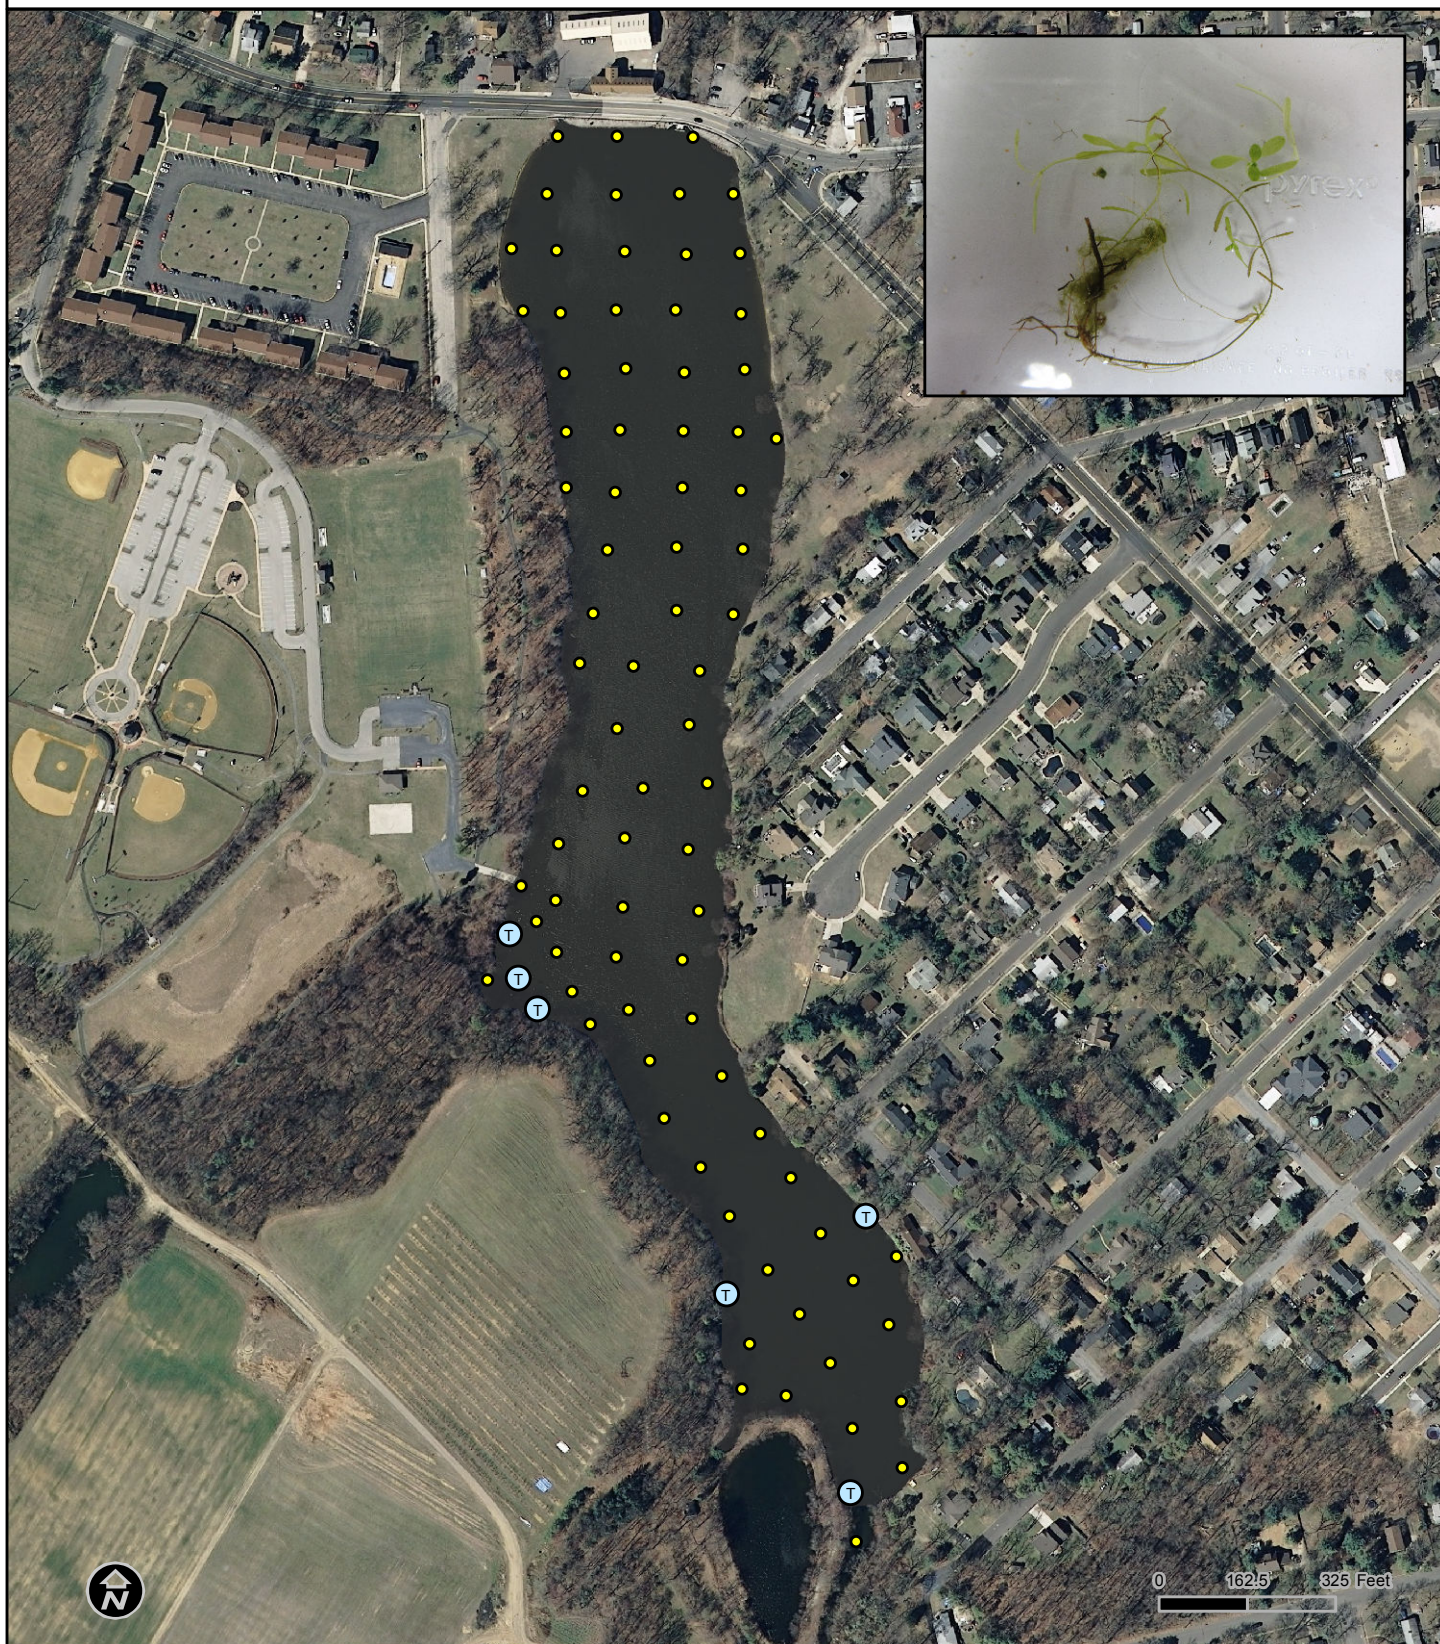
# Common Water Starwort (*Callitriche* sp.) Distribution

Six sites (7%) contained trace amounts of common water starwort (*Callitriche* sp.). Three sites in the cove just south of the launch and the other three sites at the southern end of the basin. Three sites (3%) supported leafy pondweed (*Potamogeton foliosus*), 2 sites with trace abundance and 1 site with sparse abundance.

Abundance	Sites	Percent
Total	6	7%
Trace	6	100%
Sparse	0	0%
Medium	0	0%
Dense	0	0%
