# 2014 Aquatic Macrophyte Survey Report

ALCYON LAKE, PITMAN, NJ

AUGUST 28, 2014

**REPORT FOR: Pitman Environmental Commission**

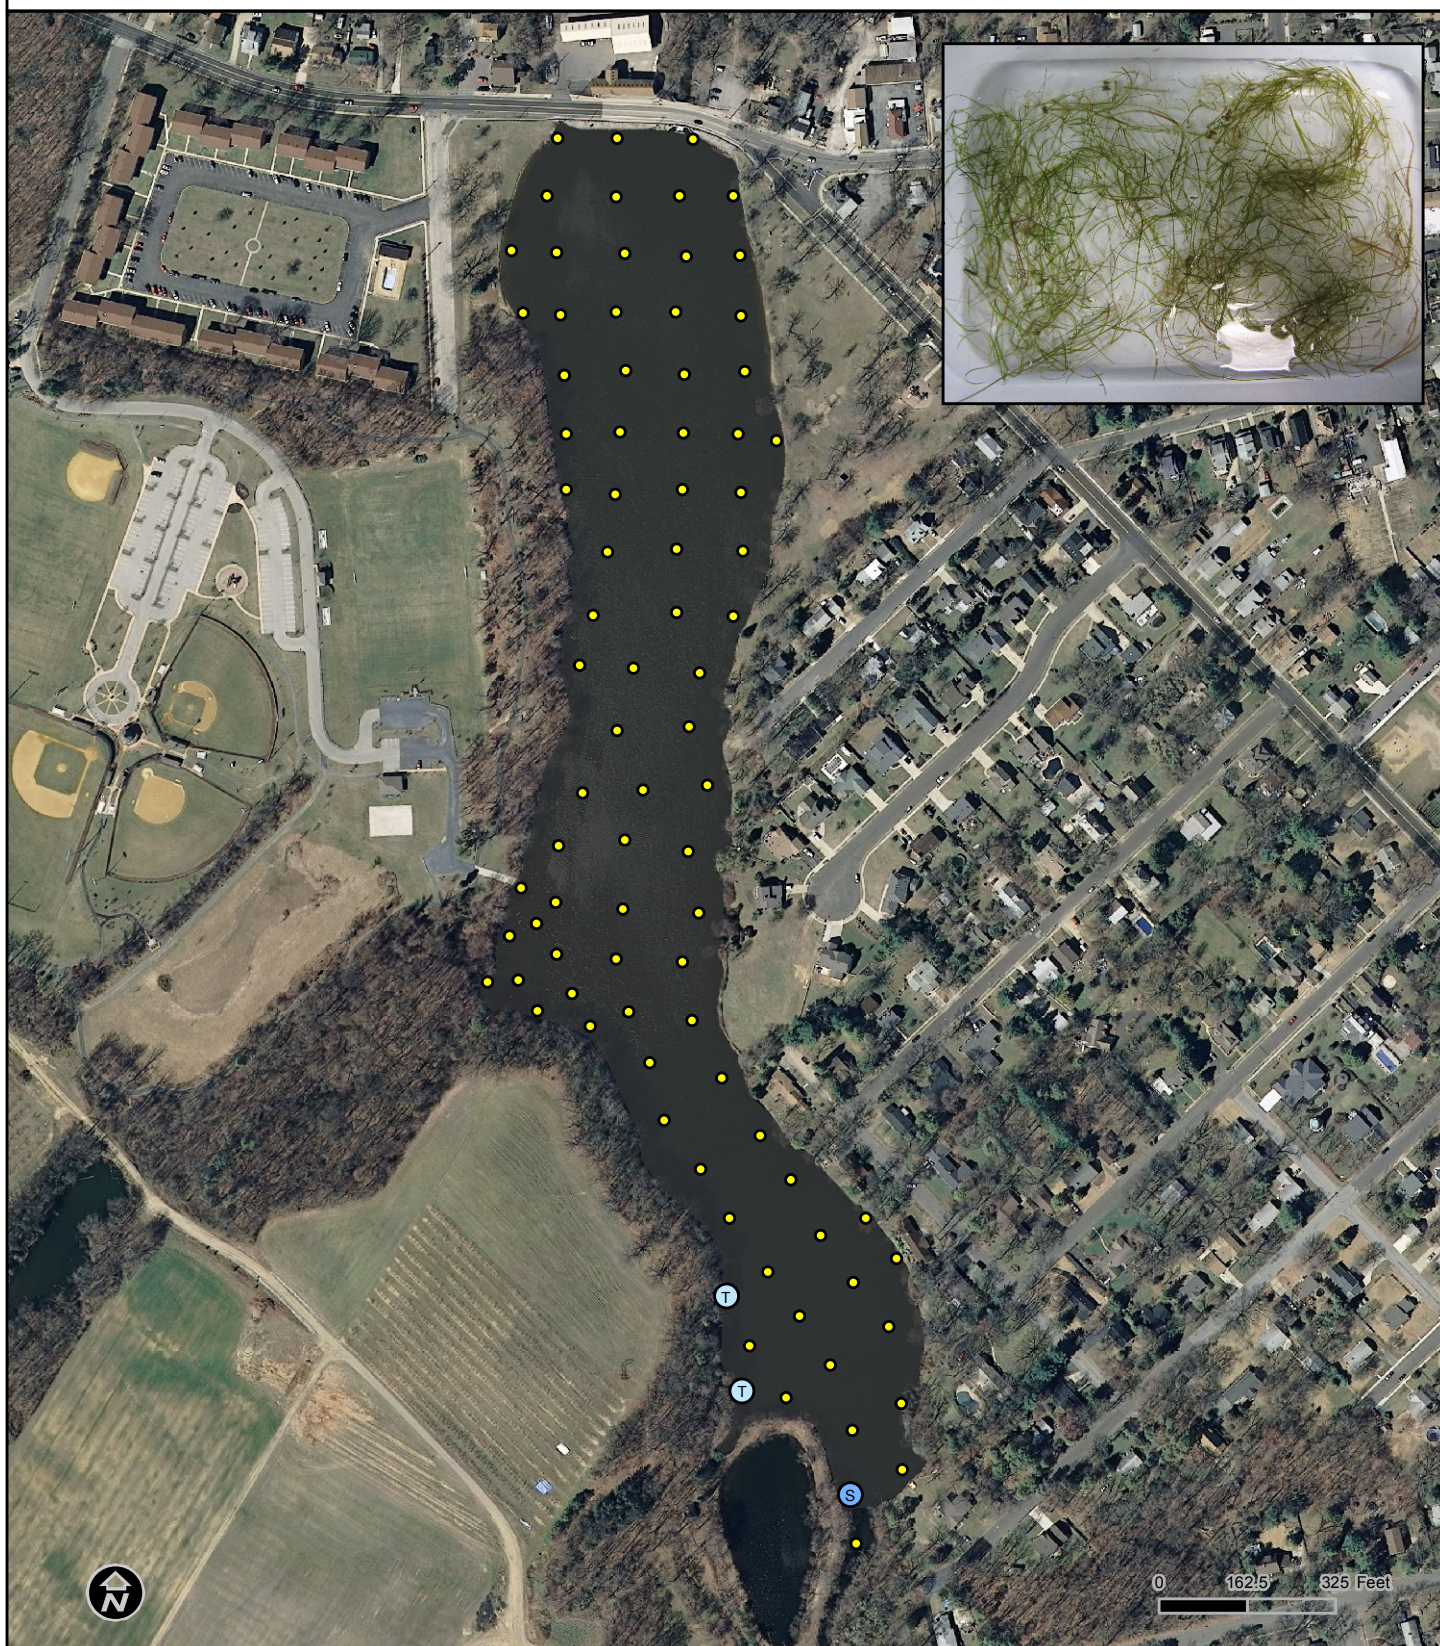
# Leafy Pondweed (*Potamogeton foliosus*) Distribution

Abundance	Sites	Percent
Total	3	3%
Trace	2	67%
Sparse	1	33%
Medium	0	0%
Dense	0	0%

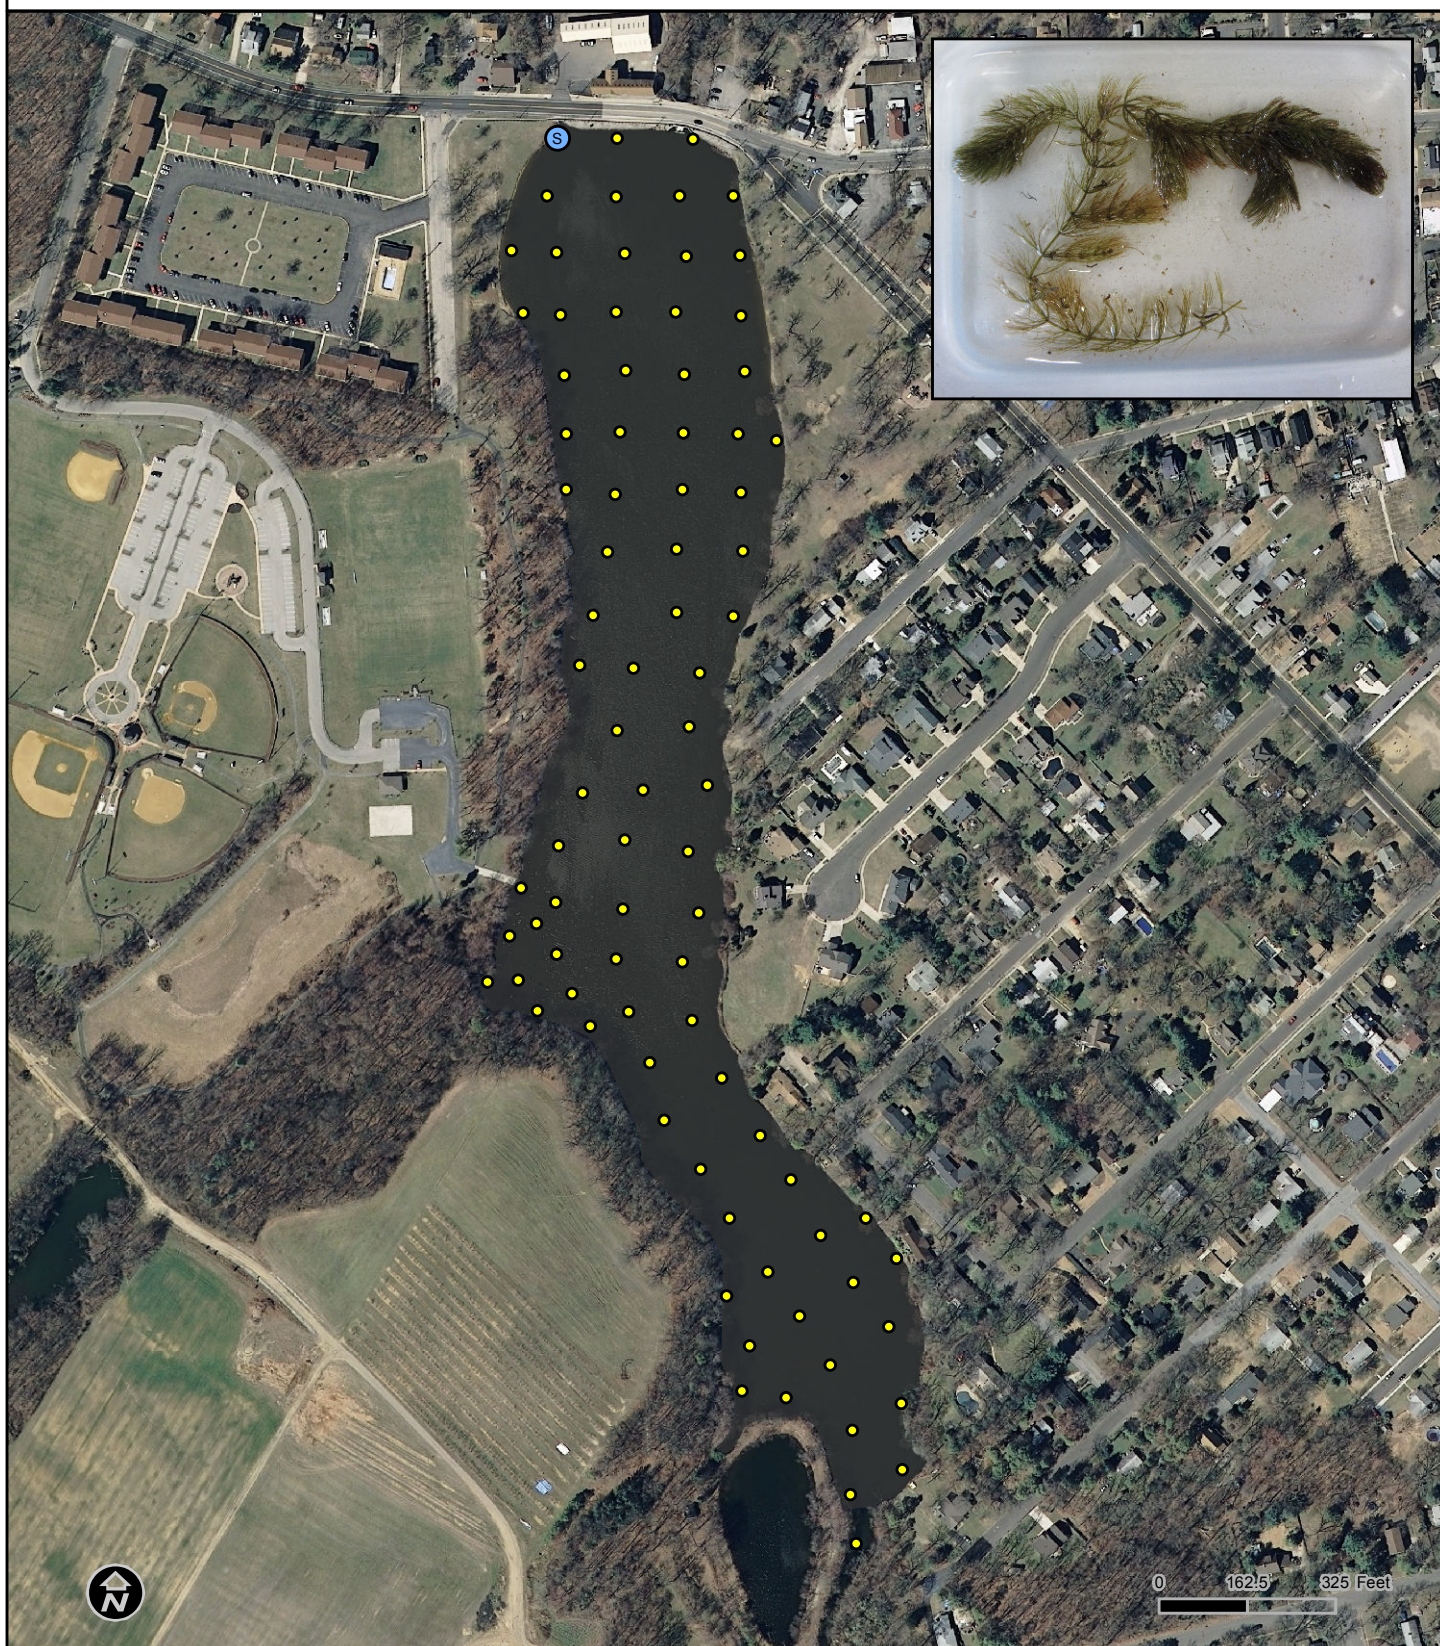
# Spiny Hornwort (*Ceratophyllum echinatum*) Distribution

Abundance	Sites	Percent
Total	1	1%
Trace	1	100%
Sparse	0	0%
Medium	0	0%
Dense	0	0%

Spiny hornwort (*Ceratophyllum demersum*) and common bladderwort (*Utricularia vulgaris*) were each observed at one site. Spiny hornwort was collected at sparse density adjacent to the dam while common bladderwort was noted at the eastern side of the basin at the north end. There is some question regarding the identification of spiny hornwort since the sample did not have any seeds or flowers. These are both desirable native species which help the overall ecology of the lake and support native biota.

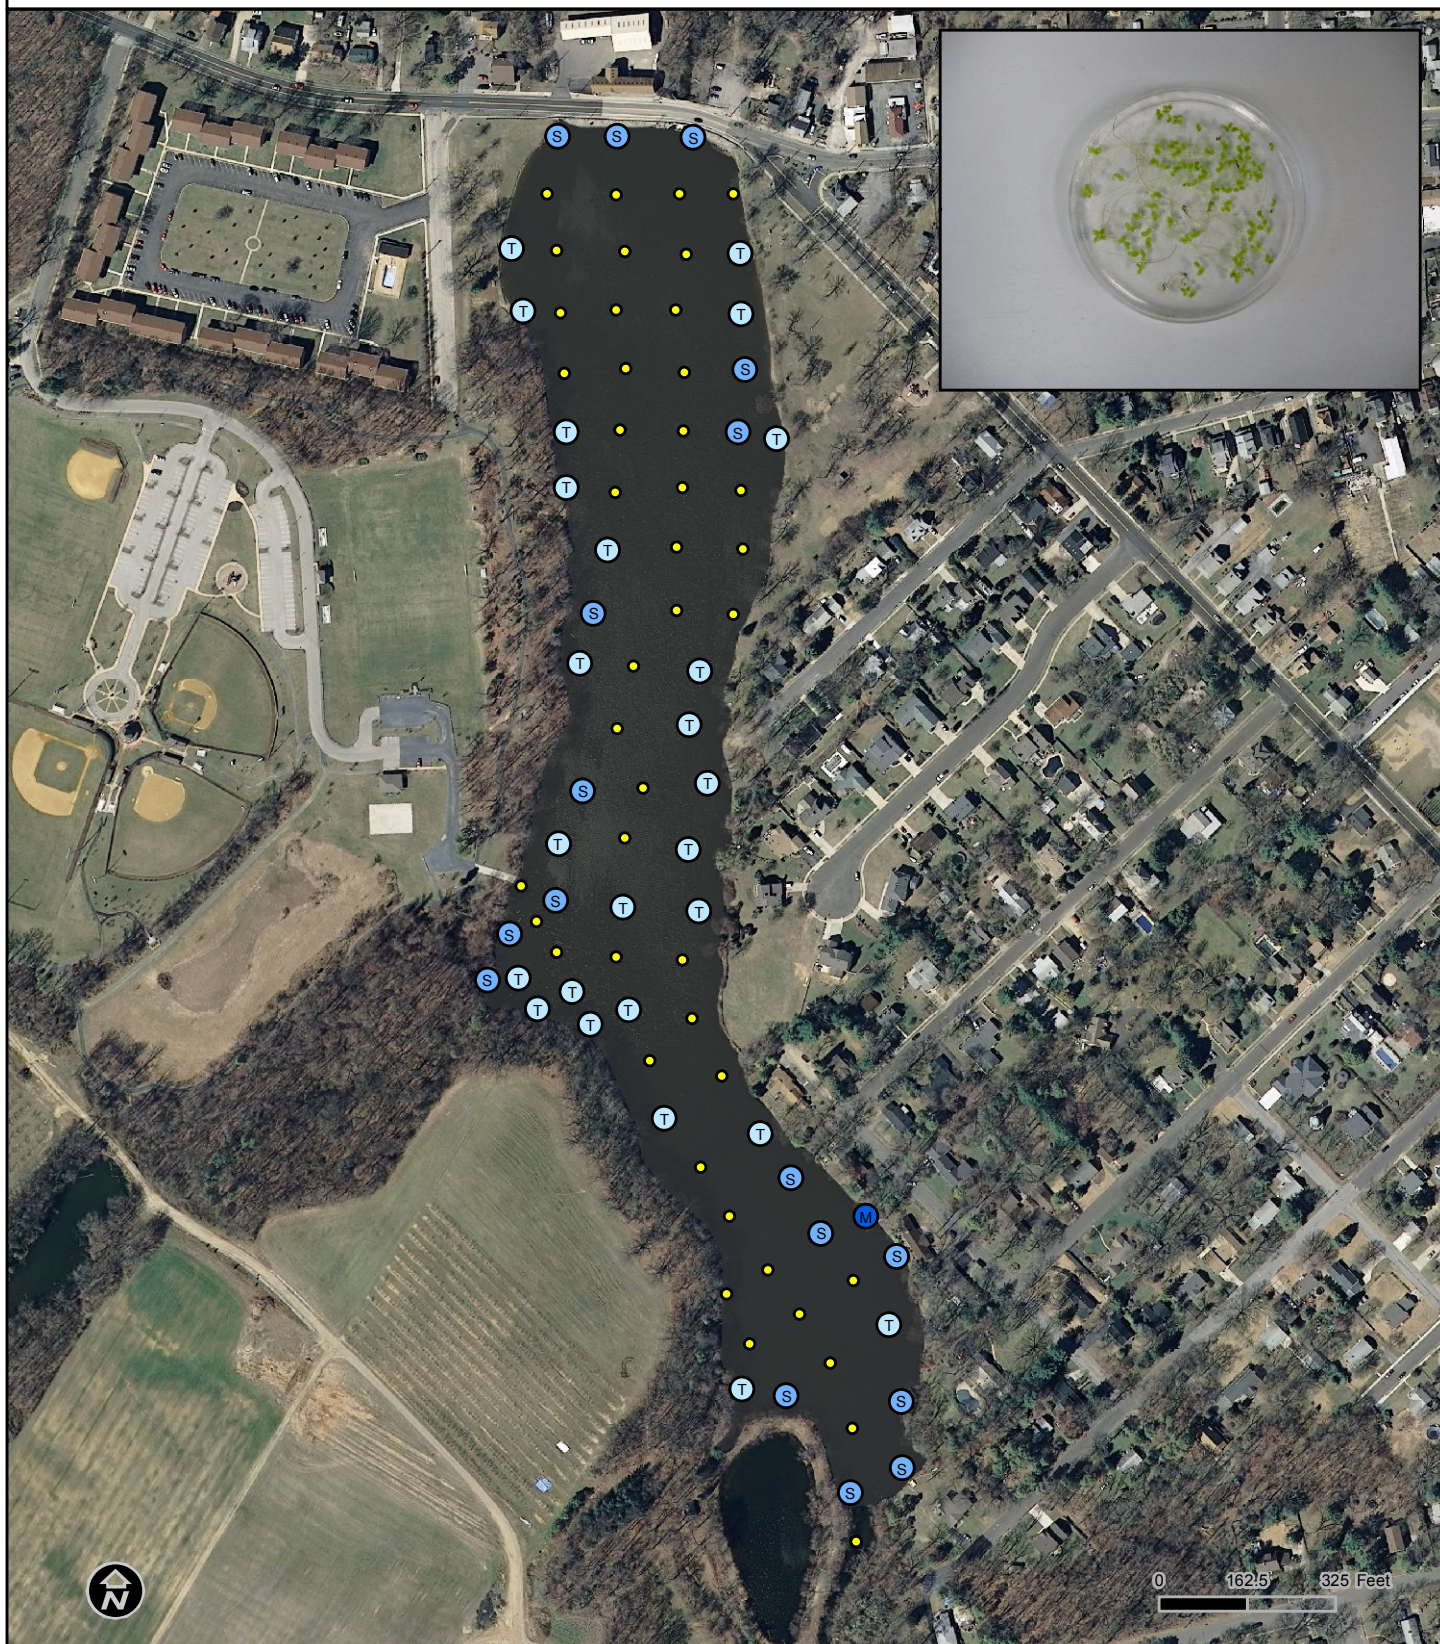
# Small Duckweed (*Lemna minor*) Distribution

Common watermeal (*Wolffia columbiana*) and small duckweed (*Lemna minor*) are both free floating plants that depend on vegetative matter to gather on the surface of a lake basin. The common watermeal was observed at 44 sites (51%) and was seen mostly in conjunction with surface level submersed macrophytes and FFA. Trace abundance was observed at 27 sites (61%) and sparse abundance was noted at 13 sites (30%), while moderate abundance was supported at 4 sites (9%). Small duckweed was observed at 43 sites (49%) with 25 sites (58%) supporting trace abundance, 17 sites (40%) supporting sparse abundance and 1 site (2%) supporting moderate abundance. No dense abundance was observed of either macrophyte.

Abundance	Sites	Percent
Total	43	49%
Trace	25	58%
Sparse	17	40%
Medium	1	2%
Dense	0	0%

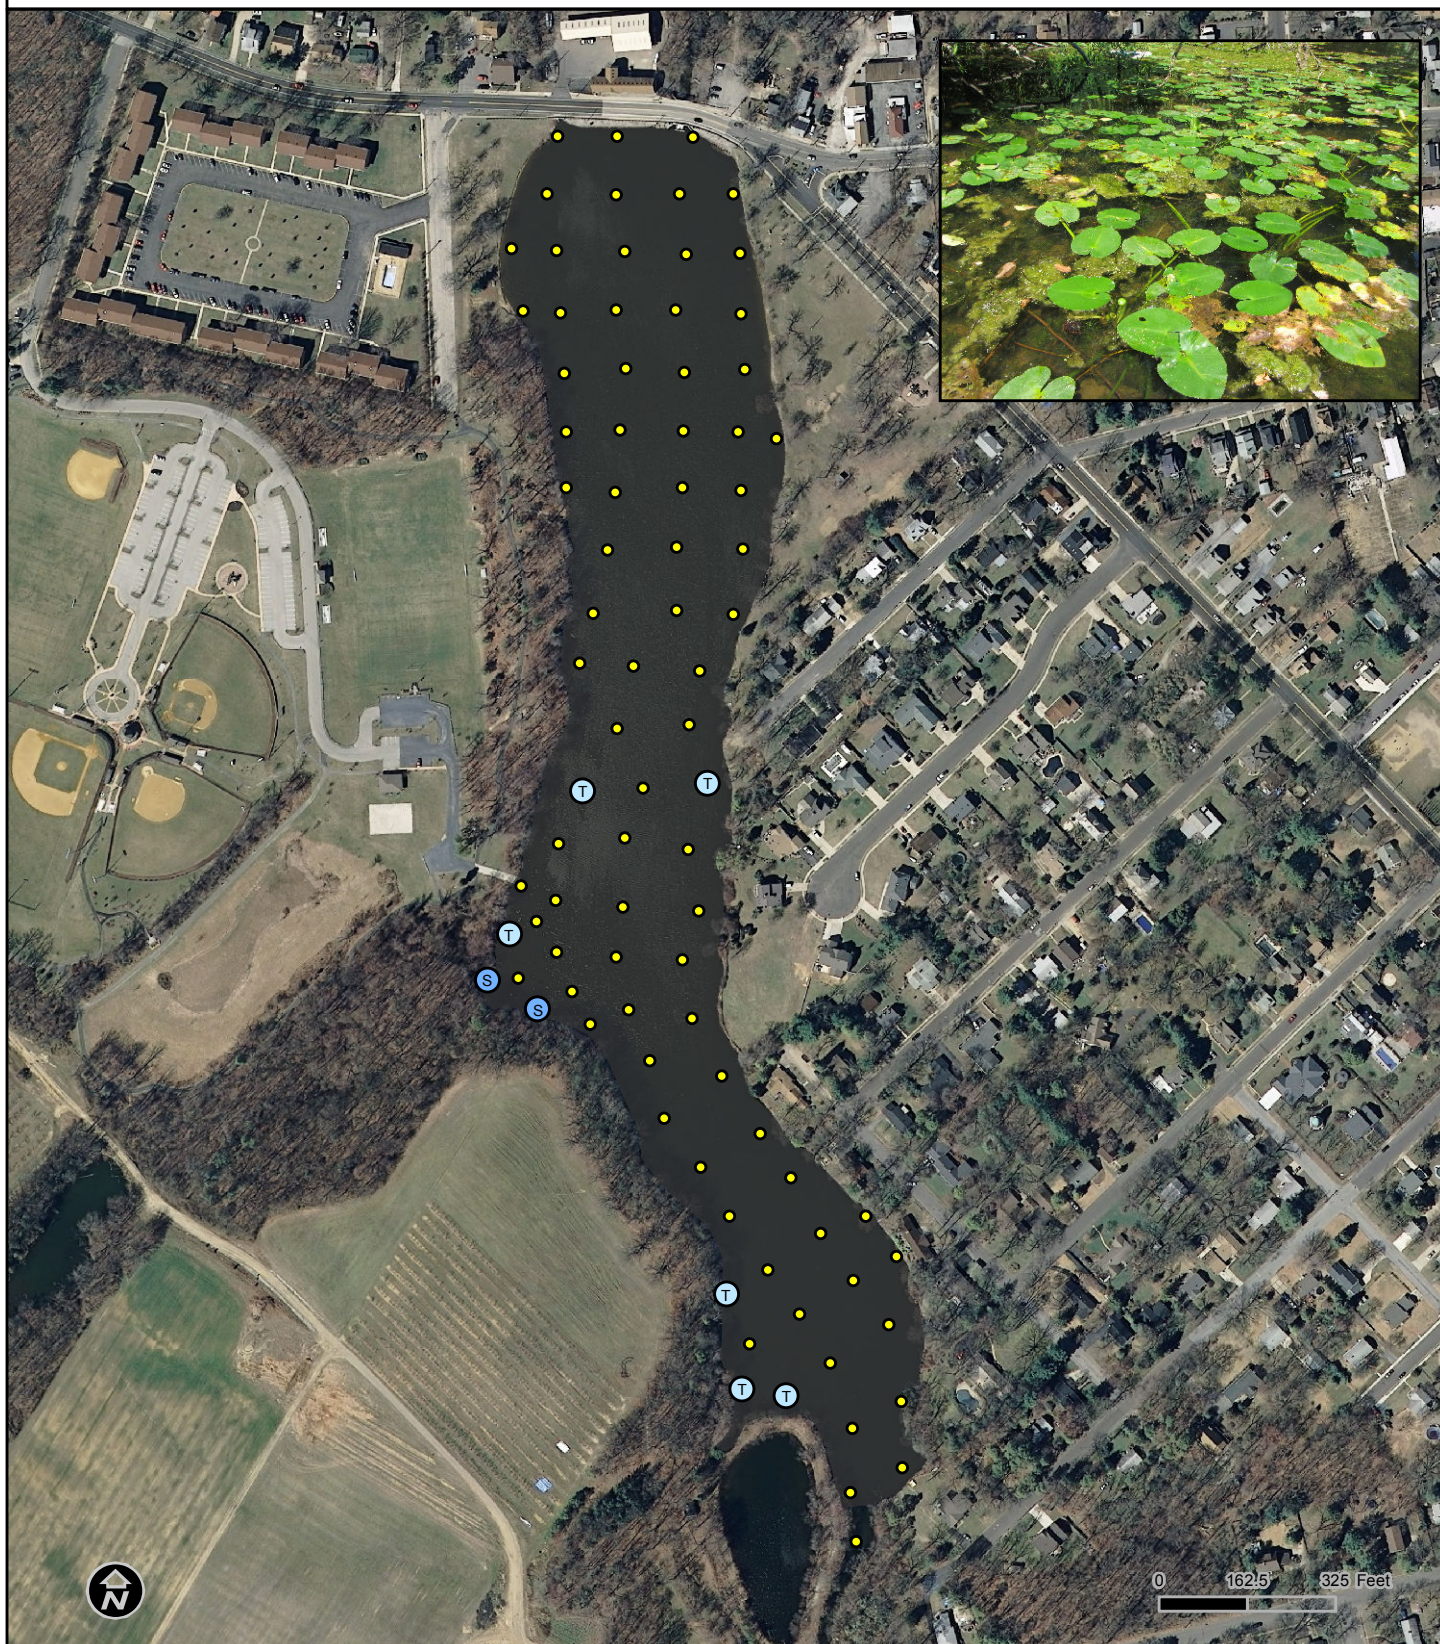
# Spatterdock (*Nuphar variegata*) Distribution

Spatterdock is the final floating macrophyte observed at Alcyon Lake. This native lily was observed at 8 sites (9%) within the basin, 6 sites supported trace density and 2 sites supported sparse density. No nuisance level areas were noted during the survey.

Abundance	Sites	Percent
Total	8	9%
Trace	6	75%
Sparse	2	25%
Medium	0	0%
Dense	0	0%
