# I-275 METRO TRAIL ASSESSMENT AND RECOMMENDATIONS

The I-275 Metro Trail Assessment and Recommendations study (MDOT #2021-0622) was completed by the MDOT Metro Region in 2022. The purpose of the study was to:

- Assess the 24.8 miles of I-275 Metro Trail through Wayne County (8 Mile Road to S. Huron Road)
- Develop recommendations that will improve trail conditions and safety, and increase use

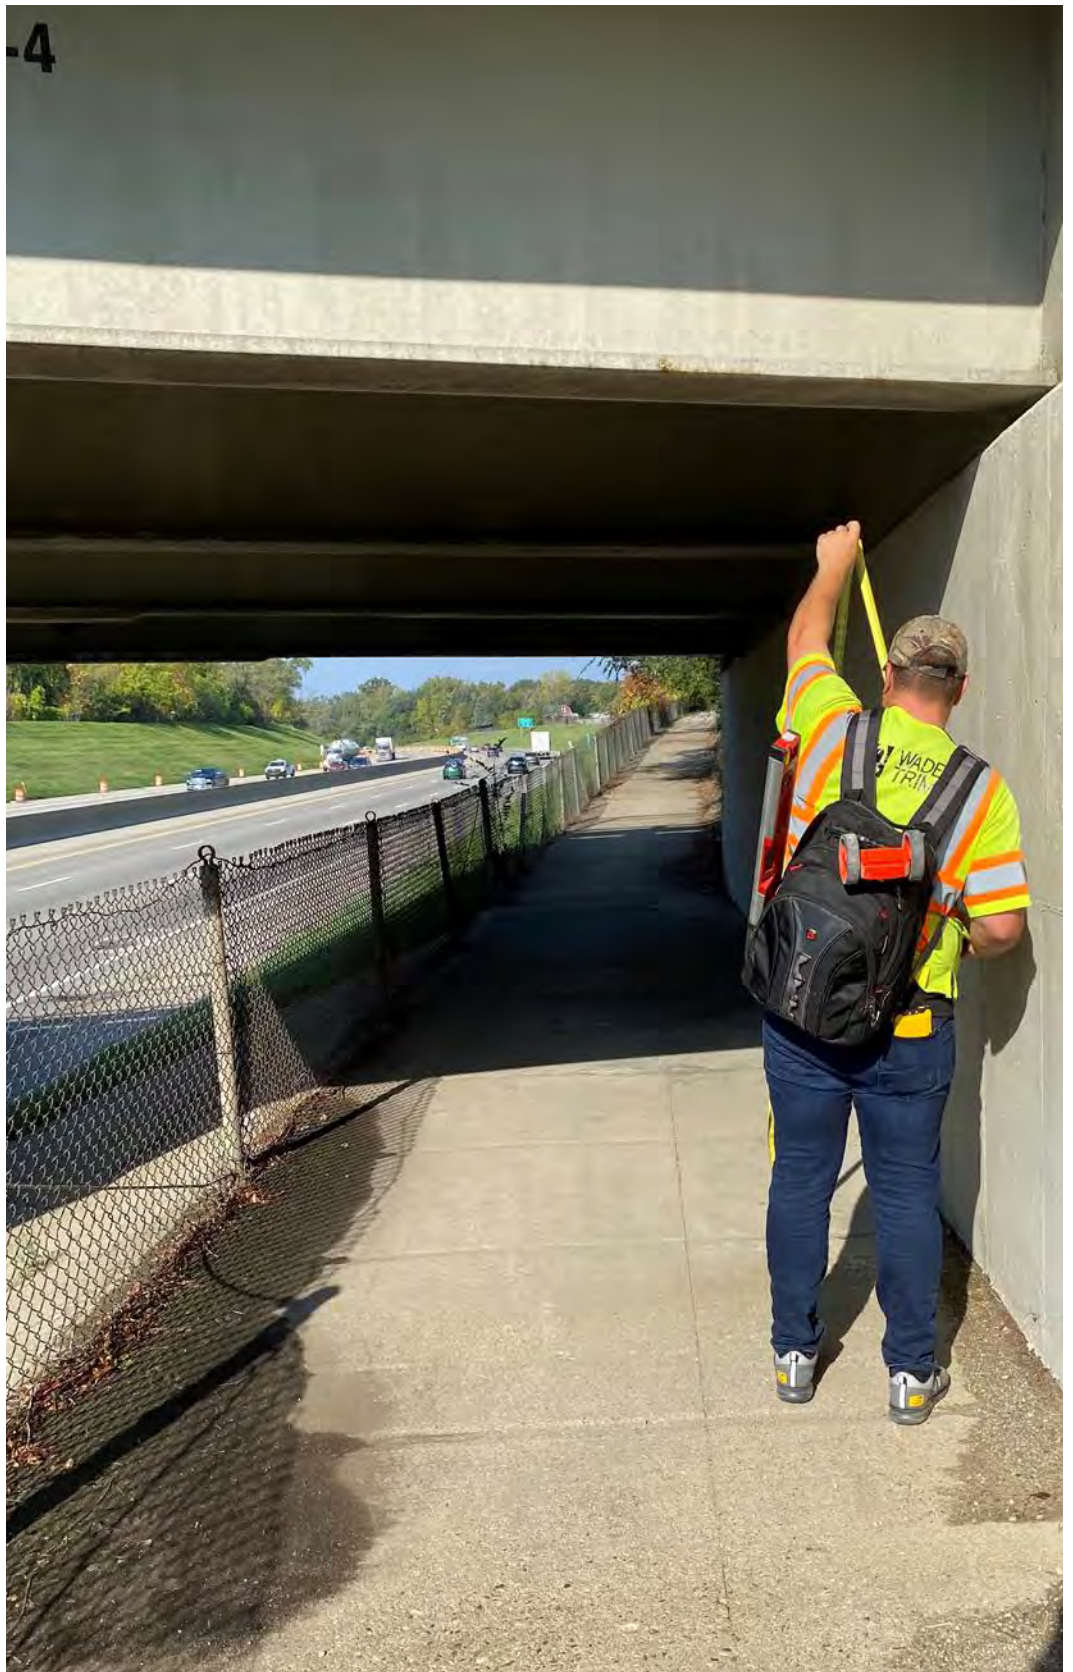
Figure ES-2: I-275 Metro Trail Fieldwork in Fall 2021

To develop recommendations, a thorough assessment of the existing trail condition was completed in 2021 and detailed in Section 3 of this report. The consultant team walked, drove, and biked the 24.8 miles of trail with hand-held tablets to capture information related to pavement condition, structure locations, road crossings, signs, drainage, connections, fence types, and general user experience (Figure ES-2). The data collected is available as an ArcGIS online map and database. In addition, under a separate contract, detailed structural assessments of all pedestrian bridges were completed in 2021 with results incorporated into this report. Key findings of the assessment include:

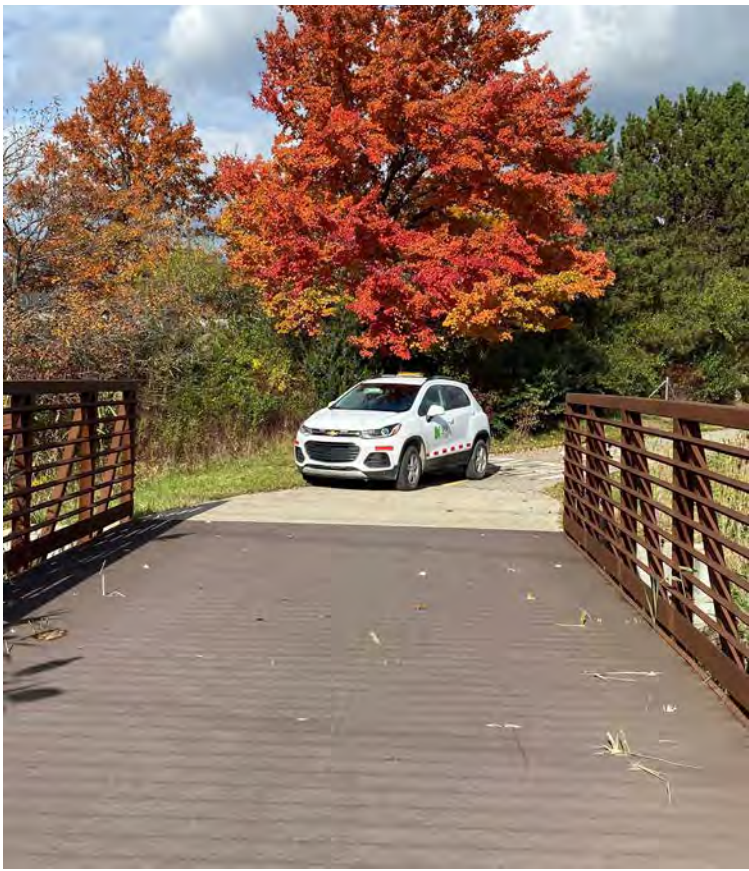
Figure 2: Field Survey, Fall 2021

To gather the detailed information needed to assess the I-275 Metro Trail, a field survey was performed in late summer-early fall 2021. A pilot of this study began in July 2021 with the bulk of field reviews completed in October and November 2021. The consultant team walked, drove, and bicycled 24.8 miles of trail to assess the conditions of the existing pavement, structures, crossings, signs, drainage, connections, experience, and fence types. This data was recorded on hand-held tablets and input directly into an ArcGIS online database. Results of this assessment are detailed in Section 3 of this report. The assessment was then analyzed and integrated into proposed recommendations as described in Sections 4 and 5 of this report.

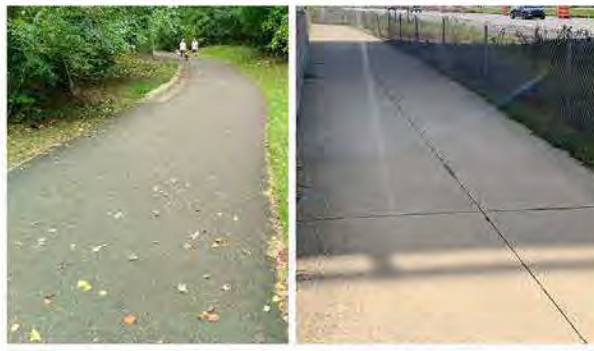
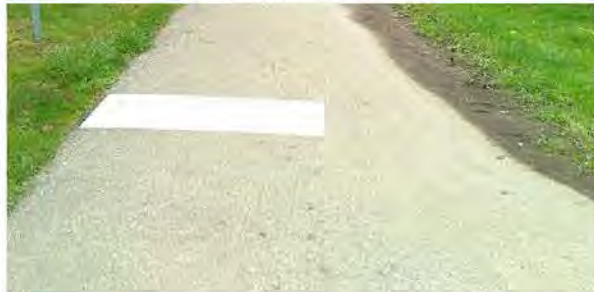
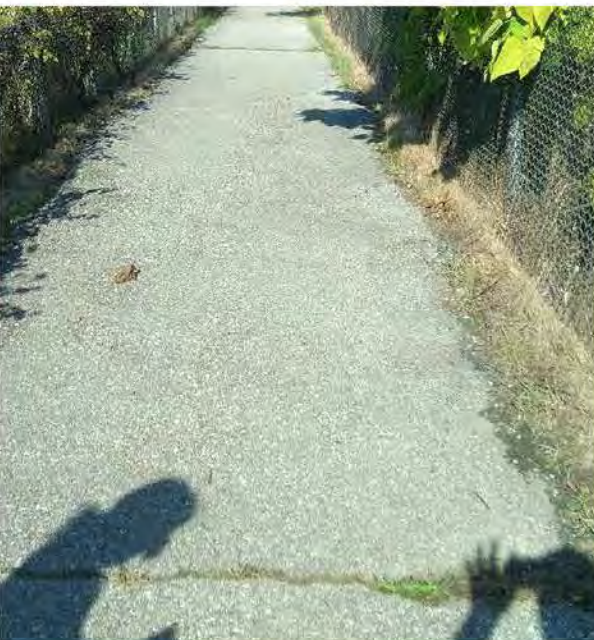
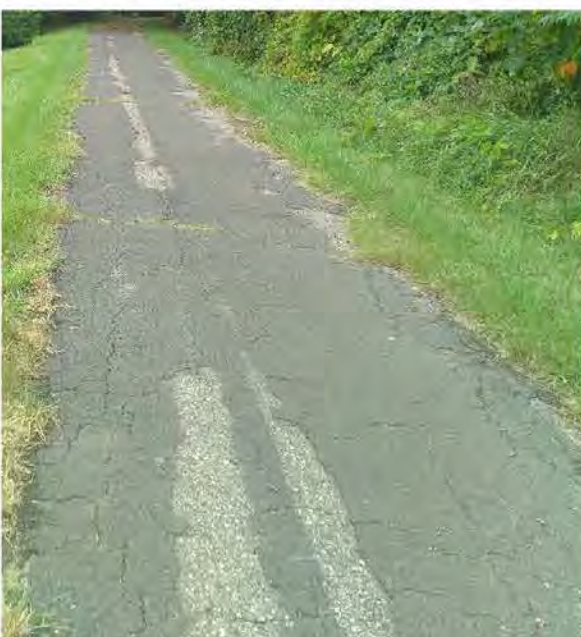
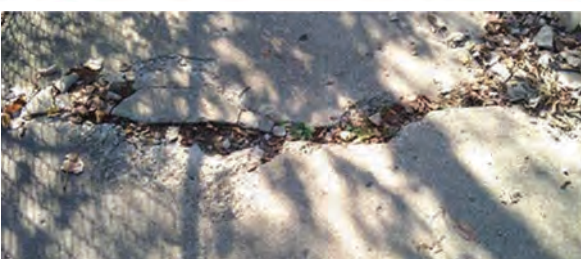
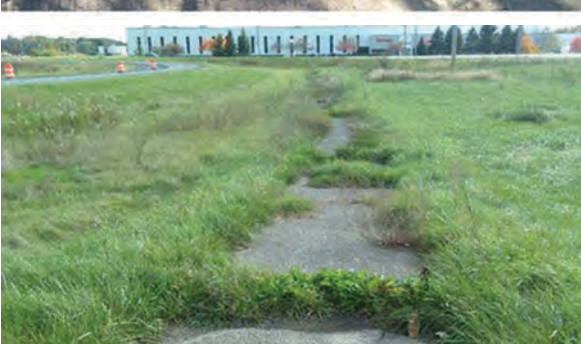
Figure 5: Pavement Assessment Categories

The I-275 Metro Trail is primarily asphalt with some short sections of concrete trail, boardwalk and bridges. The condition of the trail was assessed and rated using four categories: excellent (9.63 miles), good (9.54 miles), fair (5.32 miles), and poor (0.3 miles). Figure 5 illustrates typical examples of the trail for each condition category. The section of trail north of Hines Drive is in the worst overall condition. Overall pavement condition results are shown in Figure 6 on the following page.

- Similar to PASER Rating 7+
- Typical surface wear
- Minor debonding of fine aggregate
- Cracks are tight or have seal treatment (<1/2")
- Minor edge cracking (<10%)

- Similar to PASER Rating 5-6
- Minor raveling of fine and coarse aggregate
- Longitudinal and transverse cracking <1/2"
- Edge alligator cracking (<25%)

- Similar to PASER Rating 3-4
- Major raveling of fine and coarse aggregate
- Longitudinal and transverse cracking >1/2" and open, potentially full depth
- Edge alligator cracking over 50% of length
- Minor heaving or uneven pavement

- Similar to PASER Rating 1-2
- Major raveling of fine and coarse aggregate
- Cracks over 1" and can see separated pavement
- Edge alligator cracking over 50% of length
- Major heaving or uneven pavement
- Unmaintained trail

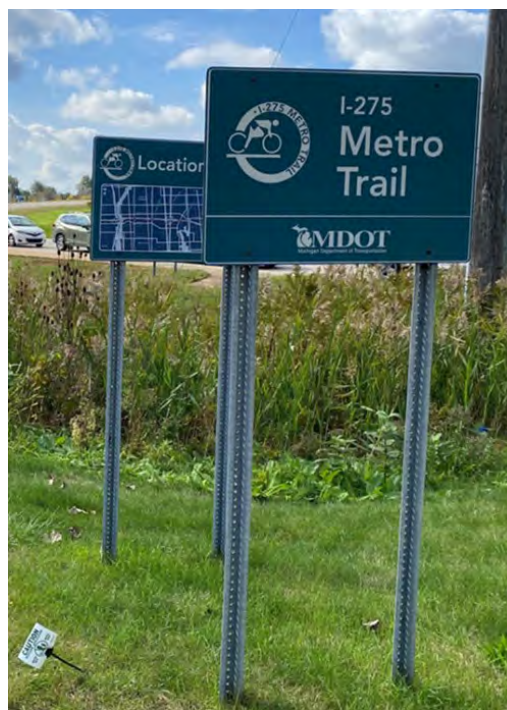
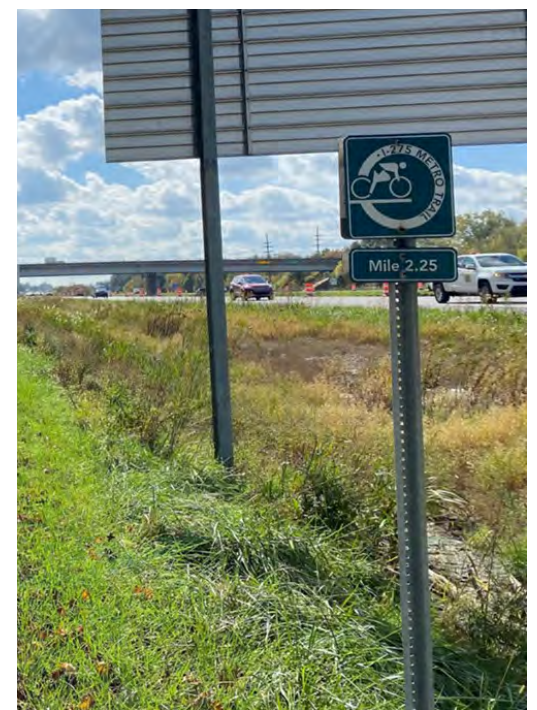
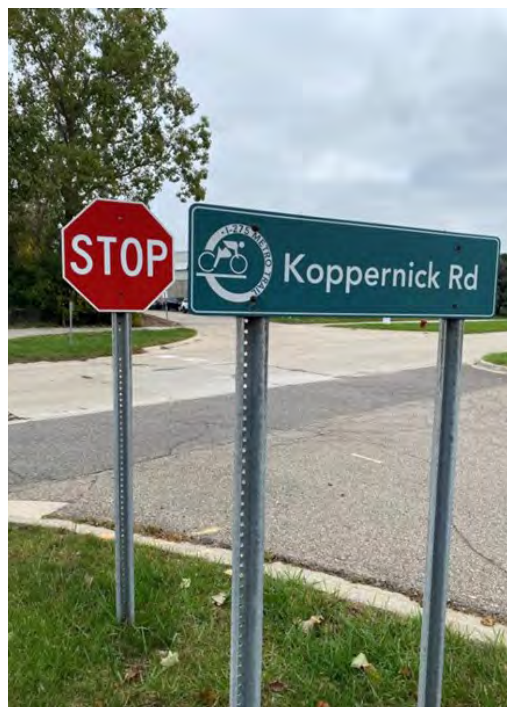
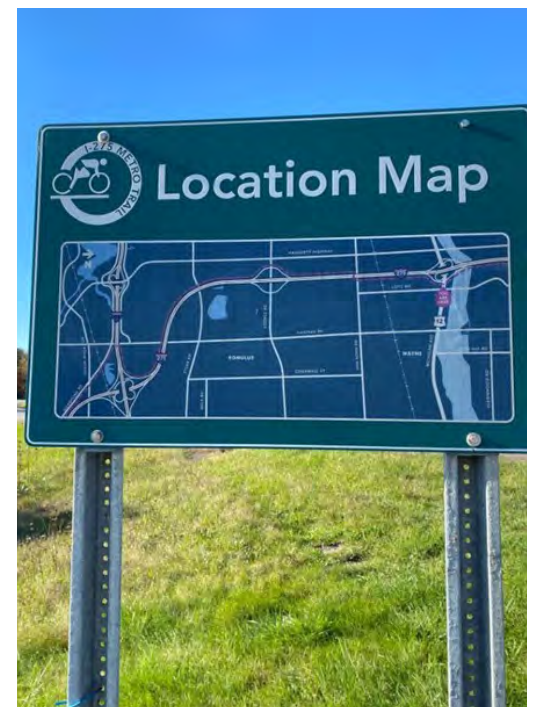
Figure 9: Sample of Existing Signs within Study Area

- With a few exceptions, the signs are in good condition
- Two different styles are used for mileage signs (one south of Hines and another north of Hines)
- Road crossings have a lot of signs (regulatory, non-regulatory, trail signs, and traffic) leading to clutter and confusion
- There is opportunity to reduce the number of signs and orient them to the proper audience (pedestrian vs. vehicle)

- Replace and renumber mile marker signs
- Reduce sign clutter at road intersections
- Consider orientation and placement of signs intended for trail users
- Consider orientation and placement of signs intended for vehicles

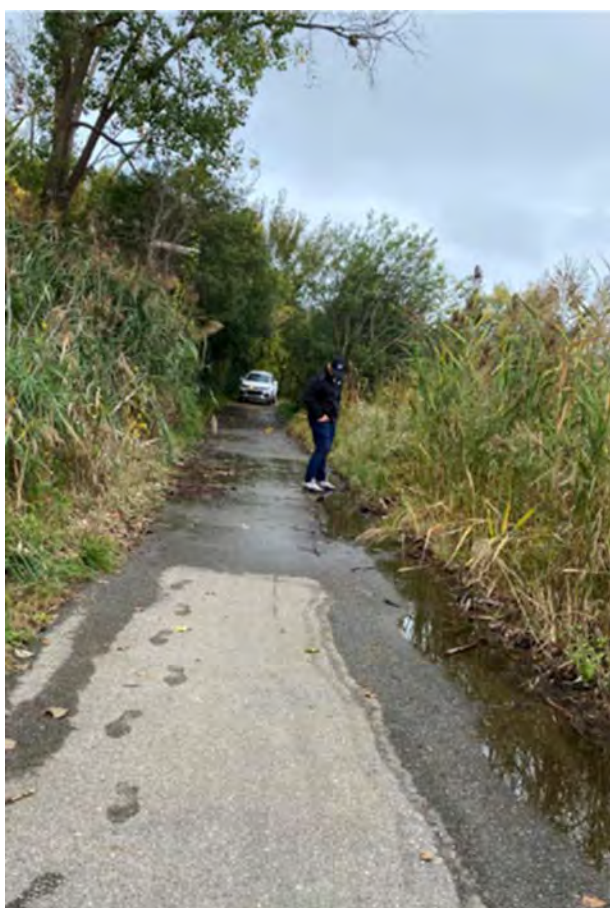
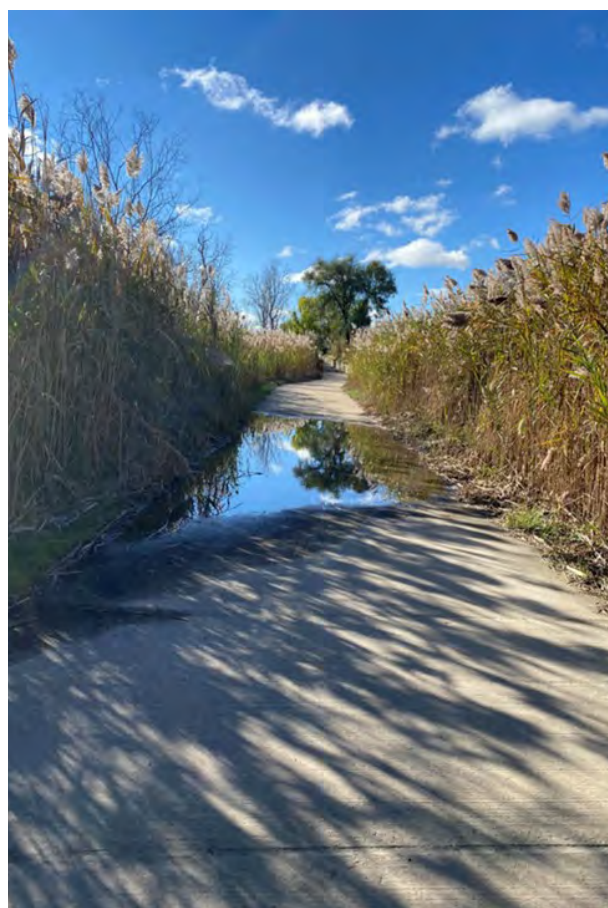
Figure 10: Instances of Water-on-Trail Encountered during Assessment

The Fall 2021 field assessment was completed primarily on days with little to no precipitation, however, the field team noted 9 locations where water on the trail indicates some type of drainage issue as shown in Figure 10. Many times there was also dirt/debris at these locations causing a ‘narrowing’ of usable trail. At several locations (i.e. the College Parkway Connector between 6 and 7 Mile Roads, and near the St. Joe’s Dome/Soccer Field), algae growth on the trail indicates frequent standing water. Water/drainage issues can lead to hazardous conditions with decreased friction on the trail, particularly for bicyclists moving at fast speeds. The three areas with the most significant water/drainage issues are:

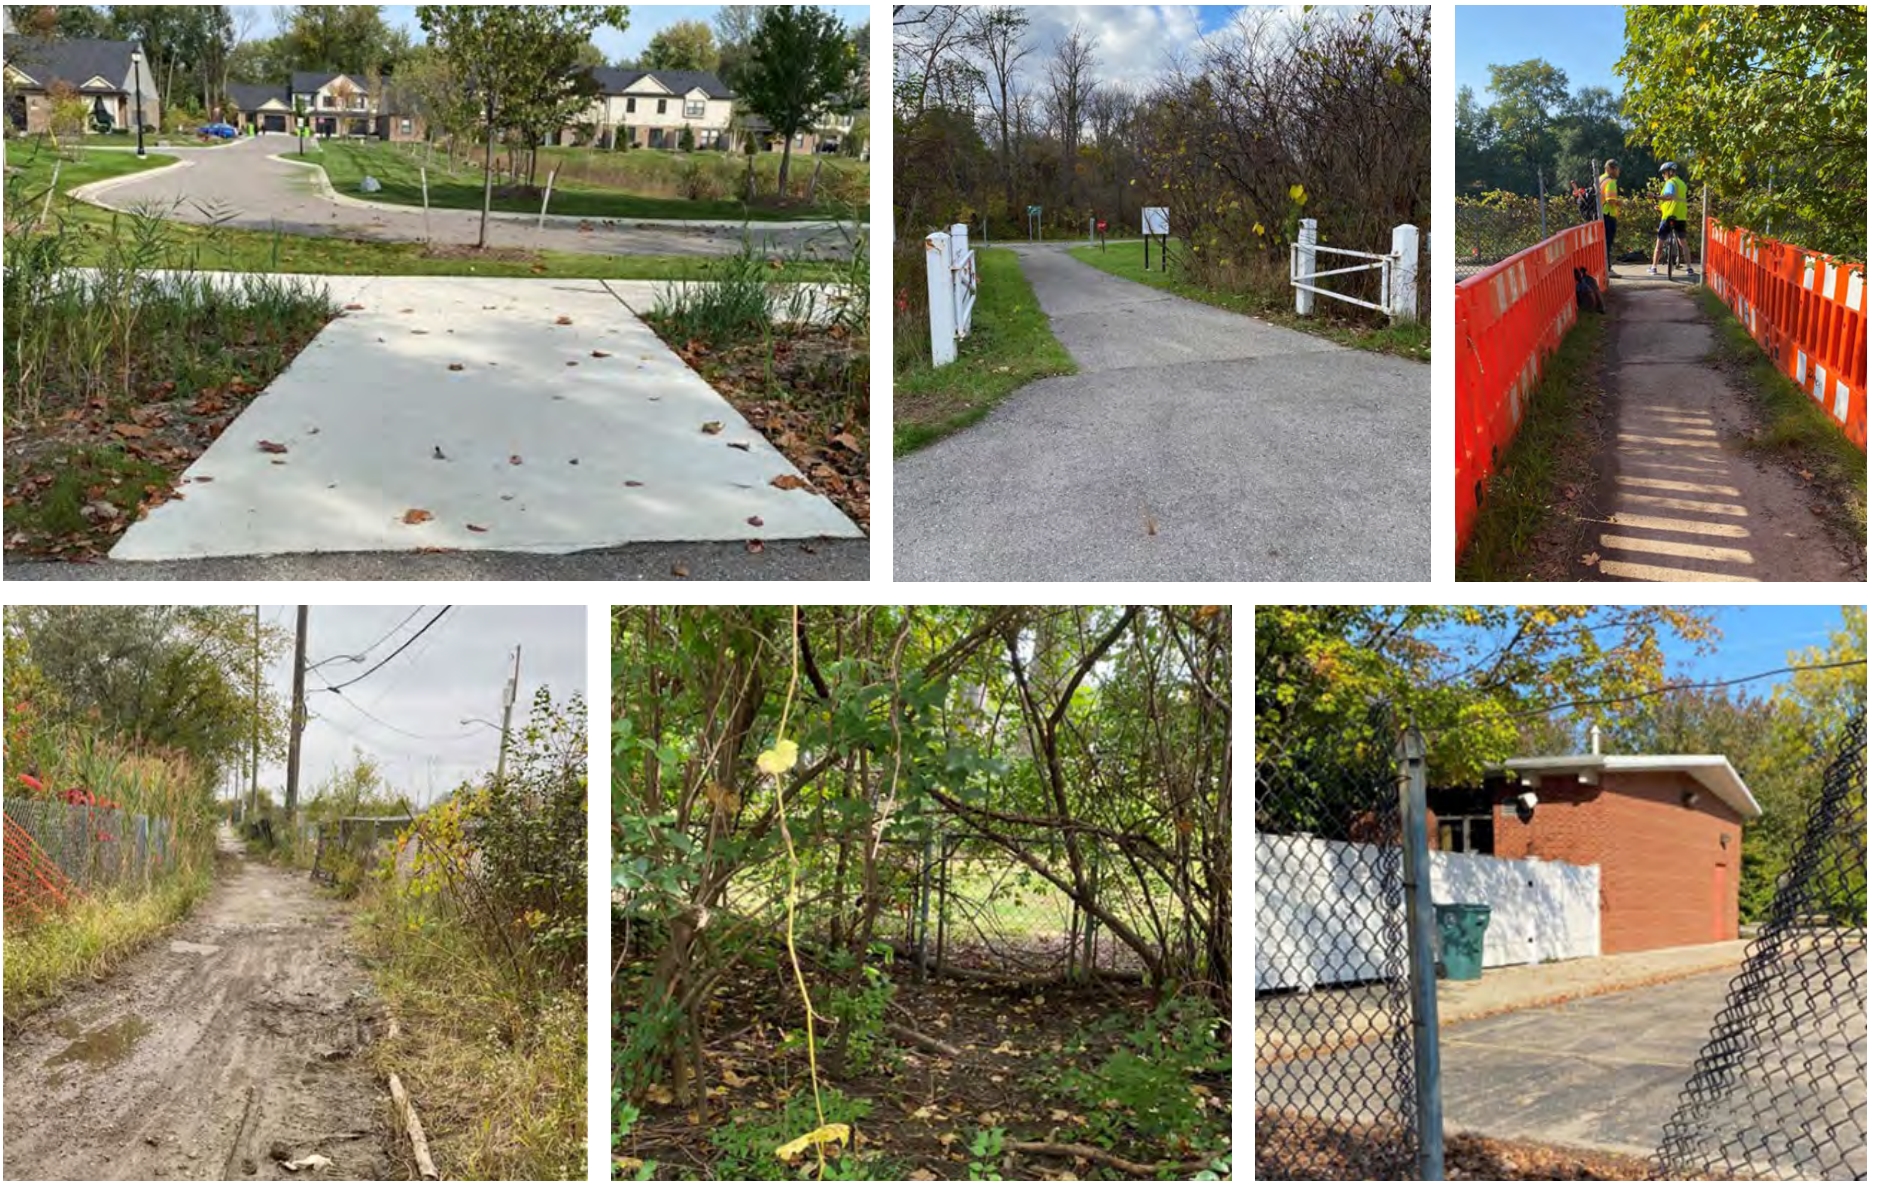
Figure 11: Existing Formal and Informal Connections along I-275 Metro Trail

In addition to major road crossings, where sidewalks often (but not always) intersect with the I-275 Metro Trail, formal and informal connections were noted along the length of the trail as shown in Figure 11. Formal connections are either concrete or asphalt in a variety of widths and conditions. The connection at the Oasis Golf Center, just north of 5 Mile Road, is in the worst condition and needs major renovation to become usable. Informal connections included locations where a gate was installed, a grass trail was mowed, or a fence panel was cut and pulled back. While not permitted, these informal connections illustrate a desire to access and use the trail network.

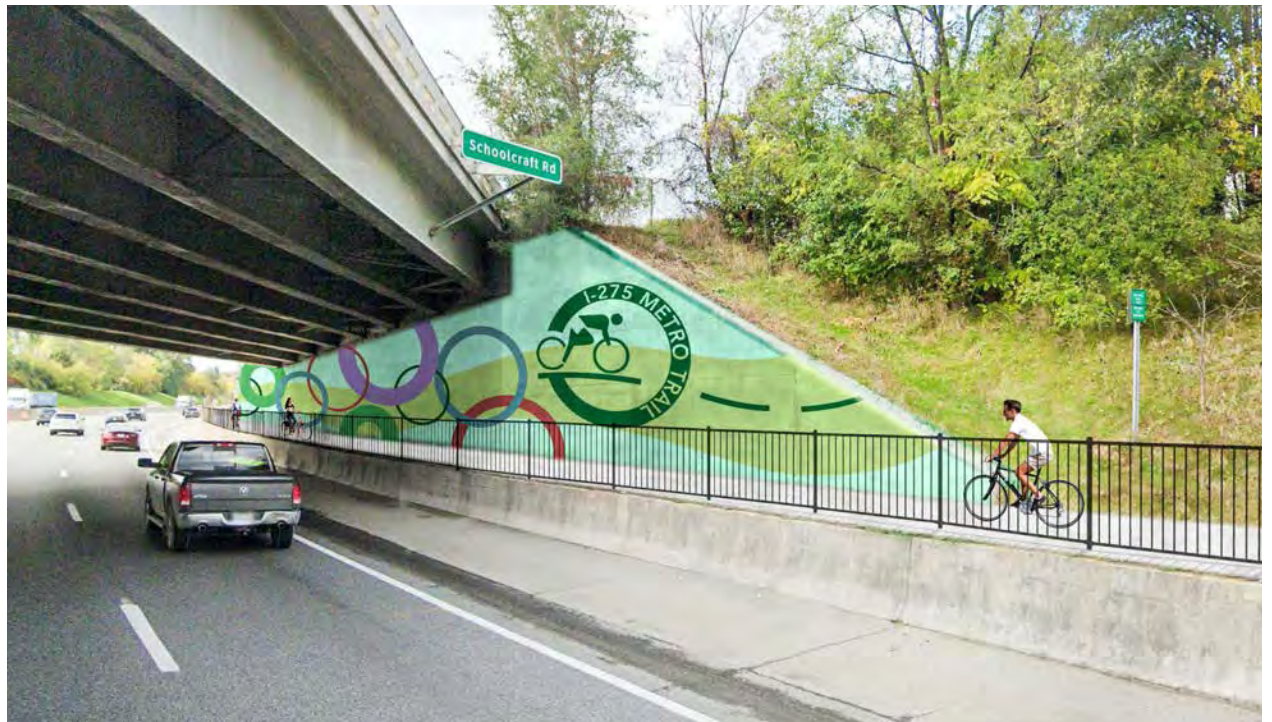
Figure 14: Trail Branding Concept for Underpass Mural

Figures 14 through 16 illustrate examples to inspire possibilities for elevating the I-275 Metro Trail brand, aesthetic, awareness, and use. Development of a Signage and Wayfinding Design Manual would include an engagement process and coordination with a number of stakeholders.

Prior to reconstruction/rehabilitation of the I-275 Metro Trail, there is an opportunity to plan for enhanced branding of the trail network to increase awareness, assist with wayfinding, and improve aesthetics and user experience along the I-275 corridor. To move this idea forward, it is recommended that a grant be pursued (perhaps from SEMCOG or The Ralph Wilson Foundation/CFSEM) to obtain funding for development of a signage and wayfinding design manual for the I-275 Metro Trail (for both Oakland and Wayne Counties). This design manual is envisioned to go beyond installation of traditional signage to consider elements such as branding and art for fencing, bridge overpasses, sound walls, concrete abutments, painted surface markings, etc. Considerations could be made for interpretive signs, trail maps, point of contact for maintenance issues, donor recognition, brand awareness, colors, materials, etc.

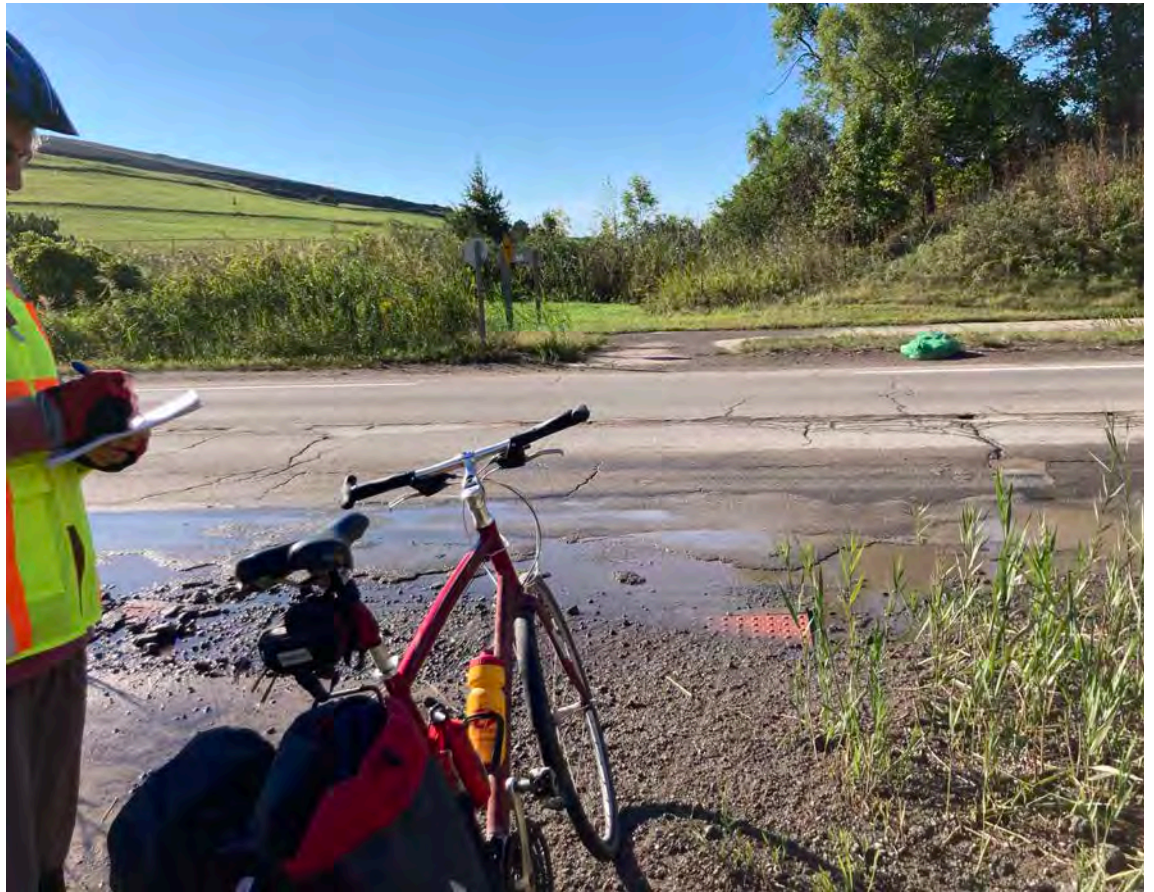
Figure 20: Intersection Field Survey

As part of the set of recommendations for the I-275 Metro Trail, an evaluation was conducted for safety and operational improvements to the trail in locations where trail users interact with vehicle drivers at at-grade intersections (Figure 20). Field reviews and analysis were also conducted for future consideration and documentation at the remaining crossings located in Oakland County and Hines Park. The following recommendations fall into standard categories across all 19 intersections within the project extent:

- Upgrade ramps and sidewalks to meet current ADA standards
- Upgrade pedestrian signals with countdown indication where existing signs are outdated style
- Install pushbuttons
- Upgrade/install pavement markings as-needed to meet current standards
- Relocate stop bars
- Improve lighting
- Add refuge islands/staggered crosswalks where recommended
- Install HAWK (high-intensity activated crosswalk beacon) at several mid-block locations
- Modernize signals

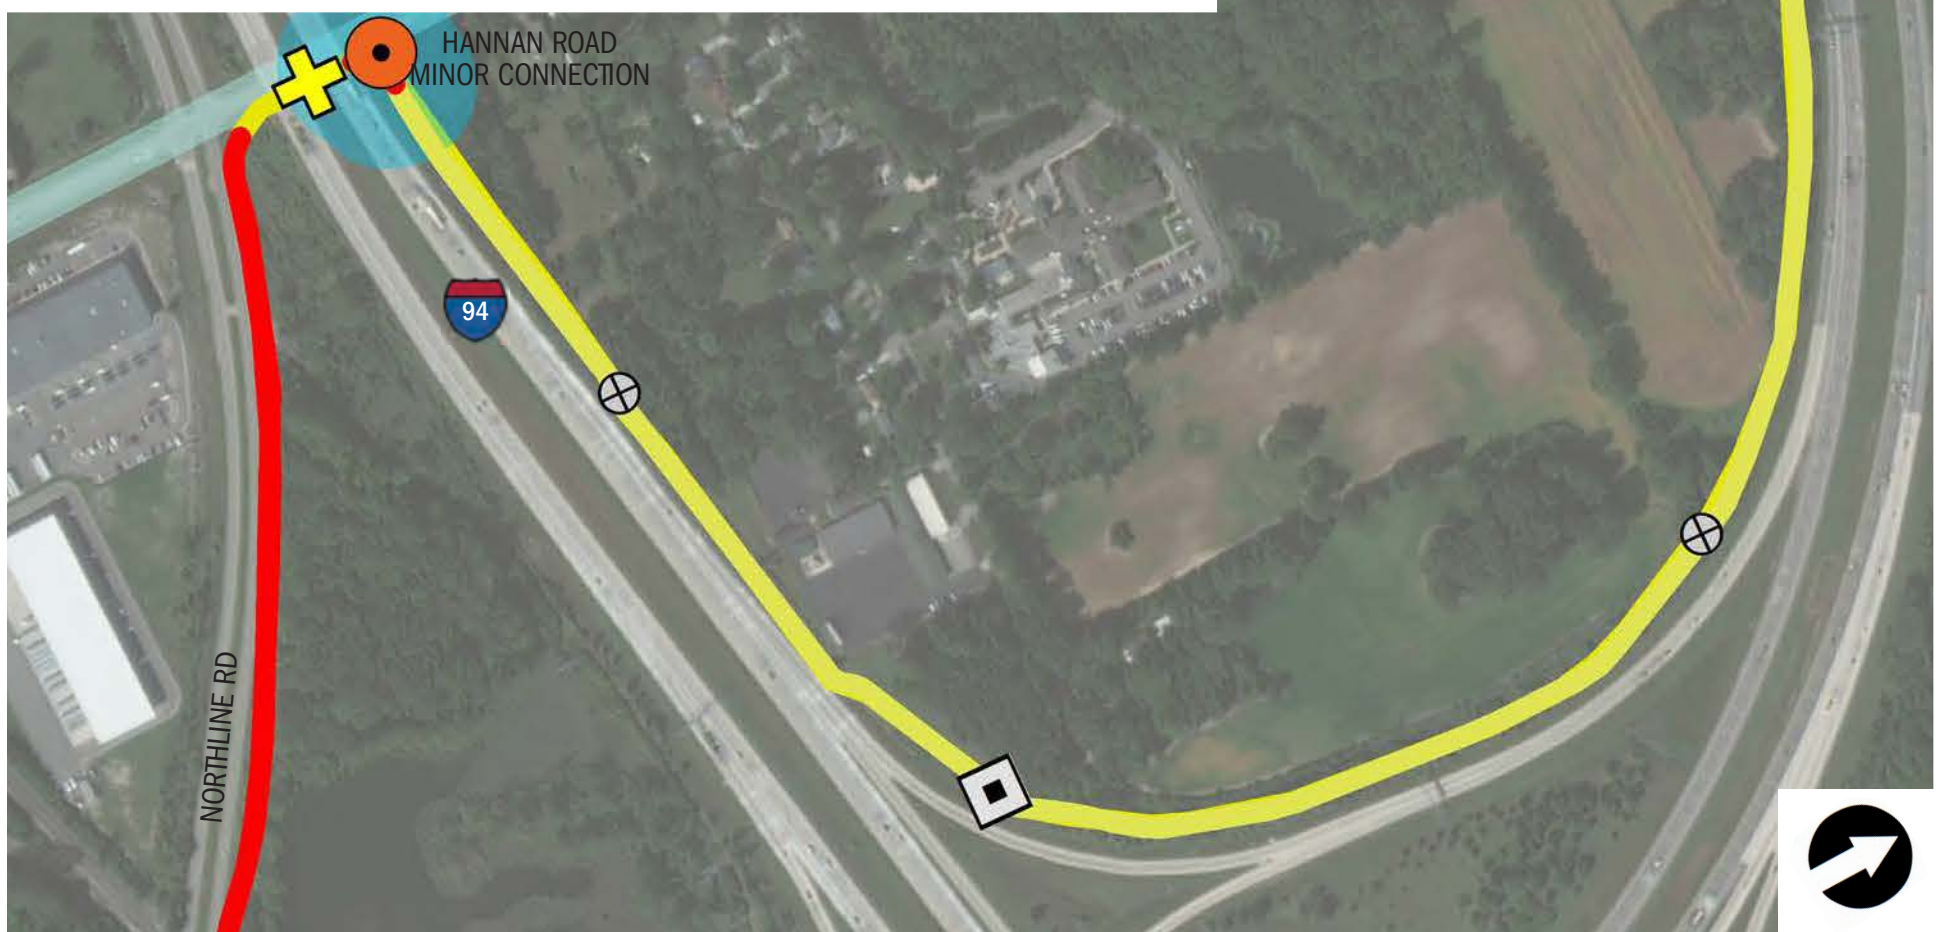
- JOINT SEALING: A lane joint has come unsealed on the Hannan Road bridge at the south end of this segment, and water runs down the side of the bridge and carries debris onto the trail. This can be addressed by resealing the joint.

- ROW FENCING: Partial fence replacement for this section was included in a previous I-275 construction project. The only fence replacement recommended is the fence adjacent to sections of trail being reconstructed.
