Goodall Brook Watershed Based Management Plan

*Prepared for the City of Sanford, Maine
by FB Environmental Associates,
York County Soil and Water Conservation District and
the Maine Department of Environmental Protection*

December 2014

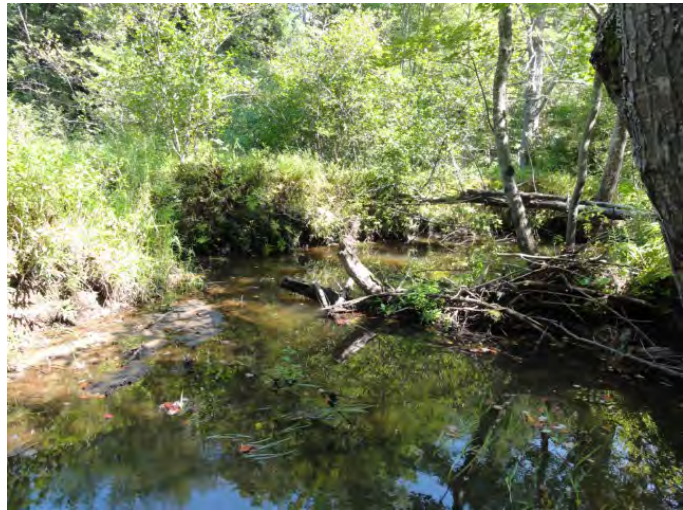
Trees and logs in this section of Goodall Brook provide habitat for aquatic organisms.

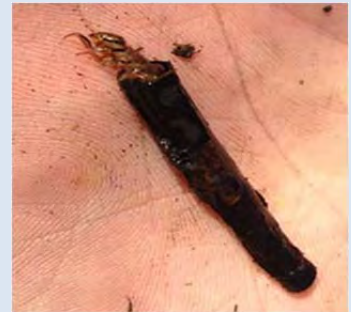
Aquatic organisms (also called macroinvertebrates) tell a lot about a stream. If sensitive organisms such as caddisflies (below) and stoneflies are abundant, then water quality is good. If only worms and other pollution-tolerant organisms are found, this points to problems with stream habitat and/or water quality.

Goodall Brook supports a healthy bug community in its lower reaches, but the upper reach is considered impaired.

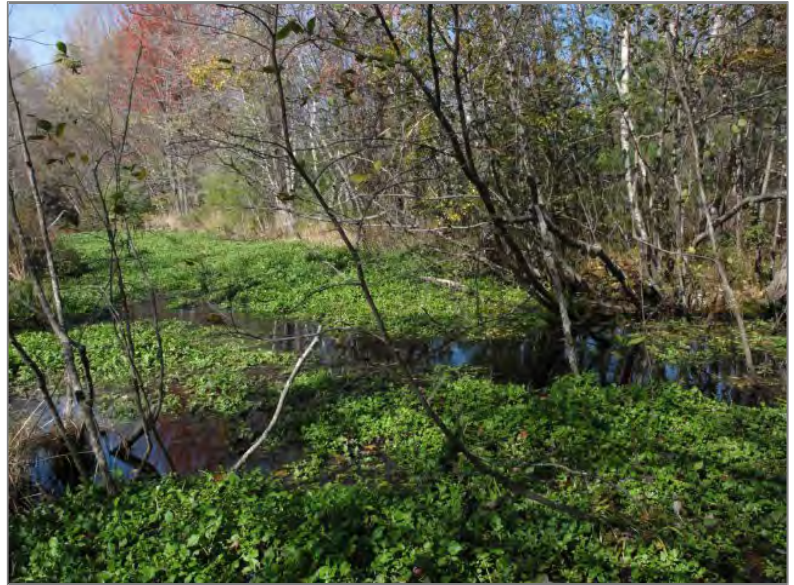
Aquatic vegetation in Goodall Brook.

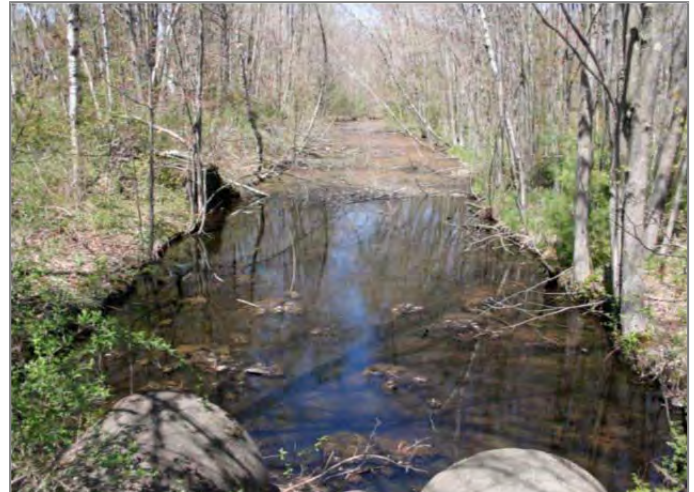
Human activity has resulted in stream channelization in many places along Goodall Brook. This condition leads to habitat degradation for aquatic life.

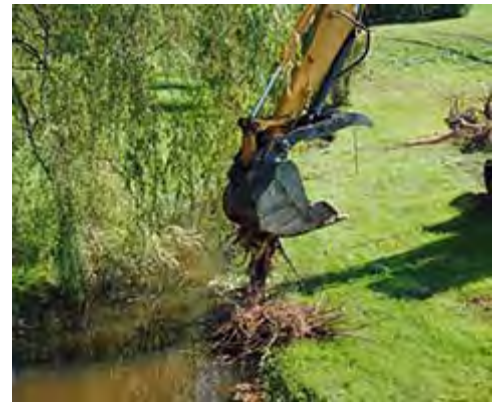
Installation of tree root wads in Blanchette Brook in Westbrook.

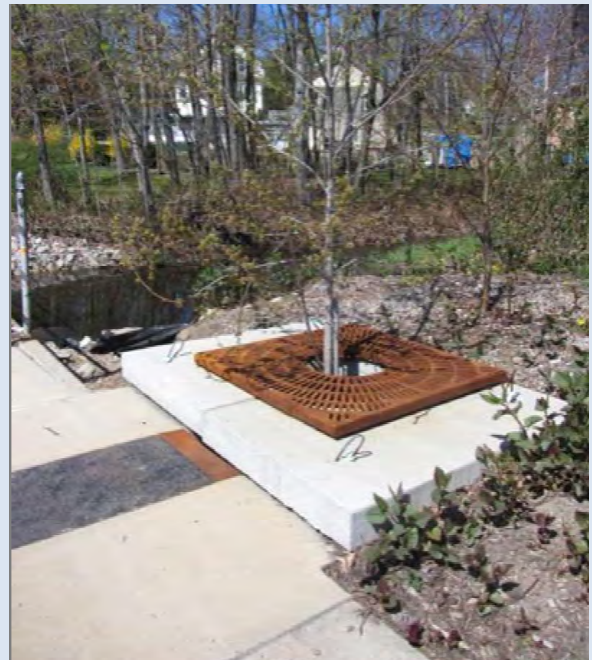
Tree boxes contain a special mix of soil that filters pollutants from stormwater.

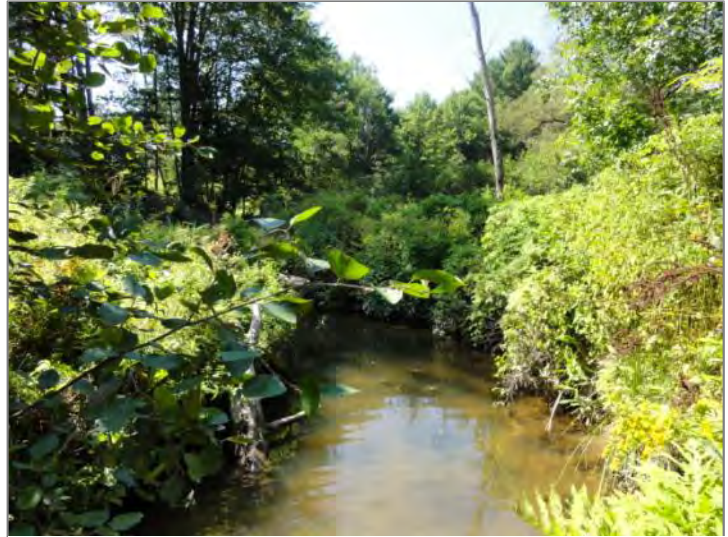
Some sections of Goodall Brook maintain a healthy vegetated riparian buffer, which helps to reduce land erosion, absorb nutrients in runoff, and keep stream water cool with shade.
